Our ref: 3000.00 L01

7 October 2010

Subject: Supplementary Hazardous Materials Assessment Report – 20 Edward Street, North Sydney 2060

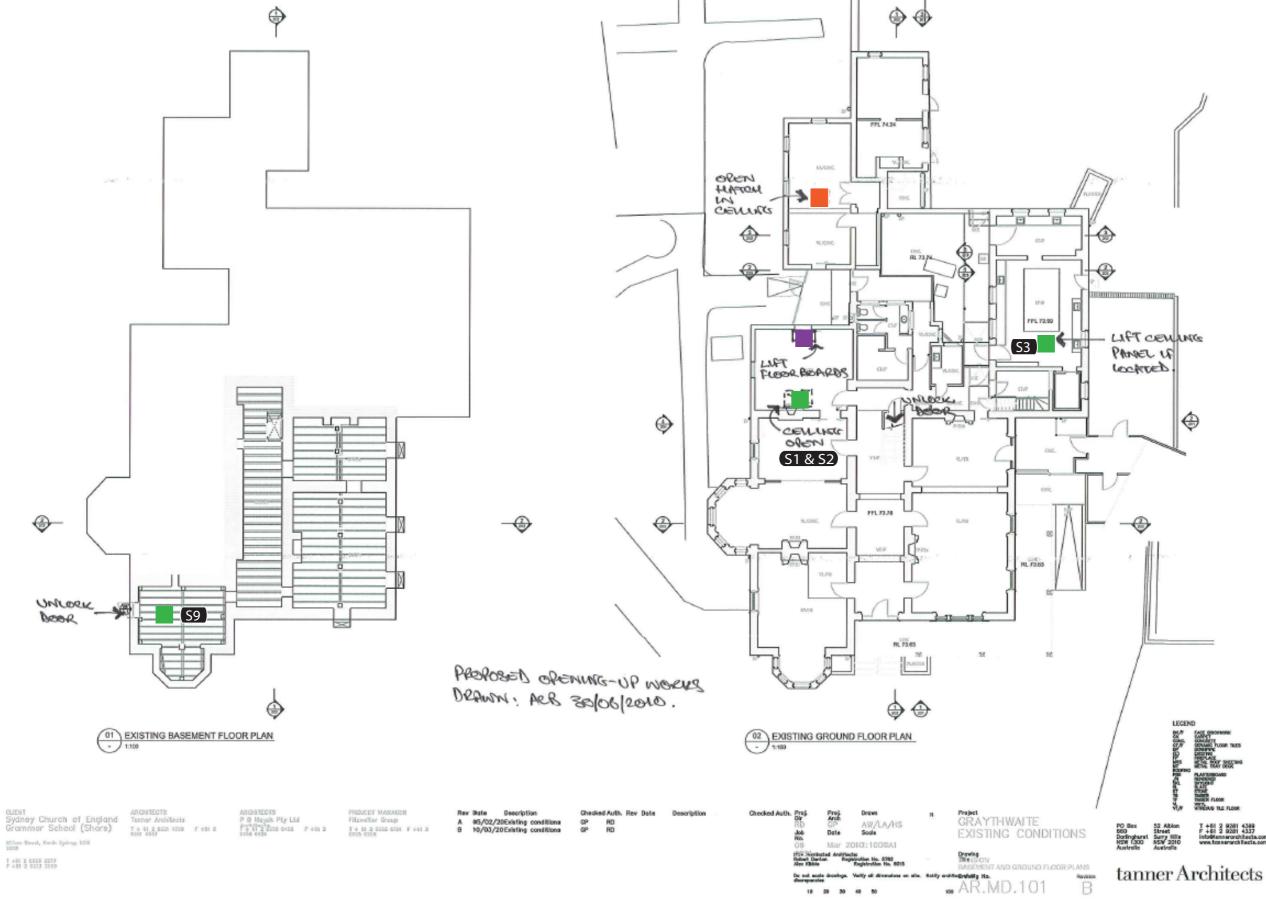
Sampling Locations - Basement and Ground Floor

Eleven (11) locations were rendered accessible for sampling including six (6) from the ceiling and five (5) from floor coverings. Eight (8) locations were sampled by WSP. Two locations could not be sampled due to safety reasons and one location was not sampled due to an absence of potential asbestos containing materials. Sampling locations are shown in Attachment A – Figure 2.

No asbestos was identified in any of the samples selected for analysis, with the exception of one (1) sample collected from the ceiling in the domestic services/ cleaning room (S3) on the existing Ground Floor. The sample reported chrysotile and amosite asbestos and covers an approximate ceiling area of 20 m². Given the relatively good condition of the ceiling and the painted surface, asbestos dust is unlikely to be generated. Should the condition of the ceiling deteriorate with time, it should be managed under the Hazardous Materials Management Recommendations.

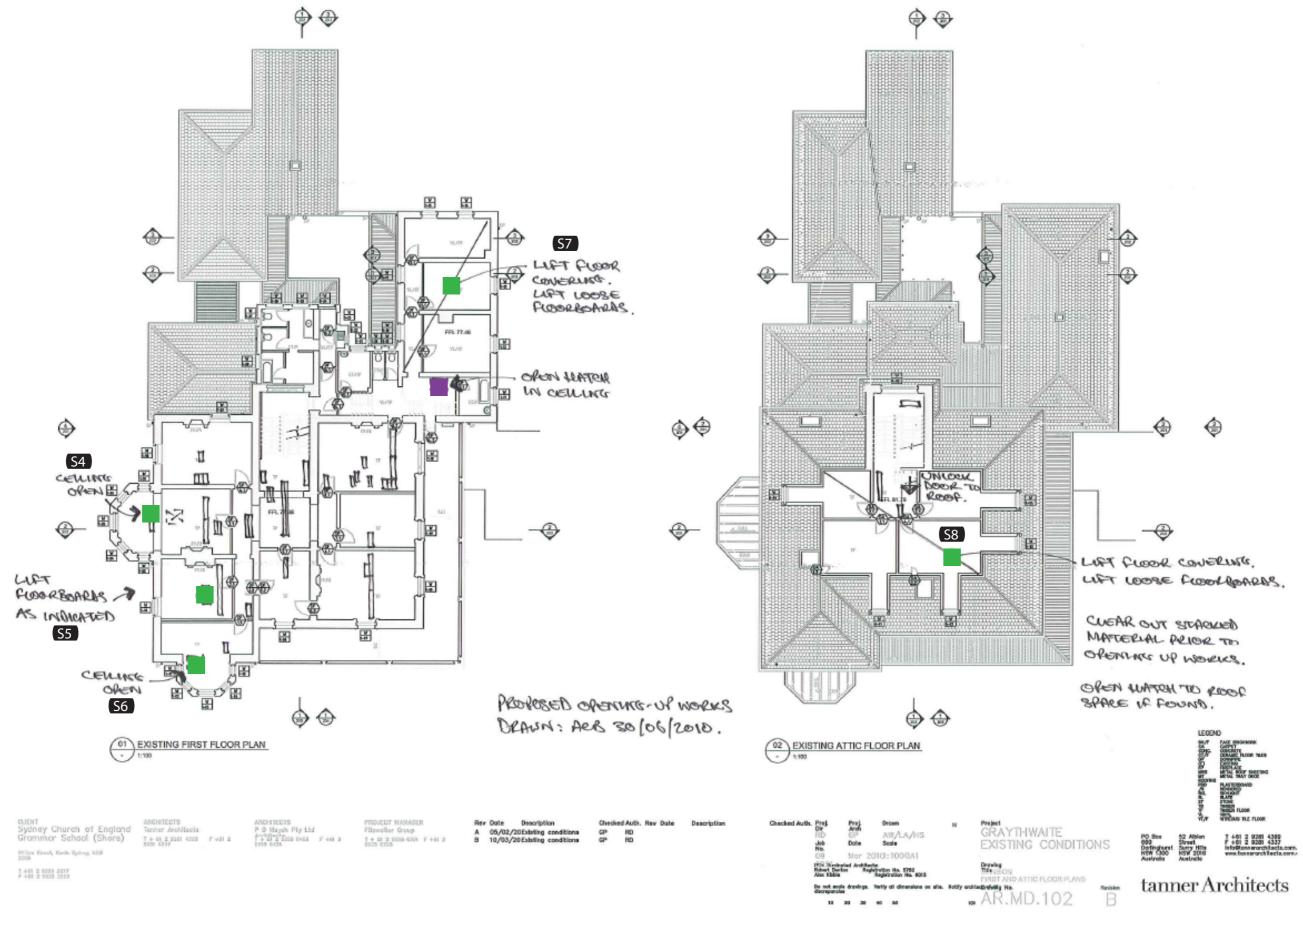
FIGURE 3

Based on the (NAA 2009) report and the WSP sampling areas shown on Attachment A - Figure 2 & 3, the following ceiling areas were noted to comprise lead based paints based on LeadCheck Swabs (0.5%) or the XRF spectrum analyser:

- Ground Floor, most northwest room, ceiling white coloured paint system;
- Ground Floor, domestic services/cleaning room, where S3 was sampled white coloured paint system of ceiling;
- First Floor, most southwest room, where S6 was sampled white coloured paint system;
- First Floor, 3rd room from the most southwest room, where S4 was sampled white coloured paint system of ceiling; and
- First floor (First exit off main stair case), hallway to bedrooms, ceiling white coloured paint system.

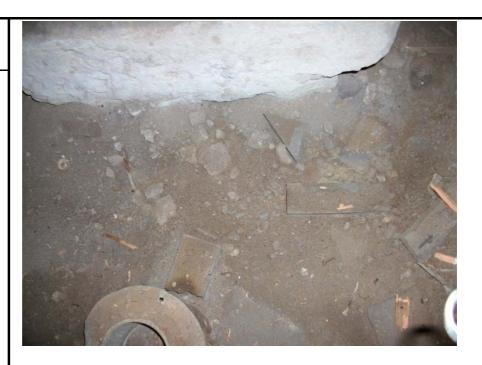
Ground Floor – fourth room from most southwest room (next to outdoor/ indoor section with plants) – Beneath floor board

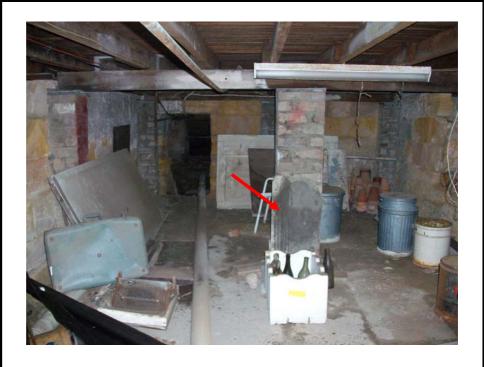
2
 15 Sept 2010

Within the basement area, one (1) sheeting of fibrous material (approximate dimensions: 0.5 m x 1 m) potentially containing asbestos was observed adjacent to a brick pylon (Attachment D – Site Photos). No potential lead-based paints were observed beneath the floor coverings and basement areas.

Basement area – fibre-cement sheeting panel adjacent to brick pylon and glass bottles on ground

Should material be identified during the demolition that are suspected to be asbestos containing material, the material should be assumed as containing asbestos, removed or stored appropriately until further sampling and analysis can be undertaken. All appropriate personnel protective equipment should be worn when handling these items. Handling of the material should also be undertaken in accordance with the guidelines listed above.

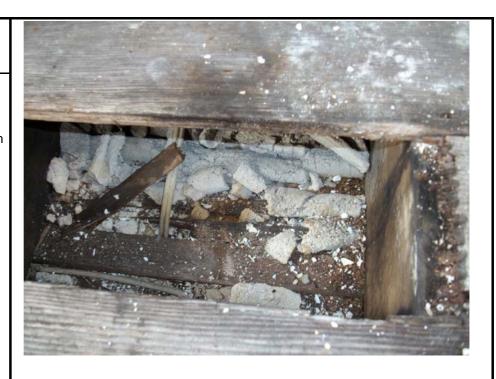
First floor, 3rd room from most southwest room – plaster/timber material beneath floor board

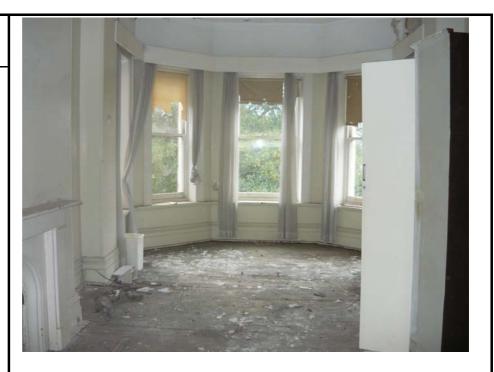
Photo No. Date
4 9 Sept 2010

First floor, 3rd room from most southwest room – ceiling material observed on floor

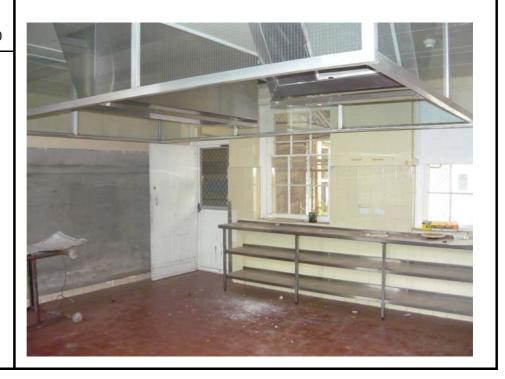
Ground floor – domestic services/cleaning room where S3 was collected

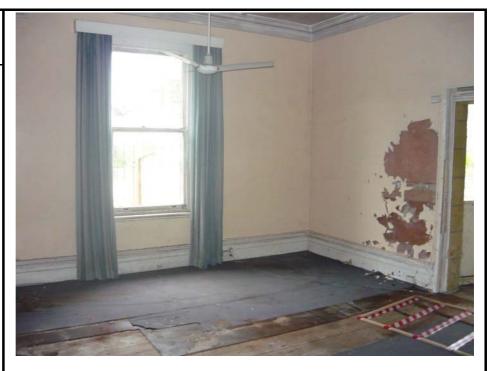
Photo No. Date
6 14 Sept 2010

Ground floor – 4th room from most southwest room where samples S1 and S2 was collected
