| Borehole Log | | Hole ID. BH9 | |
|---|---|---|---|
| <p><b>WSP</b><br/>WSP Environment &amp; Energy</p> <p>Level 1, 41 McLaren Street<br/>North Sydney NSW 2060<br/>Office: +61 (0)2 8925 5700<br/>www.wspenvironmental.com</p> | Project Name: | Columbia Precinct, Homebush | Date Started: 28/01/2011 |
| | Location / Site: | Cnr Parramatta Rd & Columbia Ln, Homebush NSW | Hole Depth: 6.20 m |

Borehole and Monitoring Well Locations  
Preliminary Contamination and Geotechnical Investigation, Homebush, NSW  
**FIGURE 3**

Site Photographs – Columbia Precinct, Homebush NSW

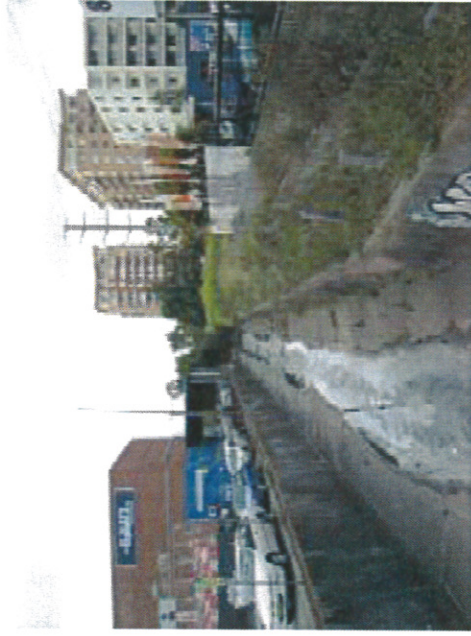
Photo 1: Stormwater drain looking south.

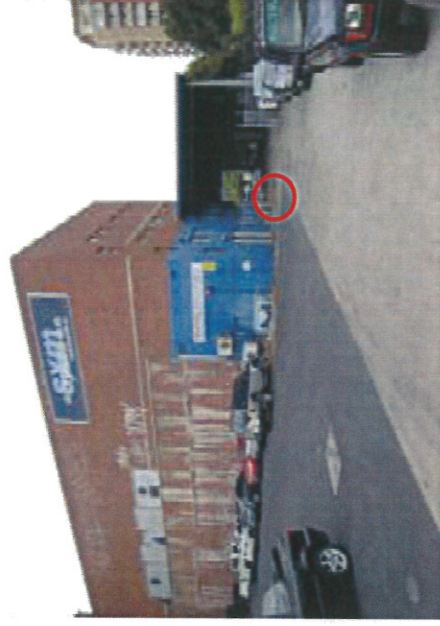
Photo 2: Location of UST

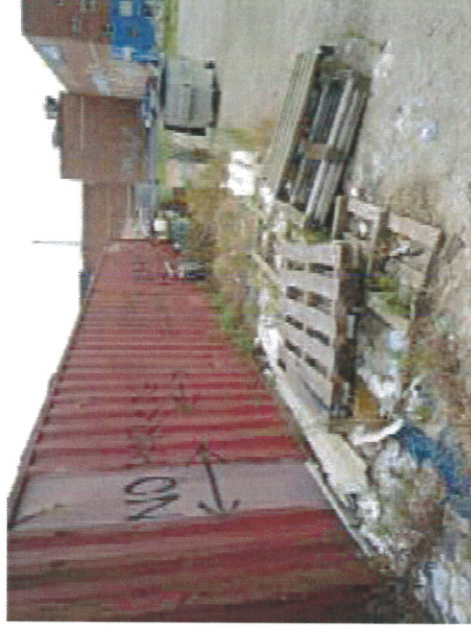
Photo 3: General rubbish looking east at 20 Parramatta Road

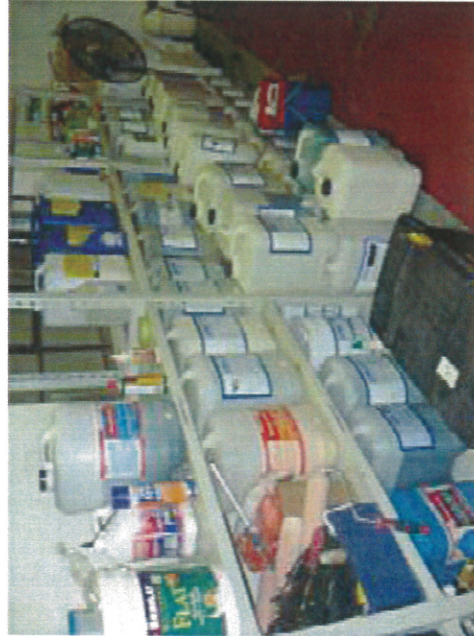
Photo 4: Chemical Storage at 11 – 13 Columbia Lane

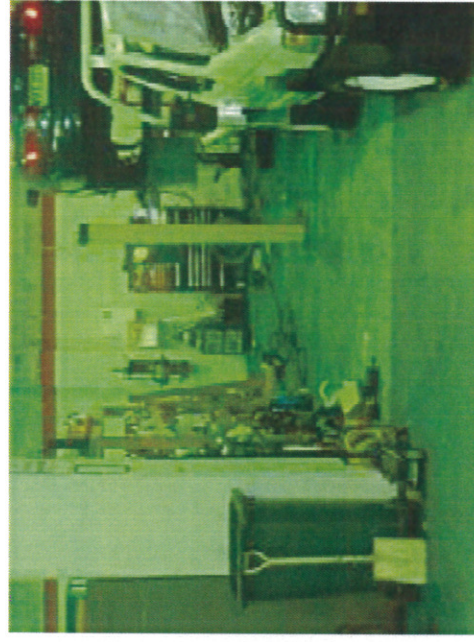
Photo 5: Auto Mechanic at rear of 18 Parramatta Road

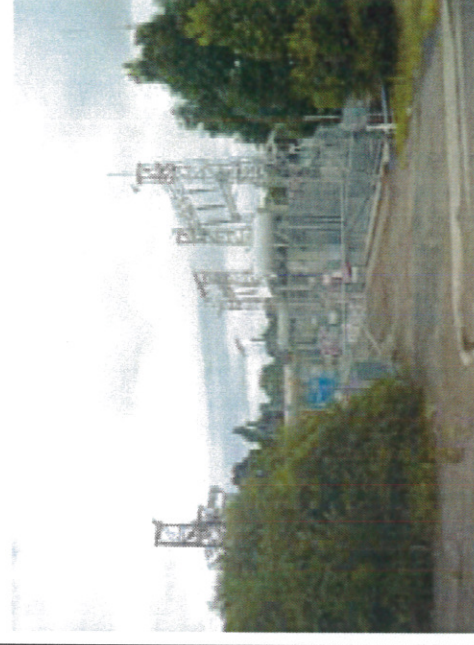
Photo 6: Electricity substation located on adjacent property, south of site
