Site Audit Report 1 Grand Avenue, Camellia

Billbergia Pty Ltd

ENVIRON Australia Pty Ltd

April 2011

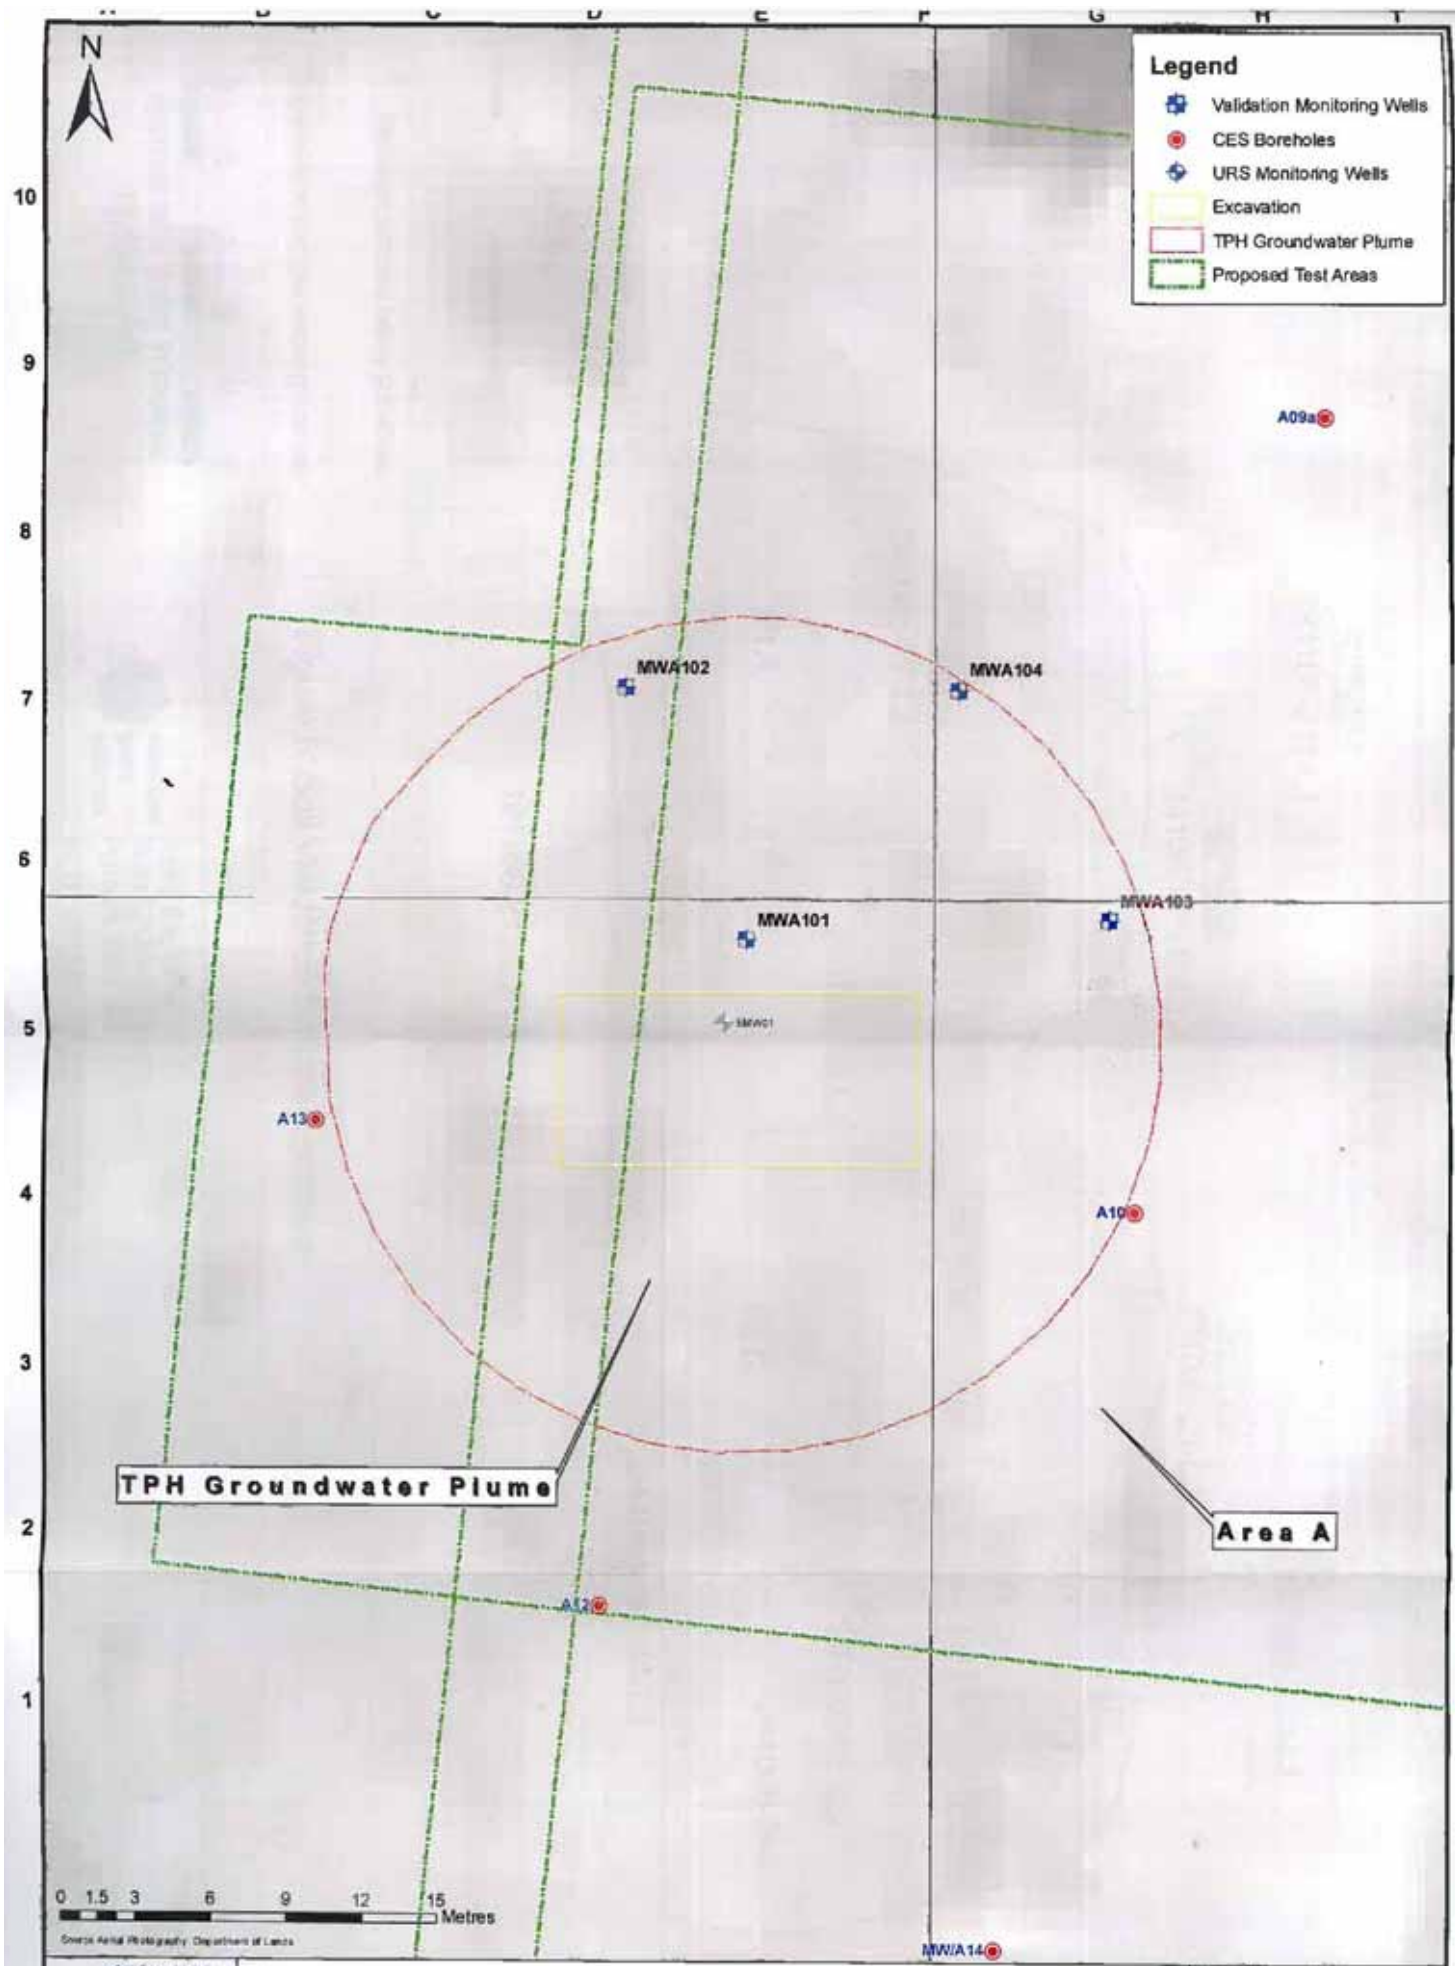
Figure 4: 1 Grand Ave, Camelia
Excavation and Monitoring Well Locations

- Pit A: CES reported no visual evidence of hydrocarbon contamination at the extent of the excavation although contaminated groundwater and free phase hydrocarbon product was noted in the base of the excavation.
- Pit B: CES reported no significant contamination observed within the pit during the excavations.

Impacts in the form of TPH (C₁₀-C₂₈) were reported in Pit A along the northern, western and southeastern walls at depths ranging between 3-6mbgs. Base samples were not collected as impacted groundwater was observed and required remediation.

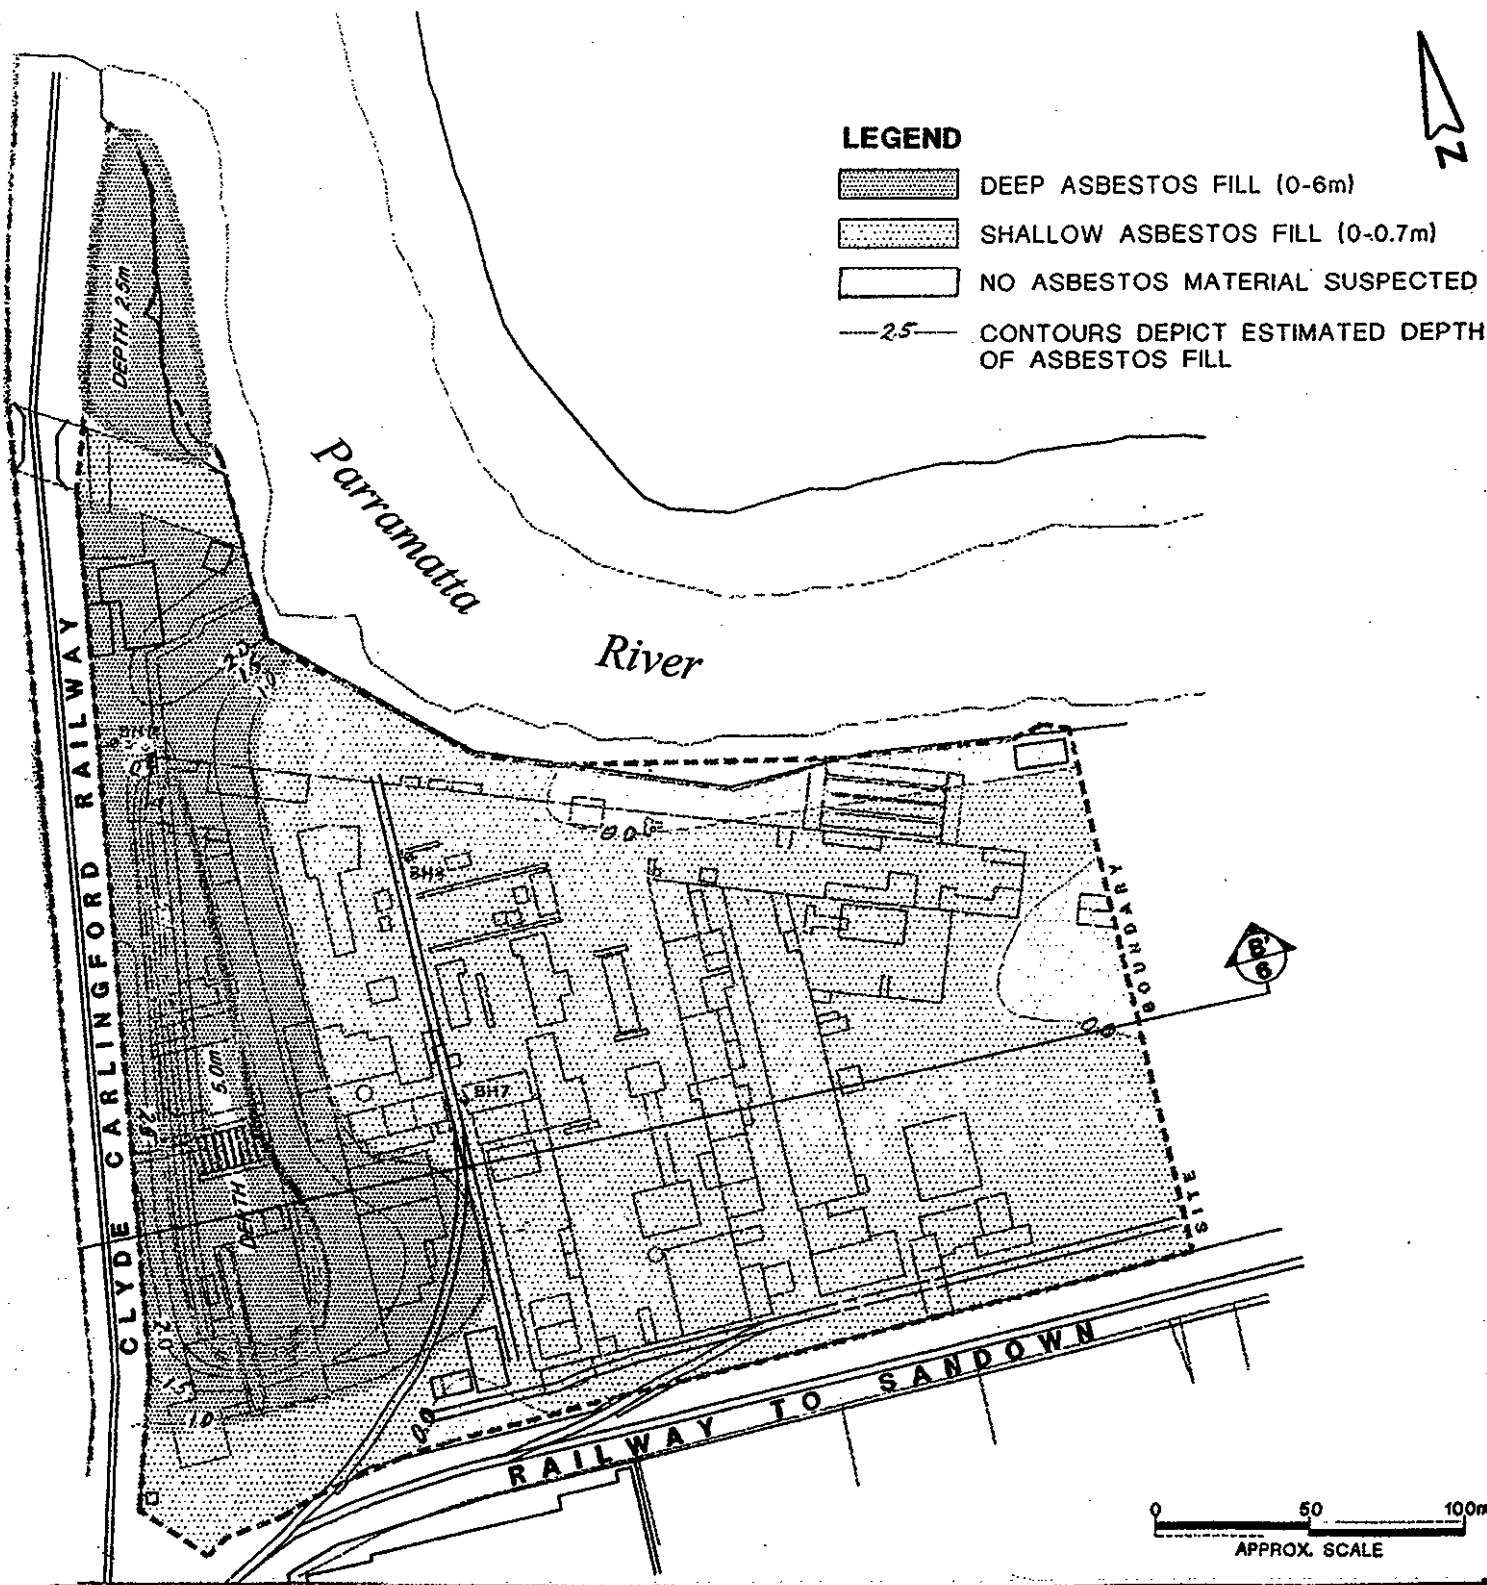
Figure 1. Indicative depth of asbestos contaminated fill, Eastern Portion of former James Hardie site (source: Woodward Clyde 1995)

- Maintenance of sealed or grassed surfaces over buried asbestos containing materials - mainly in the form of bonded fibro-cement sheeting but also including some non-bonded material - with depths ranging from 0.1 to 5.0 metres below ground level (Fig.1). All asbestos fill is beneath concrete or bitumen surfaces or well grassed road verges (Fig.3). All asbestos fill is considered to be protected from casual contact or erosion and so does not represent a significant health hazard for non-intrusive activities on the site.
- Excavation for sole purpose of repair or maintenance of underground services – may expose contaminated soils.
- Any other required excavation - may expose contaminated soils.

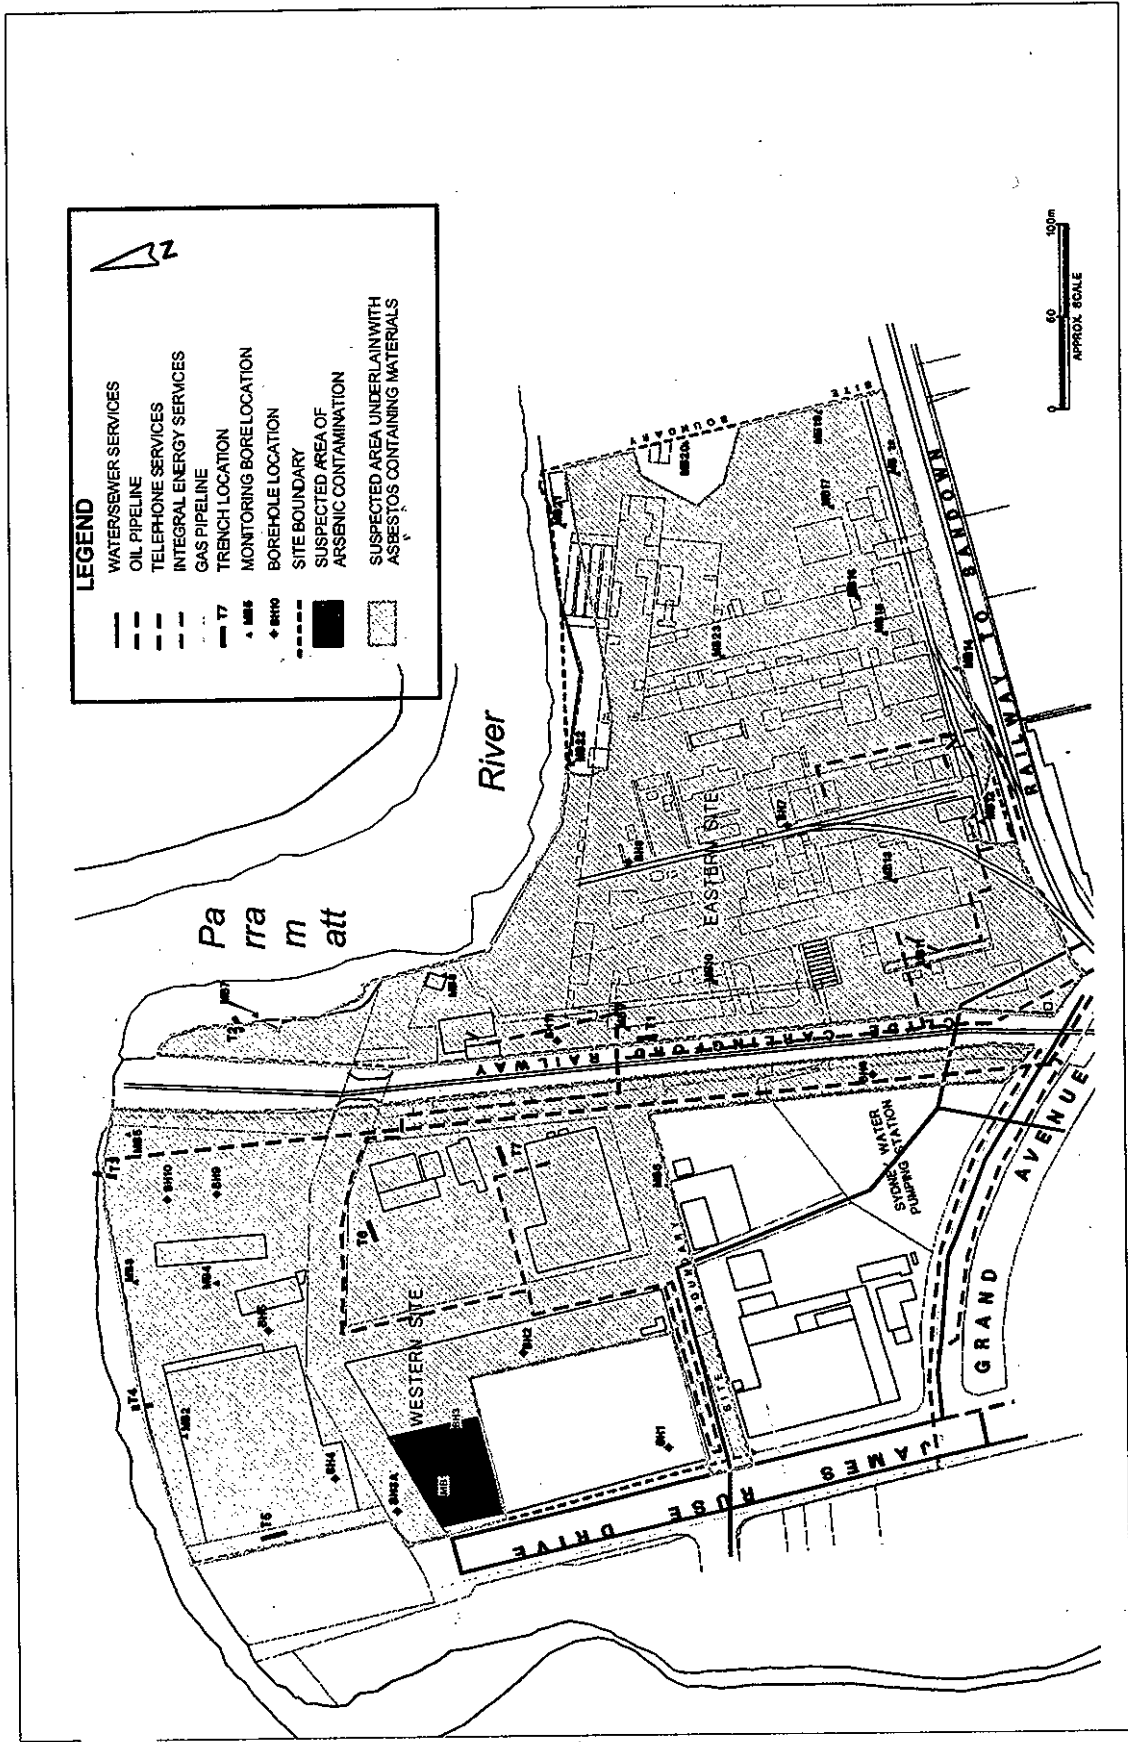
Figure 1: Areas of Suspected Contamination, Former James Hardie Site.

- TPH impacts are known to be associated with the area in the vicinity of the sewage discharge point, the former oil press, mould wash down area, acid tank, former USTs, pipe dipping tank and the former boiler house. The lateral and vertical extent of impacts has not been determined. CES and URS reported that the validation methodology would require 'chasing out' of the impacted materials. Subsequent to this CES noted that excavation of the site was problematic due to the extensive asbestos impacts across the site and the remediation strategy was amended to include only excavation of the significant contamination associated with Area A. Currently the site is managed through a Site Management Plan (SMP) which is recorded on a positive covenant on the property lodged by the EPA under section 88E(3) of the Conveyancing Act 1919. This is further discussed in section 10.
