H28	53	N22			
H29	54	N23			
H30	55	N24			
H32	56	N25

NOT RECEIVED

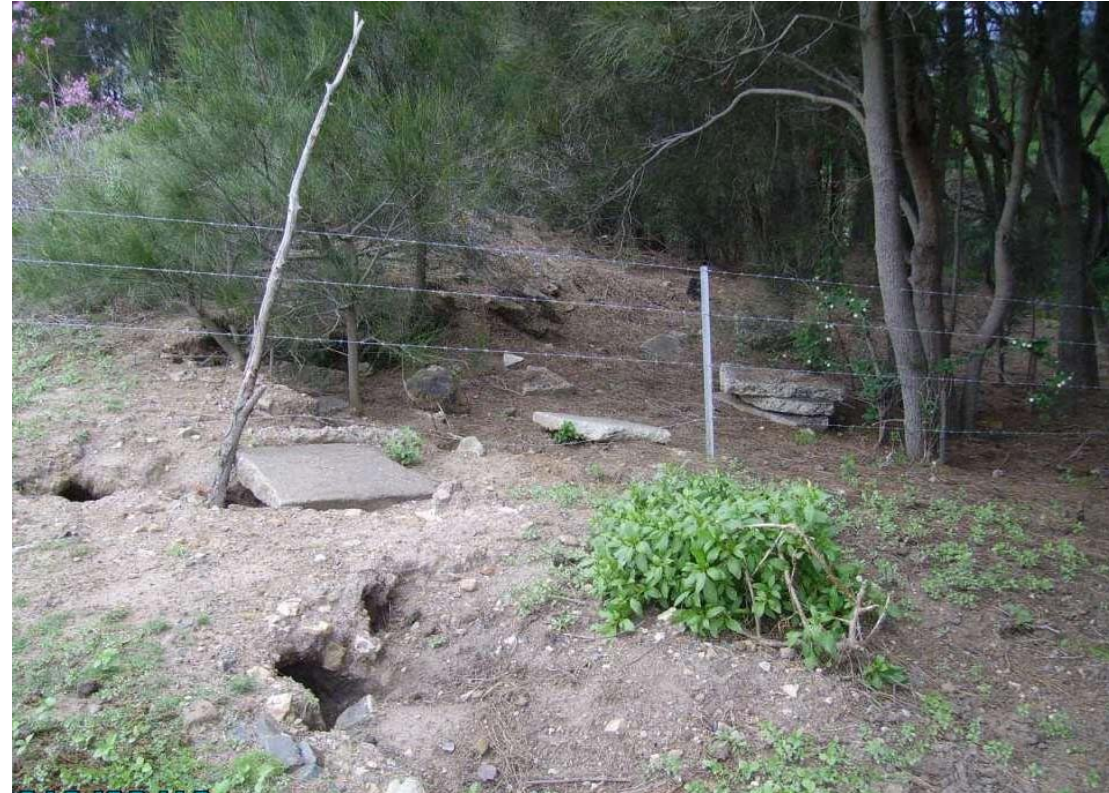
Photo 6 - Fill soils with brick and concrete fragments/slabs nearby the dams located in the central northern portion of Zone 1 (B). Also note voids caused by rabbit burrows.

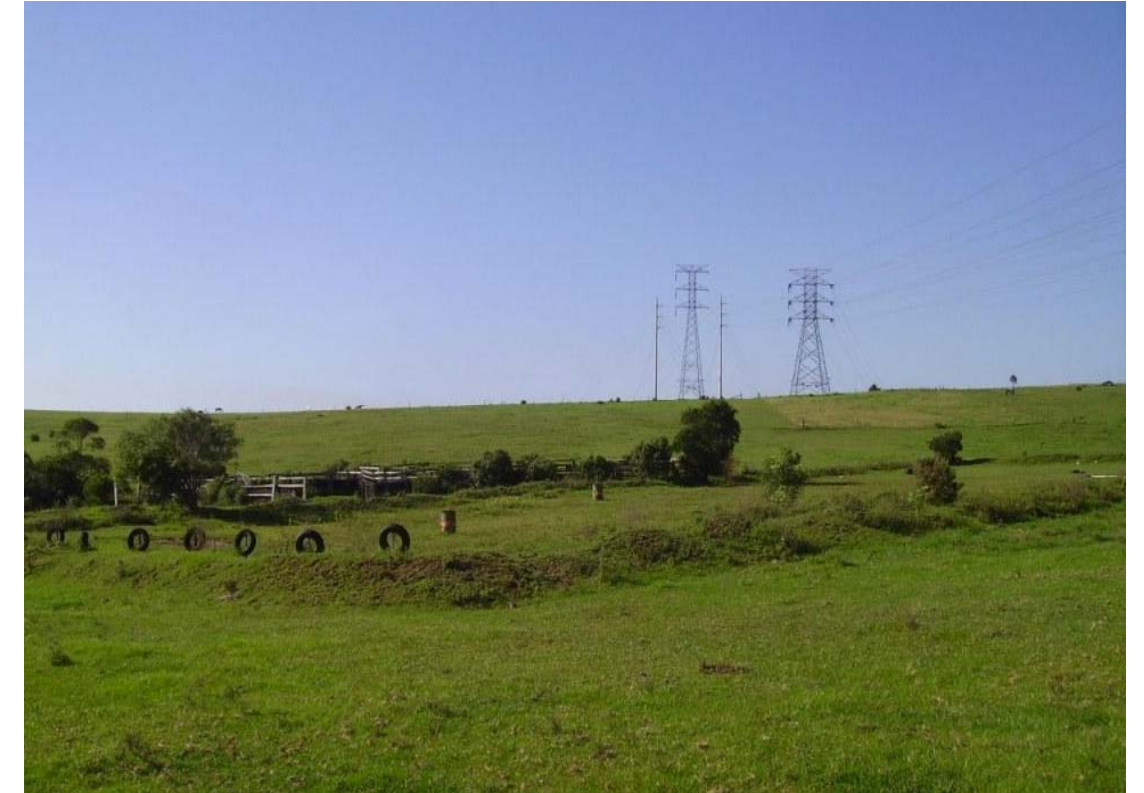
Photo 7 - Horse riding yard constructed from mounded fill soils denoted by rubber tyres in Zone 1(B)

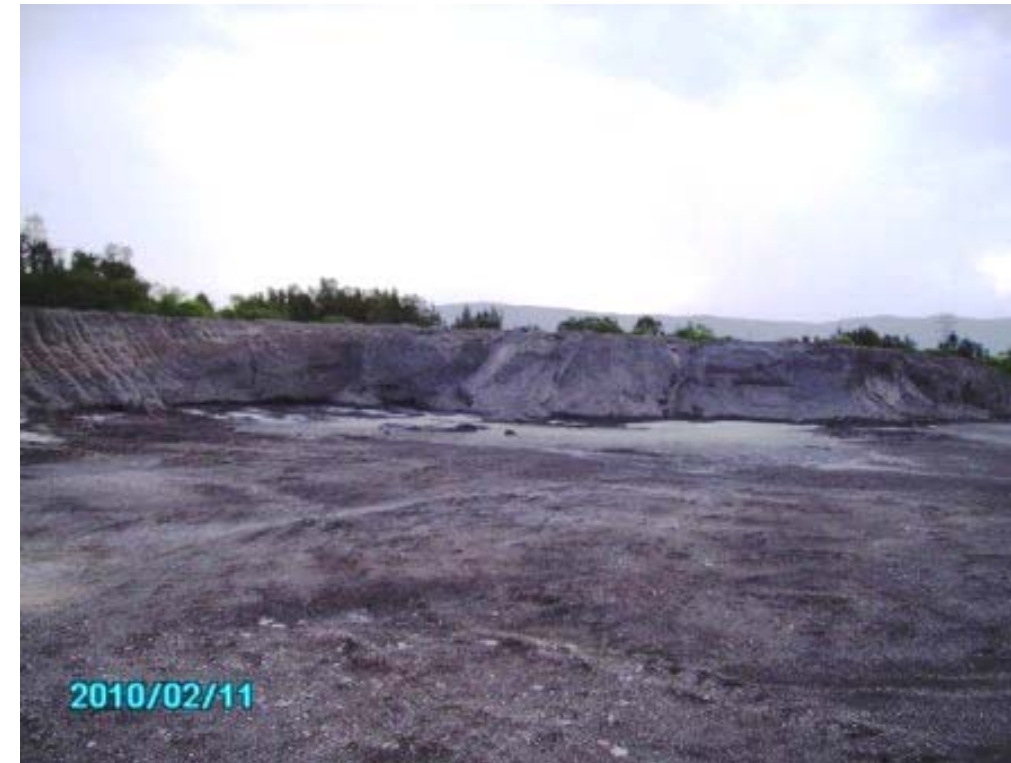
Photo 23 - Looking south at a stockpile of slag fill. Slag noted on the surface of most of the access roadways in Zone 2(A)

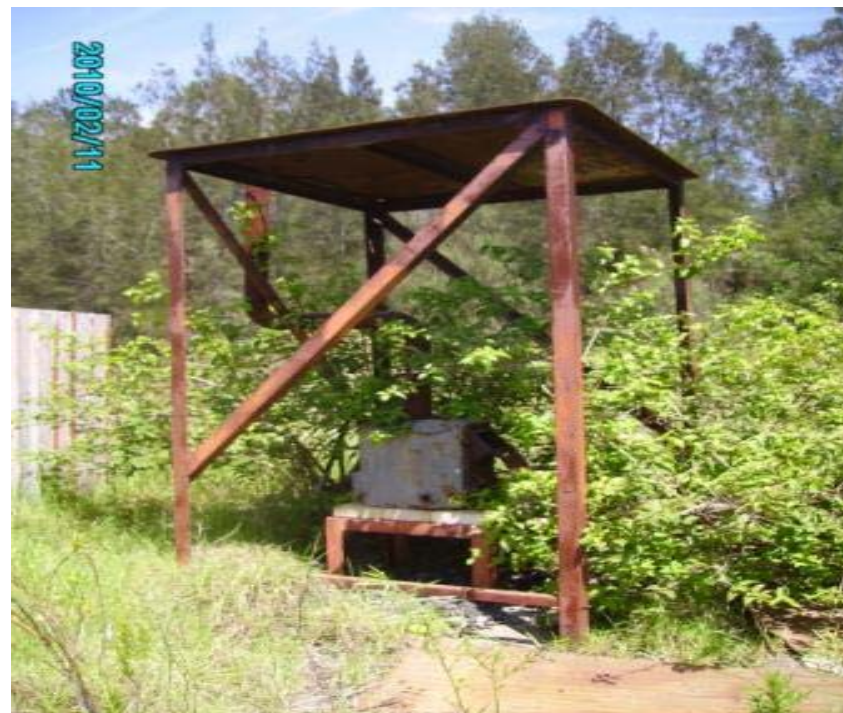
Photo 24 - Looking west at the former coal fired burner in Zone 2(A)

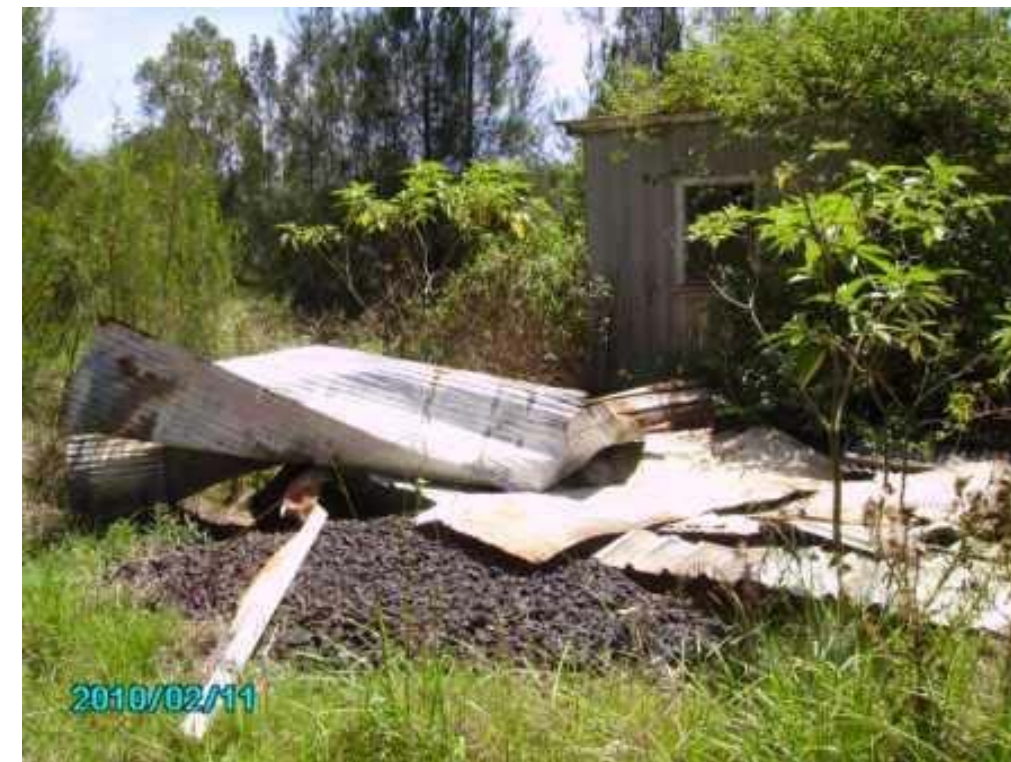
Photo 25 - Looking West at a mound of coal used by the burner indicated in Photo 24 , sheet metal debris and a disused shed in the background of Zone 2(A)

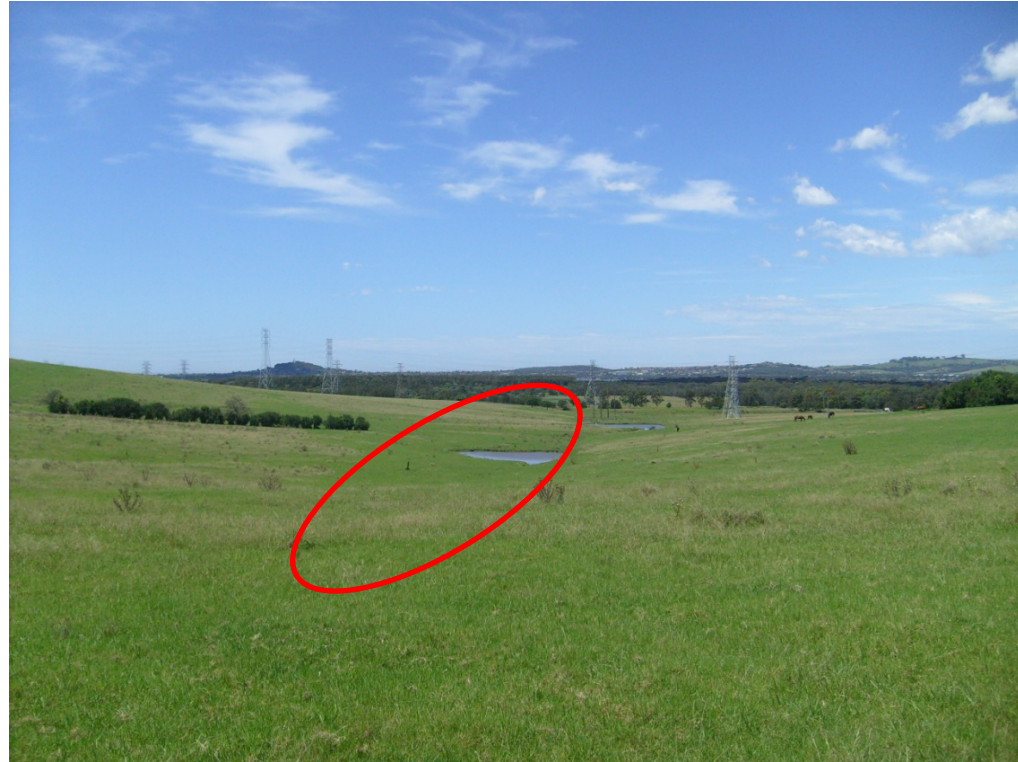
Photo 26 – Valley with creek channel running from northwest to southeast through dams (background of photo). A soft boggy zone is highlighted.
