ARBORICULTURAL ASSESSMENT – BUILDINGS C & D

s.96 Proposal for Approved Development:

Stage 1 Works, 120-128 Herring Road, Macquarie Park, NSW

10 August, 2012 Rev. 11/10/2012

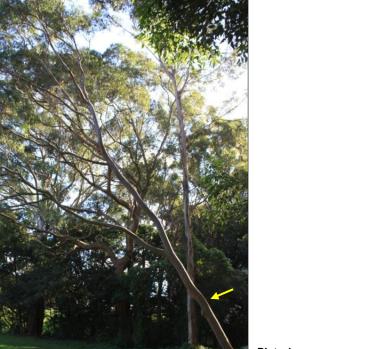
This tree was proposed for retention, however it has suffered a partial failure at the roots and now leans heavily to the southeast (Plate 1). The tree has subsequently had a limb removed as it was in contact with the ground and interfering with the existing playing field.

The tree is considered to be unstable and at risk of imminent whole tree failure. The tree must be removed as soon as practicable and certainly prior to any works commencing in its vicinity.

Plate 1 Tree 2 has recently suffered a partial root failure and now leans heavily southeast over the existing playing field. This tree must be removed as it may fail at any time.

- 24. Tree 2 – Remove for safety reasons.
- 25. Tree 15 – Remove due to identified significant excavation and construction impacts resulting from the approved development.
- 26. Tree 18 – Remove, as this tree is dead.
- 27. Tree 20 – Remove due to identified significant excavation and construction impacts resulting from the approved development.
- 28. As trees will be removed along the east boundary, the 'Offset Restoration Planting' (Landscape Dwg L14/B) should be amended to provide at least one replacement canopy tree for every 30m².
