ROAD SAFETY AUDIT

REMONDIS PTY LTD AUGUST 2012

STAGE 5 ROAD SAFETY AUDIT FOR PROPOSED RECYCLING PLANT CAMELLIA

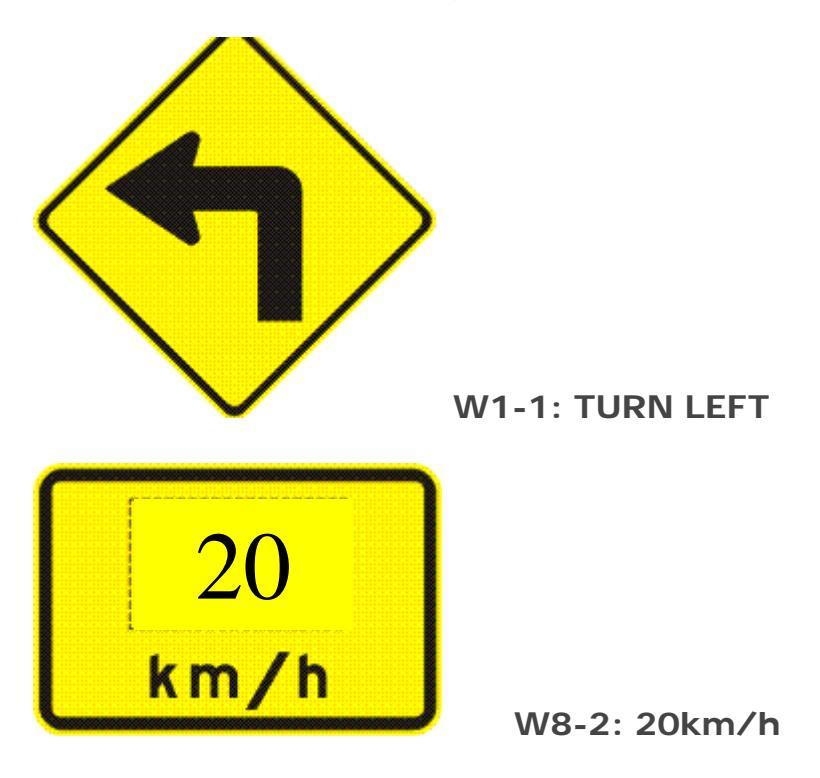
Warning Sign W1-1 (as shown below with 20km/h advisory speed plate sign W8-2) should be implemented facing eastbound motorists in Grand Avenue at a location **50m west** of the Grand Avenue North junction to advise the car driver the type of corner and appropriate turning speed.

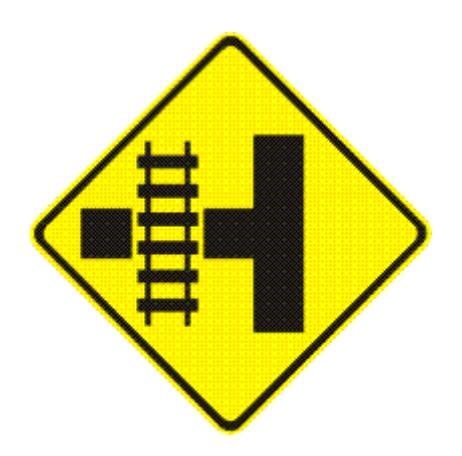
W7-12: RAIL CROSSING ON SIDE ROAD

Further, a "Rail Crossing on Side Road" warning sign W7-12 (as shown below) should be implemented facing eastbound motorists in Grand Avenue at a location **80m west** of the Grand Avenue North junction to advise the car driver the presence of the railway crossing on the side road.

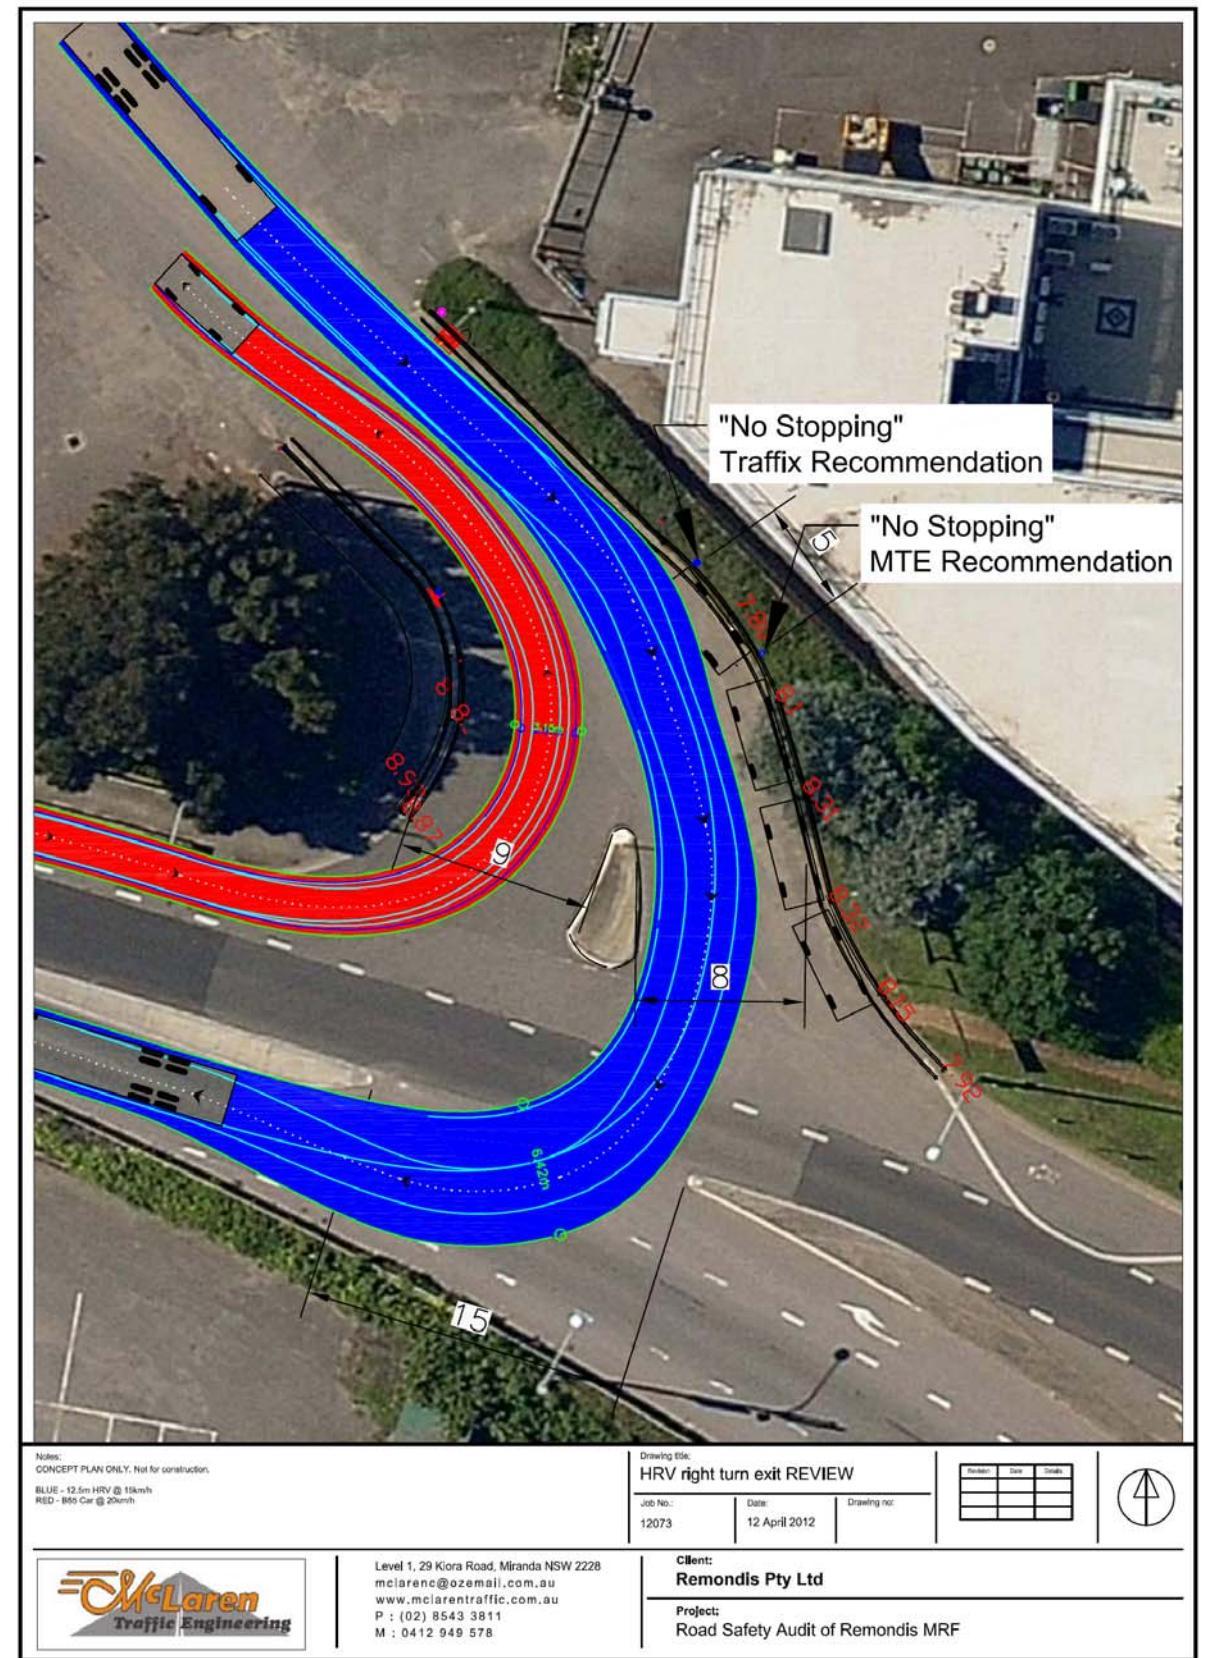
ANNEXURE B: HRV SWEPT PATH REVIEW

in the successful manoeuvring of the heavy vehicles from the site. Review of these swept paths (shown in **Annexure B**) suggests that the "No Stopping" on the northern side should be 10.6m from its current position (5m further than indicated in the *Traffix* report).

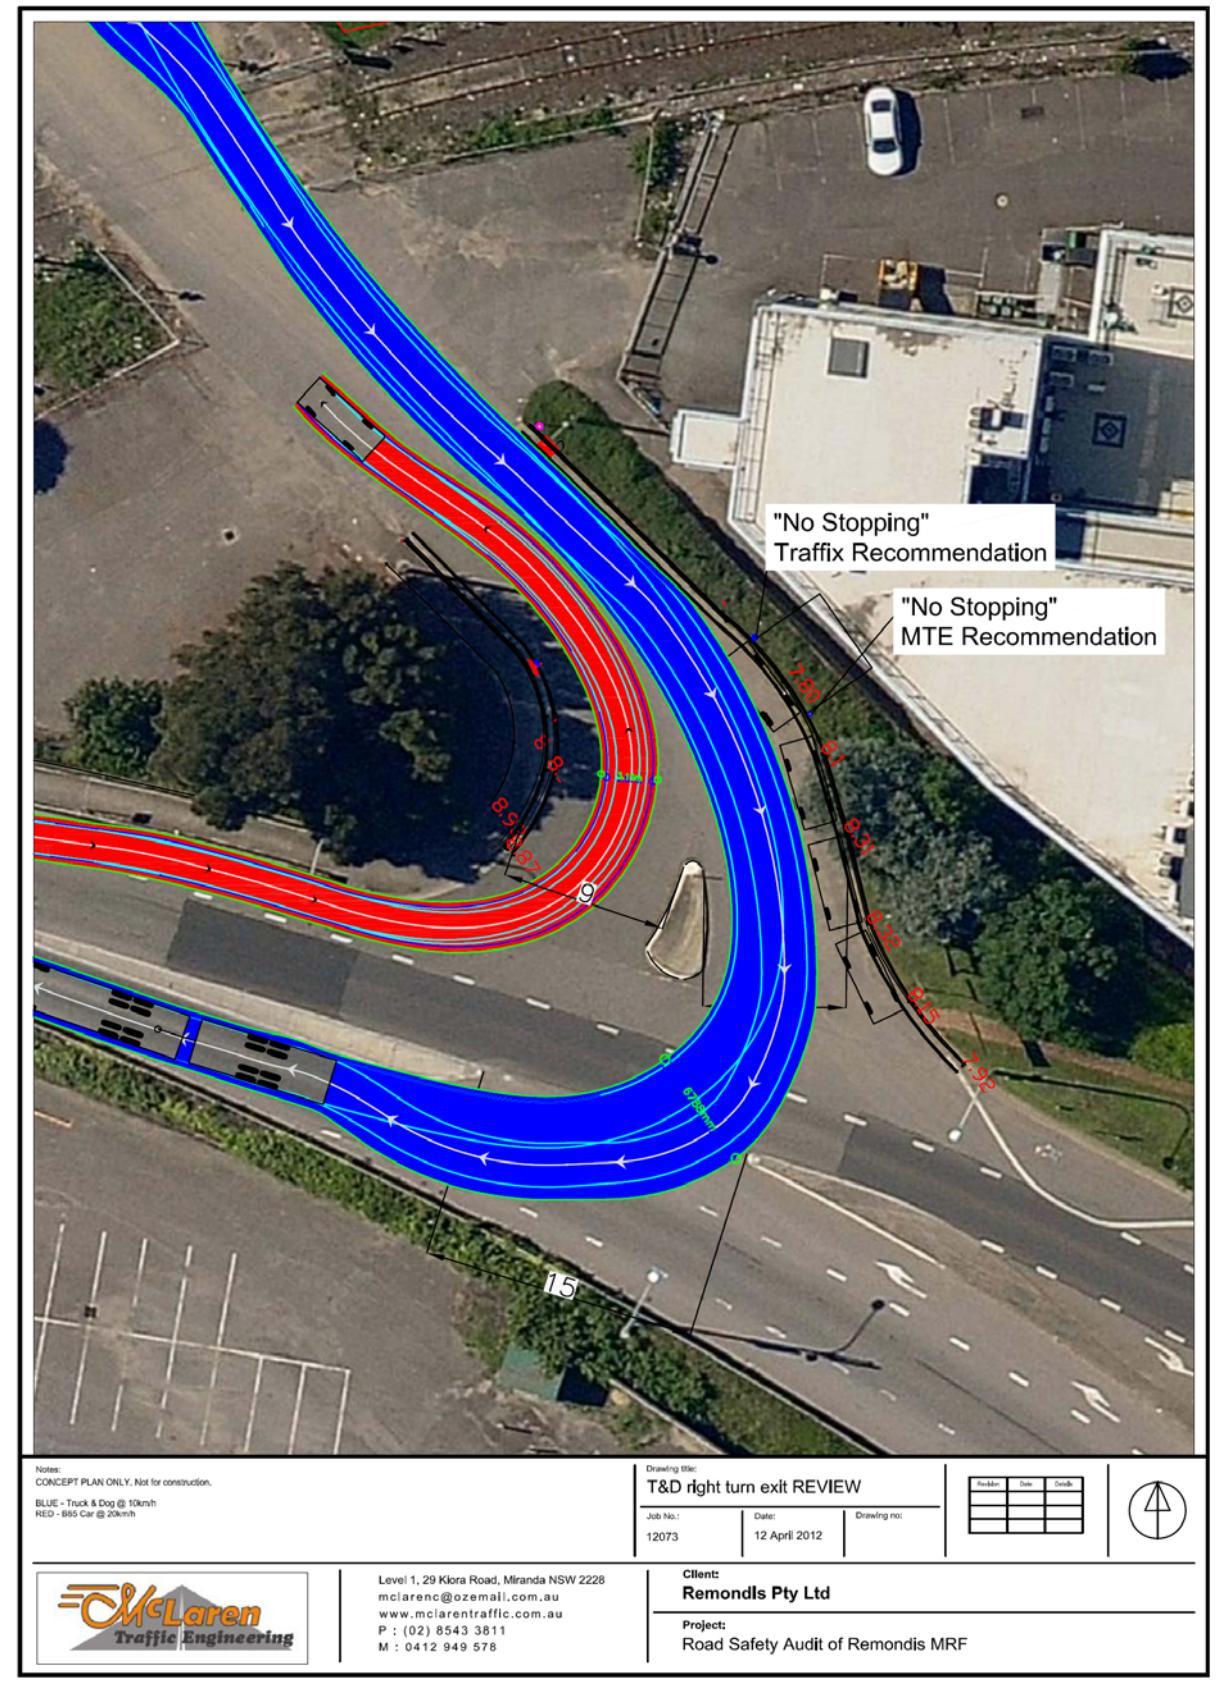
ANNEXURE B: TRUCK & DOG SWEPT PATH REVIEW

Further to the abovementioned, the HRV and Truck & Dog do not wholly fit into the auxiliary left turn lane and complete the turn while being half way in the turn bay and adjacent through lane. According to the Australian Road Rules, for vehicles greater than 7.5m, this type of manoeuvre is acceptable and is required because if the turn was completed from being wholly within the left turn bay, two-way passing on Grand Avenue North cannot be achieved.
