## **Graythwaite, Union Street, North Sydney**

Section 75W Modification  
Concept Approval No. MP10\_0149 and  
Stage 1 Project Approval No. MP10\_0150

Proposed minor modifications  
Statement of Heritage Impact

Prepared for  
SYDNEY CHURCH OF ENGLAND GRAMMAR SCHOOL

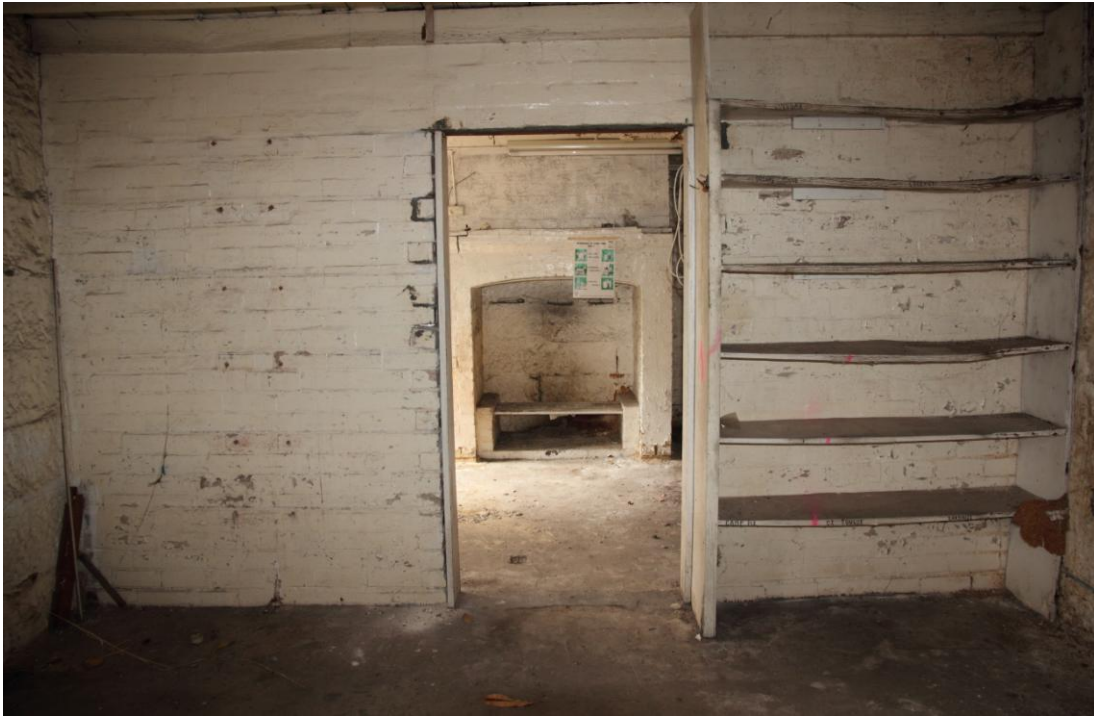
The proposed demolition of the brick wall in the Stables Building is proposed in order to create one large room, in place of the existing two room configuration (see Figure 4). Previously thought to be of early (but not original) construction, physical investigation of the wall has confirmed that it is of 20th century provenance. It is constructed on top of the earlier sandstone flagged floor, and the bricks themselves are of modern origin. The heritage significance of the wall is limited insofar as it demonstrates a later phase of alteration and functioning of the building.

Figure 4 The existing wall between rooms G19a and G19b proposed to be removed.  
Source: TKD Architects, 2013

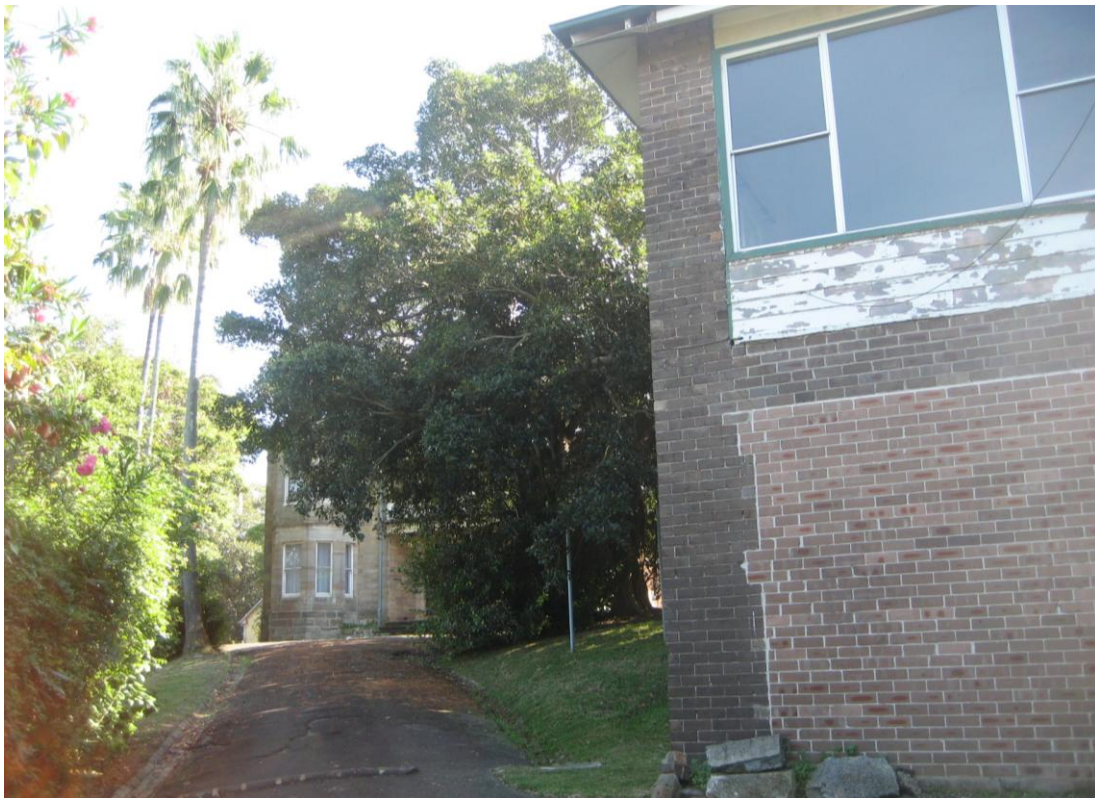
A large *Port Jackson Fig* tree (tree number T60) at the upper section of the driveway is proposed to be removed and replaced with a tree of the same species. T60 has been determined by the arborist as structurally weak (refer to the 2011 tree report in Appendix A and the subsequent 2013 addendum in Appendix B); with the presence of an increasing probability of structural failure of several branches at their point of attachment to the tree. This increased risk of failure results in an approximate 1:180 000 risk of serious harm or death should these branches fall. Whilst the health of the tree is considered good, the useful life expectancy of the tree has been determined as transient, at no longer than 5 years, with a low retention value.

The tree is located in an area which requires decontamination; ground in which the remediation engineer has recommended excavation of between 250mm and 500mm depth within the Tree Protection Zone for T60. Excavation methods, in particular when undertaken mechanically, have been determined as likely to damage significant sections of the woody and fine tree root system, leading to a significant and detrimental impact on the health of the tree.

Figure 6 T60 *Port Jackson Fig* tree, located at the top of the driveway adjacent the Ward Building.  
Source: TKDA, 2010

This tree has been assessed in the Conservation Management Plan (2011) as being of high significance. As a significant part of the original planting of Graythwaite, the removal of the tree unavoidably results in a negative heritage impact on the landscape at Graythwaite. Accepting the need to remove the tree owing to the required remediation works, its structural weakness and limited life expectancy, the negative heritage impact is proposed to be mitigated through the propagation of a new tree from T60, and replanted in the same location once decontamination of the ground has been completed.

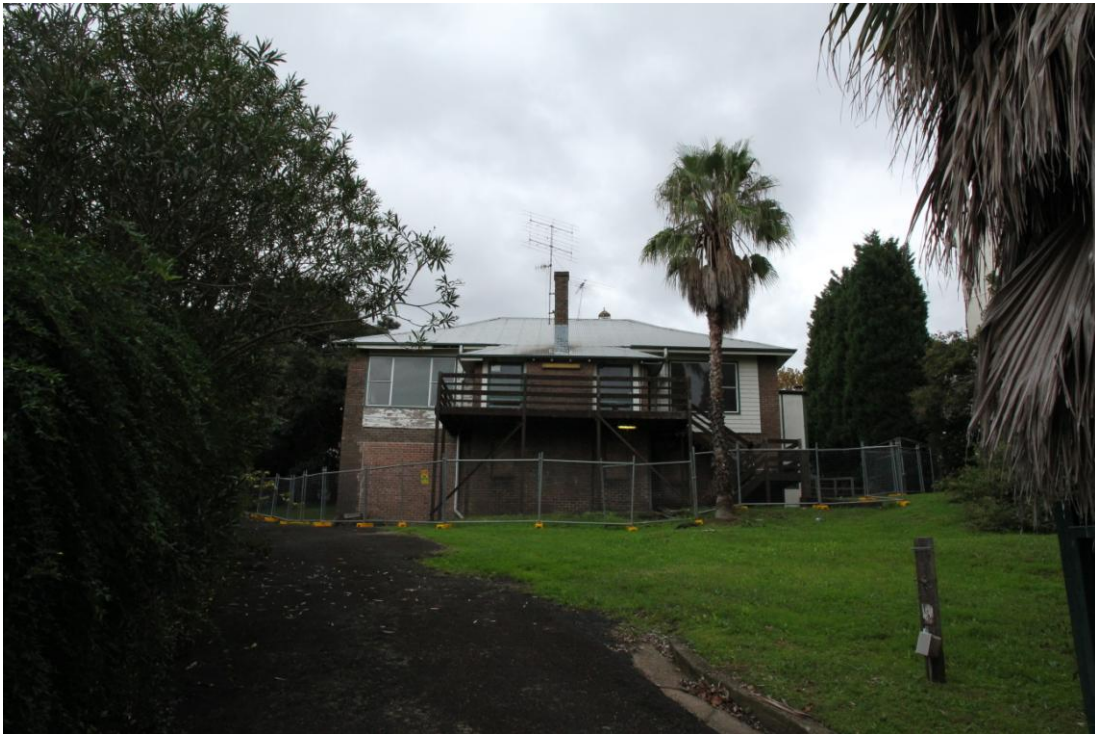
Additionally, a *Washington Palm* tree (tree number T51) located in front of the Ward Building is also proposed to be removed. Whilst the tree has been determined by the arborist as structurally sound, it has been listed as of little heritage significance in the 2011 CMP. Likely to be planted c1970s, the tree does not contribute to the understanding of the historical cultural landscape of the Graythwaite site. Its removal is therefore not considered to have a negative heritage impact (refer to Appendix B).

Figure 7 T51 *Washington Palm* tree, located in front of the Ward Building.  
Source: TKDA, 2010

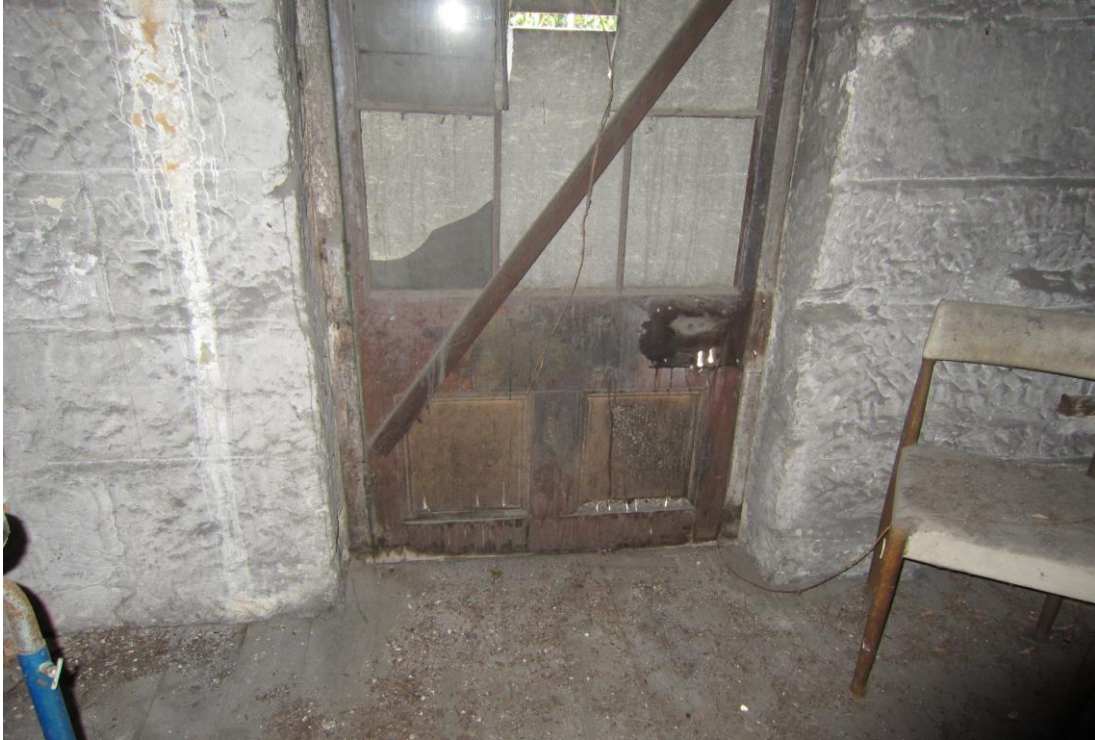
The present loft door is glazed and timber panelled and is presumed to be either original to the construction of the building or late nineteenth century (Figure 8 and Figure 9). To avoid any negative impacts associated with modification of the historic door to incorporate a mechanical services vent, it is proposed to carefully remove the door and frame and safely store it within the loft. The door would be replaced with a simple timber door incorporating an air intake vent in its fanlight.

Figure 8 Internal view of the Stable Building loft door.  
Source: TKDA, 2011.

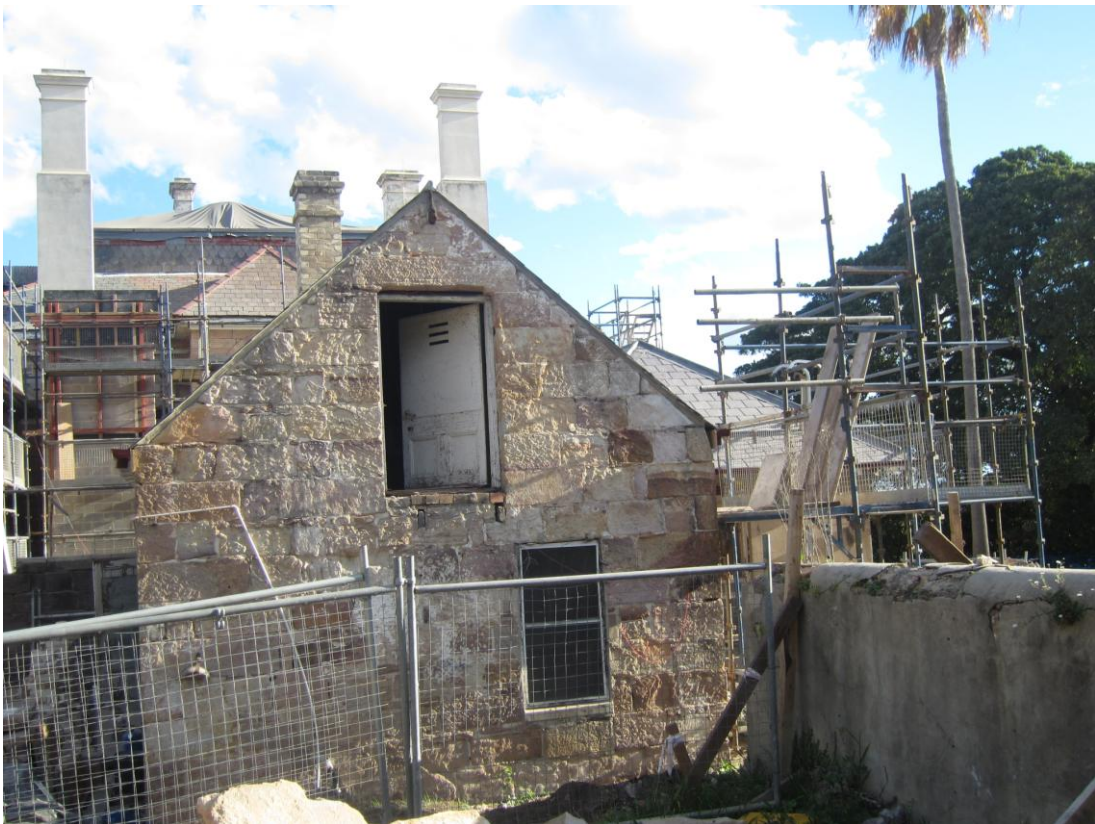
Figure 9 North elevation of Stables Building showing loft door.  
Source: TKDA, 2013.

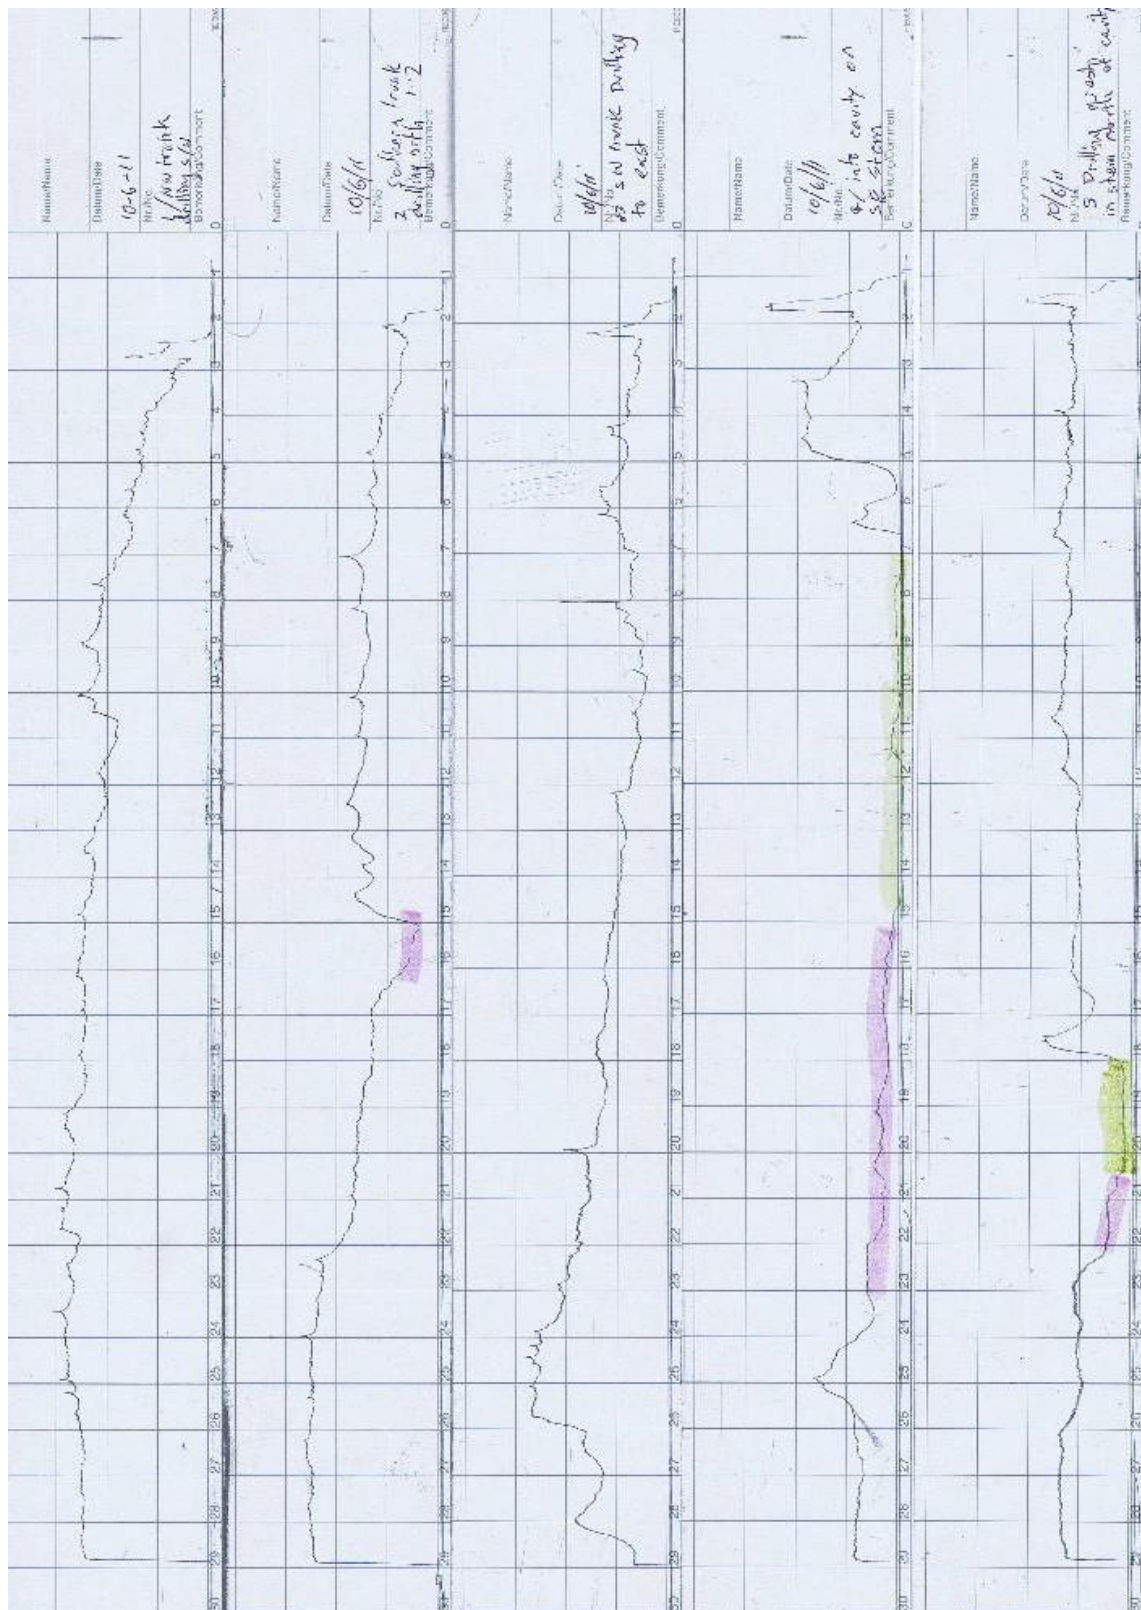
The test results are contained in appendix 2. The sections shown in yellow on the graphs are area of decay. The sections shown in pink are areas of early strength loss associated with decay. The remaining sections of the graphs show the wood has not been altered to any significant extent by decay.

The Resistograph results confirmed the VTA and sounding observations. With the exception of the decay present around the cavity there is no other significant decay that is likely to impact on the stability of the tree.

Graphs four and five show that there is a column of decay in the south eastern portion of the trunk. An examination of canopy above this wound revealed that there was not a significant load from branches on this portion of the tree. In fact, it would appear that this portion of the tree might have declined significantly after the lopping resulting in the reduced growth and the increased deterioration of the wood.

Yellow = cavity; Pink = Decaying or degraded tissue.

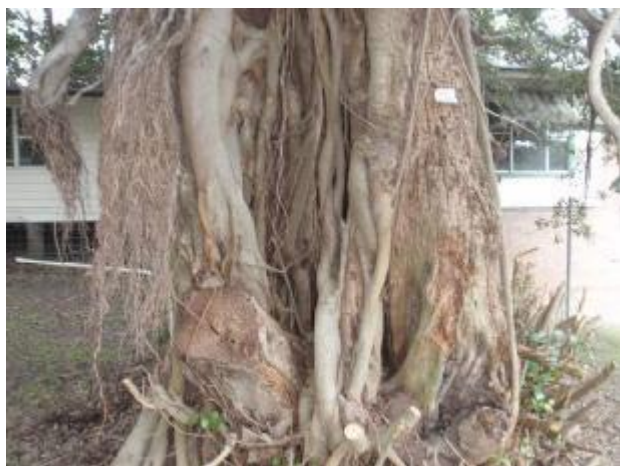
**Image 7:** Aerial roots over much of the old tree

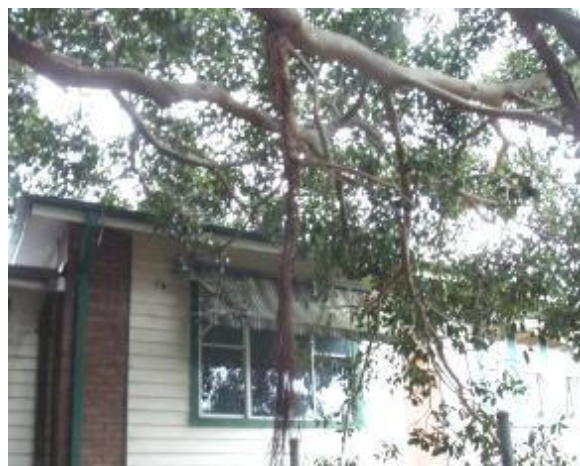
**Image 8:** Aerial roots coming from the branches

In addition, there is significant benefit in considering encouraging aerial roots to develop, including the development of several as prop roots on several of the limbs, in order to provide additional support for the tree and reduce the likelihood of limb failure.

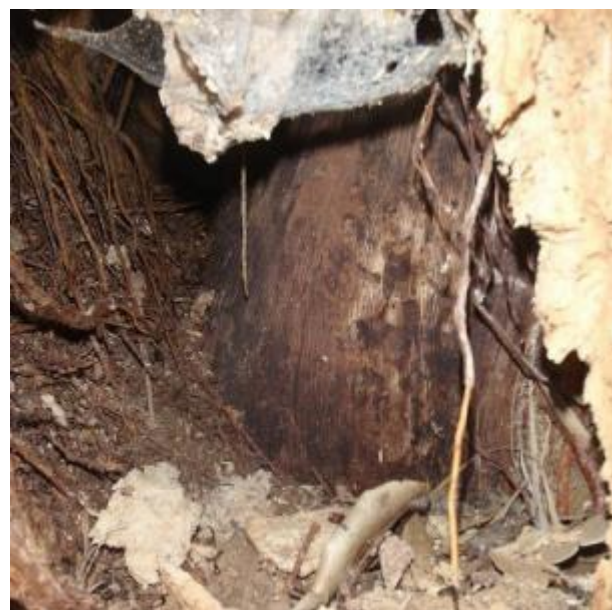
A cavity was present on the south eastern side of the tree about 1.2 metres above ground. No other areas of significant decay could be detected either by visual observation or by sounding of the trunk.

**Image 10:** the cavity opened up

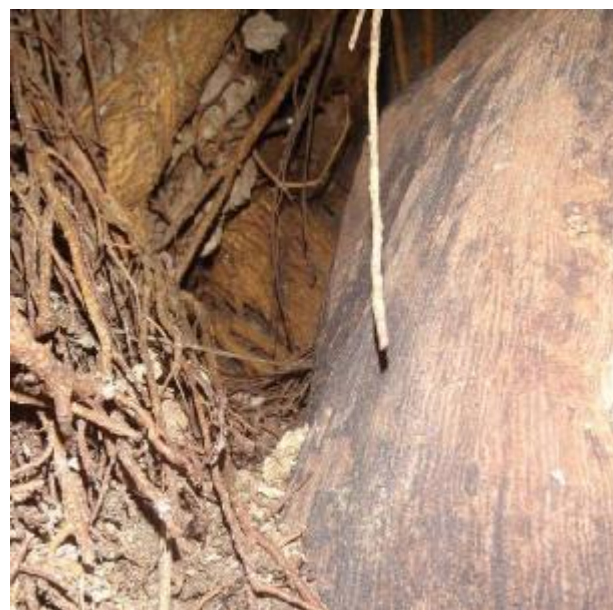
**Image 11:** Roots clearly visible inside cavity

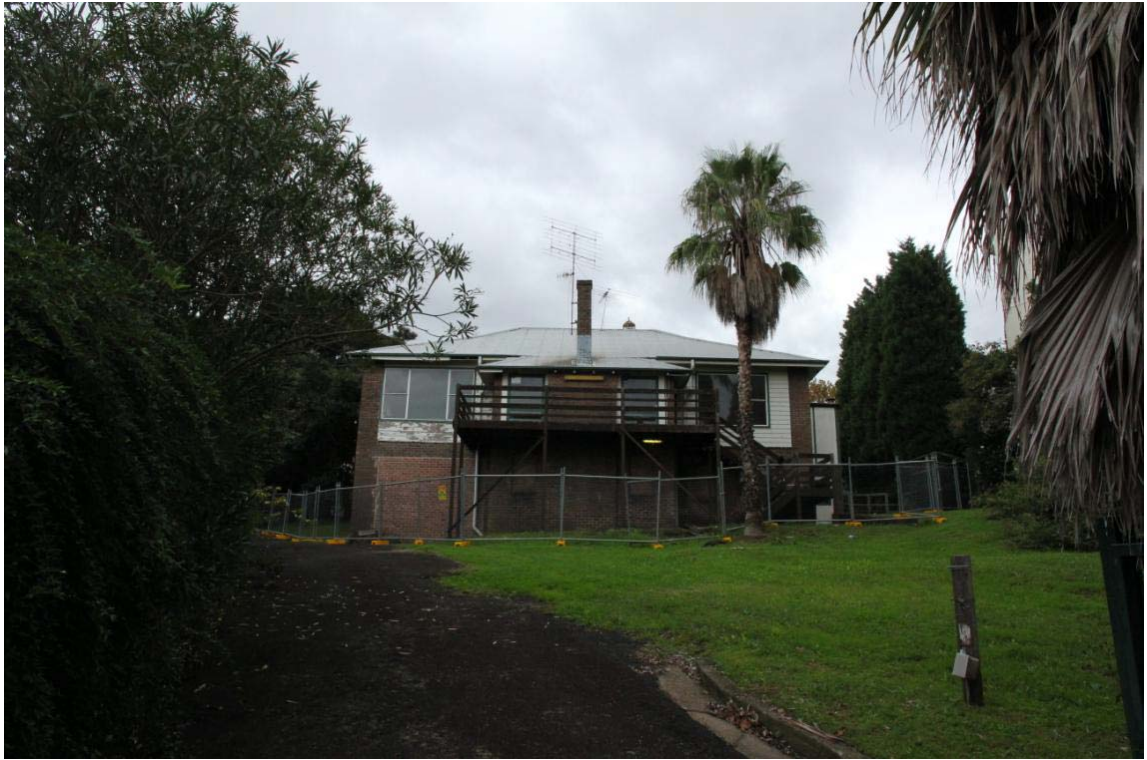
Plate 1 – Showing south side of the ward building with T51 (Washington Palm) adjacent

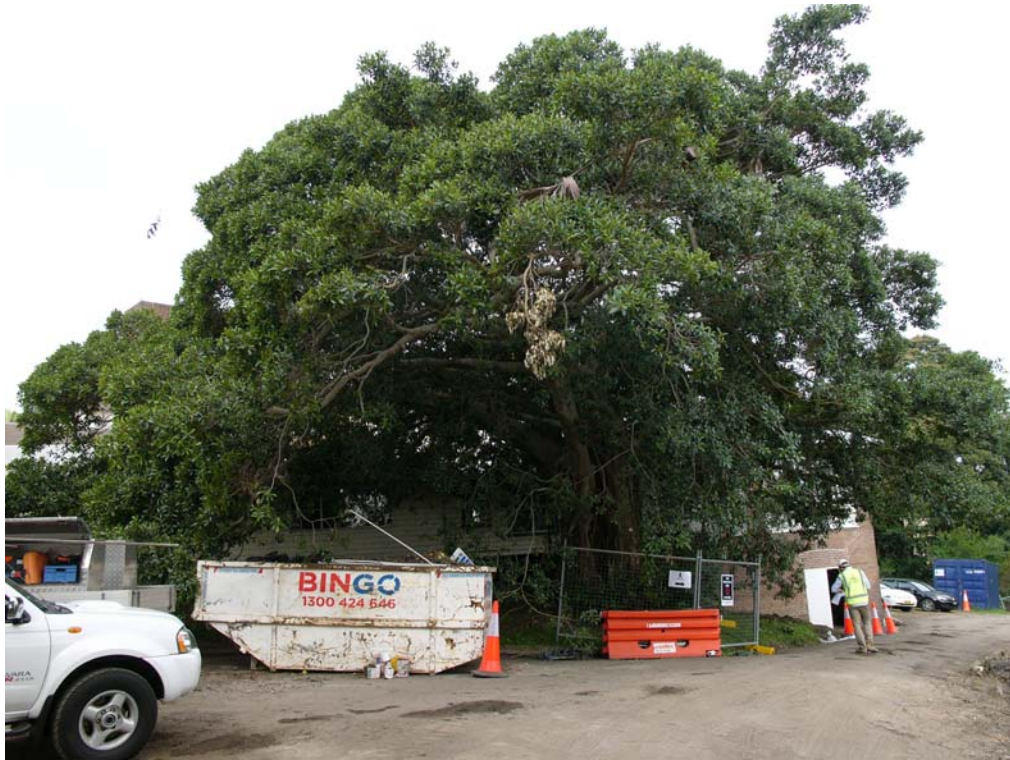
Plate 2 – T60 (Small-leaf Fig), despite having an apparently health crown, is structurally defective

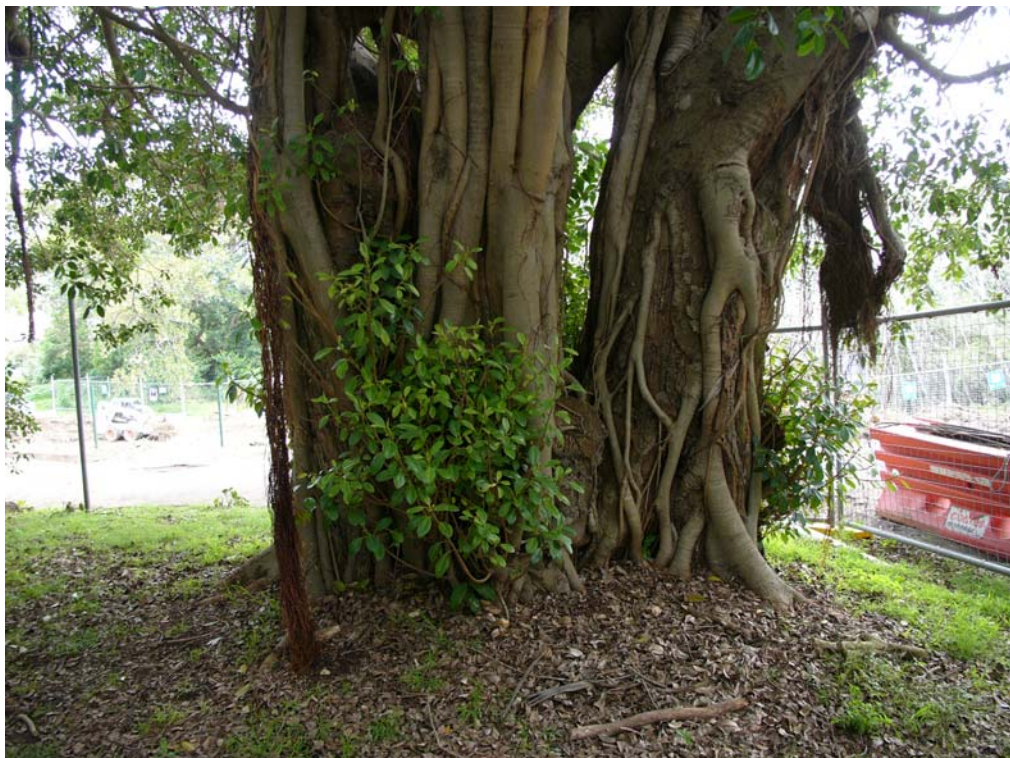
Plate 3 – Lower trunk of T60. The aerial roots seen cover extensive wounding and decay in the lower trunk, with the larger of the two trunks being completely hollow

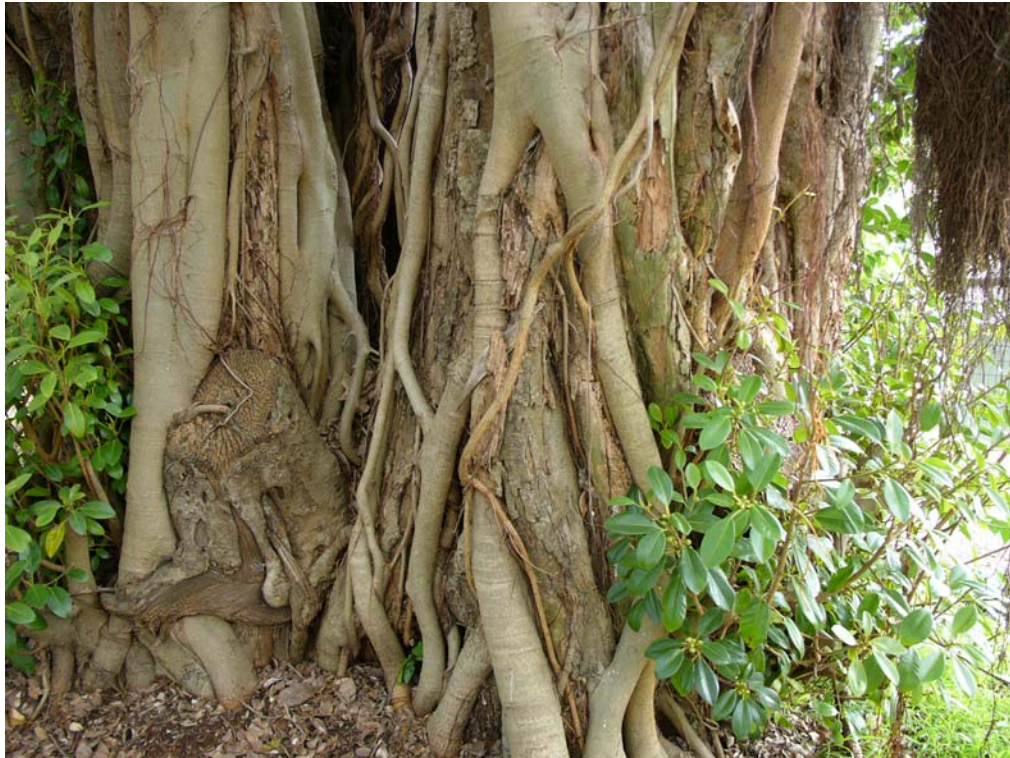
Plate 4 – T60 (Small-leaf Fig), showing aerial roots covering extensively decayed lower trunk

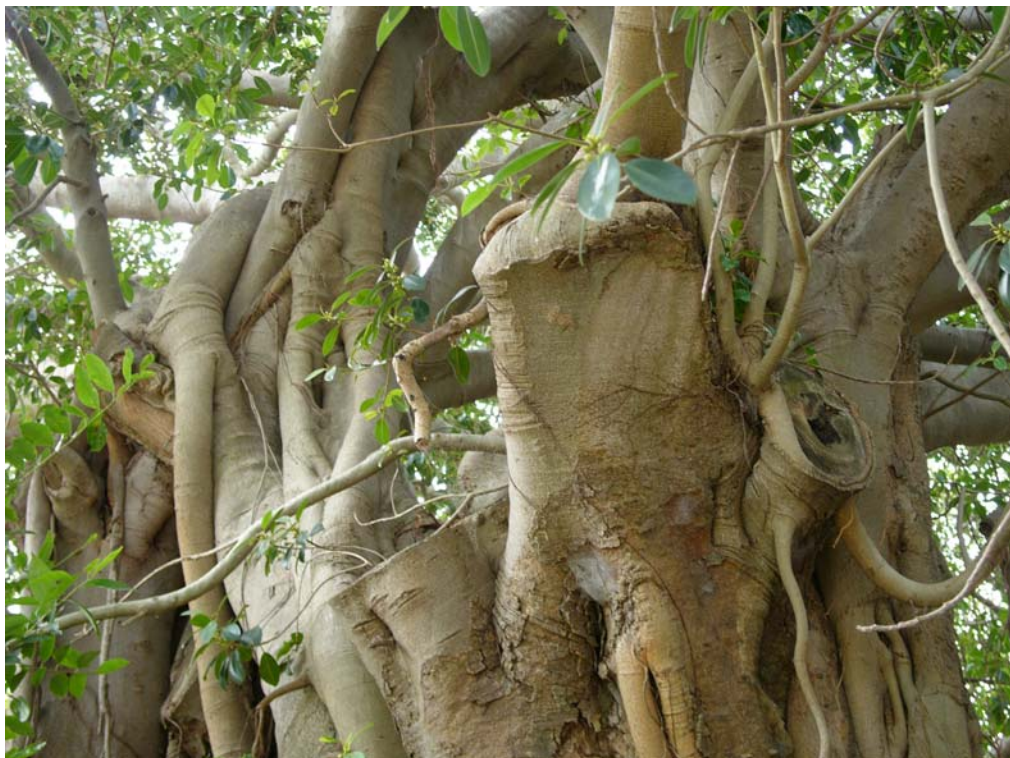
The tree appears to have been lopped at some stage in the past. This lopping appears to be the cause of a number of wounds. There are a number of old cuts with the remnants of an old wound dressing still apparent. Because of this prior lopping, a number of branches coming from the main stem have somewhat irregular points of attachment.

The lopping has given rise to two significant problems. The first problem is the death of trunk tissue, and the exposure of that dead tissue to decay and the second problem is the poor branch attachments that formed around the cuts after the tree had been lopped.

Plate 5 – T60 (Small-leaf Fig), showing multiple wounds on primary and secondary limbs due previous lopping, with majority of crown formed from epicormic re-growth.
