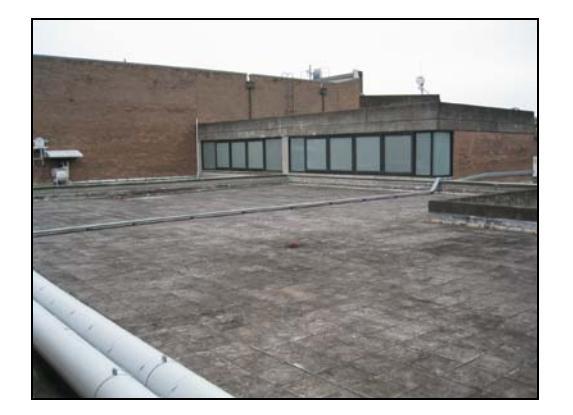
Plate 1: Asbestos Containing Roof Tiles KGO2

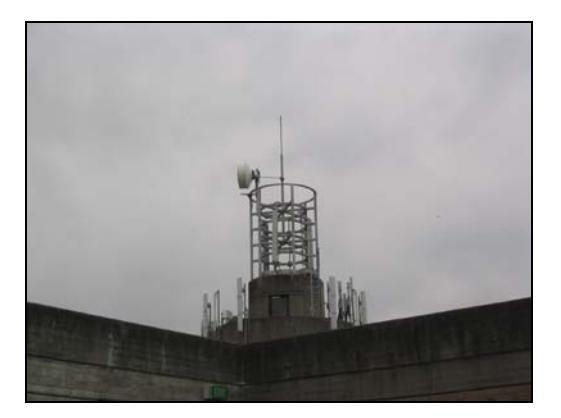
Plate 4: Telecommunications Tower – Library Rooftop

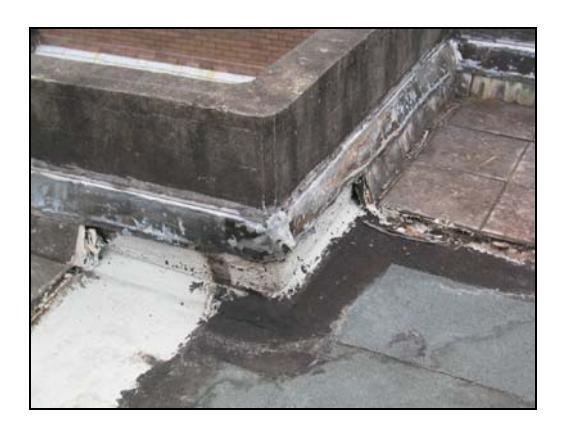
Plate 2: Lead Flashing Roof top KG02

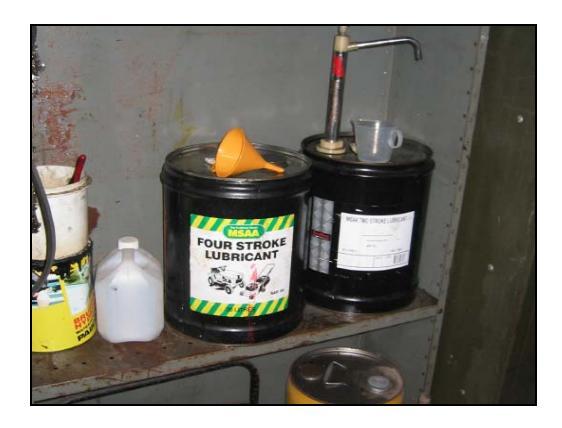
Plate 5: Oil and Lubricant Storage in Maintenance Workshop

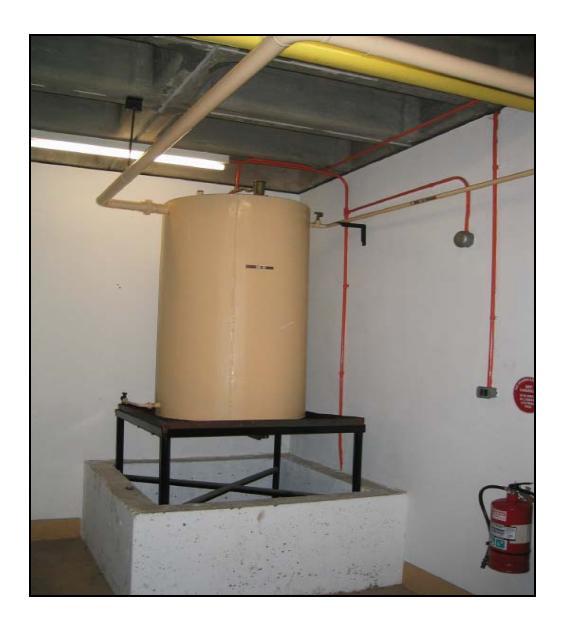
Plate 3: Diesel Oil Tank – Plant Room, Library Roof

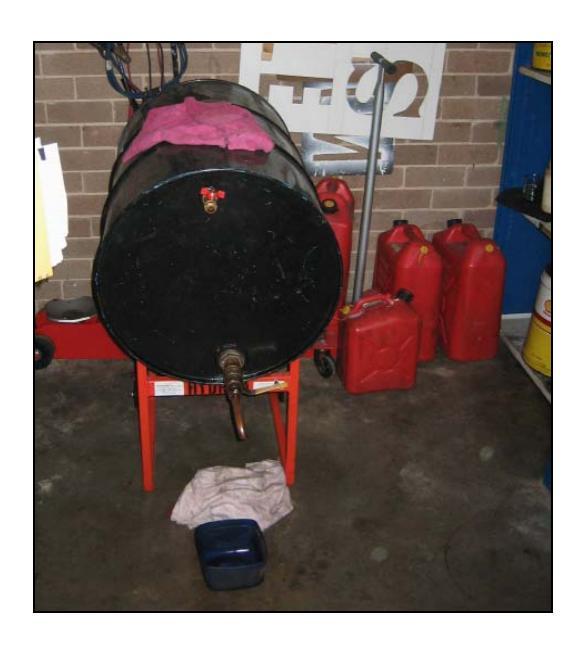
Plate 6: Diesel storage in Hazardous Store (Maintenance)

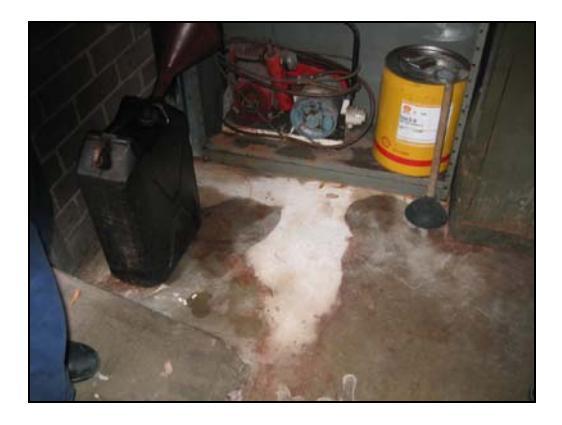
Plate 7: Surface Staining and Corrosion Inside Hazardous Store

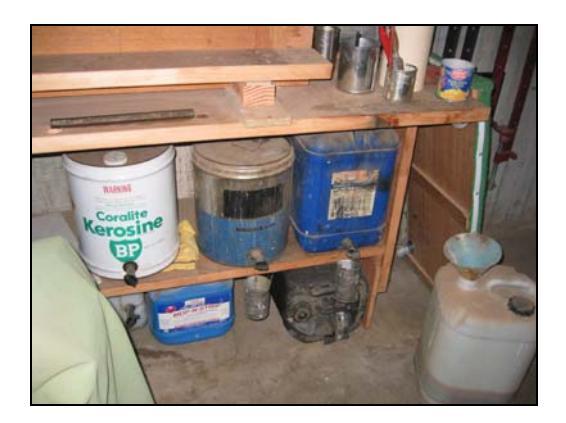
Plate 8: Chemical Storage in Woodworking Workshop

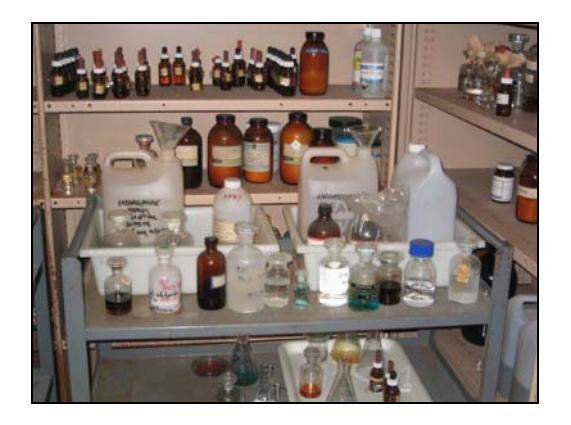
Plate 9: Chemistry Storeroom – chemical storage

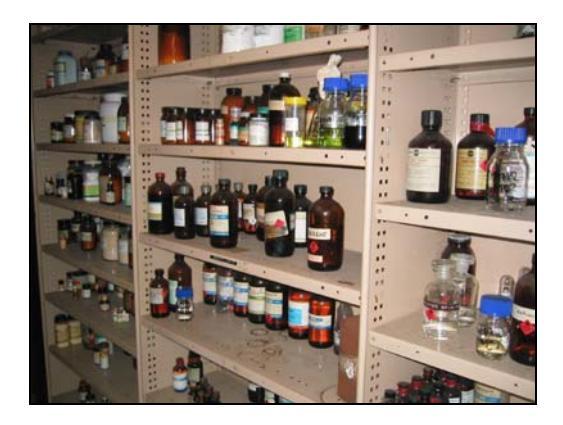
Plate 10: Chemistry Storeroom November 2003

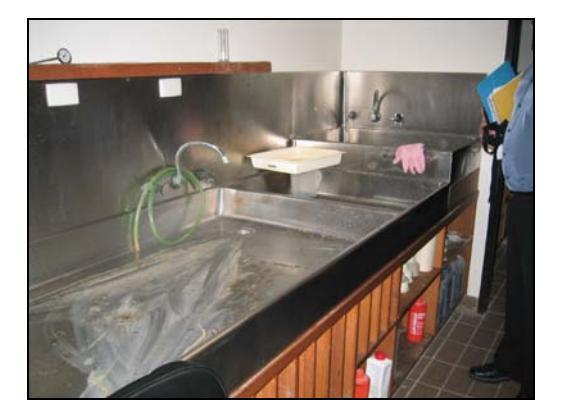
Plate 11: Photographic Studio and Washbay

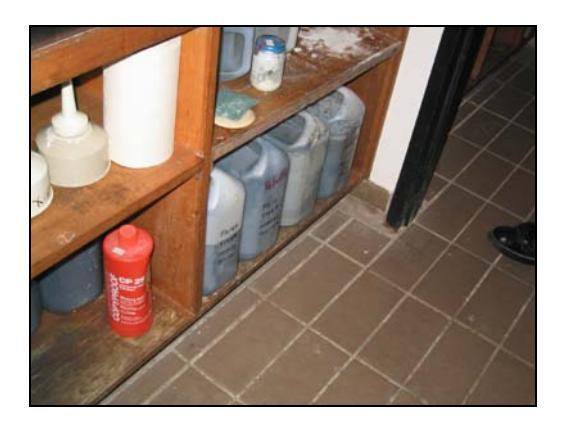
Plate 12: Photography Dark Room Chemical Storage (developers, fixers)

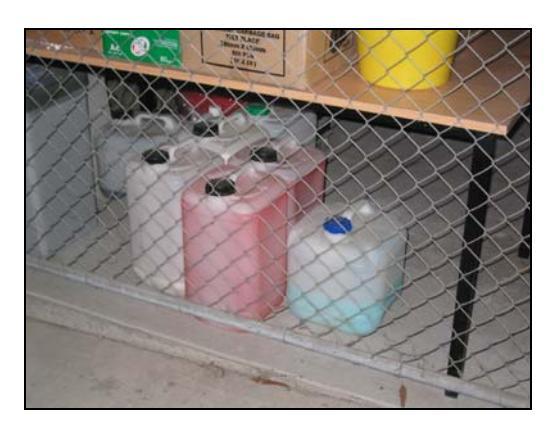
Plate 13: Cleaning Chemicals Storage

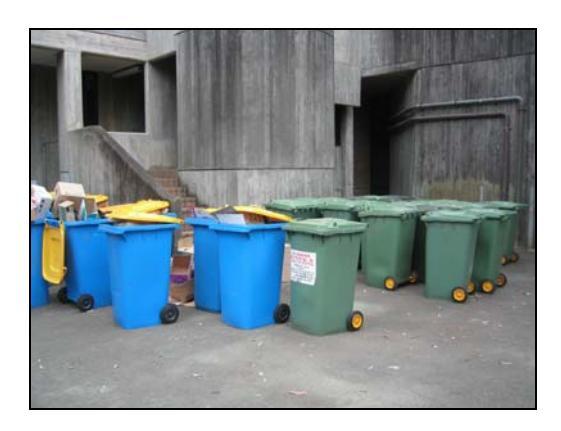
Plate 14: Waste Storage Area and Loading Bay

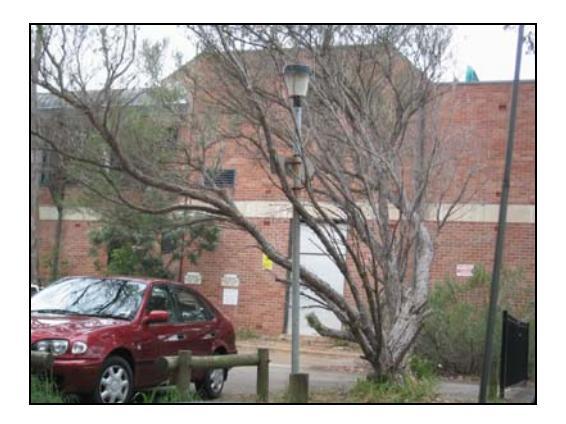
Plate 15: Film Australia – UST located inside building, tank vent located outside of building

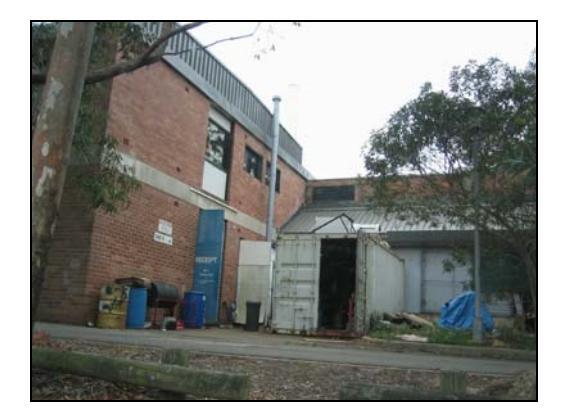
Plate 16 : Film Australia – Waste Storage Area and access road adjoining UTS northern property boundary

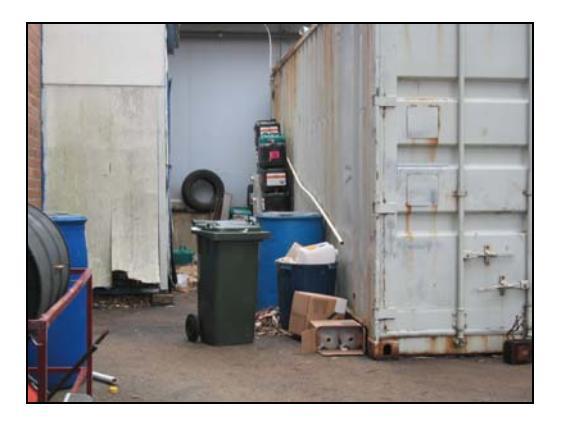
Plate 18: Film Australia – Chemical Waste Storage Area. Lack of Bunding, Inappropriate Labelling and Segregation

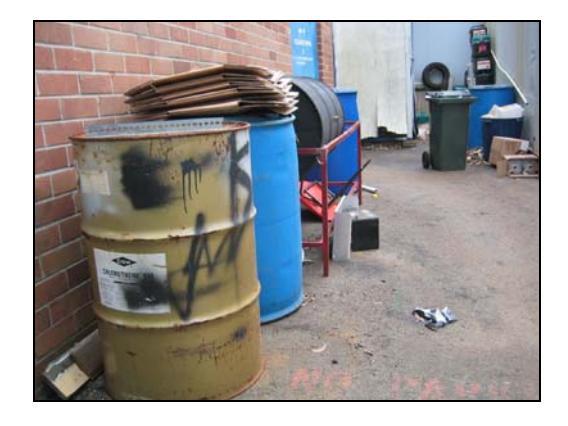
Plate 19: Film Australia - Waste Storage Area

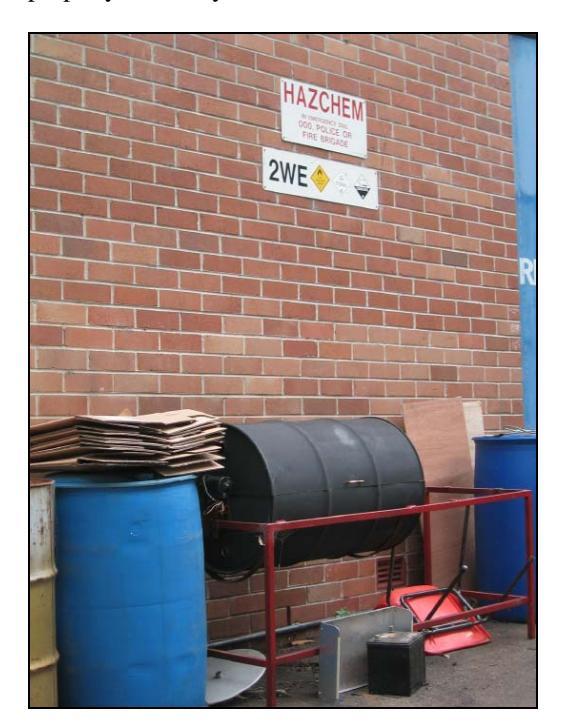
Plate 17: Film Australia – Hazardous Chemical Storage

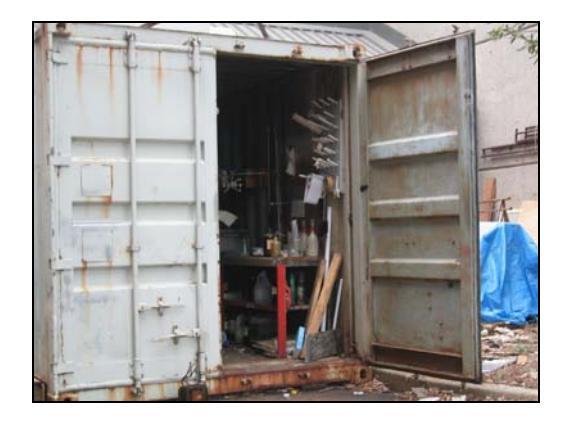
Plate 20: Film Australia – Waste Storage Area
