## Tree Assets Report

### UTS Ku-ring-gai Campus Lindfield

Reissued July 2006

Reissued October 2007

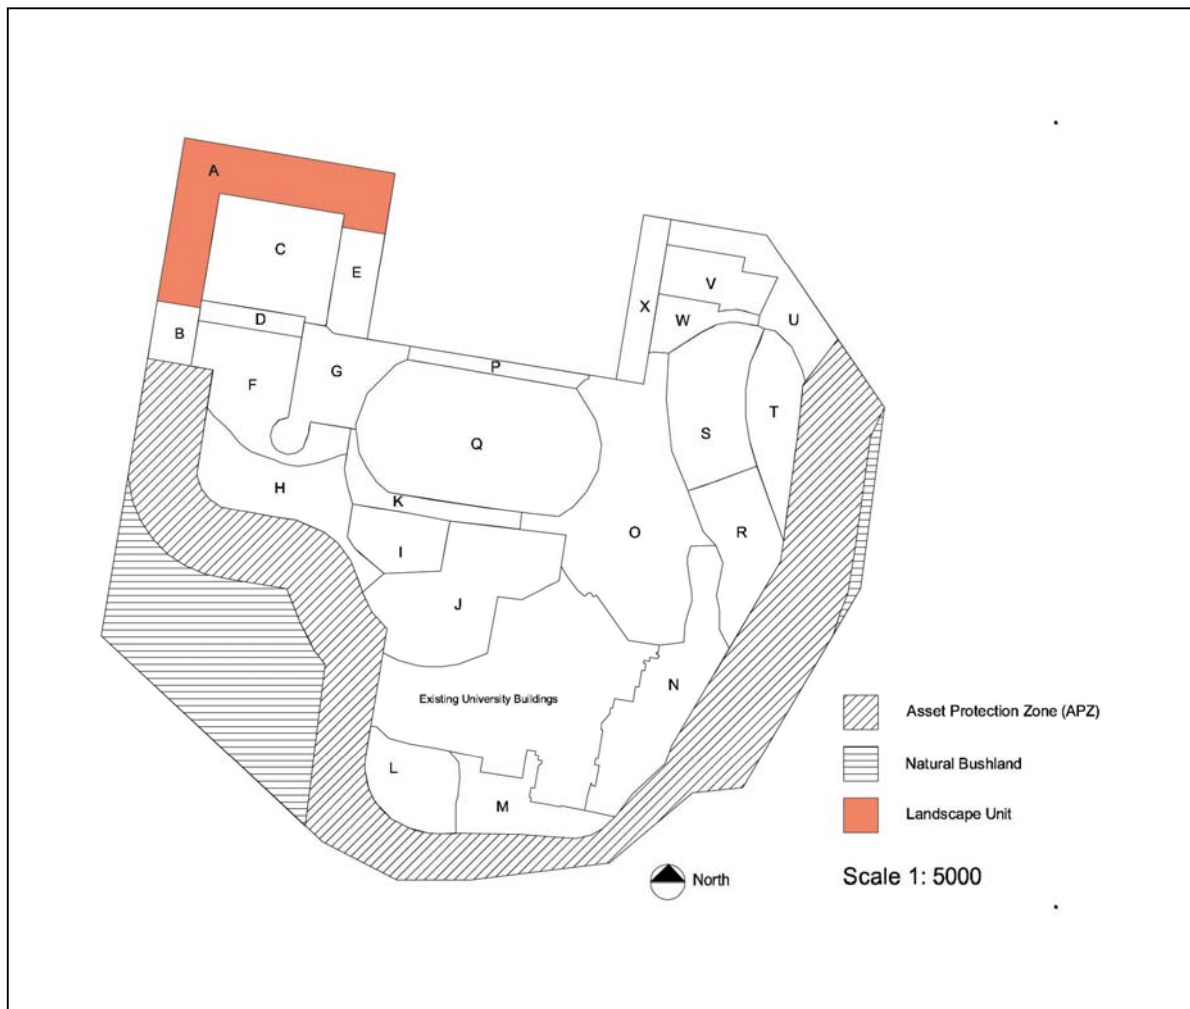
## Landscape Unit A

Perimeter of north-west carpark, adjoining residential properties. Trees occur in remnant vegetation associated with landscaping incursions by neighbours. The site slopes gently in places and contains areas of exposed rock.

**Comments:** A few of the existing trees would be a valuable asset to the area. They should be selected on the basis of health, structural soundness and amenity values. The removal of the remainder would be required for hazard management. Replacement plantings should be of the same species, with regard for hazard management and scale.

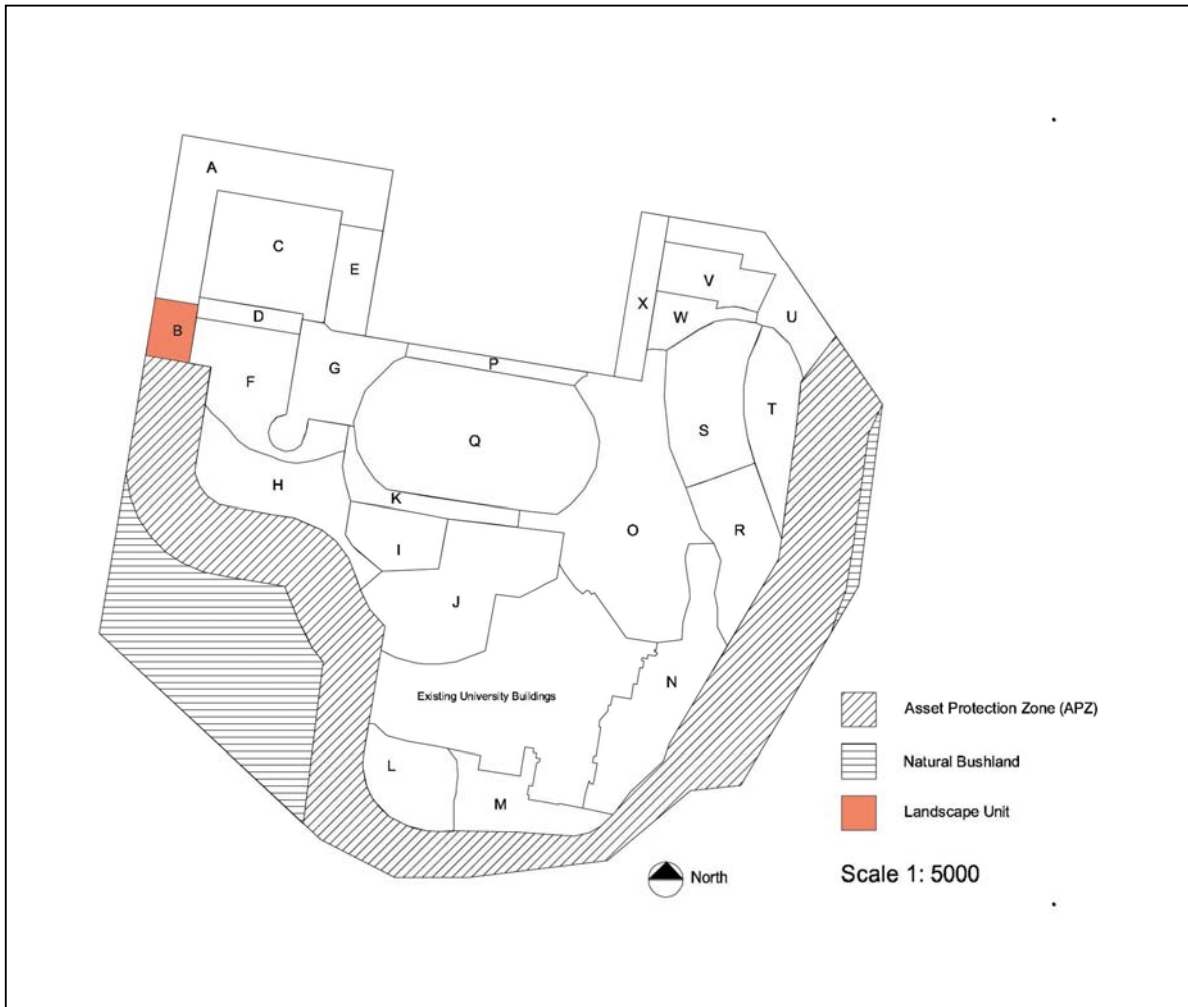
## Landscape Unit B

Bushland along the western boundary south of the north-west carpark. Trees occur in dense remnant vegetation. Stormwater run-off from the carpark is directed into the bushland. The area slopes gently to moderately. Clearing along the boundary with residential properties has occurred.

**Comments:** Development of this area would reduce bushfire hazards to adjoining properties. The trees in the south-west are valuable environmental and landscape amenity resources that will contribute on-going ecological values to the site within an acceptable bushfire management framework.

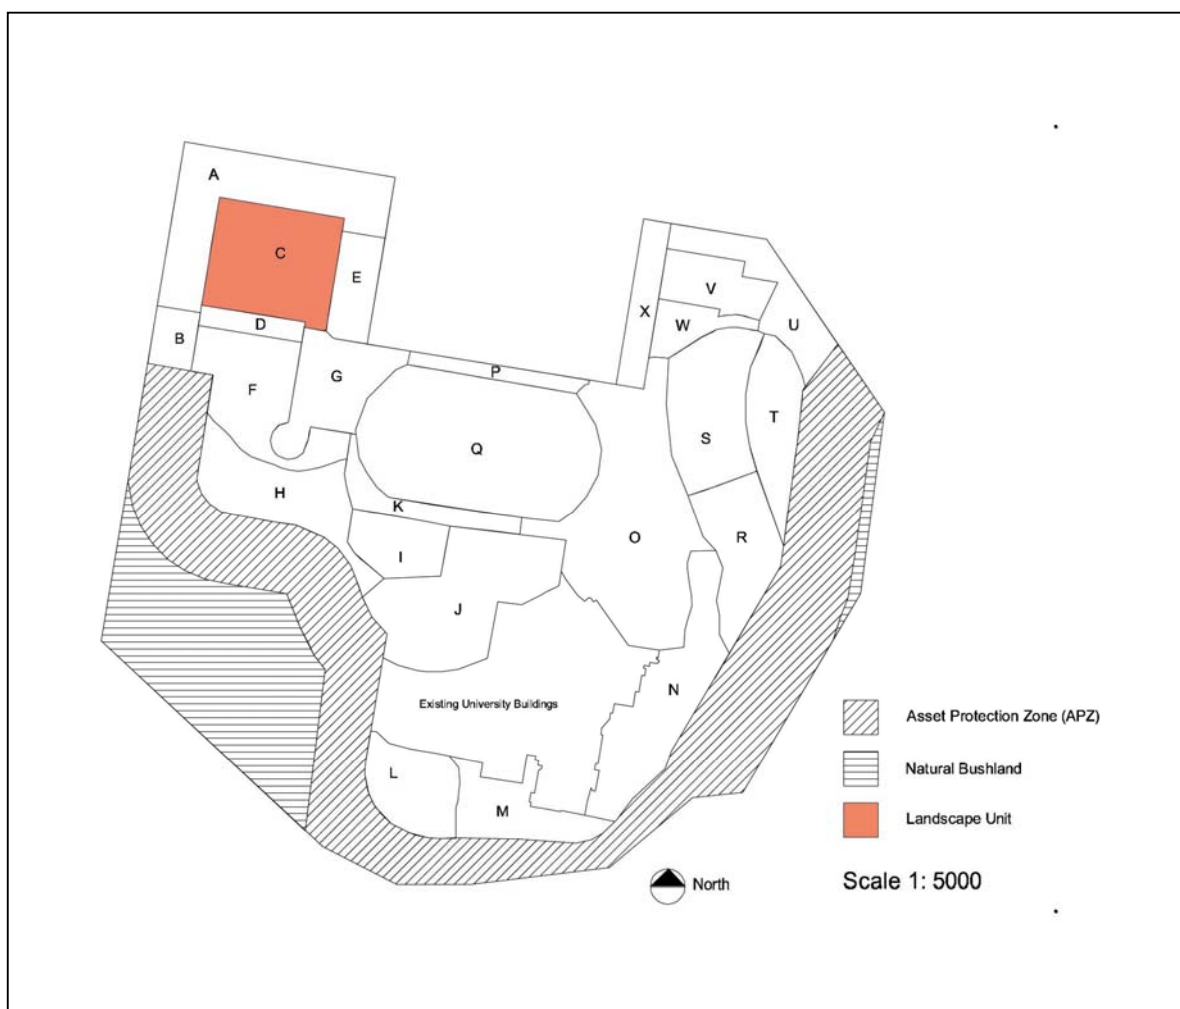
## Landscape Unit C

North-west carpark. Trees occur in narrow corridors of remnant vegetation separating alleys of the carpark. The site is level and exposed.

**Comments:** The proposed site lay-out would require the removal of many of the substantial, significant trees in this area.

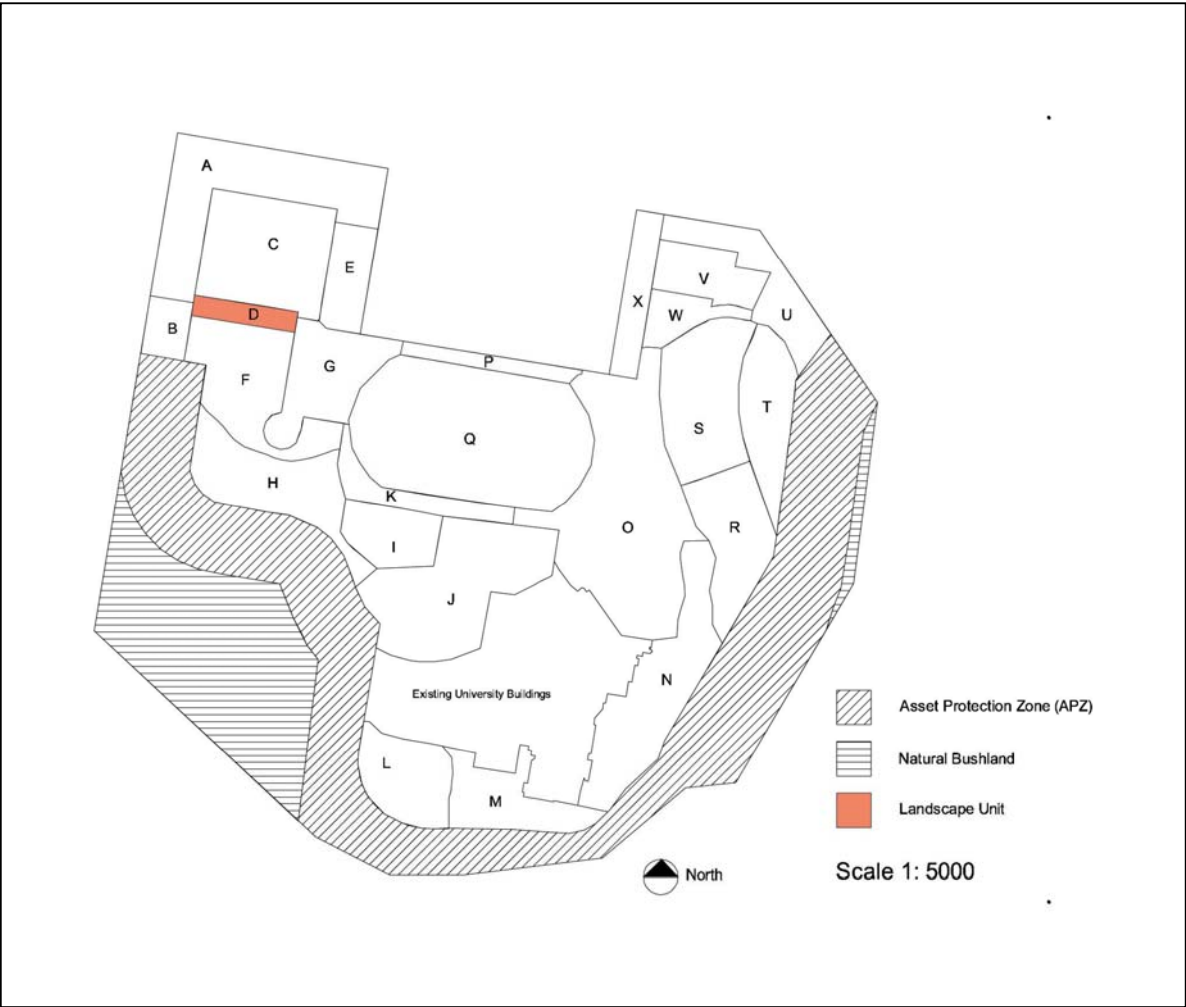
Landscape Unit D

Embankment between upper Childcare Centre Carpark and lower north-west carpark. Remnant bushland. The site slopes gently.

**Other Comments:** This area contains a few specimens worthy of retention. They should be assessed for structural problems prior to making any decisions about sub-division. It may be that retention is inadvisable.

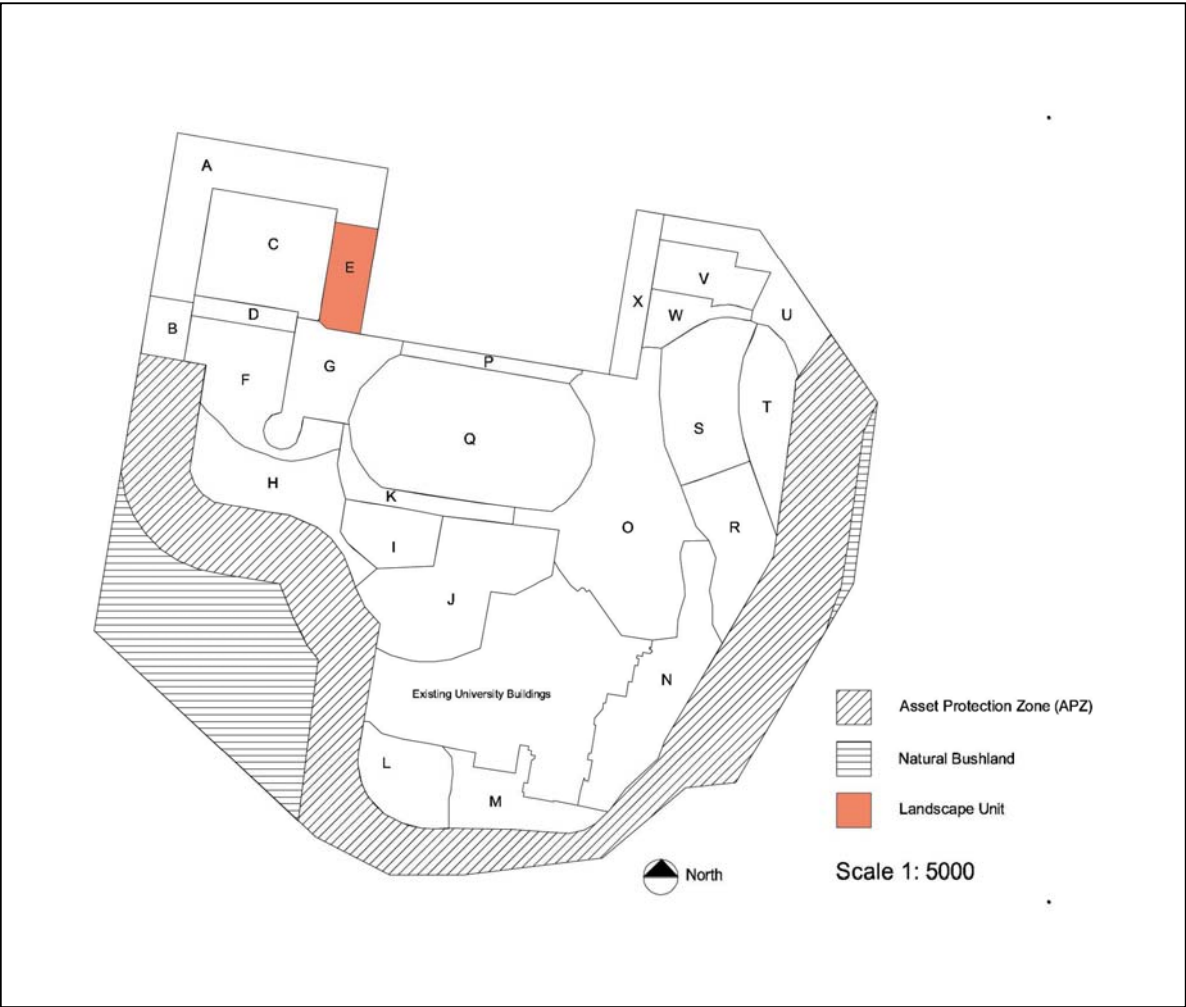
Landscape Unit E

Boundary between Sportsground Carpark and Film Australia. Trees are part of remnant vegetation associated with landscape plantings in the neighbouring property.

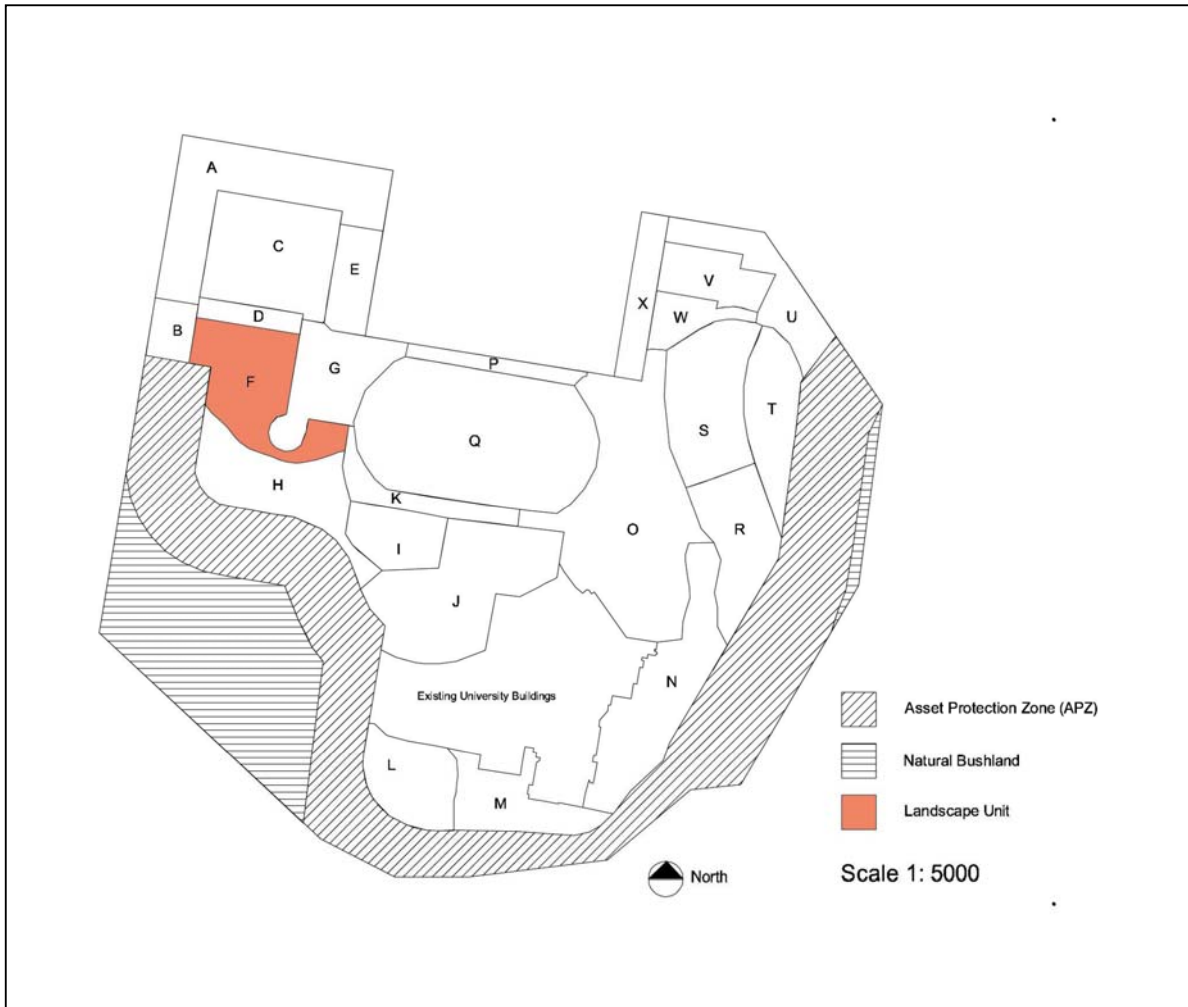
## Landscape Unit F

Bushland below the Childcare Centre Carpark and the Maintenance Workshop. Trees occur in an undeveloped area of remnant bushland subject to run-off from areas above. The site slopes very steeply above rock outcrops in places.

**Other Comments:** This landscape unit needs careful assessment prior to the development of any site lay-out. Parts of it are a valuable 'natural' landscape asset.

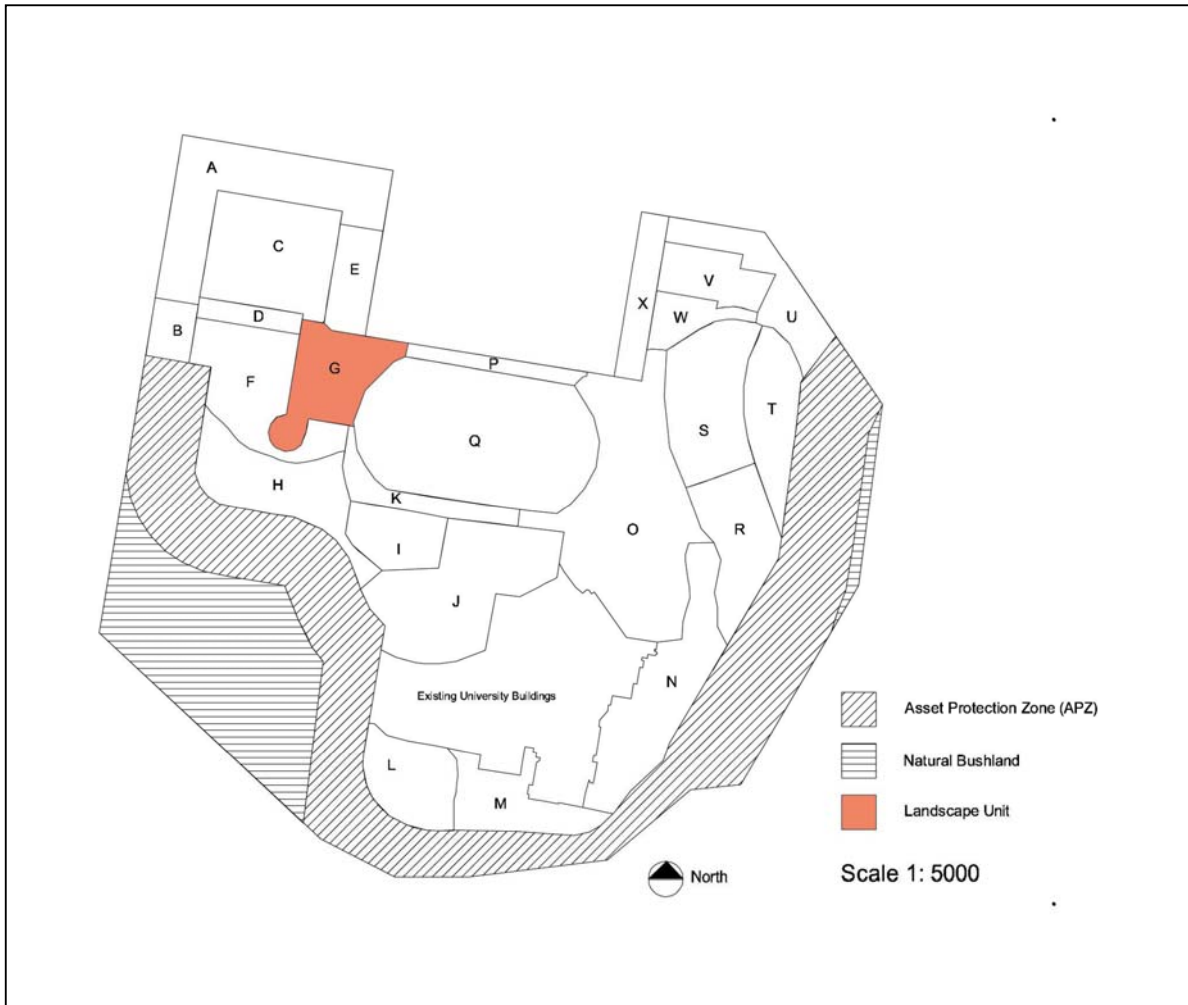
## Landscape Unit G

Childcare Centre, Carpark and Maintenance Facility. A level landscape unit with embankments above bushland (landscape units D and F directly and, indirectly, landscape units B and H). Mostly cleared with buildings, roadways and parking. Landscaped areas contain planted and possibly remnant trees.

**Other Comments:** Most trees in this landscape unit are worthy of retention for their amenity and environmental values.

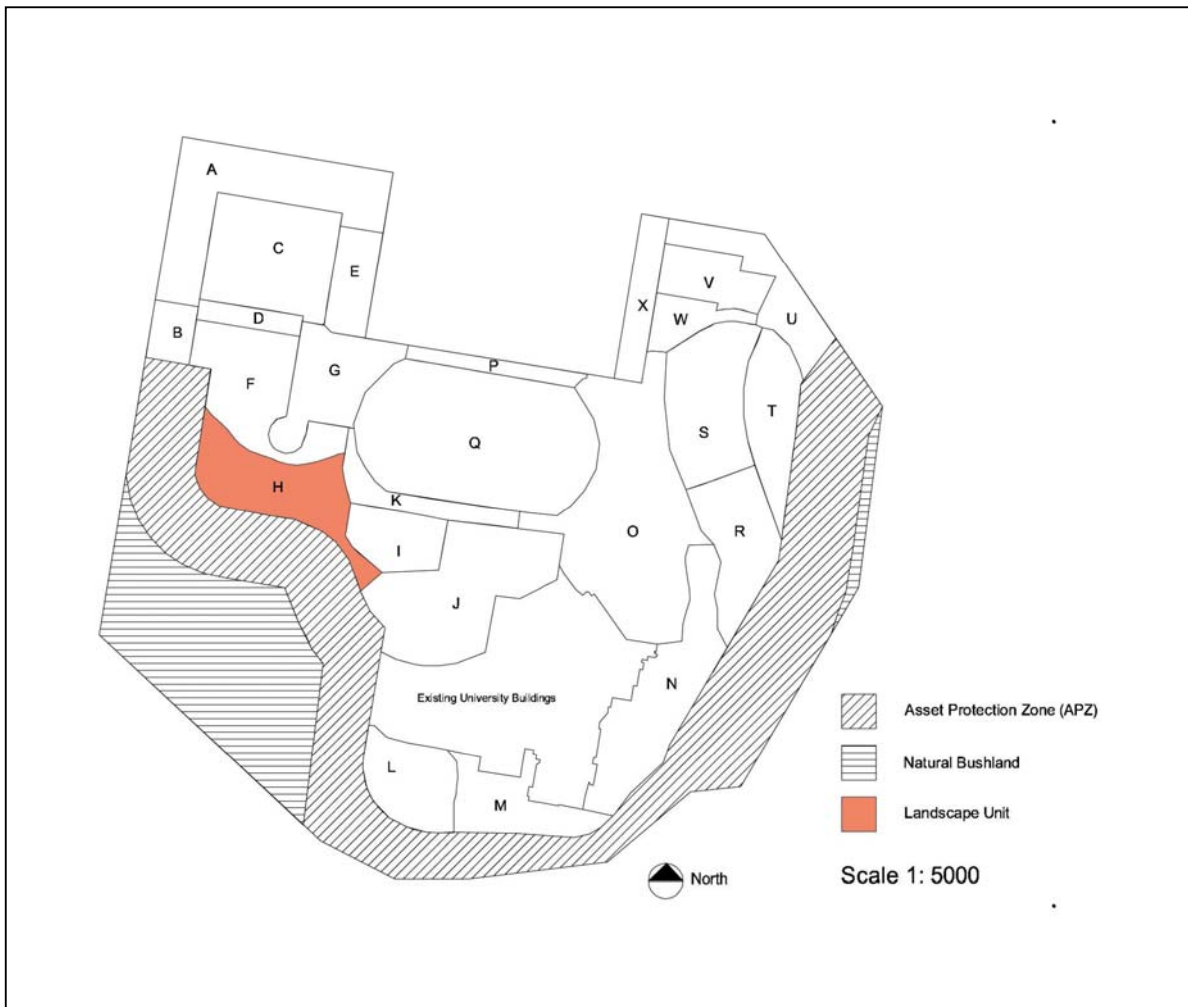
## Landscape Unit H

Bushland west of the tennis courts. Trees occur in remnant vegetation subject to minor impacts from land uses above. The landscape unit contains rocky outcrops and steep sandstone cliffs.

**Comments:** The trees here are a highly valuable asset to the site, whatever its future.

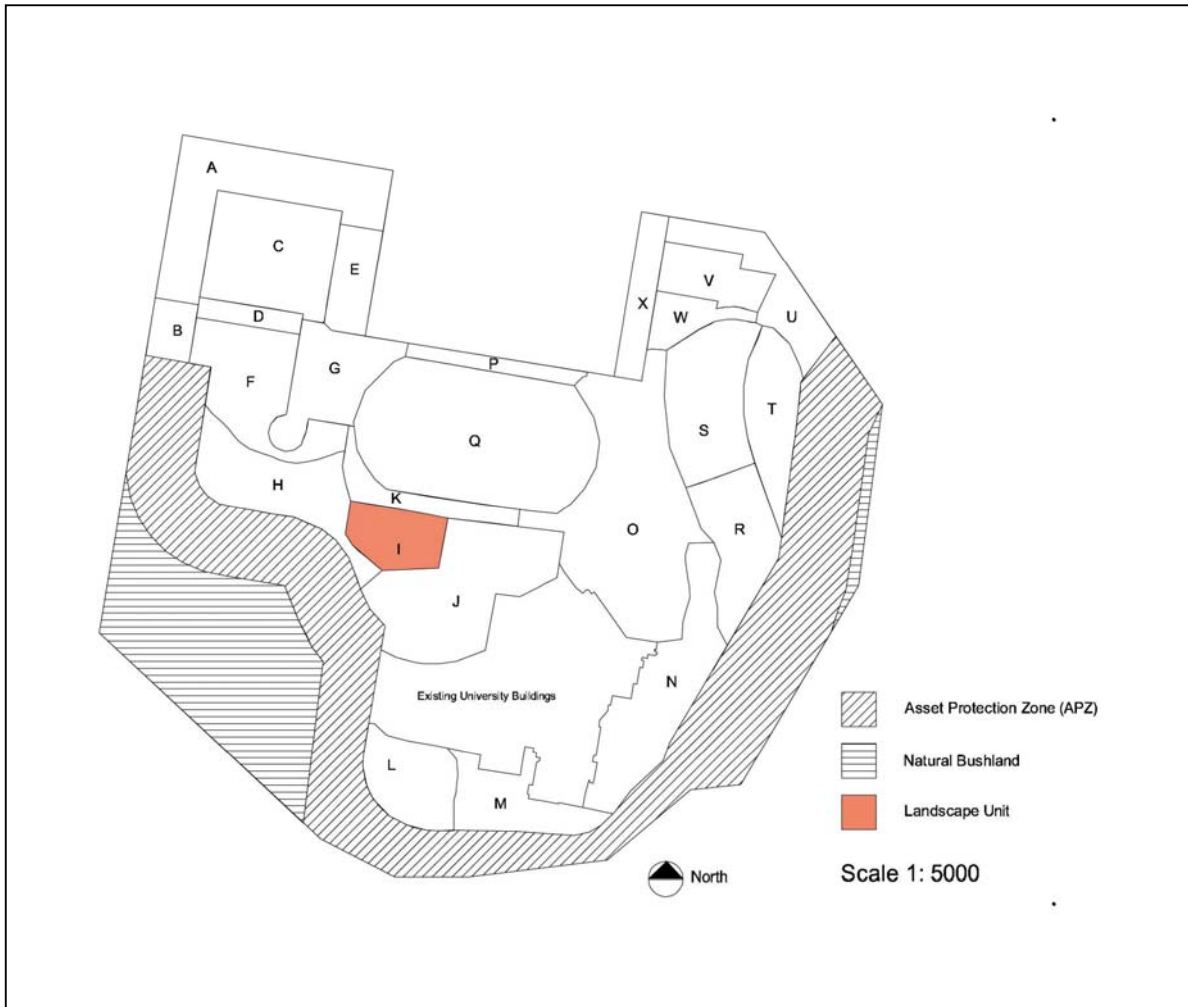
## Landscape Unit I

Terrace containing western tennis courts and its southwestern and western perimeter embankment. Trees occur in the perimeter embankment and appear to have regenerated or grown from revegetation sowings. An invasive exotic species (*Celtis australis*) is establishing. The areas containing trees are steep embankments below the terrace.

**Other Comments:** This landscape unit could be managed and replanted for improved outcomes.

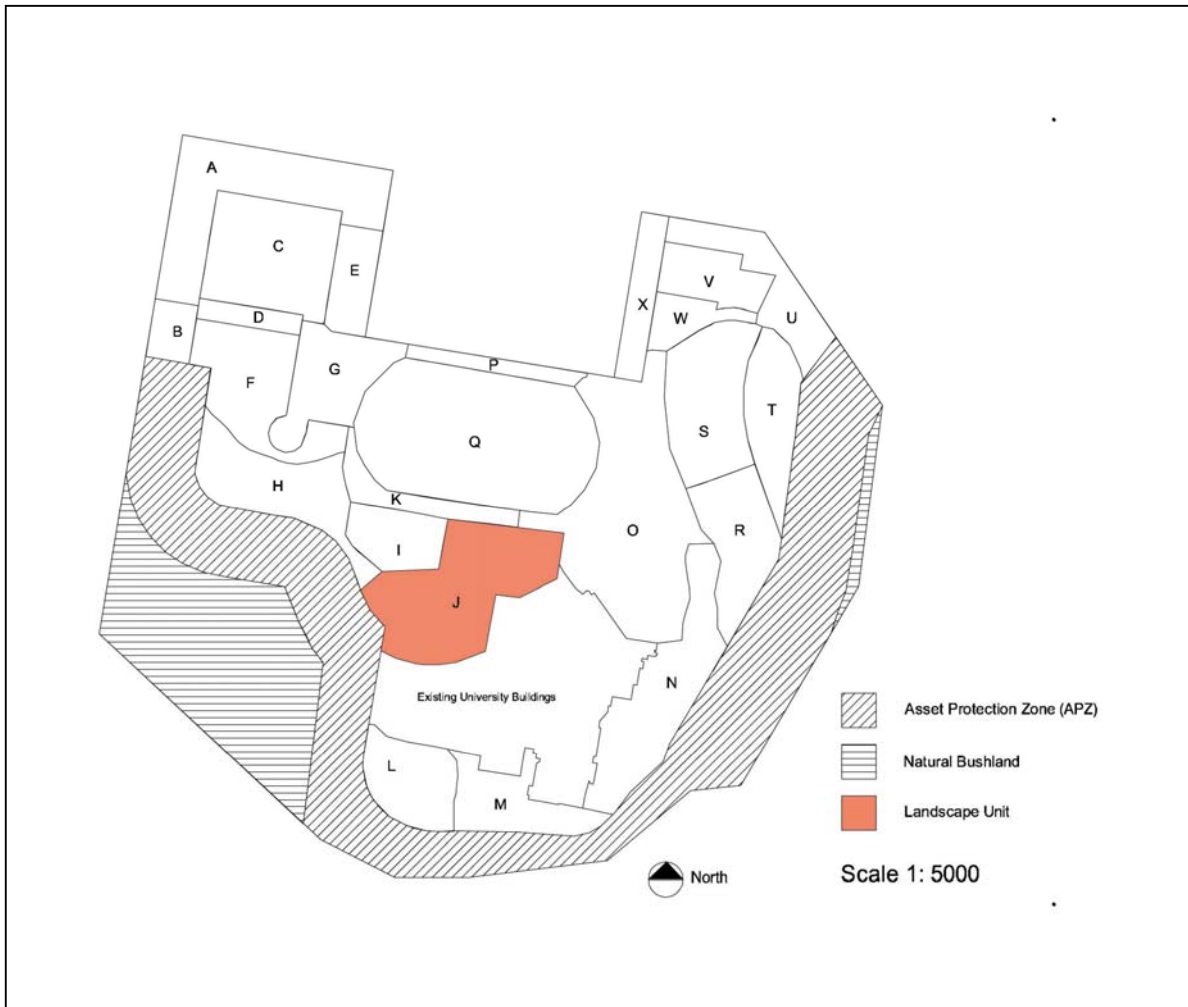
## Landscape Unit J

The central and south tennis courts below the oval. Trees occur in a defined area to the east and southeast and in a small grove at the eastern end of the embankment below the sports oval. Many appear to be the product of natural regrowth that occurred in constructed or disturbed landscape areas.

**Other Comments:** The trees in the dense plantings are not worthy of retention under the existing management regime. They require thinning and their removal and replacement in subsequent landscaping works should be acceptable. The few substantial trees to the southwest could be replaced. The trees in the grove are very valuable and should be preserved.

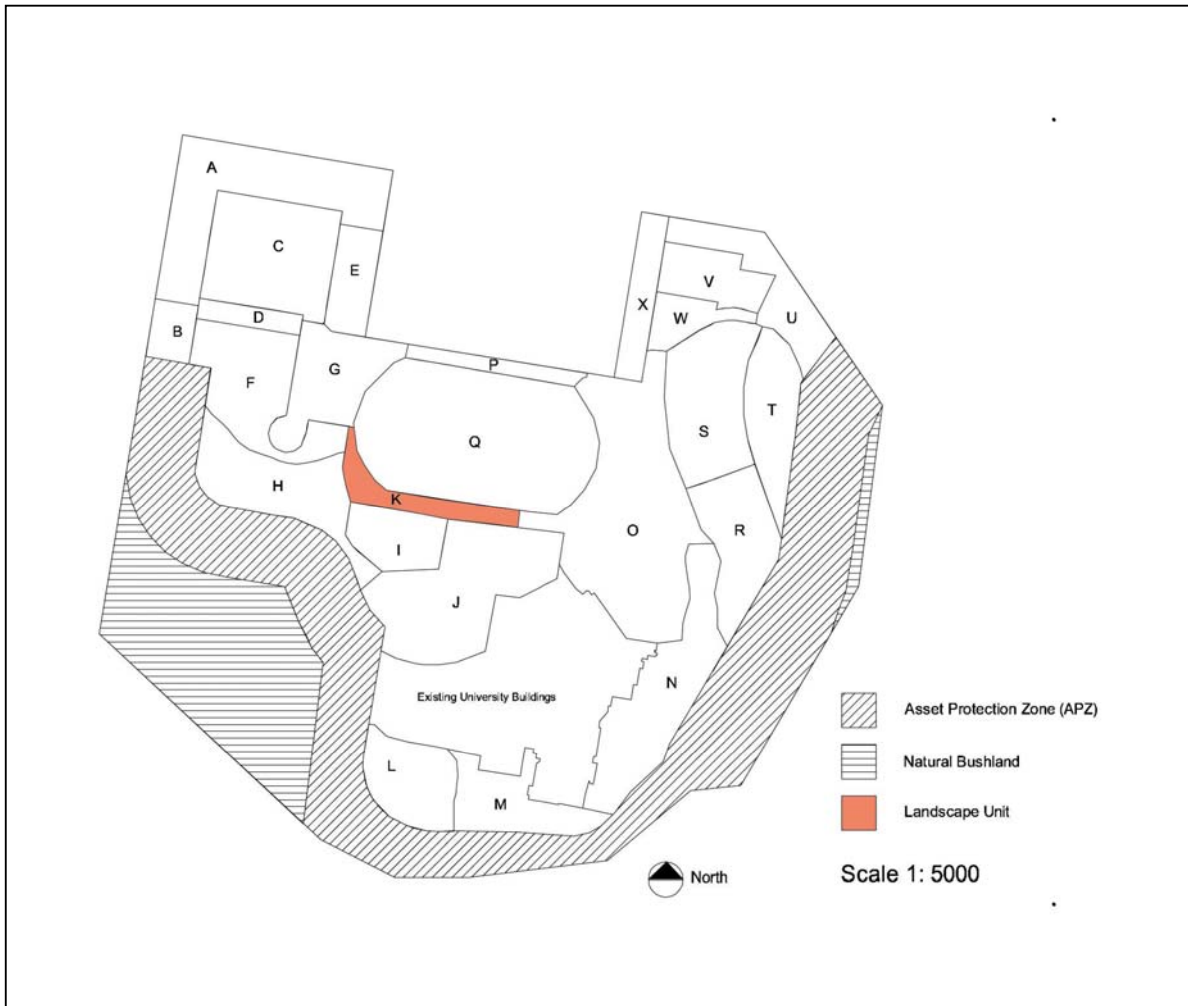
## Landscape Unit K

The embankment below the oval to the south. Trees occur along the embankment. They are the product of natural regrowth and subsequent plantings that occurred after construction of the embankment.

**Other Comments:** Trees along the embankment are very valuable, despite being in mixed condition. They should be preserved.

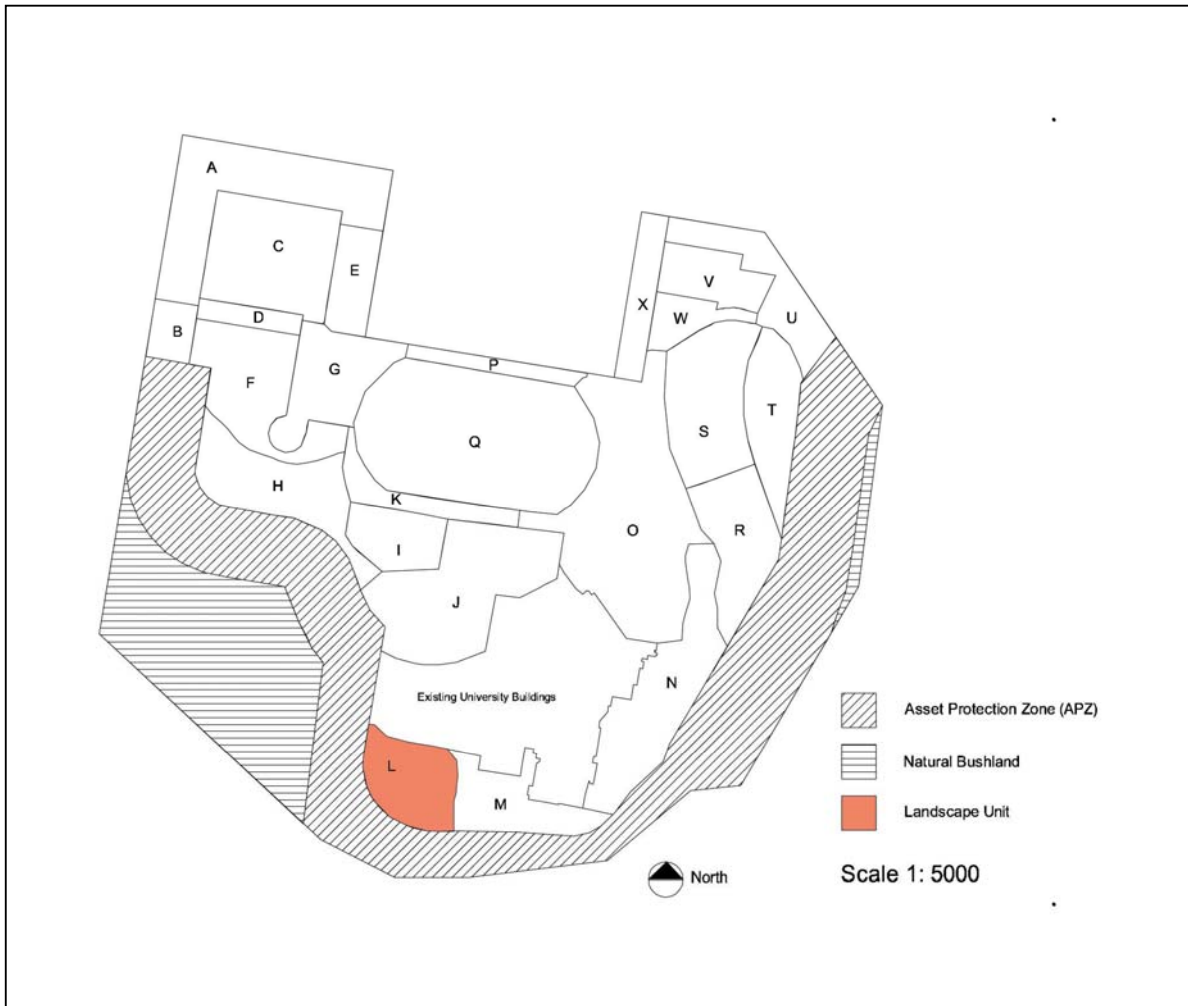
## Landscape Unit L

Remnant heathland adjoining the southwest lawn behind the Conference Centre. Trees occur as naturally stunted specimens due to the environmental conditions of the area; they are not subject to Ku-ring-gai Council's Tree Preservation Order. The landscape unit is level with a gentle fall to the southwest.

**Other Comments:** Despite its lack of trees and its degraded condition, this landscape unit is of high significance to the integrity of the amenity landscape at the rear of the university buildings.

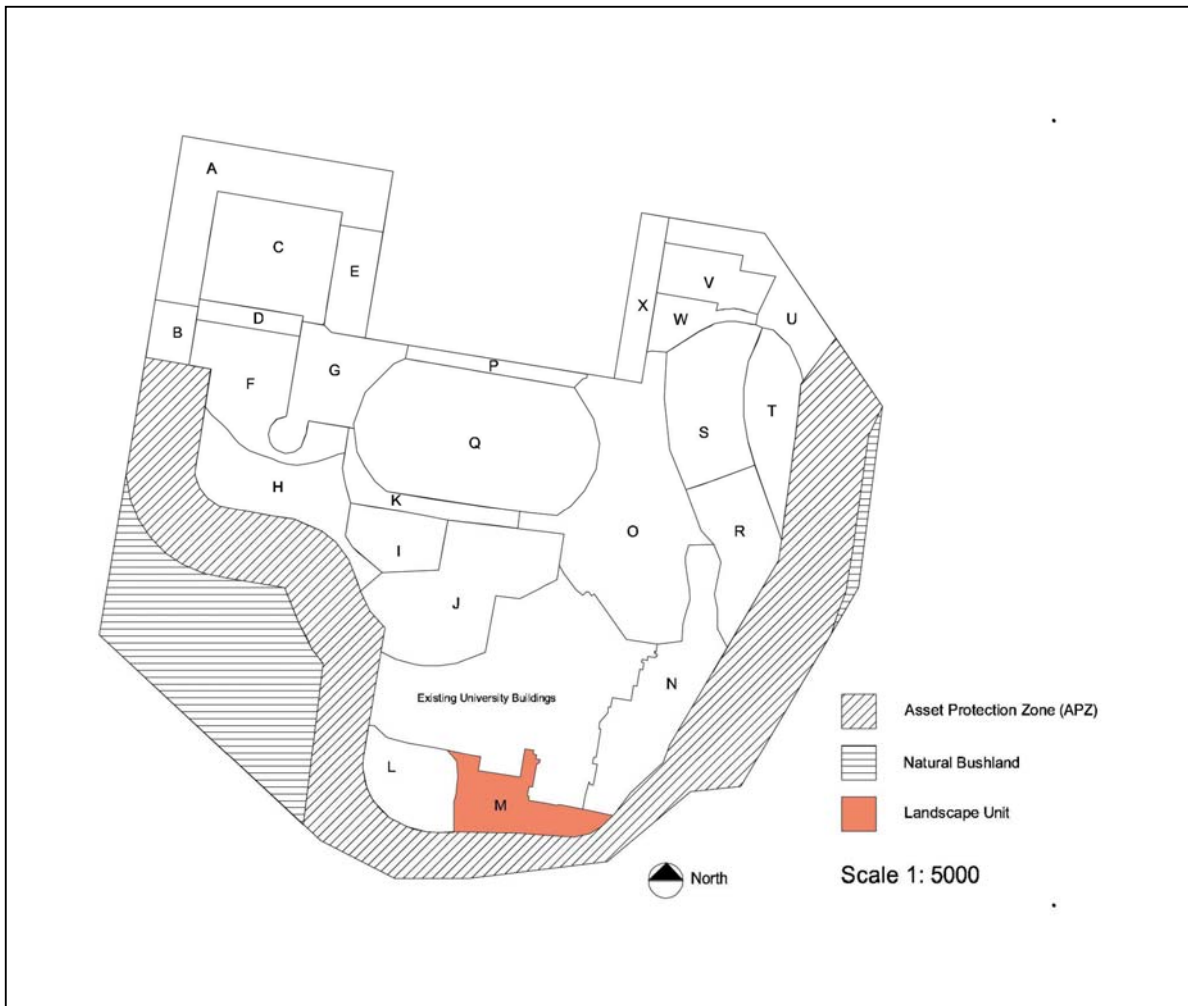
## Landscape Unit M

Landscape to the southeast of the Conference Centre. Trees occur in open landscaped area with natural rock outcrops and mown lawns. The landscape unit is mostly level or gently sloping.

**Other Comments:** Trees are an integral component of the landscape in this landscape unit and they should be retained and managed.

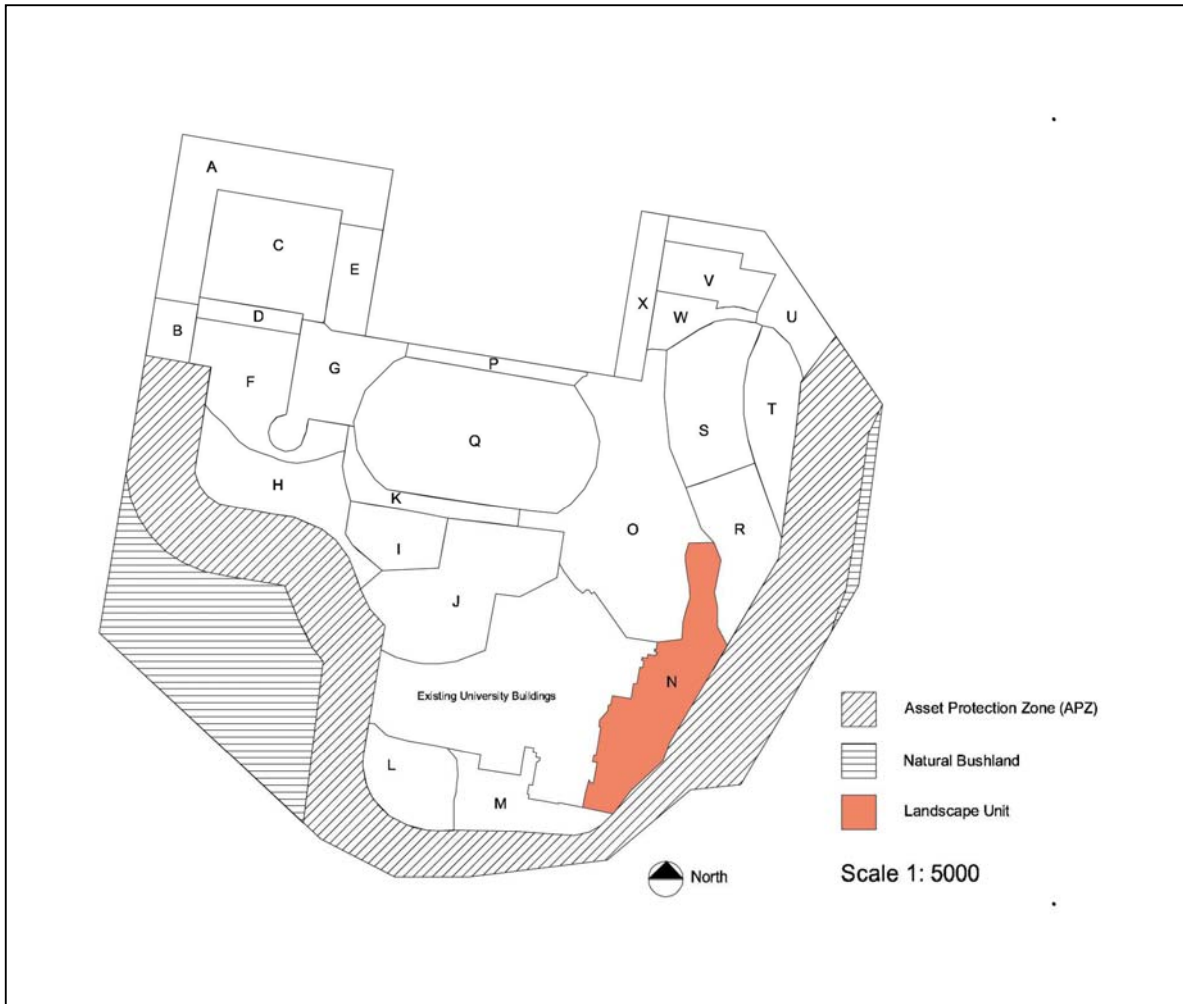
## Landscape Unit N

Southeastern area of the site in the vicinity of the Conference Carpark. Trees occur in naturalistic landscape areas beside roads and around carparks. The landscape unit is moderately steep and the carparks form terraces in the hillside. Vegetation occurs on the slopes.

**Other Comments:** Attractive views out of the site are screened by trees in this area, but this part of the site is highly visible from Fullers Bridge Road to the southeast. The trees have an important role in providing a vista of bushland landscape in which the buildings are visually minimised.

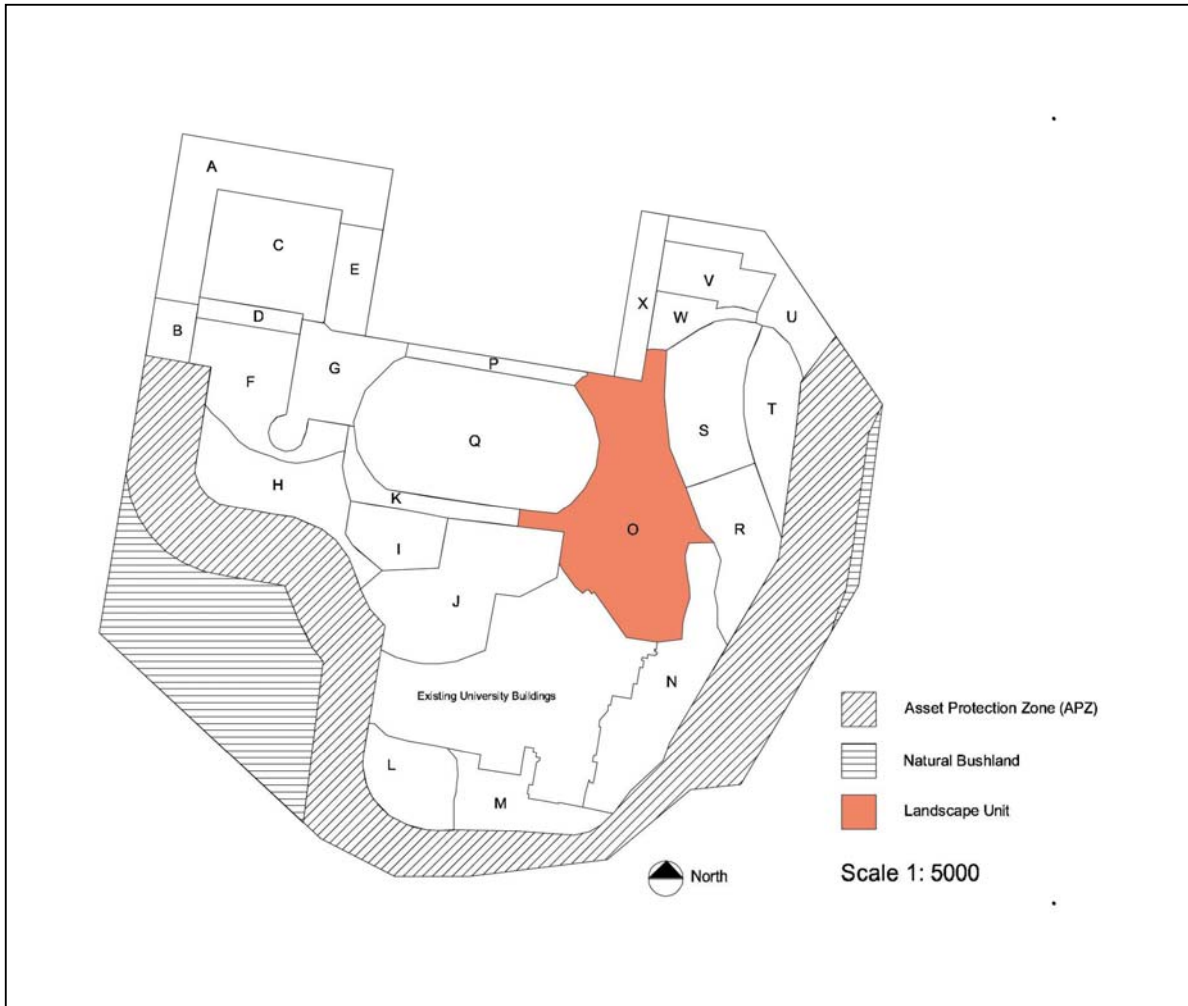
## Landscape Unit O

Front entry to the buildings with access paths, roadways and small carparks. Level to gently sloping landscape containing areas of remnant vegetation and regrowth of trees, and a central landscaped area containing lawns, clipped shrubbery and planted specimen trees.

**Other Comments:** A detailed landscape and vegetation assessment to develop a plan for the rehabilitation of this landscape unit is needed. This is a component of a landscape of potential heritage significance.

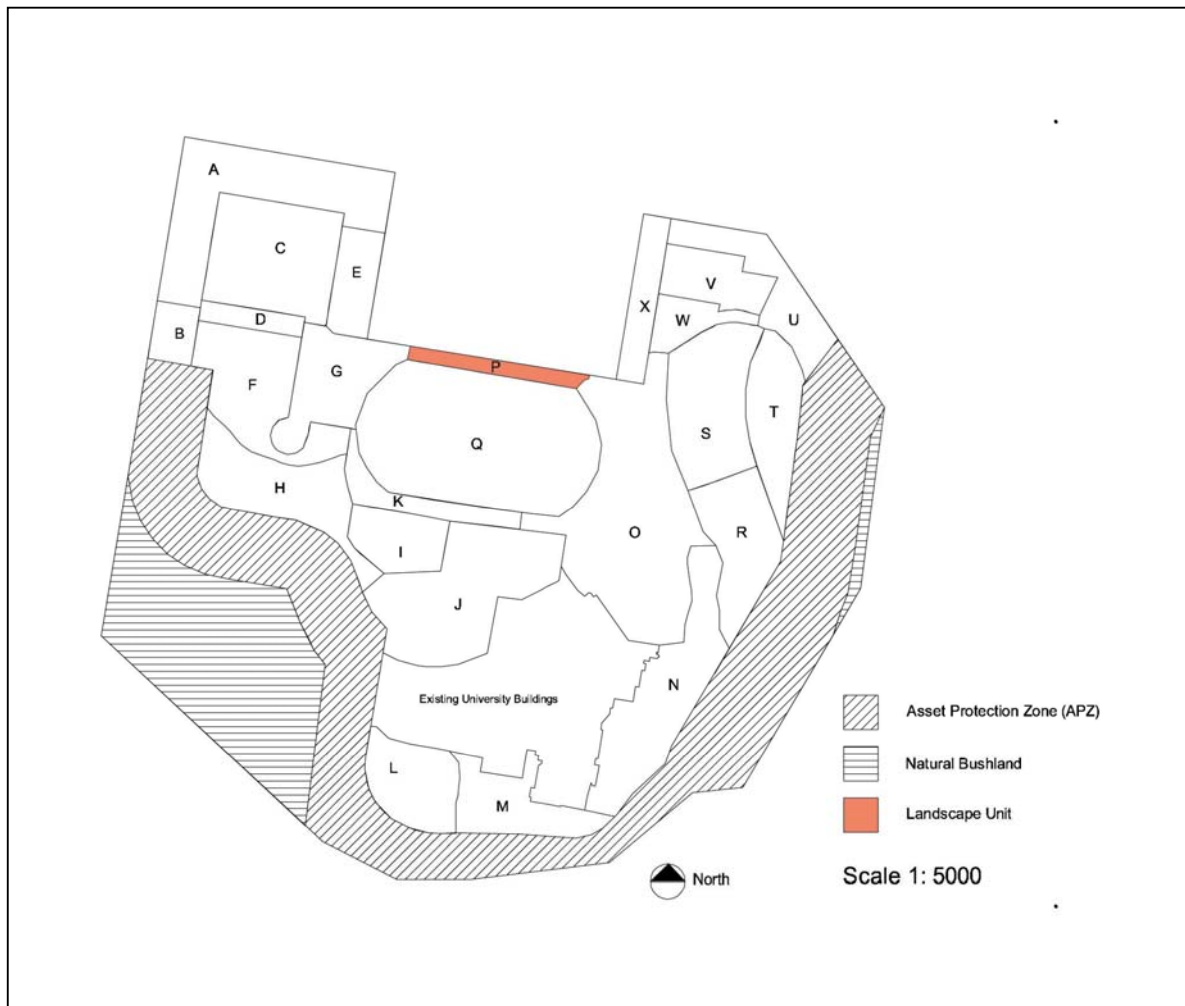
## Landscape Unit P

The access road to the Childcare Centre and sportsfield carpark. Trees occur in a dividing median strip between the two lanes of the road. The area is level.

**Other Comments:** These trees are highly significant to the existing landscape of the site and will remain so under the development proposal.

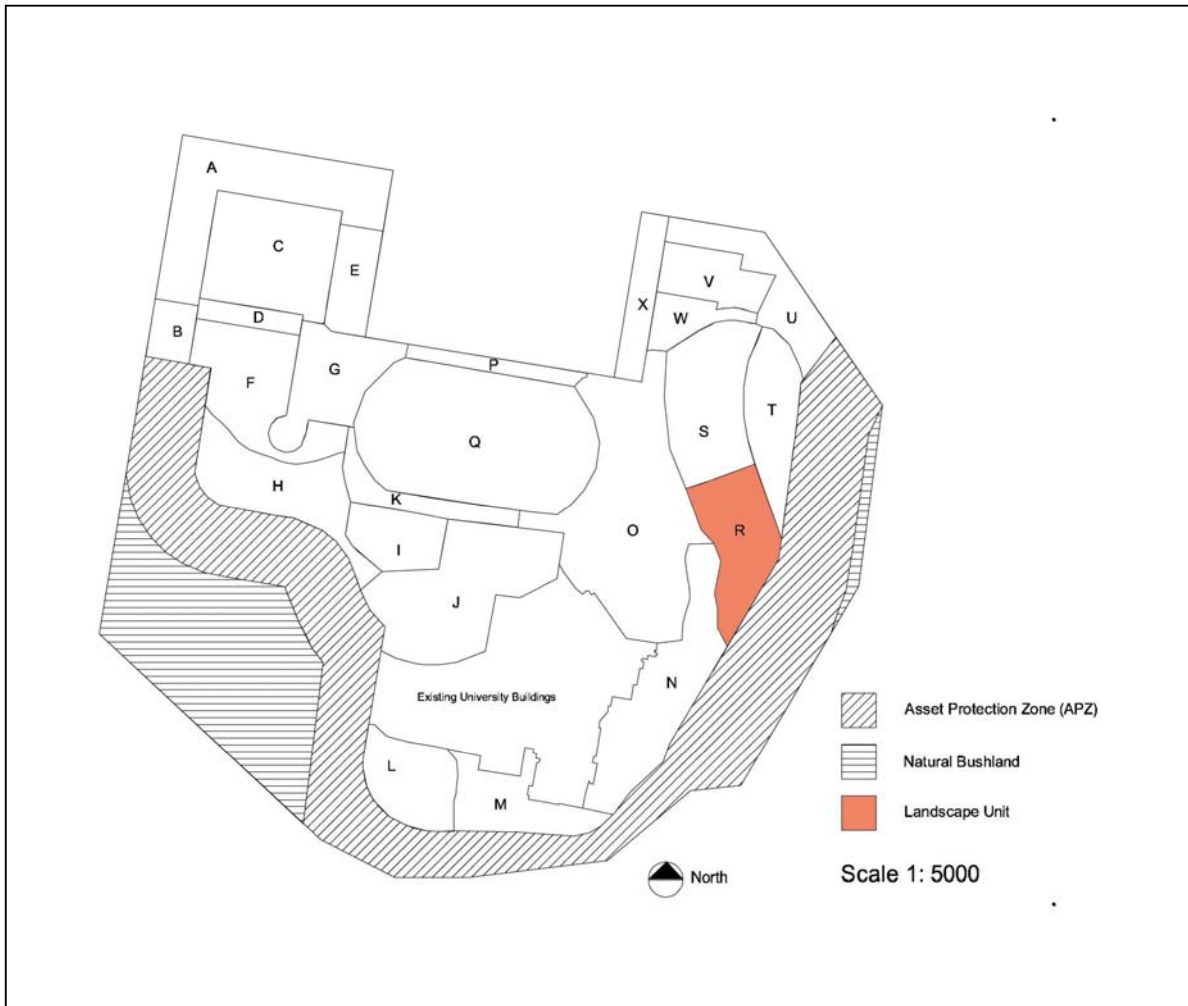
## Landscape Unit R

Area from the southern section of the northeast carparks to the northern section of the Conference Centre Carpark. Trees occur in natural landscapes surrounding carparks. The landscape unit slopes moderately to steeply from west to east.

**Other Comments:** Trees and vegetation in this landscape unit are generally in poor condition and require management to improve their health and long-term viability.
