## Tree Assets Report

### UTS Ku-ring-gai Campus Lindfield

Reissued July 2006

Reissued October 2007

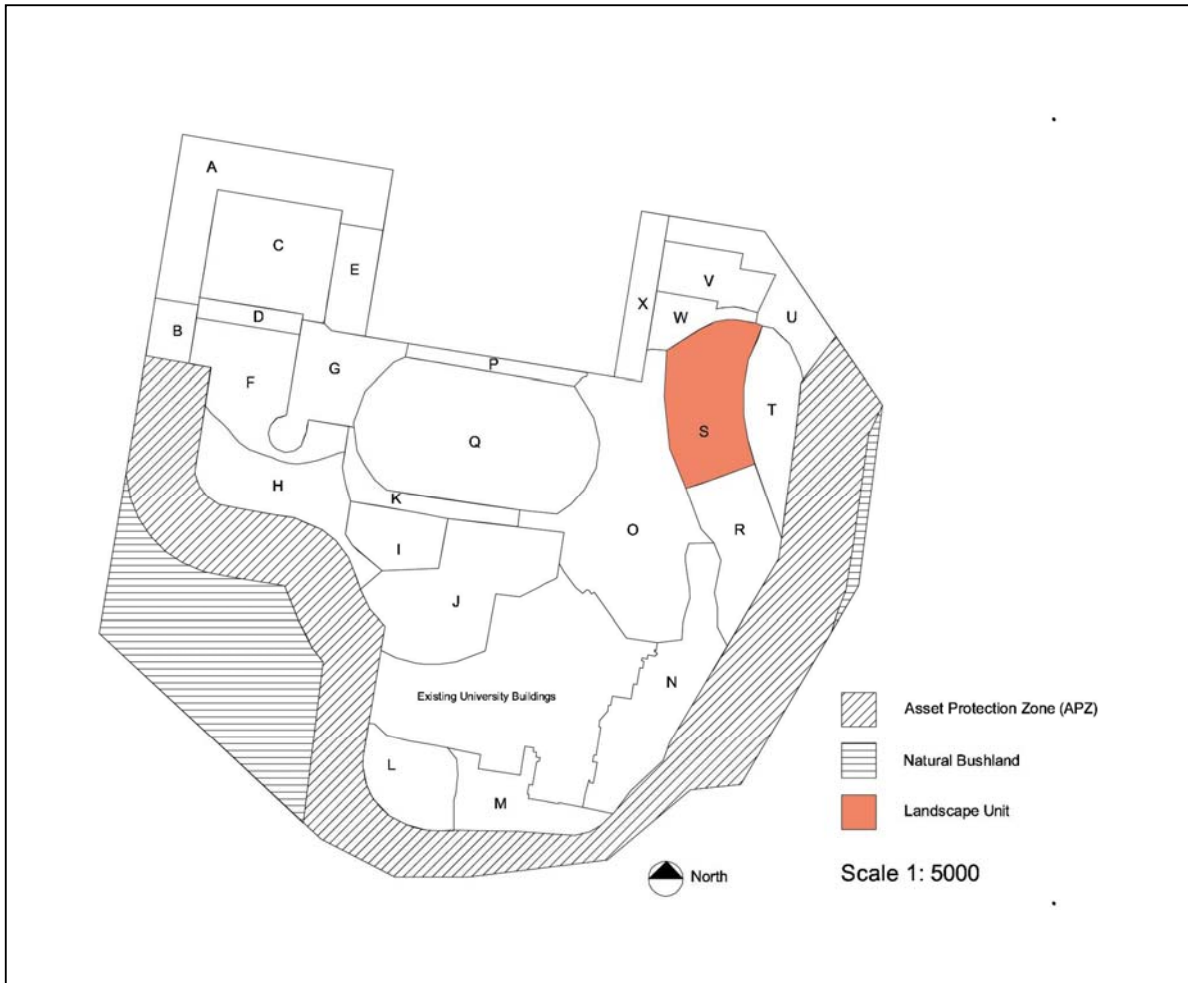
## Landscape Unit S

Upper terrace of northeastern carpark. Trees occur in natural vegetation surrounding roadways and carparks. Carparks are terraces cut into sloping site. Retaining walls have been built to stabilise cuts.

**Other Comments:** Trees are an excellent asset in this landscape unit.

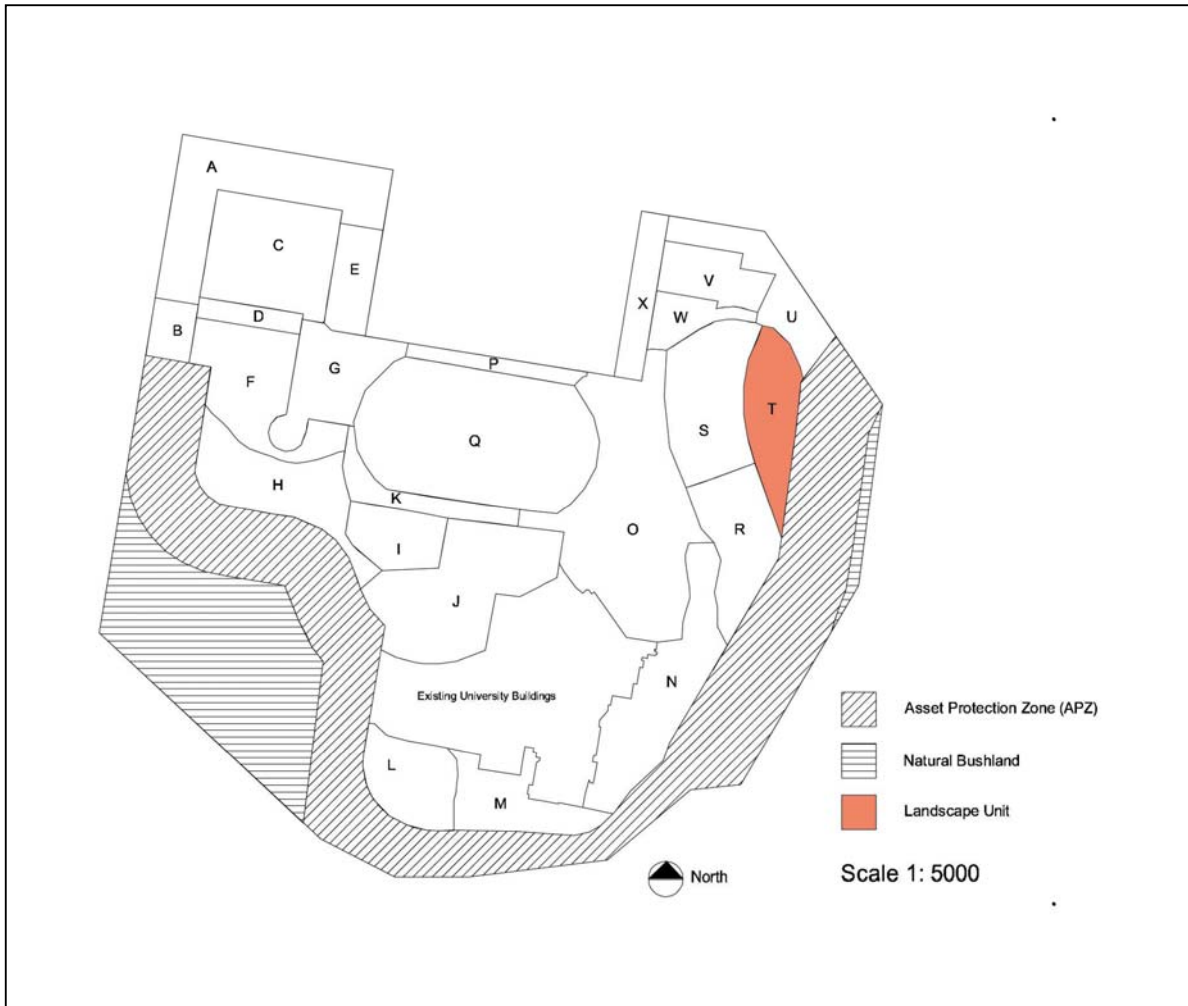
## Landscape Unit T

Lower terrace of northeastern carpark. It faces east to northeast; residential housing lies to the northeast. Trees occur in the natural bushland beside the carpark. A steep embankment runs along the eastern side of the carpark. Beyond the embankment the land falls gently to the east.

**Other Comments:** Valuable tree assets occur in this landscape unit.

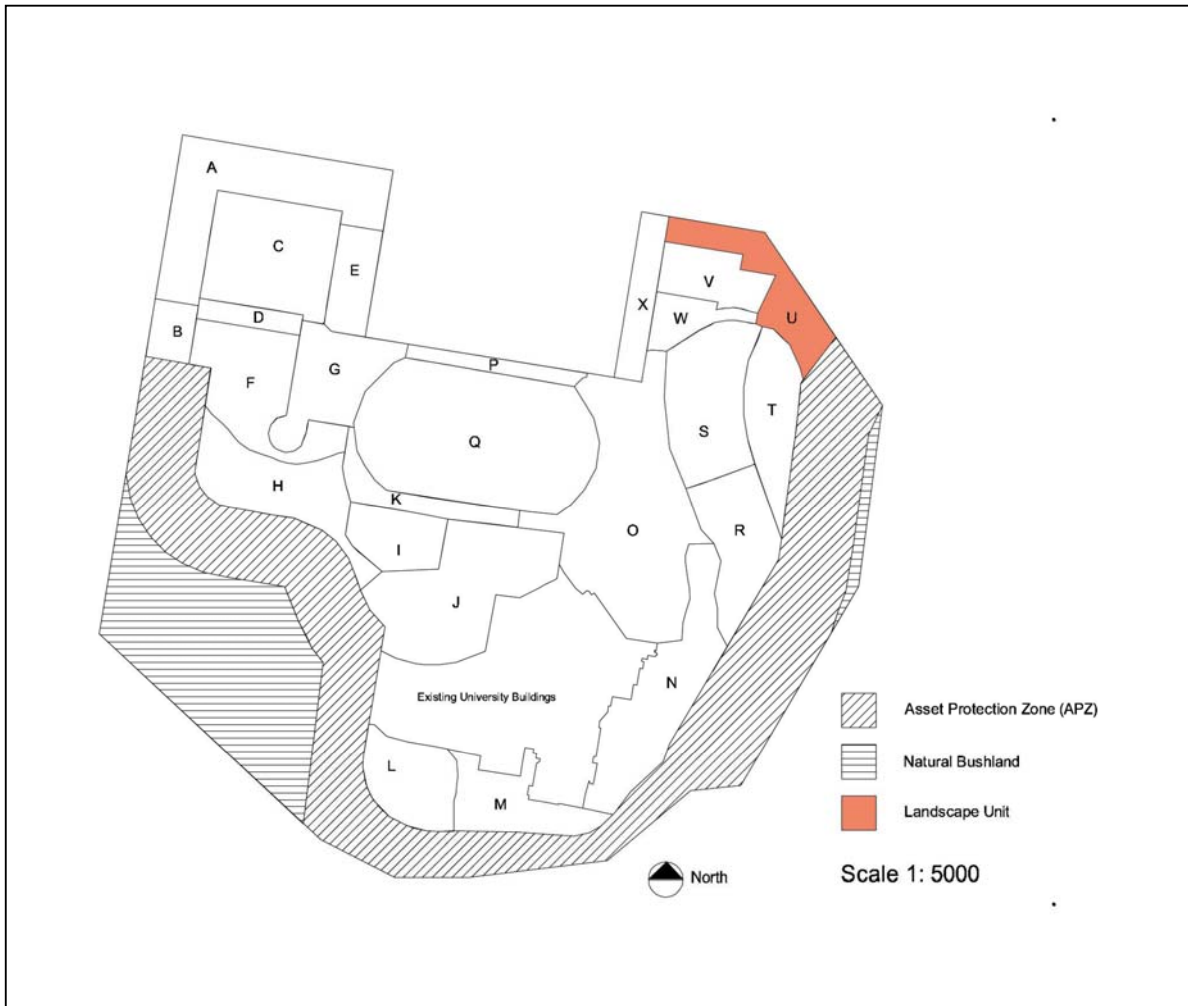
## Landscape Unit U

Boundary with residential properties to the north and northeast. Trees occur in disturbed bushland areas and cleared, 'gardened' landscapes along backyard boundaries. The land falls gently from west to east.

**Other Comments:** Few trees in this area are a constraint on any development proposal.

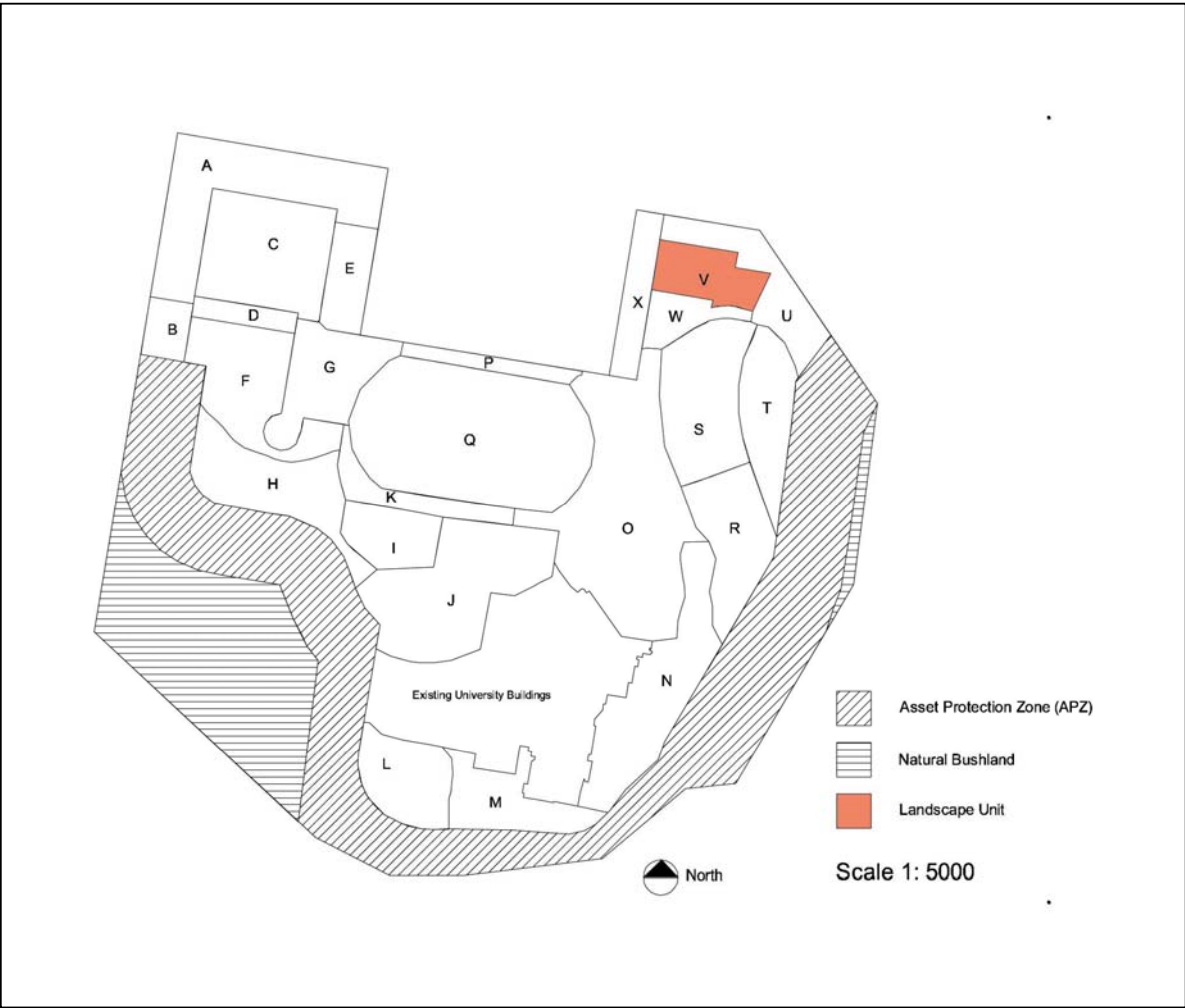
Landscape Unit V

Northeast area of the site in the vicinity of the elevated bus turning bay. Trees occur in disturbed natural bushland. The land falls gently to the northeast.

**Other Comments:** The sub-division should take advantage of the tree assets by allowing for building footprints based on the removal of poor specimens and the retention of the fine trees.

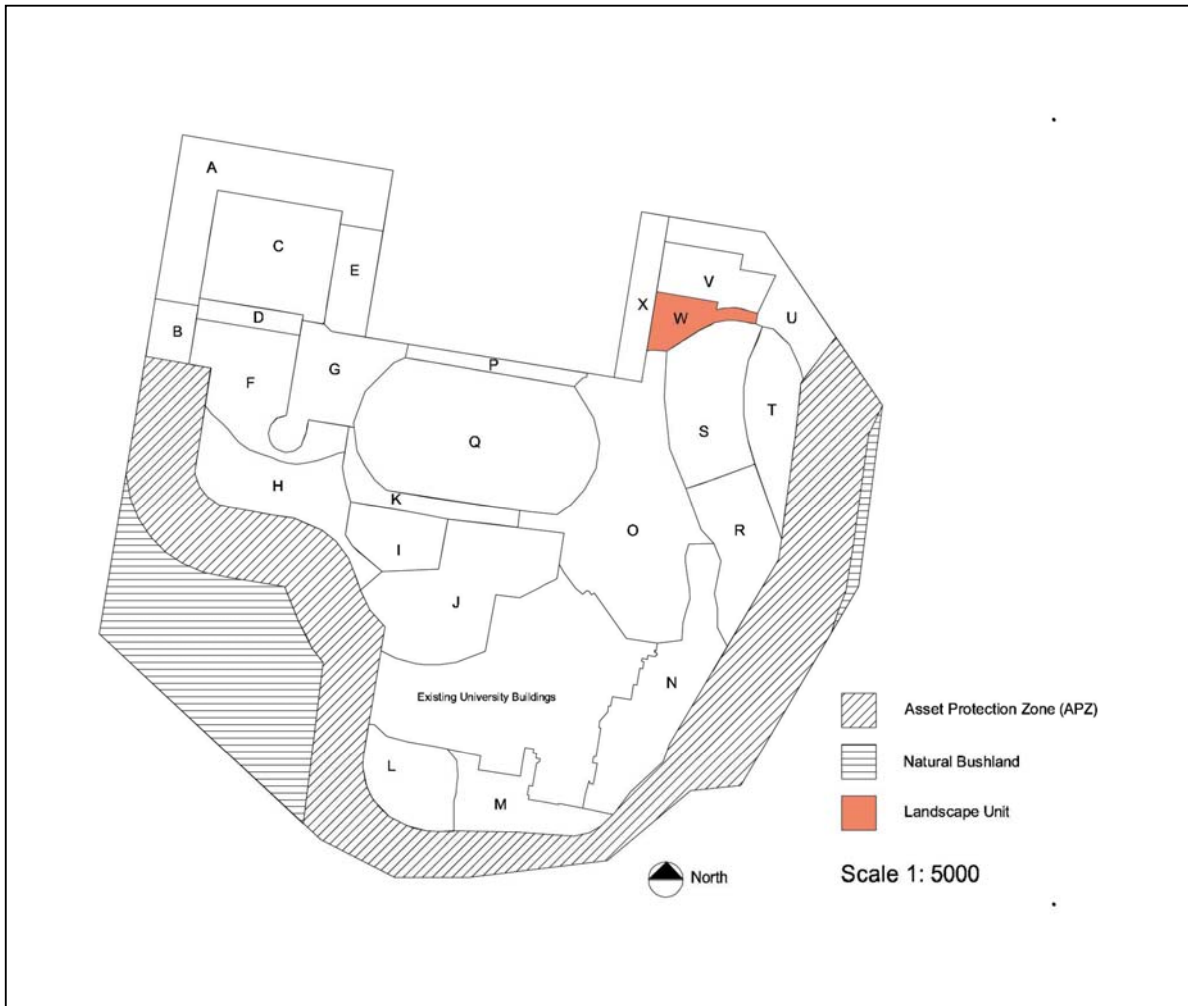
## Landscape Unit W

A small section in the northeast of the site to the south of the bus turning bay and along the roadway to the northeastern carparks. Trees occur in a disturbed and modified natural landscape. The boundaries along the roads are steep, constructed embankments. The unaltered landform below the embankments falls gently to the east and northeast.

**Other Comments:** The substantial, healthy trees in this landscape unit give a park-like character to the interface between the site and the adjoining residential properties.

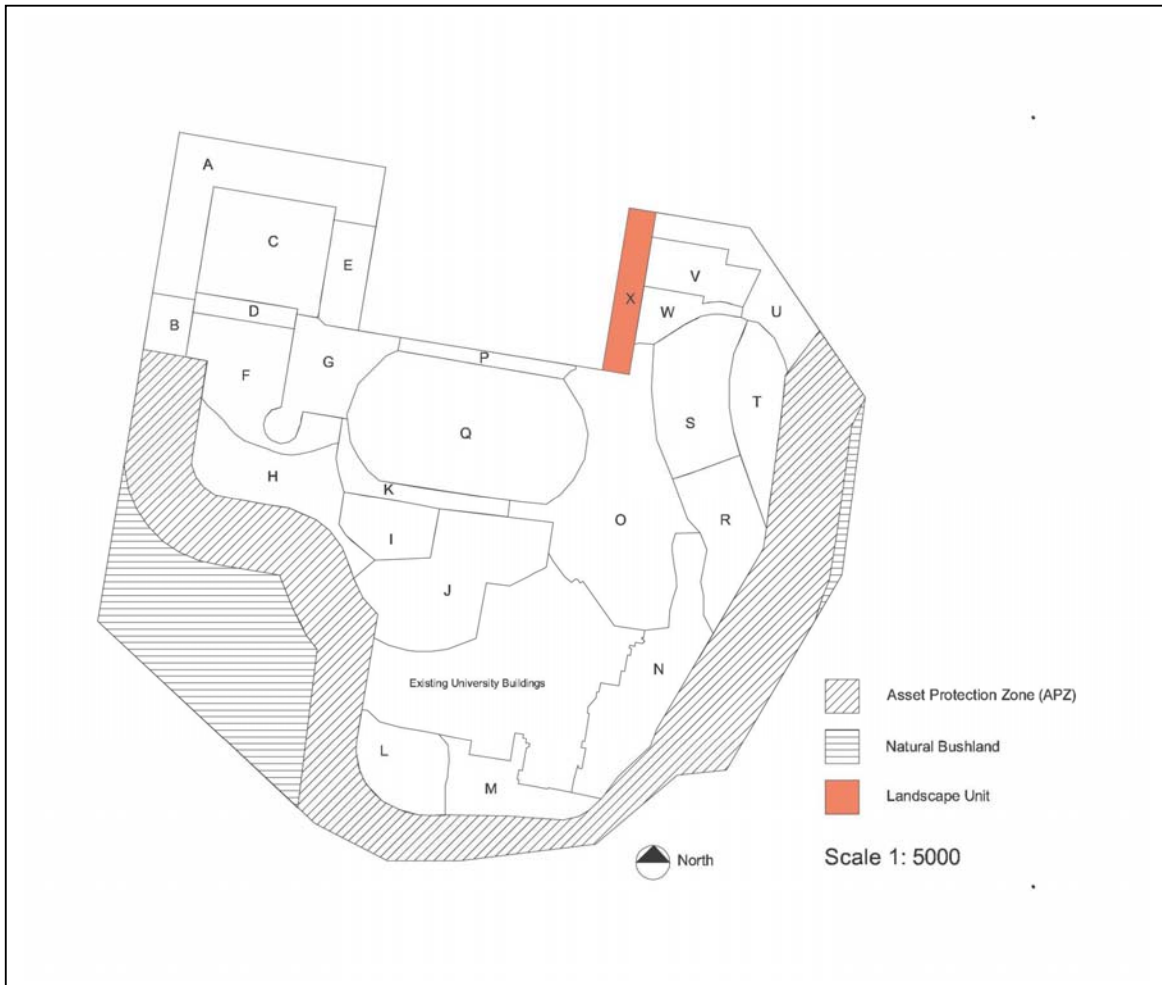
## Landscape Unit X

The entry road to the university campus. Trees occur on both sides of the road. The northern side has a pedestrian path beside the road. The site drops steeply down an embankment below the footpath and trees occur along the ungrassed embankment at different levels within it. The southern side adjoins the property of Film Australia. The trees occur along the verge with the road in grass.

**Other Comments:** This landscape unit is of particular importance as the point of entry and arrival to the site. A future design response may propose tree plantings more in keeping with the character of the site beyond and with the function of this landscape unit.

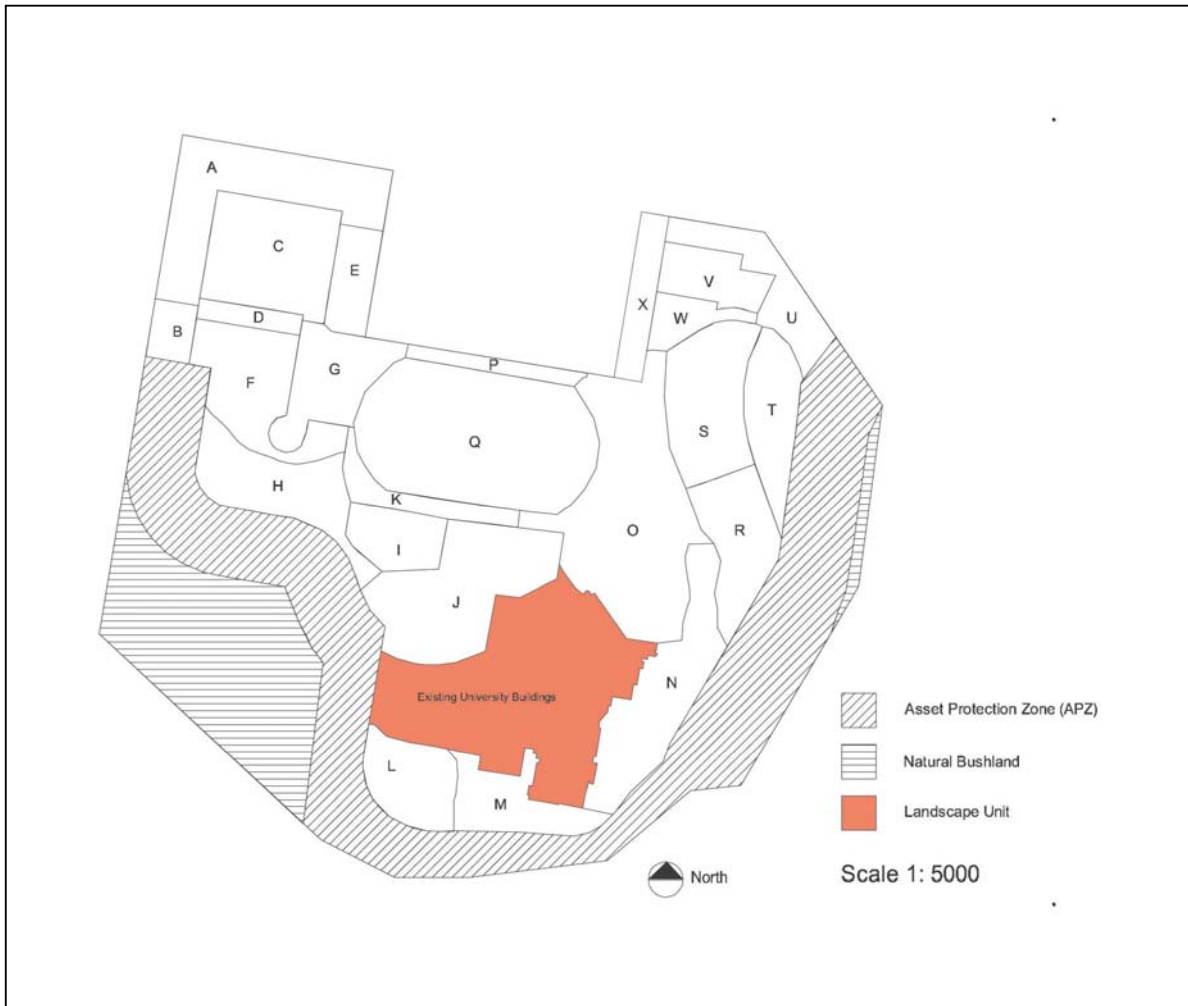
## Landscape Unit Existing University Buildings

A few landscaped areas in close proximity to the university buildings. Trees occur in a few small gardens and edges of other landscape areas. The landscape unit is mostly level or gently sloping and contains paths, roads and buildings. A small area of lawn is located in the south of the landscape unit.

**Other Comments:** The development of a future landscape masterplan for the site should involve the evaluation of the heritage and landscape values of the plantings in this landscape unit.
