SUMMARY REPORT

SITE ASSESSMENTS

NORTH COORANBONG INVESTIGATION AREA

Project 31720A

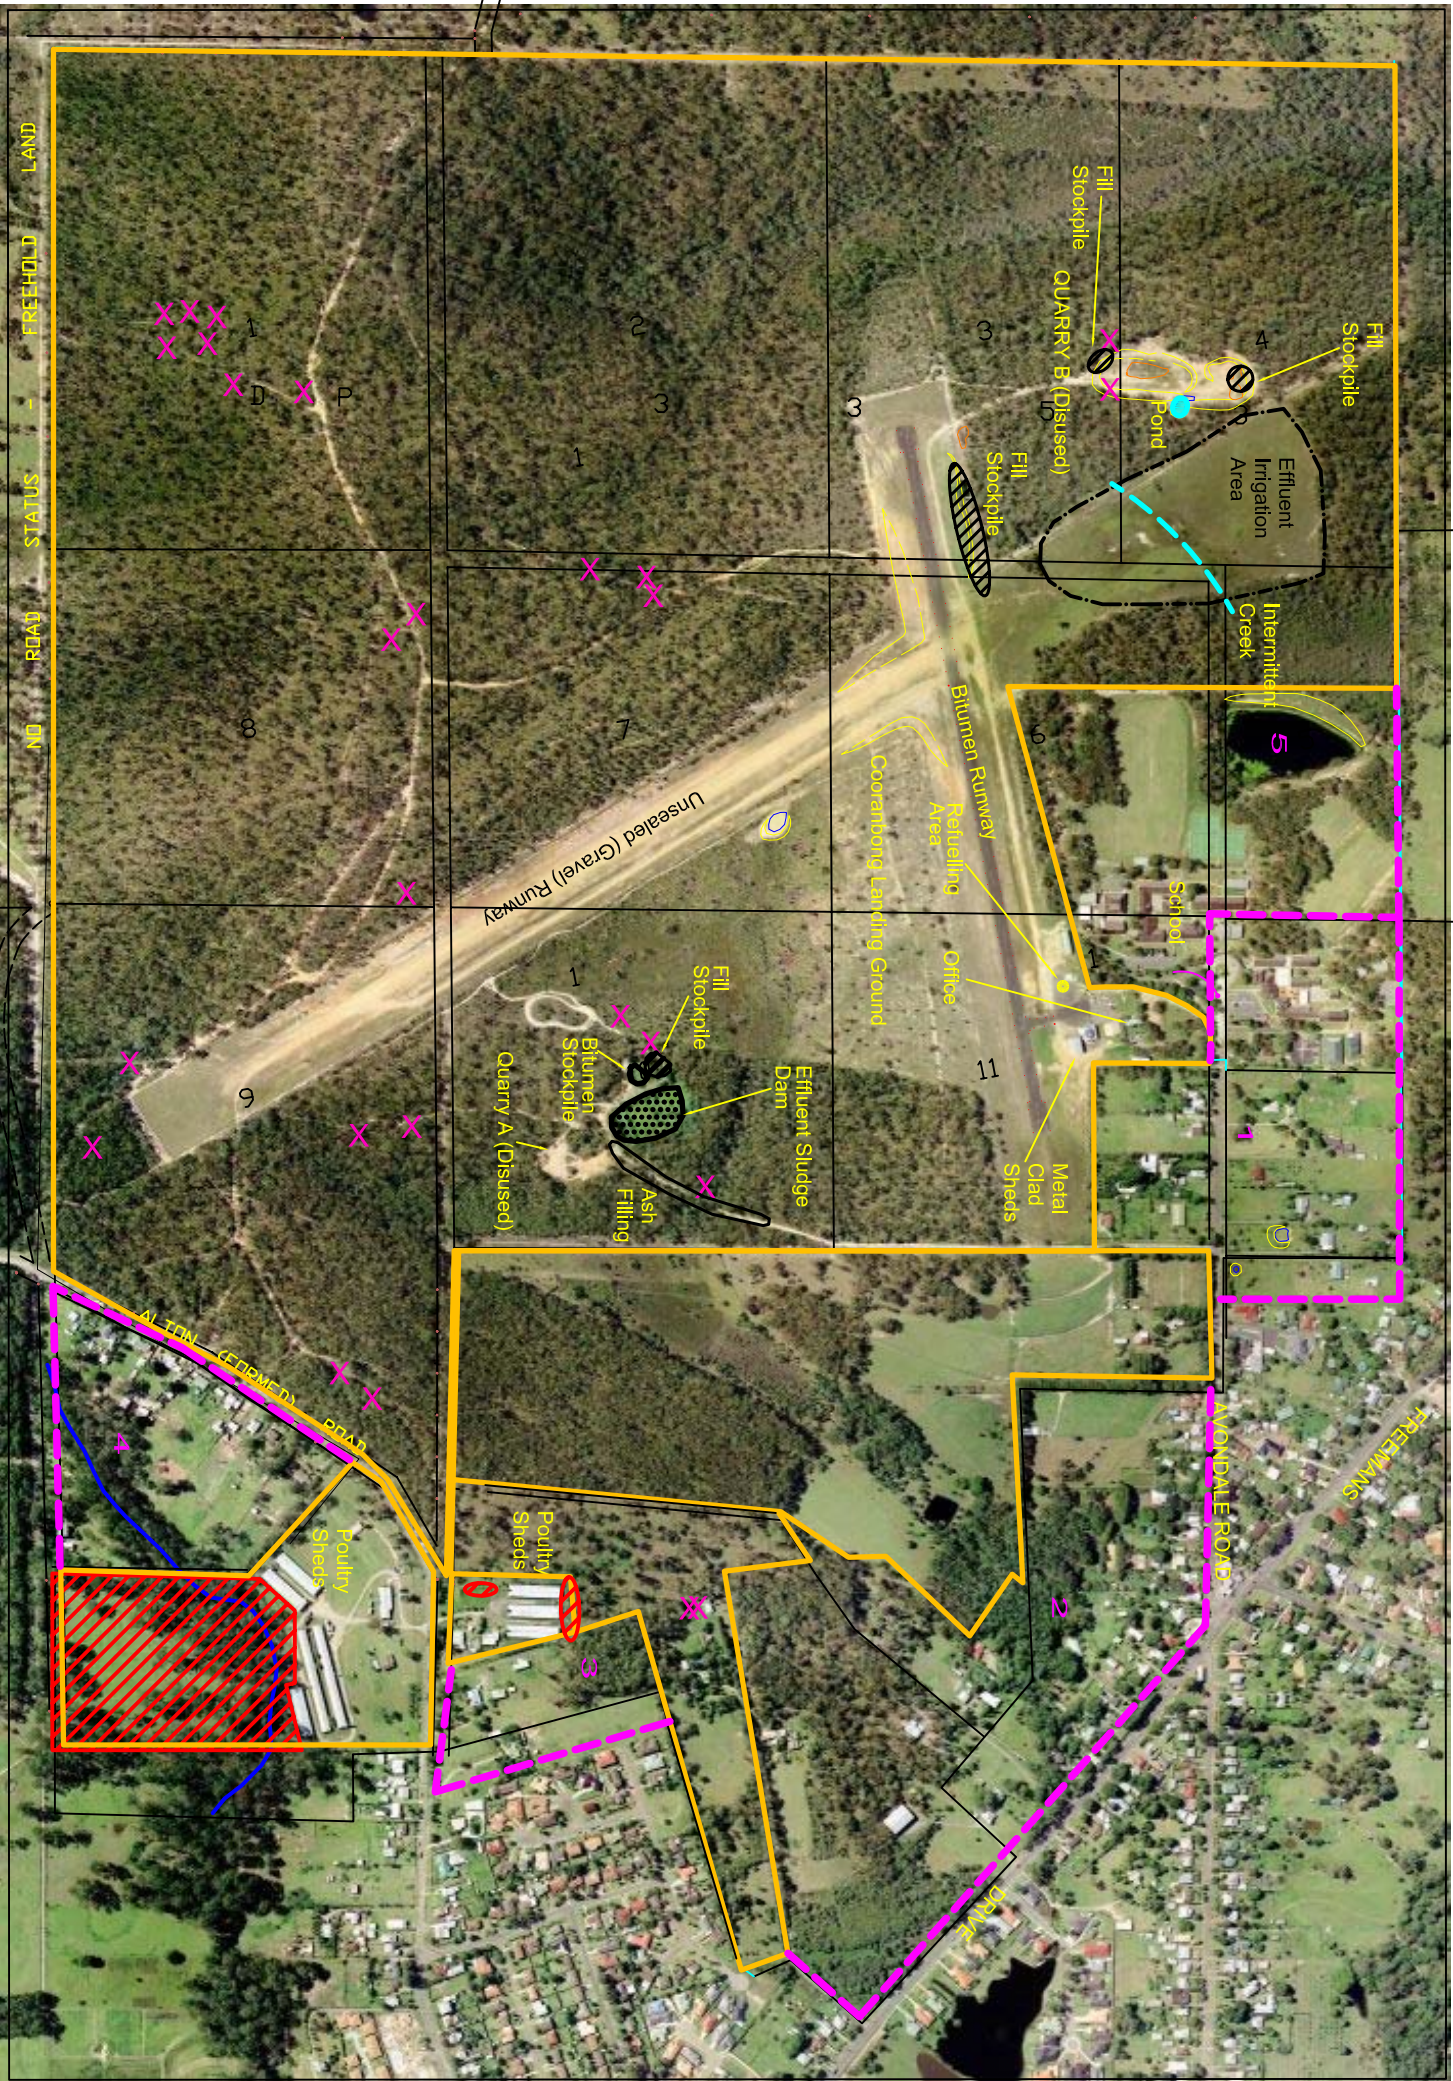
- LEGEND**
- APPROXIMATE SITE BOUNDARY
 - APPROXIMATE CAR WRECK LOCATION
 - FILL STOCKPILE
 - EFFLUENT IRRIGATION AREA
 - INTERMITTENT CREEK
 - APPROXIMATE SITE BOUNDARIES - ADJACENT PROPERTIES
 - APPROXIMATE AREA IDENTIFIED TO CONTAIN CHICKEN BURIAL PITS AND MANURE STOCKPILES
 - FELLED TIMBER CREEK
 - ADJACENT SITE AREAS - REFER TO TEXT

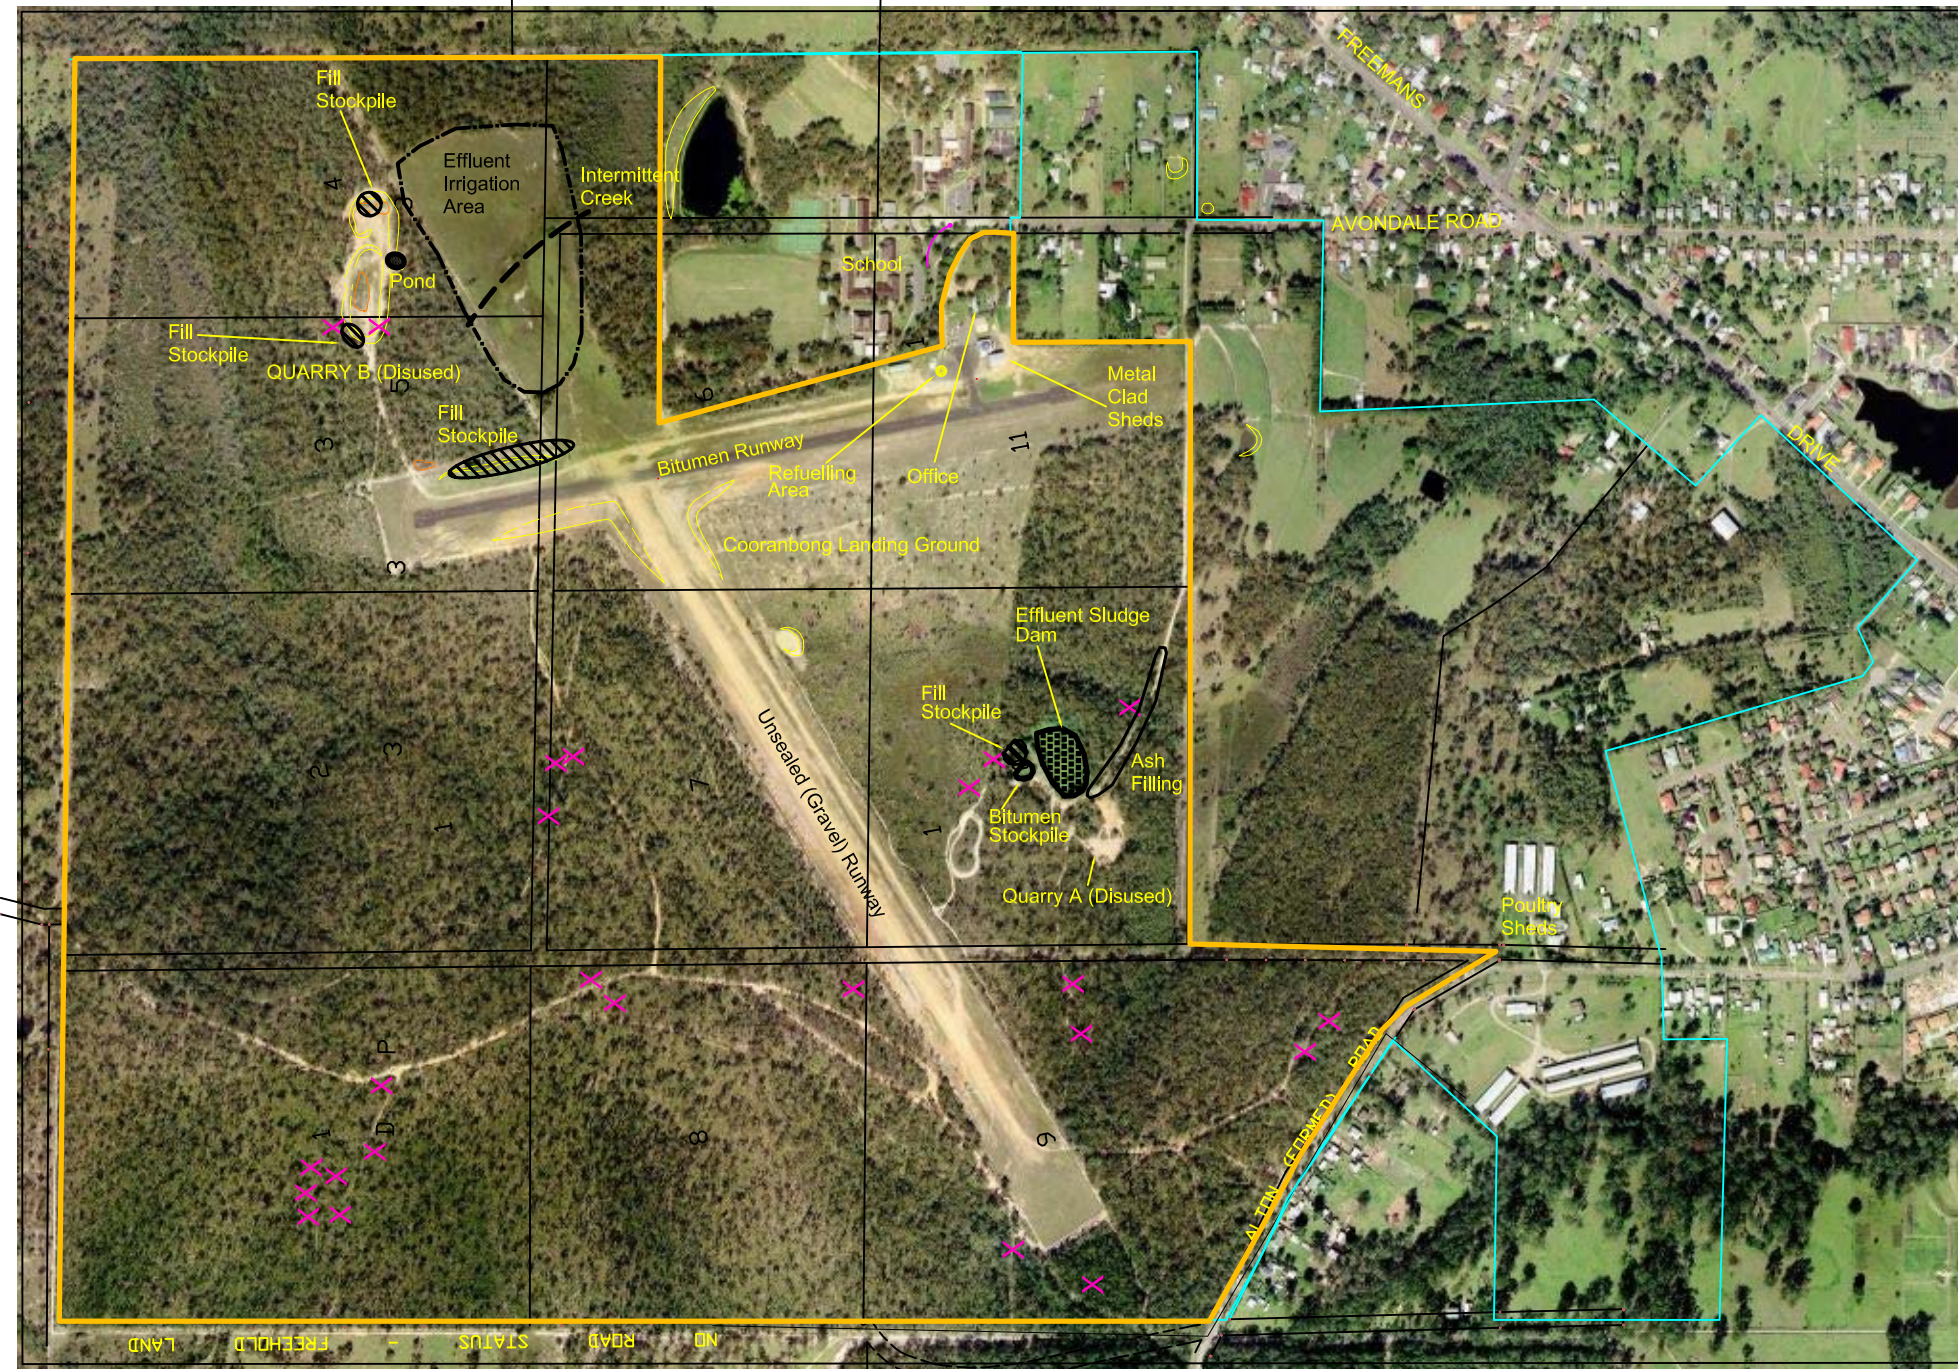
Localised areas of filling including stockpiles placed in an uncontrolled manner were observed in the following areas; as shown on attached Drawing 1:
