**GEOTECHNICAL INVESTIGATION**

**PROPOSED TRINITY POINT MARINA AND  
TOURIST DEVELOPMENT  
49 LAKEVIEW ROAD  
MORISSET PARK**

**JOHNSON PROPERTY GROUP PTY LTD**

***Project 39823***

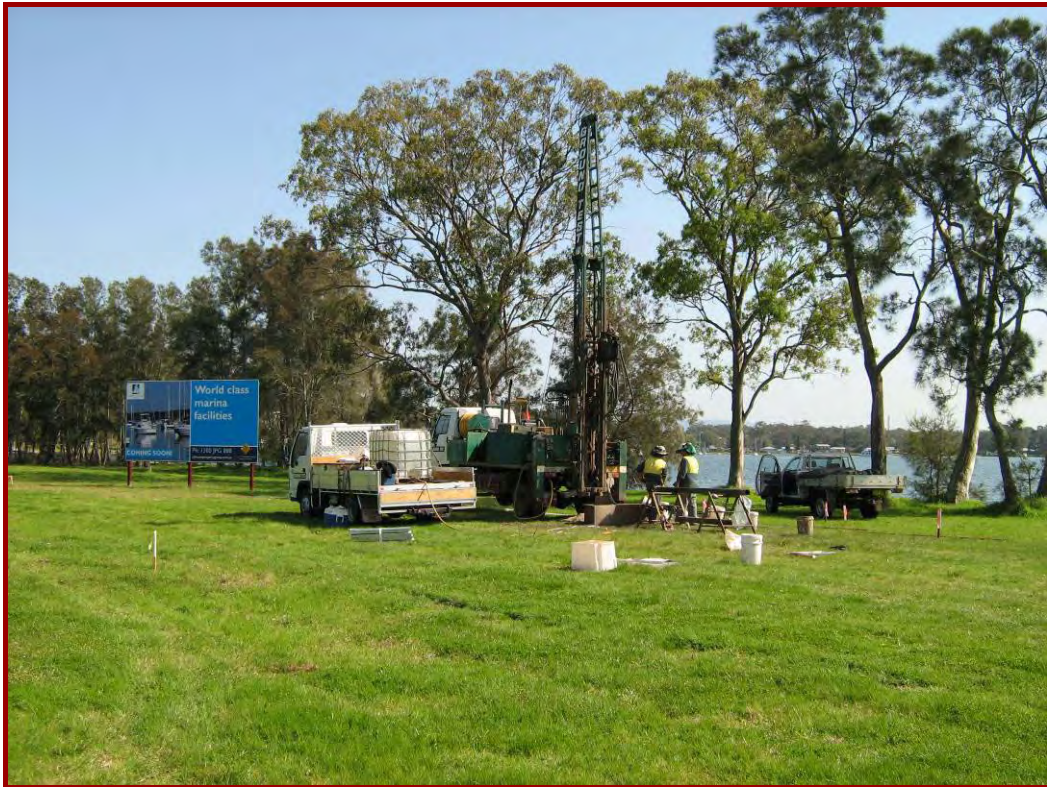
***Photo 1 – set up on Bore 101, in the area of the proposed marina***

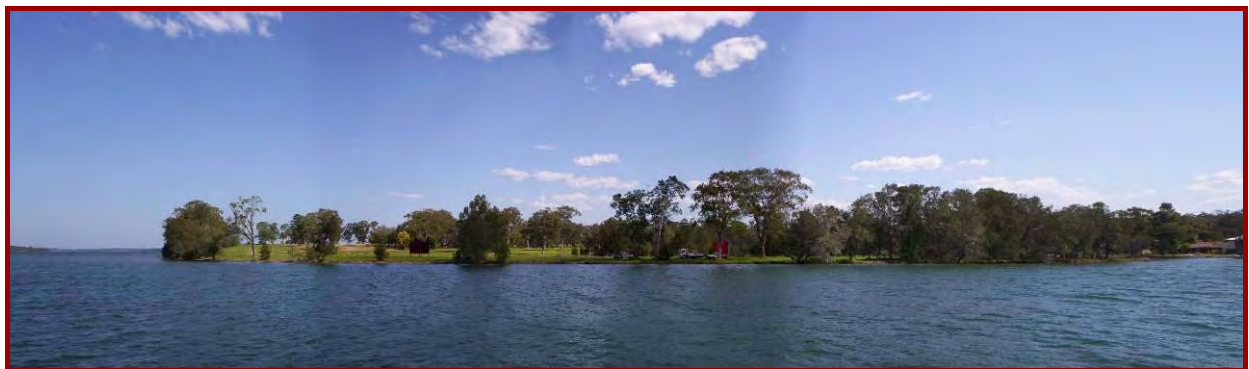
***Photo 2 – view of site from the Lake***

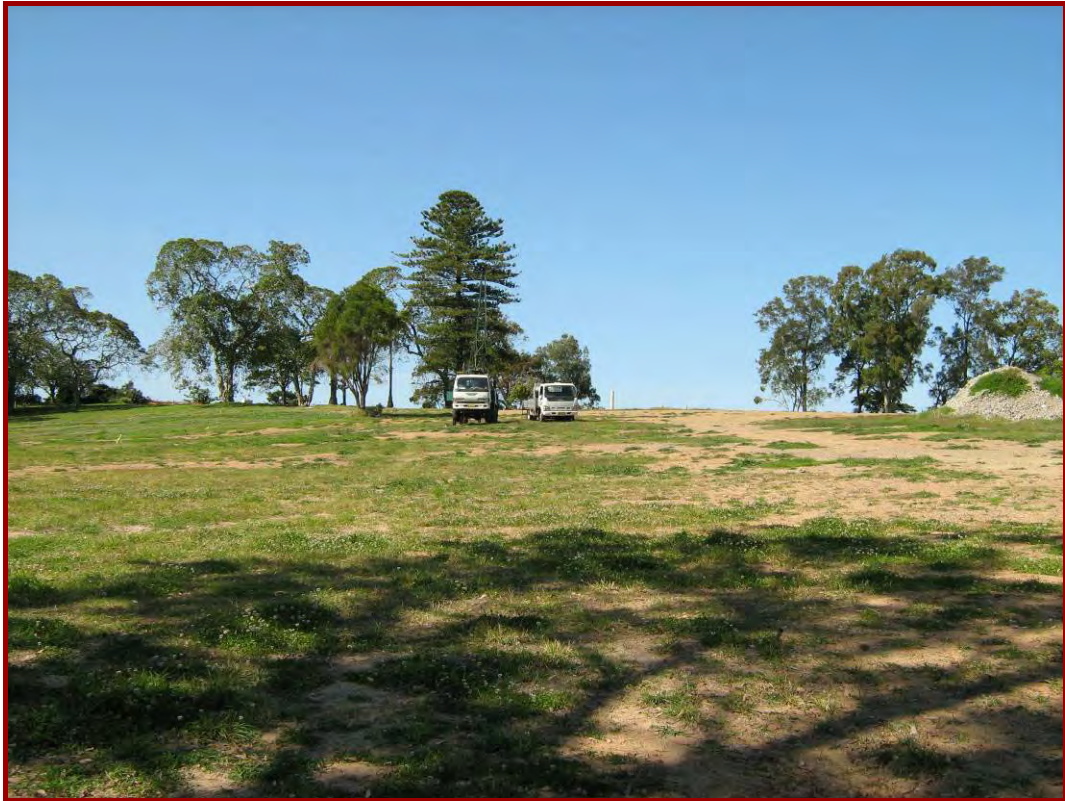
***Photo 3 – looking south towards the crest of Bluff Point, in the area of the proposed tourist village***

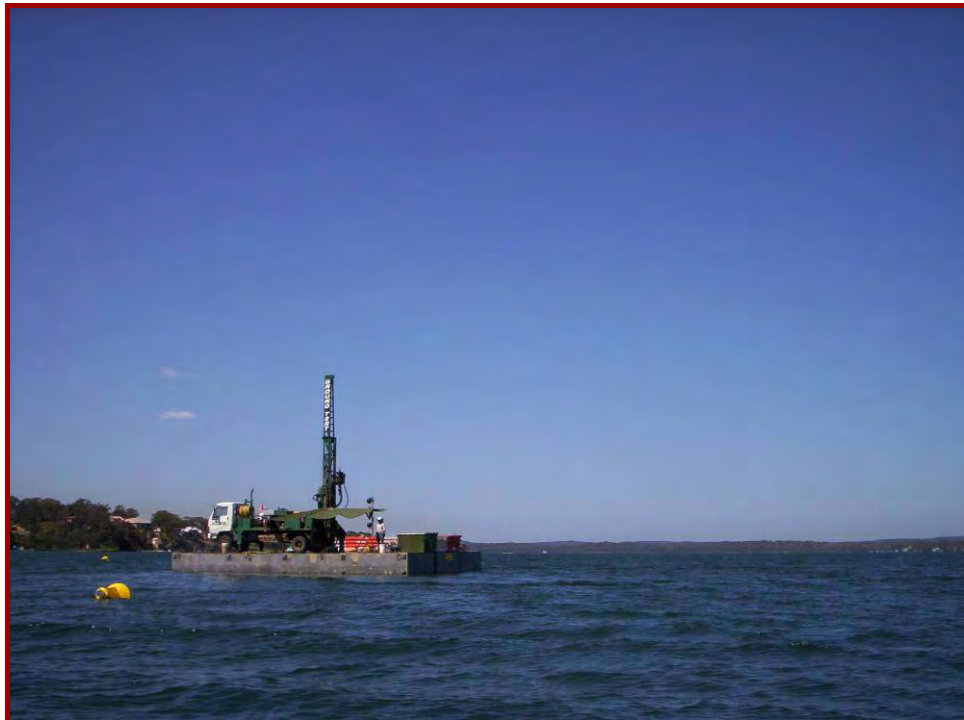
***Photo 4 – drill rig set up on modular barge, in proposed marina area***

The over-water bores were also drilled using a truck mounted drilling rig, set up on a modular barge (refer Photo 4). The target depth for the over-water bores was 3 m into rock, however this was not able to be achieved at all locations. Bore 201 had to be abandoned early due to strong winds and unsafe working conditions.
