JC03029A-r3

**Re Oxford Falls Retirement Resort
Oxford Falls Road, Barnes Road and Wearden Road, Oxford Falls
Geotechnical and Contamination Review**

JC03029A-r2

Re Oxford Falls Retirement Resort
Oxford Falls Road, Barnes Road and Wearden Road, Oxford Falls
Site Contamination Remediation and Ground Subsidence Issues

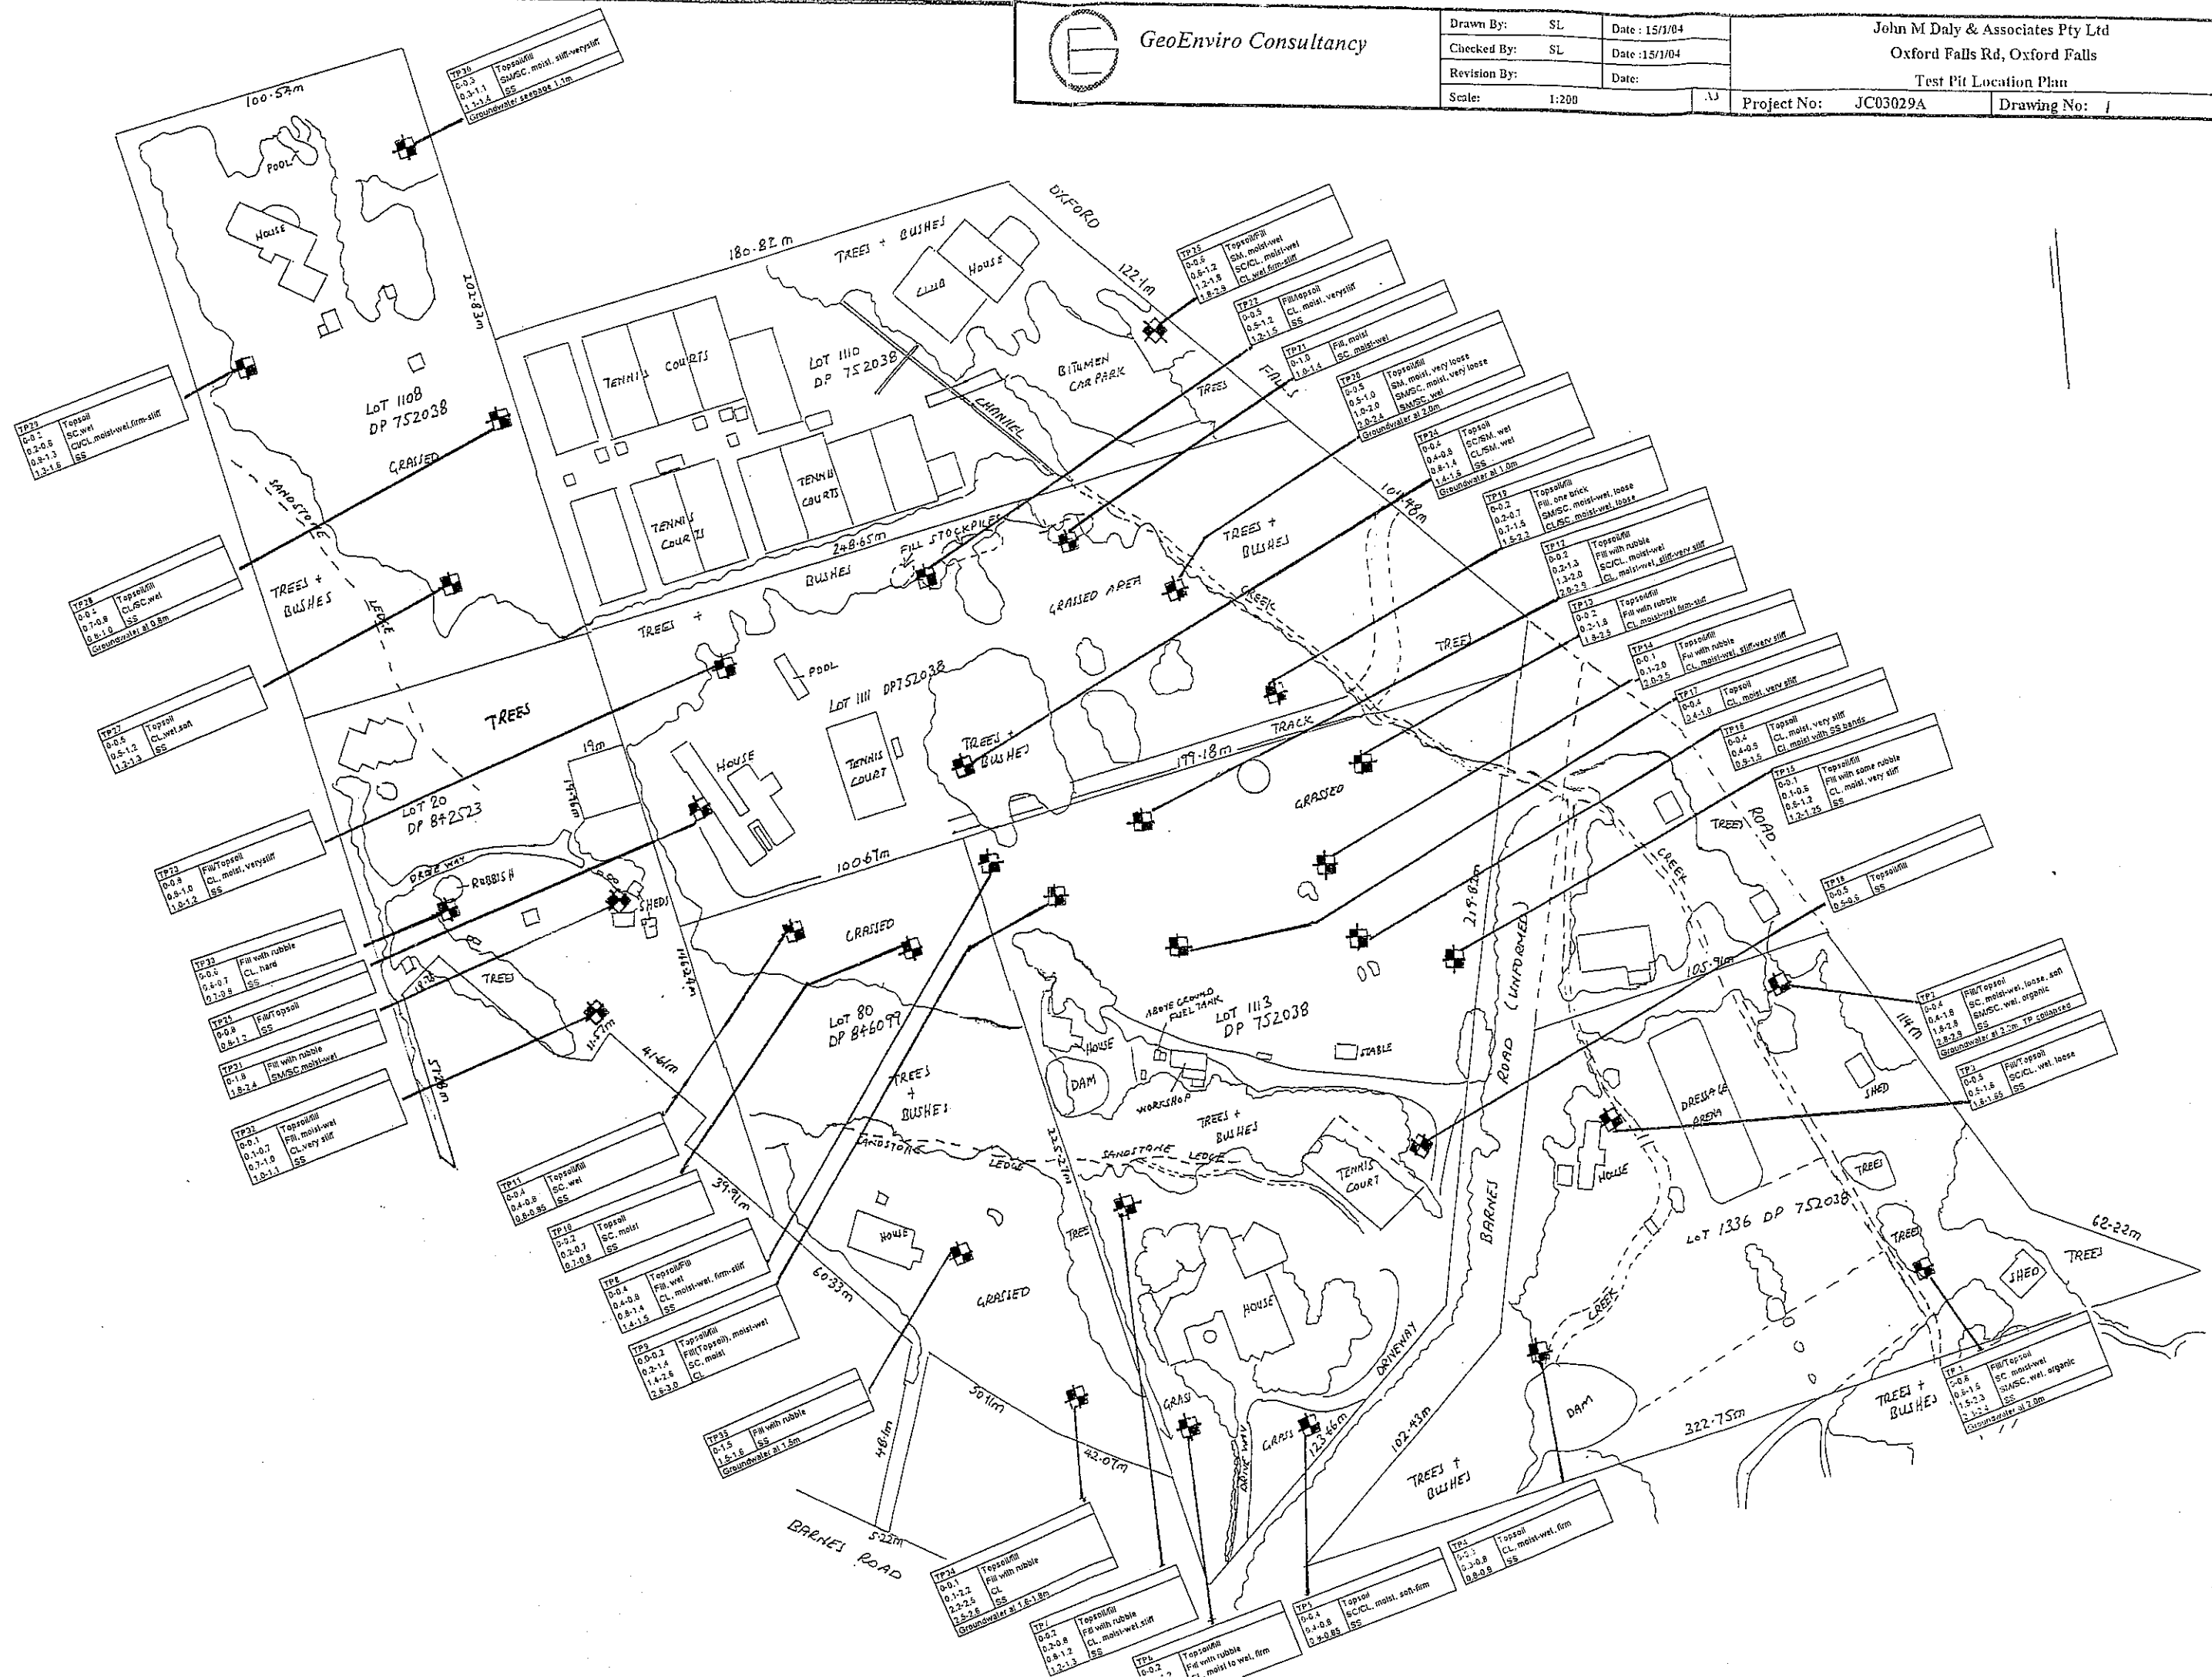
John M Daly & Associates Pty Ltd		
Oxford Falls Rd, Oxford Falls		
Test Pit Location Plan		
Project No:	JC03029A	Drawing No: 1

The subsurface conditions of the site were assessed by excavation of 35 test pits (TP 1 to 35) across the site using a rubber tyred backhoe on 4th December 2003. The test pits locations are shown on the attached Drawing No 1. Details of the subsurface profiles encountered are outlined on the attached Table A.

- Fill with varying quantities of building material (eg bricks, concrete, steel, etc) was encountered at the north eastern portion of Lot 1113. Depths of fill as indicated in TPs 12, 13, 14 and 15 vary from 0.6m to 2.0m. TP 8 and 9 which were excavated on the northern portion of Lot 1113 also encountered fill but without building rubble. Depths of fill in TP 8 and 9 were found to be about 0.8m and 1.4m respectively.

- Fill with some building material was also encountered on the southern portion of Lot 1113 to depths of about 1.2m in TP 6 and 0.8m in TP 7.
- Fill containing building rubble was encountered in TP 31 and 33 which were located in Lot 20. Depths of fill in TP 31 and 33 were found to be about 1.8m and 0.6m respectively.

- Fill containing building rubble was encountered in TP 34 and 35 which were located on the southern portion of Lot 80. Depths of fill in TP 34 and 35 were found to be about 2.2m and 1.5m respectively.

- Relatively thick sandy and clayey soil profile was encountered along the creek on the eastern portion of the site as indicated in TP 1, 2, 19, 20 and 26. The soil profile was generally found to be moist to wet and relatively weak (ie very loose to loose for cohesionless soil and soft to stiff for cohesive soil). Sandstone bedrock was encountered in TP 1 and 2 at depths of about 2.3m and 2.8m respectively. TP 19, 20 and 26 which were excavated to depths varying from 2.2m to 2.9m did not encounter bedrock.

- Sandy soil overlying sandstone bedrock at relatively shallow depths of less than 1.5m generally occurs on the western and southern portion of the site, on the sandstone hill slopes and crests. Typical of sandstone hill slopes, there will be some localised deepening of sandstone bedrock caused by drops and benches of the sandstone formation. The sandy soil was generally found to be moist to wet and relatively weak.

- Groundwater was encountered in TP 1, 2, 20, 24, 28, 30, 34 and 35 at depths varying from 0.8m to 2.2m
- Information on subsurface profile in Lot 1110 is limited due to the built-up nature of the site with tennis courts, buildings and car parks.
