Tree Assessment Report

**OXFORD FALLS SENIORS
LIVING RESORT**

**OCTOBER 2008
REF: 8054T**

**OXFORD FALLS ROAD AND BARNES ROAD,
OXFORD FALLS**

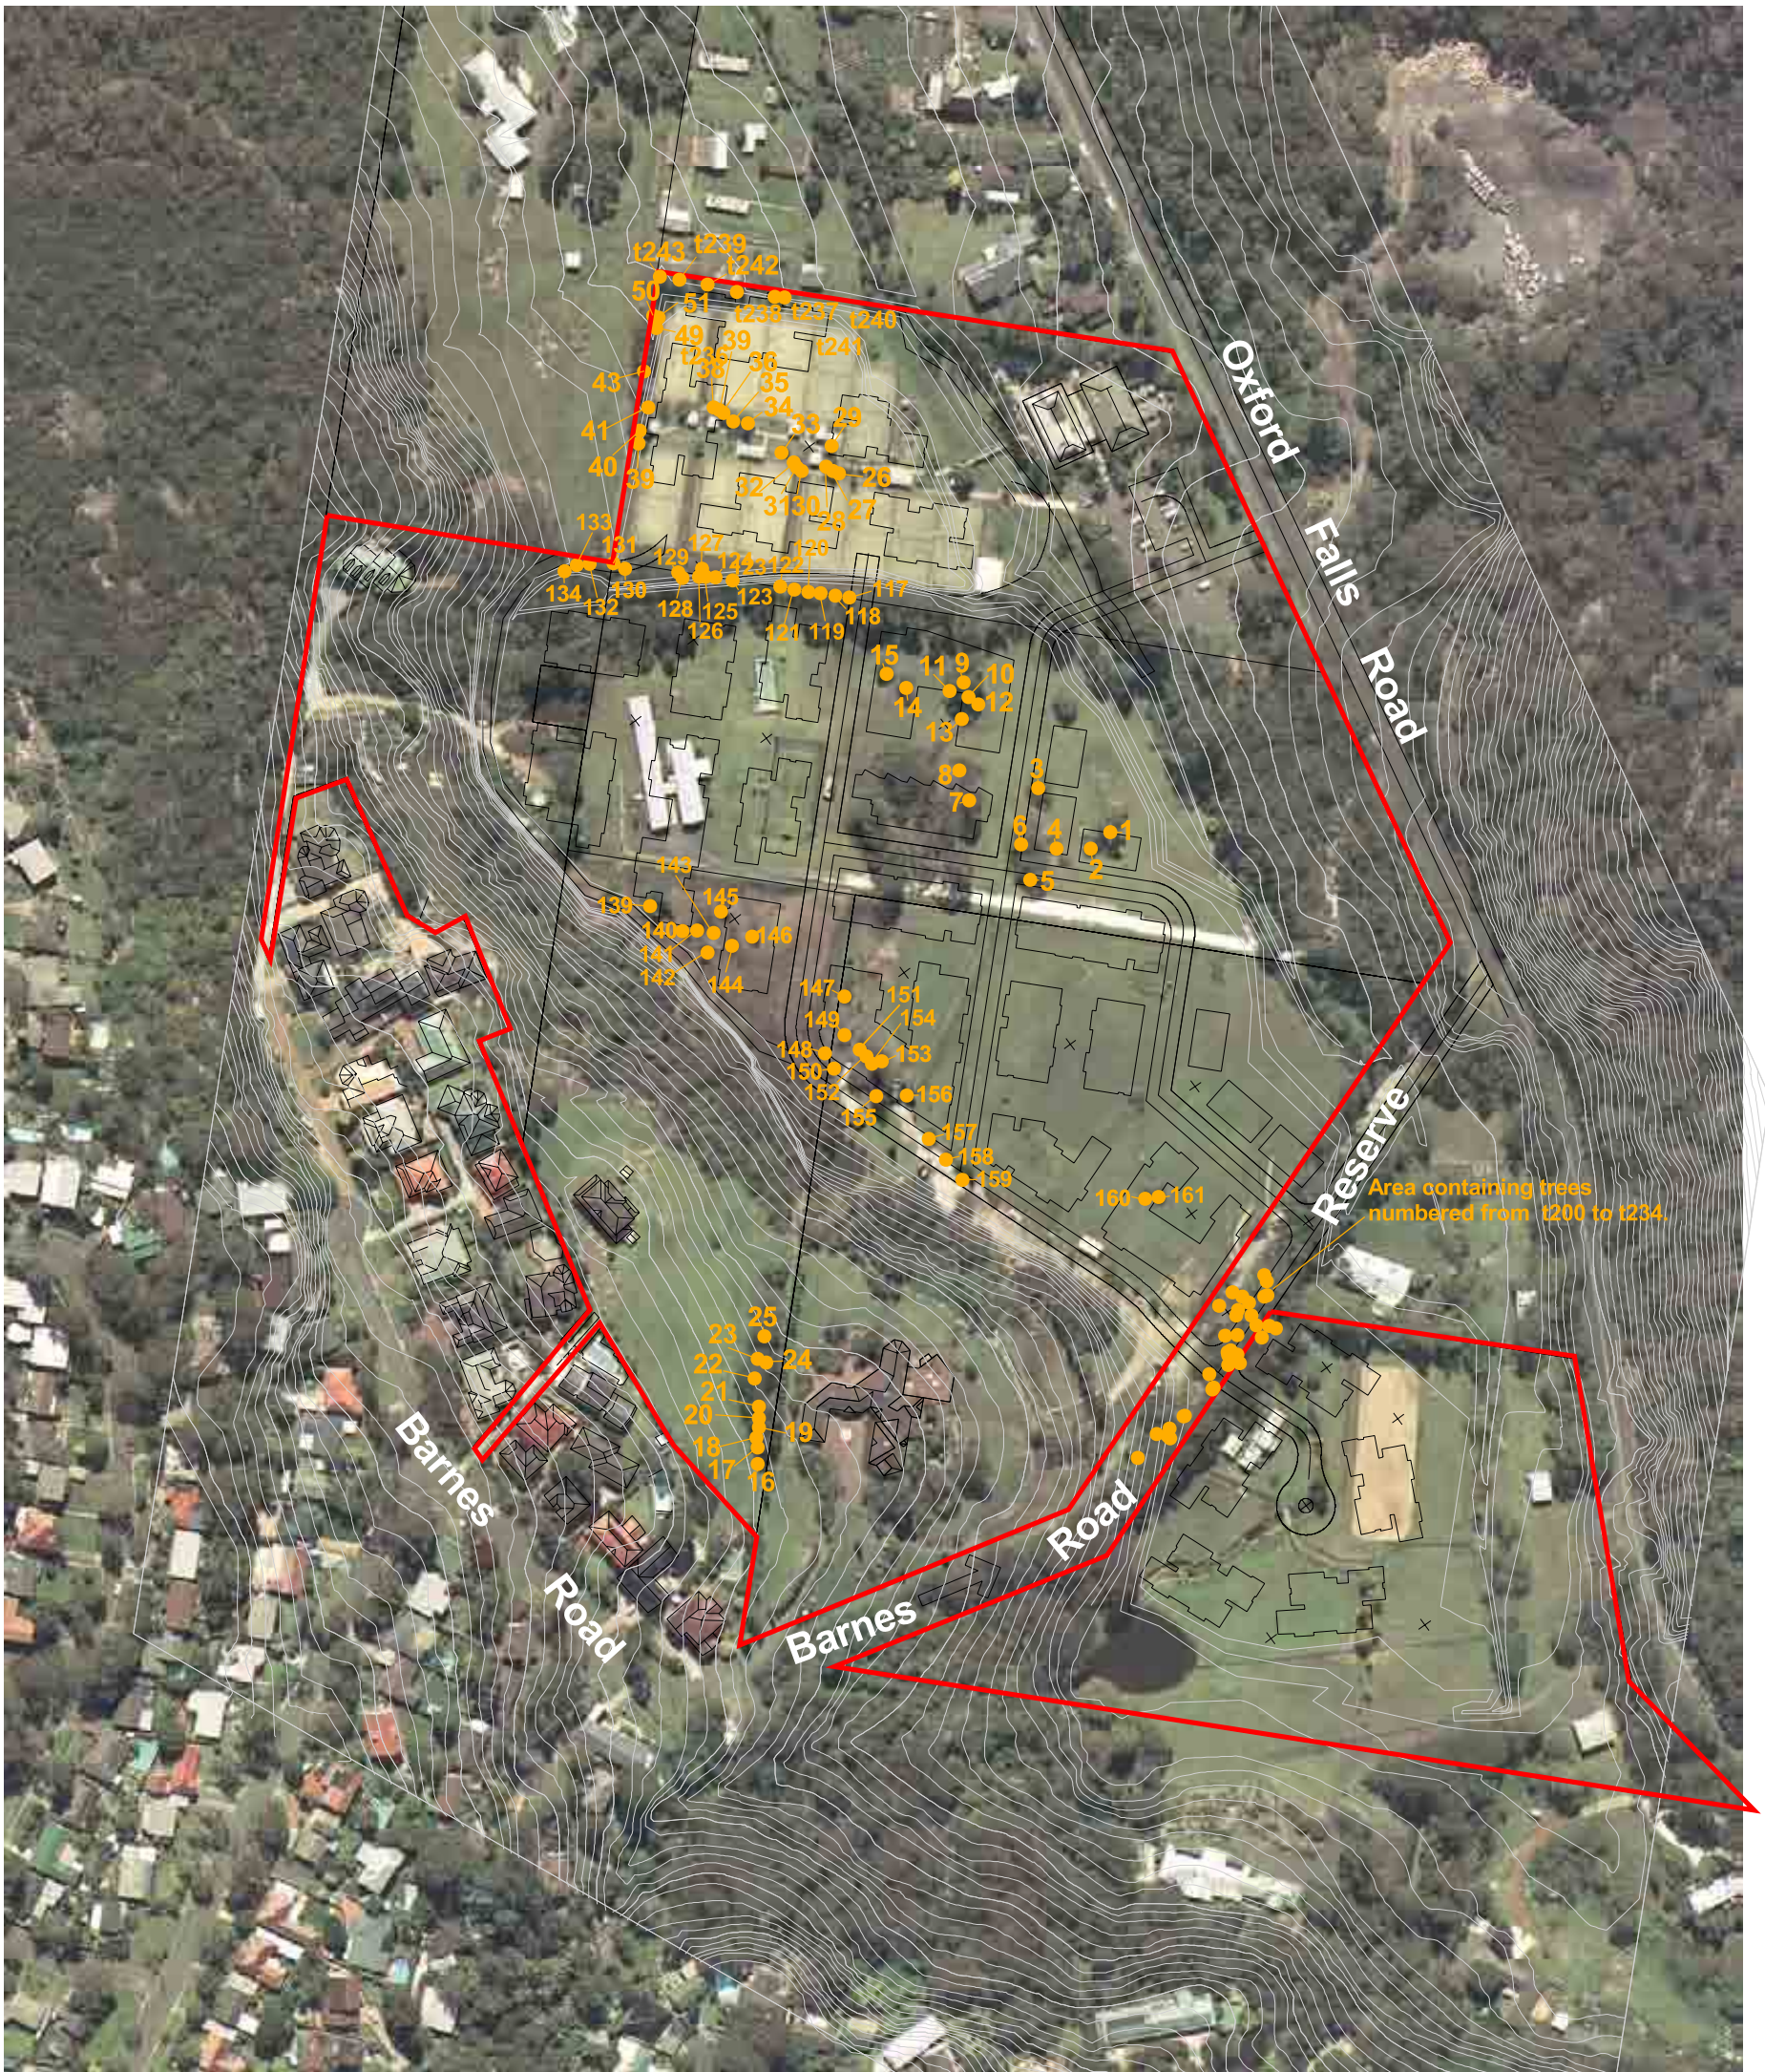
SCHEDULE 2 – Tree Plan

Tree No	Scientific Name	Common Name	DBH (cm)	Height (m)	Spread (m)	Vigour %	SULE	Comments & Recommendations	Retained / Removed
1	<i>Eucalyptus piperita</i>	Sydney Peppermint	100	16	16	75	2D	small deadwood, poor form, leaning	Removed
2	<i>Eucalyptus piperita</i>	Sydney Peppermint	10, 6, 6, 8	8	9	90	2D	poor form	Removed
3	<i>Eucalyptus punctata</i>	Grey Gum	40	10	10	85	2A	small deadwood	Removed
4	<i>Eucalyptus piperita</i>	Sydney Peppermint	30	13	8	70	2D	exposed roots, leaning	Removed
5	<i>Erythrina sykesii</i>	Coral Tree	60,80,40,30	12	15	80	2D	exposed roots, poor form	Removed
6	<i>Eucalyptus piperita</i>	Sydney Peppermint	90	16	18	70	2D	exposed roots, crown dieback	Removed
7	<i>Angophora costata</i>	Sydney Red Gum	70, 30	18	14	90	2D	exposed roots	Removed
8	<i>Eucalyptus punctata</i>	Grey Gum	45	15	14	90	2A		Removed
9	<i>Eucalyptus piperita</i>	Sydney Peppermint	100	18	8	30	4C	(H17) hollow trunk, exposed roots	Removed

Tree No	Scientific Name	Common Name	DBH (cm)	Height (m)	Spread (m)	Vigour %	SULE	Comments & Recommendations	Retained / Removed
27	<i>Archontophoenix alexandrae</i>	Alexandra Palm	30	6	6	90	2A		Removed
28	<i>Archontophoenix alexandrae</i>	Alexandra Palm	35	6	6	90	2A		Removed
29	<i>Archontophoenix alexandrae</i>	Alexandra Palm	30	6	6	90	2A		Removed
30	<i>Archontophoenix alexandrae</i>	Alexandra Palm	15	6	6	70	2D		Removed
31	<i>Archontophoenix alexandrae</i>	Alexandra Palm	20	6	6	90	2A		Removed
32	<i>Archontophoenix alexandrae</i>	Alexandra Palm	35	6	6	90	2A		Removed
33	<i>Livistona australis</i>	Cabbage Palm	40	5	5	90	2A		Removed
34	<i>Banksia integrifolia</i>	Coast Banksia	10, 15	10	8	90	2A		Removed
35	<i>Banksia integrifolia</i>	Coast Banksia	20	10	8	90	2A		Removed
36	<i>Banksia integrifolia</i>	Coast Banksia	15	10	8	90	2A		Removed
37	<i>Banksia integrifolia</i>	Coast Banksia	20	10	8	90	2A		Removed
38	<i>Banksia integrifolia</i>	Coast Banksia	20	10	8	90	2A		Removed

Tree No	Scientific Name	Common Name	DBH (cm)	Height (m)	Spread (m)	Vigour %	SULE	Comments & Recommendations	Retained / Removed
117	<i>Casuarina cunninghamiana</i>	River She-oak	40	18	8	90	2A	small dead wood	Retained
118	<i>Casuarina cunninghamiana</i>	River She-oak	30	8	6	80	2C	suppressed, poor form	Retained
119	<i>Pinus elliotti</i>	Slash Pine	12	9	5	80	2C	suppressed	Retained
120	<i>Pinus elliotti</i>	Slash Pine	25	12	5	80	2C	suppressed	Retained
121	<i>Pinus elliotti</i>	Slash Pine	15	8	4	80	2C	suppressed	Retained
122	<i>Casuarina cunninghamiana</i>	River She-oak	50	18	9	90	2A		Retained
123	<i>Eucalyptus deanei</i>	Round-leaved Gum	90	24	16	90	2A		Retained
124	stag	stag	75	10	5	0	4A	dead	Removed
125	<i>Eucalyptus deanei</i>	Round-leaved Gum	75	22	15	90	2A		Retained
126	<i>Eucalyptus piperita</i>	Sydney Peppermint	100	20	20	90	2C	suppressed, canopy entangled with tree 127	Retained
127	<i>Eucalyptus deanei</i>	Round-leaved Gum	30	18	10	80	2C	suppressed, canopy entangled with tree 126	Retained

Tree No	Scientific Name	Common Name	DBH (cm)	Height (m)	Spread (m)	Vigour %	SULE	Comments & Recommendations	Retained / Removed
143	<i>Allocasuarina torulosa</i>	Forest Oak	9	9	3	90	2A		Removed
144	<i>Allocasuarina torulosa</i>	Forest Oak	9	8	3	90	2A		Removed
145	<i>Allocasuarina torulosa</i>	Forest Oak	12	8	6	90	2A		Removed
146	<i>Allocasuarina torulosa</i>	Forest Oak	6	6	4	70	4C	poor form, leaning s	Removed
147	<i>Eucalyptus robusta</i>	Swamp Mahogany	25	15	8	90	2A		Removed
148	<i>Eucalyptus piperita</i>	Sydney Peppermint	30	18	9	80	4C	epicormic growth at base of trunk, roots exposed	Removed
149	<i>Eucalyptus robusta</i>	Swamp Mahogany	40	22	8	80	2D	damaged at base	Removed
150	stag	stag	35	16	8	0	4A	dead	Removed
151	<i>Populus sp</i>	Poplar	25	18	10	90	2A		Removed
152	<i>Populus sp</i>	Poplar	25	18	10	90	2A		Removed
153	<i>Eucalyptus piperita</i>	Sydney Peppermint	150	18	14	60	4C	1x large broken trunk, poor form	Removed

154	<i>Pinus ellioti</i>	Slash Pine	30	15	10	90	2A		Removed
155	<i>Pinus ellioti</i>	Slash Pine	40	15	12	90	2A		Removed
156	<i>Toxicodendron succedanium</i>	Rhus Tree	10,10,10,10,15	6	6	80	4C	poor form, toxic hazard	Removed
157	<i>Toxicodendron succedanium</i>	Rhus Tree	15,15,10	7	7	80	4C	poor form, toxic hazard	Removed
158	<i>Toxicodendron succedanium</i>	Rhus Tree	10,15,10,15	7	7	80	4C	poor form, toxic hazard	Removed
159	<i>Araucaria heterophylla</i>	Norfolk Island Pine	25	8	8	90	2A		Removed
160	<i>Eucalyptus piperita</i>	Sydney Peppermint	20	6	6	90	2A		Removed
161	<i>Eucalyptus piperita</i>	Sydney Peppermint	25	7	6	90	2A		Removed
t200	<i>Eucalyptus sieberi</i>	Silvertop Ash	43	13	8	80	2B	in powerlines	Removed
t201	<i>Eucalyptus sieberi</i>	Silvertop Ash	25	13	3	80	2D	leans s	Removed
t202	<i>Eucalyptus sieberi</i>	Silvertop Ash	28, 25	14	6	50v	3D	larger trunk rotten	Removed
t203	<i>Eucalyptus sieberi</i>	Silvertop Ash	33, 27	13	12	70	2D	slight lean	Removed

Tree No	Scientific Name	Common Name	DBH (cm)	Height (m)	Spread (m)	Vigour %	SULE	Comments & Recommendations	Retained / Removed
t209	<i>Eucalyptus piperita</i>	Sydney Peppermint	35	17	7	60	3D	moderate dead wood	Removed
t210	<i>Eucalyptus sieberi</i>	Silvertop Ash	40	21	9	40	3D	moderate dead wood	Removed
t211	stag	stag	35	21	5	0	4A	dead	Removed
t212	<i>Angophora Costata</i>	Smooth Barked Apple	40	17	15	15	4A	declined health	Removed
t213	<i>Erythrina sykesii</i>	Coral Tree	40, 35	9	16	60	3D	stabililising creek bank	Removed
t214	<i>Eucalyptus sieberi</i>	Silvertop Ash	40, 15	18	7	55	3D	large dead branch	Removed
t215	<i>Angophora Costata</i>	Smooth Barked Apple	40	26	11	55	3D	moderate dead wood	Removed
t216	stag	stag	50	23	6	0	4A	dead	Removed
t217	<i>Eucalyptus sieberi</i>	Silvertop Ash	38	22	8	60	3D	moderate dead wood, good form	Removed
t218	<i>Eucalyptus sieberi</i>	Silvertop Ash	30	21	5	80	2D	slight lean e	Removed

Tree No	Scientific Name	Common Name	DBH (cm)	Height (m)	Spread (m)	Vigour %	SULE	Comments & Recommendations	Retained / Removed
t239	<i>Melaleuca styphelioides</i>	Prickly-leaved Paperbark	27	7	5	80	2A	good form	Retained
t240	<i>Casuarina glauca</i>	Swamp Oak	22	18	5	90	1A	good form	Removed
t241	<i>Casuarina glauca</i>	Swamp Oak	22	13	5	90	1A	good form	Removed
