Report on Preliminary Geotechnical Assessment

Section 75W Modification to Sandon Point Concept Plan Lots 2 & 3 DP1176767 Geraghty Street, Bulli

> Prepared for Anglicare

Project 40618.02 July 2018

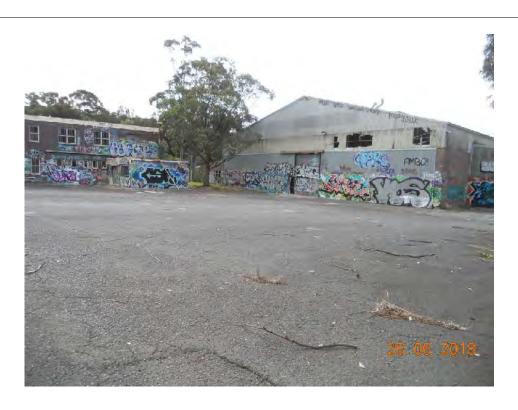
- Structures and pavements associated with the (now decommissioned) industrial plant in variable (but generally poor) condition (refer Photos 1 7, 9, 10, 12);

Photo 3 – General view of existing structures.

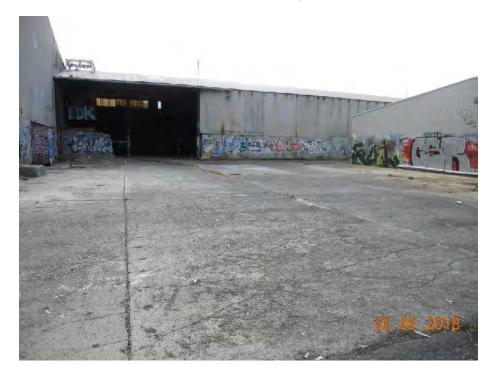
Photo 4 – General view of existing structures.

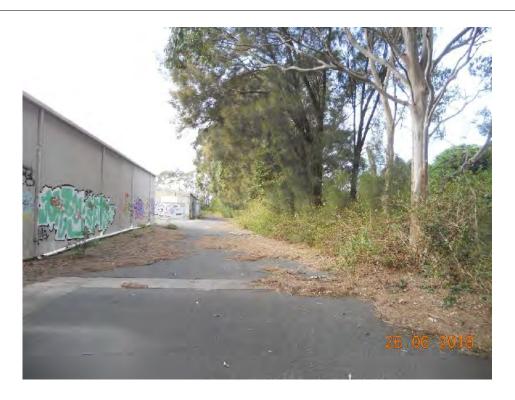
Photo 5- View along southern section of the site. Batter to Tramway Creek to the right of the stand of trees.

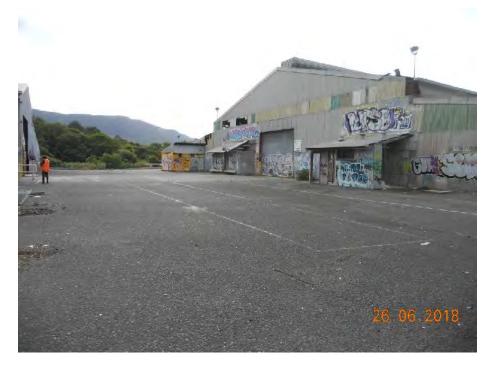
Photo 6 – General view of existing structures.

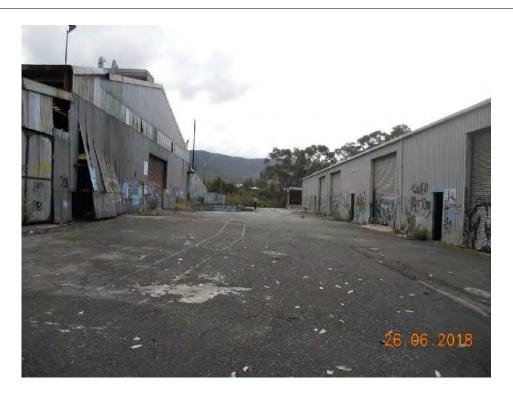
Photo 7 – General view of existing structures.

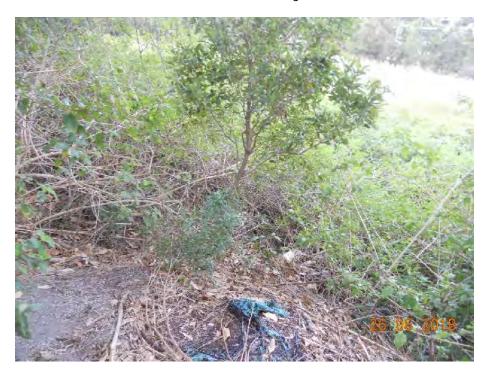
- The presence of filling to create a near-level terrace in the southern (ie developed) section of the site (refer Photos 8 and 11);
- Evidence of previous investigations such as damaged standpipe piezometers (refer Photo 9);

Photo 8 – Batter in filling leading to Tramway Creek.

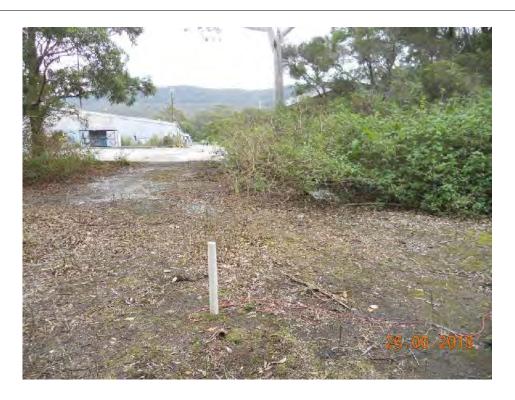
Photo 9 – View of MW03 (damaged).

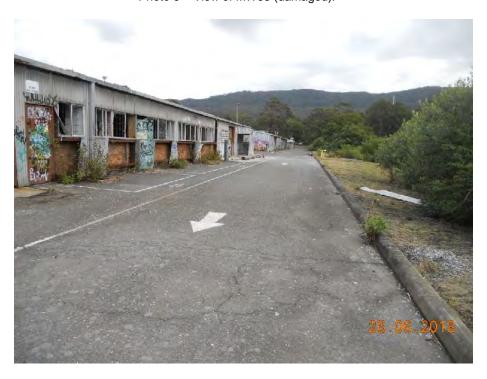
Photo 10 – General view of existing structures.

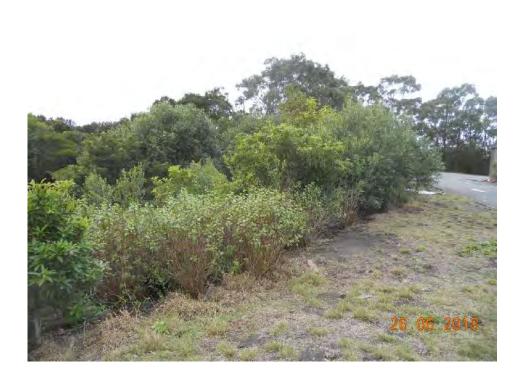
Photo 11 – Batter in filling leading to lower central area between the Ocean View and Village Centre Precincts.

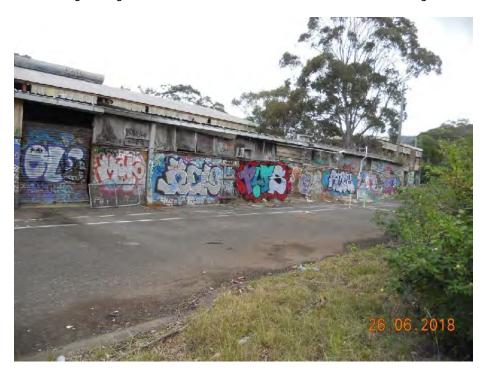
Photo 12 – General view of existing structures.

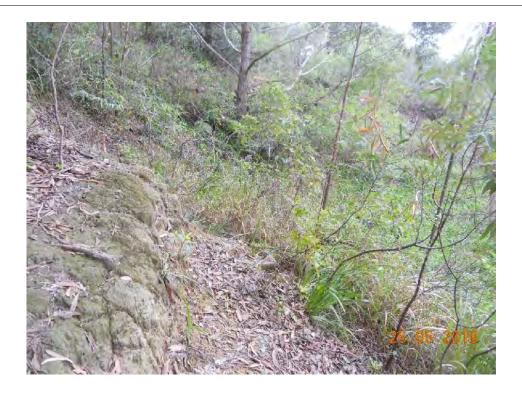
Photo 17 – View of the former quarry in the north-western section of the proposed Ocean View Precinct.

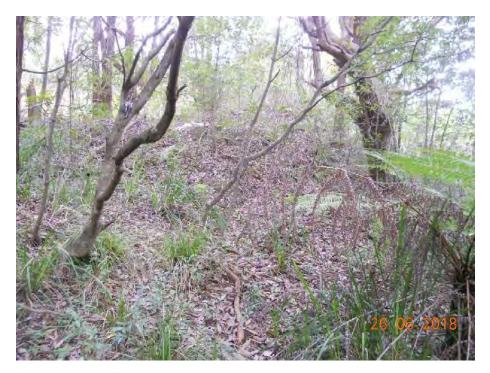
Photo 18 – Fill mound of likely quarry spoil in the southern section of the proposed Ocean View Precinct.

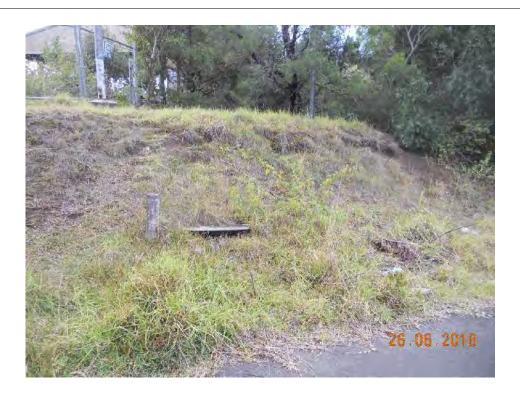
Photo 23 - 1.5 - 2m high cut batter exposing residual soils.

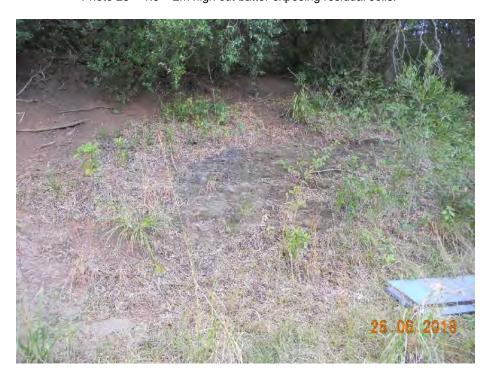
Photo $24-3\,\mathrm{m}$ high cut batter exposing residual soils overlying medium strength sandstone.

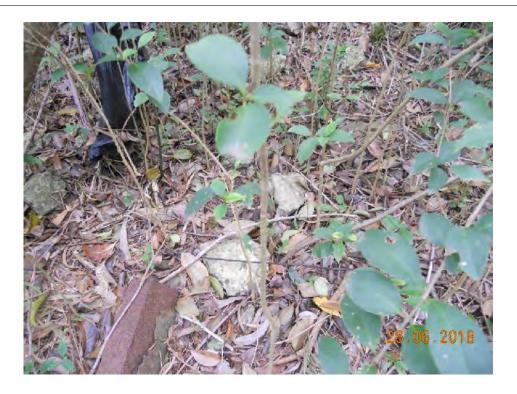
- Uncontrolled filling within the proposed Hill Top Precinct (refer Photos 25 and 26);
- With the exception of ongoing deterioration of existing structures and vegetation regrowth, surface conditions are virtually unchanged from those observed at the time of the DP 2006 and 2008 investigation.

Photo 25 – Concrete pieces on the surface.

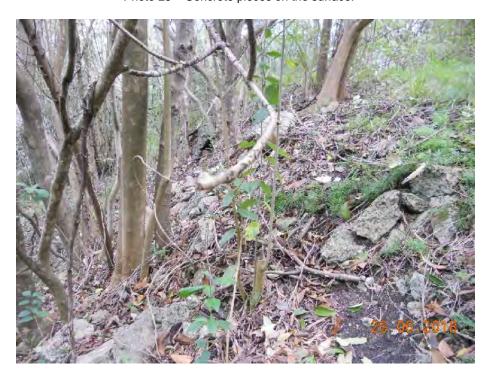
Photo 26 – Concrete pieces surface of batter probably formed with uncontrolled filling.
