**REPORT  
ON  
LAND CAPABILITY ASSESSMENT**

**PROPOSED DEVELOPMENT  
WESTERN SYDNEY PARKLANDS**

*Prepared for*  
**LANDCOM**

**PROJECT 40465  
JANUARY 2006**

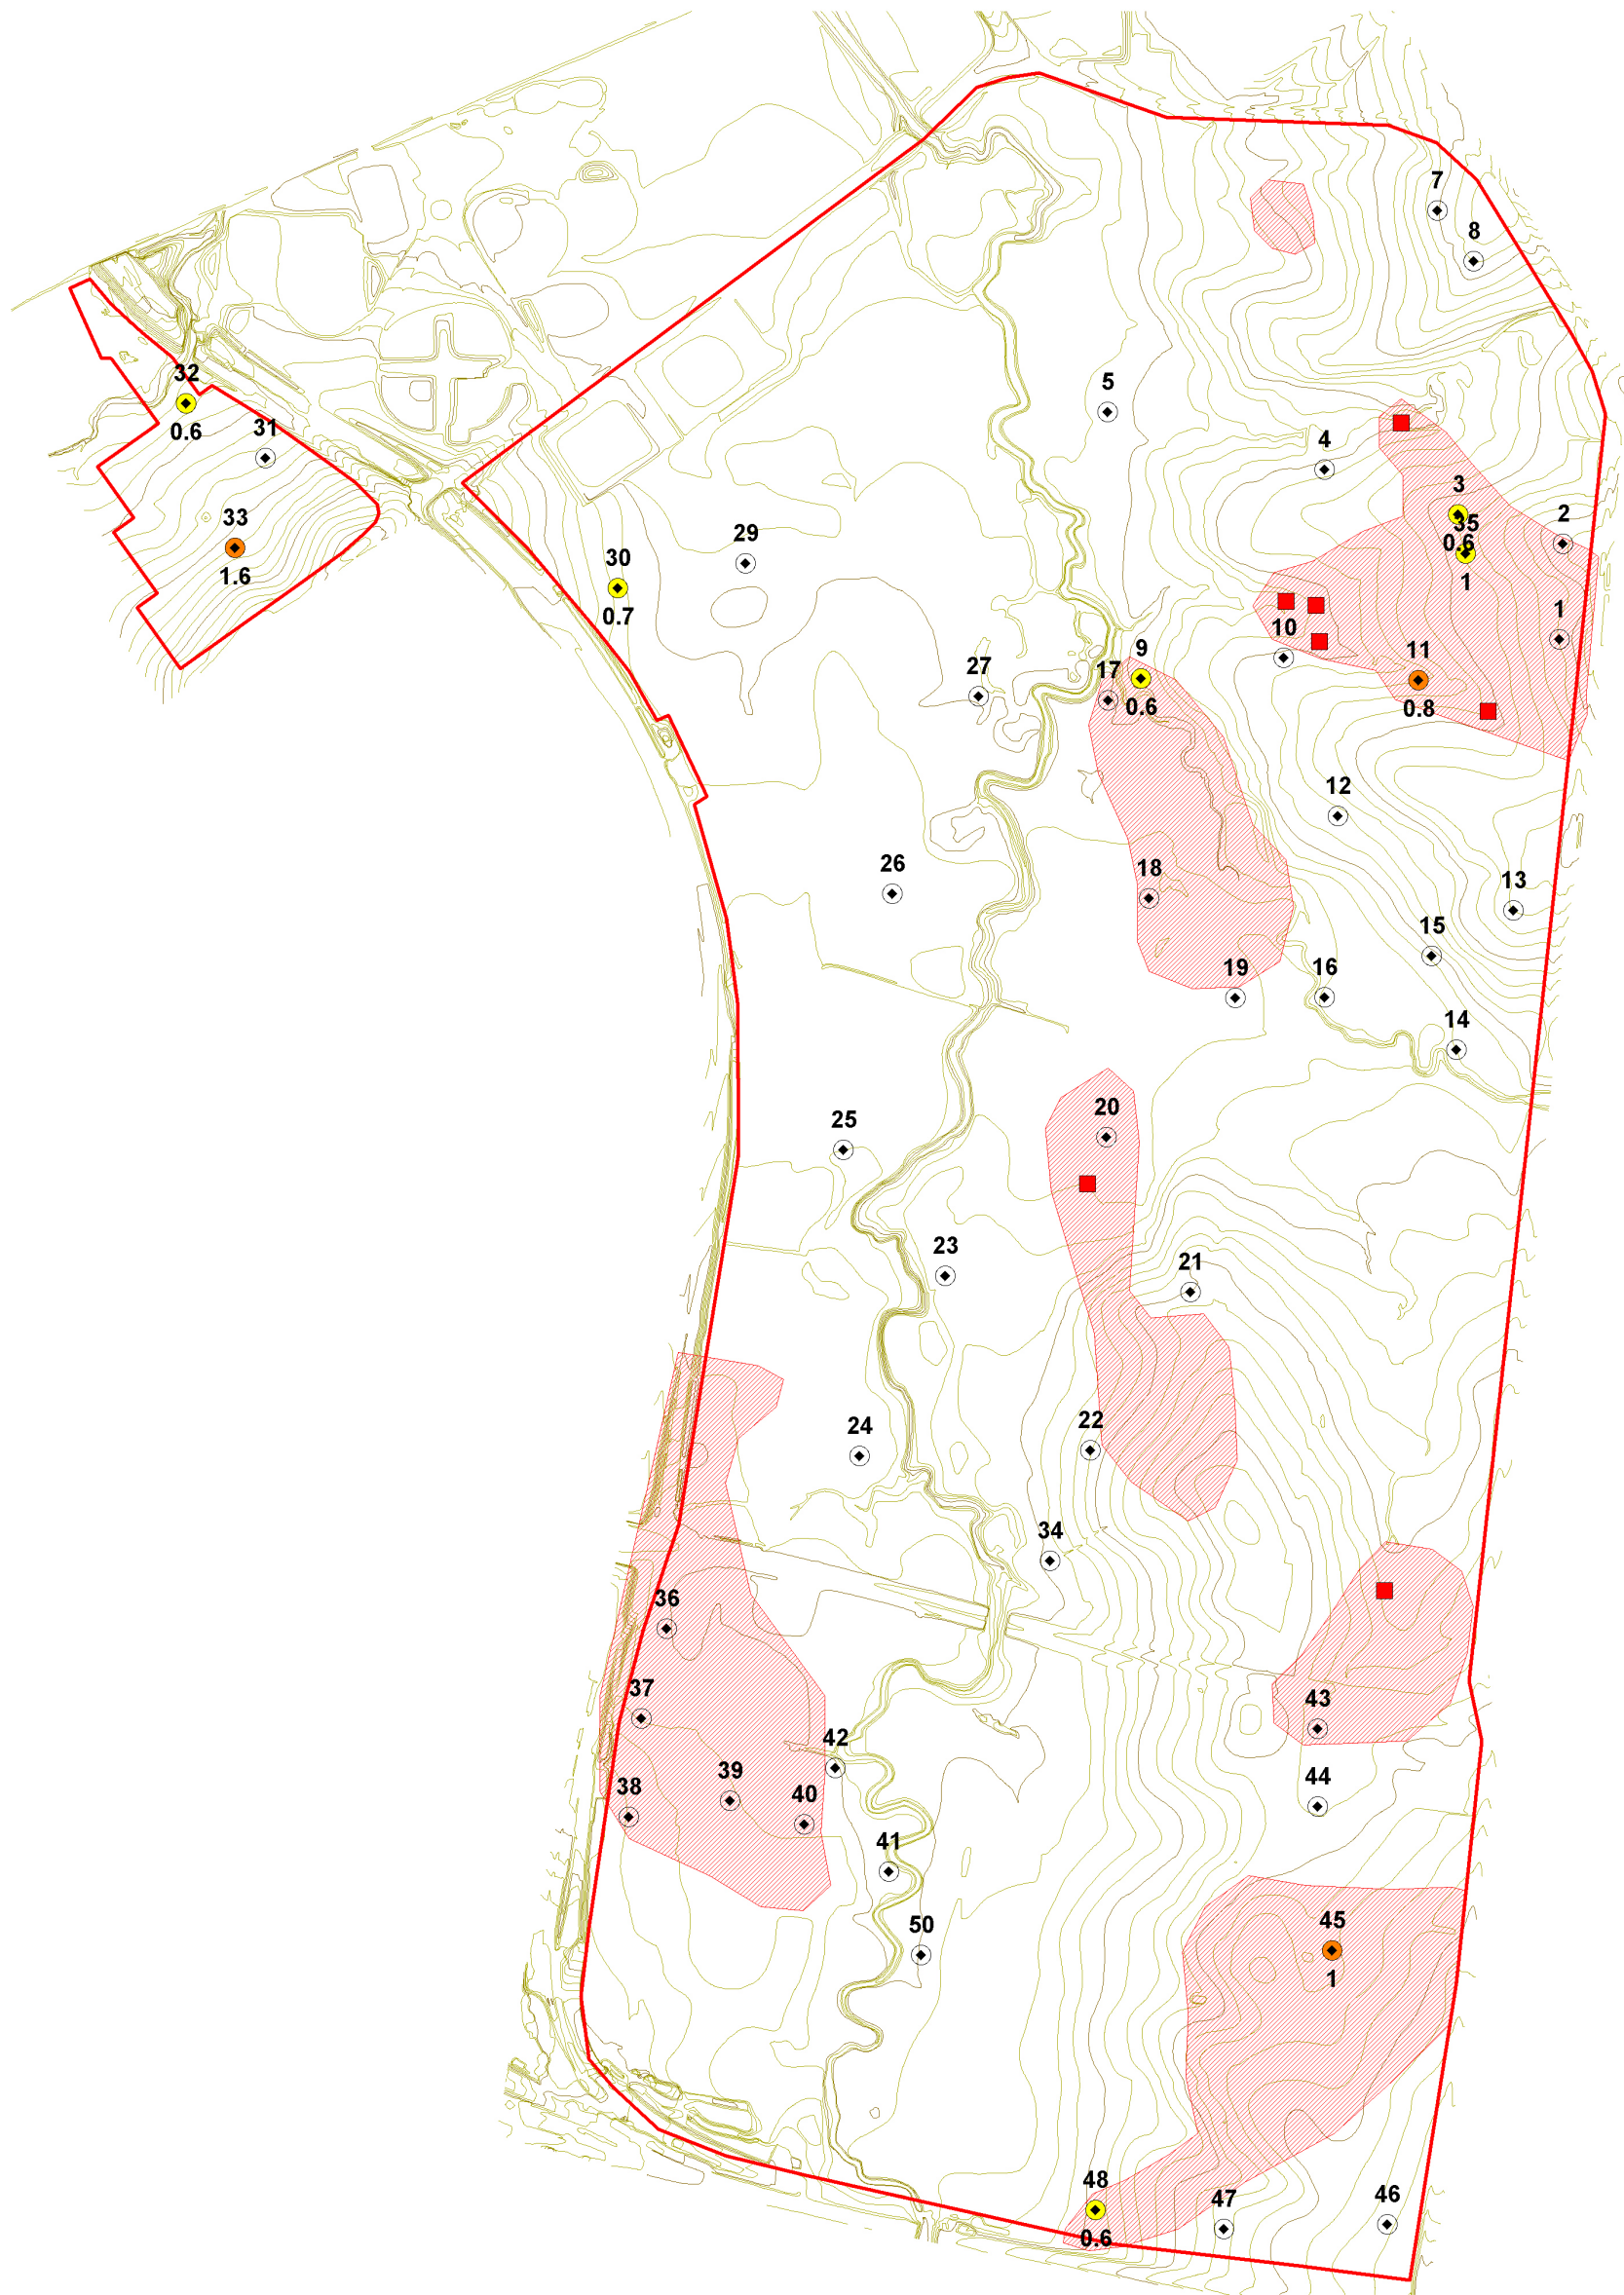
DRAWING No: 8

On the basis of these factors, areas of moderate or greater salinity risk have been inferred and outlined. When considering the results, it should be noted that high apparent salinities to the east of Pits 11, 12 and 13 result from steel fences and are not included in risk assessment.

Within the areas identified in Drawing 8, it is recommended that strategies be employed for the management of moderate or greater salinity.

Soil from specific building sites or services alignments which are impacted by Salinity Risk (as shown on Drawing 8) should be sampled, tested and classified for soil salinity, aggressivity and corrosivity to the proposed depth of excavation. Additional investigation should include analysis of pH, electrical conductivity, TDS, sodicity, and sulphates and chlorides. At least one groundwater bore per risk area must be installed. This investigation will identify any highly saline sites not identified in this preliminary study.

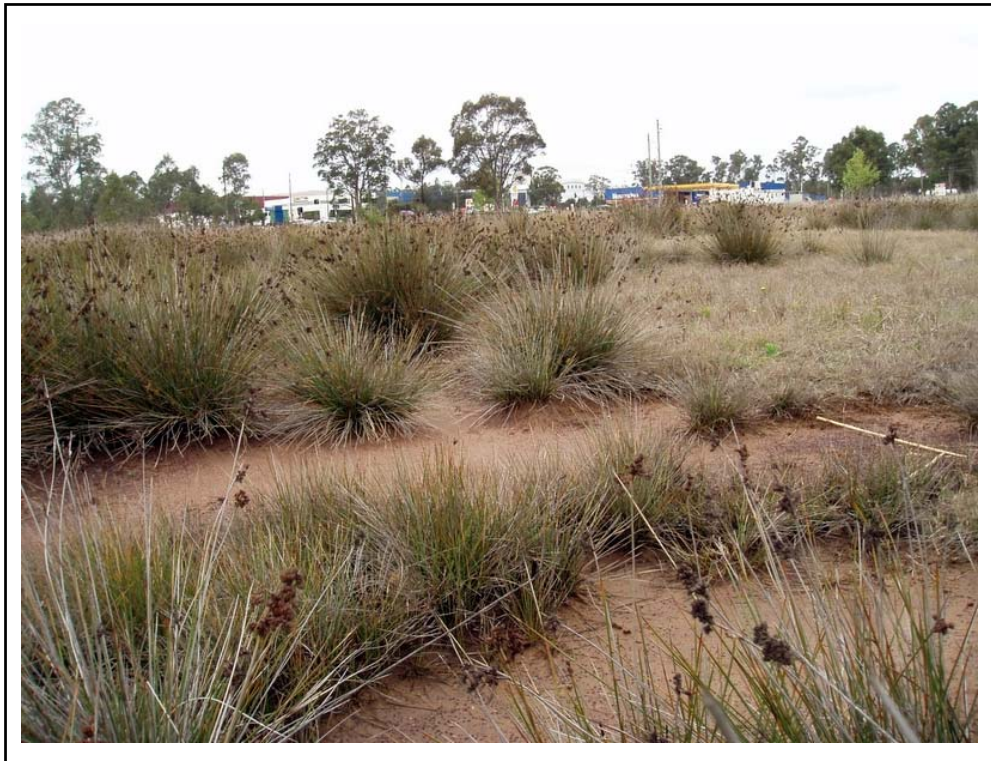
**PHOTO 3: Spiny Rush growing in salt affected area. Parcel 4.**

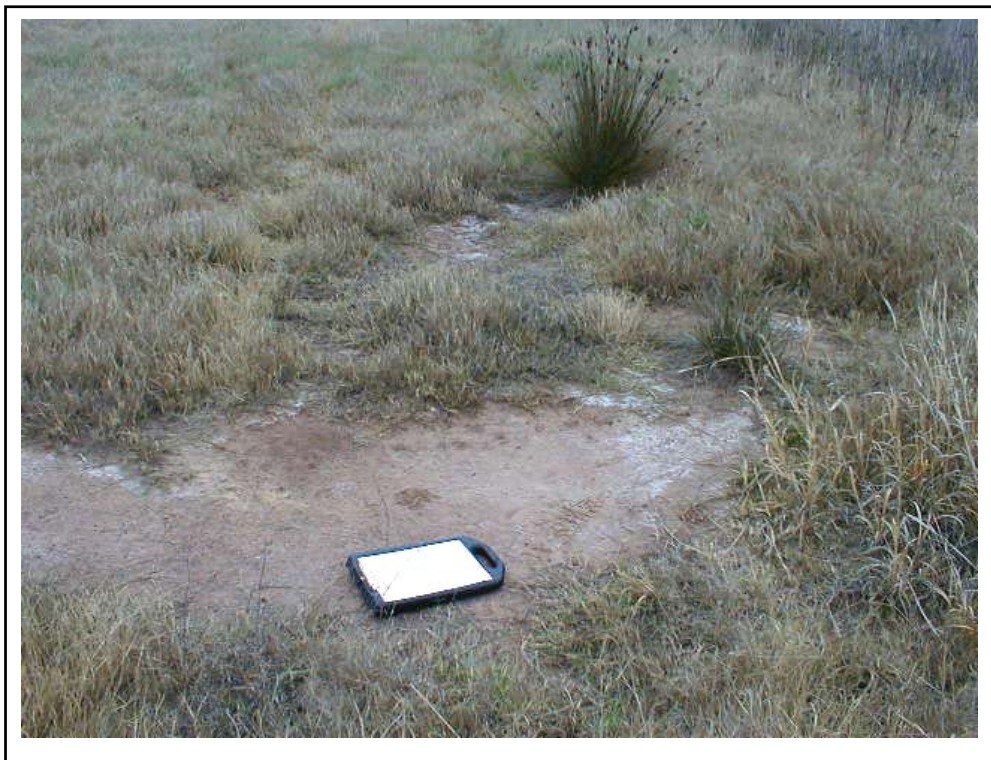
**PHOTO 4: Salt Efflorescence and salt resistant vegetation.**

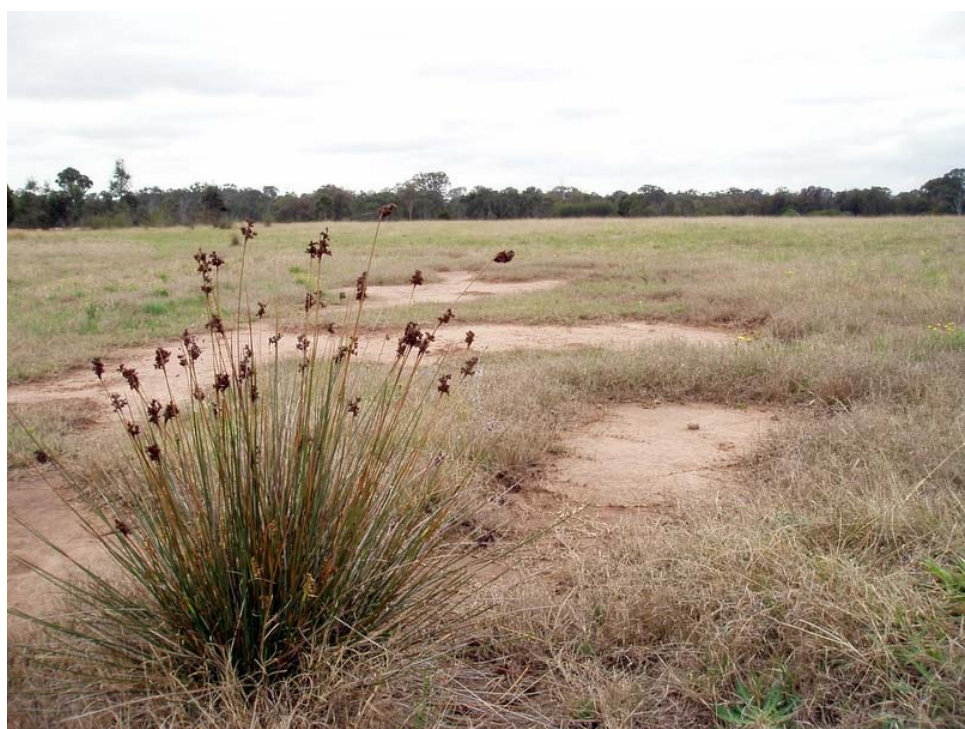
**PHOTO 6: Spiny Rush and salt scalds. Western portion of the Parklands Precinct.**

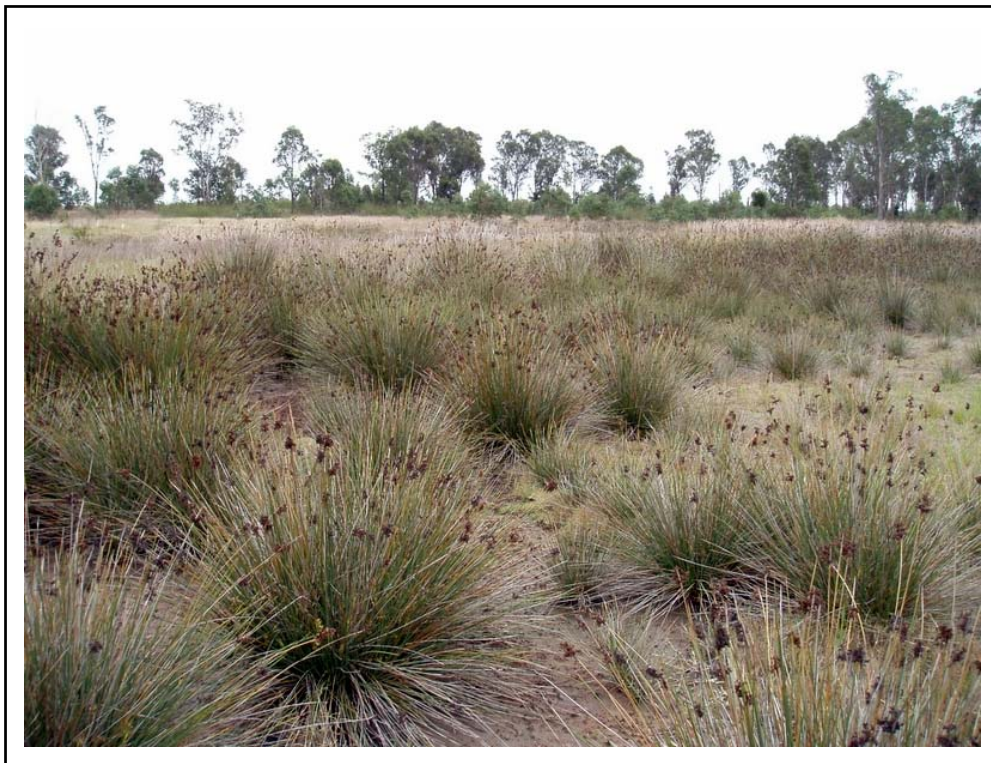
**PHOTO 7: Infestation of Spiny Rush in a water logged, saline area. Parklands Precinct.**

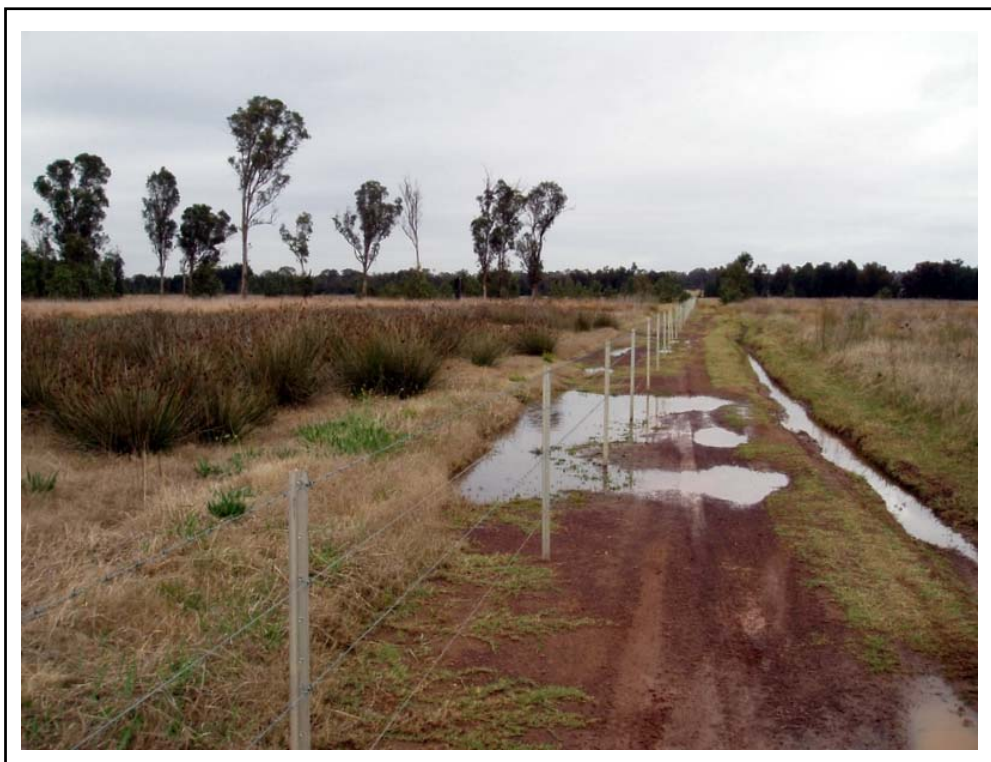
**PHOTO 8: Water ponding and salt resistant vegetation. Parklands Precinct.**

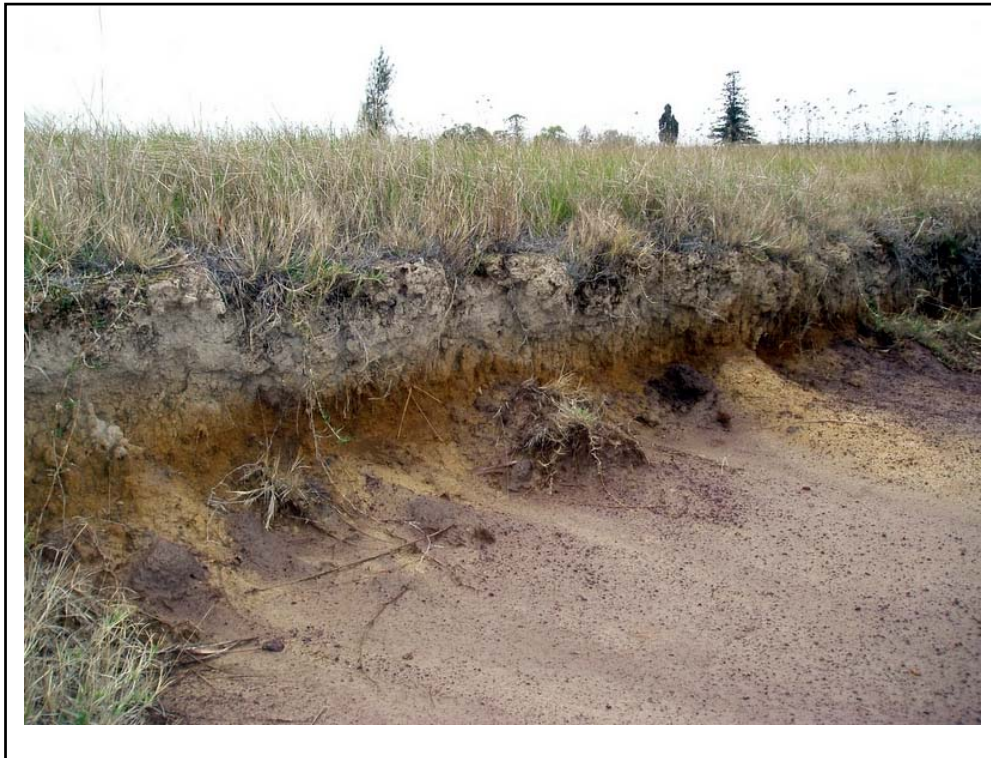
The site inspections identified several shallow gullies entrenching recent alluvial deposits within stream courses and the residual soil profiles. Localised areas of sheet erosion are also noted in areas of previous surface disturbance.

**PHOTO 9: Eroded bank showing soil horizons A and B.**

- filling using select materials (i.e. non-dispersive or erodible) placed under controlled conditions;
- provision of temporary surface cover (e.g. pegged matting) during the period of gully floor revegetation;
- channel lining in sections of rapid change in gully floor grade;
- piping of flow where appropriate;
- the re-establishment of a zone of tree cover along gully banks.

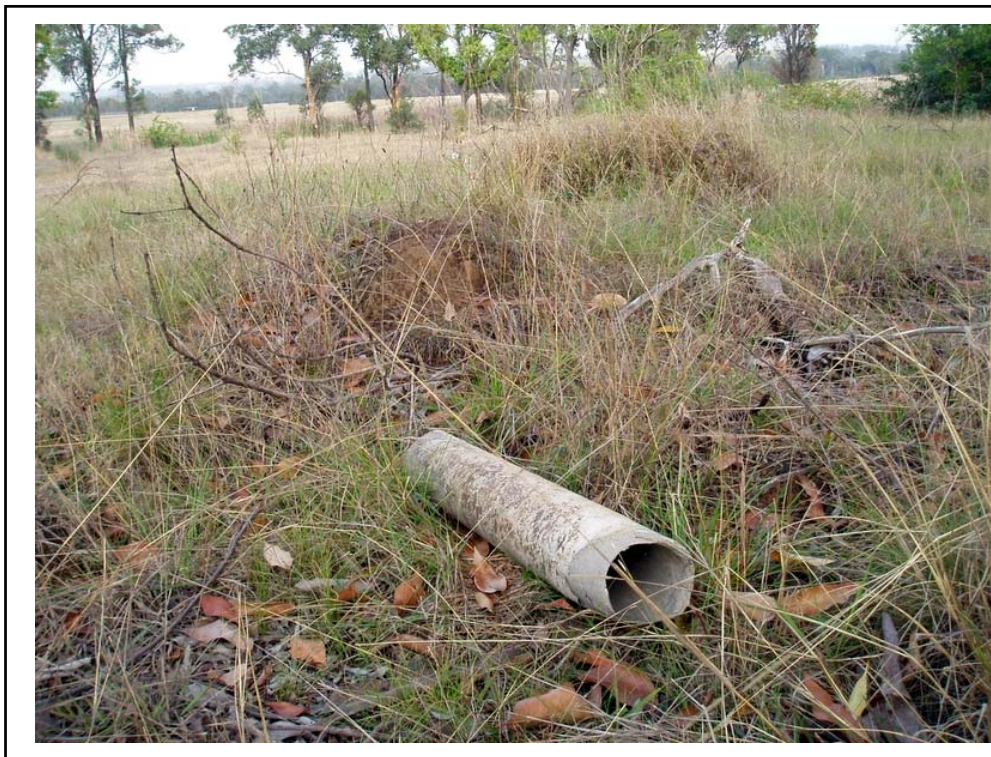
**PHOTO 10: Possible asbestos pipe and small stockpiles. Parcel 3.**

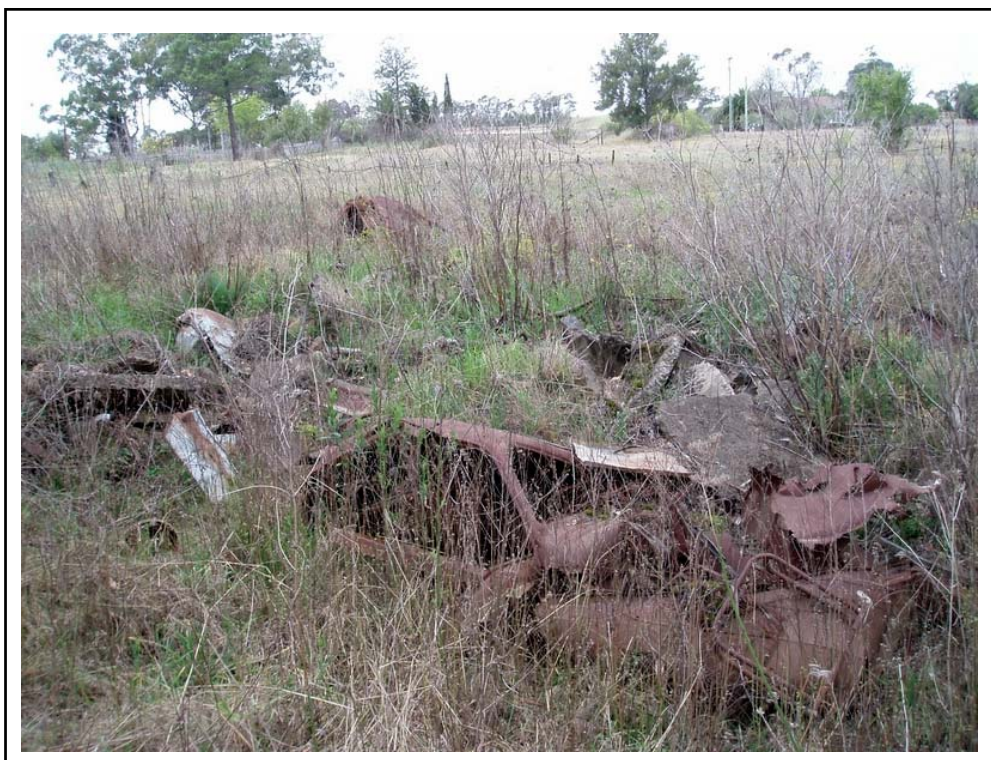
**PHOTO 12: Dumped cars and scrap. Parcel 3.**

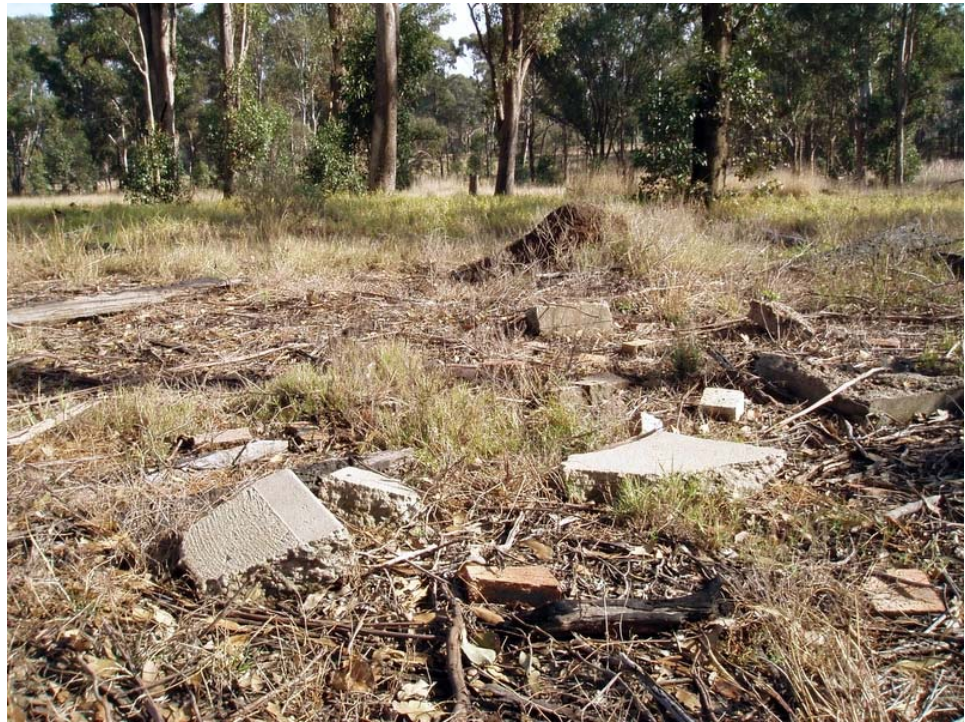
**PHOTO 13: Dumped building rubble. Central portion of Parcel 3.**

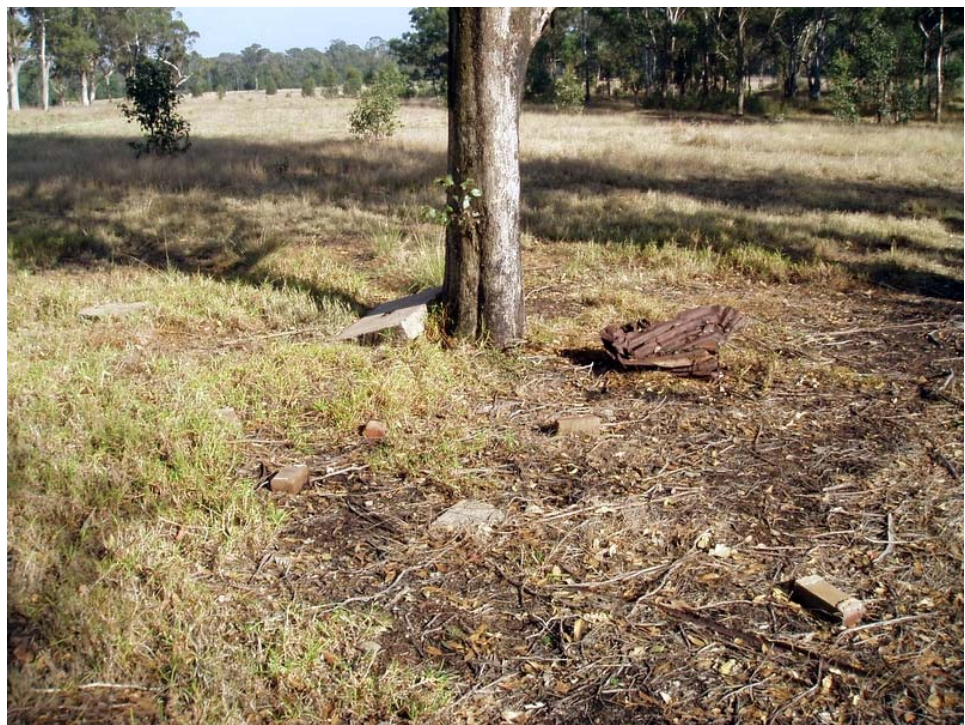
**PHOTO 14: Dumped building rubble and scrap metal. Central portion of Parcel 3.**

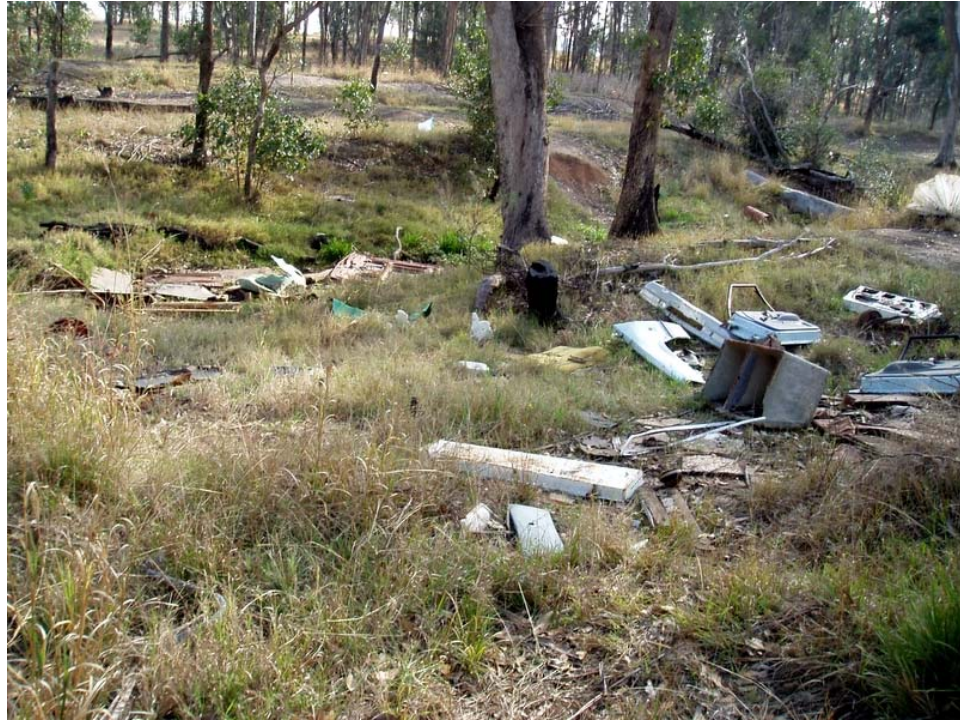
**PHOTO 15: General dumped material. Central portion of Parcel 3.**

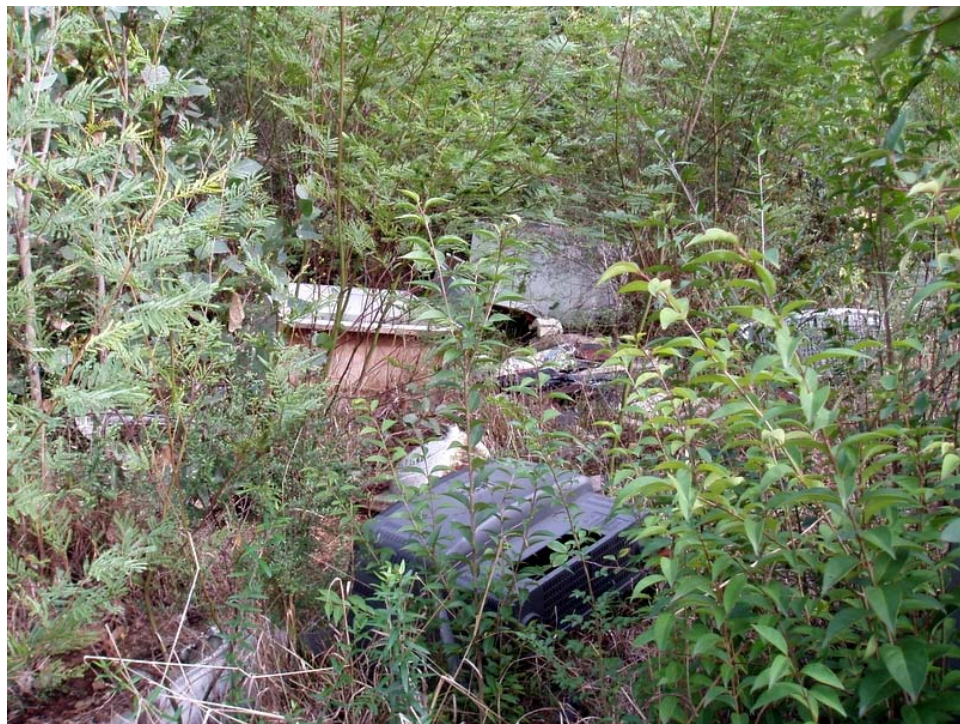
**PHOTO 18: Dumped rubbish western portion of Parklands Precinct, beneath powerlines.**

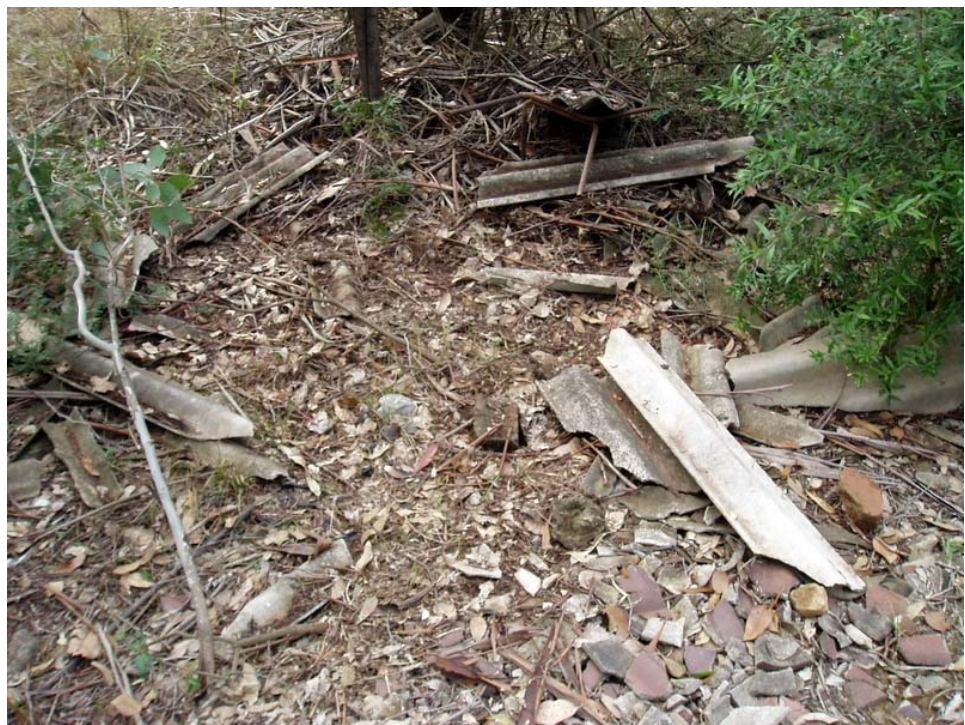
**PHOTO 20: Dumped asbestos sheeting, Central portion of Parklands Precinct.**

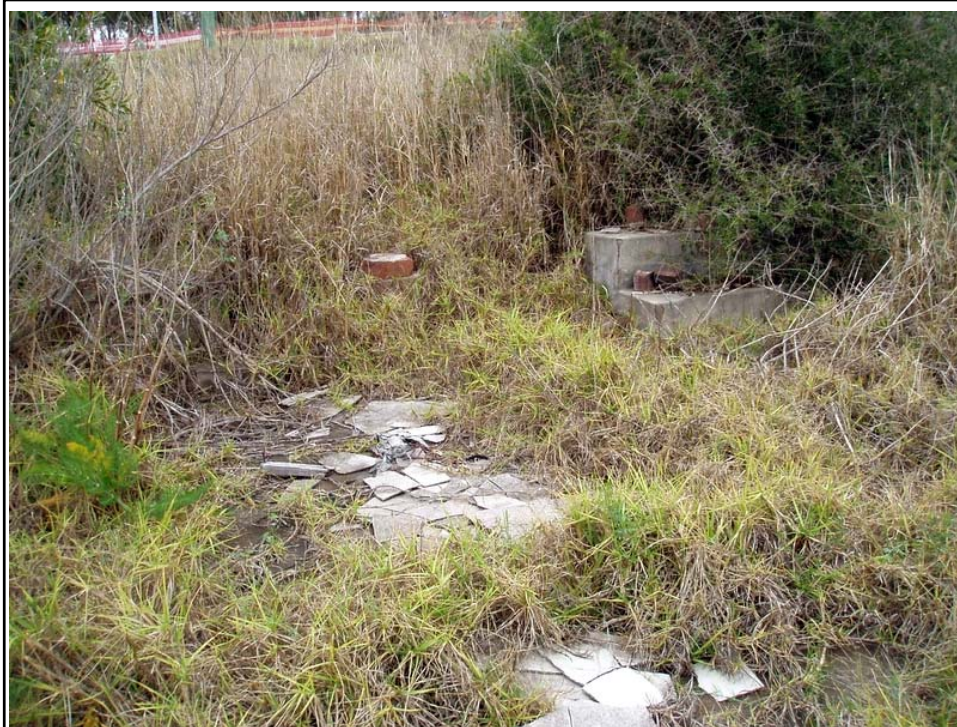
**PHOTO 21: Remnant slabs and asbestos sheeting, from building demolition, Parcel 2.**

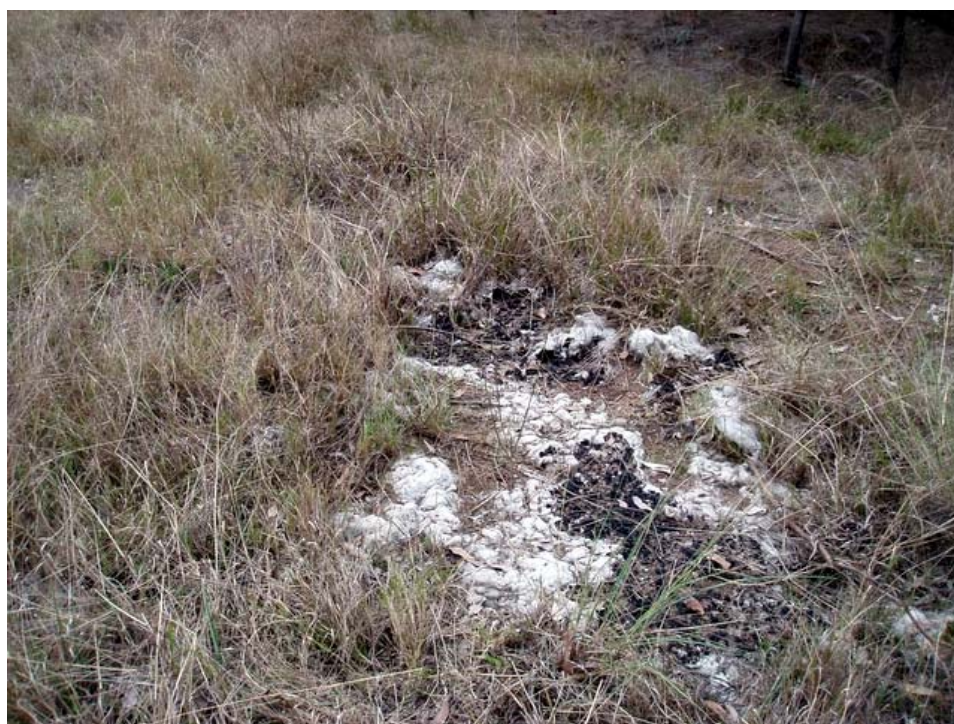
**PHOTO 22: Dumped lagging, possible asbestos or other synthetic mineral fibre (SMF), Parcel 2.**

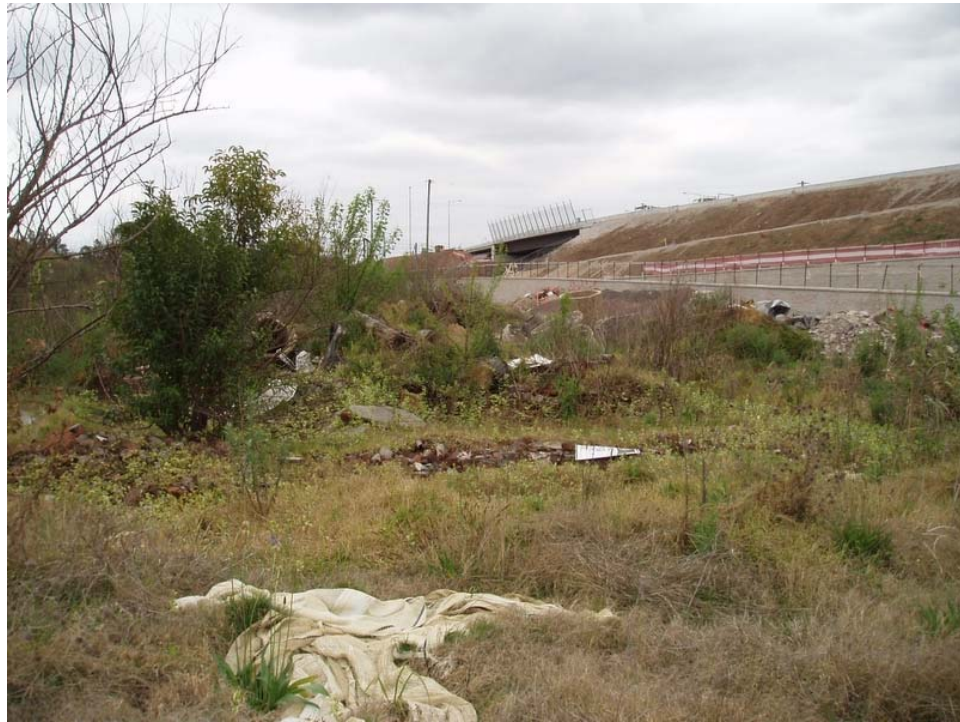
**PHOTO 23: General building rubble, near M7 alignment, Parcel 2**

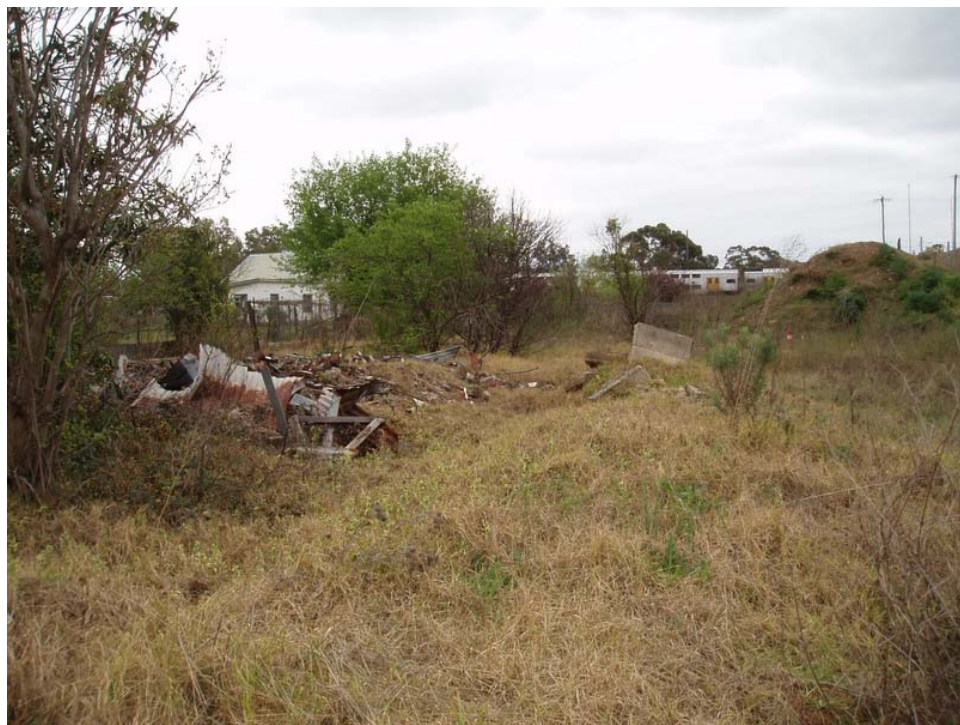
**PHOTO 24: Dumped scrap and soil stockpiles, Parcel 2.**

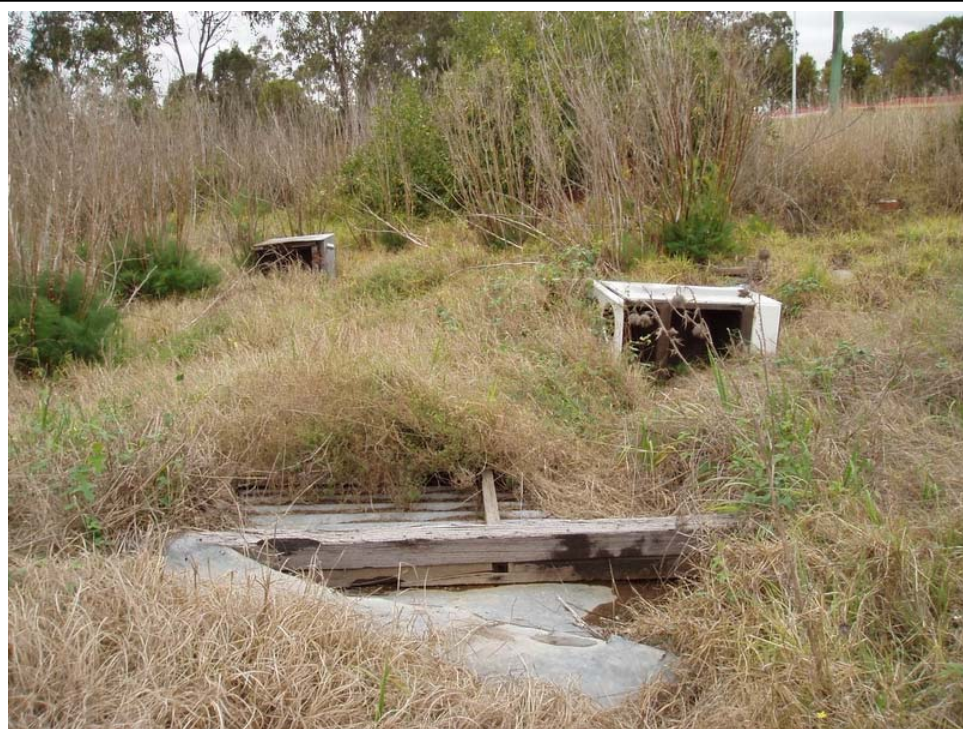
**PHOTO 26: Dumped timber and scrap metal, Southern portion of Parcel 2.**

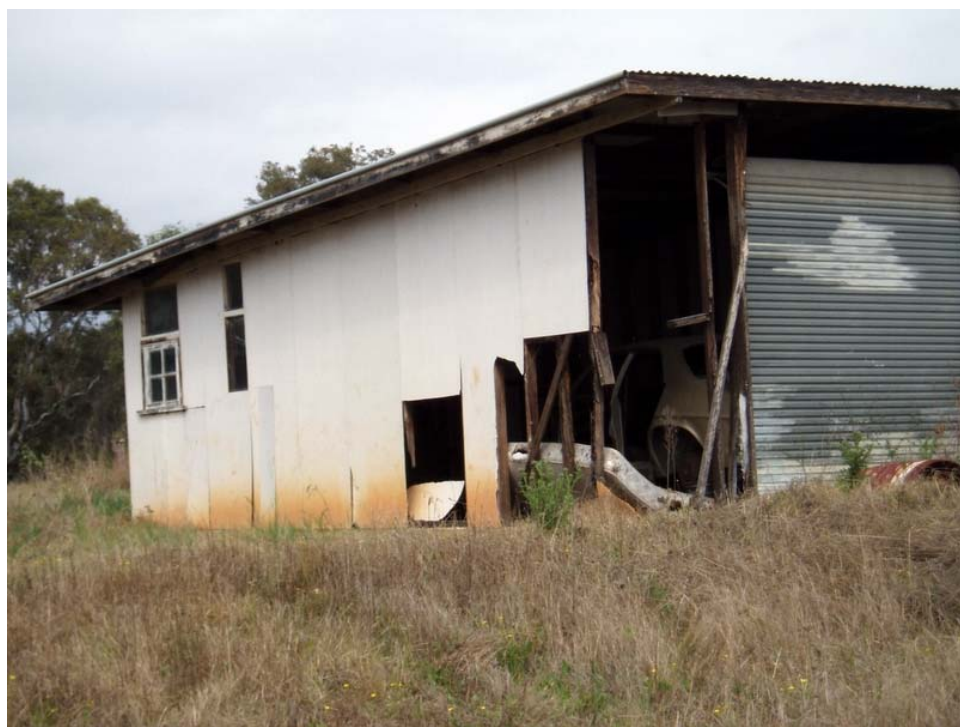
**PHOTO 30: Fibre board structure (possible asbestos). Parcel 4.**

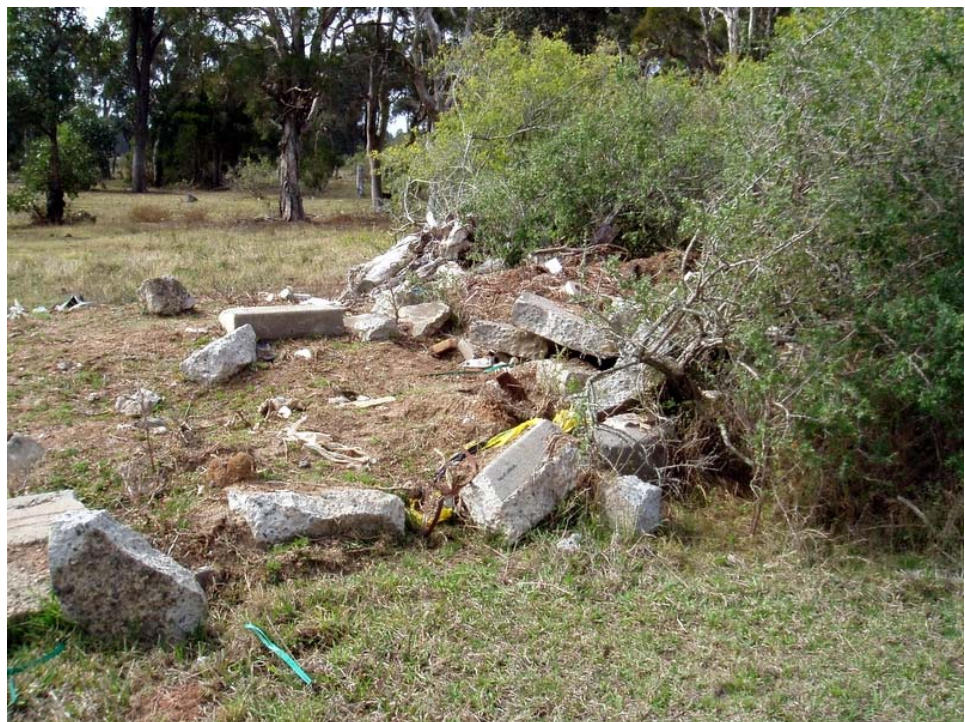
**PHOTO 32: Dumped building rubble, Parcel 4.**
