## TILLEGRA DAM DESIGN - CONSULTANCY 361802

Storage Rim Stability and Seepage Potential  
Engineering Geotechnical Report

Report No. 08–GN31A–R2, Final Report V 4.1  
February 2009

## Tillegra Dam - Storage Rim Landslide Risk Assessment

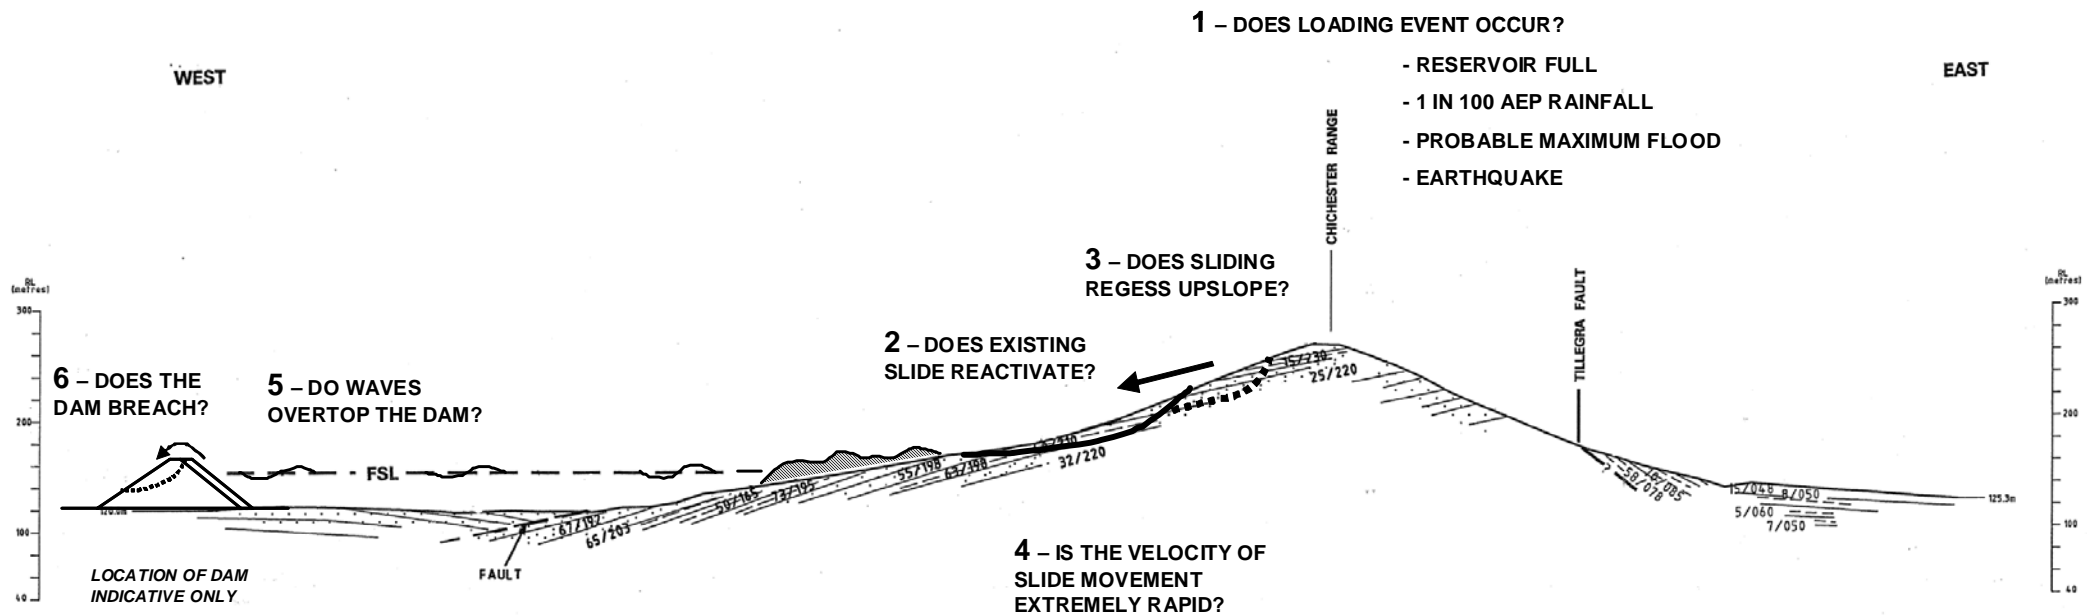
Figure 3-2 Schematic cross section showing the sequence of events for Domain 2 storage rim instability

- Domain 1 – Potential large scale, first time slide of the ridge leading to uncontrolled release of the storage.
- Domain 2 – Mobilisation of the pre-existing medium scale slide 2A feature, leading to the formation of a wave in the storage and overtopping failure of the dam structure.
- Domain 5 – Potential medium scale, first time slide of the inner slope leading to the formation of a wave in the storage and overtopping failure of the dam structure.

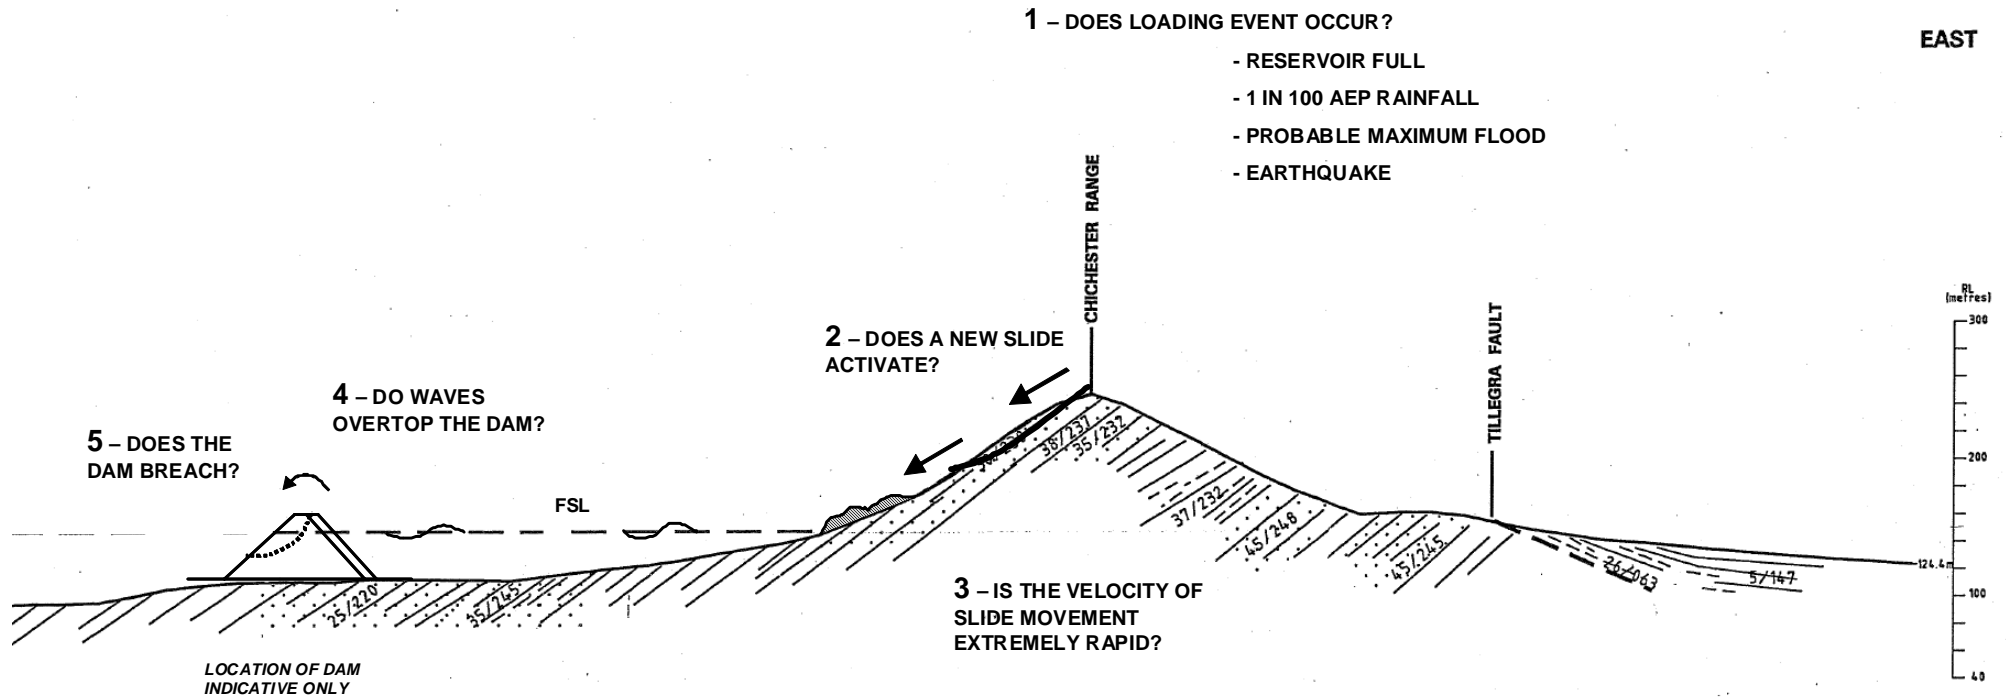
Figure 3-3 Schematic cross section showing the sequence of events for Domain 5 storage rim instability

- A first time slide at location 5A in Domain 5 would require a bedding plane failure within the rock mass and a breakout across bedding at the toe. Geological mapping did not find any evidence for adversely orientated joint sets or other geological features which could provide a breakout at the toe. The outcrops at location 5A show massive sandstone in the toe region.

- Domain 5 – Potential medium scale, first time slide of the inner slope leading to the formation of a wave in the storage and overtopping failure of the dam structure.

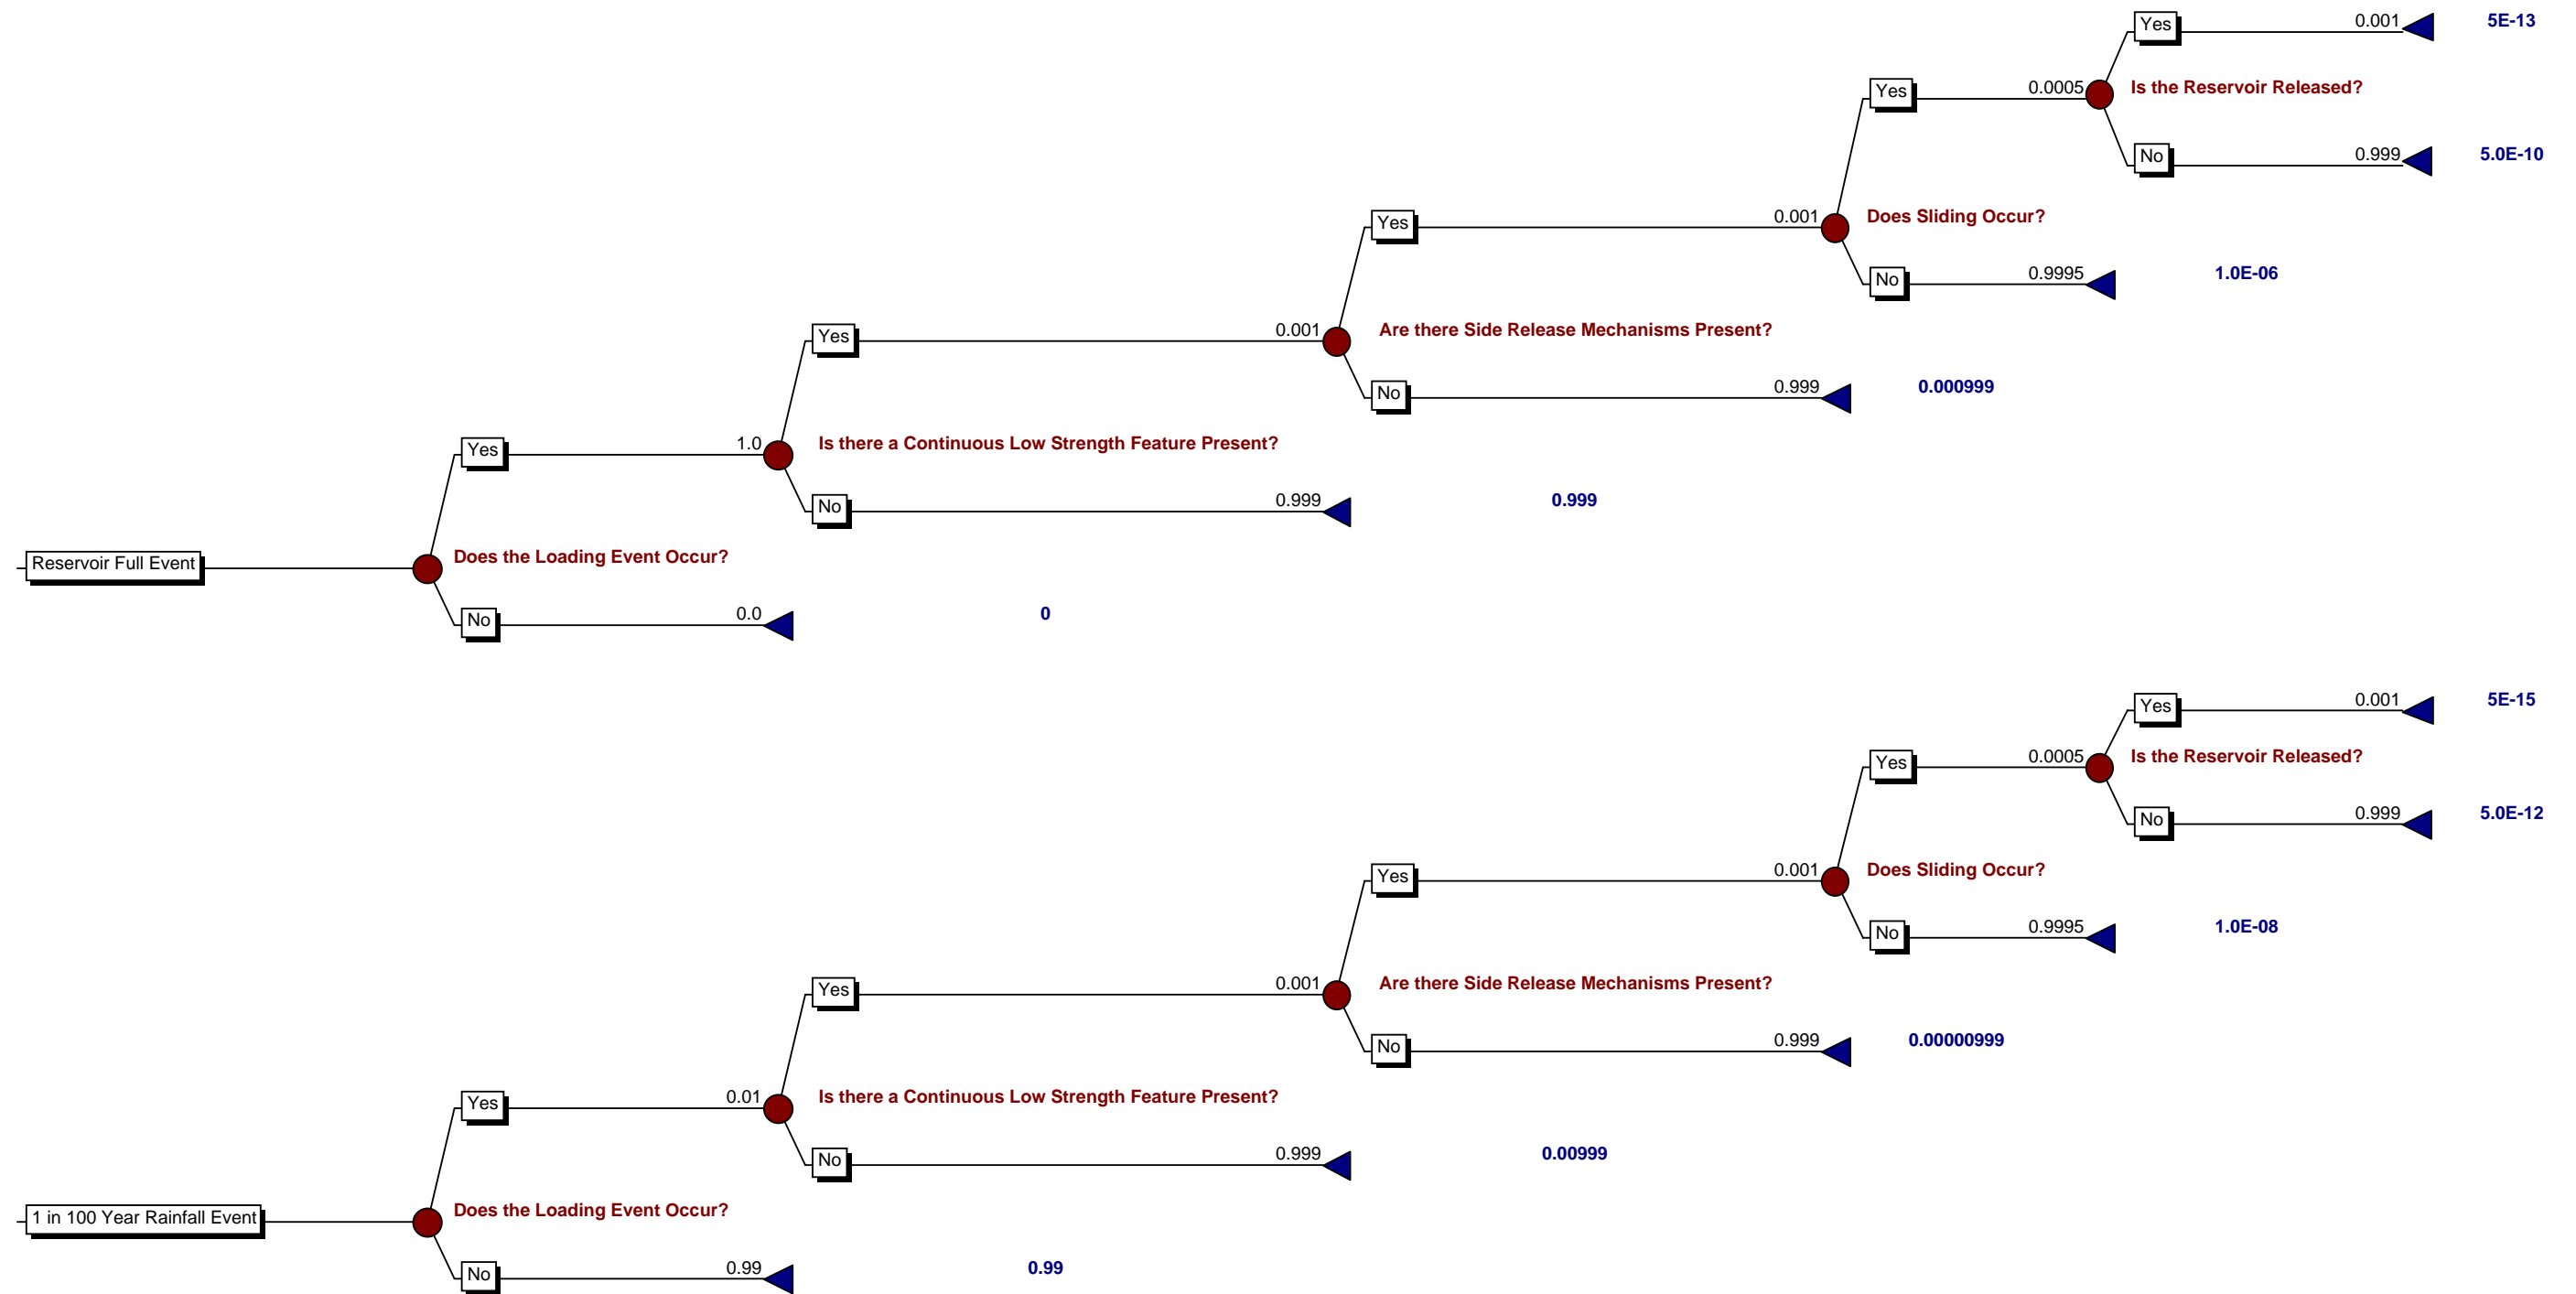
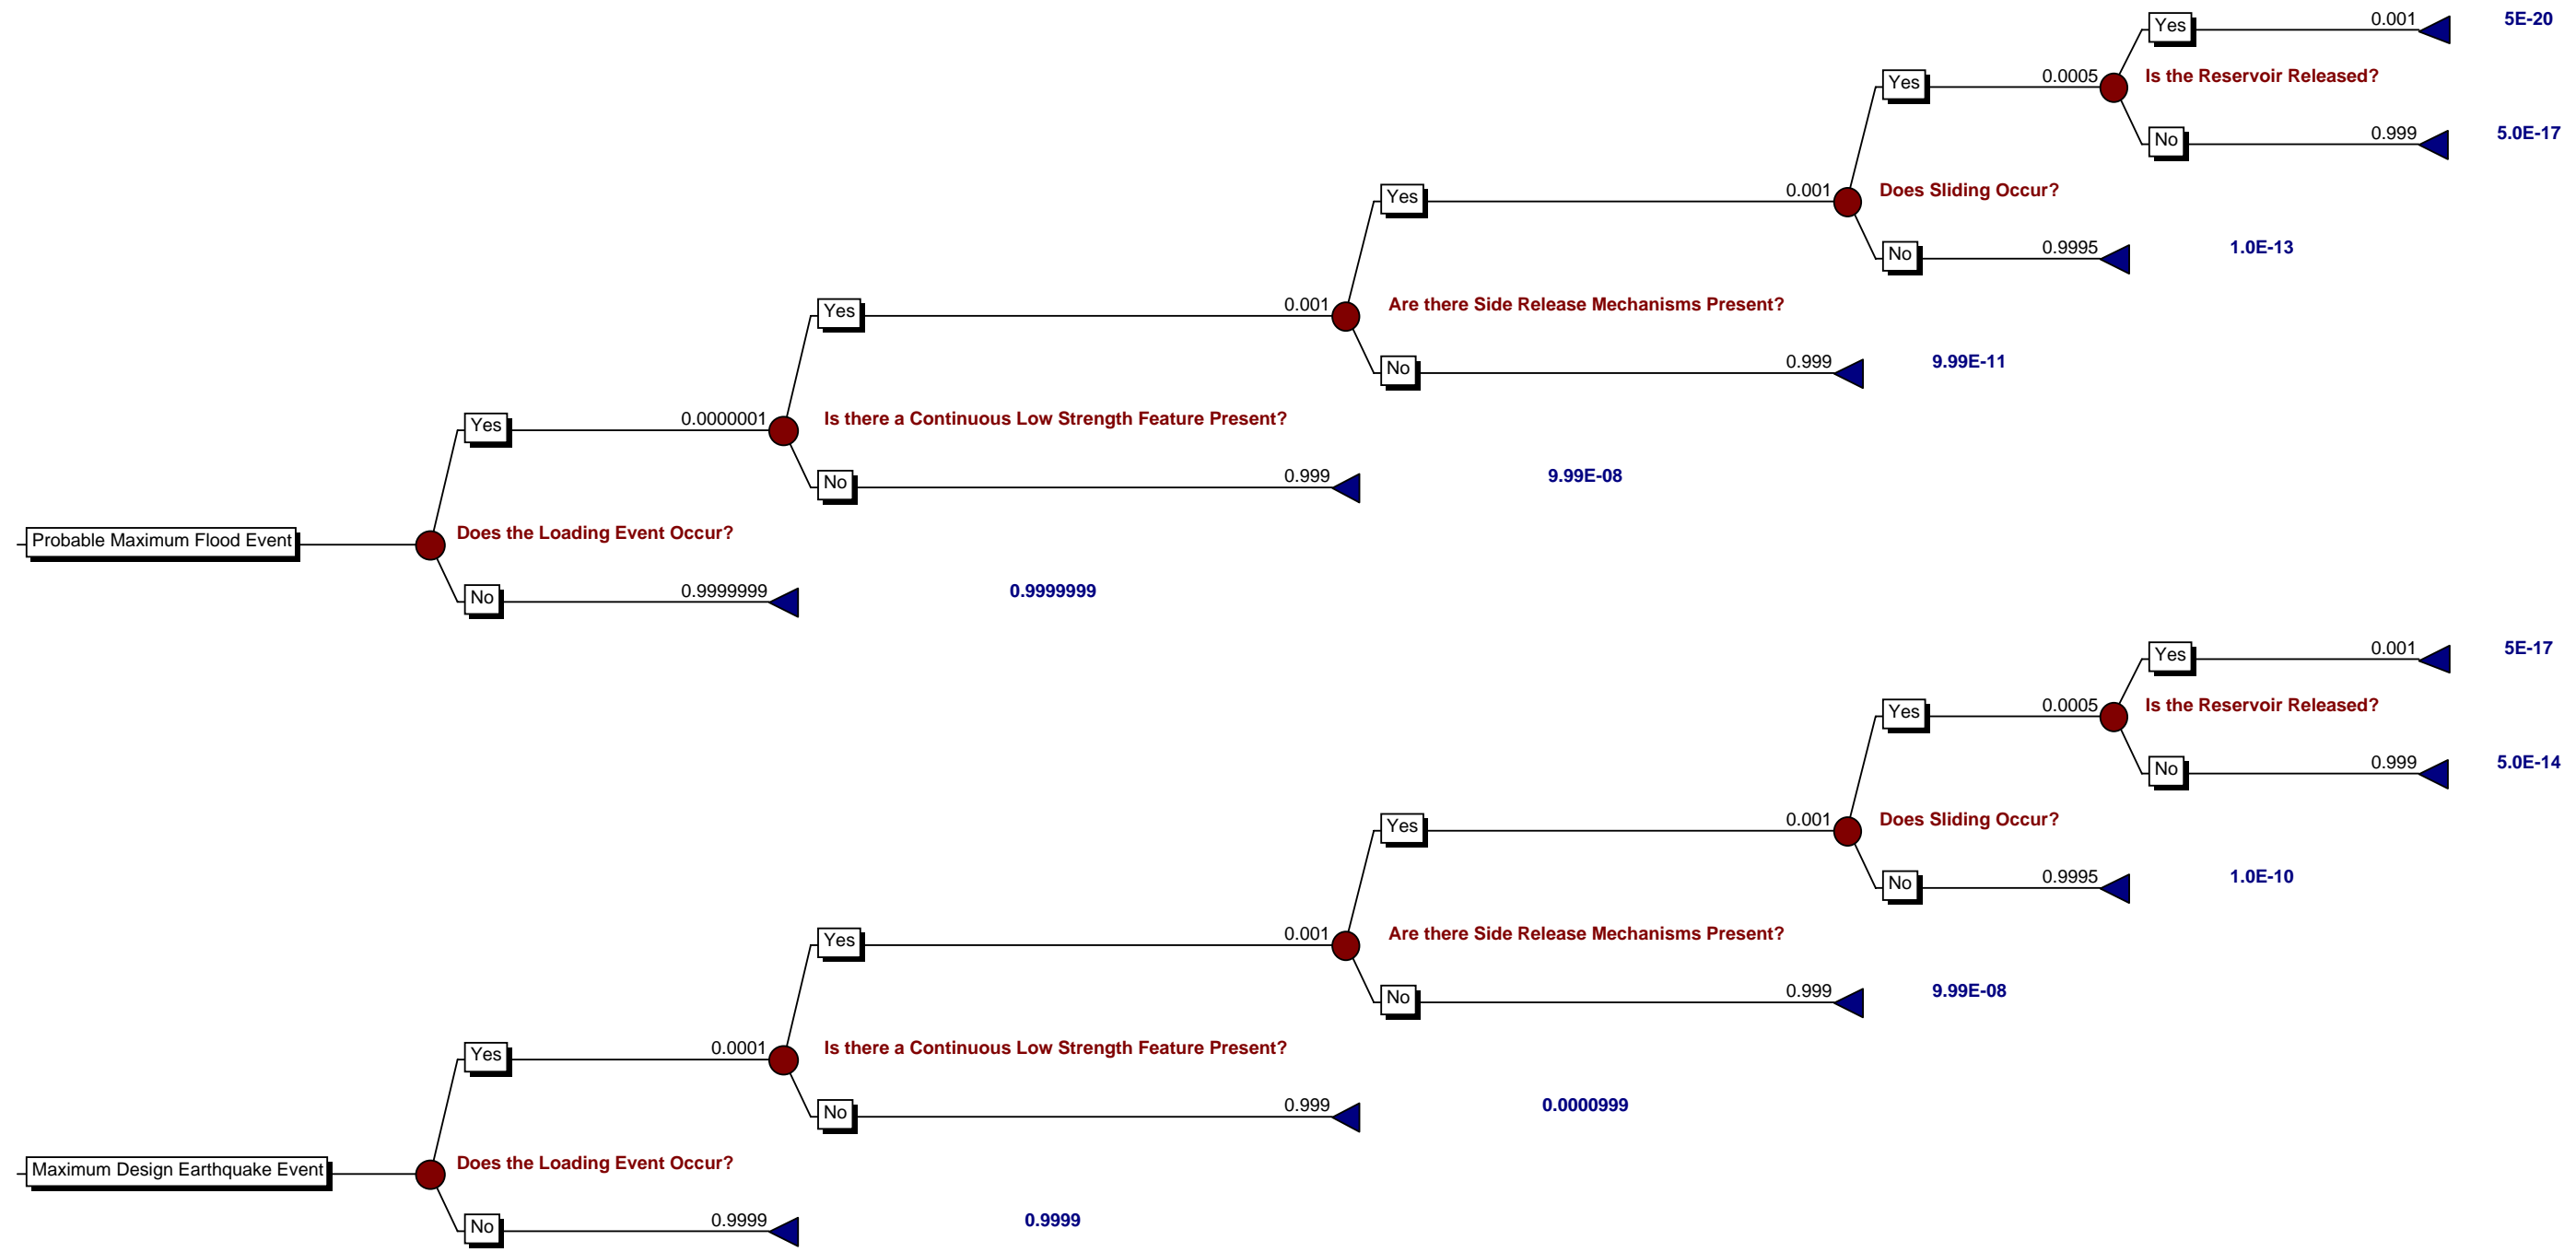
**Domain 1**

Loading Condition	Reasoning	Assigned Probability
Does the Loading Event Occur?	Reservoir filling assumed to occur each year	1
Is there a Continuous Low Strength Feature Present?	<ul style="list-style-type: none"> <li>• No evidence of bedding surface shears along bedding or across bedding - have seen no evidence for this.</li> <li>• Feature would need to be very long - 600m long</li> <li>• Two known mapped faults are geometrically not related to the domain and are dipping in directions such that failure is not kinematically feasible</li> </ul>	0.001
Are there Side Release Mechanisms Present?	<ul style="list-style-type: none"> <li>• Large three dimensional effects from side shear</li> <li>• Requires geological features to provide side release mechanisms - assessed to be not conceivable</li> </ul>	0.001
Does Sliding Occur?	<ul style="list-style-type: none"> <li>• 2D stability analyses (i.e. ignoring side resistance) indicate factor of safety for a deep outer slide without the dam is 2.2, and 2.1 with the dam (cohesion 0 kPa, <math>\phi=12^\circ</math>).</li> <li>• The 2D analyses used conservative strength and piezometer surfaces and ignoring 3D effects, so actual factor of safety will be greater</li> <li>• Requires friction angle <math>\phi=6^\circ</math> to get FOS=1 (in 2D analysis), and can't envisage shear strength this low.</li> </ul>	0.0005

Is the Reservoir Released?	<ul style="list-style-type: none"> <li>• The slide mass would need to travel a long distance for a catastrophic release of the storage to occur - can't envisage a mechanism for the slide mass to travel on a low angle shear surface</li> <li>• If sliding were to occur, can't envisage uncontrolled release of the storage, could lead to leakage</li> </ul>	0.001

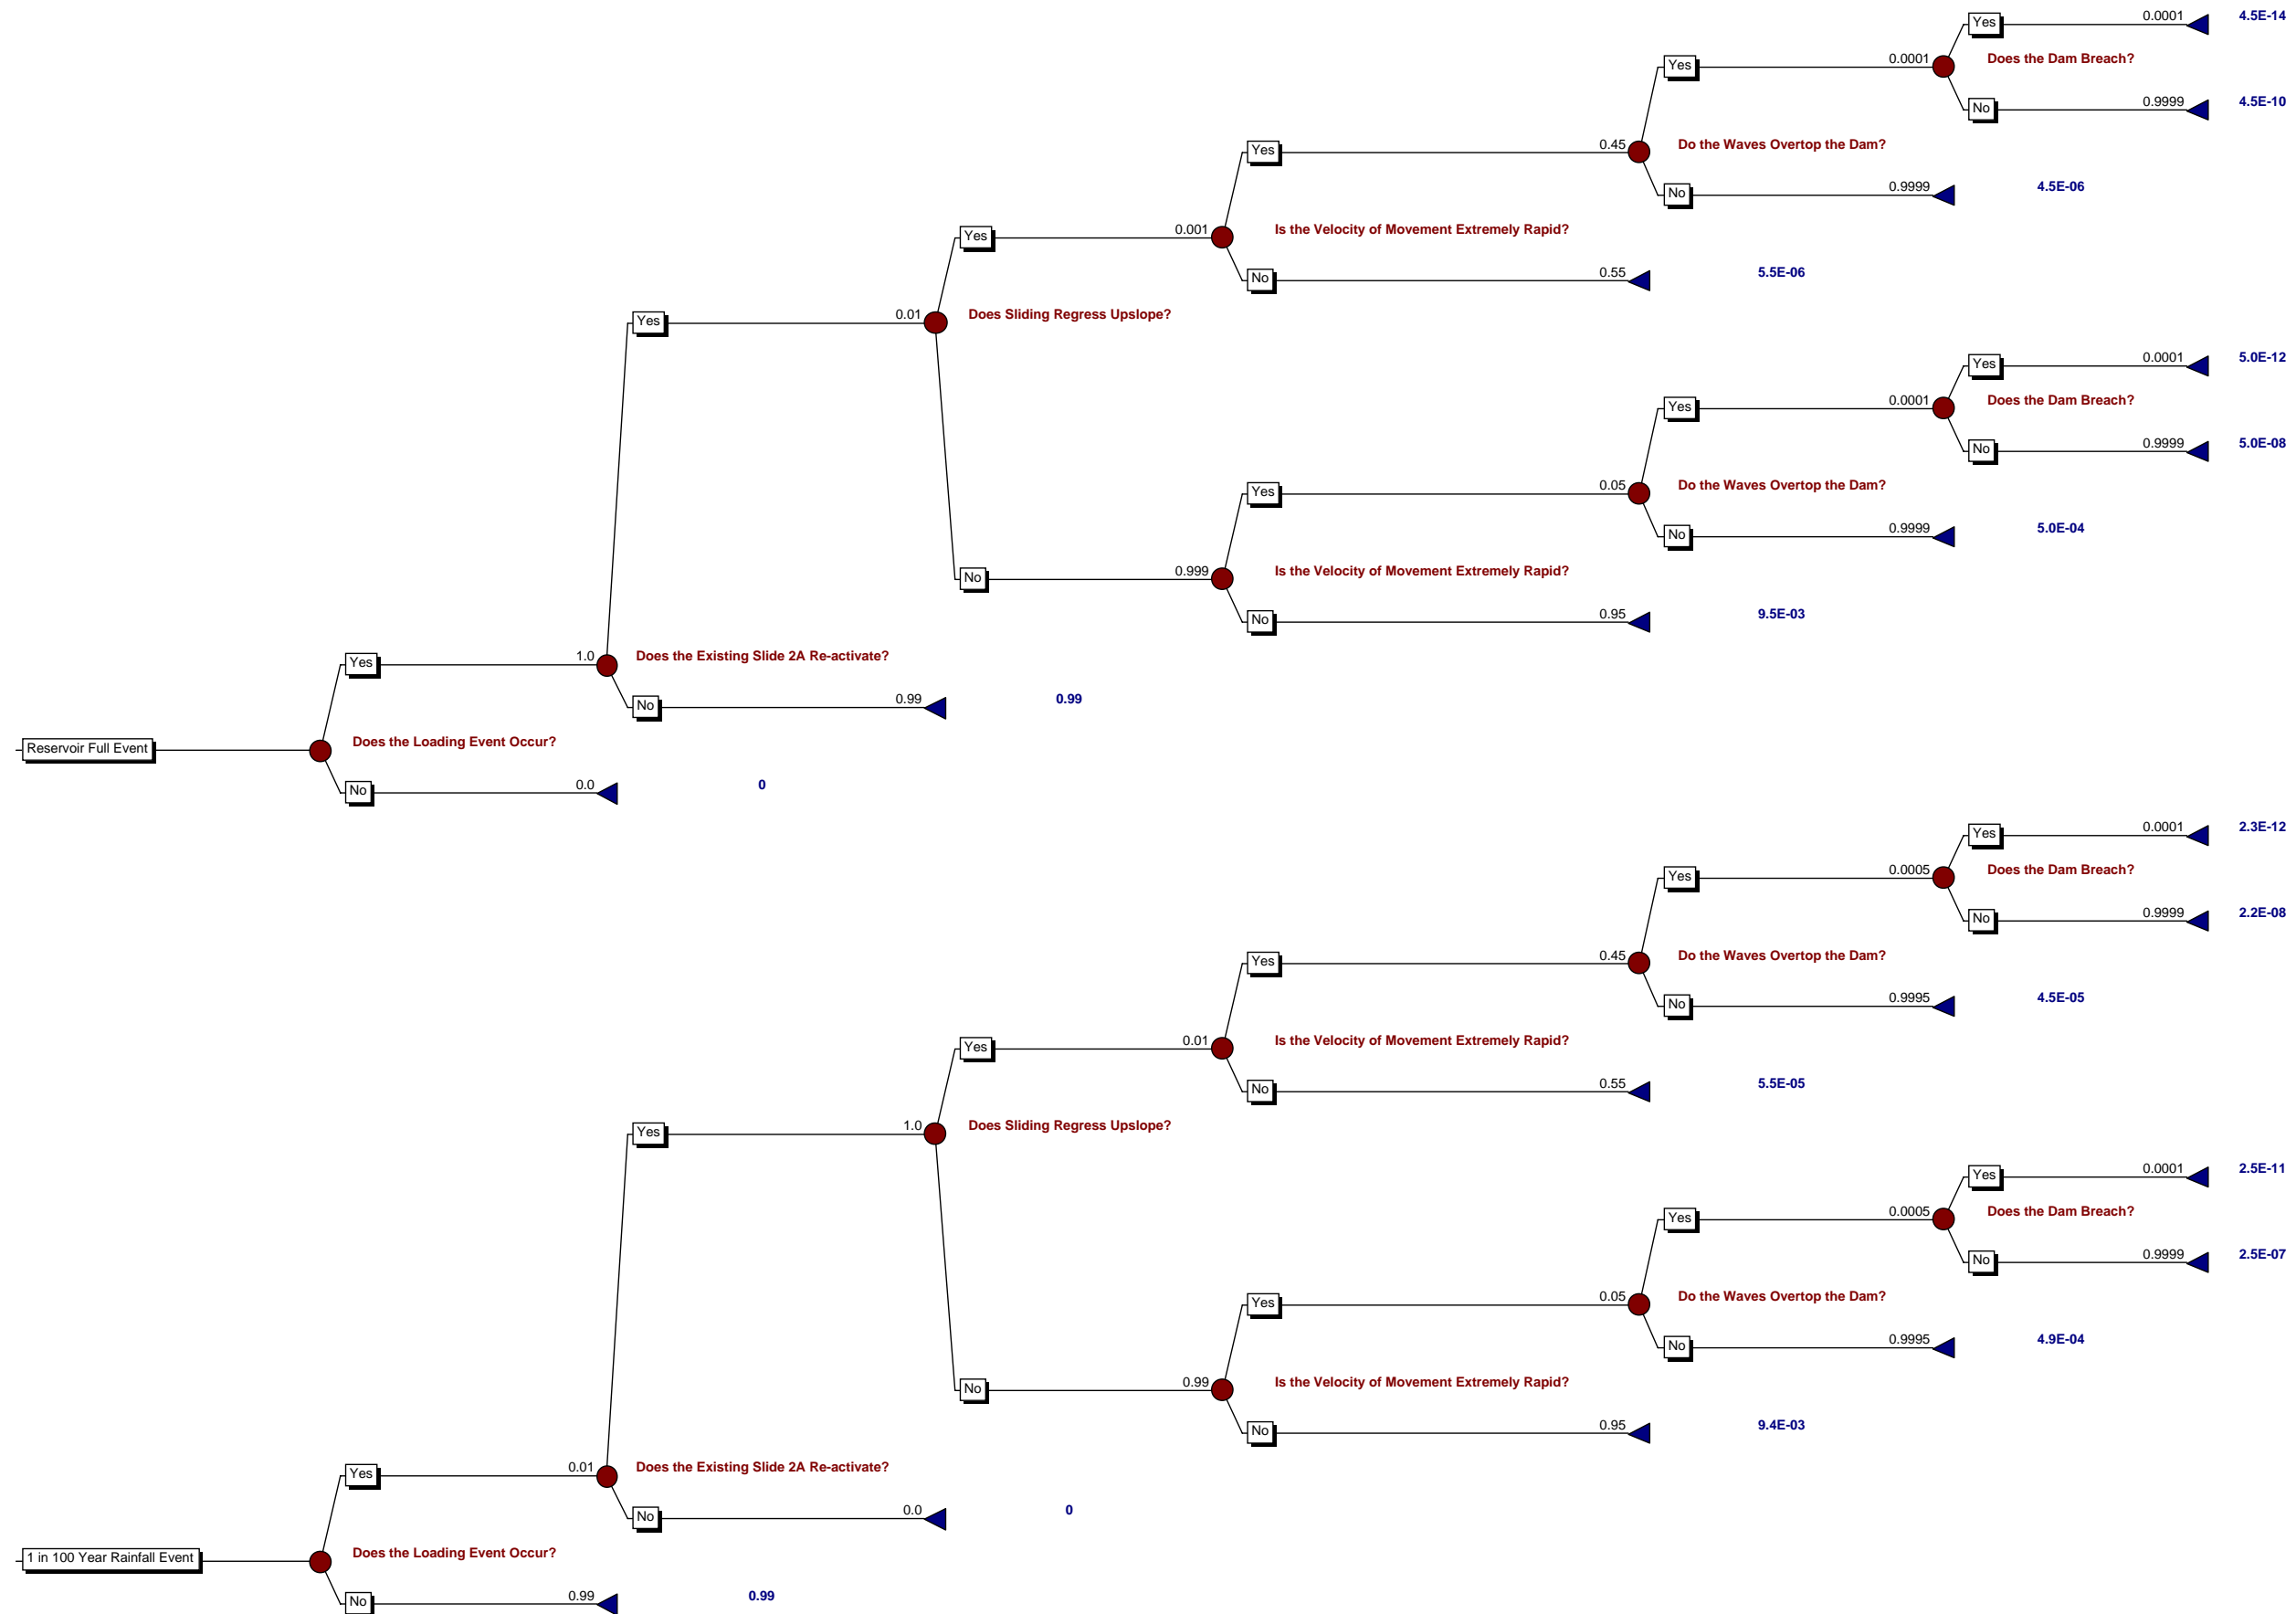
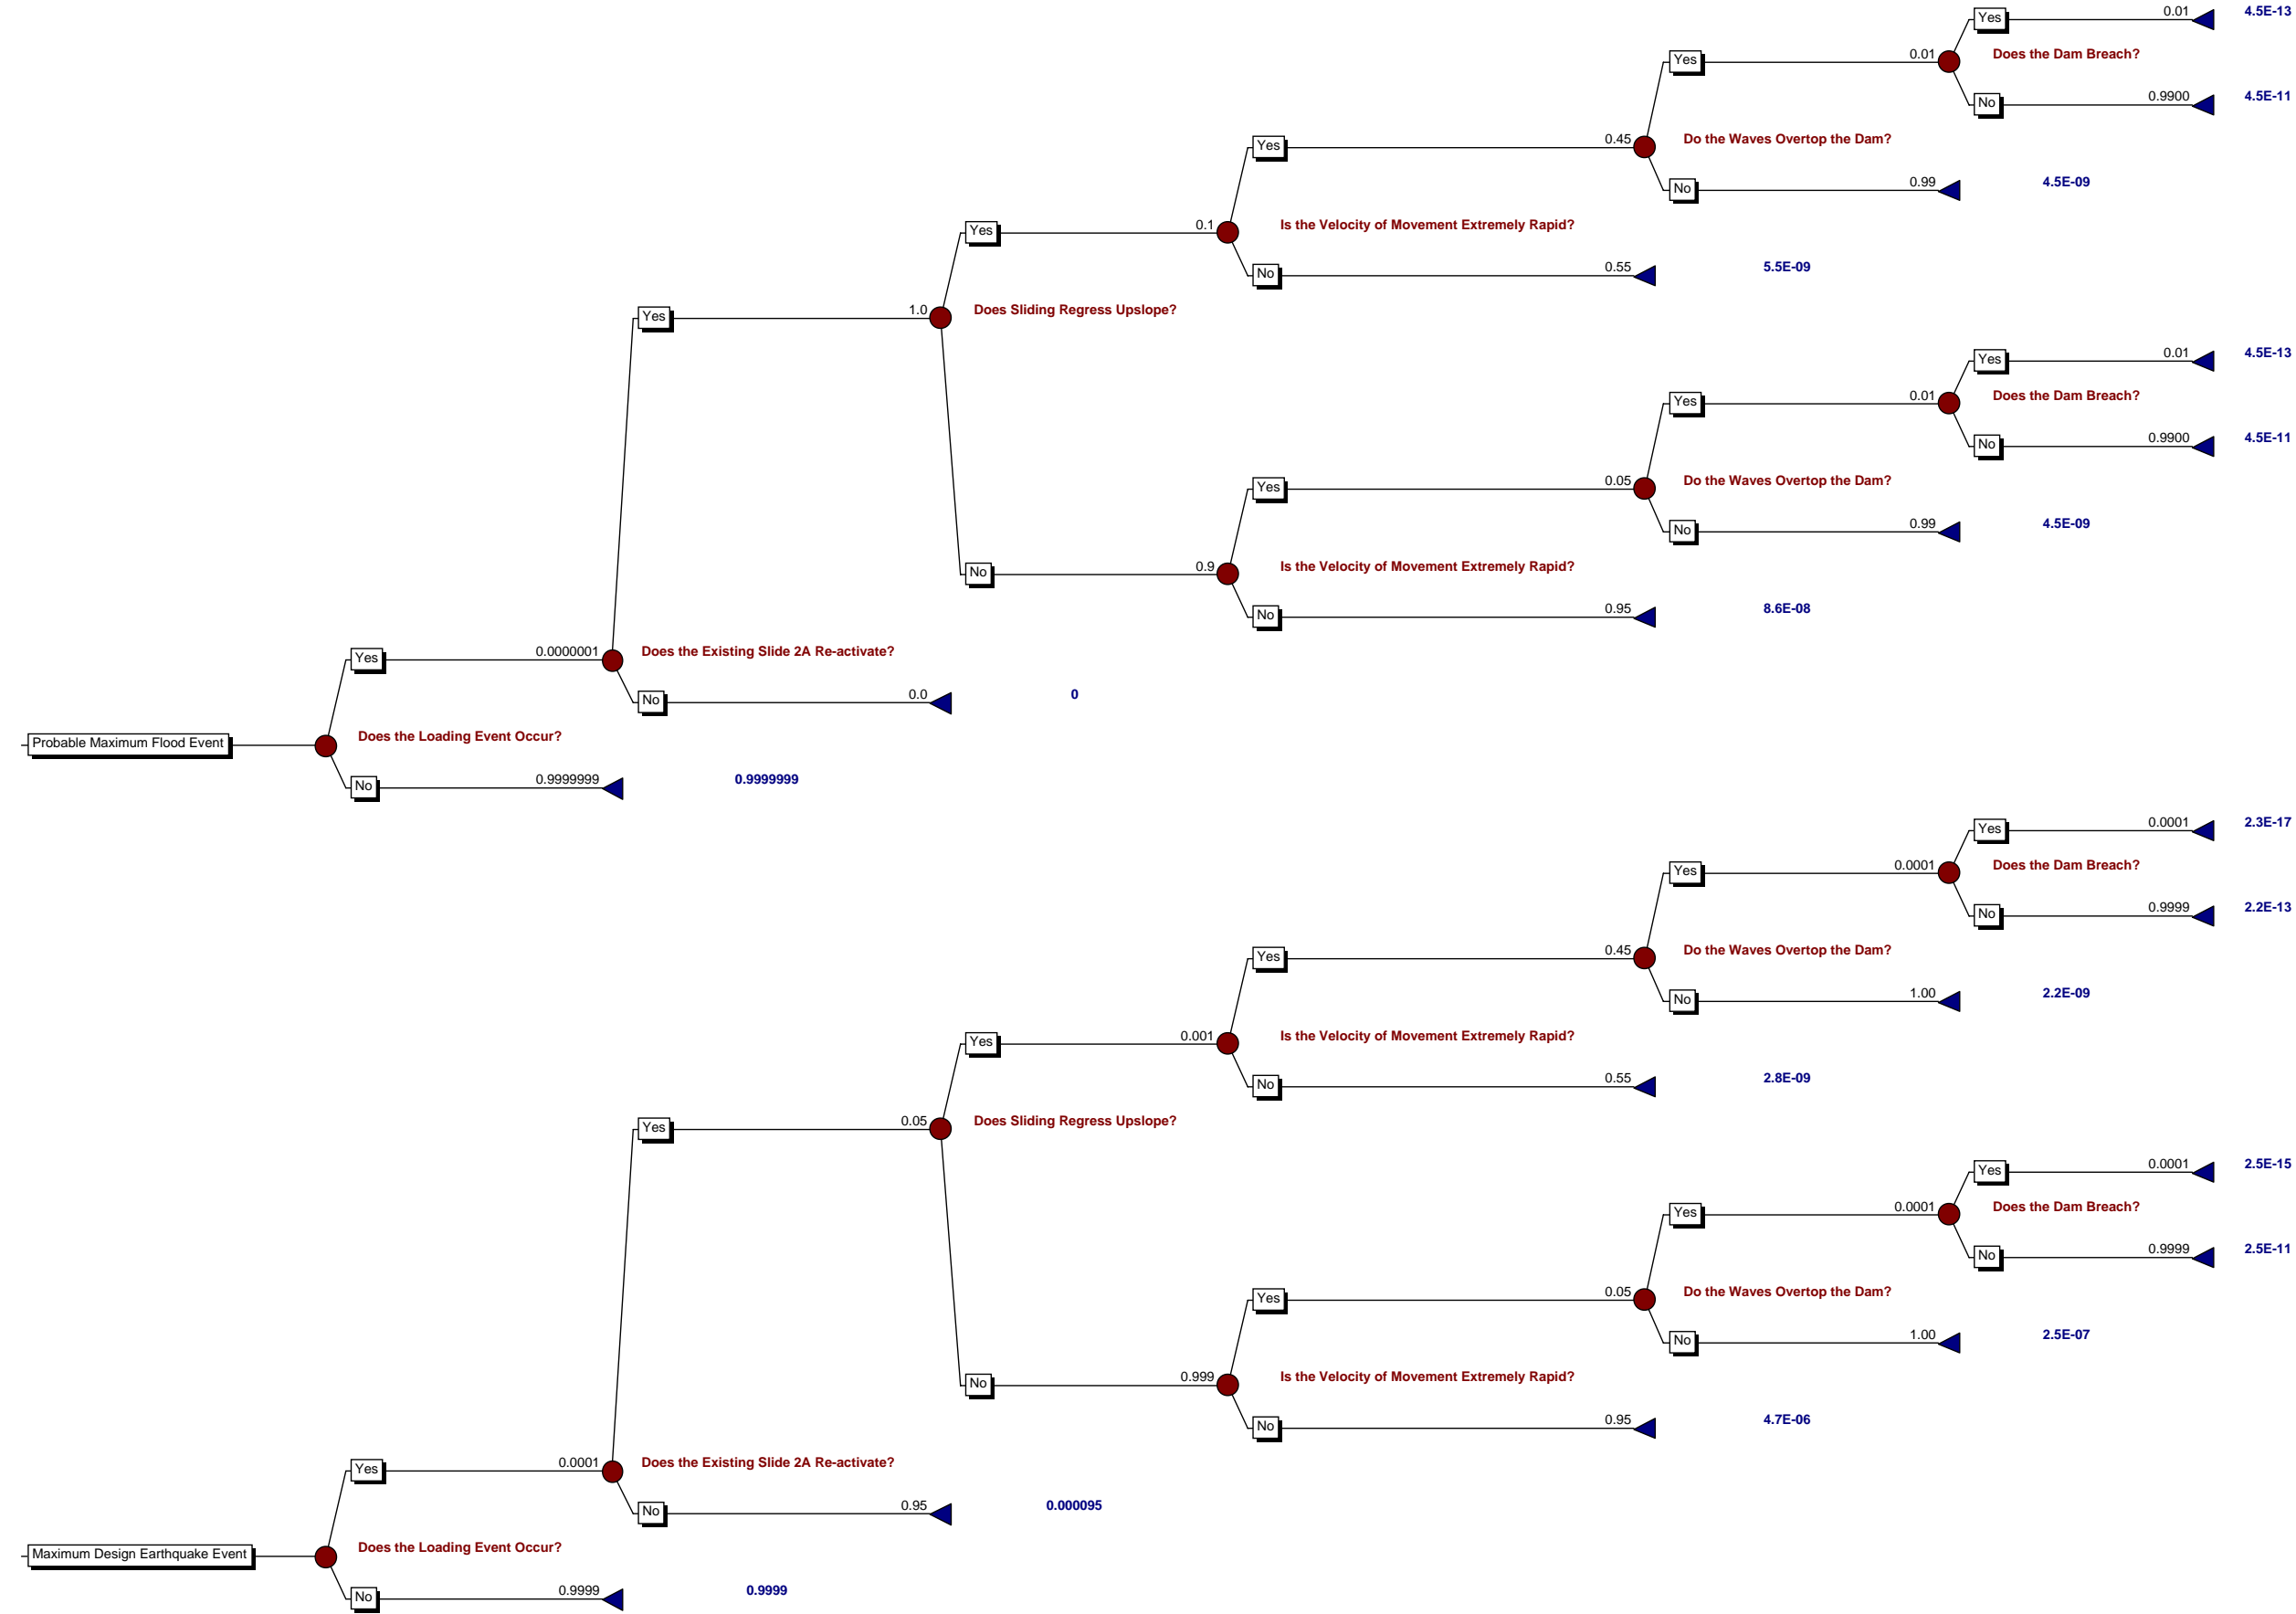
## Domain 2

Loading Condition	Reasoning	Assigned Probability
Does the Loading Event Occur?	Reservoir filling assumed to occur each year	1
Does the Existing Slide Re-activate?	<ul style="list-style-type: none"> <li>Existing slide is approximately 370,000 m<sup>3</sup> in size</li> <li>The toe of the existing slide 2A would be inundated by about 15m by the storage filling</li> <li>Test pits indicated no evidence of groundwater</li> <li>No evidence of springs, but Melaleuca Trees above scarp indicate likely wet conditions</li> <li>Filling of the storage to FSL would inundate the toe of the slide. Stability analysis by PSM 2008 indicates factor of safety reduces from 1.79 for dry case to 1.49 for FSL case (i.e reduces FOS by about 17%, but FOS still greater than 1.0)</li> <li>A possible scenario is erosion to undermine the toe (not likely under first fill)</li> <li>Mechanism of movement for Slide 2A is rainfall induced saturation of the slide mass</li> </ul>	0.01

Is the Velocity of Movement Extremely Rapid?	<ul style="list-style-type: none"> <li>• Surface of rupture is already at residual strength</li> <li>• The toe area is a thick "shove zone" of brecciated rock - this is not expected to give a brittle release mechanism.</li> <li>• Past performance shows long history of slow movements despite high rainfall events over a long period</li> <li>• Assigned probability of 0.05 for case where sliding does not regress upslope based on Glastonbury and Fell method (refer to PSM 2009).</li> <li>• Probability assessed using the Glastonbury and Fell method is 0.45 if upslope regression occurs (refer to PSM 2009).</li> </ul>	<p>0.45 (if sliding regresses upslope)</p> <p>0.05 (if upslope sliding does not occur)</p>
Do the Waves Overtop the Dam?	<ul style="list-style-type: none"> <li>• Slide is not in direct path to dam (dam face oblique to wave direction) and would require waves to reflect off Elwari Mountain</li> <li>• Analysis by PSM indicates only relatively small wave heights if the slide moves extremely rapidly (7.6m waves for 2D analysis, and &lt;0.1m allowing for 3D effects of waves reaching the dam).</li> <li>• The amount of freeboard for the 1 in 100 flood event (i.e. height between maximum reservoir level and crest level of the dam) is 5.5m - this is less than the FSL condition but still larger than the predicted wave runup on the face of the dam</li> <li>• Assigned event probability of 0.0005 - 5 times higher than the reservoir full condition.</li> </ul>	<p>0.0005 (if sliding regresses upslope)</p> <p>0.0005 (if sliding does not regress upslope)</p>
