## TILLEGRA DAM DESIGN - CONSULTANCY 361802

Storage Rim Stability and Seepage Potential  
Engineering Geotechnical Report

Report No. 08–GN31A–R2, Final Report V 4.1  
February 2009

## Tillegra Dam - Storage Rim Landslide Risk Assessment

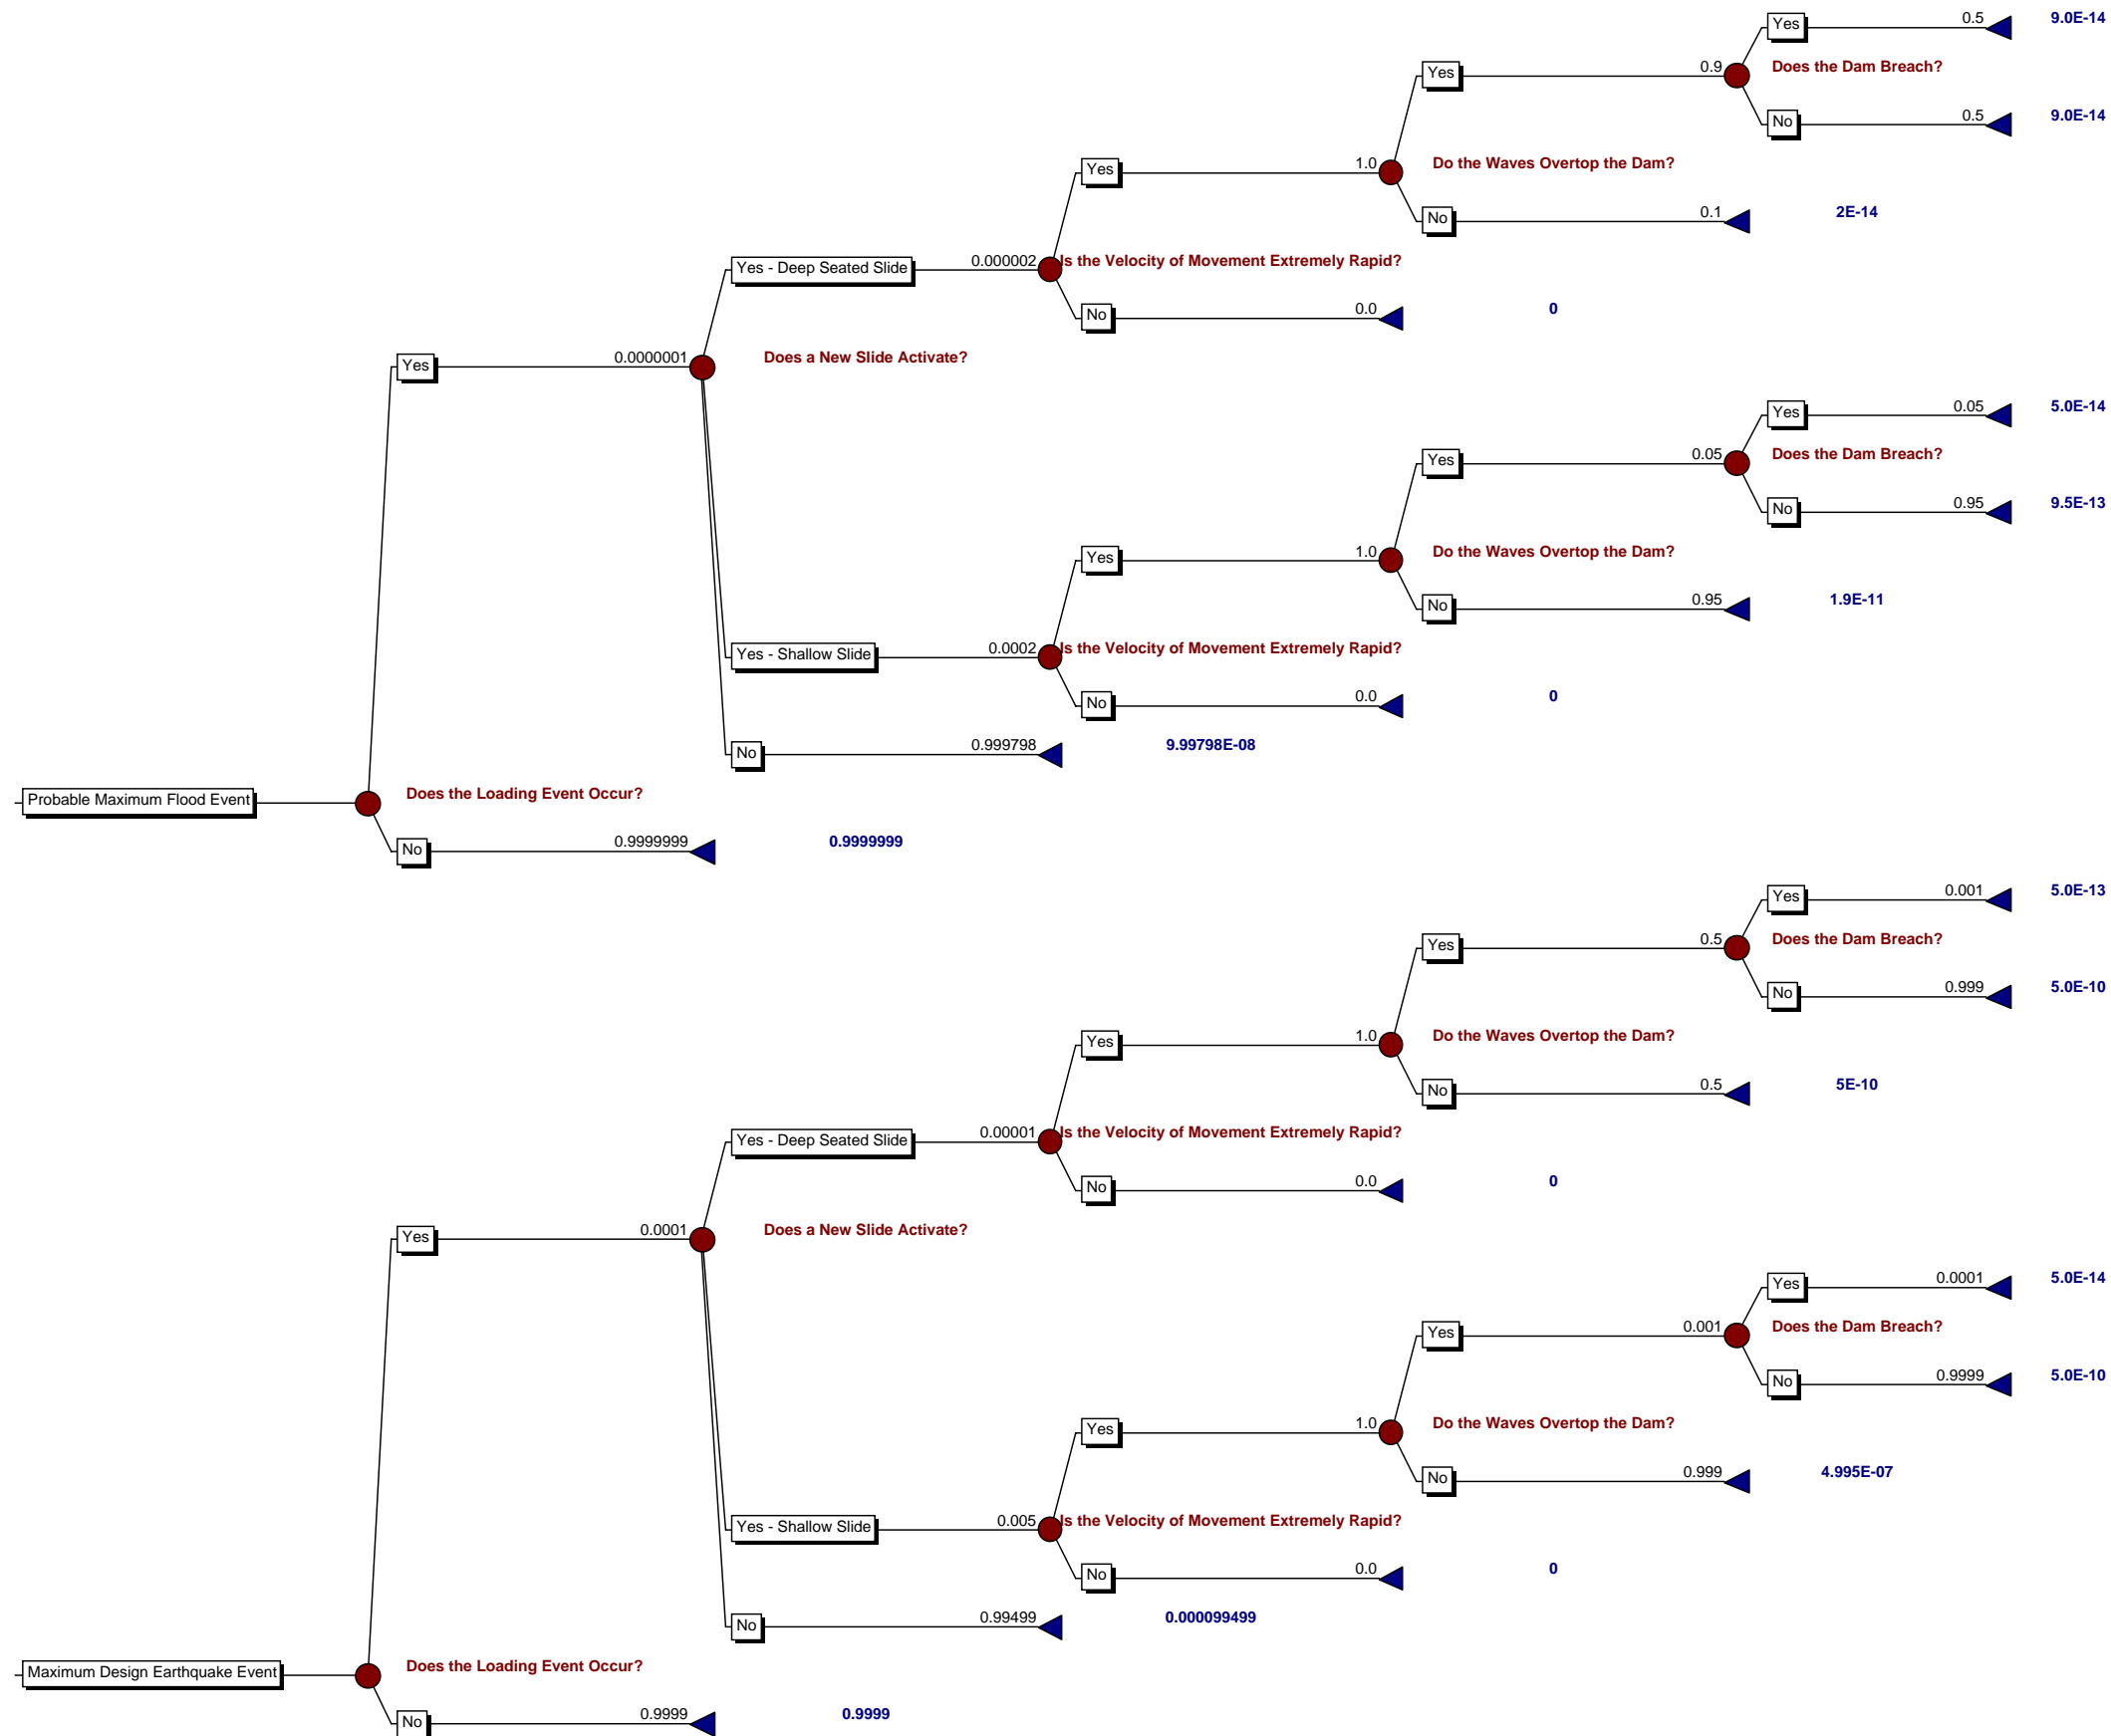
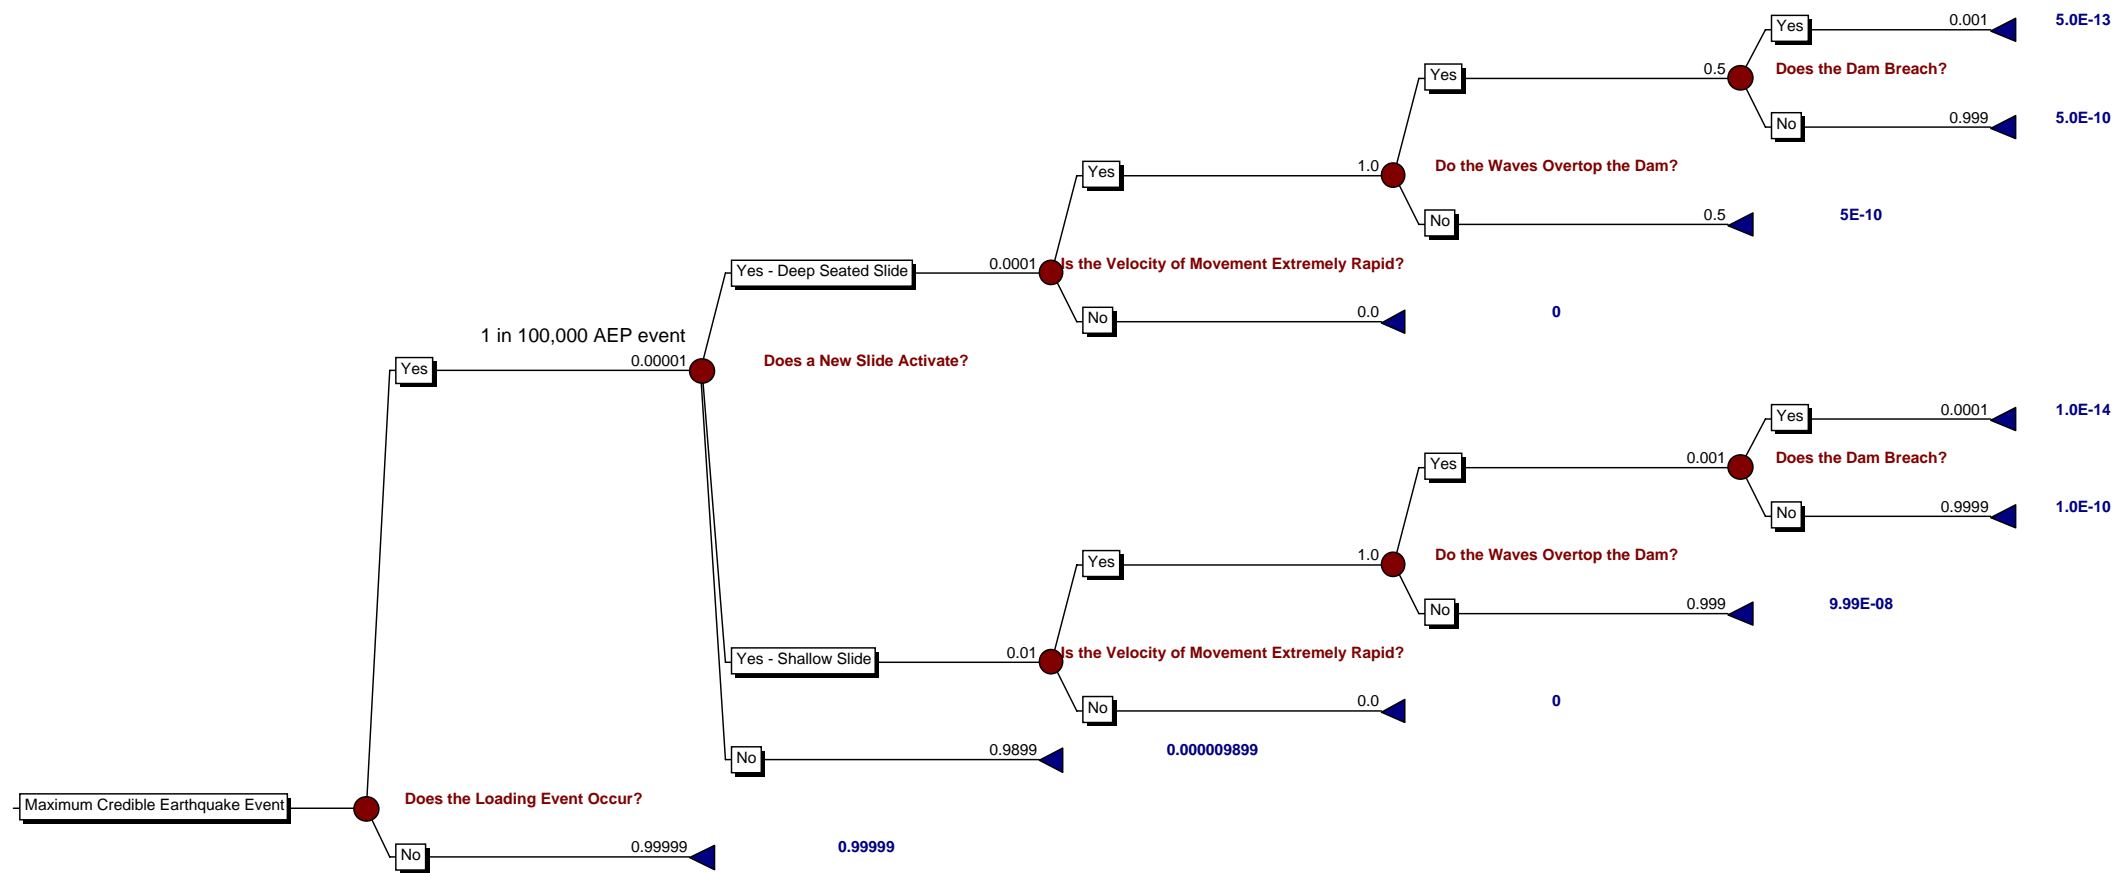
### Domain 5

- A first time slide at location 5A in Domain 5 would require a bedding plane failure within the rock mass and a breakout across bedding at the toe. Geological mapping did not find any evidence for adversely orientated joint sets or other geological features which could provide a breakout at the toe. The outcrops at location 5A show massive sandstone in the toe region.
