**Tree Report**  
**Residential Development**  
**at 128 Herring Rd Macquarie Park NSW**  
**for Lipman Properties Pty Ltd**  
**March 2010**

# **Tree Report**

## **Residential Development at 128 Herring Rd Macquarie Park NSW**

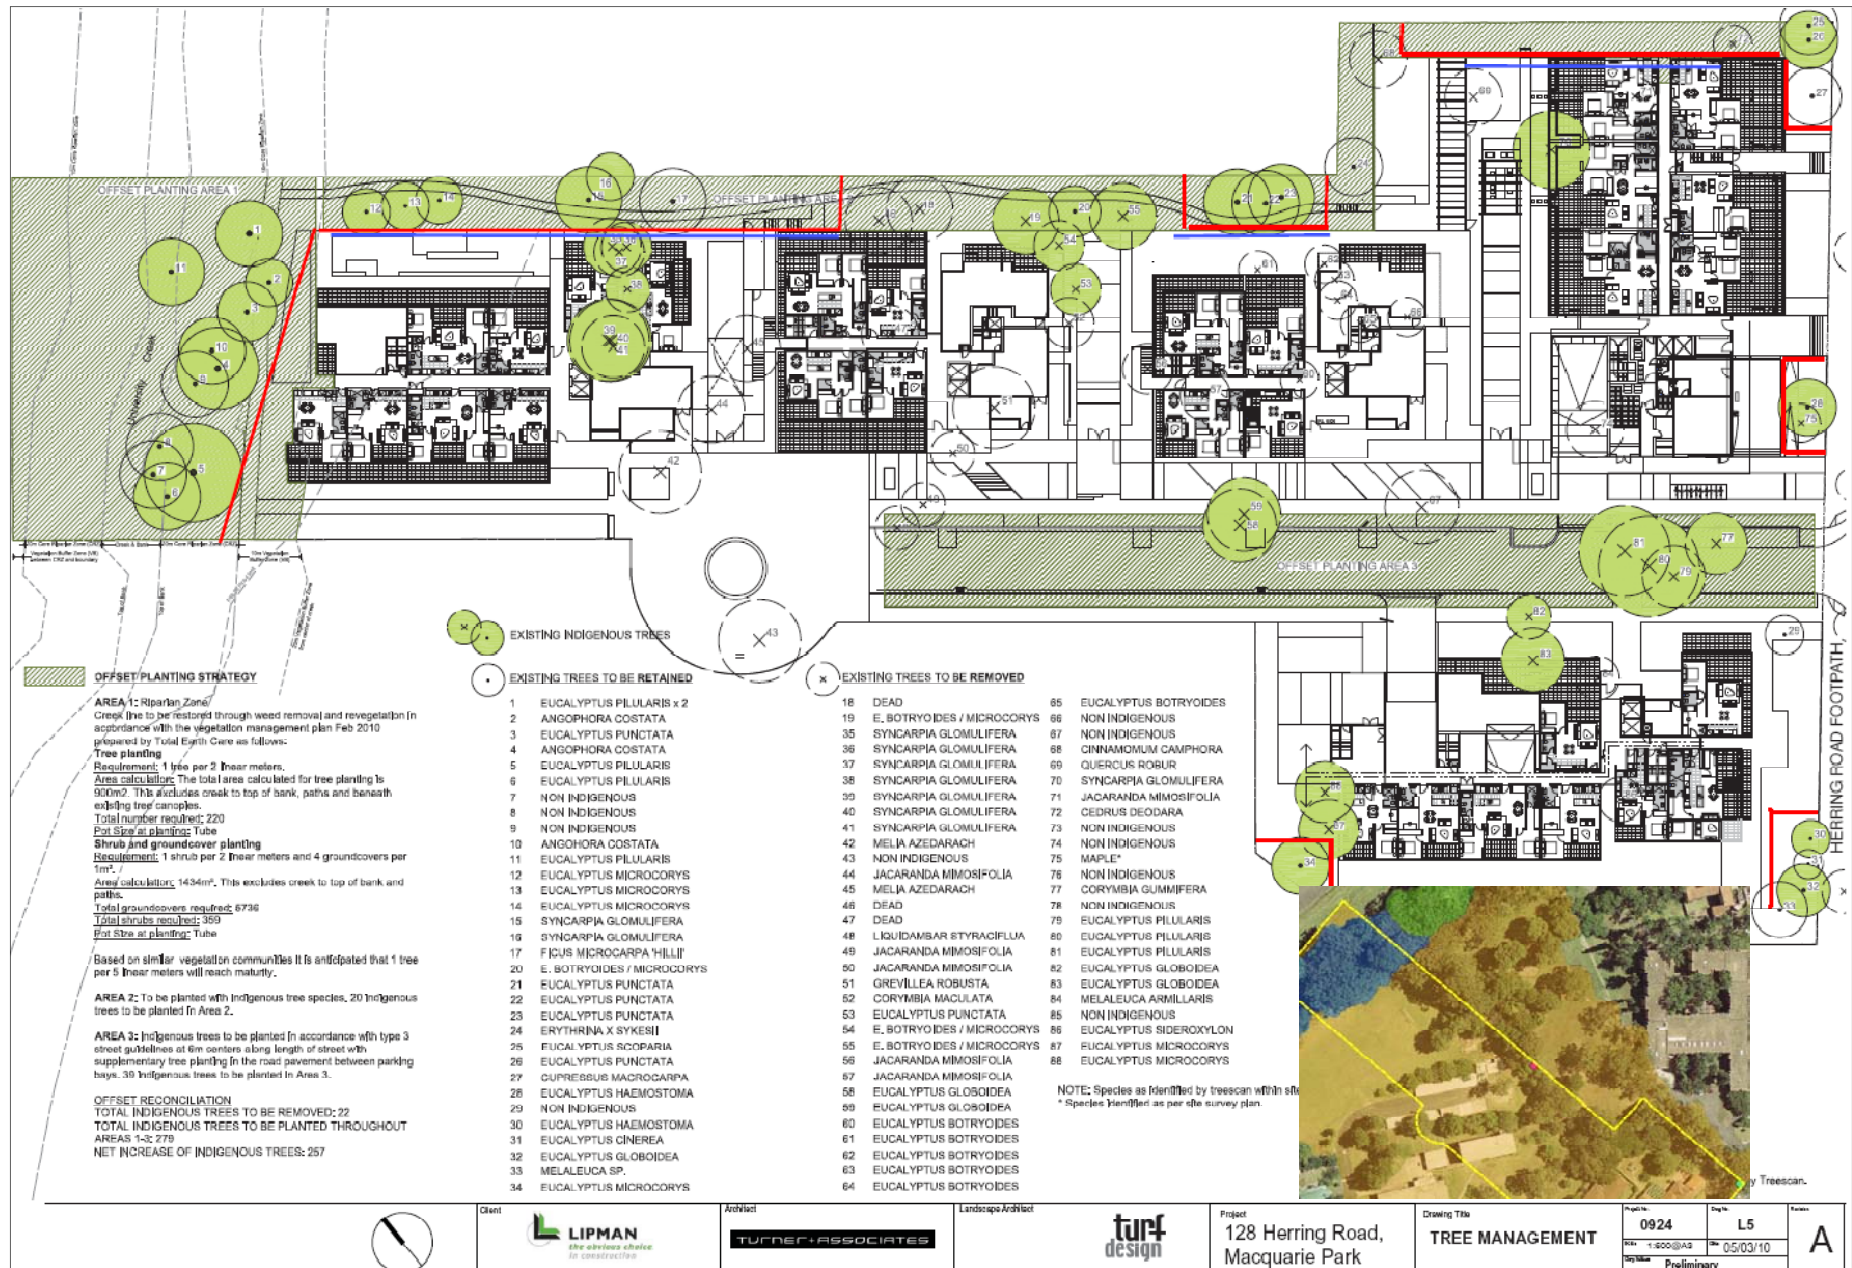
## Tree protection plan

Blue line: vertical cut

Red line: tree protection zone fence

Location of tree protection zone fences is approximate only and would be verified on site at the time of installation

Fences along northeast boundary are required to protect root systems of trees on the neighbouring property; see aerial view in thumbnail below

The approximate location of special excavation measures and tree protection fences is noted on the plan attached. The excavations would be within the theoretical root zone of several of the trees, and the maximum root system spread of the larger trees has been estimated as a radius of 8m from the trunk centres.

These measures would apply to the entire length of the excavation for Buildings A and D, as well as most of Building C as noted on the plan attached.

Where excavation is to occur within 8m radius of the trunk centres the line of the excavation should be carefully trenched by hand prior to bulk excavation. Any roots found should be cut cleanly with a hand saw.

The excavation for the carparks within 8m radius of the trunk centres should be limited to a vertical cut at the 6m setback from the boundary, without overexcavation for battering or benching.

The 6m wide setback area between the excavation and the boundary within an 8m radius of the trees should be fenced off as noted above, or if access is required the soil surface should be retained intact and protected by fencing or by the installation of a rigid surface (eg planking or timber boardwalk or deck) for the entire construction period. See Figures 4 and 5 below, from AS4970. This information should be added to tender and construction drawings.
