Commercial Development, 177-199 Pacific Highway, North Sydney

Desktop Study Report - Geotechnical and Groundwater

Report No F0002-AA003230-NSR-01

Date 14 May 2010

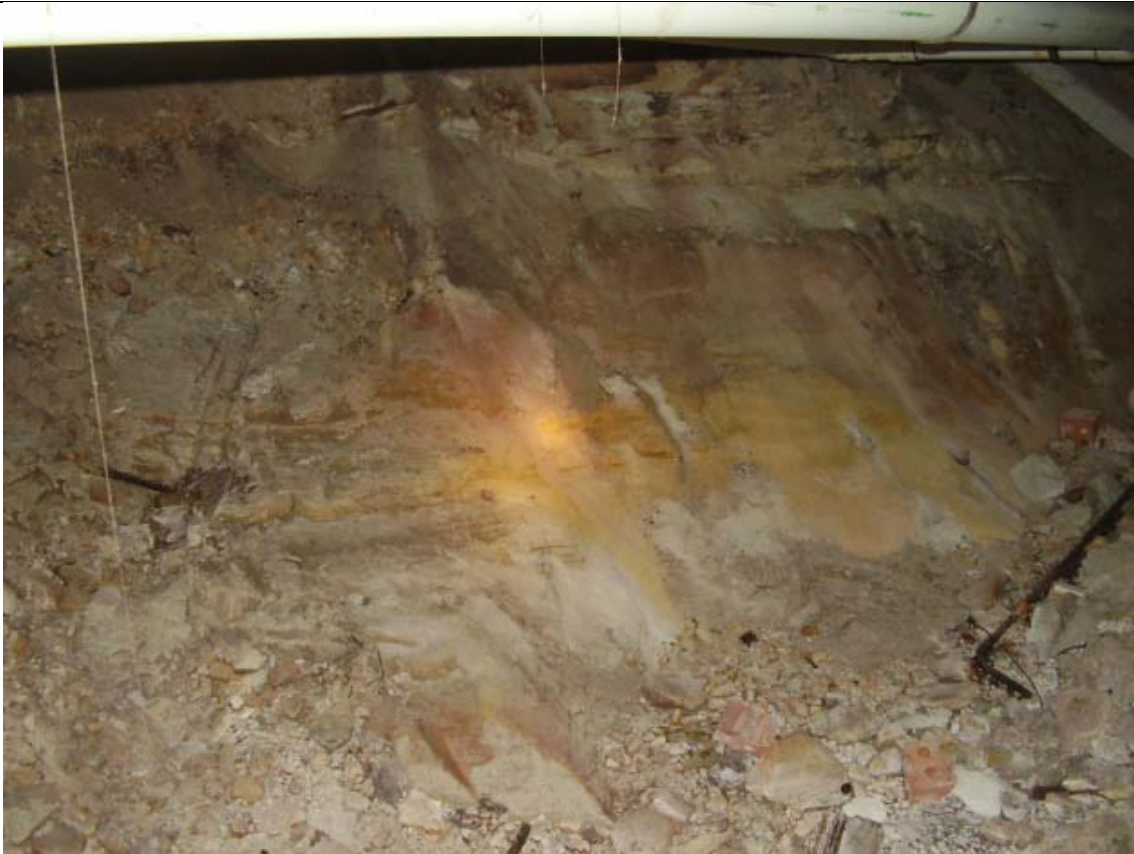
- Sandstone bedrock exposed at the base of excavation as shown on Figure 2.
- A drain was constructed using gravel as shown on Figure 3. It was advised by Mr Bob Astill, building manager, that there used to have occasional seepage from the adjacent basement walls, and that the basement site is generally “dry” after the construction of the gravel drain.
- It can be noted from Figure 4 that the retaining wall was constructed using concrete and block works.
- Figure 5 shows the “mud” deposited at the low spots within the underground space over the past time.
- No apparent groundwater seepage was noted during the site visit

Figure 2: Exposed sandstone rock

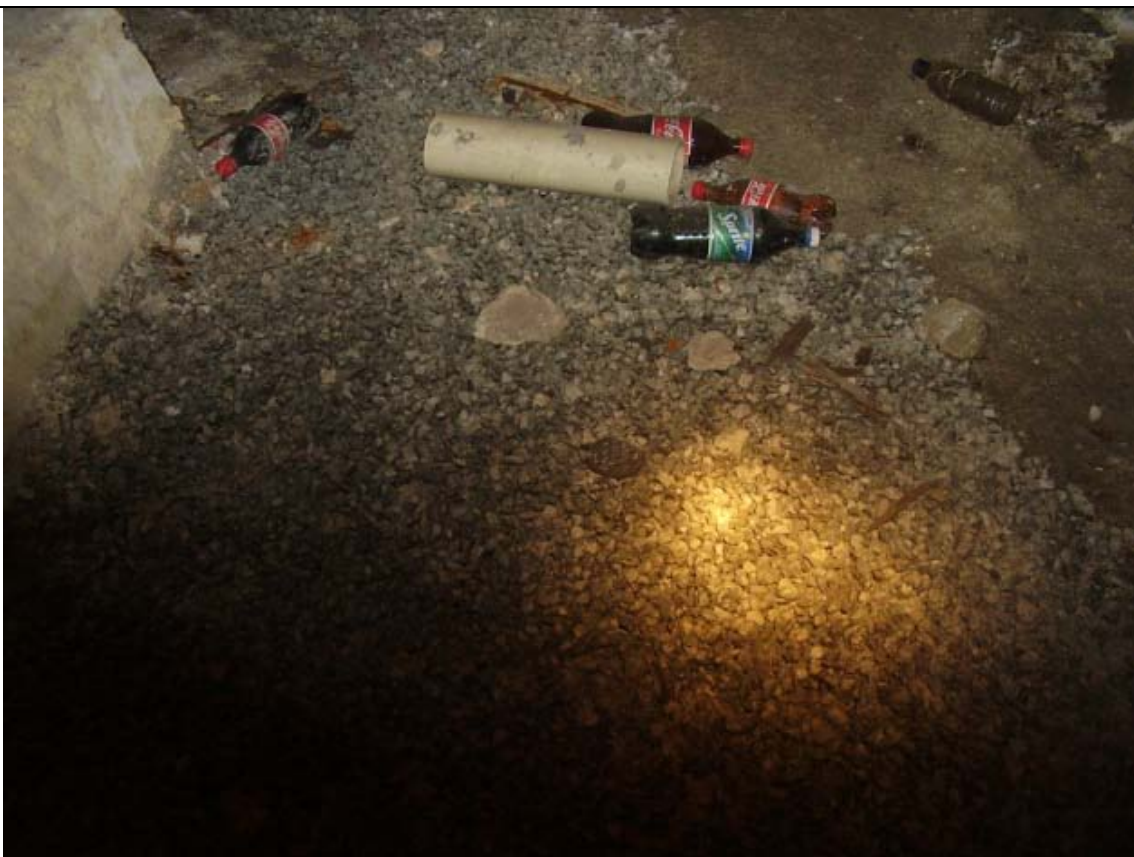
Figure 3: Gravel drain

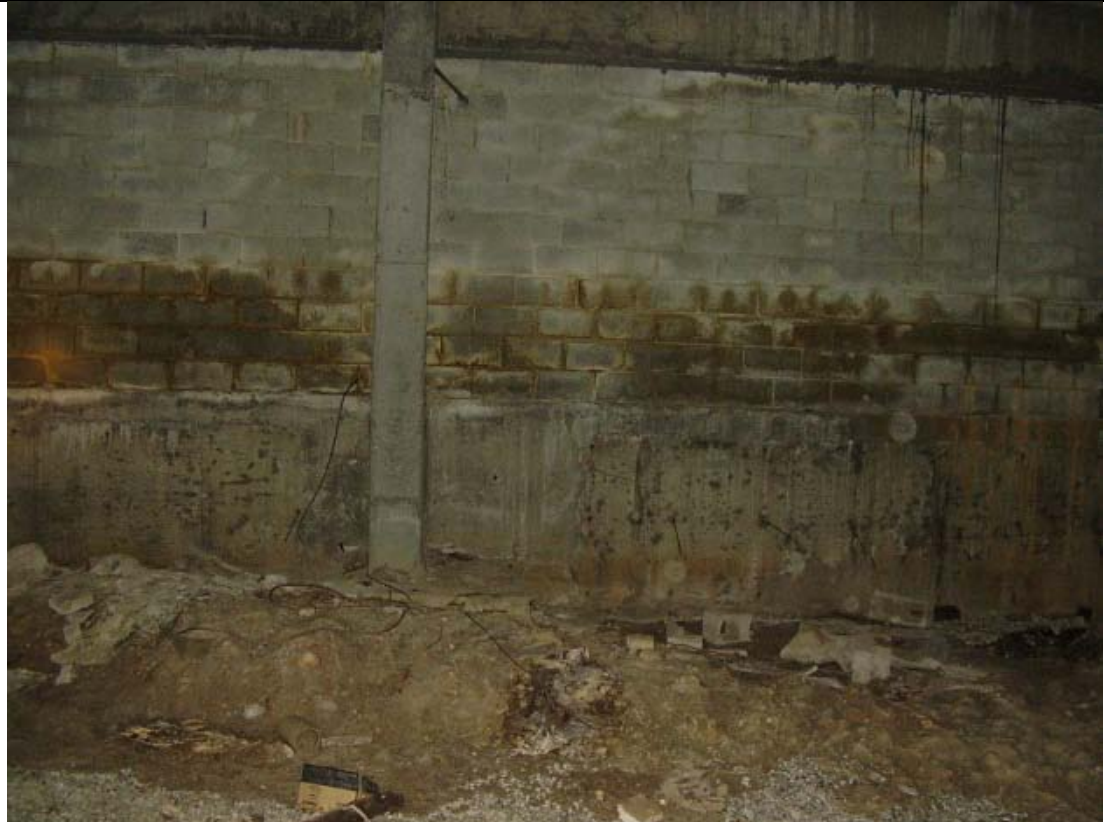
Figure 4: Concrete and block retaining wall

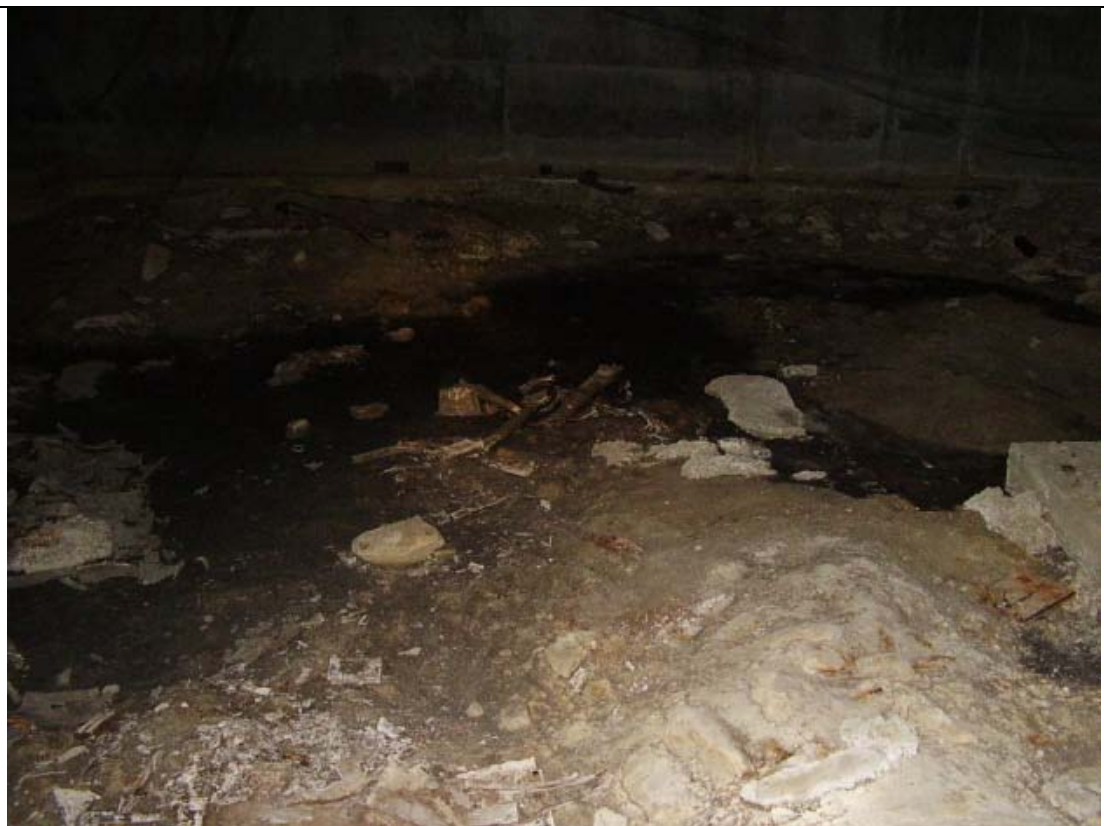
Figure 5: "Mud" settled at the low spots
