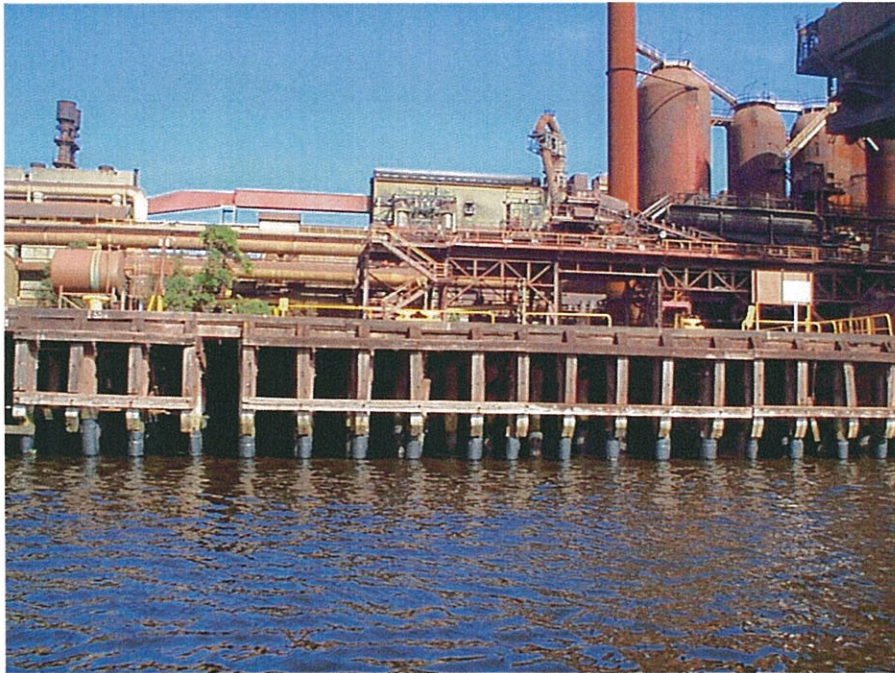
Figure 6.3 View South. Shows area of East end of original timber wharf location. No portion or structure of original timber wharves remains.

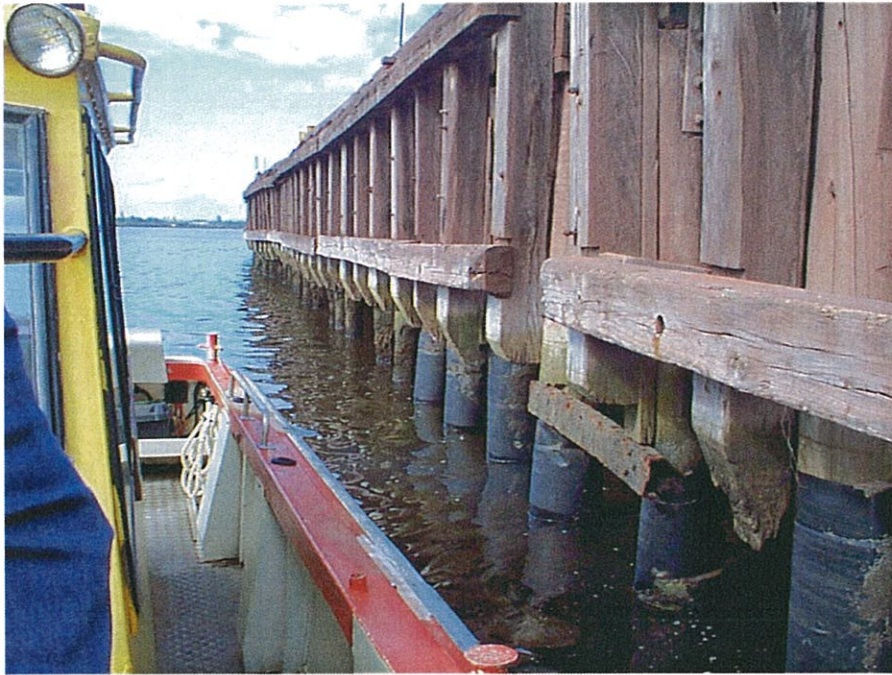
Figure 6.6 View South/East. Shows junction of recent re-piled section with membrane collars and older section beyond.

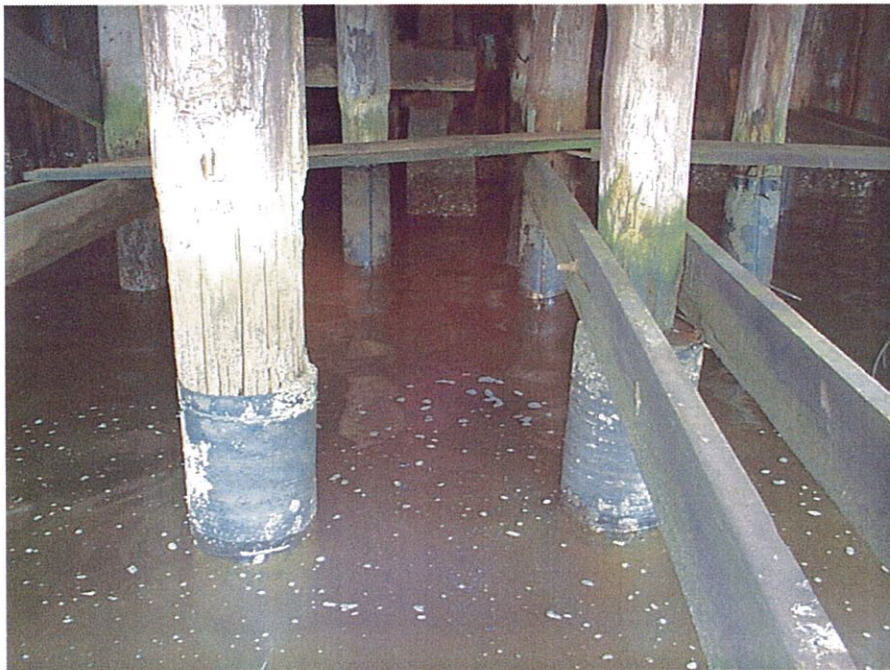
Figure 6.7 View South. Shows newer piling with rubber membrane collars and granular fill.

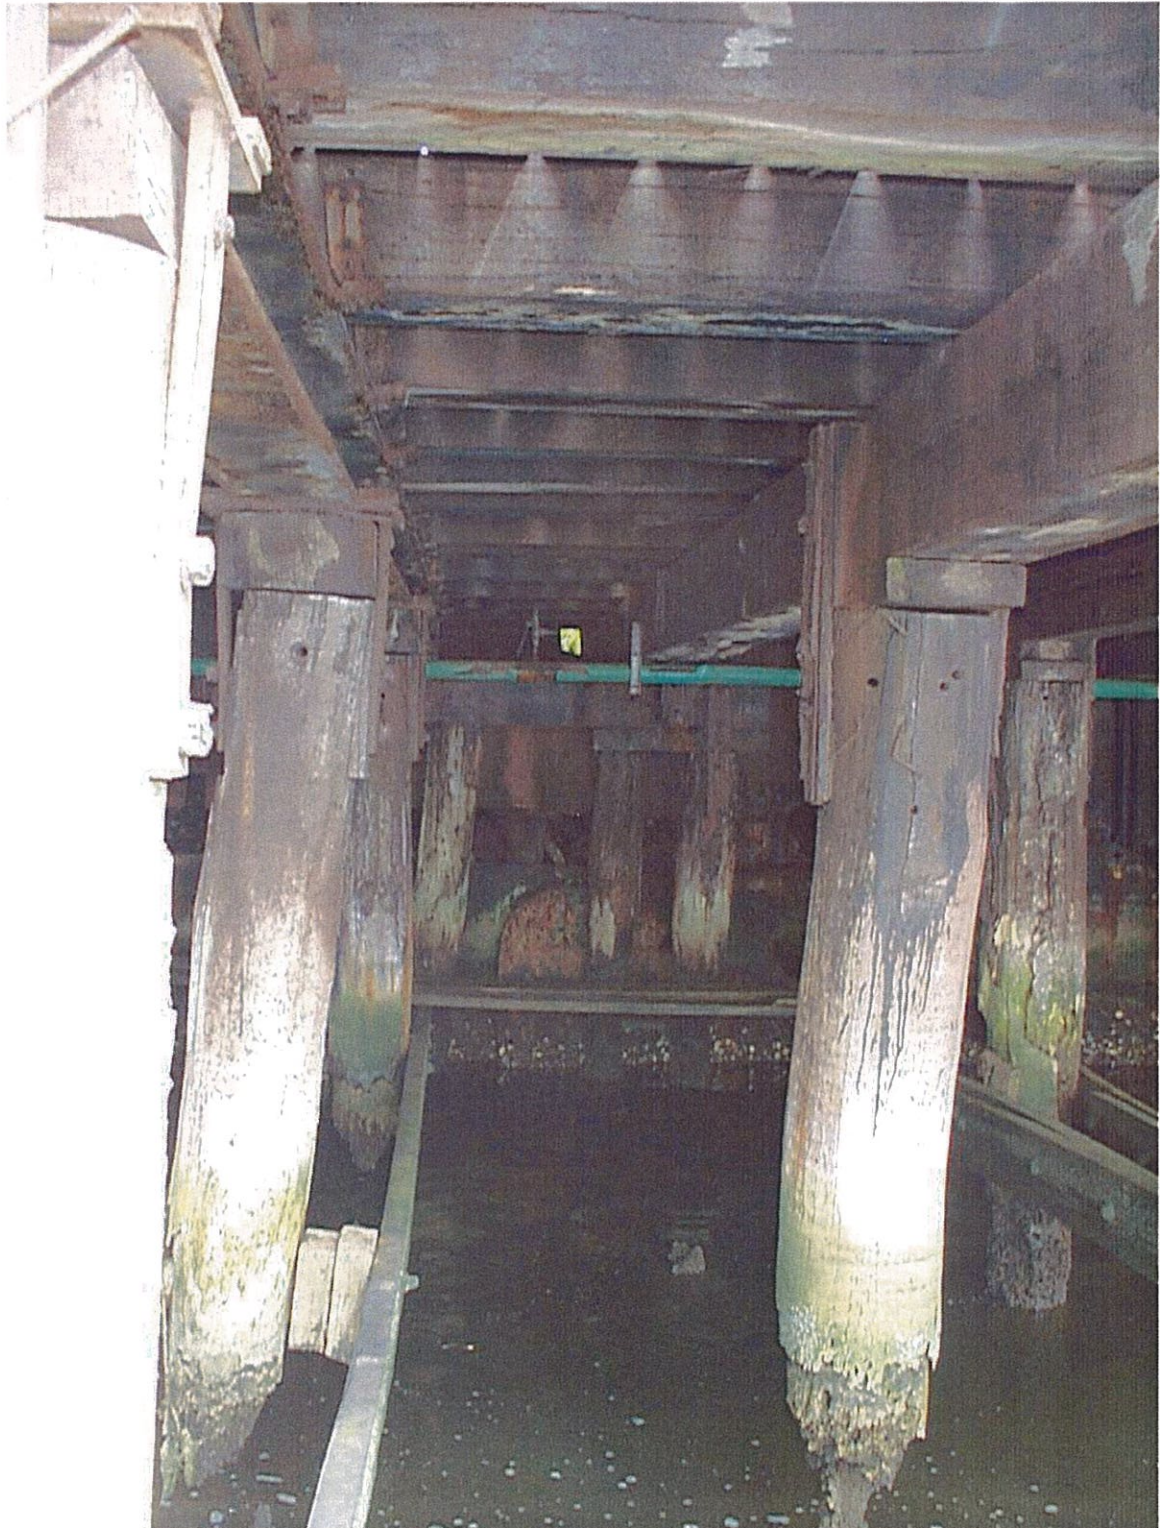
Figure 6.9 View South. Steel beam left and timber beam right. Some piles eaten through completely.
