**TECHNICAL REPORT NO 7**

**RAIL RISK ASSESSMENT**

**RISK ASSESSMENT**

**CAMELLIA LEVEL CROSSING**  
**and ENVIRONS**

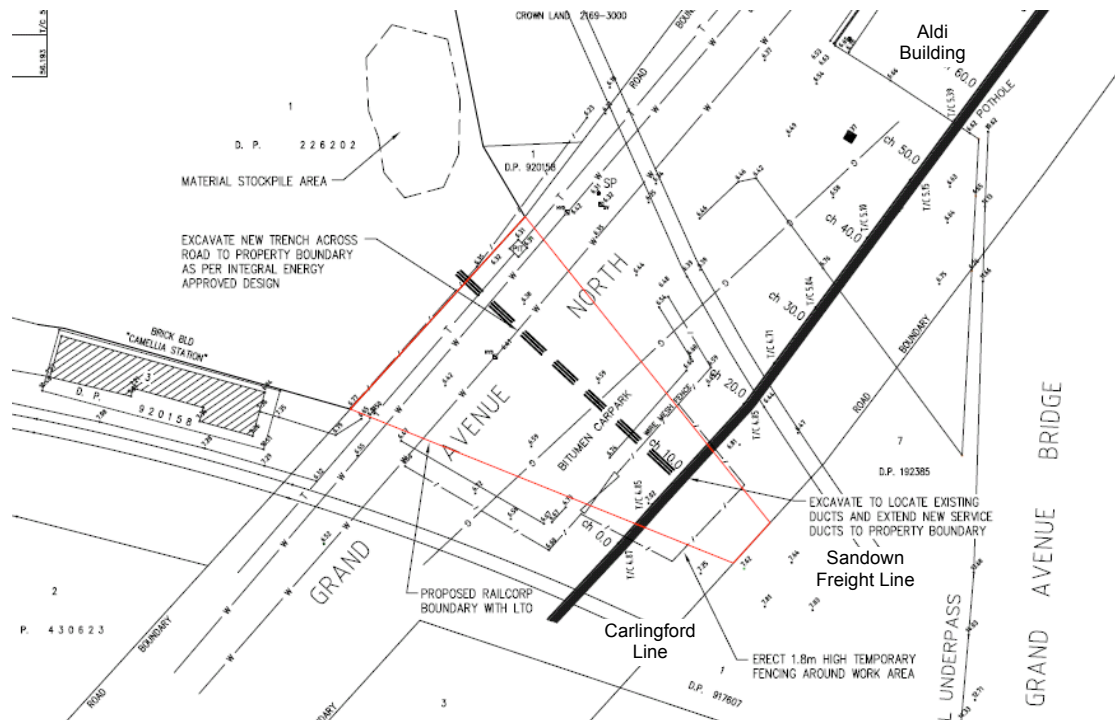
Specific construction risks may arise as a result of the proposal for Billbergia to access power conduits to bring power to their site and the presence in the area of overhead cables.

Plan showing the proposed electrical works Billbergia will undertake. The RailCorp boundary is shown in red as determined (surveyed) by RailCorp.
