71 Macquarie Street—Response to Submissions on Archaeology by Sydney Water and Heritage Council of NSW, May 2012

Godden Mackay Logan Heritage Consultants (GML) have prepared the following report in response to submissions from Sydney Water and the Heritage Council of NSW regarding potential archaeological issues arising from the proposed development at 71 Macquarie Street, Sydney

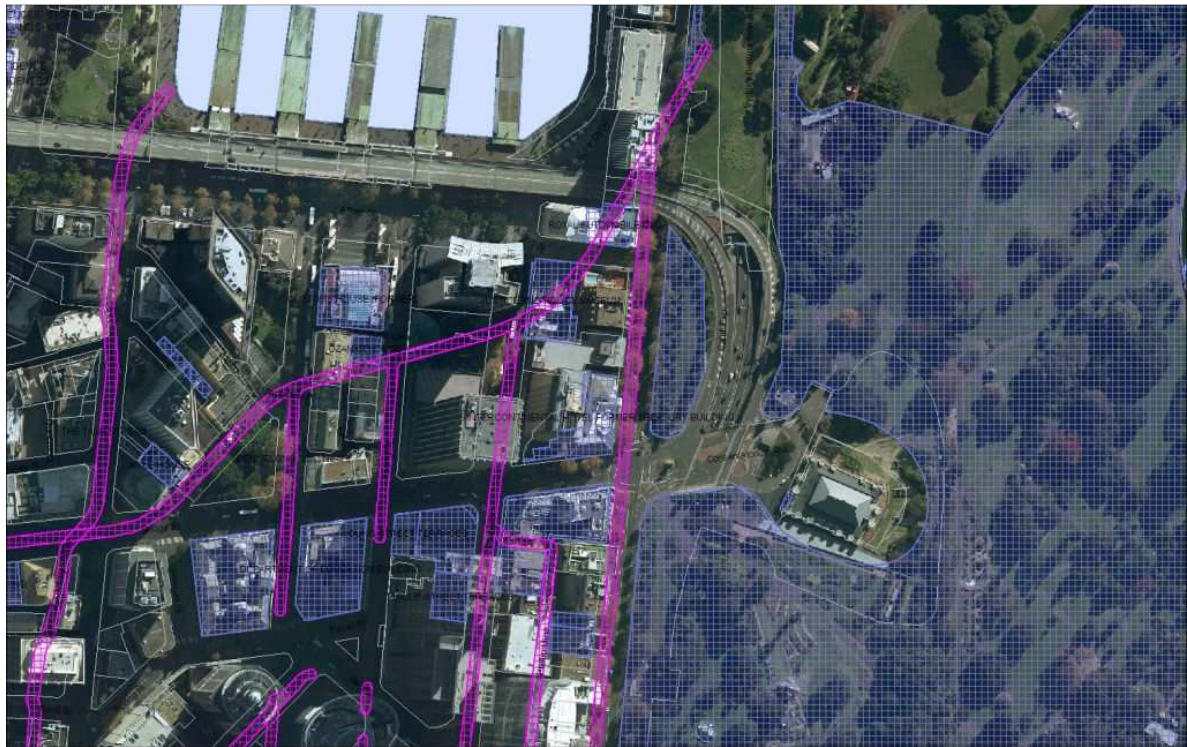
Figure 1: Aerial photograph showing the lines of the Bennelong Drain (purple) in relation to 71 Macquarie Street (at the north centre part of the image). (Source: Sydney Water).

Aerial photographs showing the location of the Bennelong Drain in relation to 71 Macquarie Street are shown in Figure 1. Sydney Water has indicated that the plans showing the location of the Bennelong Drain are indicative only and may not show the exact location of the drain. Mirvac have mapped the locations of the drains in relation to location of the proposed building (Figure 7).

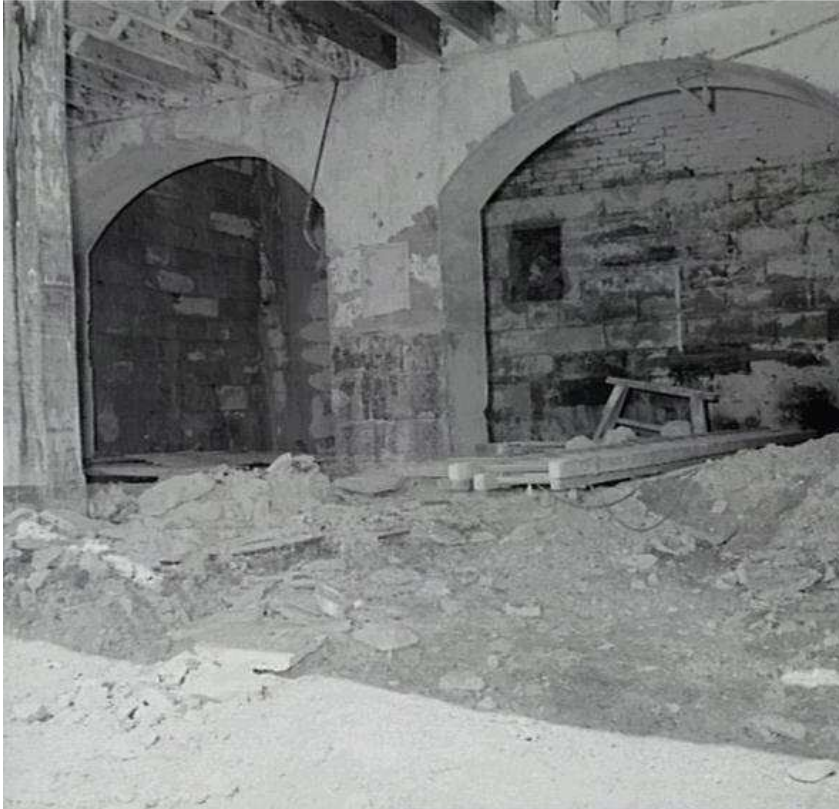
Figure 2: Photograph of sandstone vaulted archways under Macquarie Street, 1964 appears to show demolition in process. (Source: City of Sydney Archives, Citation: NSCA CRS 48/3825).

A site visit was undertaken by GML on 4 April 2012 to basement levels one and two of 71 Macquarie Street, Sydney, to look for evidence of the arches and the sandstone gallery from the warehouse phase (from c1860s). The arches and gallery are shown in historic photos (Figures 2 and 3).

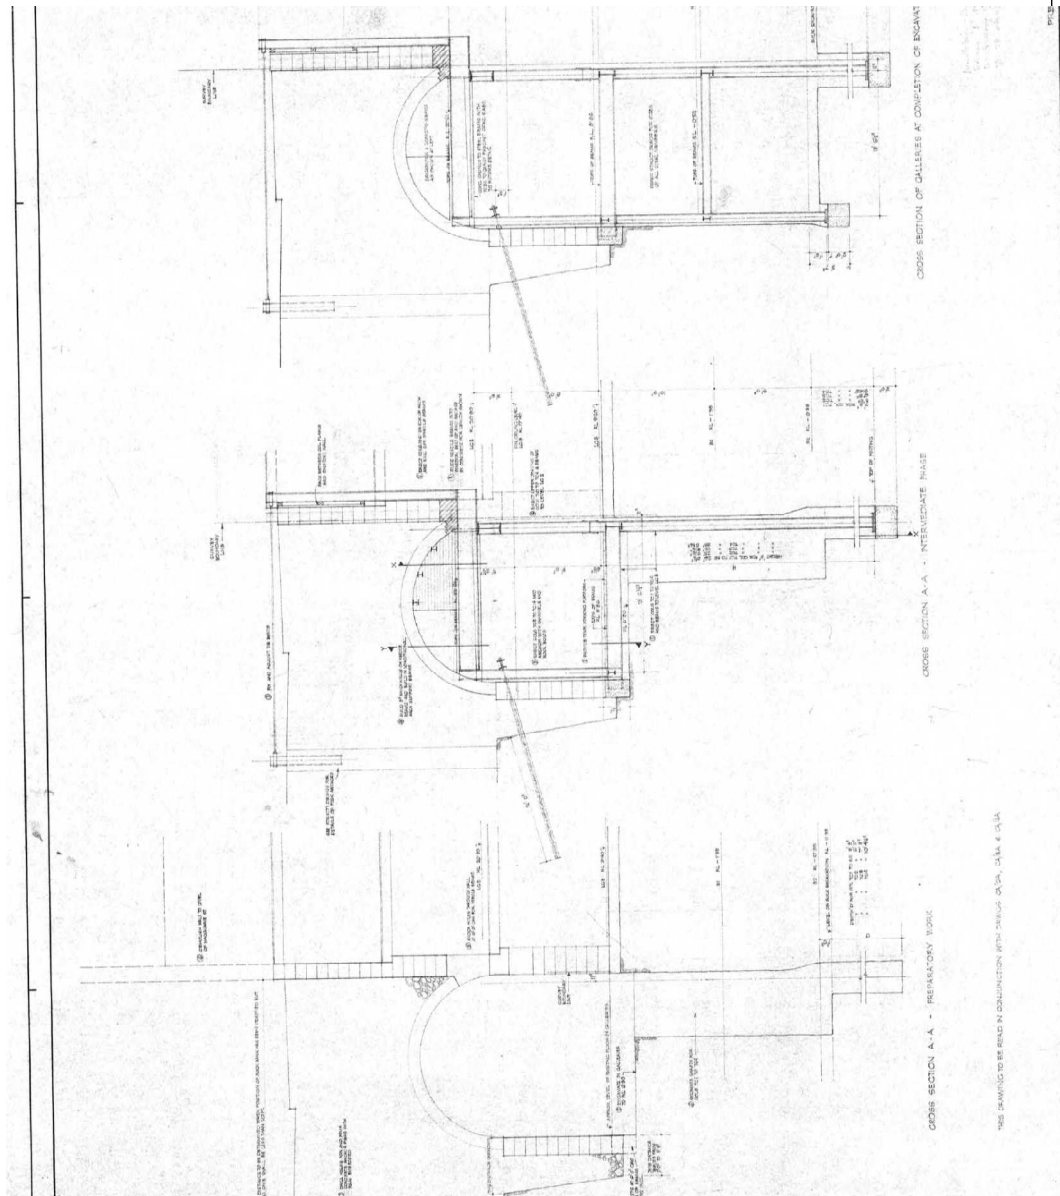
Based on results of the site visit on 4 April, it appears the arches of the sandstone gallery have been removed. Further, analysis of the historic plans of the sandstone arches reveals a demolition plan (Figure 4). It is likely that the sandstone arches were removed during demolition of the warehouses and construction of the present Amatil Building in the 1960s.

Figure 4: Plan of the British Tobacco Company Building (Source; Demolition and Excavation Scheme 'B' Modifications to Gallery Construction, Stephenson & Turner Architects, 1963).

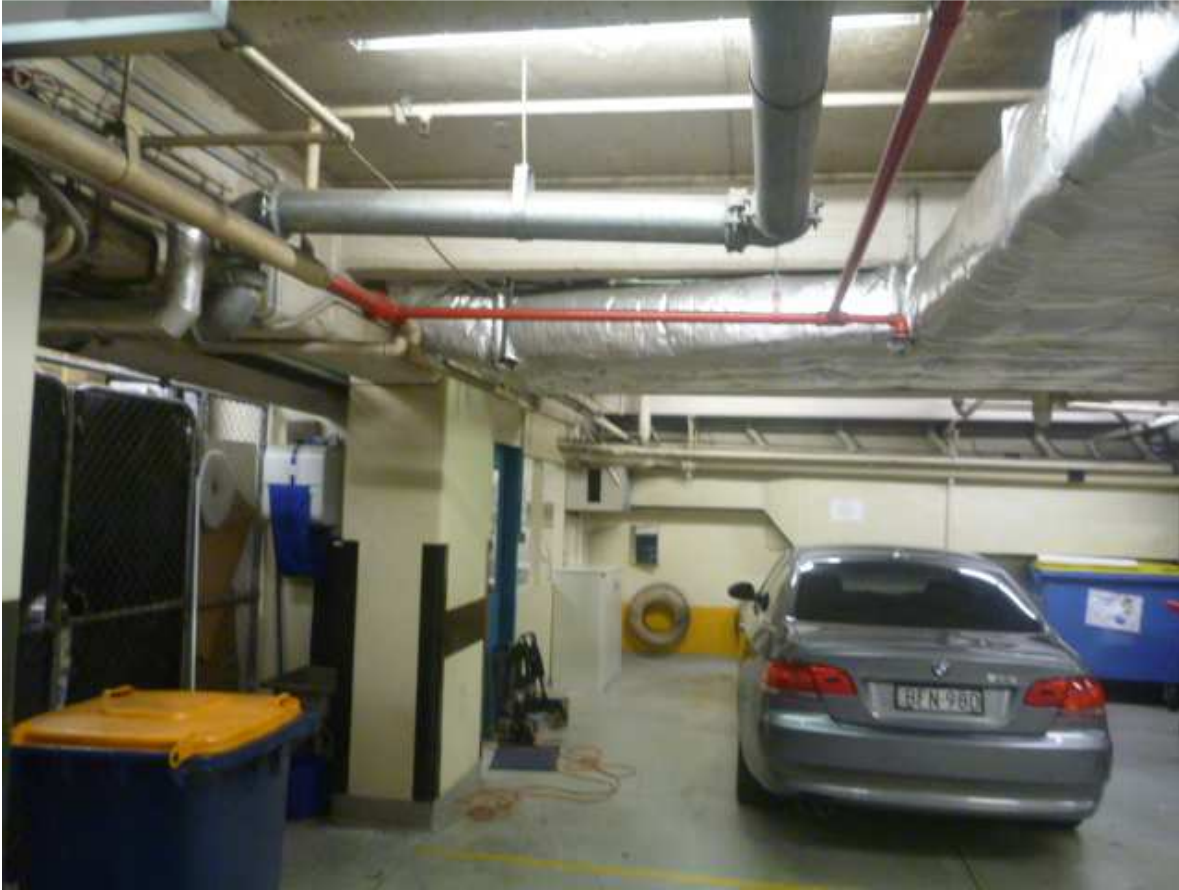
The space of the former gallery is presently used as a carpark in basement level one (Figure 5) and a storage space in the basement level two (Figure 6). Figure 7 shows this storage space and also the proximity of the Bennelong Drain to the present building.

Figure 5: Level one basement showing car space. (Source: GML, 2010)

While it appears the historic arches have been removed, there is potential that remains of some of the sandstone walls of the gallery exist on the other side of the concrete walls in the storage space area on basement levels one and two. The extent of remains of any sandstone walls may be established during demolition of the present building. Archaeological test excavation and recording of any historic features remaining may be required to assess the likelihood of any elements surviving. Given that these elements (if surviving) are likely to date from the 1860s (i.e. post-colonial period) warehouses that occupied the site, and would have limited research potential, it is considered unlikely that they would be of such significance to warrant in situ retention. However, this will be further assessed in the detailed Archaeological Assessment to be prepared following the Concept Plan.

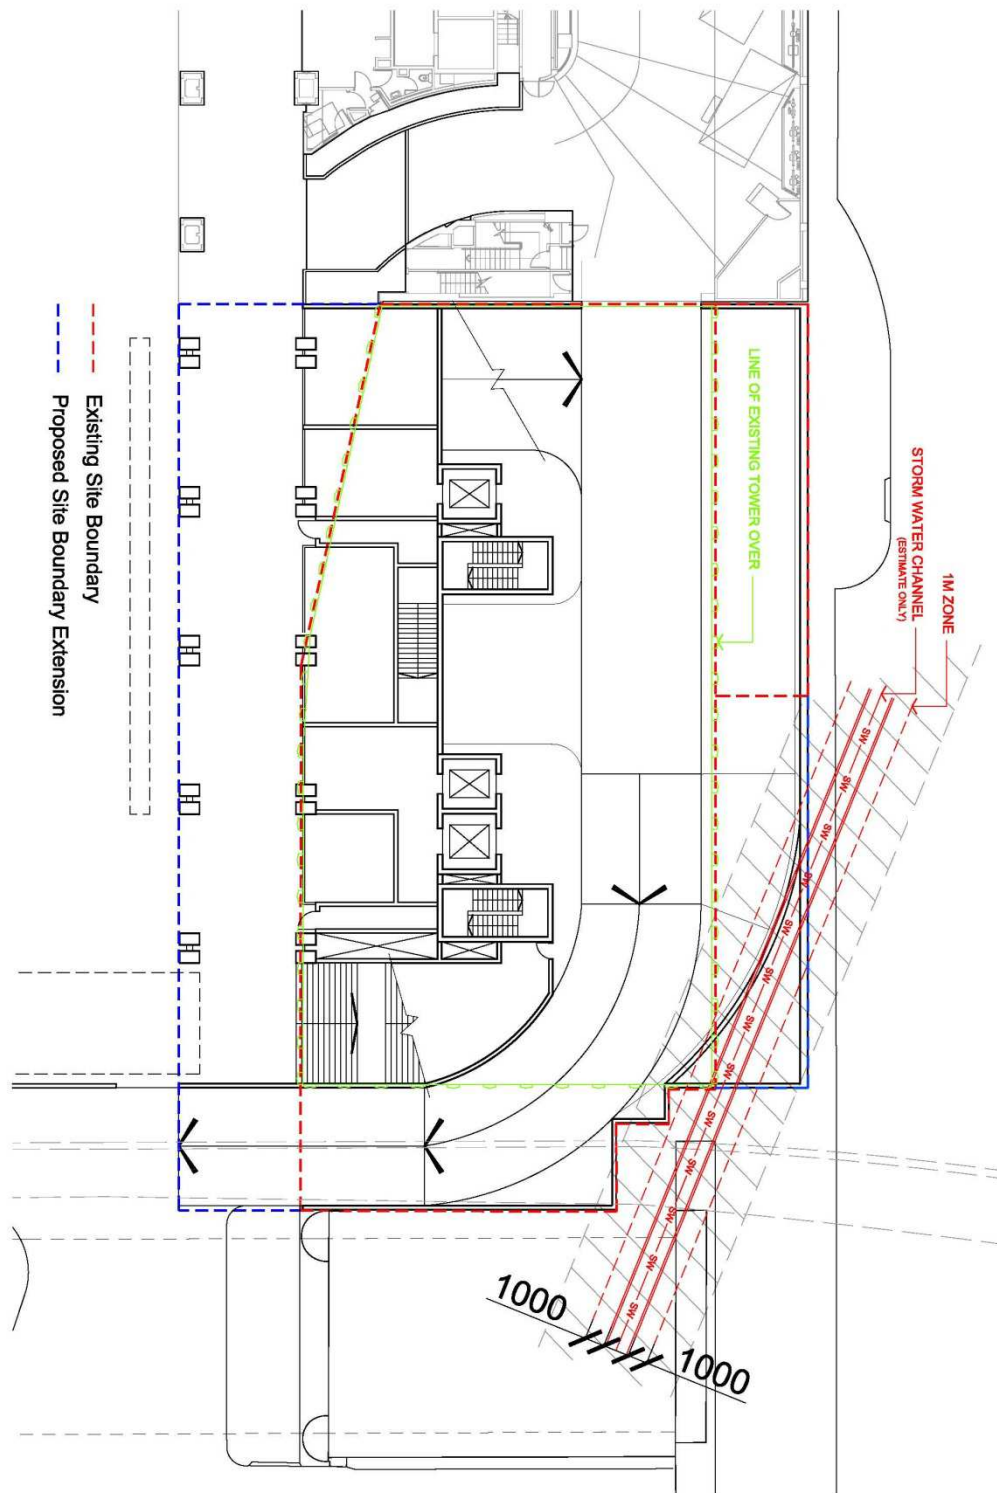
Figure 7: Plan showing the area of the former gallery (marked by 'Line of existing tower over') and proximity of the Bennelong Drain and buffer zone to 71 Macquarie Street. (Source: Hassell / Sydney Water Authority 2012).

The impact of any proposal would be assessed in a Heritage Impact Statement (HIS) and any other methods required by Sydney Water. No major changes are anticipated to the Bennelong Drain or within the one metre curtilage. However in the event that impact to the drain is required, following consultation and approval from Sydney Water, archival and photographic recording would be undertaken as per the recommended management as outlined on the Bennelong Stormwater Channel No 29 listing on the Heritage Branch website³, with a copy of the records lodged with Sydney Water archives and the NSW Heritage Office.
