# Vegetation, Clearing and Grubbing Protocols

## Wallgrove Redevelopment

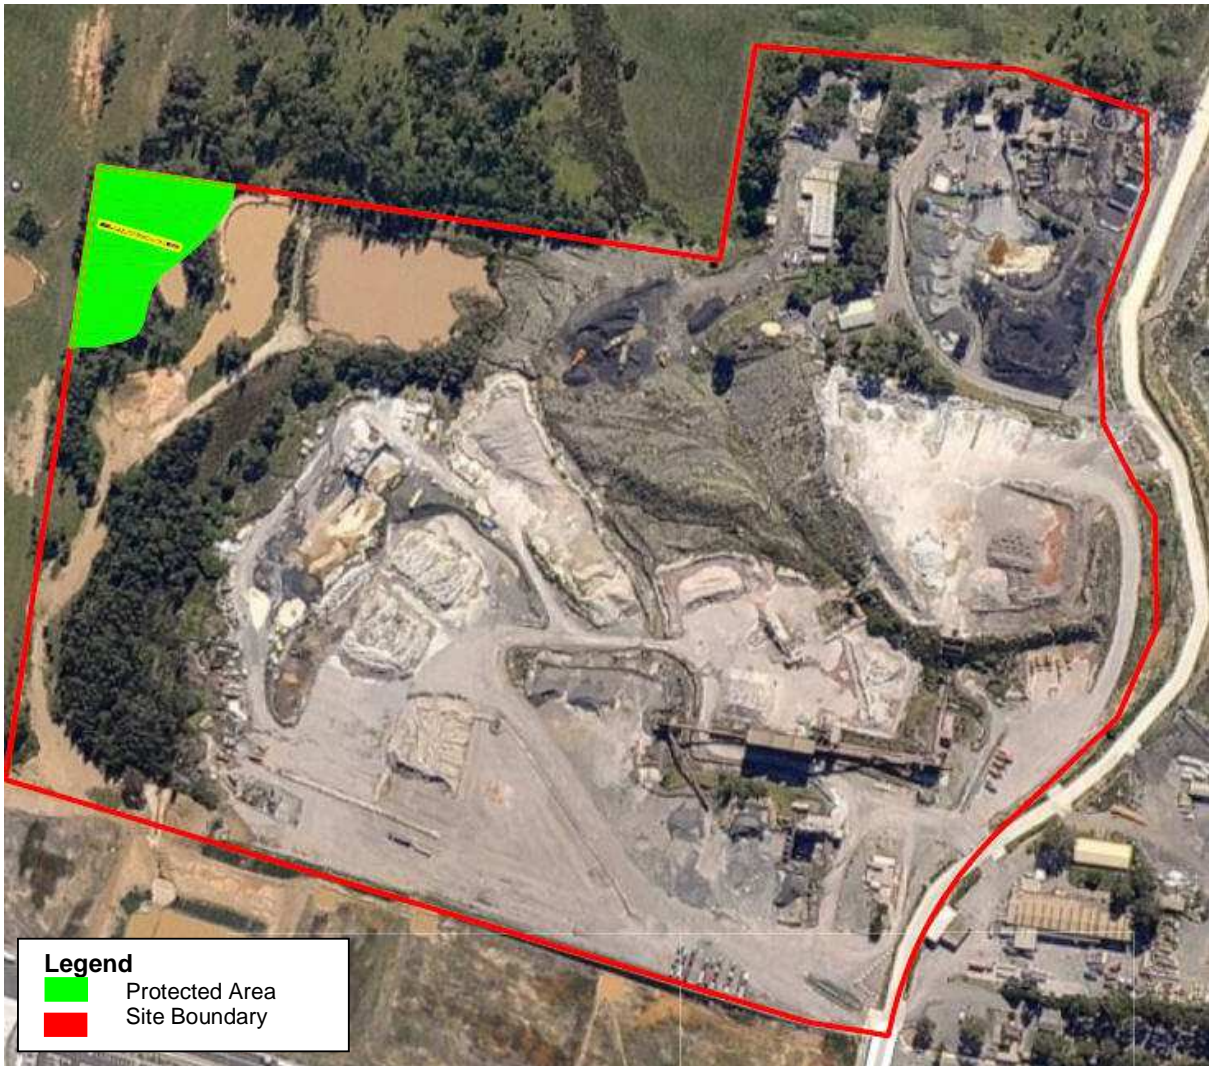
## 9 Environmental Constraints Map

An Environmental Constraint Maps (ECM) that includes the clearing limits of the project has been compiled and included in the plan. All areas beyond these limits will be delineated as 'no-go' or exclusion zones to minimise impacts to areas of conservation significance such as the riparian corridor. If additional vegetation is to be removed, the proposed variation of scope would be referred to the Development Manager to determine if additional impact assessment is required. No additional vegetation will be cleared until approval is granted.

- A final Vegetation Clearing and Grubbing assessment
- Sensitive Area Plans (updated Environmental Constraints Maps)
