client:	TRUENERGY
project:	GEOTECHNICAL, CONTAMINATION AND GROUNDWATER INVESTIGATION TALLAWARRA LANDS, YALLAH, NSW
title:	INFERRED SOFT SOIL THICKNESS CONTOURS
project no:	ENVIWOLL00250AB-R05
figure no:	FIGURE 9

**Geotechnical, Contamination and Groundwater Investigation,  
Tallawarra Lands, Yallah, NSW**

**REPORT  
ON  
ASBESTOS CONTAMINATION ASSESSMENT**

**TALLAWARRA LANDS  
TALLAWARRA**

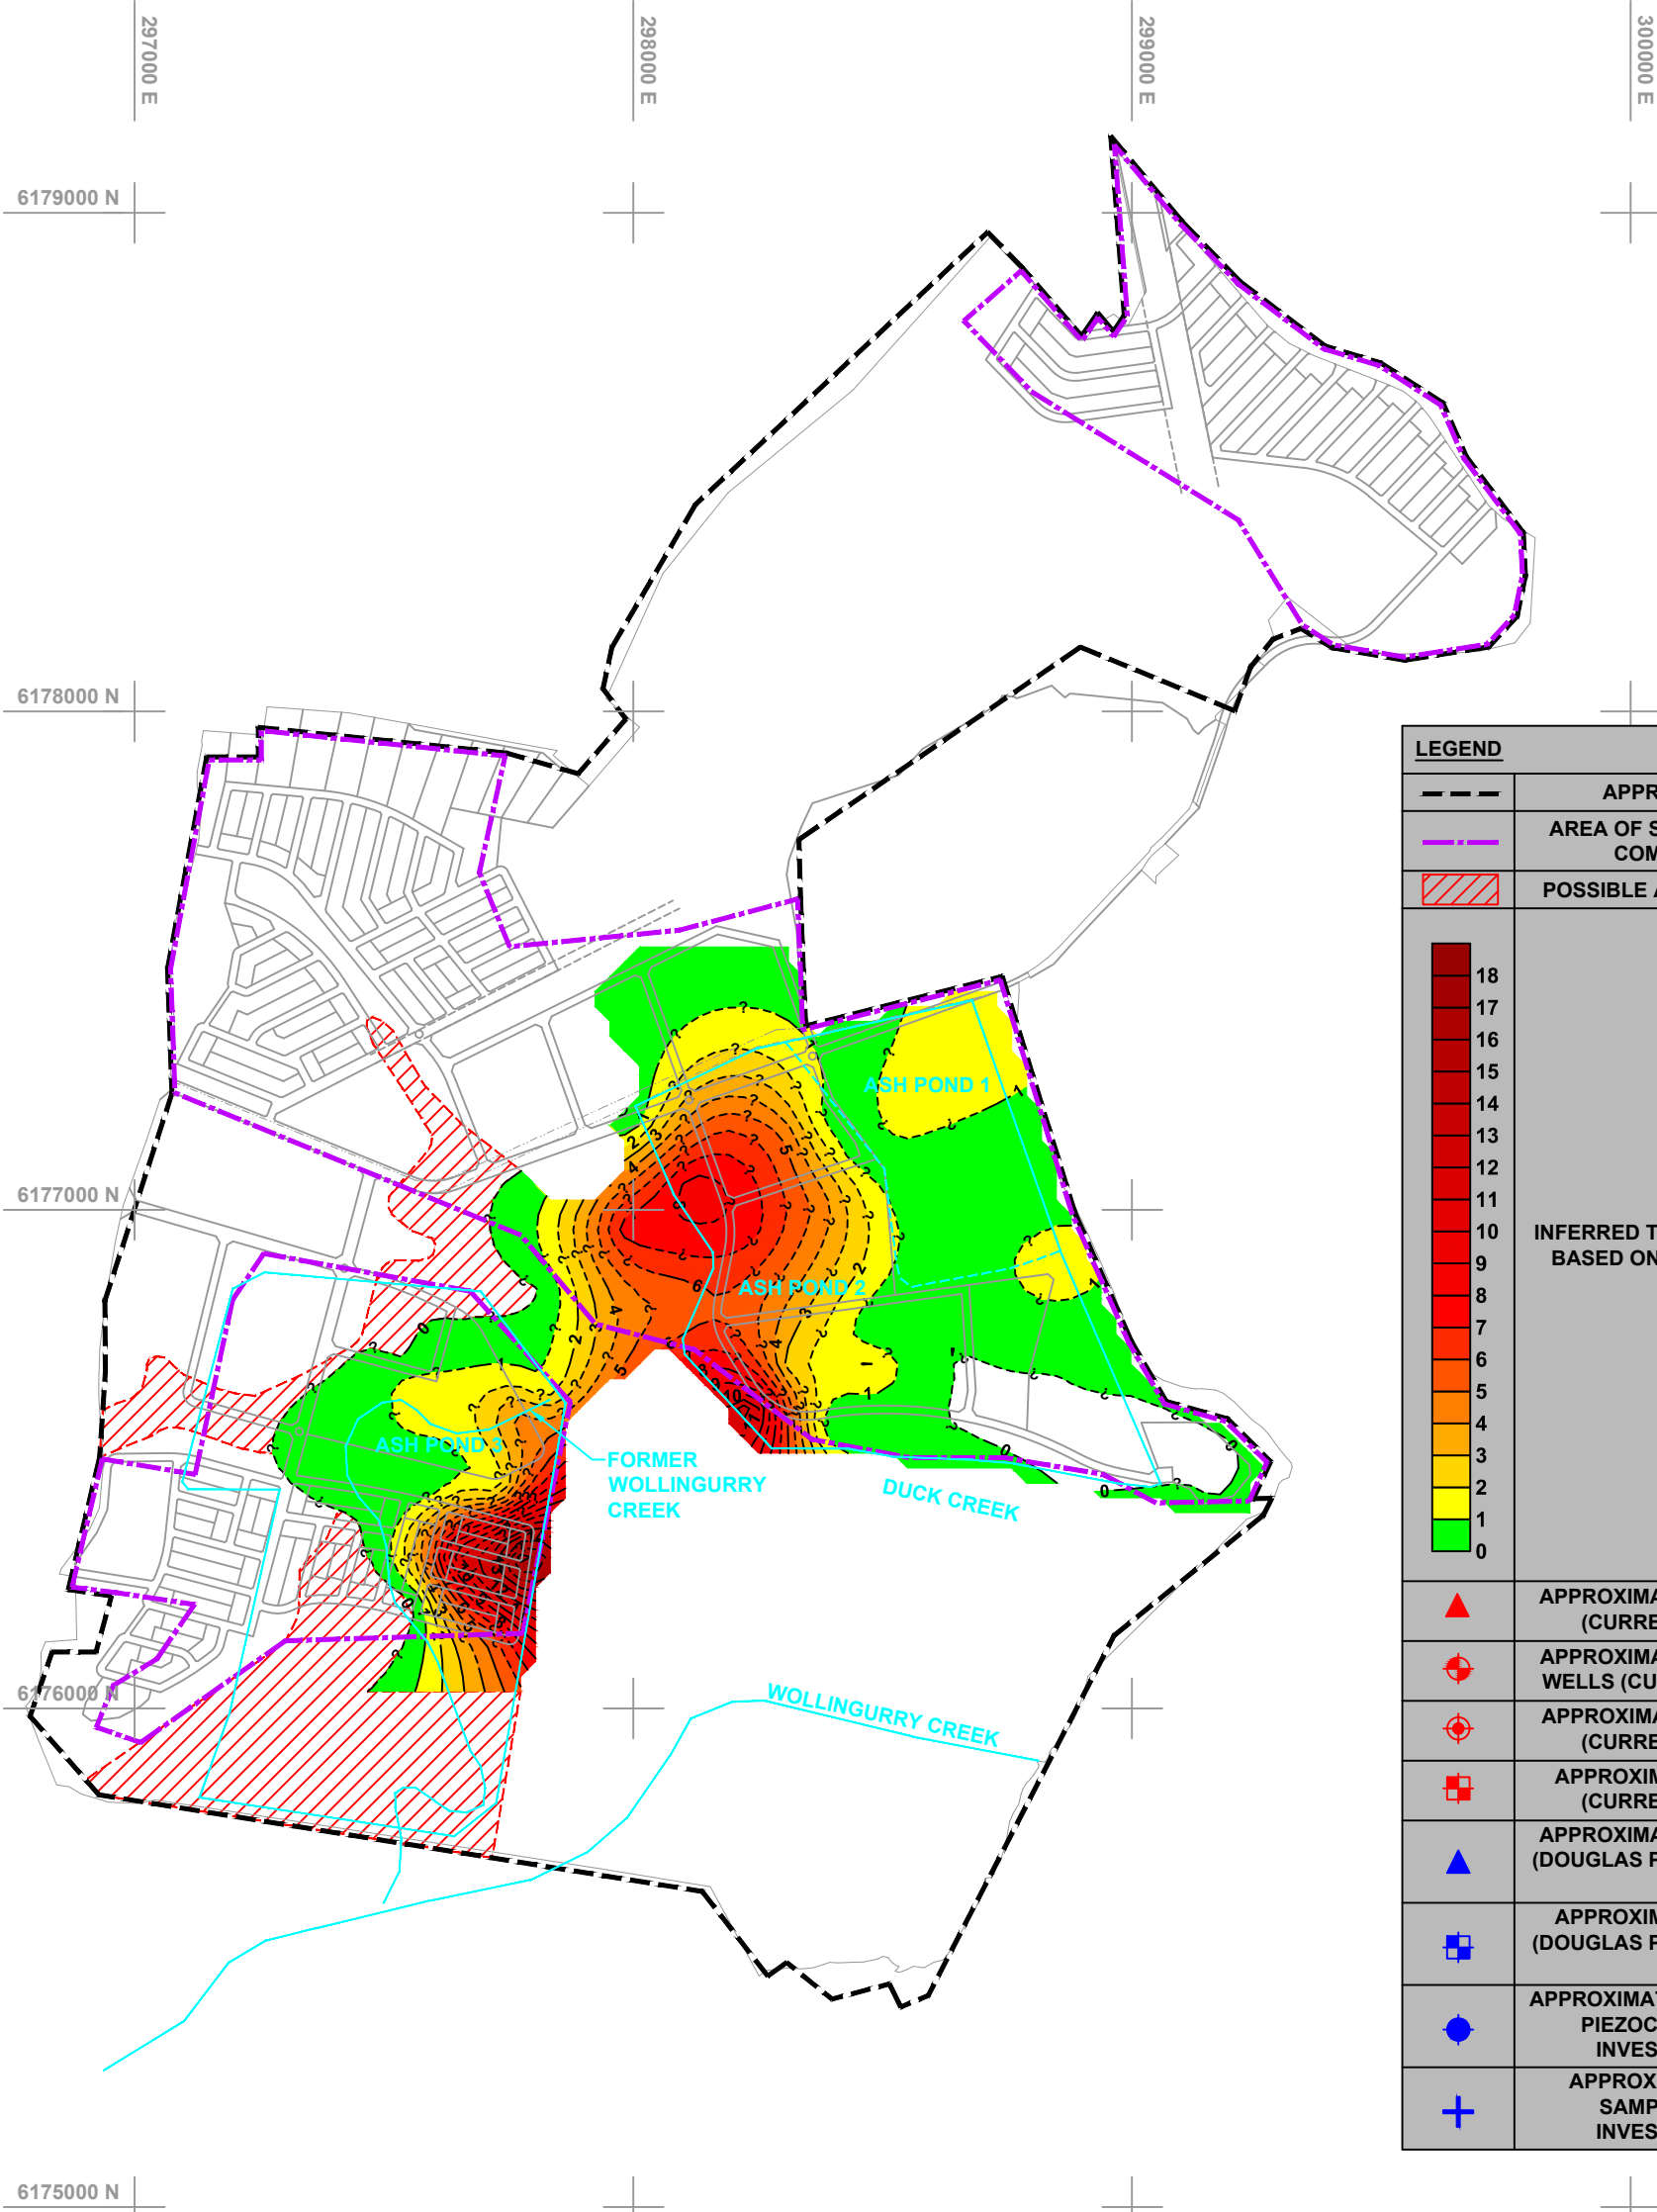
**NOTE:** THE BACKGROUND CONTOURS SHOWN IN THIS DRAWING ARE INTERPOLATED CONTOURS BETWEEN A LIMITED NUMBER OF TEST LOCATIONS WHERE THE DEPTH/THICKNESS OF THE RELEVANT UNIT IS KNOWN AND HAS BEEN DONE TO PROVIDE A PRELIMINARY THREE DIMENSIONAL PICTURE OF THE RELEVANT GEOLOGICAL UNIT DEPTH OR THICKNESS. THE GROUND CONDITIONS ARE ONLY ACCURATE AT THE TEST LOCATIONS SHOWN IN THE FIGURE. THOSE READING AND USING THIS DRAWING SHOULD NOTE THAT THE CONTOUR DATA HAS BEEN PRESENTED TO PROVIDE A BROAD INDICATION OF GROUND CONDITIONS FOR CONCEPT MASTER PLANNING PURPOSES. THE CONTOUR DATA IN THIS DRAWING SHOULD NOT BE USED FOR DETAILED DESIGN PURPOSES. DUE TO THE INHERENT VARIABILITY OF NATURAL GROUND CONDITIONS AND THE SIGNIFICANT 'MAN MADE' DISTURBANCE AT THIS SITE, SOME VARIABILITY BETWEEN THE INTERPOLATED CONTOUR DATA SHOWN HERE AND ACTUAL GROUND CONDITIONS MAY OCCUR. FURTHER ADVICE ON POSSIBLE FUTURE SUBSURFACE INVESTIGATION WORKS SHOULD BE SOUGHT FROM COFFEY IF DETAILED PLANNING OR DESIGN WORK IS TO BE CARRIED OUT FOR FUTURE DEVELOPMENT AT THIS SITE'

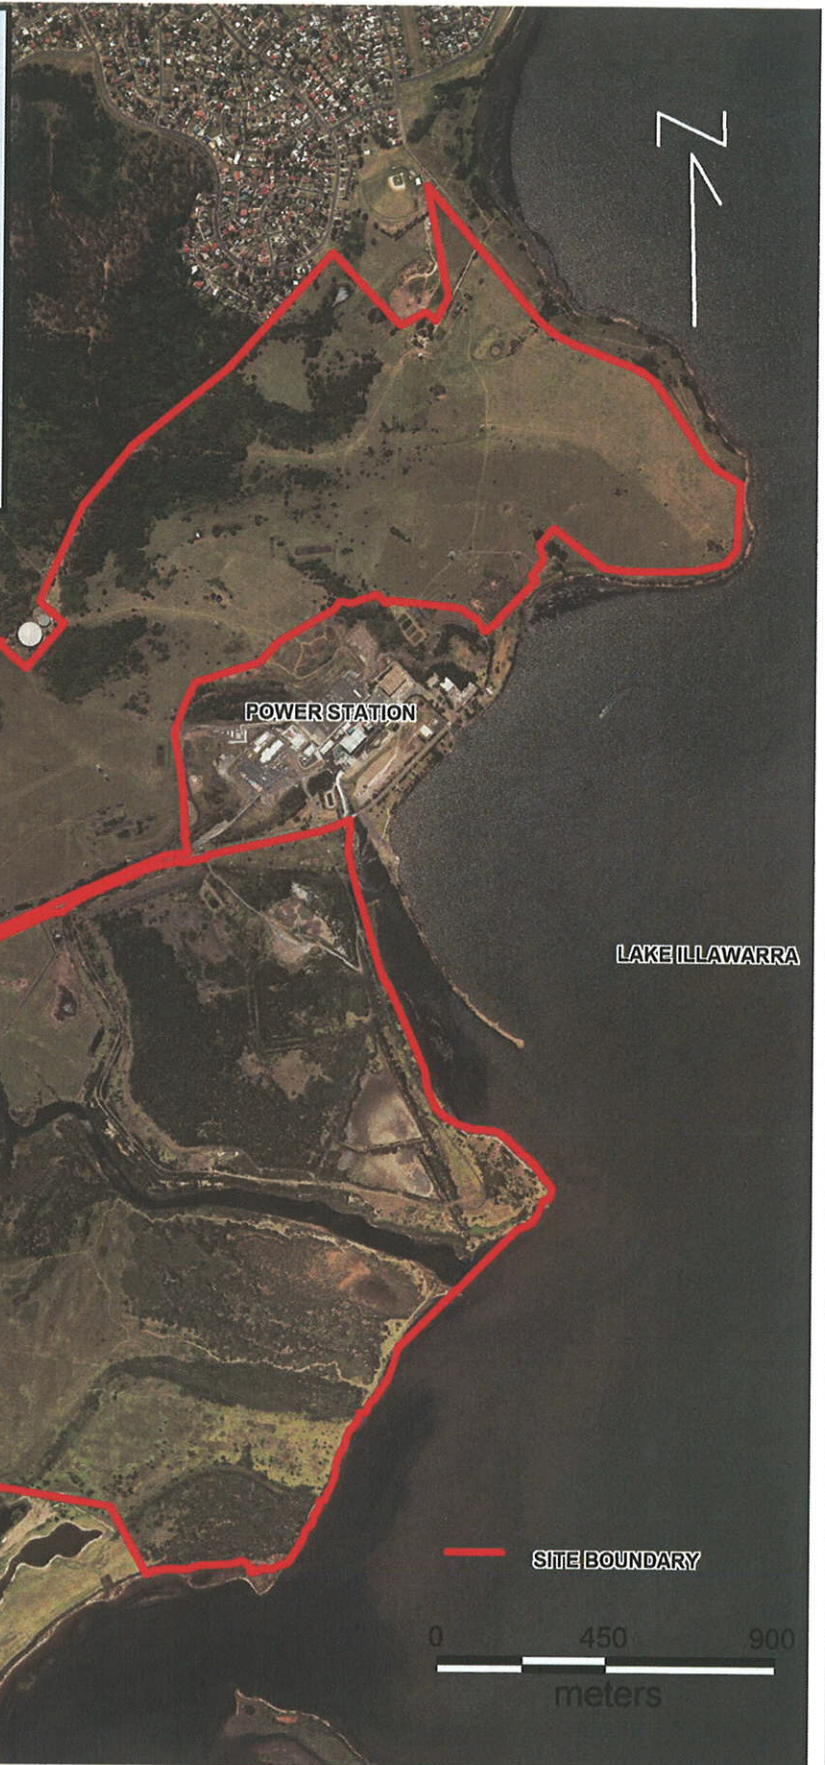
TITLE: SITE LOCATION AND SITE BOUNDARY  
 ASBESTOS CONTAMINATION ASSESSMENT  
 TALLAWARRA LANDS, TALLAWARRA

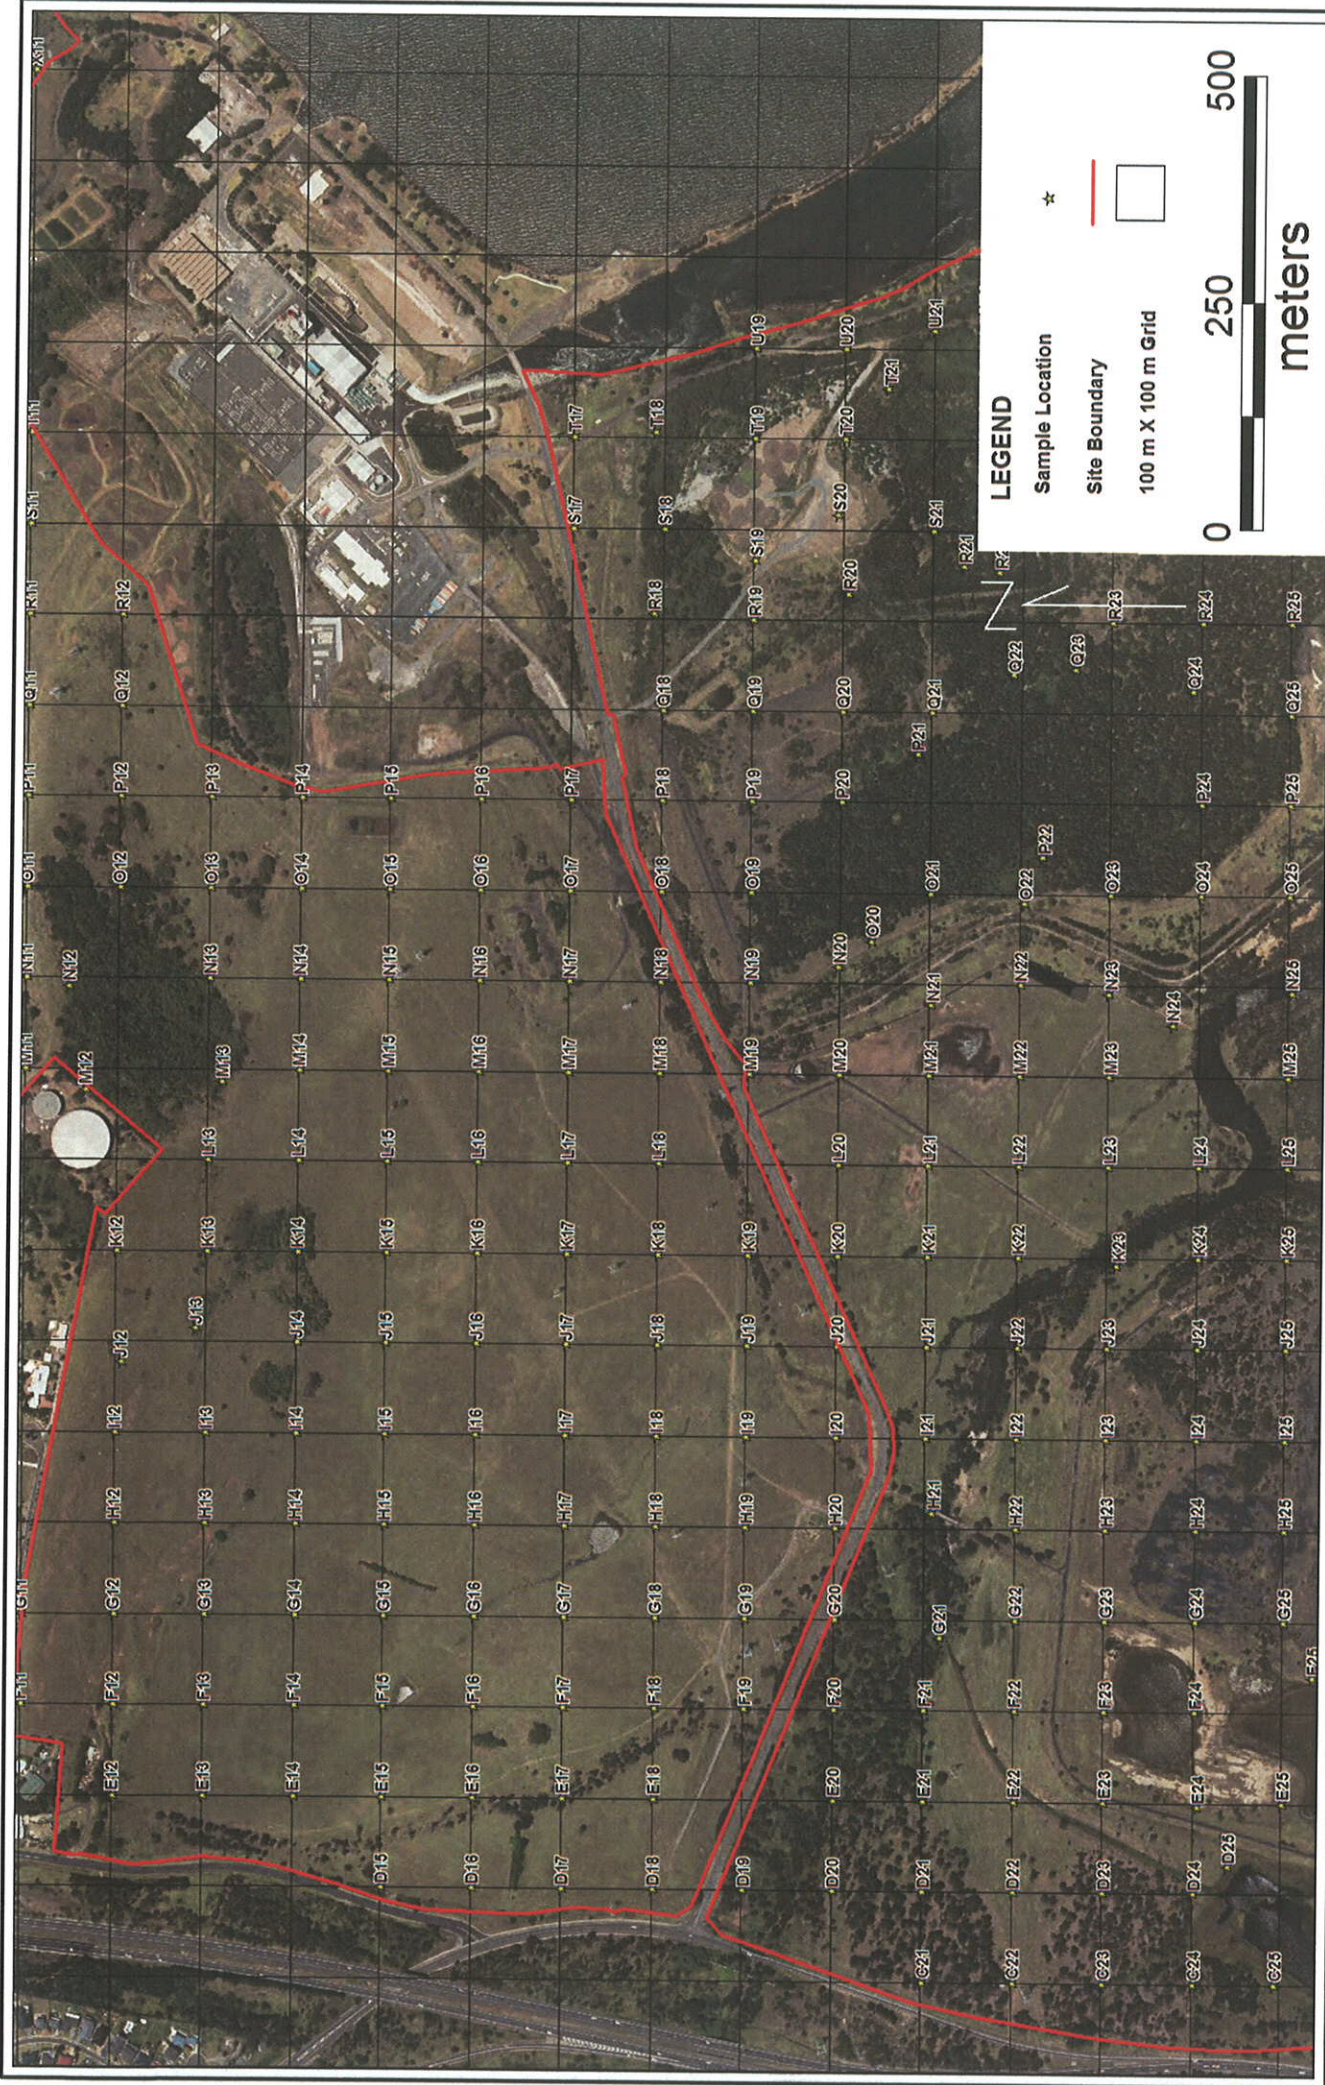
PROJECT: 40661.03  
 DRAWING: 3  
 REVISION:

TITLE: CENTRAL WESTERN PORTION OF SITE  
 ASBESTOS CONTAMINATION ASSESSMENT  
 TALLAWARRA LANDS, TALLAWARRA

Sample locations are indicated in Drawing 2 - 5, Appendix B. A total of 536 surface sample locations were selected across the site based on the 100 m x 100 m grid pattern.
