WEST DAPTO RELEASE AREA
REVISED CURTILAGES IN RELATION TO THE PROPOSED WATER AND WASTEWATER SERVICES
 Source: LPMA (2011)

5.2 Project Approval Area

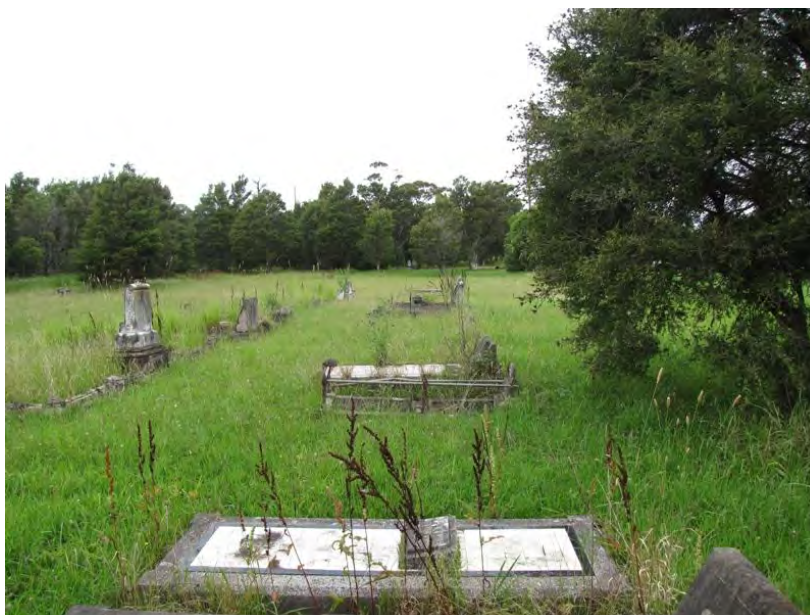
Figure 26 View south of Settlers Cemetery showing typical grave markers and layout of cemetery.

The Kembla Grange Settler's Cemetery is overgrown and surrounded by swampy land which is vegetated with reeds. The cemetery is laid out in rows oriented east-west, and the tombstones face east. The two rows of graves closest to Reddalls Road are well formed, however, there is then located a gap and another row to the east – as if there is potential for a row located in between. There is also a gap between a group of graves to the south and north. The graves to the south are interspersed with trees which have been planted in the last twenty years or so. The first row of graves is located 11.5 m from the sealed road surface. There is a Telstra data cable easement along the eastern road edge. The earliest grave sighted during the field inspection dated to 1907. The most recent headstone dates to 1967. The cemetery is closed and does not appear to be visited often, however the monuments are generally in good order and the grounds are partially maintained and are in reasonable condition, although when the site was inspected on the 17th February 2011 the site was relatively overgrown. However, aerial images of the cemetery clearly show the remains of the cemetery layout.

IMPACT AND RECOMMENDATIONS	
Impact	<p>A water pipeline is identified as being constructed along Reddalls Road. The first two rows of graves are within 25m of the boundary of Reddalls Road. These are within the Anglican and Presbyterian sections of the cemetery.</p> <p>The major concern is whether construction on either side of the road will impact on known or unknown burials. A problem with cemeteries is the presence of graves that lack markers (whether by accident or design) which render them almost invisible on the ground surface. The first line of evidence that can be used to answer this question is the extent of the graves shown on the aerial images of the site on the 2nd November 1951. This shows that the visible grave markers are orientated along the main north-south axis of the main drive in the cemetery. Thus it seems likely that the land Tubemakers acquired was considered to be vacant at the time it was resumed and sold. However this impression is based on surface grave markers visible on aerial images only. It was common for suicides and paupers to be buried outside the fence.</p> <p>It is therefore impossible to definitively state that the construction of the water pipeline would not impact on any sub-surface graves, although it should be possible to avoid known existing graves.</p>

Recommendations	<p>The first management option is to avoid the impact by rerouting the water pipeline although it is recognised that this may not be possible.</p> <p>If rerouting is not an option then it is recommended that Sydney Water commission a more detailed archaeological assessment of the land impacted by construction of the pipeline. This assessment should involve the following tasks:</p> <ul style="list-style-type: none"> • Detailed historical research for any plans of interments at the Cemetery. There is likely to be some correspondence regarding Tubemakers expansion. • A remote sensing survey along the route to identify the possibility of sub-surface graves being located during construction. • Development of appropriate management options (likely to be either excavation underneath any possible grave locations or salvage and reburial of interred bodies) • An application for appropriate permits from the Heritage Branch Department of Planning (either a Section 139a or Section 140 permit) • A program of community consultation is undertaken in order that the community has the opportunity to understand the proposed works and comment on them to ensure that the burials are treated in an ethical and respectful manner in accordance with Anglican and Presbyterian beliefs. • It is relevant to note that if burials are encountered and or need to be exhumed then there are statutory requirements in addition to any heritage requirements – these are partially covered in the NSW Health Policy Directive: Burials – Exhumation of Human Remains (2008). Any exhumation would need to cover the whole burial. <p>Management of the existing graves monuments during construction would require the following works:</p> <ul style="list-style-type: none"> • The location of all known graves and the alignment of the internal cemetery roads within 15 m of the pipe alignment be marked on all plans of the work in this area as items of heritage significance so as to avoid inadvertent disturbance. • Site facilities such as toilets and work sheds be placed to avoid disturbance to graves and to avoid offence (e.g. no toilets within the cemetery) • Temporary fencing of the graves by a parra-webbing fence running parallel to Reddalls Road in this section to avoid accidental damage by machinery • All contractors and sub-contractors and Sydney water staff should be briefed on the potential of the area to contain human burials and the procedures (including respectful treatment of human remains and grave sites) to be followed. <p>Provisions for briefing of personnel and for the mitigation works outlined above should be incorporated in any environmental or construction planning for the project such as Environmental Management Plans.</p> <p>Sydney Water should undertake a program of specific community consultation in order that the community has the opportunity to understand the proposed works and comment on them to ensure that the burials are treated in an ethical and respectful manner in accordance with Anglican and Presbyterian beliefs. This would avoid unnecessary community concern about possible disturbance of graves.</p>

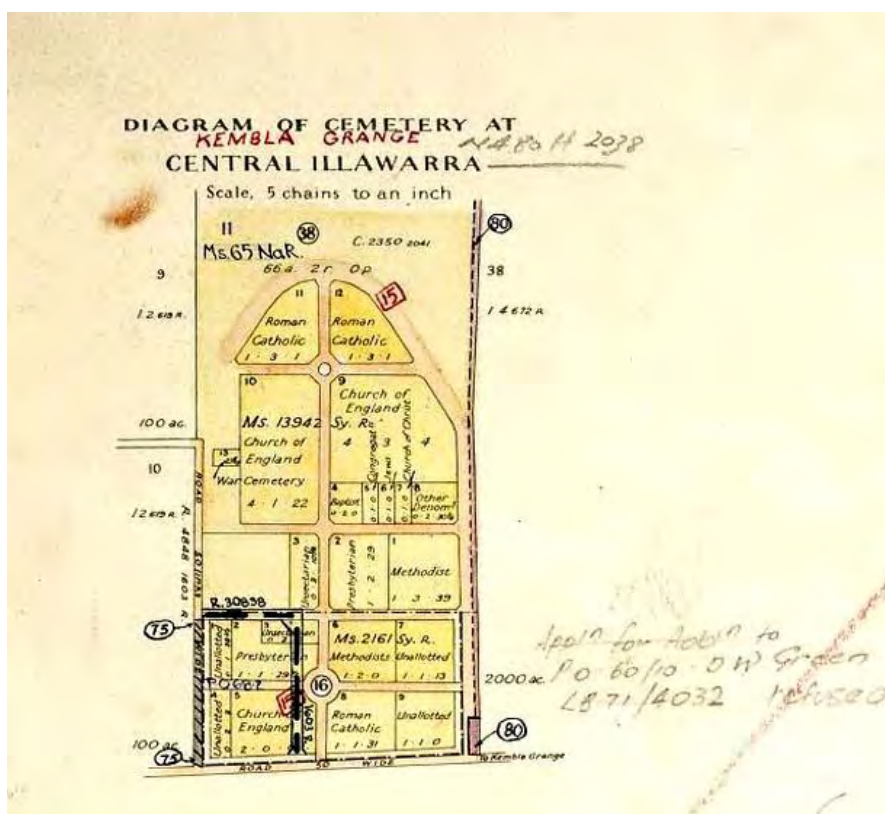
Figure 27 Crown Land Plan – Diagram of Cemetery at Kembla Grange, Central Illawarra. N480142038. Department of Lands

The Cemetery was extended to the north on the 26th November 1954 (including the Kembla War Cemetery). In 1968 the existing alignment of Reddalls Road was altered to allow Tubemakers Australia to expand to occupy part of the cemetery. The land was resumed and a new road reserved on the 5th July 1968. The old road alignment was closed on the 6th September 1968. It appears that the new section of Reddalls Road is constructed on an embankment raising the road above the level of the cemetery.

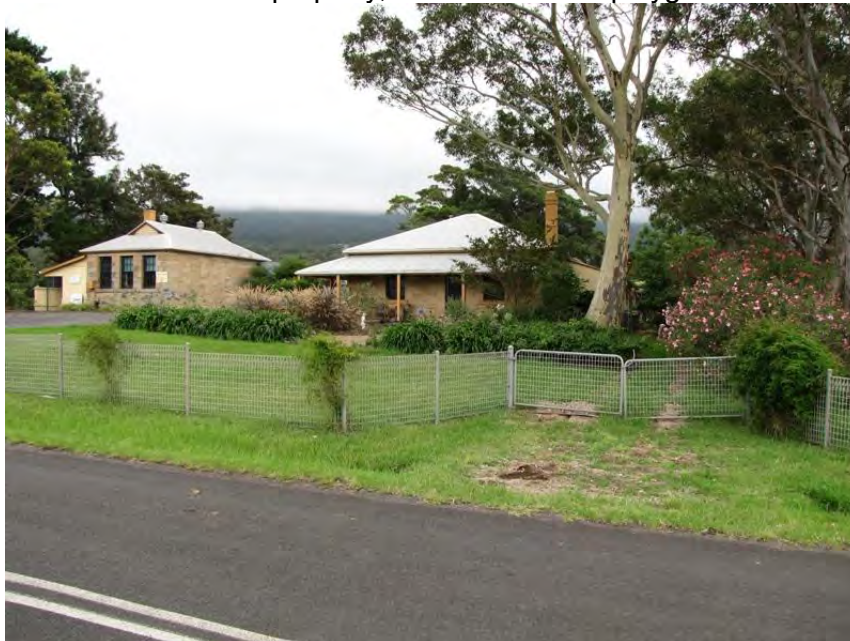
Figure 29 West Dapto Public School. The school building is on the left and the school master's residence on the right. The proposed pipeline route is to the right of the image on the right hand side of the vegetation lining the fence. View north north west

Comprises two main components – a schoolmaster's residence to the east and the school buildings to the west. Both buildings are constructed of sandstone with skillion roofs of corrugated iron. The residence has a verandah on the southern and western elevations. Modern buildings have been inserted at the rear of the property, as has a fenced playground.

IMPACT AND RECOMMENDATIONS	
Impact	A water pipeline is proposed to be constructed along the eastern boundary of the West Dapto Public School. The heritage items may be subject indirect vibration impacts during construction.
Recommendations	Vibration impacts to the West Dapto Public School are anticipated. The impacts will be managed in accordance with the German Standard DIN 4150: Part 3 - 1986.

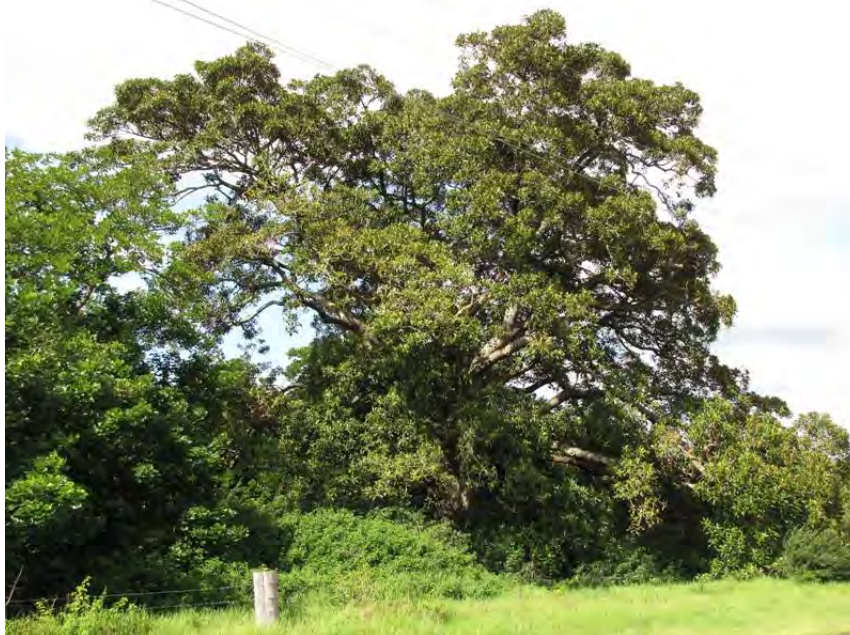
Figure 33 View of Moreton Bay Fig Tree

The site consists of an exceedingly large Moreton Bay Fig on the south eastern bend of West Dapto Road. During field survey it was not possible to survey underneath or around the tree due to impenetrable vegetation. The trunk is located 15 m from the boundary fence.

IMPACT AND RECOMMENDATIONS	
Impact	It is possible that construction work may have an impact on Moreton Bay Fig (17b) by disturbing its roots or by requiring its removal. Root disturbance may lead to a reduction in the lifespan of the tree. The death or removal of the tree will obliterate the Fig's heritage significance.
Recommendations	<p>The tree is of local significance and listed on the 2010 Wollongong LEP. It is therefore recommended that impact be avoided. The tree also marks the potential site of New Archaeological Site 4 – Cottage (185). It is therefore, on this second count, recommended that the area be avoided and the pipelines located within the road reserve. If this is not practicable the following management is recommended:</p> <ul style="list-style-type: none"> Align pipes 10 m from the fig tree canopy. If this is not possible it is recommended an arborist is consulted regarding the health of the trees and the best way to proceed: <ul style="list-style-type: none"> Develop a clearer understanding of the archaeological potential of the site by undertaking the following: <ul style="list-style-type: none"> Vegetation removal to allow for a more detailed visual inspection A remote sensing survey along the route to identify the possibility of sub-surface remains of the buildings being located during construction Development of appropriate management options (likely to be either test excavation prior to construction, archaeological monitoring during construction or no further archaeological work).

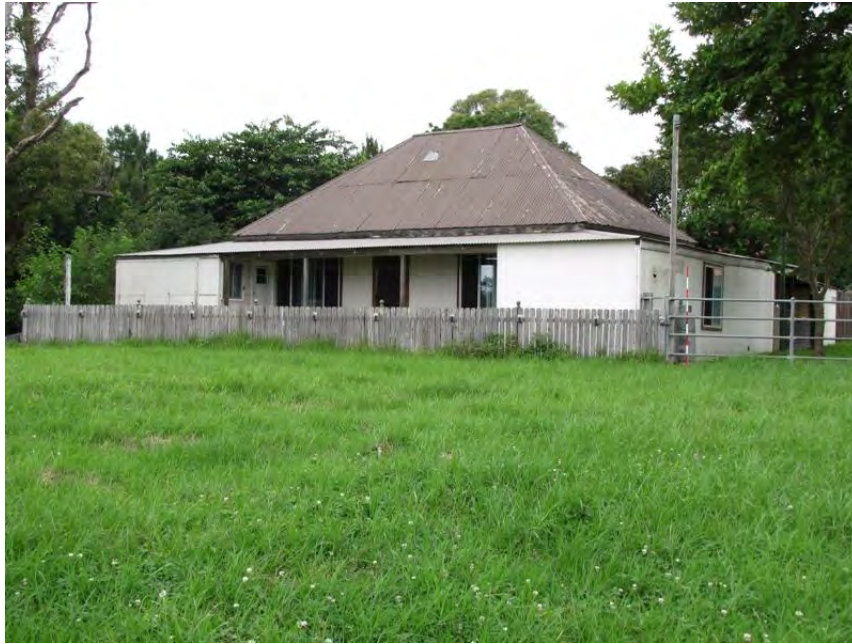
Figure 34 Brisbane Grove House – front elevation. View south west

On the right of the homestead there are several small citrus plantings and a European Beech Tree. A large mature Moreton Bay Fig tree is situated between the original homestead and the modern house. A row of Poplars line the entrance to the property.

Several dairy outbuildings provide a representation of traditional dairy featuring a timber milking shed, washroom, concrete drainage platform, separator and washroom, bailing area, stock and holding yards. The outbuildings consist of corrugated iron, weatherboard and Besser block extension as well as a new shed and silo. The property includes a complete cattle run which appears to still be in use but not on a day to day basis.

IMPACT AND RECOMMENDATIONS	
Impacts	<p>A water pipeline and wastewater pipe are proposed to be constructed along West Dapto Road however the older and heritage listed buildings are over 70m from the boundary so the construction of these lines will have no impact on heritage values.</p> <p>A wastewater pipeline is proposed to branch from West Dapto Road and run along the western side of the buildings. Construction of this may result in the demolition of some farm buildings including the old dairy buildings. The original homestead will be just within 25m of the wastewater pipeline route.</p>
Recommendations	<p>The first and preferred option is to move the wastewater pipeline 25m to the north west (parallel to its current proposed route) to avoid impacts on the farm outbuildings.</p> <p>If the outbuildings are to be demolished then they are of sufficient heritage significance to justify an archival recording being made of the building using the guidelines <i>How to prepare Archival Recording of Heritage Items</i> issued by the New South Wales Heritage Office in 1998. The requirements for items of Local Significance and for items involving Industrial Archaeological Evidence should be followed.</p> <p>Vibration impacts to Brisbane Grove are anticipated. The impacts will be managed in accordance with the German Standard DIN 4150: Part 3 - 1986.</p>

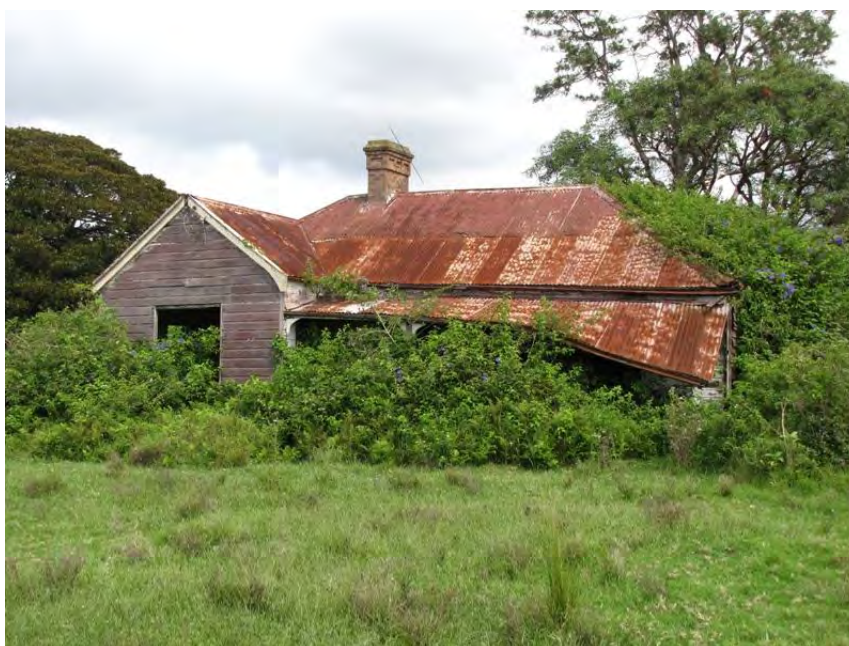
Figure 35 House (19), view west showing distance from road

The site comprises a derelict homestead, remnant gardens and outbuildings. The house is situated at road level approximately 50-60 m from West Dapto Road. The house is an L shaped, single storey weatherboard house with a corrugated iron hipped roof and front verandah. The homestead has five main rooms and although deteriorating, has original features including timber architrave, decorative pressed ceilings, timber panelled doors and brick fireplaces and chimneys (indicative of c. 1880s). The homestead is surrounded by dense lantana and rubbish, however there is evidence of a previous garden containing small shrubs, geranium plantings and a Flame Tree. A mature Moreton Bay Fig Tree is situated to the north of the homestead.

There are several small iron and timber sheds, a container from a truck, two water tanks and a garage amongst the overgrown lantana. Of note is a large timber shed containing an extensive line of intact original timber feed troughs and pens, most likely relating to a former piggery. A Telstra service cable is just within the property boundary, disturbing the archaeological integrity of the boundary.

IMPACT AND RECOMMENDATIONS	
Impact	Will not be impacted as is well beyond 25m from the property boundary on West Dapto Road
Recommendations	No management is required as the site will not be impacted

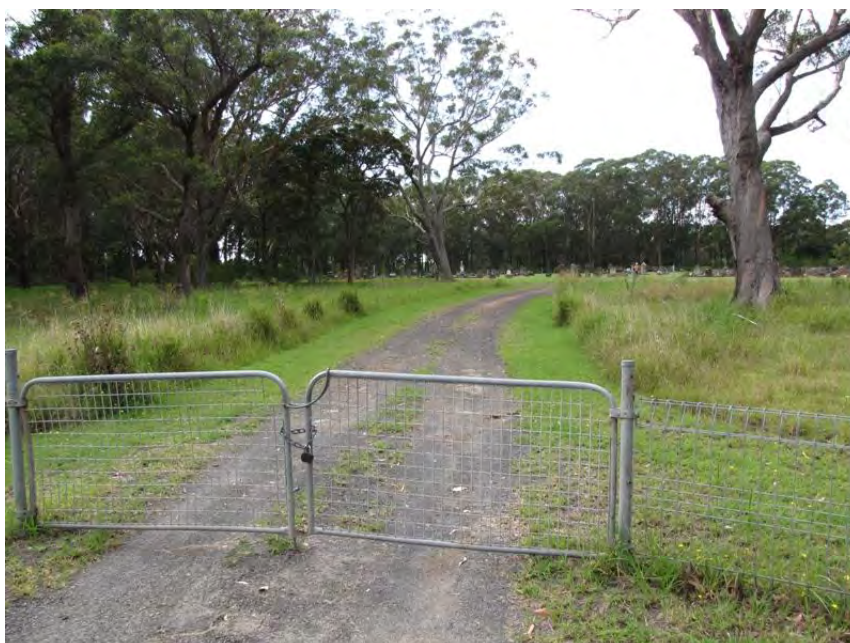
Figure 36 West Dapto Catholic Cemetery (20)

West Dapto Catholic Cemetery is a well maintained cemetery. The fenced cemetery area is 70m from the property boundary fence. The cemetery is divided into two main sections by a grass path. The 'right' section is more sparsely populated and features earlier dated headstones. The site is bounded by a wire and timber fence and mature eucalypts. Entrance is via a decorative (c.1940s) metal gate. Unusually, the headstones face west, except for a single row at the rear of the cemetery, which face east.

IMPACT AND RECOMMENDATIONS	
Impact	Water pipeline and wastewater pipes are proposed to be constructed along West Dapto Road, which may impact on the archaeological site of the former Roman Catholic Chapel. As the burials are set 70 m from the boundary fence, they are unlikely to be impacted by the concept.
Recommendations	<p>It is recommended that the area be avoided and the pipelines located within the road reserve to avoid impacting the potential site of the former Chapel. If this is not practicable the following management is recommended:</p> <ul style="list-style-type: none">• Develop a clearer understanding of the archaeological potential of the site by undertaking the following:• Vegetation removal to allow for a more detailed visual inspection• A remote sensing survey along the route to identify the possibility of sub-surface remains of the buildings being located during construction• Development of appropriate management options (likely to be either test excavation prior to construction, archaeological monitoring during construction or no further archaeological work). <p>It is also recommended that Sydney Water undertake specific consultation with the Catholic community to explain the project and to assure the community that there will be no heritage impacts on the internments.</p>

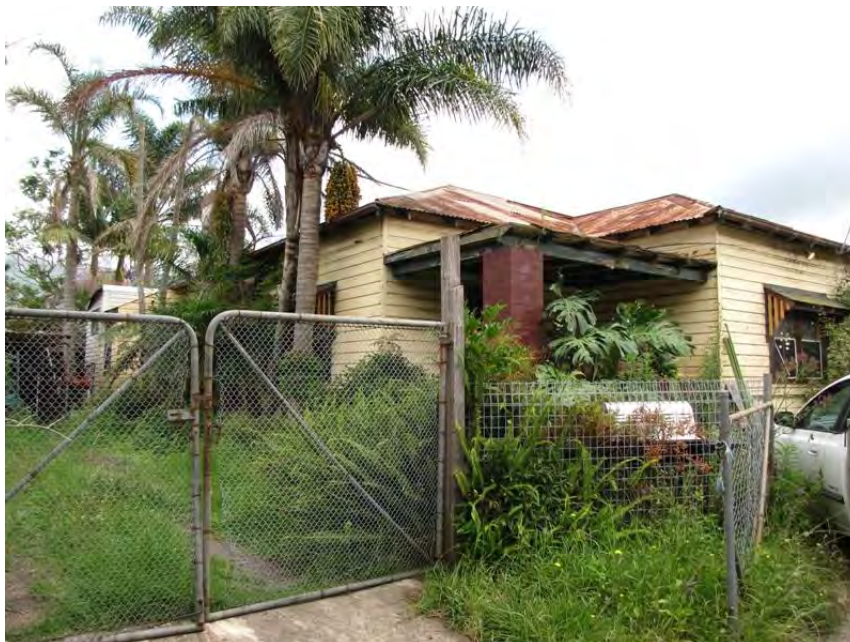
Figure 37 206 West Dapto Road, front elevation, view north north west

The house (c. 1940s) is situated 12 m from the property boundary, just to the south of a 90° bend and faces south east. The house is of timber weatherboard with leadlight windows in the front room. These appear to be original. The front facade is L shaped and in-filled with a verandah supported by brick posts.

There is a partially dismantled garage to the west of the house. An assortment of other outbuildings surround the house. To the north east, near the Concrete Bridge (22) two railway sleepers have been reused to create gateposts. The House is also associated with the Derelict House (19) and may have been constructed as a replacement.

RECOMMENDATIONS	
Impact	A water pipeline is proposed to be construction along West Dapto Road. Depending on which side of Dapto Road it is constructed there will be either be indirect vibration impacts or potentially a direct impact, requiring removal of the house and adjacent tin shed.
Recommendations	<p>First management option is to minimise the impact by ensuring that the water pipeline is located on the south eastern side of the road or is located within the current road reserve.</p> <p>If the house is to be demolished then it is of sufficient heritage significance to justify an archival recording be made of the building using the guidelines <i>How to prepare Archival Recording of Heritage Items</i> issued by the New South Wales Heritage Office in 1998. The requirements for items of Local Significance should be followed.</p> <p>The tin shed can be removed without any further recording.</p> <p>If the House is to remain, vibration impacts are anticipated. The impacts will be managed in accordance with the German Standard DIN 4150: Part 3 - 1986.</p>

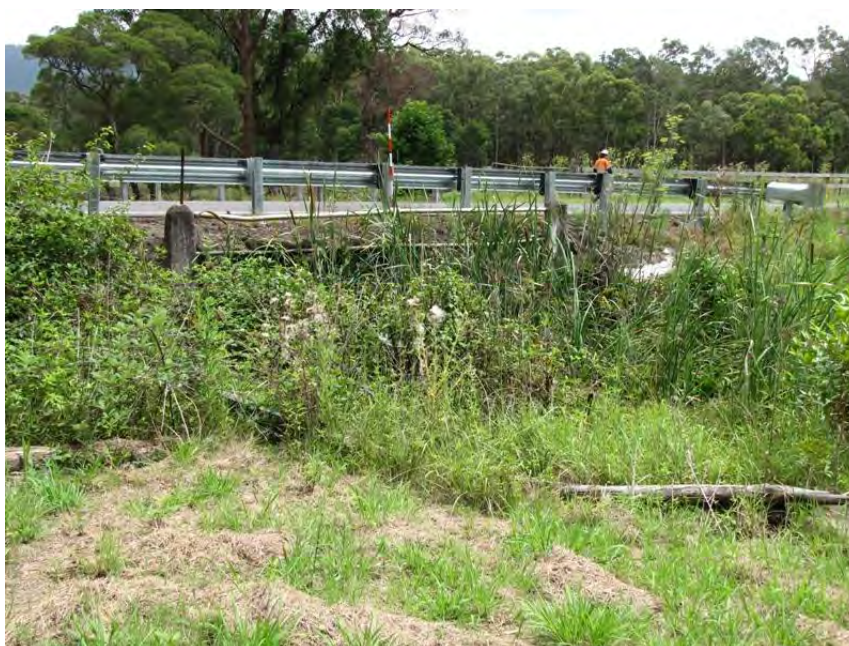
Figure 38 Concrete Bridge off West Dapto Road

This item consists of a small reinforced concrete bridge, dating to c. 1920, which is located on West Dapto Road as it crosses a tributary of Robins Creek. The bridge is constructed from concrete supports and base with steel railings supported by four concrete pillars. The field inspection conducted in February 2011 revealed that since 2005, when it was originally recorded by HLA, it appears that the road has been raised and new steel guard rails erected. An earlier railing is still evident on the southern side but has been removed from the north. A sewer rising main is located on the southern side of the bridge.

This bridge is an intact example of the use of reinforced concrete and steel in the early twentieth century, which rapidly superseded the use of timber at the end of World War 1. This bridge most likely replaced an earlier, less stable timber bridge.

IMPACT AND RECOMMENDATIONS	
Impact	A water pipeline is proposed to be constructed along West Dapto Road. Impacts will depend on how the pipeline is to cross the creek. If it crosses on a separate structure there will be no impact as the visual curtilage is not of significance. If it crosses by bolting it to the bridge then the impact on this item will be minimal and no further work will be required.
Recommendations	It is not listed and not a relic so no further heritage consideration is necessary as the bridge is of a standard design and is not of heritage significance.

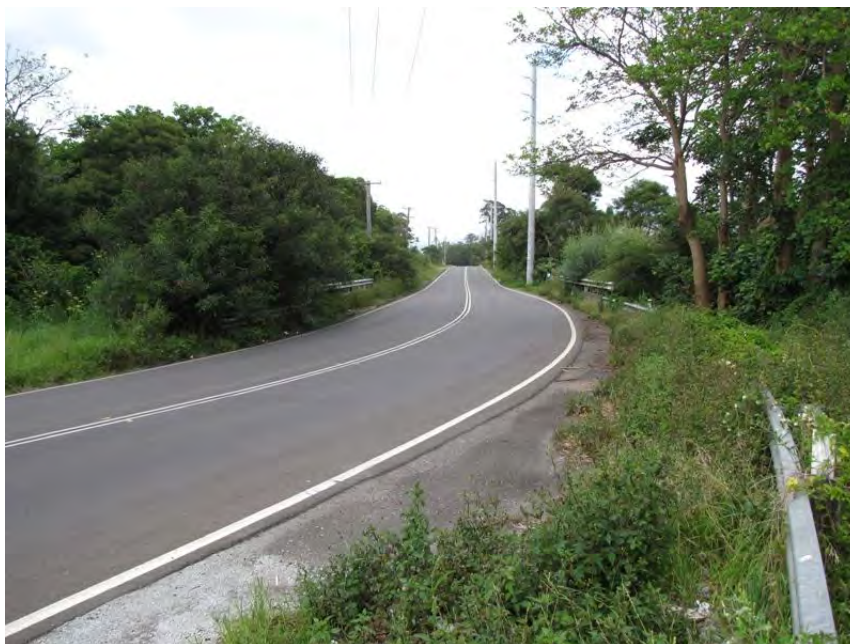
Figure 39 Concrete bridge (22b), view south

Concrete bridge topped with latter steel guard rails. Original section appears to be formed poured on site. Later pre-fabricated additions on either side. Two steel water mains adjacent to Southern side of bridge.

IMPACT AND RECOMMENDATIONS	
Impact	A water pipeline is proposed to be constructed along West Dapto Road. Impacts will depend on how the pipeline is to cross the creek. If it crosses on a separate structure there will be no impact as the visual curtilage is not of significance. If it crosses on by bolting it to the bridge then the impact on this item will be minimal and no further work will be required
Recommendations	This item is not of heritage significance and does not require heritage mitigation measures

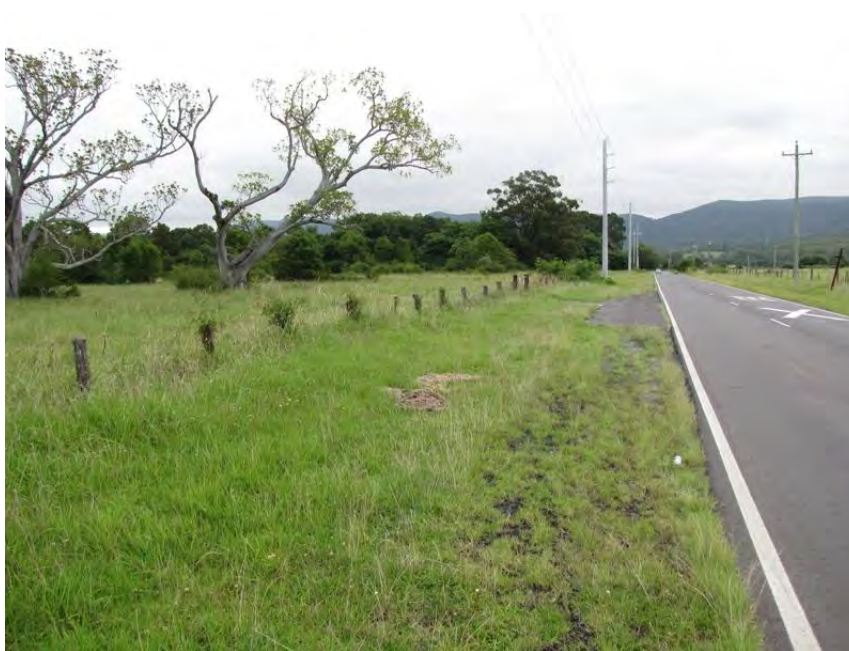
Figure 40 Fence, view west

This item consists of an extensive section of early remnant post and rail fencing located along West Dapto Road, running parallel to two significant mature fig trees (Refer to Mature Fig Trees 17a). It was recorded by HLA as featuring a small section of early post and rail fencing which remains from a previous extensive property boundary. Intact morticed wooden fence posts with holes measuring approximately 20cm high by 10cm wide are present. Three rows of barbed wire replaces original timber rails. Some posts have been replaced with star pickets.

A field inspection in February 2011 identified no immediate evidence of former rails from early post and rail fencing as recorded by HLA. The gate is marked as an access point for Integral Energy. The twin fig trees are also in poor condition.

IMPACT AND RECOMMENDATIONS	
Impact	A water pipeline is proposed to be constructed along West Dapto Road in this area. It is possible that construction work may require the removal of the fence
Recommendations	The fence is no impediment on heritage grounds. No management is required

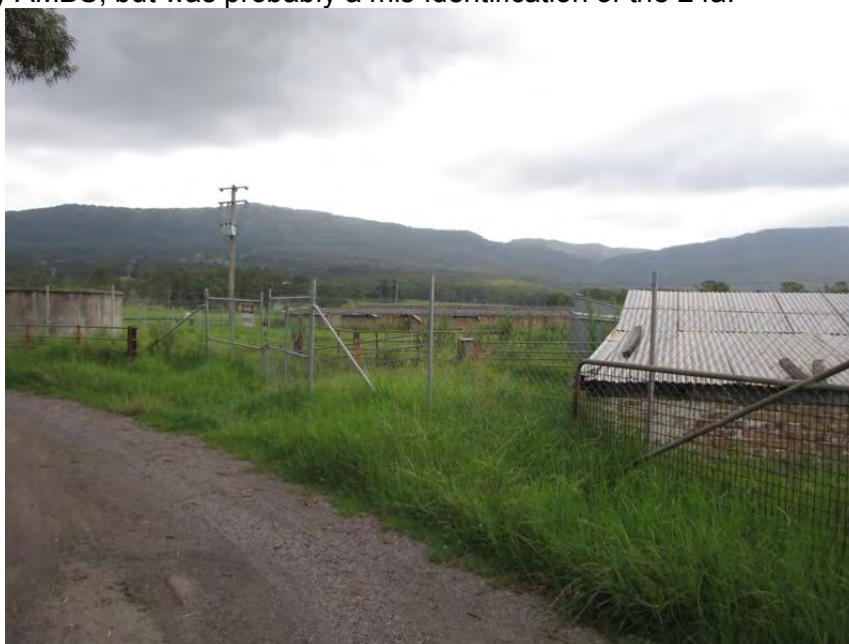
Figure 41 Farm Building, approximately 40m from the road.

This item comprises a modern c.1990 brick house set over 300 m from the Road. A collection of c.1980s farm buildings are located approximately 40 m from the road. It is unclear why this item was identified by AMBS, but was probably a mis-identification of the 24a.

IMPACT AND RECOMMENDATIONS	
Impact	A water pipeline runs through the derelict farm buildings and is likely to result in their demolition.
Recommendations	No recommendations are required as the item is not considered to be of heritage significance

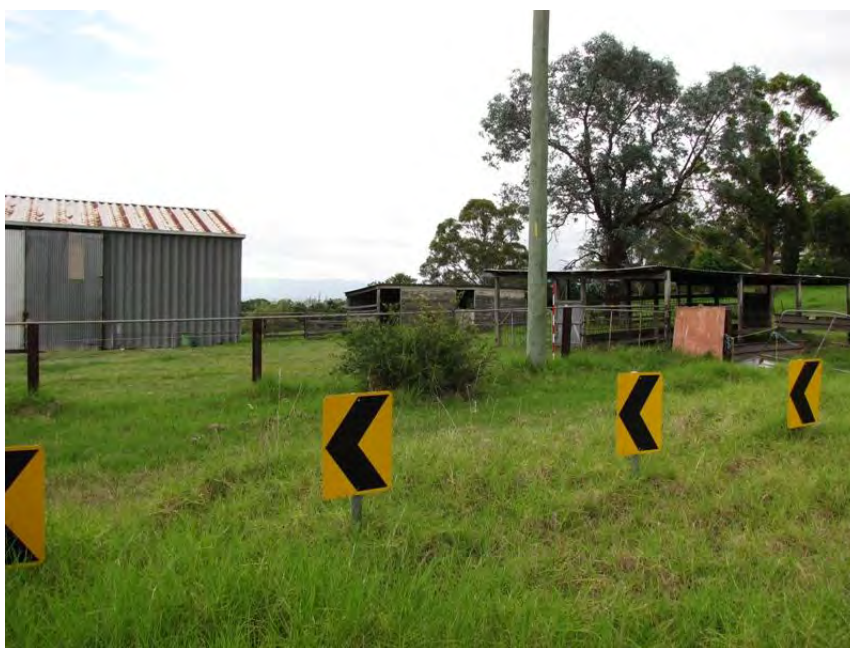
Figure 43 Barlyn dairy buildings. View south east

The dairy is intact and retains its original layout. Structures include a reinforced concrete silo, stockyard, holding yards, concrete drainage area, brick milking shed with c. 1940s equipment, open feed shed with mesh troughs for hay and associated timber and corrugated iron sheds.

IMPACT AND RECOMMENDATIONS	
Impact	<p>A wastewater pipeline is proposed to run along the south west side of Darkes Road and onto the property. The house and garden is over 60m from the route of this pipeline and will not be impacted.</p> <p>The pipeline will run between or through a large galvanised iron shed and a timber building. These buildings do not appear in the 1949 aerial. It is presumed that some of these buildings may have to be removed for the construction the wastewater pipeline.</p>
Recommendations	<p>The house and garden do not require any mitigation work as no impact is predicted. The outbuildings relating to the dairying use of the property will be impacted. If practical the pipeline should be rerouted to the west to avoid these buildings but it is recognised that this may not be practical.</p> <p>If the outbuildings are to be demolished then they are of sufficient heritage significance to justify an archival recording be made of the building using the guidelines <i>How to prepare Archival Recording of Heritage Items</i> issued by the New South Wales Heritage Office in 1998. The requirements for items of local significance and for items involving Industrial Archaeological Evidence should be followed.</p>

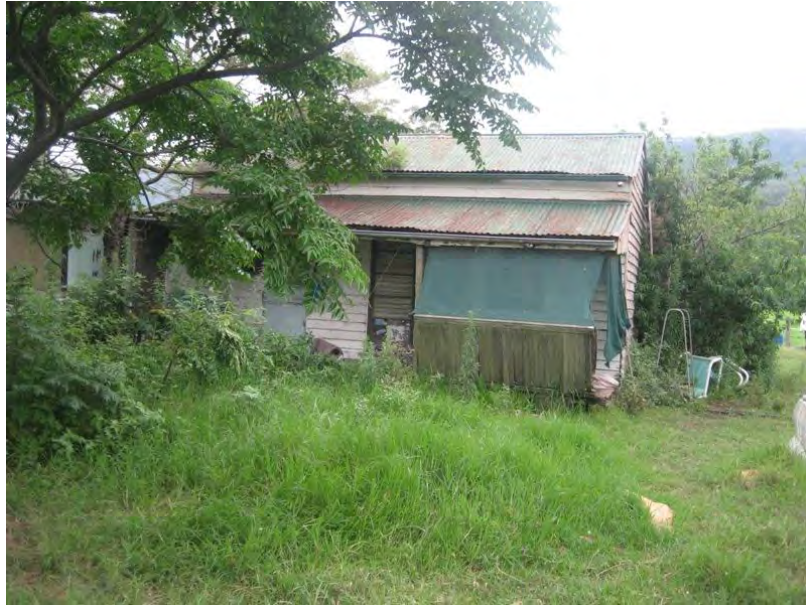
Figure 44 Coral Vale Kitchen (32), view west

The original attached kitchen of "Coral Vale" homestead (Site 31) was relocated directly across the road in 1930 and was used as a residence, although it had been abandoned by the 2011 field survey. It is a timber weatherboard structure with a brick chimney, and has a corrugated iron roof, a skillion added to the west elevation, and a verandah on the east.

IMPACT AND RECOMMENDATIONS	
Impact	A wastewater pipeline is proposed to run down the creek valley immediately south of the buildings. The pipeline is proposed to commence about 15m to the south west of the building
Recommendations	As it seems unlikely the wastewater pipeline will impact on the site no management actions are proposed

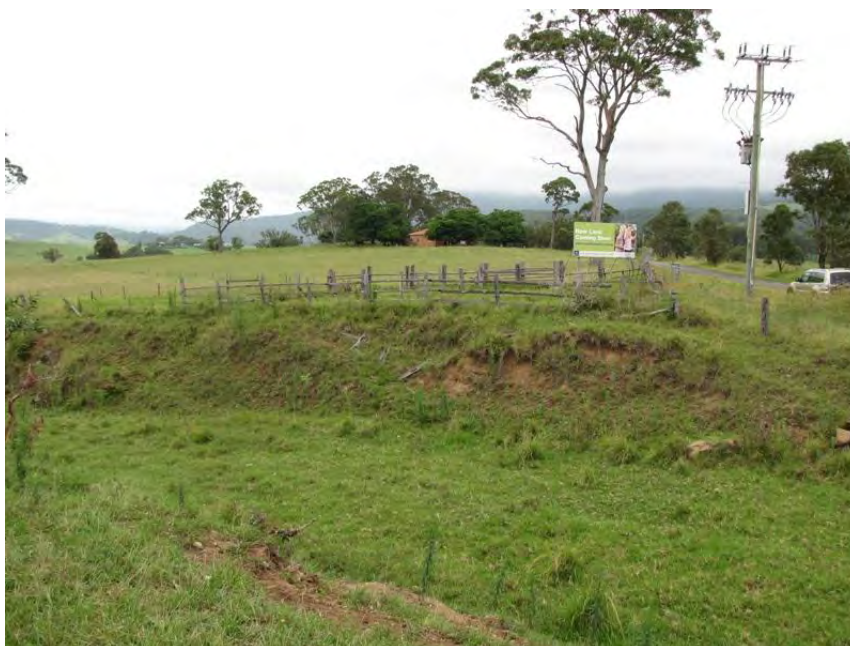
Figure 45 Stockyard, view west. Note tramway cutting in foreground

The Bong Bong Road Stockyard consists of a stockyard which now simply consists of a the exterior fence line. There is some evidence of the former ramp, which appears to have been constructed of slag from the smelter. AECOM was informed that this site was to be removed within the coming weeks.

IMPACT AND RECOMMENDATIONS	
Impact	Water pipeline is proposed to be constructed along Bong Bong Road; the stockyard is located on the property boundary.
Recommendations	AECOM ascribes no heritage significance to this stockyard, the fabric or the form of the stockyard meet does not the criteria for local significance. The item can be removed without impacting the historical record of the West Dapto region.

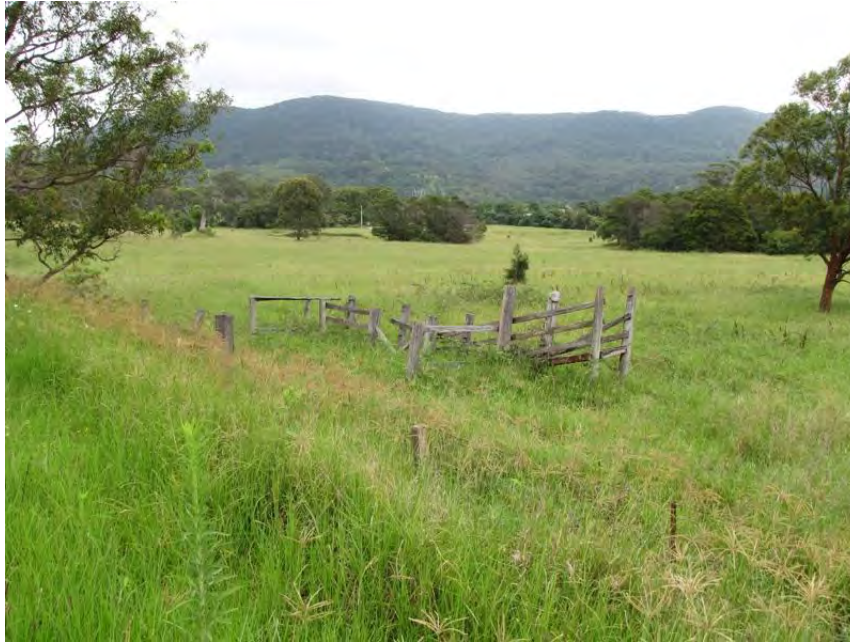
Figure 46 Stockyard – view North West

The Bong Bong Road Stockyard consists of a relatively intact loading ramp. There is evidence that it was formally attached to a small holding yard constructed of bush timber. The yard is not in a good state of repair. The stockyard is located in an empty paddock close to the road alignment.

IMPACT AND RECOMMENDATIONS	
Impact	Water pipeline is proposed to be constructed along Bong Bong Road; the stockyard is located on the sou boundary adjacent to the railway cutting.
Recommendations	AECOM ascribes no heritage significance to this stockyard, the fabric or the form of the stockyard does not meet the criteria for local significance. The item can be removed without impacting the historical record of the West Dapto region

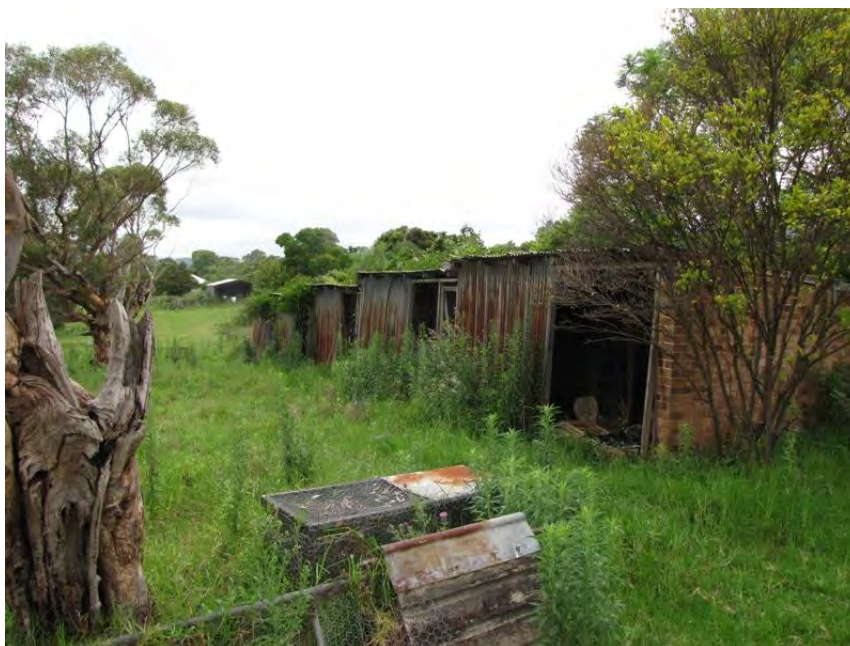
Figure 48 Poultry sheds, view south south west

An L shaped property including an original cottage, poultry sheds and modern residence (c.1980s). The poultry sheds are of corrugated iron. The original cottage (1920s) has four main rooms and has been constructed in three parts.

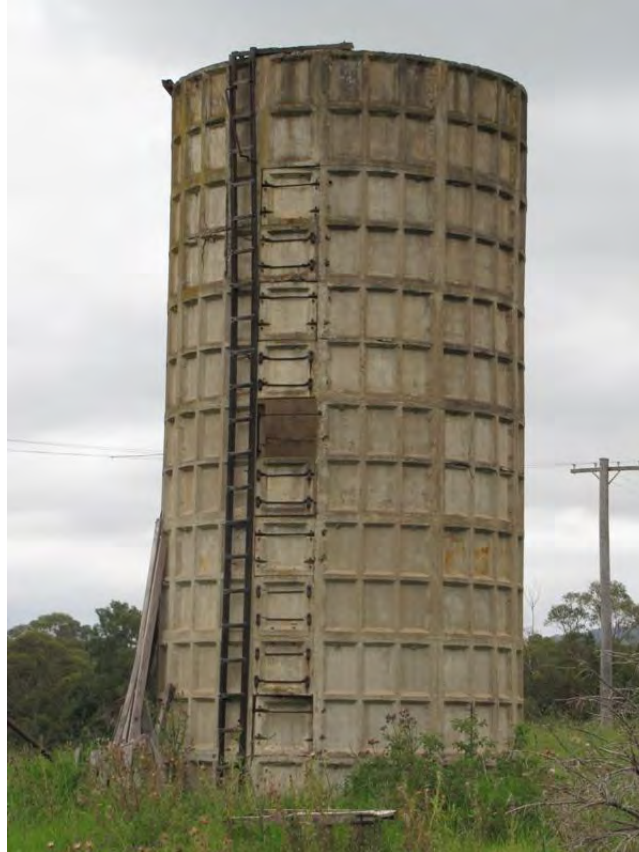
Figure 49 Modular silo imported from England associated with house and dairy

This property could not be accessed during field survey and this description is taken from HLA 2006. Buildings include an original cottage, stable foundations, silo and remnant outbuildings associated with the operation of a dairy. The silo was imported from England.

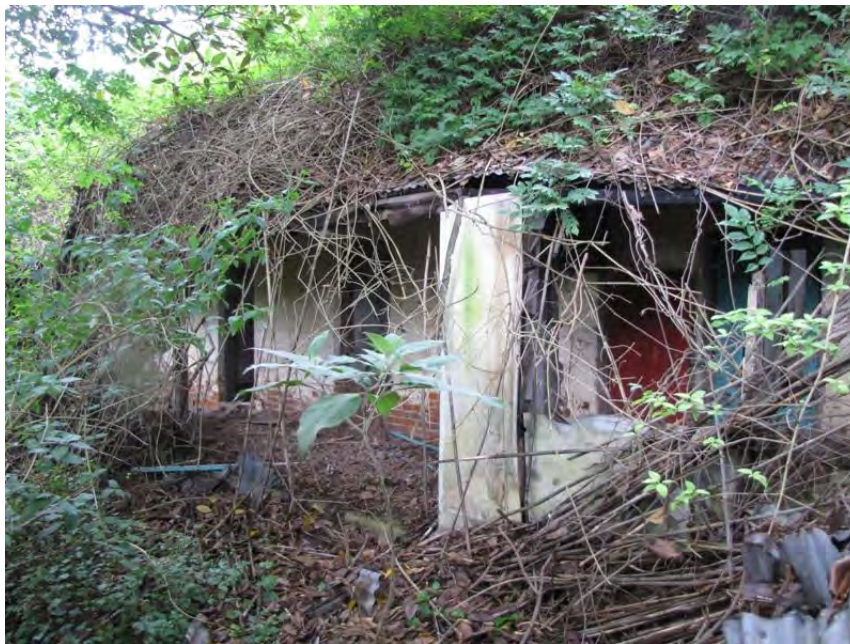
Figure 50 Cleveland House, front elevation. View south east

The field inspection conducted in February 2011 revealed that the structure is not well maintained and is in a state of disrepair. The homestead is collapsing and is covered in lantana. A GPS line had to be taken across the front of curtilage as the vegetation was too dense to get all the way around. There is a partial avenue of trees (poplars?) on the road out between the creek and Cleveland Road. These trees are a part of the landscape and it is recommended that they are not impacted. To the north of the house are located 2 massive Moreton Bay Fig trees, and Byna Pines are also evident. A single line of Coral trees and an isolated palm tree occur along the southern side of Cleveland Road. It is advised that impacts to these trees are also avoided.

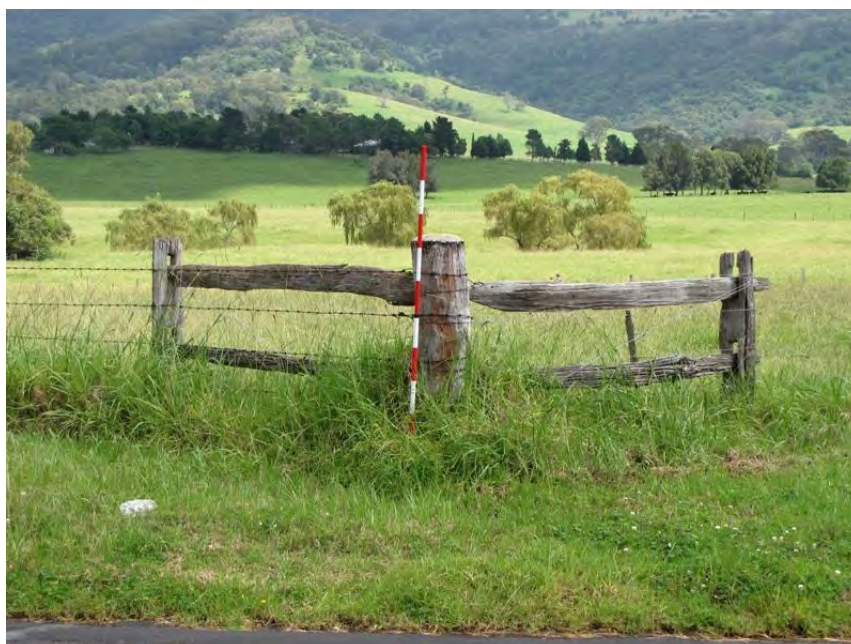
Figure 54 Fence Corner

The item consists of a thick corner strainer with metal cap, supported by an angled treated pine post. There is a single post with 2 rails in each direction. It is a small section of early post and rail fencing remaining from a previous extensive property boundary.

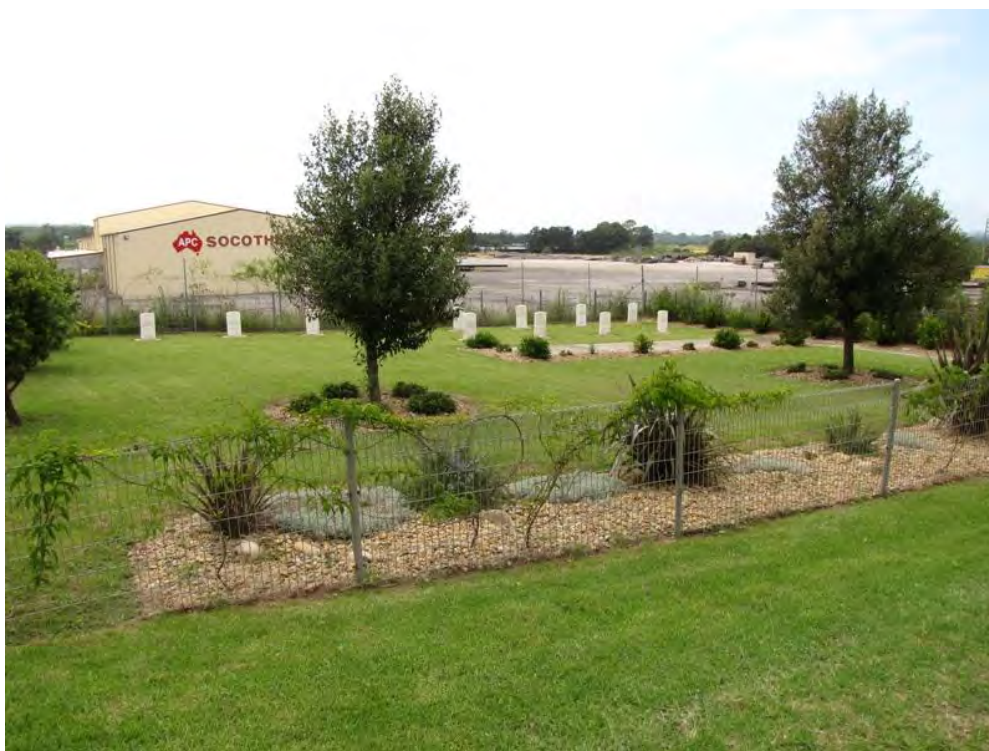
Figure 57 Kembla Grange War Cemetery, view east

The Kembla Grange War Cemetery occupies a square of land located on a right angle in Reddalls Road. It consists of twelve engraved, white marble headstones set out in two rows and positioned at the rear of the fenced area. There are eight graves present in the back row, and four in the front. The graves are oriented east – west, and face west. The remainder of the area is grassed and landscaped, and a concrete path extends from the front access gate to a central platform, which is most likely used for commemoration ceremonies. A small garden surrounds the site boundary and the southern border of the property is lined with hibiscus. The cemetery contains the graves of 11 Australian Army personnel and one Royal Australian Navy seaman, most of who were killed in training accidents during World War 2. It is an official war cemetery.

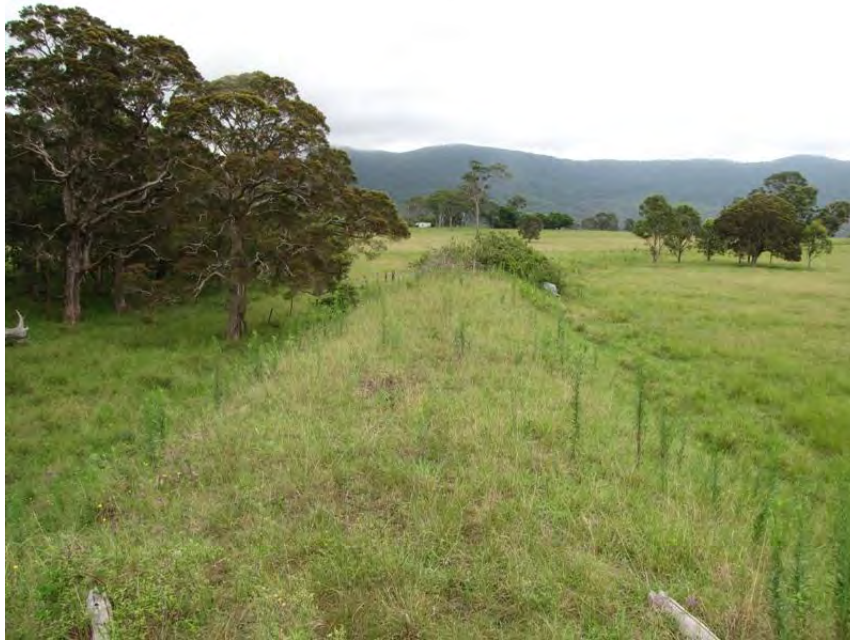
Figure 59 Tramway embankment, south east of Bong Bong Road. View west.

built across a former cutting. The Tramway curves to south south east before running almost due east until it intersects with the Princes Highway. At the Bong Bong Road end the Tramway is visible as a cutting. At the point where the line turns eastwards the Tramway is on an embankment of variable height to raise it above the swampy ground. Towards the eastern end the embankment becomes less visible. During field survey Wollongong Council were undertaking works ahead of a subdivision and had cut through the embankment. There was no stratigraphic evidence of the construction of the embankment.

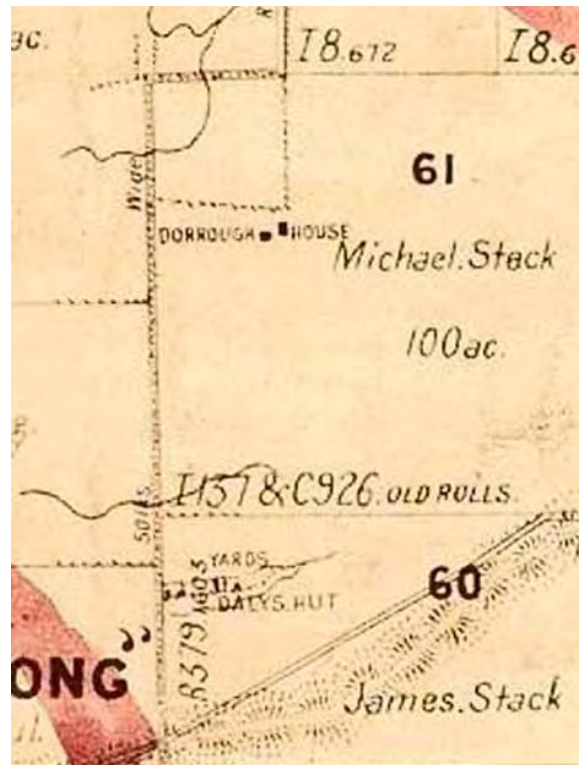
Figure 61 1889 Kembla Parish Plan showing Hayes Lane near the intersection with Bong Bong Road.
Department of Lands

The 1889 Parish Plan indicates that there was a hut and yards near the junction of Hayes Lane and Bong Bong Road (Figure 61). The Plan attributes ownership of the structures to the Daly family.

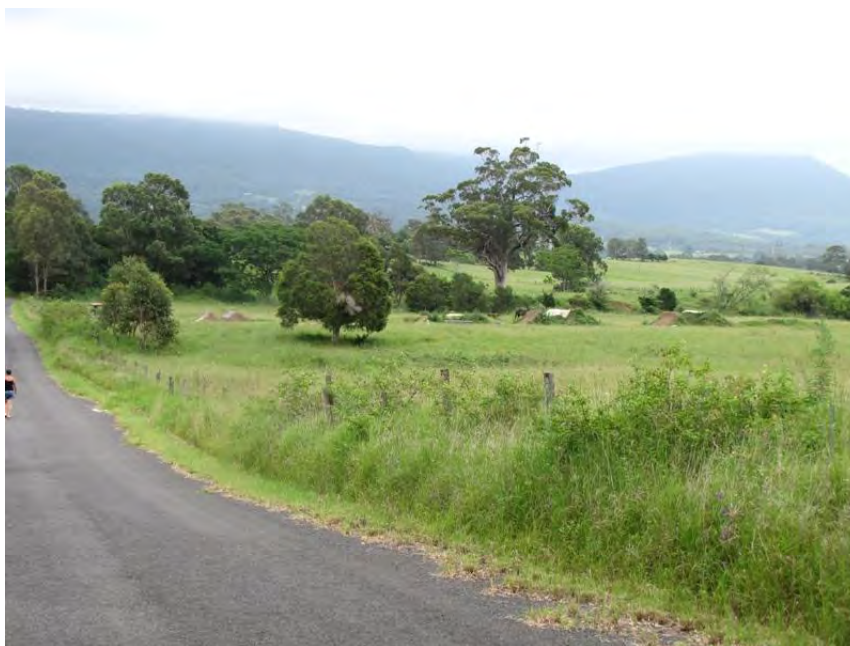
Figure 63 Bike Ramp (189)

Treated timber and steel bike ramp and earth mounds. The ramp is decorated with flames cut from plastic sheeting.
