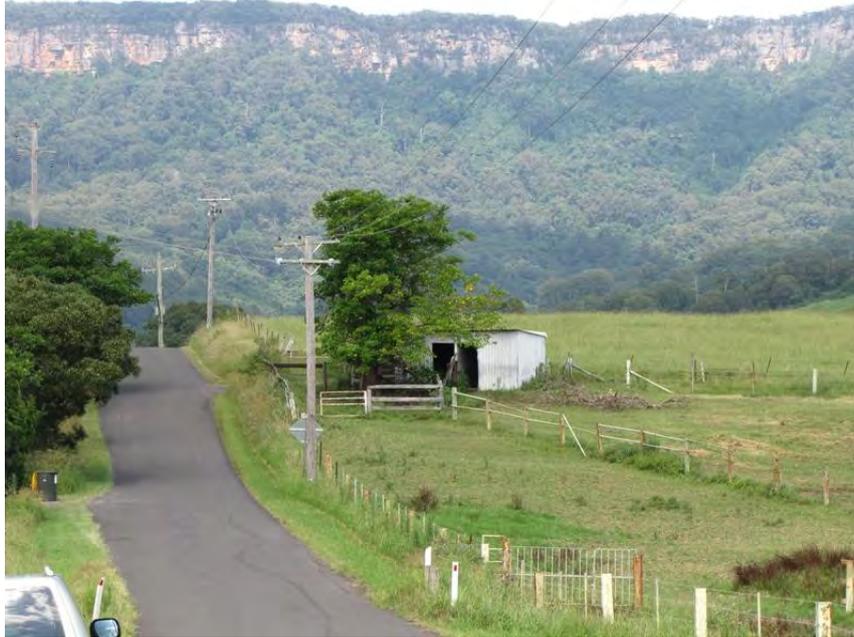
Figure 65 Shed - Potential (194)

This item does not meet the significance threshold.

IMPACT AND RECOMMENDATIONS	
Impact	A water and wastewater pipeline is proposed to run along Cleveland Road. It may require the removal of the shed.
Recommendations	The shed is not of heritage significance and does not pose an impediment on heritage grounds.

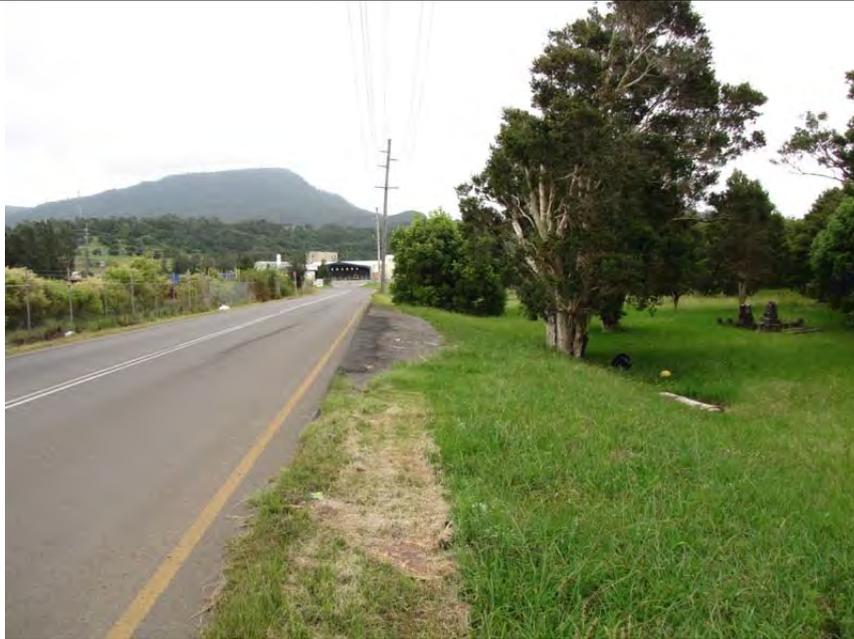
Image caption	View north of Settlers Cemetery showing road embankment.				
Image year	2011	Image by	Iain Stuart	Image copyright holder	AECOM

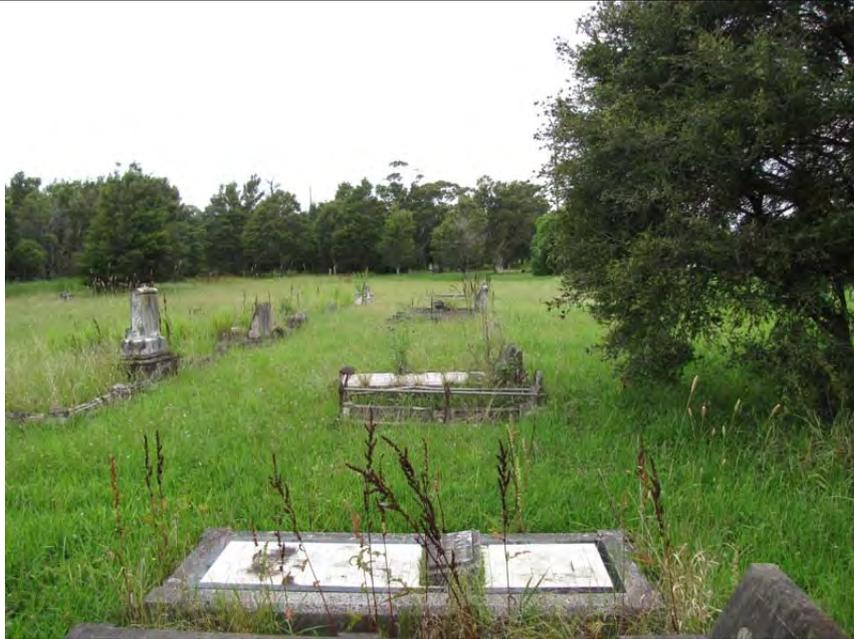
Image caption	View south of Settlers Cemetery showing typical grave markers and layout of cemetery.				
Image year	2011	Image by	Iain Stuart	Image copyright holder	AECOM

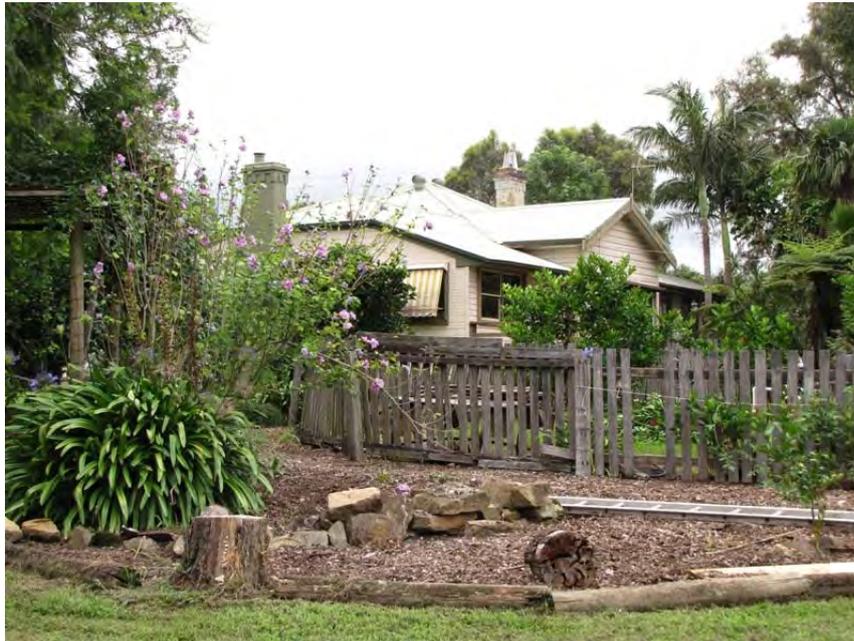
DESCRIPTION							
Designer	NA						
Builder/ maker	NA						
Physical Description	"Glen Ayr" homestead is of local significance for its representative and rarity values. It is a simple inter-war period bungalow, uncommon of this period in the region. It is a good example of an early twentieth century farmhouse associated with dairying in the Dapto region, which was a significant industry in the development and history of the area.						
Physical condition and Archaeological potential	'Glen Ayre' is in good physical condition and possesses moderate archaeological potential.						
Construction years	Start year	1922	Finish year			Circa	<input checked="" type="checkbox"/>
Modifications and dates	NA						
Further comments

Image caption	Glen Ayr house, view south south west				
Image year	2011	Image by	Iain Stuart	Image copyright holder	AECOM

Impact	A wastewater pipeline is proposed to be constructed between a creek and the homestead building on the western side of the site. Based on the plans it seems the pipeline would be about 10m west of the homestead and outbuildings. The heritage item may be subject indirect impacts from construction.
Recommendations	Vibration impacts to Glen Ayr are anticipated. The impacts will be managed in accordance with the German Standard DIN 4150: Part 3 - 1986.

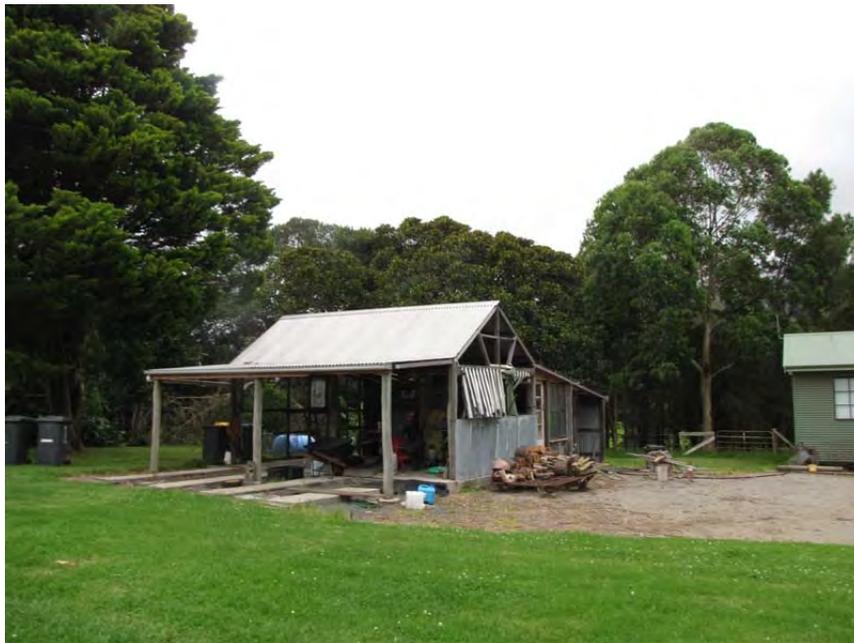
Image caption	Glen Ayr outbuildings – these structures are the closest to the proposed pipeline route. View north north west.				
Image year	2011	Image by	Iain Stuart	Image copyright holder	AECOM

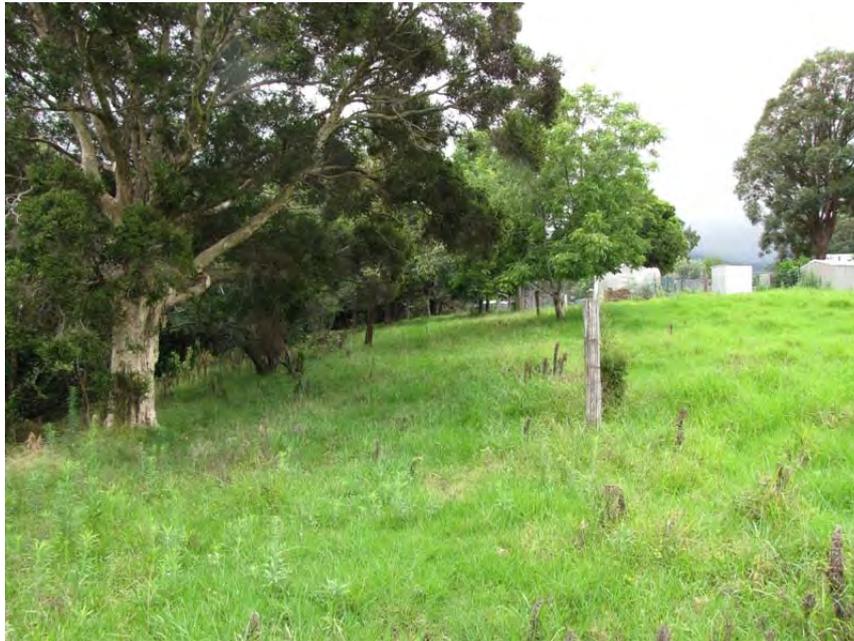
Image caption	Rear of Glen Ayr indicating approximate pipeline route. View north				
Image year	2011	Image by	Iain Stuart	Image copyright holder	AECOM

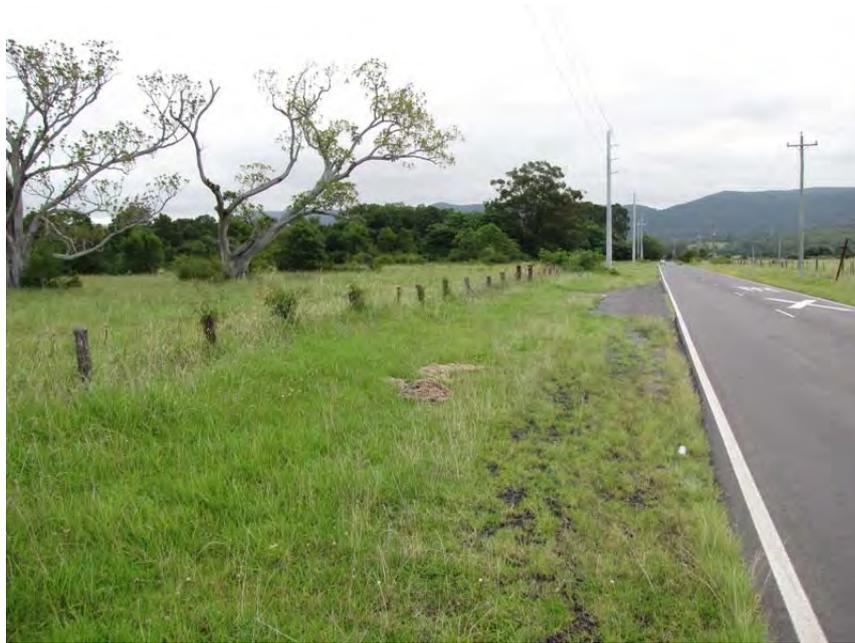
DESCRIPTION						
Designer	NA					
Builder/ maker	NA					
Physical Description	<p>Two adjacent Moreton Bay Figs (<i>Ficus macrophylla</i> var <i>hillii</i>) situated in a cleared paddock. The specimens are parallel to a significant section of early timber and wire fencing. Both trees are in a poor condition, they are possibly nearing the end of their lifespan. Their branches are rotting and they have only sparse foliage. There is no evidence of associated cultural activity. One tree is approximately 23m from the property fence, and it is approximately 7m from the edge of the sealed road to the boundary fence. The canopy of the tree is 5m from the boundary fence.</p>					
Physical condition and Archaeological potential	<p style="color: blue;">These trees are in poor physical condition, they are possibly nearing the end of their lifespan. Due to the limited ground visibility during the survey further investigation is required to determine whether evidence remains of the public house..</p>

Image caption	View of fig trees, west				
Image year	2011	Image by	Iain Stuart	Image copyright holder	AECOM

Impacts	A water pipeline is proposed to be constructed along West Dapto Road in this area. It is possible that construction work may impact on Site 17a – the two figs by disturbing their roots or by requiring their removal.
Recommendations	<p>The trees themselves are not of heritage value, however, they do mark the potential site of New Archaeological Site 3 – Potential Remains of J Barretts Farm (184). It is therefore recommended that the area be avoided and the pipelines located within the road reserve. If this is not practicable the following management is recommended:</p> <ul style="list-style-type: none"> ○ Align pipes 15 m from the fig tree trunks. If this is not possible it is recommended an arborist is consulted regarding the health of the trees and the best way to proceed; ○ Develop a clearer understanding of the archaeological potential of the site by undertaking the following: <ul style="list-style-type: none"> ○ Vegetation removal to allow for a more detailed visual inspection ○ A remote sensing survey along the route to identify the possibility of sub-surface remains of the buildings being located during construction ○ Development of appropriate management options (likely to be either test excavation prior to construction, archaeological monitoring during construction or no further archaeological work)

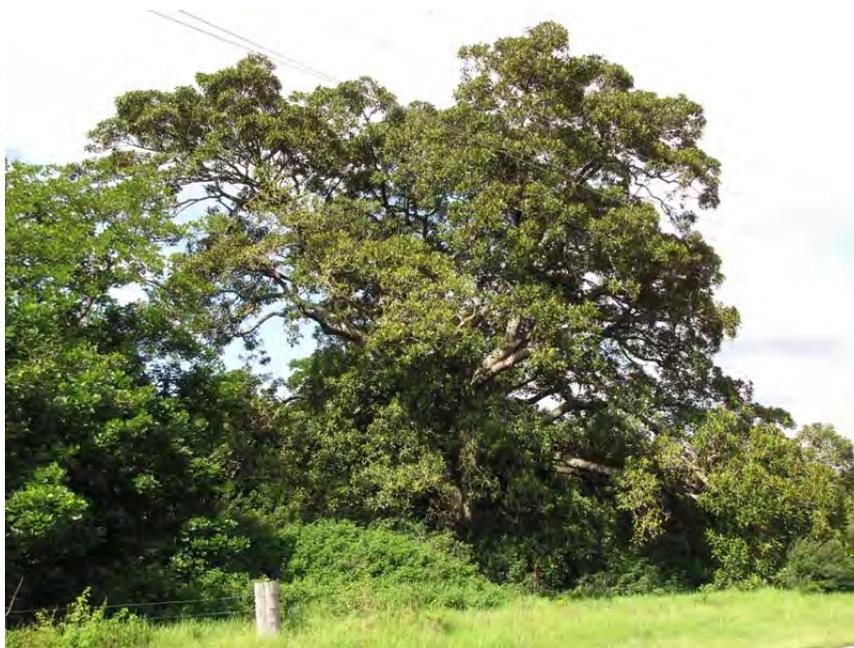
DESCRIPTION							
Designer	NA						
Builder/ maker	NA						
Physical Description	Large, mature, flourishing Moreton Bay Fig surrounded by dense vegetation. AMBS name – Moreton Bay Fig – West Dapto Road – adjacent to Dapto Creek. Trunk 15m from boundary fence. Canopy touches boundary fence and road corner.						
Physical condition and Archaeological potential	The Moreton Bay Fig tree is in excellent physical condition. There is moderate to high potential for archaeological deposits associated with the cottage indicated on the 1889 Kembla Parish Map to be in the vicinity.						
Construction years	Start year	NA	Finish year	NA	Circa	<input type="checkbox"/>	
Modifications and dates	NA						
Further comments	NA

Image caption	Moreton Bay fig tree				
Image year	2011	Image by	Iain Stuart	Image copyright holder	AECOM

Impact	It is possible that construction work may have an impact on Moreton Bay Fig (17b) by disturbing its roots or by requiring its removal. Root disturbance may lead to a reduction in the lifespan of the tree. The death or removal of the tree will obliterate the Fig's heritage significance.
Recommendations	<p>The tree is of local significance and listed on the 2010 Wollongong LEP. It is therefore recommended that impact be avoided. The tree also marks the potential site of New Archaeological Site 4 – Cottage (185). It is therefore, on this second count, recommended that the area be avoided and the pipelines located within the road reserve. If this is not practicable the following management is recommended:</p> <ul style="list-style-type: none"> • Align pipes 10 m from the fig tree canopy. If this is not possible it is recommended an arborist is consulted regarding the health of the trees and the best way to proceed; • Develop a clearer understanding of the archaeological potential of the site by undertaking the following: <ul style="list-style-type: none"> ○ Vegetation removal to allow for a more detailed visual inspection ○ A remote sensing survey along the route to identify the possibility of sub-surface remains of the buildings being located during construction ○ Development of appropriate management options (likely to be either test excavation prior to construction, archaeological monitoring during construction or no further archaeological work).

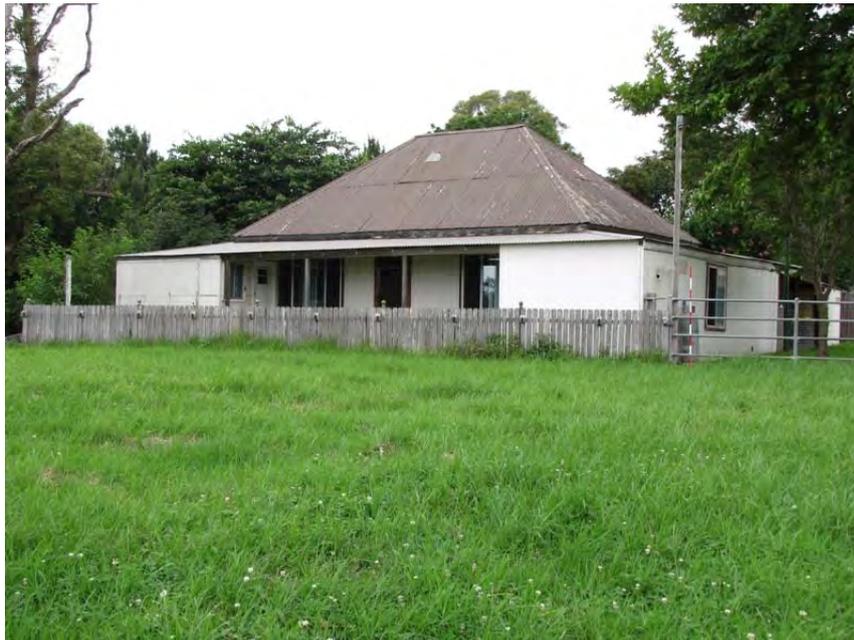
Physical condition and Archaeological potential	This item is in a reasonably good physical condition and has a moderate level of archaeological potential.						
Construction years	Start year				Finish year		
					Circa	<input type="checkbox"/>	
Modifications and dates	Several, but particulars unspecified.

Image caption	Brisbane Grove House – front elevation. View south west				
Image year	2011	Image by	Iain Stuart	Image copyright holder	AECOM

Impacts	<p>Water pipeline and Wastewater pipe are proposed to be constructed along West Dapto road however the older and heritage listed buildings are over 70m from the boundary so the construction of these items will have no impact on heritage.</p> <p>A Wastewater pipeline is proposed to branch from West Dapto Road and run along the western side of the buildings. Construction of this will result in the demolition of some farm buildings including the old dairy buildings. The original homestead will be just within 25m of the wastewater pipeline route.</p>
Recommendations	<p>The first and preferred option is to move the wastewater pipeline 25m to the north west (parallel to its current proposed route) to avoid impacts on the farm outbuildings.</p> <p>If the outbuildings are to be demolished then they are of sufficient heritage significance to justify an archival recording being made of the building using the guidelines How to prepare Archival Recording of Heritage Items issued by the New South Wales Heritage Office in 1998. The requirements for items of Local Significance and for items involving Industrial Archaeological Evidence should be followed.</p> <p>Vibration impacts to Brisbane Grove are anticipated. The impacts will be managed in accordance with the German Standard DIN 4150: Part 3 - 1986.</p>

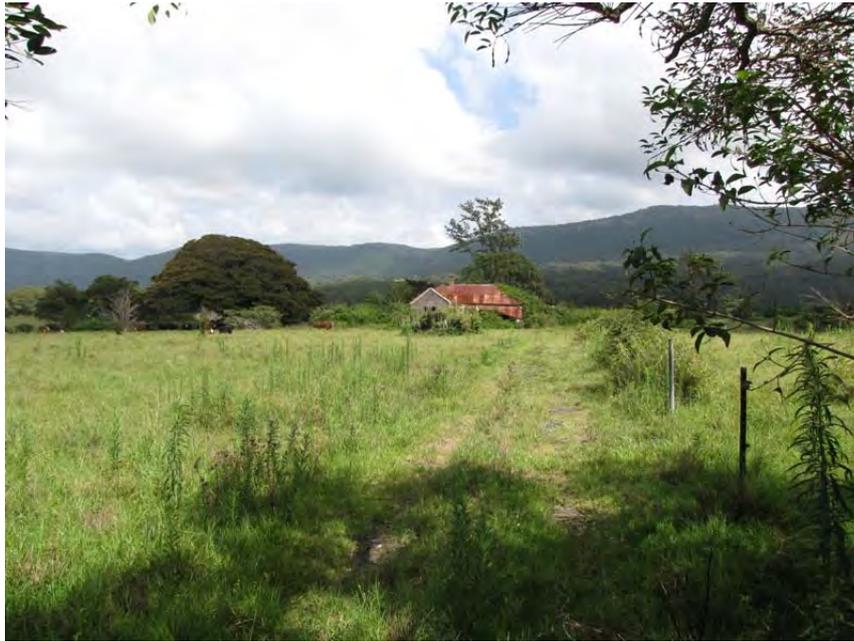
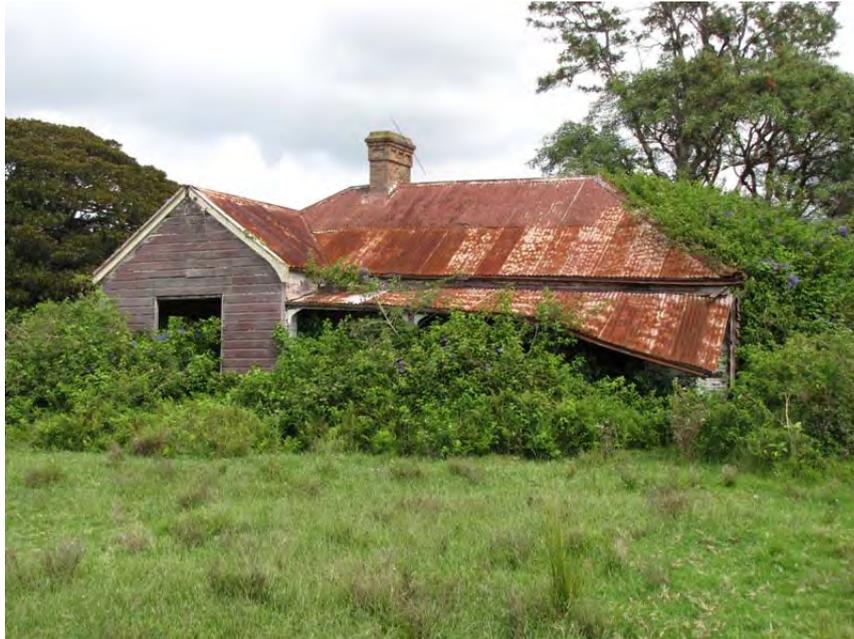
DESCRIPTION							
Designer	NA						
Builder/ maker	NA						
Physical Description	<p>The site comprises a derelict homestead, remnant gardens and outbuildings. The house is situated at road level approximately 50-60 m from West Dapto Road. The house is an L shaped, single storey weatherboard house with a corrugated iron hipped roof and front verandah. The homestead has five main rooms and although deteriorating, has original features including timber architrave, decorative pressed ceilings, timber panelled doors and brick fireplaces and chimneys (indicative of c. 1880s). The homestead is surrounded by dense lantana and rubbish, however there is evidence of a previous garden containing small shrubs, geranium plantings and a Flame Tree. A mature Moreton Bay Fig Tree is situated to the north of the homestead.</p> <p>There are several small iron and timber sheds, a container from a truck, two water tanks and a garage amongst the overgrown lantana. Of note is a large timber shed containing an extensive line of intact original timber feed troughs and pens, most likely relating to a former piggery. A Telstra service cable is just within the property boundary, disturbing the archaeology.</p>

Physical condition and Archaeological potential	This item is in poor to fair condition and possesses moderate archaeological potential.						
Construction years	Start year			Finish year			Circa <input type="checkbox"/>
Modifications and dates	NA

Image caption	House (19), view west showing distance from road				
Image year	2011	Image by	Iain Stuart	Image copyright holder	AECOM

IMPACT AND RECOMMENDATIONS	
Impact	Will not be impacted as is well beyond 25m from the property boundary on West Dapto Road
Recommendations

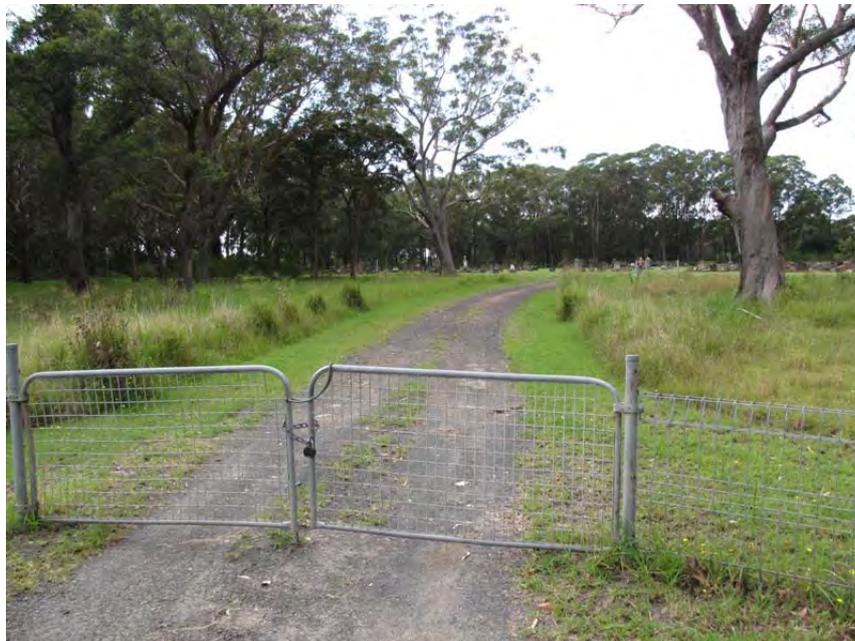
Image caption	Entrance gate to the cemetery				
Image year	2011	Image by	Iain Stuart	Image copyright holder	AECOM

Impact	None
Recommendations	Despite no heritage impacts being identified it is recommended that Sydney Water undertake specific consultation with the Catholic community to explain the project and to assure the community that there will be no heritage impacts on the Cemetery.

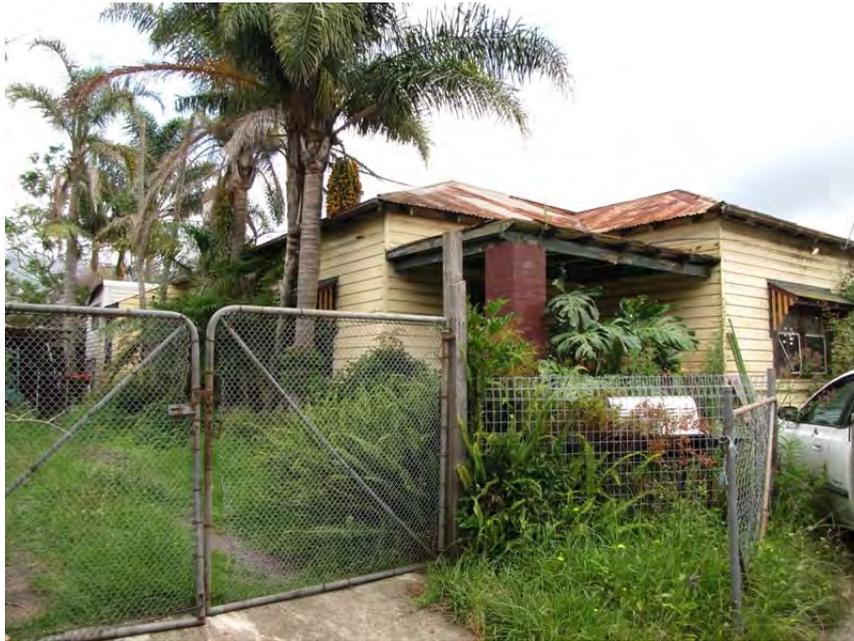
Image caption	206 West Dapto Road, front elevation, view north north west				
Image year	2011	Image by	Iain Stuart	Image copyright holder	AECOM

RECOMMENDATIONS	
Impact	<p>A Water pipeline is proposed to be construction along West Dapto Road. Depending on how the water pipeline is to cross Dapto Creek and on which side of Dapto Road it is constructed there will be either no impact or potentially a direct impact.</p> <p>If the pipeline is constructed the north-west side of West Dapto Road then potentially the house will be impacted by construction of the water pipeline. The tin shed fronting West Dapto Road will be impacted on.</p>
Recommendations	<p>First management option is to minimise the impact by ensuring that the water pipeline is located on the south eastern side of the road or is located within the current road reserve.</p> <p>If the house is to be demolished then it is of sufficient heritage significance to justify an archival recording be made of the building using the guidelines How to prepare Archival Recording of Heritage Items issued by the New South Wales Heritage Office in 1998. The requirements for items of Local Significance should be followed.</p> <p>The tin shed can be removed without any further recording.</p> <p>If the House is to remain, vibration impacts are anticipated. The impacts will be managed in accordance with the German Standard DIN 4150: Part 3 - 1986.</p>

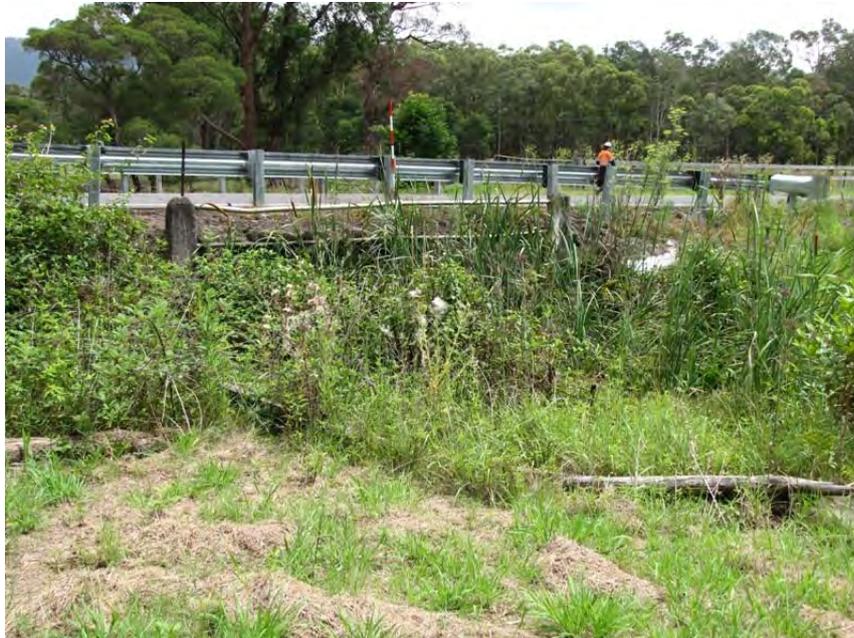
Image caption	Concrete Bridge at West Dapto				
Image year	2011	Image by	Iain Stuart	Image copyright holder	AECOM

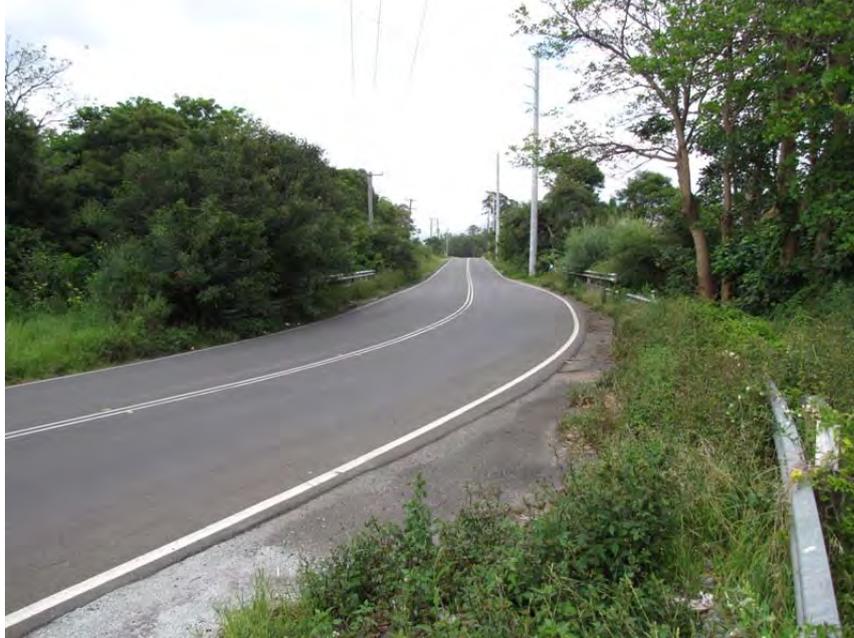
Image caption	Concrete bridge (22b), view south				
Image year	2011	Image by	Iain Stuart	Image copyright holder	AECOM

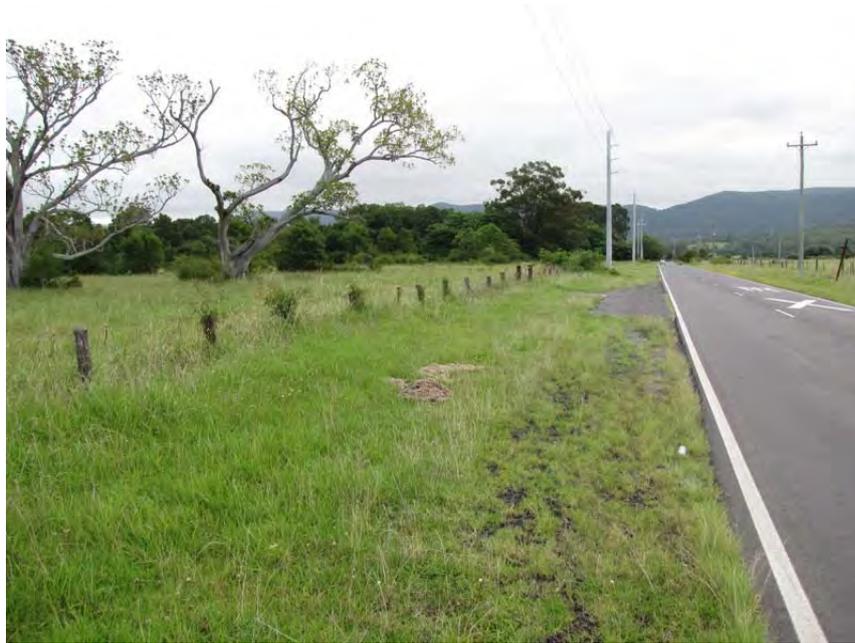
DESCRIPTION						
Designer	NA					
Builder/ maker	NA					
Physical Description	<p>This item consists of an extensive section of early remnant post and rail fencing located along West Dapto Road, running parallel to two significant mature fig trees. It was recorded by HLA as featuring a small section of early post and rail fencing which remains from a previous extensive property boundary. Intact morticed wooden fence posts with holes measuring approximately 20cm high by 10cm wide are present. Three rows of barbed wire replaces original timber rails. Some posts have been replaced with star pickets.</p> <p>A field inspection in February 2011 identified no immediate evidence of former rails from early post and rail fencing as recorded by HLA. The gate is marked as an access point for Integral Energy. The twin fig trees are also in poor condition.</p>					
Physical condition and Archaeological potential	This item is in poor physical condition and possesses limited archaeological potential.

Image caption	Fence, view west				
Image year	2011	Image by	Iain Stuart	Image copyright holder	AECOM

Impact	A water pipeline is proposed to be constructed along West Dapto Road in this area. It is possible that construction work may require the removal of the fence
Recommendations	The fence is no impediment on heritage grounds. No management is required

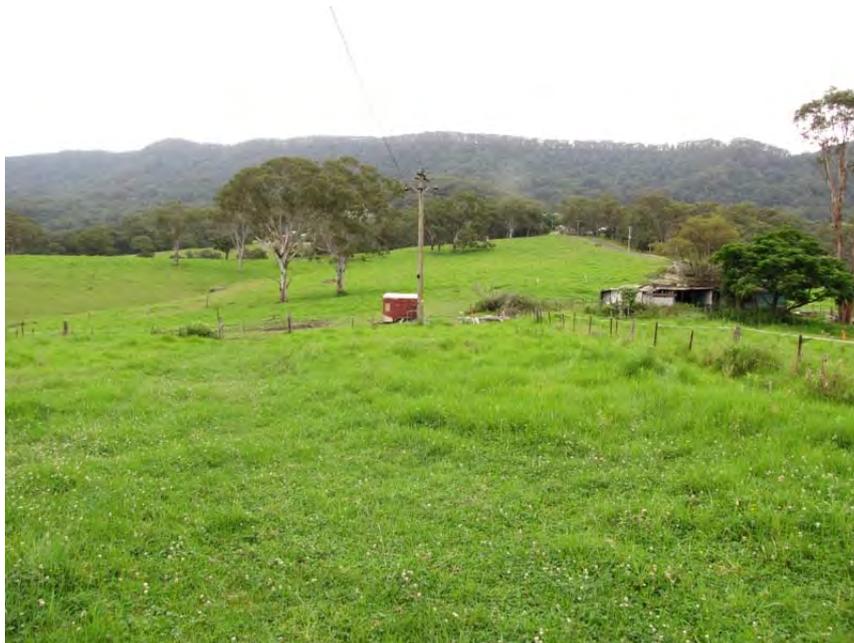
Image caption	Coral Vale Kitchen , view west. Pipeline is proposed to run in the vicinity of the two gum trees visible in the centre left of the image				
Image year	2011	Image by	Iain Stuart	Image copyright holder	AECOM

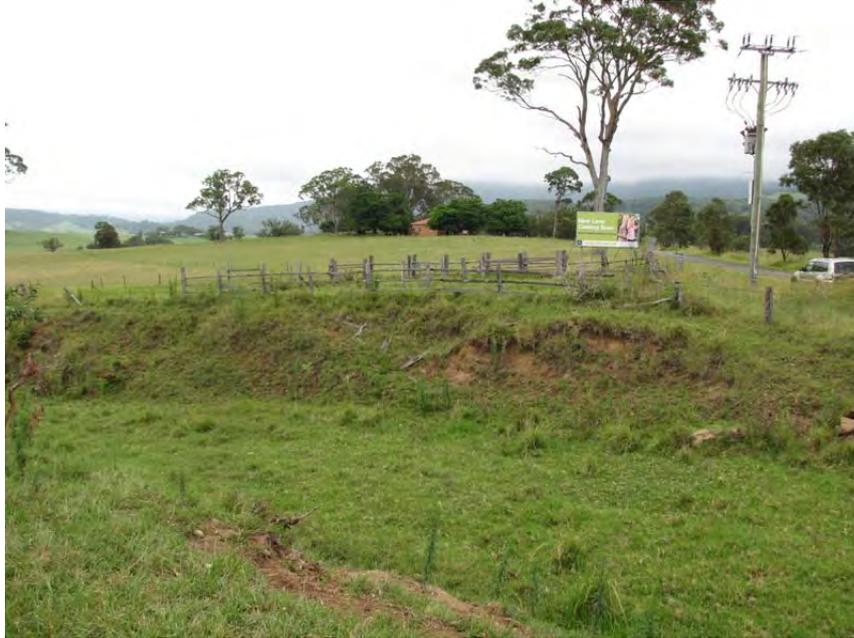
Image caption	Stockyard, view west. Note tramway cutting in foreground				
Image year	2011	Image by	Iain Stuart	Image copyright holder	AECOM

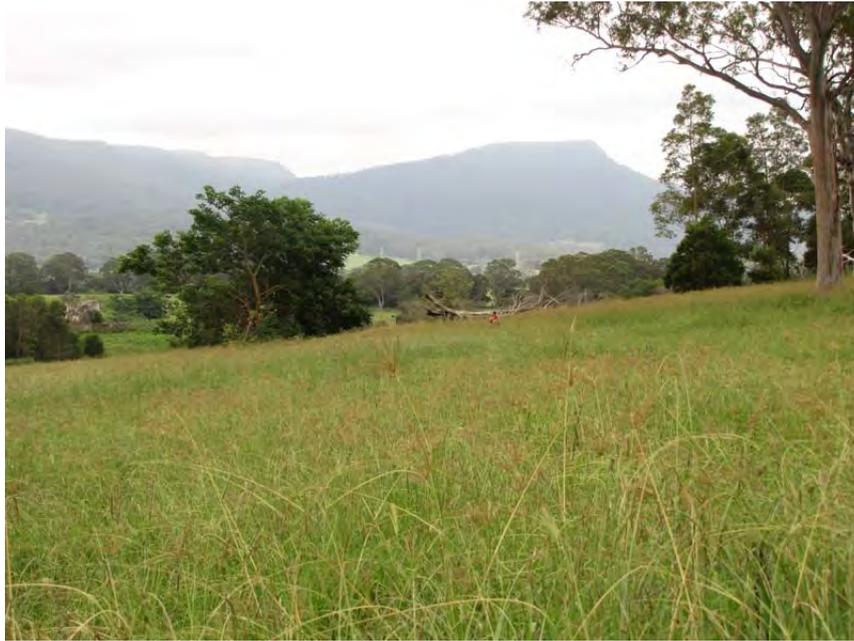
Image caption	Approximate route of pipeline adjacent to house and dairy.				
Image year	2011	Image by	Iain Stuart	Image copyright holder	AECOM

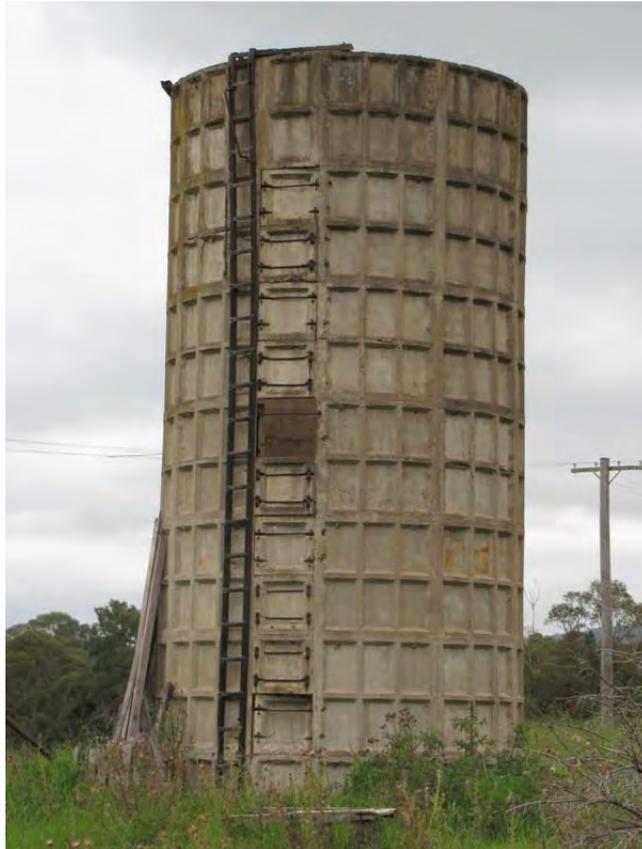
Image caption	Modular silo imported from England associated with house and dairy.				
Image year	2011	Image by	Iain Stuart	Image copyright holder	AECOM

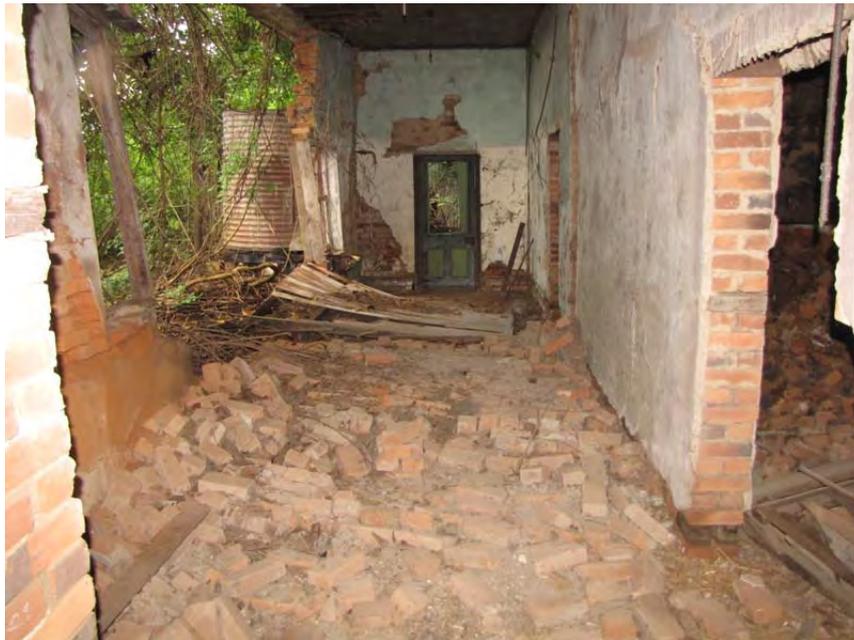
Image caption	Cleveland House (47), internal view of easternmost room showing state of disrepair. View south.				
Image year	2011	Image by	Iain Stuart	Image copyright holder	AECOM

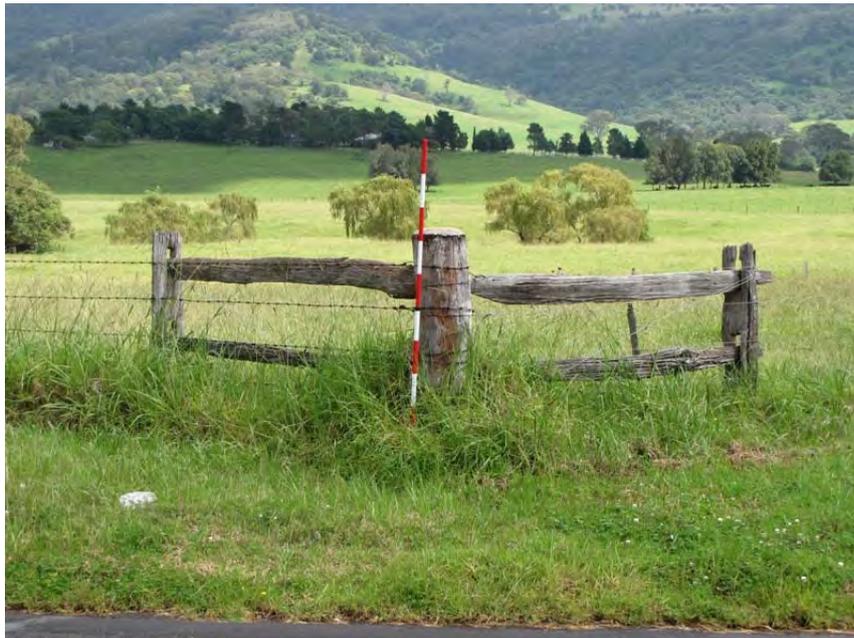
DESCRIPTION									
Designer	NA								
Builder/ maker	NA								
Physical Description	The item consists of a thick corner strainer with metal cap, supported by an angled treated pine post. There is a single post with 2 rails in each direction. It is a small section of early post and rail fencing remaining from a previous extensive property boundary.								
Physical condition and Archaeological potential	The item is in poor to fair physical condition and is of limited archaeological potential.								
Construction years	Start year				Finish year			Circa	<input type="checkbox"/>
Modifications and dates	NA								
Further comments	The item is not on the corner of Cleveland Road as stated by HLA. Item within the Project Approval Area.

Image caption	Fence corner				
Image year	2011	Image by	Iain Stuart	Image copyright holder	AECOM

IMPACT AND RECOMMENDATIONS	
Impact	It is proposed that a Water pipeline will be constructed along South Avondale Road
Recommendations	The site is not of historical significance and does not require heritage management

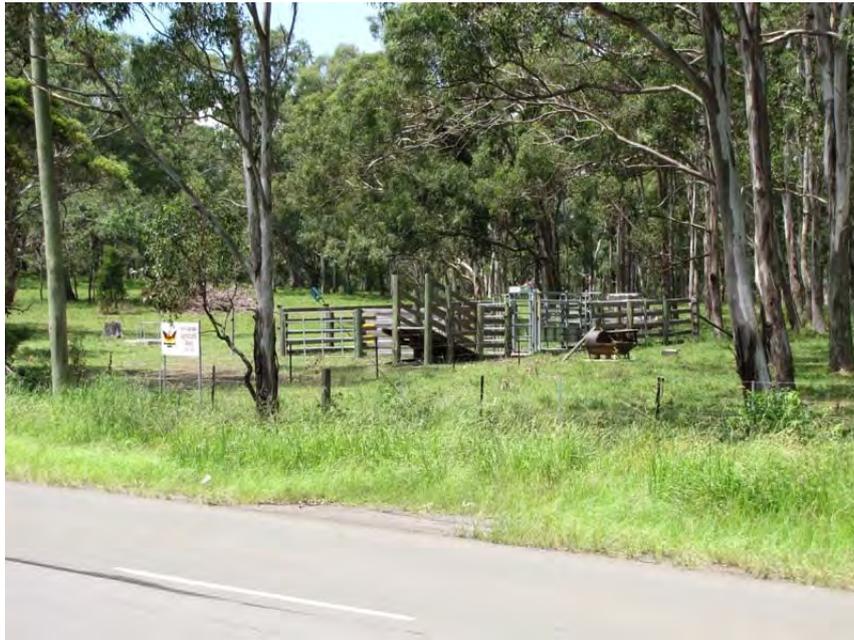
DESCRIPTION							
Designer	NA						
Builder/ maker	NA						
Physical Description	HLA recorded a stockyard in this location as being constructed of bush timbers. During the AECOM field survey such an item could not be located, however a modern stockyard was at the same location. This site has been removed and replaced by a treated pine and metal stockyard. The current stockyard does not hold historical significance.						
Physical condition and Archaeological potential							
Construction years	Start year			Finish year			Circa <input type="checkbox"/>
Modifications and dates	NA

Image caption	Stockyard, view south south west				
Image year	2011	Image by	Iain Stuart	Image copyright holder	AECOM

Impact	No impact on stockyard is anticipated as it is set back further than 25 m from the boundary fence.
Recommendations	The site is not of historical significance and does not require heritage management

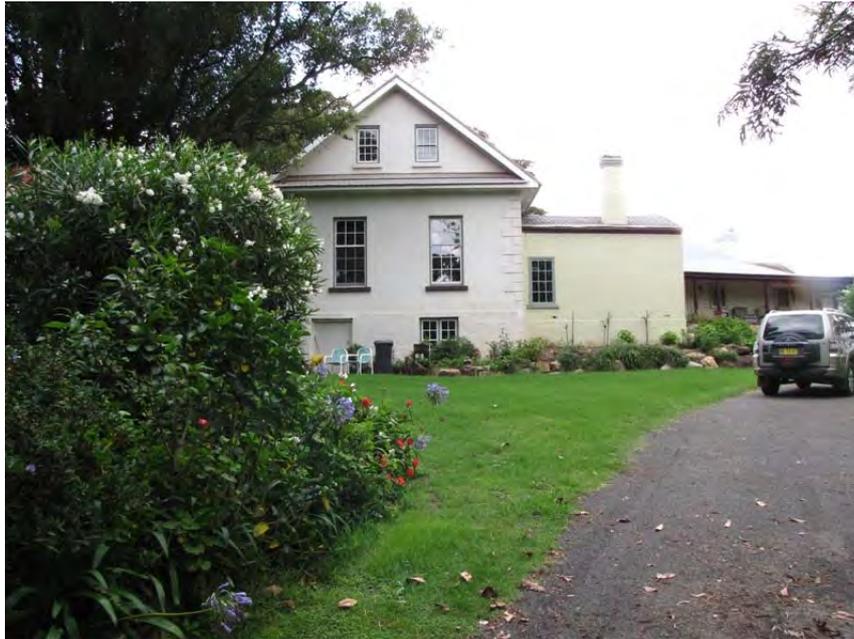
DESCRIPTION							
Designer	NA						
Builder/ maker	NA						
Physical Description	<p>"Marshall Mount" is a colonial style homestead which was constructed in two parts of rendered brickwork and weatherboard. The single storey was built c.1838; and the two-storey adjoining wing was subsequently erected in the 1840s and features a hall and cedar staircase. Other internal features of note include two imported Italian marble mantle pieces. The front elevation features French windows leading onto a stone paved verandah. This verandah has been replaced with modern tiles, however, the original sandstone pavers have been retained at the base of the entrance steps. The roof comprises grey tiles, which replace the original slate. A covered well is sited on the eastern elevation. A brick rendered barn is sited on the eastern elevation of the homestead and was constructed from bricks made on the property. The barn is rectangular with gable ends built by convict labour. The roof is timber framed and lined with corrugated iron sheeting. The building currently stores movable heritage items. Small sheds are 20th century inclusions. The garden retains its original setting, with a circular driveway, raised garden beds, and several ornamental Moreton Bay figs. There is remnant sandstone garden edging at the rear of the homestead. Significant views from the property have also been retained.</p> <p>There is a distance of 50m between the boundary and the homestead, and a steep road cutting forms a good curtilage along the road edge.</p>

Physical condition and Archaeological potential	This item is in very good physical condition and possesses good archaeological potential.						
Construction years	Start year	1838	Finish year			Circa	<input checked="" type="checkbox"/>
Modifications and dates	Two storey adjoining wing added to original single storey structure in the c.1840s.						
Further comments	NA

Image caption	Marshall Mount House front elevation. View east				
Image year	2011	Image by	Iain Stuart	Image copyright holder	AECOM

Impact	Water pipeline is planned to be constructed along Marshal Mount Road. If constructed along the south-east side of Marshal Mount Road there is the possibility of direct construction impacts on the gardens and one outbuilding.
Recommendations	Given the heritage significance of the buildings and gardens at "Marshall Mount" Homestead, Garden and Outbuildings, it is strongly recommended that the water pipeline be rerouted to avoid impact on these items. No direct impacts to the Homestead or Outbuildings are acceptable. It is recommended that impacts to the Garden be avoided, however, this may be difficult to achieve given the terrain at this location. It is also difficult to see how constructing a pipeline through the garden could be achieved without significant damage to the gardens. If it is necessary to put the pipeline through the garden it is recommended an arborist be consulted regarding the best way to proceed. Vibration impacts to Marshall Mount House and Outbuildings is anticipated, dependant on the final alignment. The impacts will be managed in accordance with the German Standard DIN 4150: Part 3 - 1986.

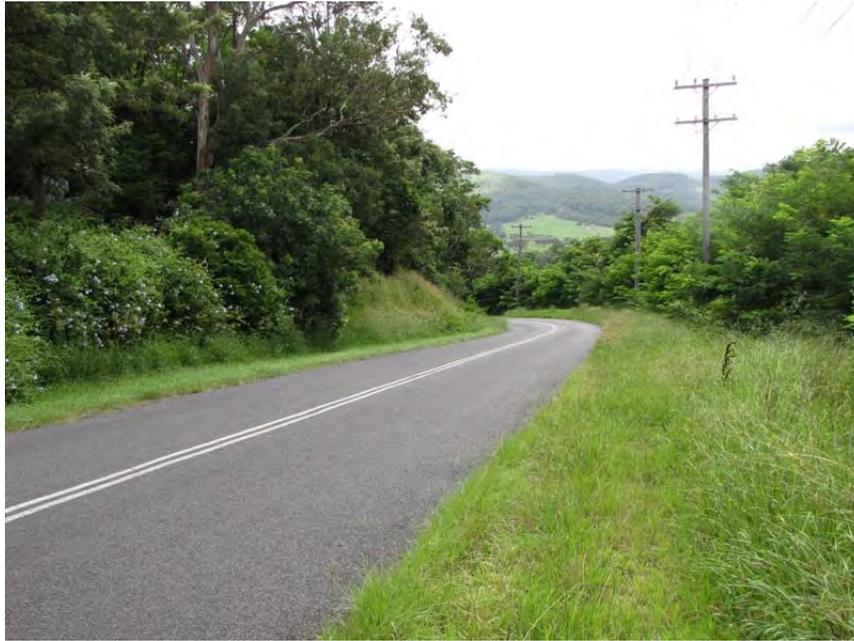
Image caption	Marshall Mount House from road. View south south east				
Image year	2011	Image by	Iain Stuart	Image copyright holder	AECOM

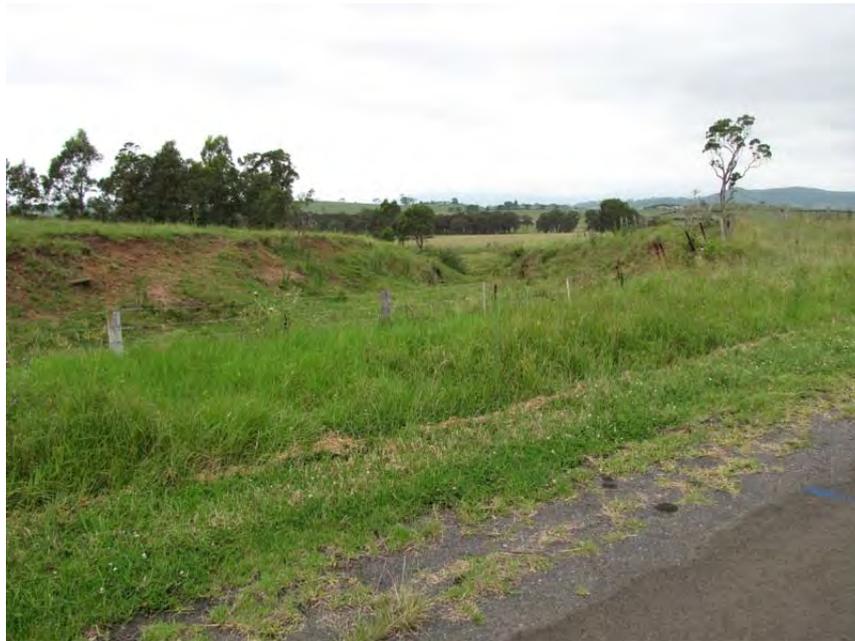
Image caption	Tramway cutting, view south from Bong Bong Road				
Image year	2011	Image by	Iain Stuart	Image copyright holder	AECOM

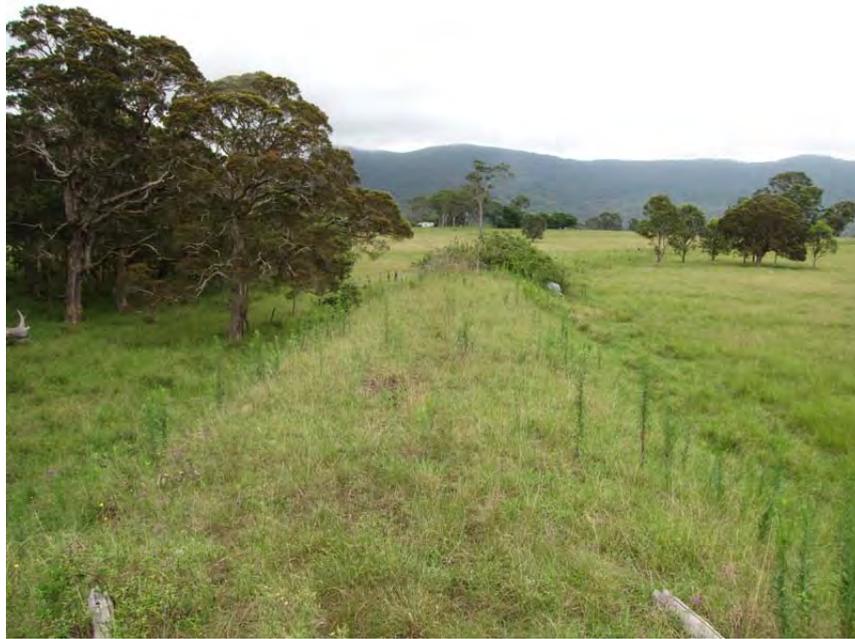
Image caption	Tramway embankment, south east of Bong Bong Road. View west.				
Image year	2011	Image by	Iain Stuart	Image copyright holder	AECOM

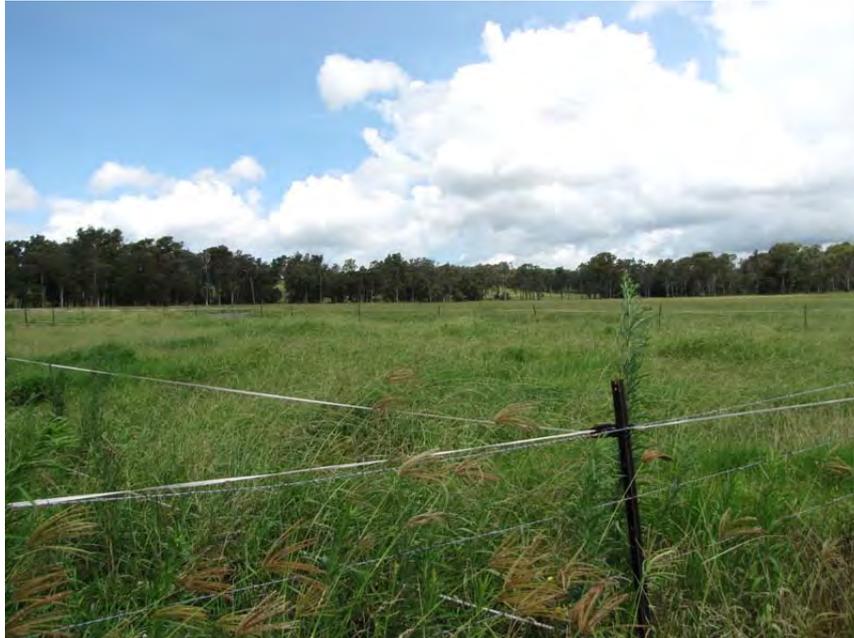
DESCRIPTION							
Designer	NA						
Builder/ maker	NA						
Physical Description	Yallah Brush is located on the corner of Marshall Mount and Yallah Roads. It is an area of lightly wooded grass paddocks. As far as could be ascertained during the field survey, there were no structures within the curtilage of heritage significance.						
Physical condition and Archaeological potential	This item is in good physical condition. It possesses limited archaeological potential.						
Construction years	Start year		Finish year		Circa	<input type="checkbox"/>	
Modifications and dates	NA

Image caption	Yallah Brush, as viewed from the corner of Marshall Mount and Yallah Roads. View south east				
Image year	2011	Image by	Iain Stuart	Image copyright holder	AECOM

Recommendations	The Bush is likely to be listed for its natural/environmental significance as a piece of remnant vegetation. Disturbing the ecosystem will therefore impact on the significance of the item. It is recommended that the pipeline be rerouted. If this is not practicable it is recommended that an ecologist assesses the pipeline route and provides mitigation/off-set recommendations.
-----------------	---
