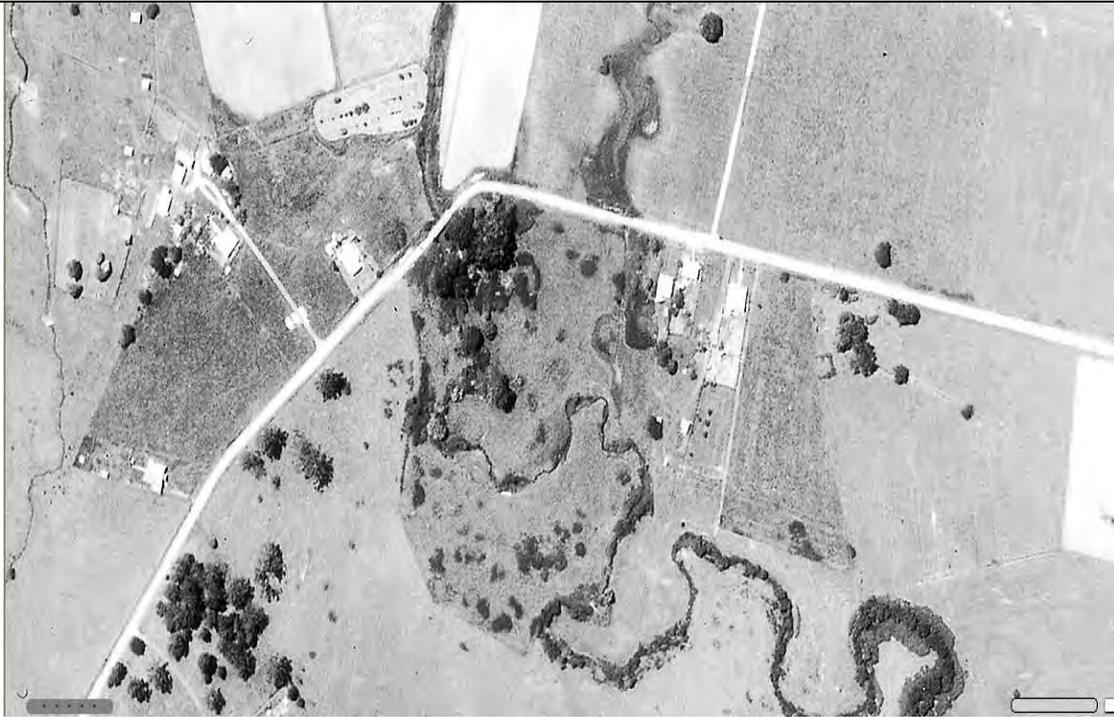
DESCRIPTION	
Designer	Unspecified
Builder/ maker	Unspecified
Physical Description	<p>There are a number of new sites located which have been dealt with as a group.</p> <p>In the course of resolving the issues about the Kembla Grange cemetery it was observed that the 2nd edition of the Parish map for Kembla had identified buildings along West Dapto Road. The 2nd edition of the Parish of Kembla map was compiled in early 1889 and the map was in use from 1889 till August 1891. As the details are lithographed on the base map they must date to early 1889. The plan shows an "Old Store", "Public House" and "Cottage" in the vicinity of West Dapto Road</p> <p>The 1927 Inch to Mile plan shows building in these locations but is not of sufficient resolution to be definitive. The 1951 Aerial was searched and clearly showed a farm in the area of "J Barrents Farm" with buildings located near the road. (See figure below)</p> <p>There is no evidence of any of these buildings on the ground or visible from current aerial images.</p> <p>New Site 1 Potential Remains of Store (182)</p> <p>This is the approximate location of a building labelled "Old Store" on the 1889 Parish Plan located on the northern side of West Dapto Road. Based on the overlay of maps and plans it is likely that some remains of the store, if they exist, would be within the 25m zone.</p> <p>There is no evidence of a building visible on the three high resolution images available on Nearmap. However, a</p>

Image caption	1951 aerial for a section of West Dapto Road. Department of Lands.				
Image year	1951	Image by		Image copyright holder	Department of Lands.

Impact	Water pipeline and Wastewater pipe are proposed to be constructed along West Dapto Road, which may impact on New Archaeological Sites 1-5.
Recommendations	<p>It is recommended that the area be avoided and the pipelines located within the road reserve. If this is not practicable the following management is recommended:</p> <ul style="list-style-type: none"> • Develop a clearer understanding of the archaeological potential of the site by undertaking the following: <ul style="list-style-type: none"> ○ Vegetation removal to allow for a more detailed visual inspection ○ A remote sensing survey along the route to identify the possibility of sub-surface remains of the buildings being located during construction ○ Development of appropriate management options (likely to be either test excavation prior to construction, archaeological monitoring during construction or no further archaeological work).

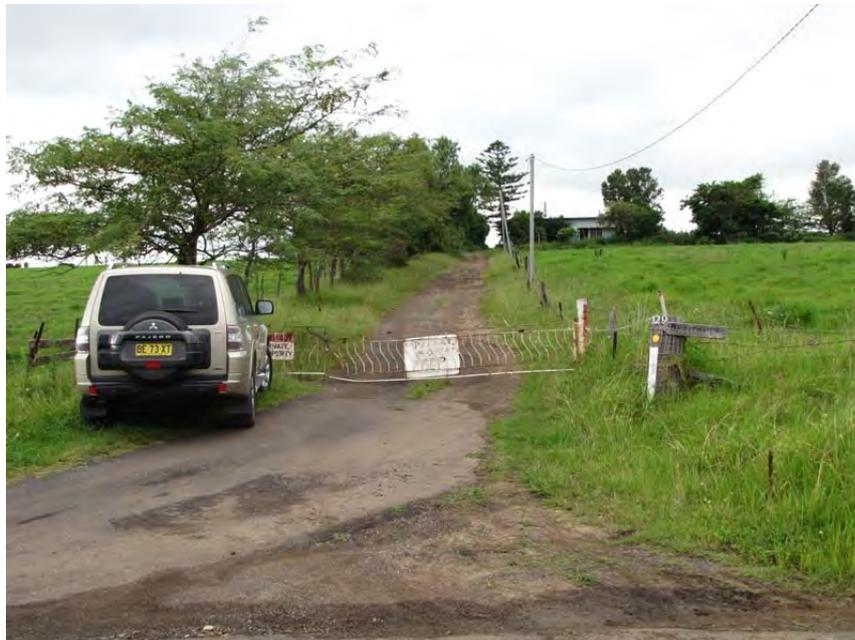
Image caption	Bridgewater property entry				
Image year	2011	Image by	Iain Stuart	Image copyright holder	AECOM

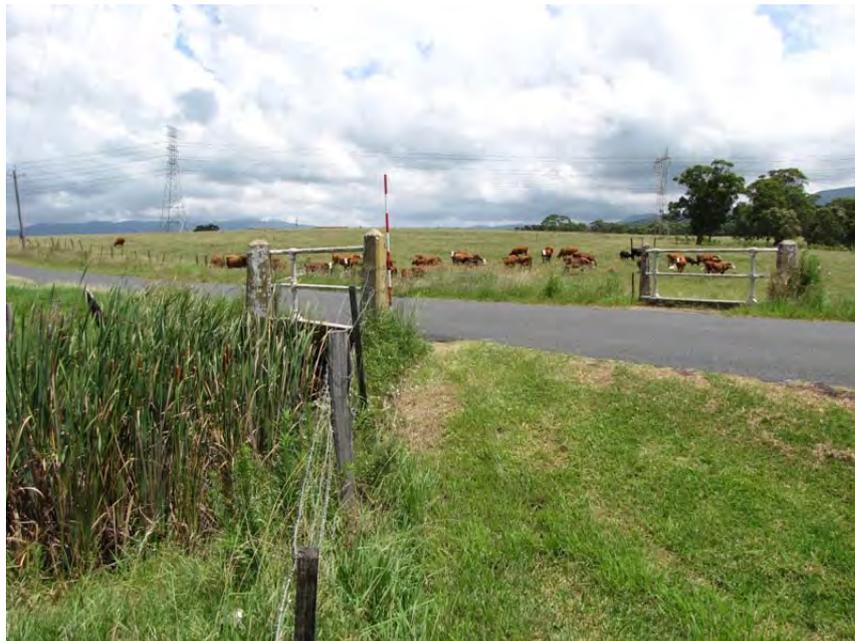
Image caption	One-Lane Bridge, view south south west				
Image year	2011	Image by	Iain Stuart	Image copyright holder	AECOM
