UNION FENOSA WIND AUSTRALIA

Crookwell 3 Wind Farm
Chapter 14

FLORA AND FAUNA IMPACTS

14 Flora and Fauna

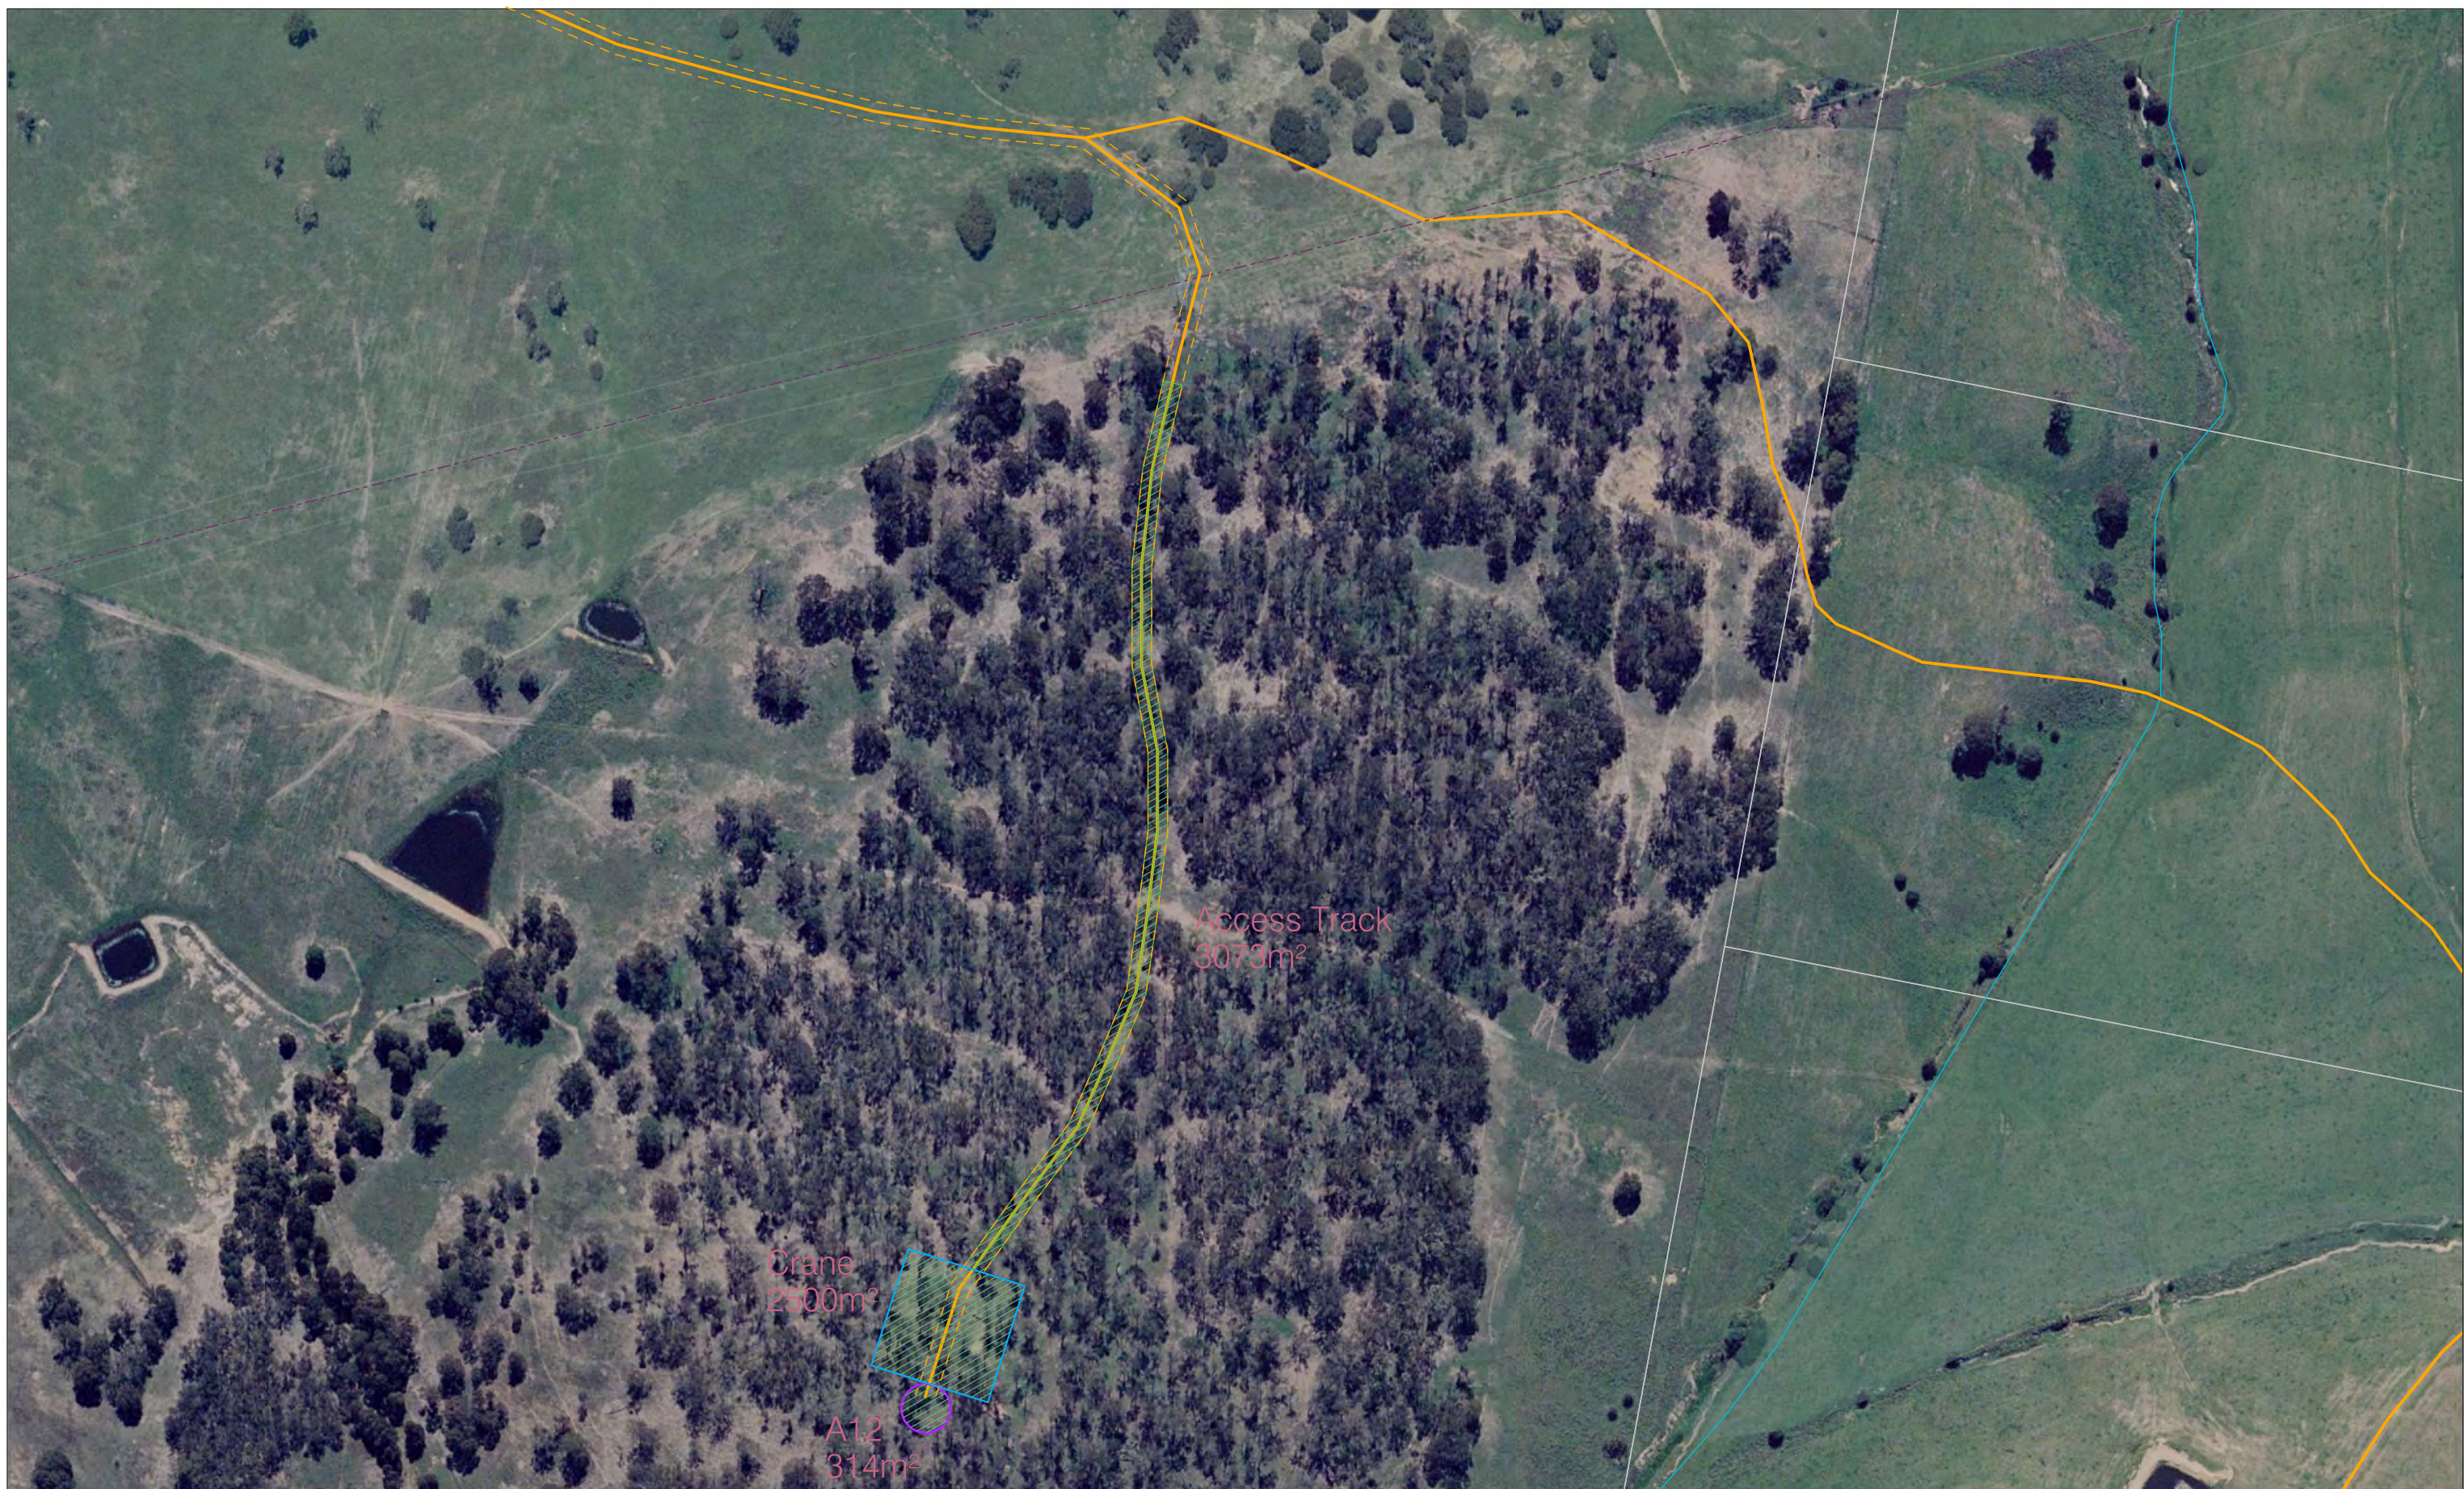
FIGURE 47 - VEGETATION REMOVAL PLAN - CROOKWELL EAST AREA 1

- Turbine A12 (314 sqm for each turbine location) with the addition of approximately 2,000 sqm for its access track, and up to 2,500 sqm for the temporary crane hard stand area (total removal of vegetation being 4,814 sqm). The removal of vegetation is within remnant E and illustrated in **Figure 47**.

Some vegetation removal is an unavoidable consequence of the project. The areas for the proposed vegetation removal are shown in **Figure 47 – Vegetation Removal**

Plan Crookwell 3 East Area 1, Figure 48 – Vegetation Removal Plan Crookwell 3 East Area 2 and Figure 49 – Vegetation Removal Plan Crookwell 3 South. The approximate areas of vegetation required to be removed are as follows;

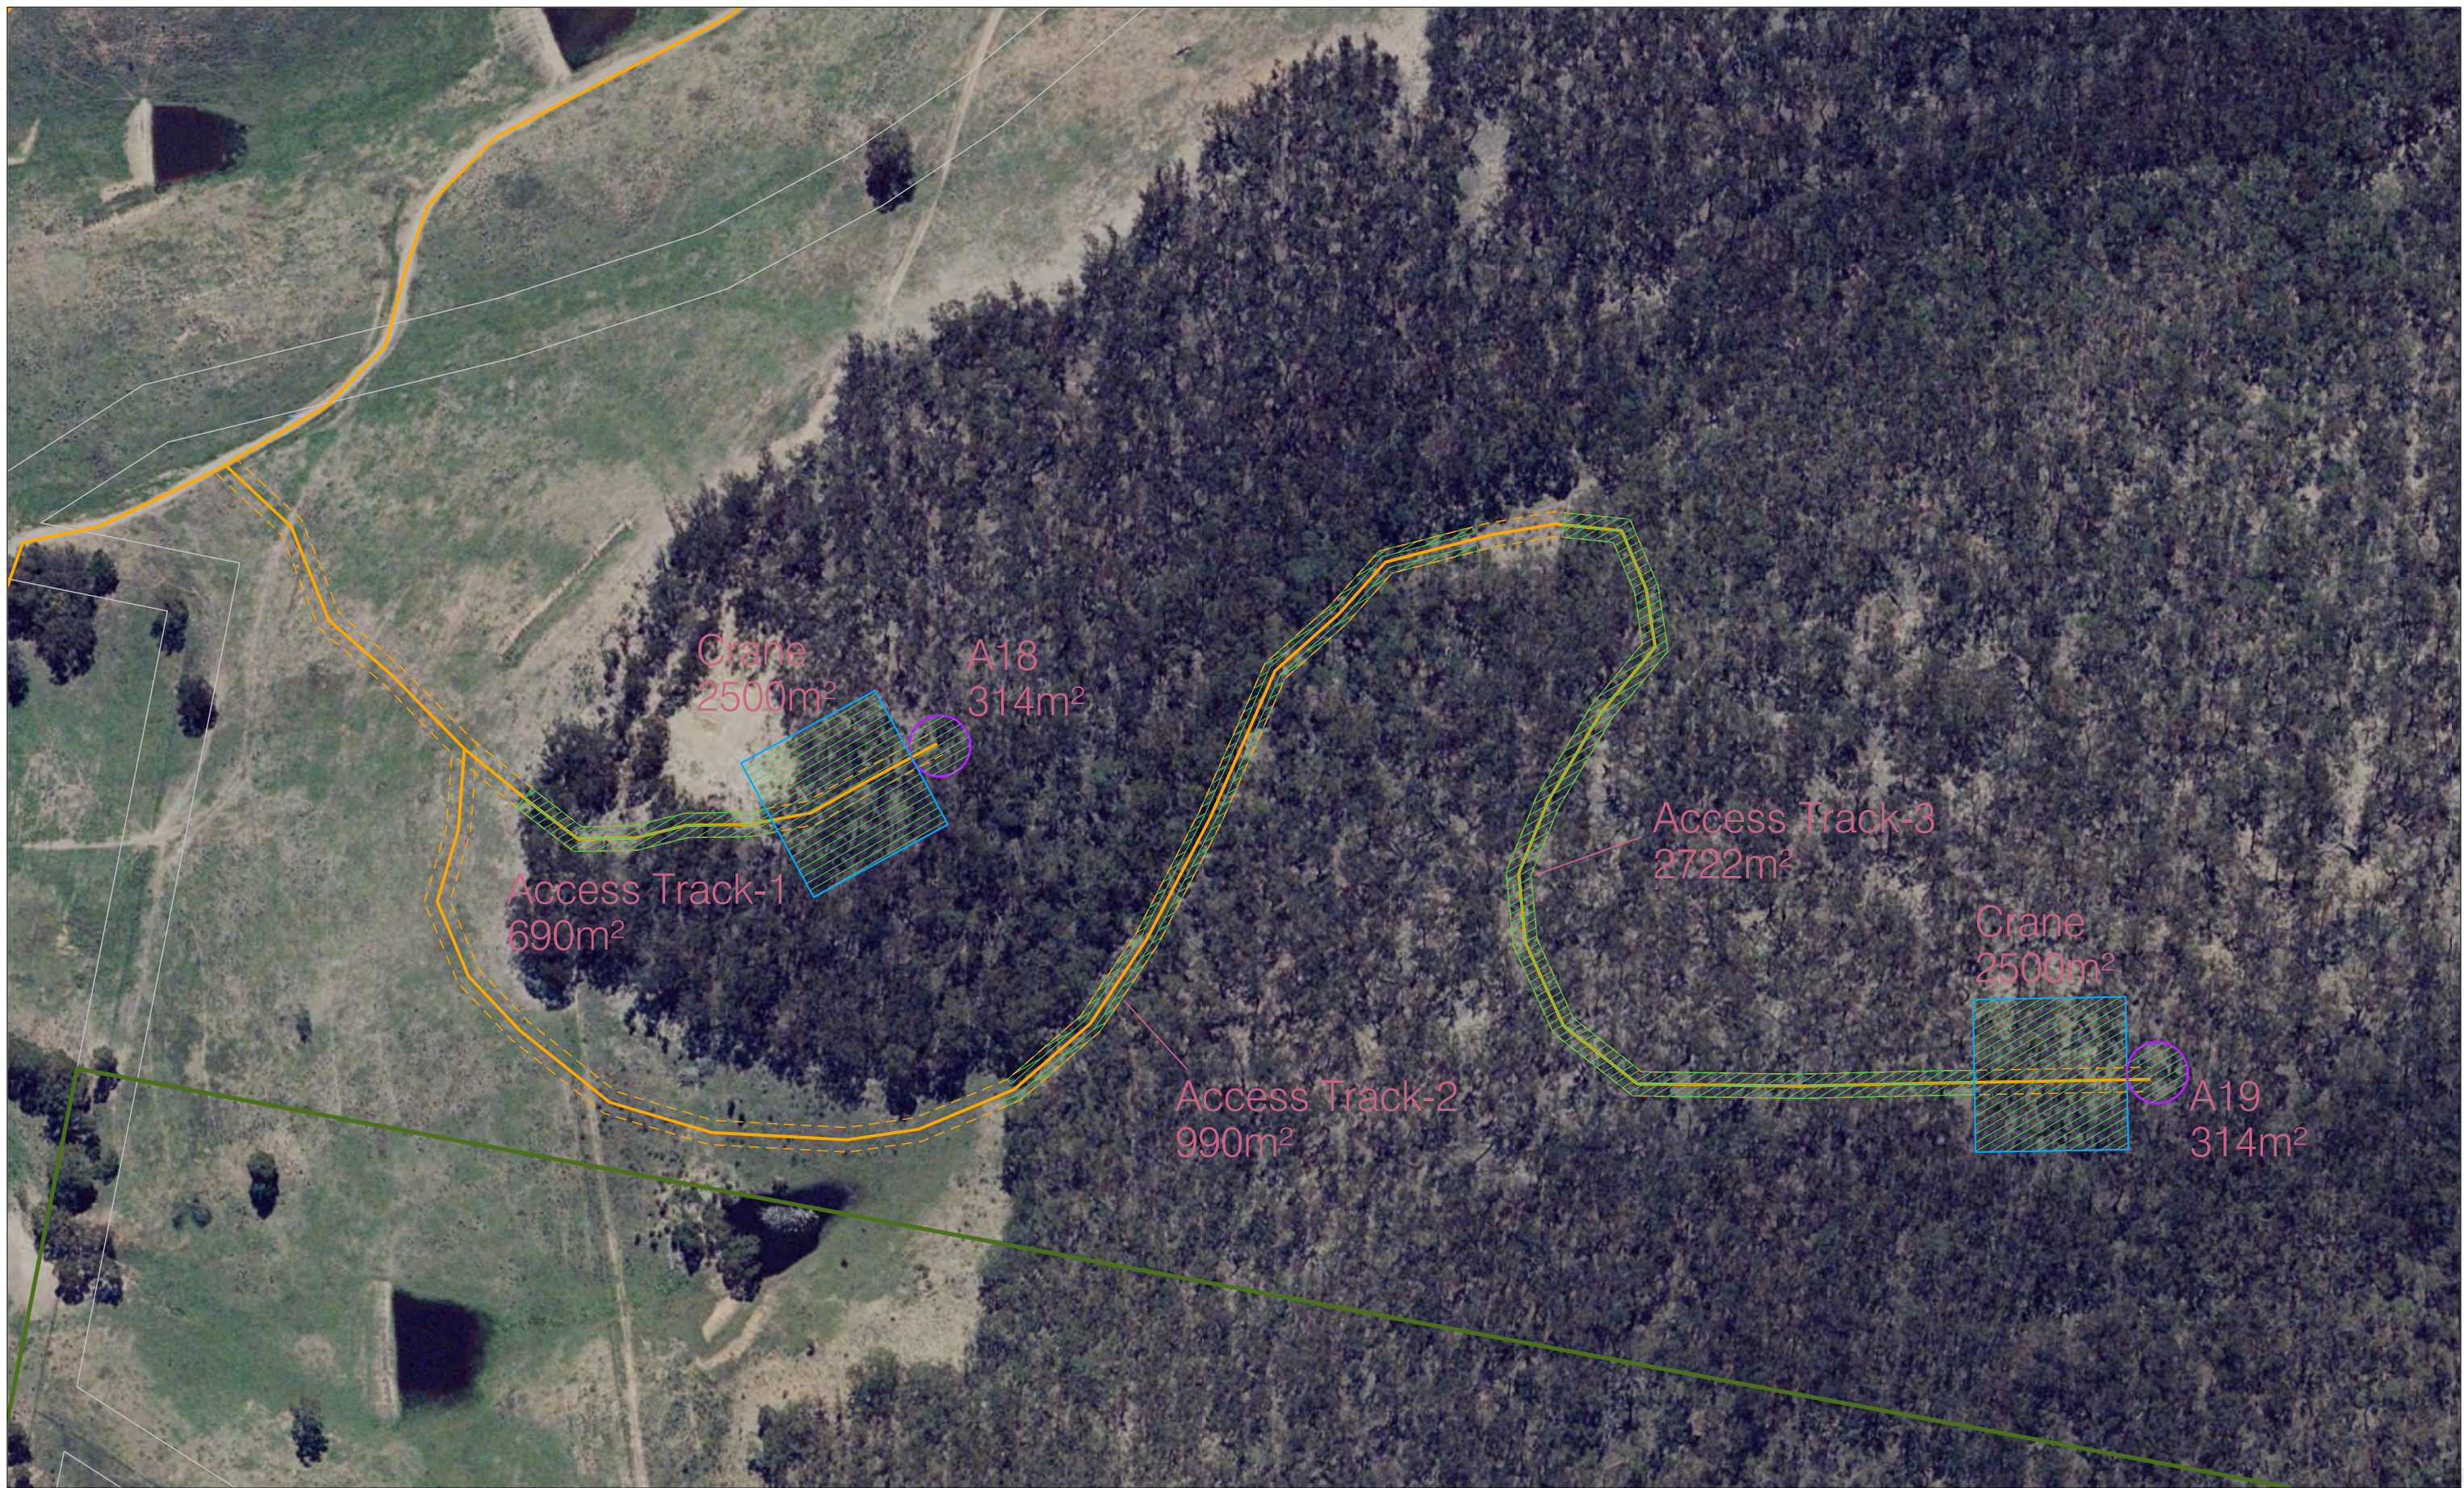
FIGURE 48 - VEGETATION REMOVAL PLAN - CROOKWELL 3 EAST AREA 2

- Turbines A18 and A19 (314 sqm for each turbine location) with the addition of approximately 4,000 sqm for their access tracks, and up to 5,000 sqm for the temporary crane hard stand areas (total removal of vegetation being 9,628 sqm). The removal of vegetation is within remnant B and illustrated in **Figure 48**.

There is an existing Property Vegetation Plan (PVP) in place on the property of 'Hillview Park' for an area of approximately 171 hectares which includes the areas where turbines A18 and A19 are proposed to be located. This area is described as 'Remnant B' in the report. This remnant is the subject of an existing Property Vegetation Plan agreement entered into by the landholder dated 17 December 2002 (2002 PVP). The 2002 PVP will expire on 17 December 2013. No works are proposed to be carried out in remnant B during the term of the 2002 PVP. Further, it is considered that the impacts from the placing of the two turbines within this remnant would be low.

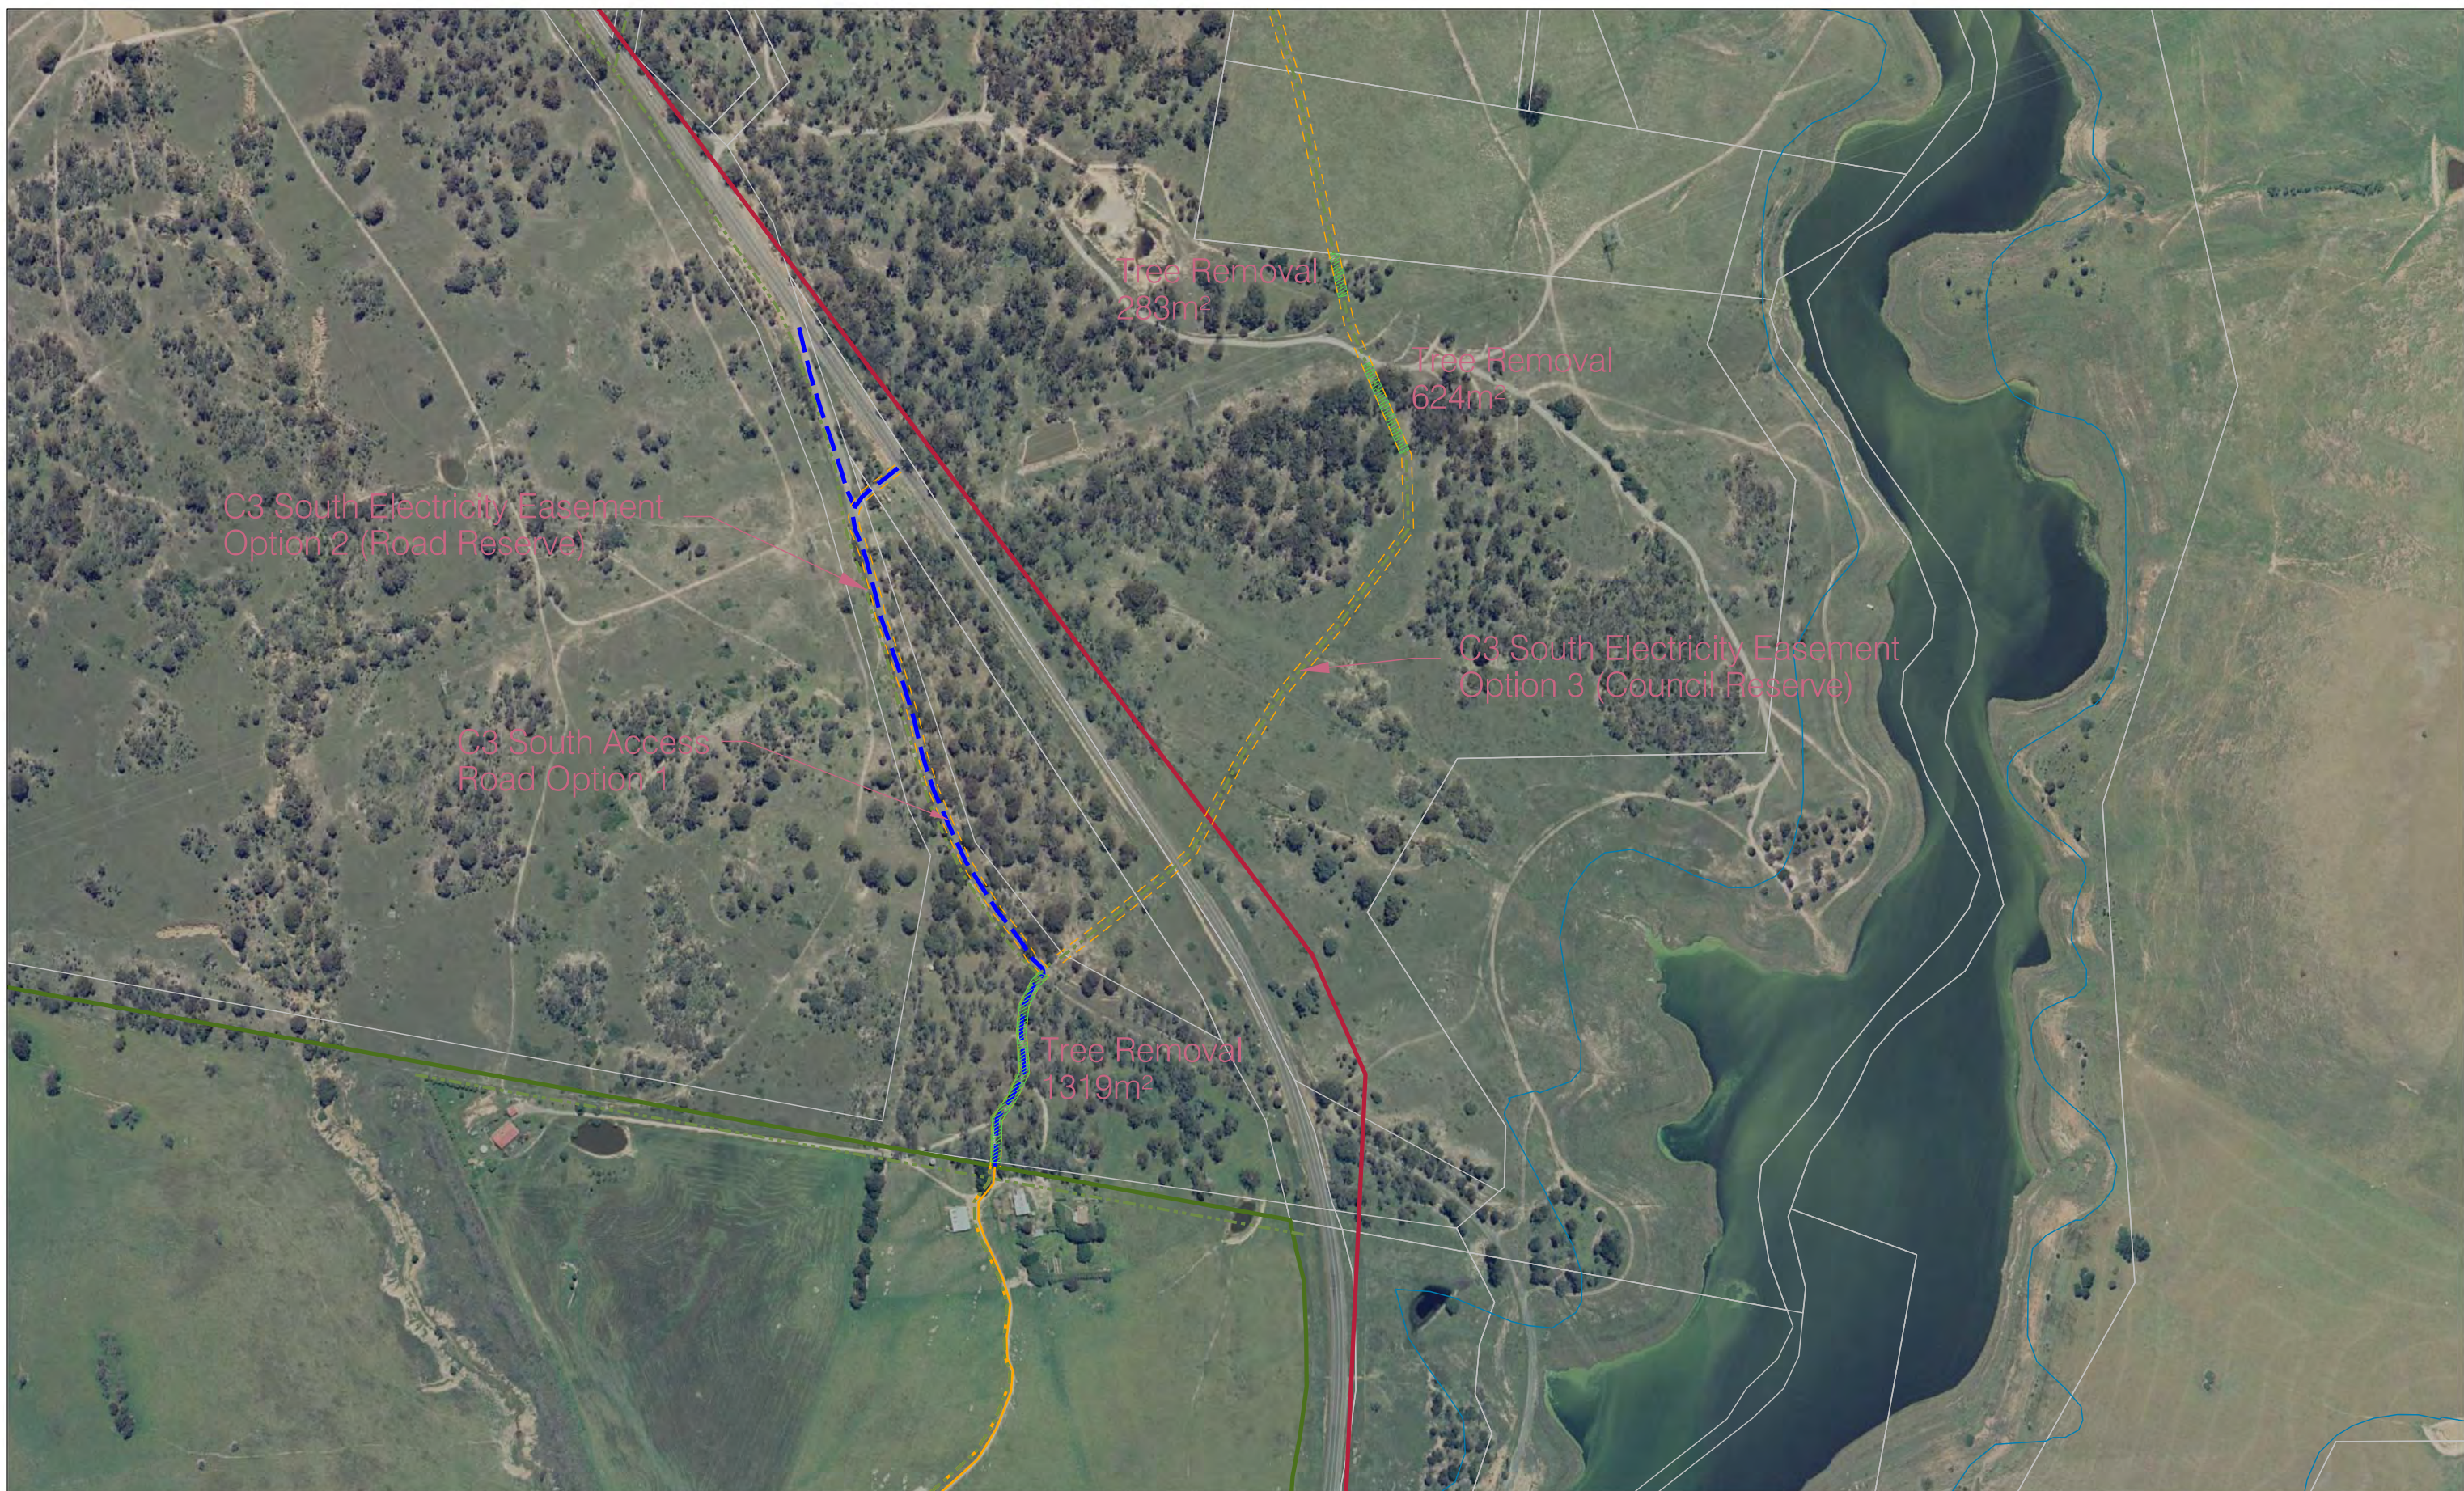
FIGURE 49 - VEGETATION REMOVAL PLAN - CROOKWELL 3 SOUTH

- Greywood Siding Road proposed access would remove approximately 5,000 sqm of vegetation combined for the whole of its route.
- Wollondilly access point and the transmission line interconnection around Pejar Dam would remove approximately 4,000 sqm of vegetation in total. The access point is located within remnant H and the transmission line is located within remnant I, as illustrated in **Figure 49**.
