**REPORT
on
PRELIMINARY CONTAMINATION ASSESSMENT**

**PROPOSED TOURIST AND RESIDENTIAL
DEVELOPMENT
COMBERTON GRANGE, JERVIS BAY**

Prepared for
SHAOLIN TEMPLE FOUNDATION (AUSTRALIA)

**PROJECT 48670
SEPTEMBER 2009**

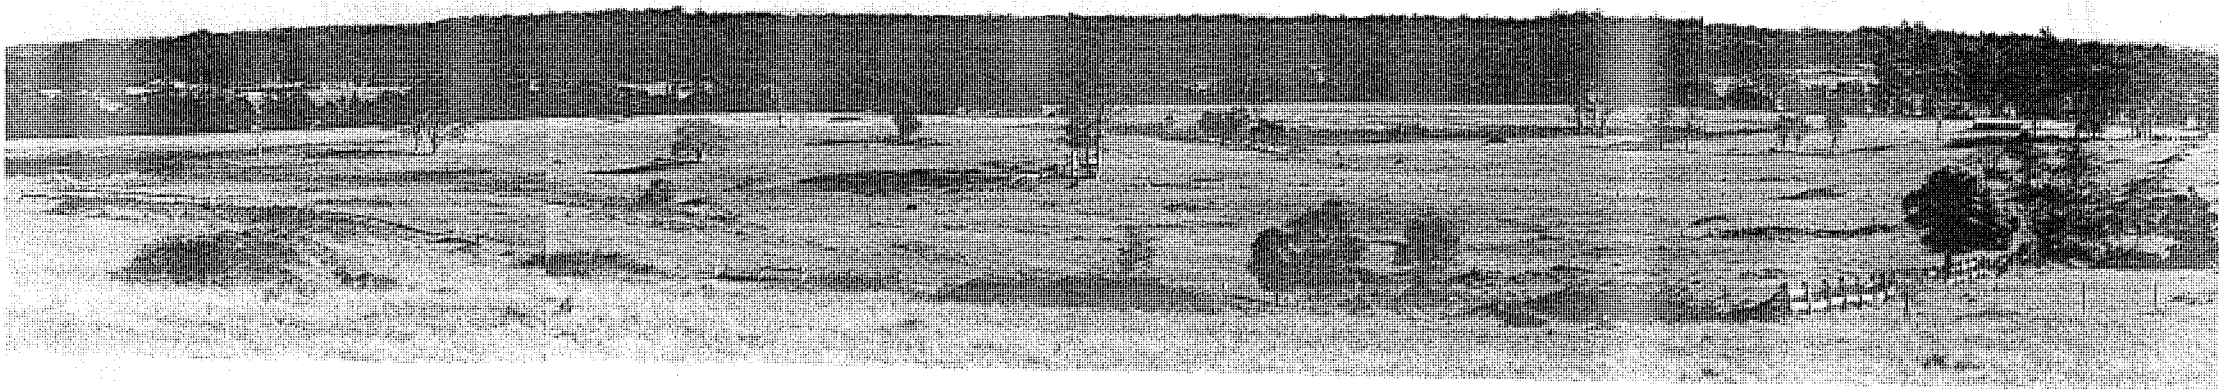
View toward the south-west. The site of proposed lots 7 to 9 is located in the mid to right of the view, inside the fence line.

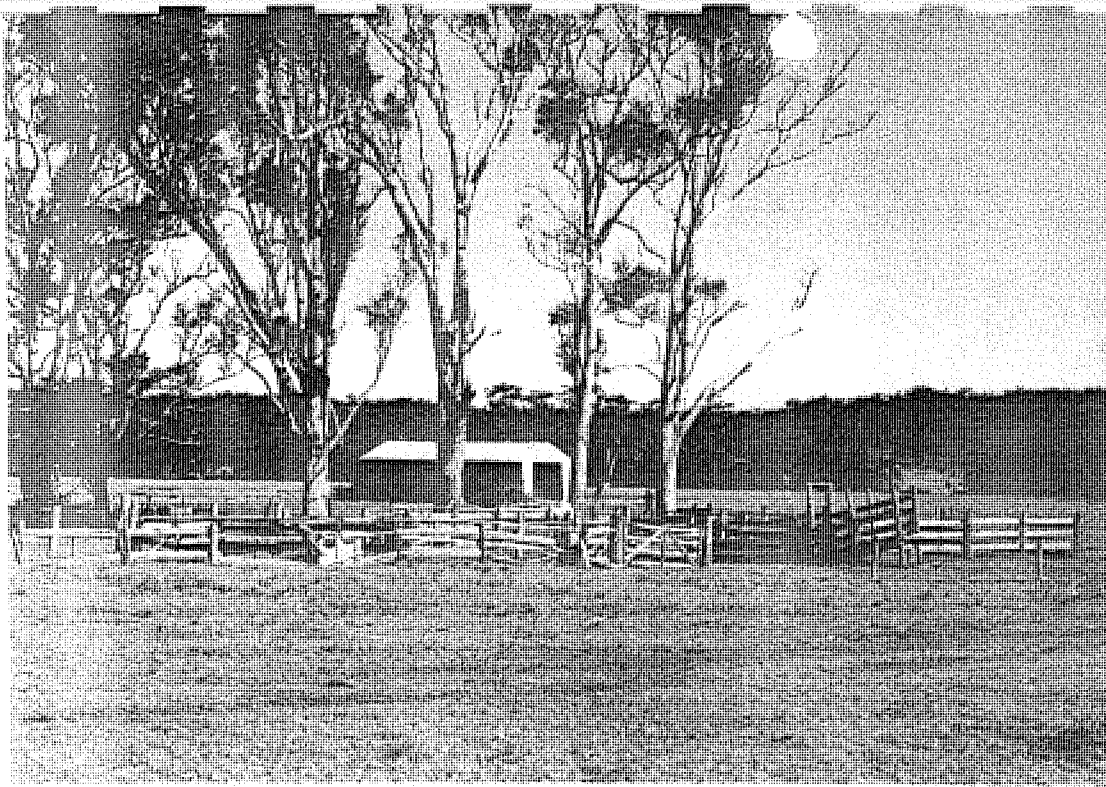
Above: Stockyard and hay shed.
