**REPORT
ON
PRELIMINARY GEOTECHNICAL INVESTIGATION**

**PROPOSED TOURIST & RESIDENTIAL DEVELOPMENT
COMBERTON GRANGE
JERVIS BAY**

Prepared for:
SHAOLIN TEMPLE FOUNDATION (AUSTRALIA)

**PROJECT 48670.02
SEPTEMBER 2009**

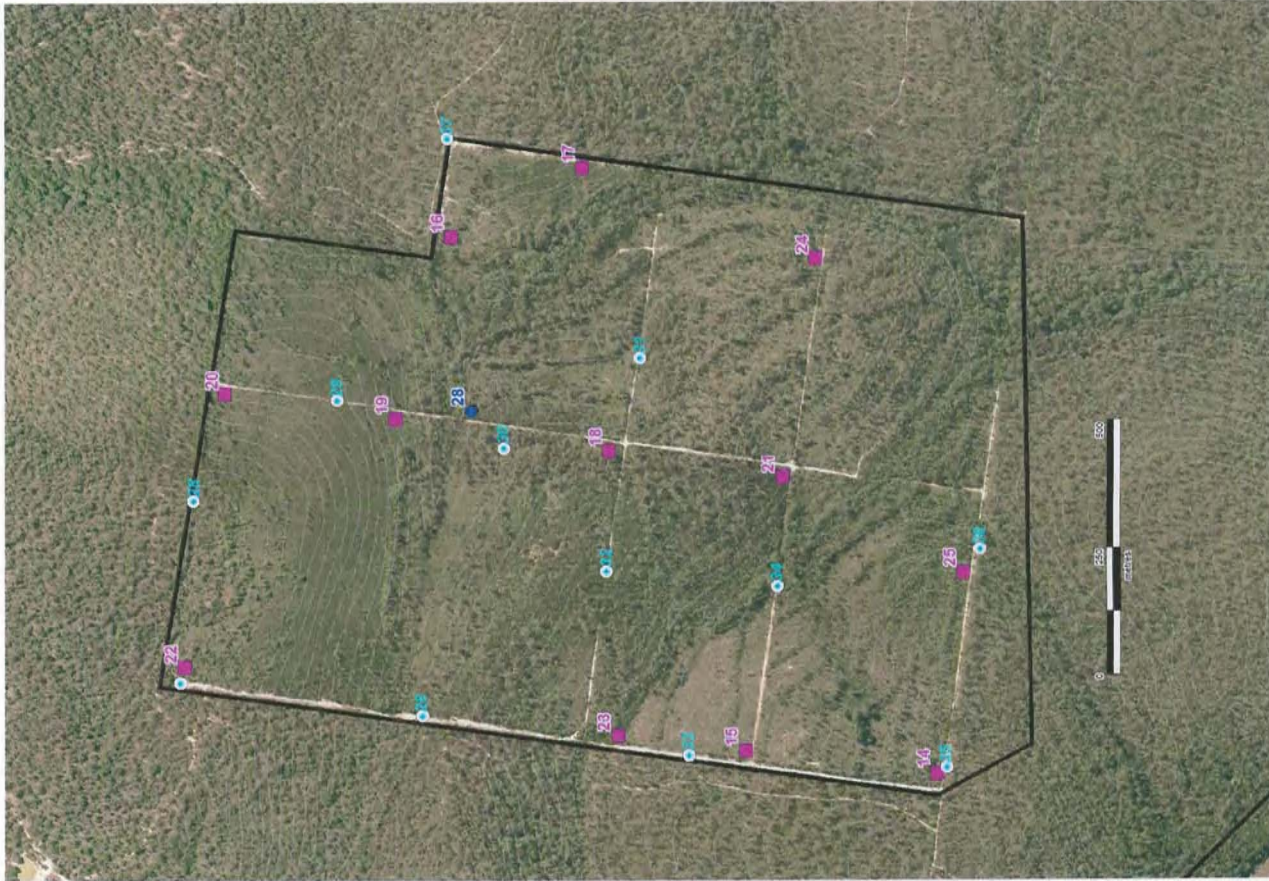
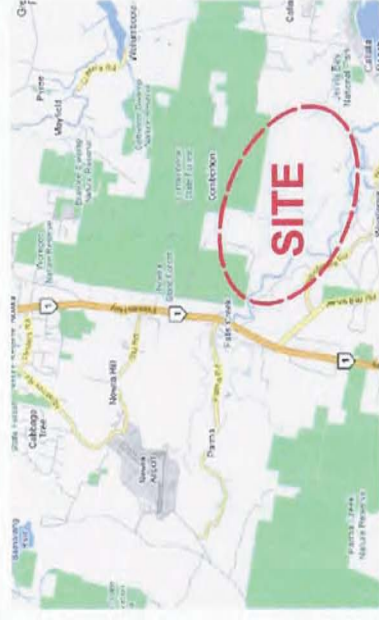
PROJECT: 48670.02
DRAWING: 1
REVISION: A

TITLE: NORTHERN AREA SITE PLAN
PROPOSED RESIDENTIAL AND TOURIST DEVELOPMENT
COMBERTON GRANGE

The field work comprised field mapping by a senior geotechnical engineer followed by test pit excavation and borehole drilling. Relevant site features noted during the inspection are shown on the colour photoplates given in Appendix B, with the locations indicated on Drawings 1 and 2 (Appendix A).

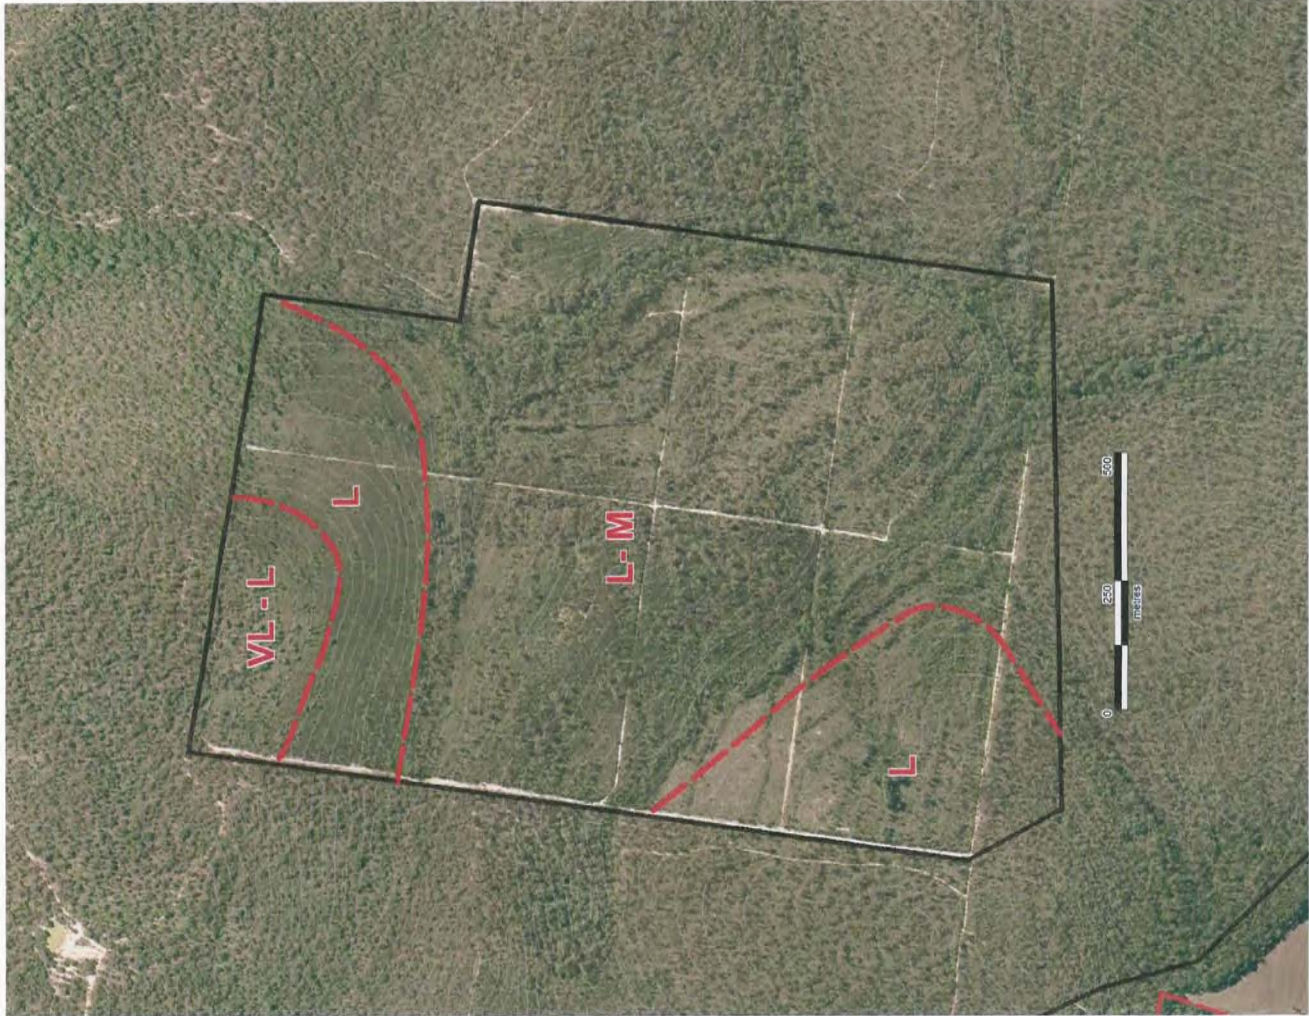
Douglas Partners Geotechnics • Environment • Groundwater	CLIENT: SHAOLIN TEMPLE FOUNDATION AUSTRALIA	TITLE: NORTHERN AREA STABILITY RISK BOUNDARIES	PROJECT: 48670.02
	DRAWN BY: JAS	PROPOSED RESIDENTIAL AND TOURIST DEVELOPMENT	DRAWING: 3
	APPROVED BY: <i>B</i>	COMBERTON GRANGE	REVISION: A

- SITE BOUNDARY
- - - STABILITY RISK BOUNDARY
- VL VERY LOW
- L LOW
- M MODERATE

In summary, it is considered that the areas of slight topographic relief are classified as either very low or low risk of damage to property occurring as a result of slope instability, whilst the area of moderate relief would be classified as moderate risk. Notwithstanding the stability classifications nominated, development of the site for the proposed development is considered geotechnically feasible with respect to slope stability, with development in moderate risk zones to be in accordance with accepted hillside practice (Ref 5) and the specific recommendations given in this report.

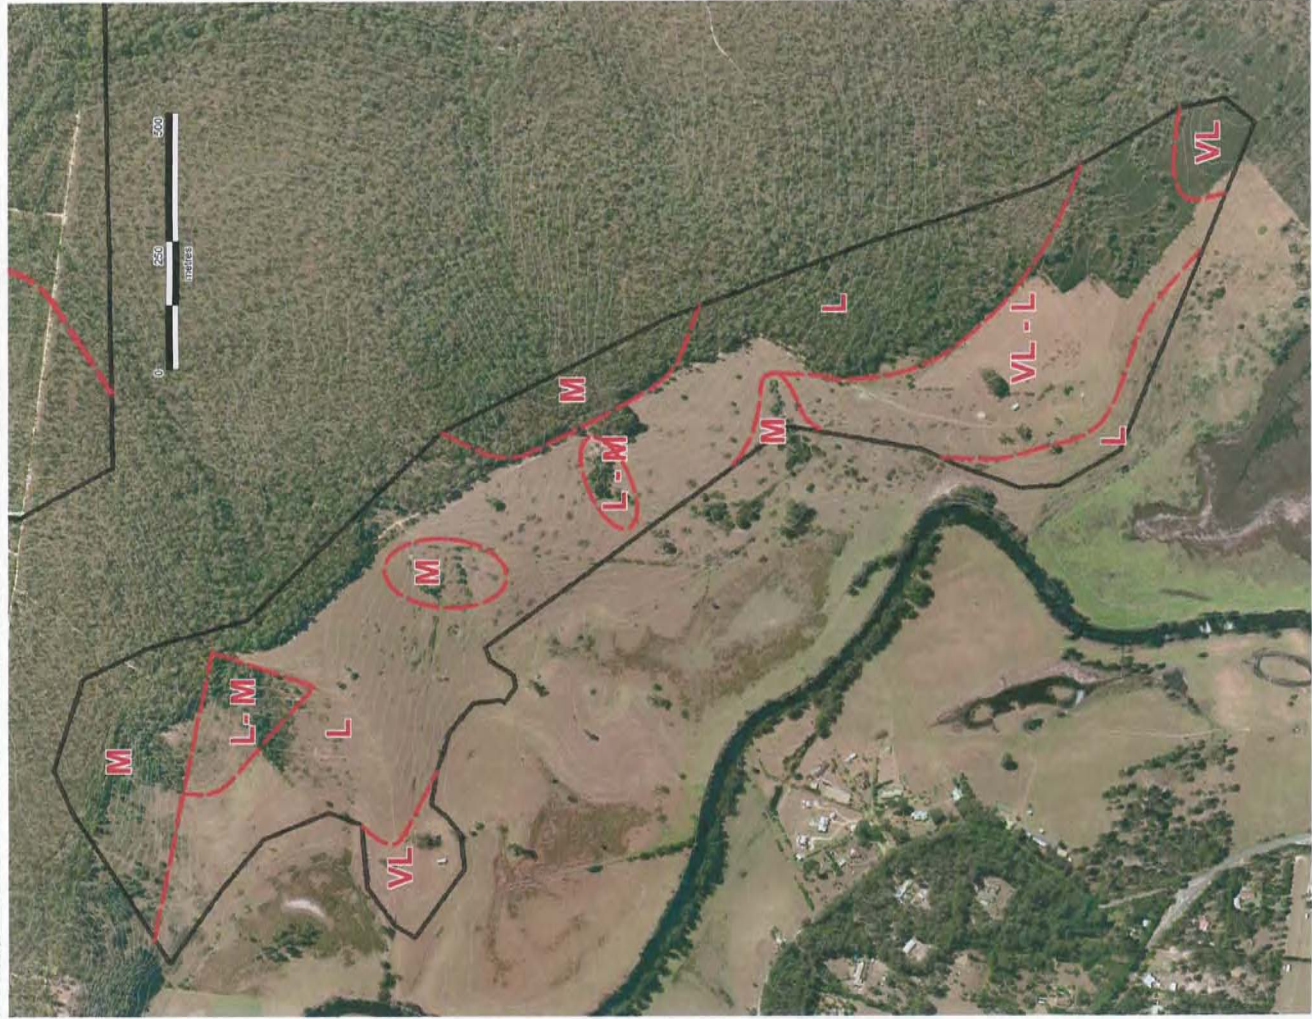
Douglas Partners Geotechnics • Environment • Groundwater	CLIENT: SHAO LIN TEMPLE FOUNDATION AUSTRALIA	TITLE: SOUTHERN AREA STABILITY RISK BOUNDARIES		PROJECT: 48670.02
	DRAWN BY: JAS	SCALE: AS SHOWN	OFFICE: WOL	DRAWING: 4
	APPROVED BY:

- SITE BOUNDARY
- STABILITY RISK BOUNDARY
- VERY LOW
- LOW
- MODERATE

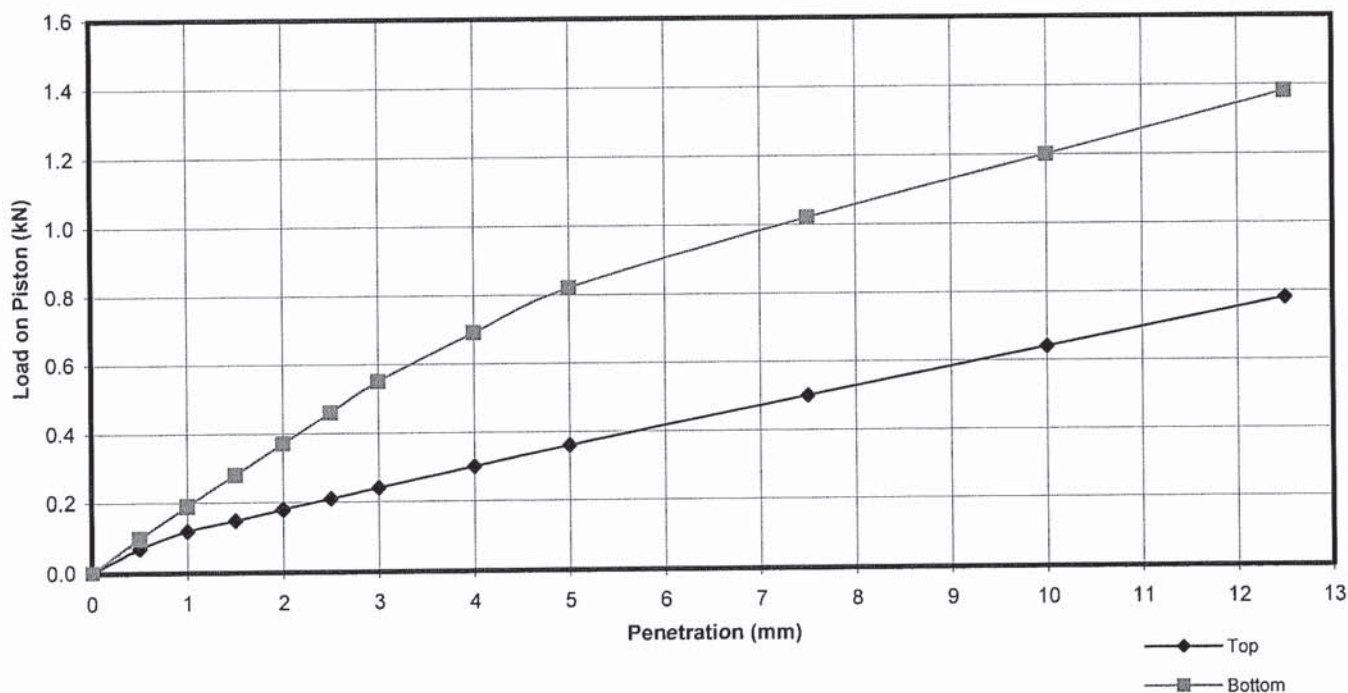
RESULT OF CALIFORNIA BEARING RATIO TEST

Description: Mottled red brown silty clay

Test Method(s): AS 1289.6.1.1-1998, AS 1289.2.1.1-2005

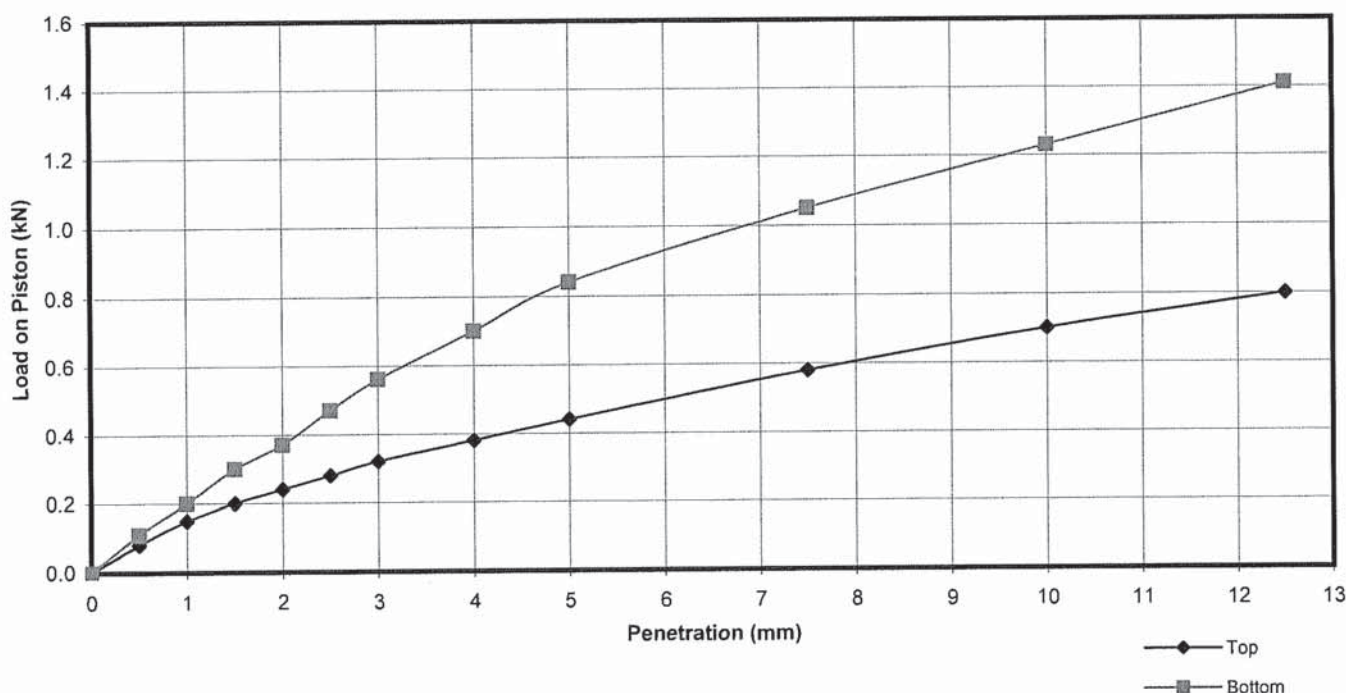
RESULT OF CALIFORNIA BEARING RATIO TEST

Description: Mottled red brown silty clay

Test Method(s): AS 1289.6.1.1-1998, AS 1289.2.1.1-2005

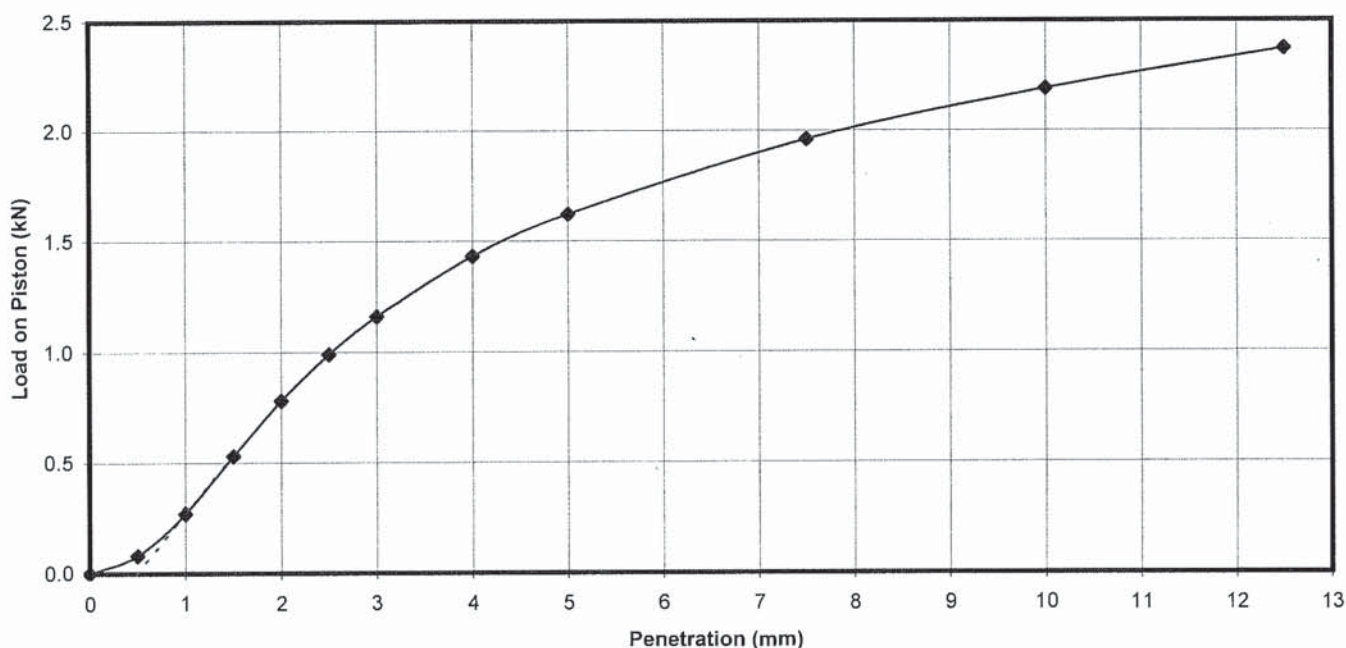
RESULT OF CALIFORNIA BEARING RATIO TEST

Description: Orange brown silty sandy clay

Test Method(s): AS 1289.6.1.1, AS 1289.2.1.1

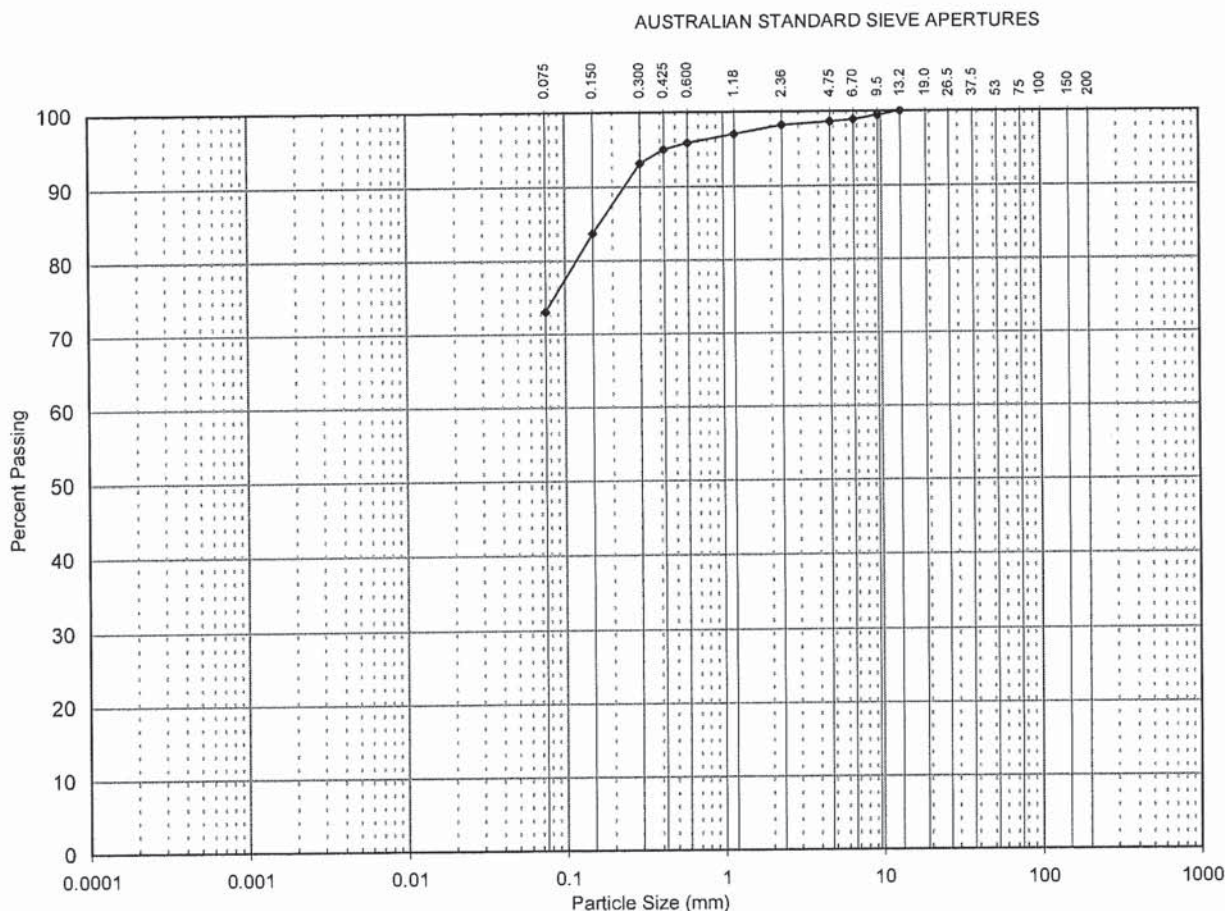
Sieve Size (mm)	% Passing
75.0	~
53.0	~
37.5	~
26.5	~
19.0	~
13.2	100%
9.5	99%
6.7	99%
4.75	99%
2.36	98%
1.18	97%
0.600	96%
0.425	95%
0.300	93%
0.150	84%
0.075	73%

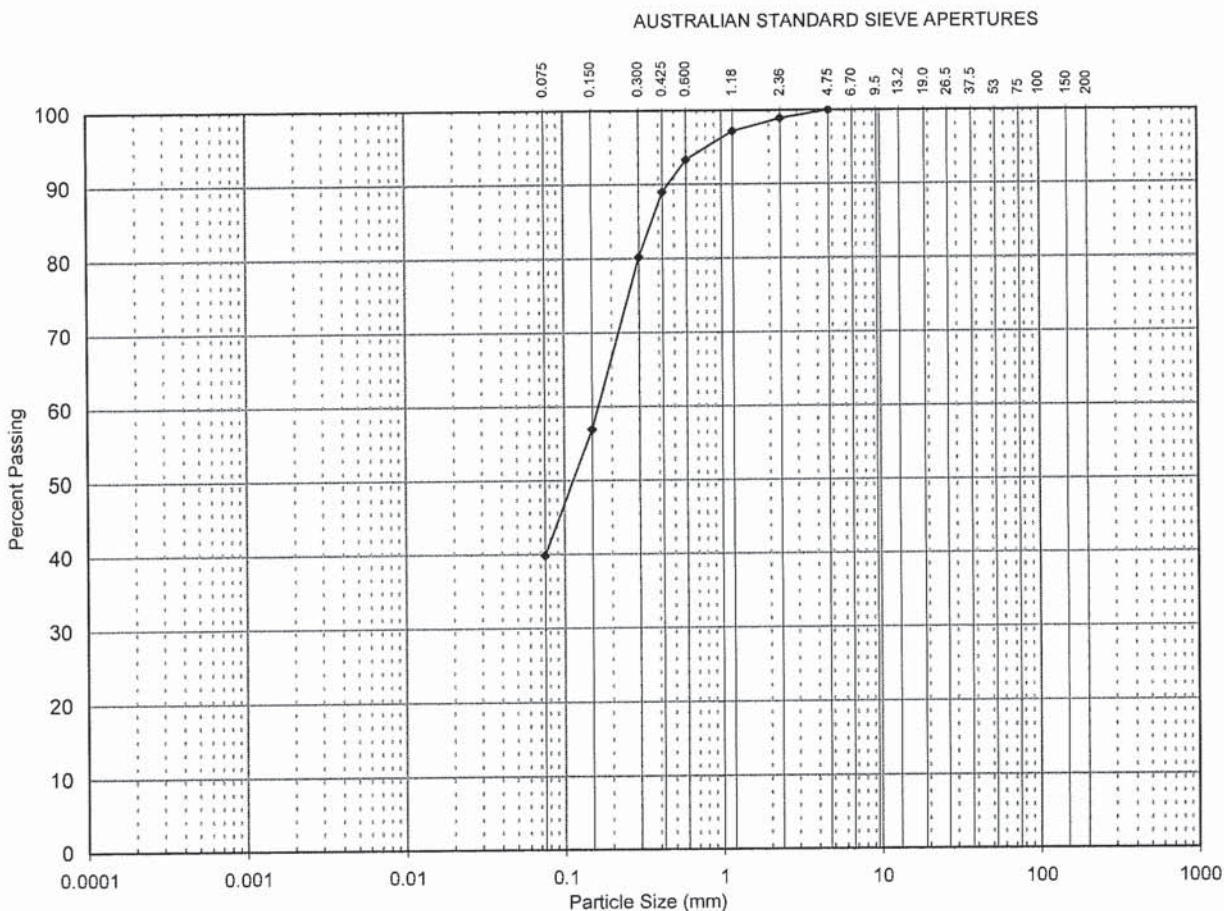
RESULTS OF PARTICLE SIZE DISTRIBUTION

Sieve Size (mm)	% Passing
75.0	~
53.0	~
37.5	~
26.5	~
19.0	~
13.2	~
9.5	~
6.7	~
4.75	100%
2.36	99%
1.18	97%
0.600	93%
0.425	89%
0.300	80%
0.150	57%
0.075	40%

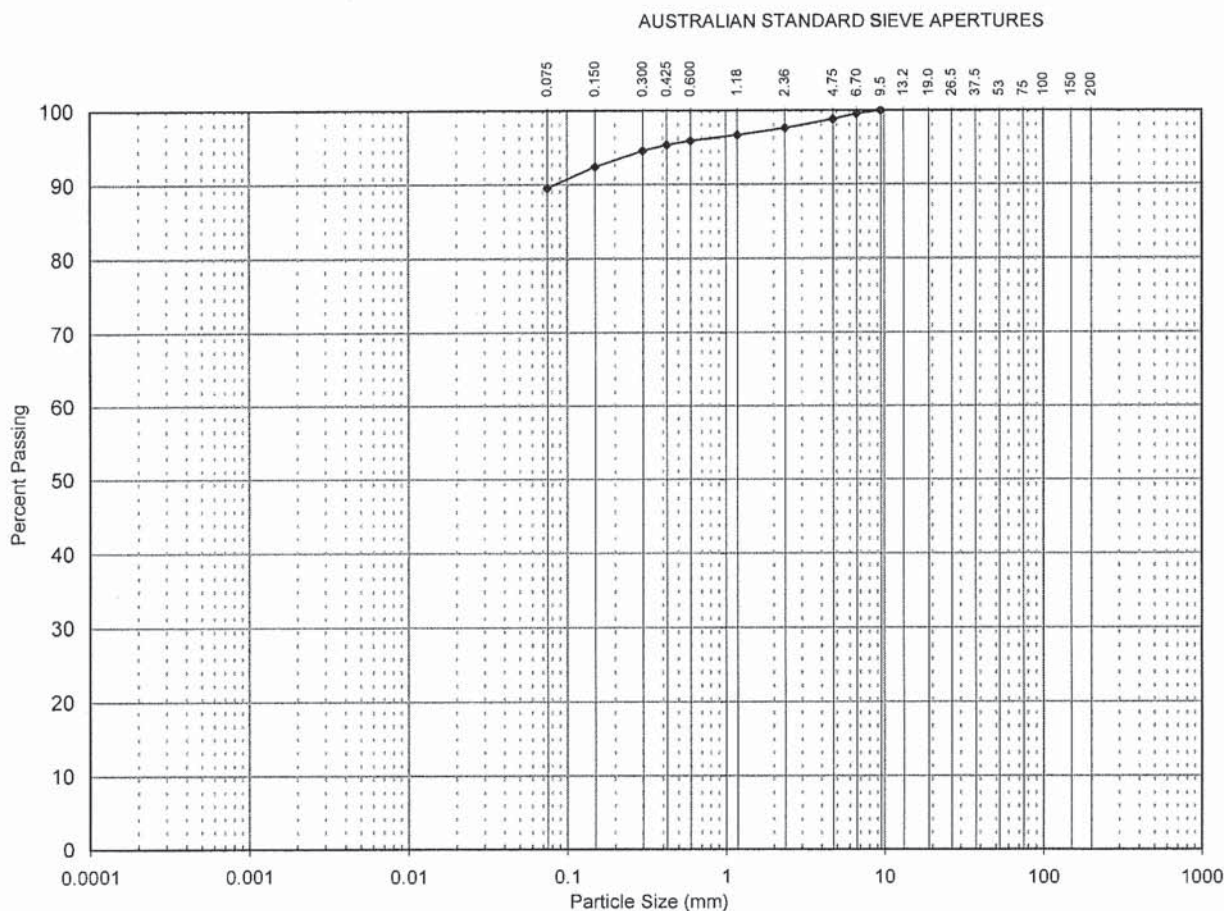
RESULTS OF PARTICLE SIZE DISTRIBUTION

Sieve Size (mm)	% Passing
75.0	~
53.0	~
37.5	~
26.5	~
19.0	~
13.2	~
9.5	100%
6.7	100%
4.75	99%
2.36	98%
1.18	97%
0.600	96%
0.425	95%
0.300	95%
0.150	92%
0.075	90%

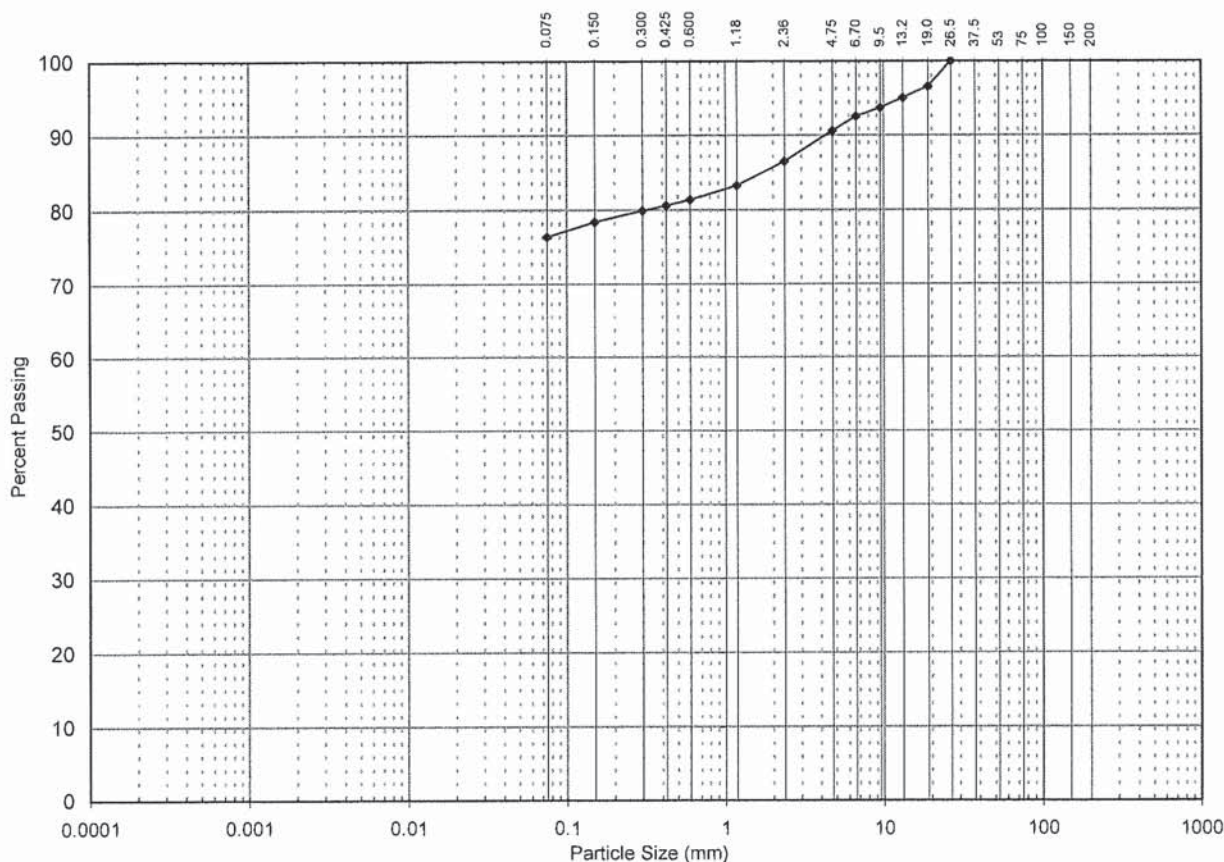
Sieve Size (mm)	% Passing
75.0	~
53.0	~
37.5	~
26.5	100%
19.0	97%
13.2	95%
9.5	94%
6.7	93%
4.75	91%
2.36	86%
1.18	83%
0.600	81%
0.425	81%
0.300	80%
0.150	78%
0.075	76%

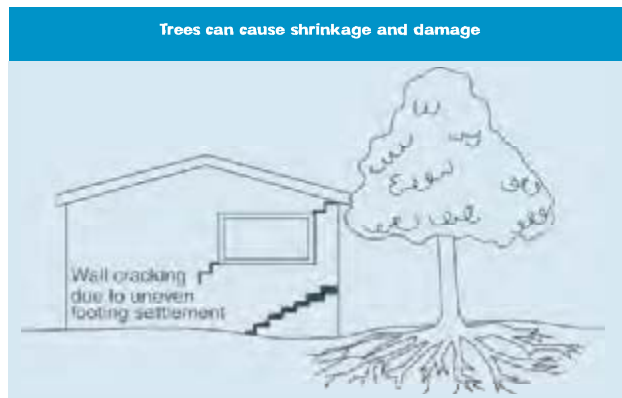
As the moisture absorption process completes its journey to the innermost areas of the building, the internal footings will rise. If the spread of moisture is roughly even, it may be that the symptoms will temporarily disappear, but it is more likely that swelling will be uneven, creating a difference rather than a disappearance in symptoms. In buildings with timber flooring supported by bearers and joists, the isolated piers will rise more easily than the strip footings or piers under walls, creating noticeable doming of flooring.

As the weather pattern changes and the soil begins to dry out, the external footings will be first affected, beginning with the locations where the sun's effect is strongest. This has the effect of lowering the external footings. The doming is accentuated and cracking reduces or disappears where it occurred because of dishing, but other cracks open up. The roof lines may become convex.

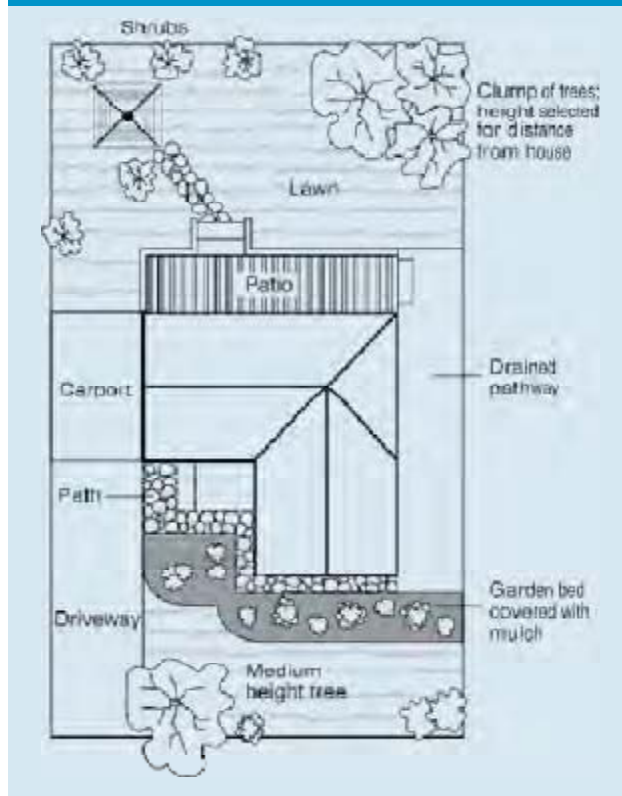
Gardens for a reactive site

should extend outwards a minimum of 900 mm (more in highly reactive soil) and should have a minimum fall away from the building of 1:60. The finished paving should be no less than 100 mm below brick vent bases.
