Foxground and Berry bypass

Princes Highway upgrade

**Technical paper:
Aquatic ecology and
water quality management**

NOVEMBER 2012

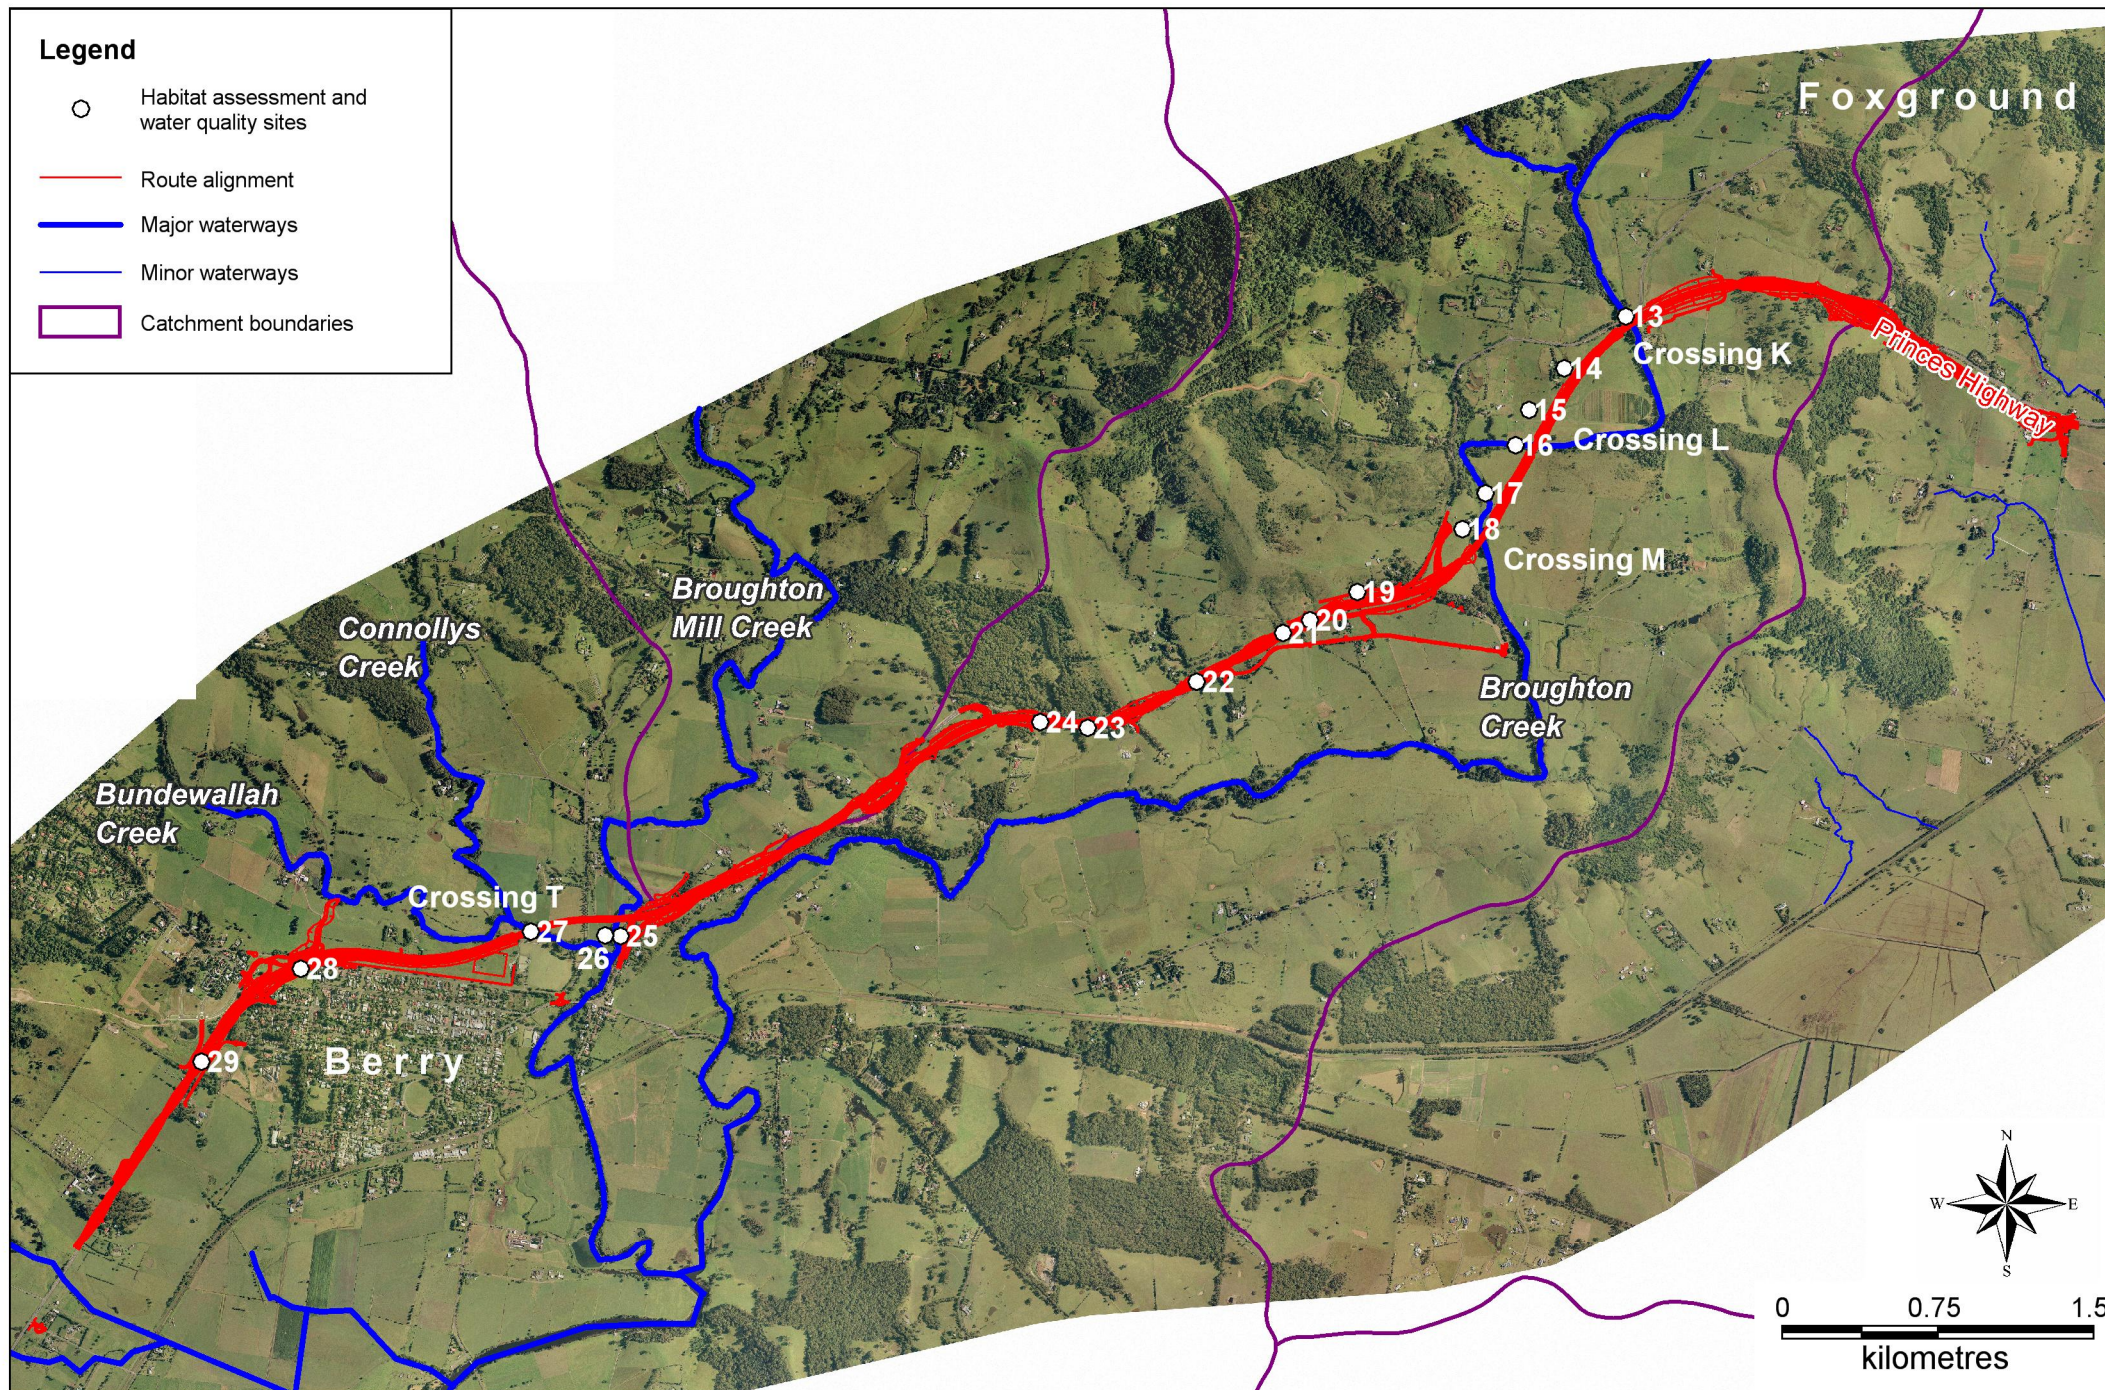
Figure 2.1: Foxground to Berry project area indicating major waterways and sites for habitat assessment and water quality

Field investigations of aquatic habitat, biota and water quality were undertaken by Cardno Ecology Lab from 15 April 2009 to 17 April 2009. Additional field investigations to identify four potential sites for temporary creek crossings were done on 28 June 2011 (Crossing K, L, M and T on **Figure 2.1**).

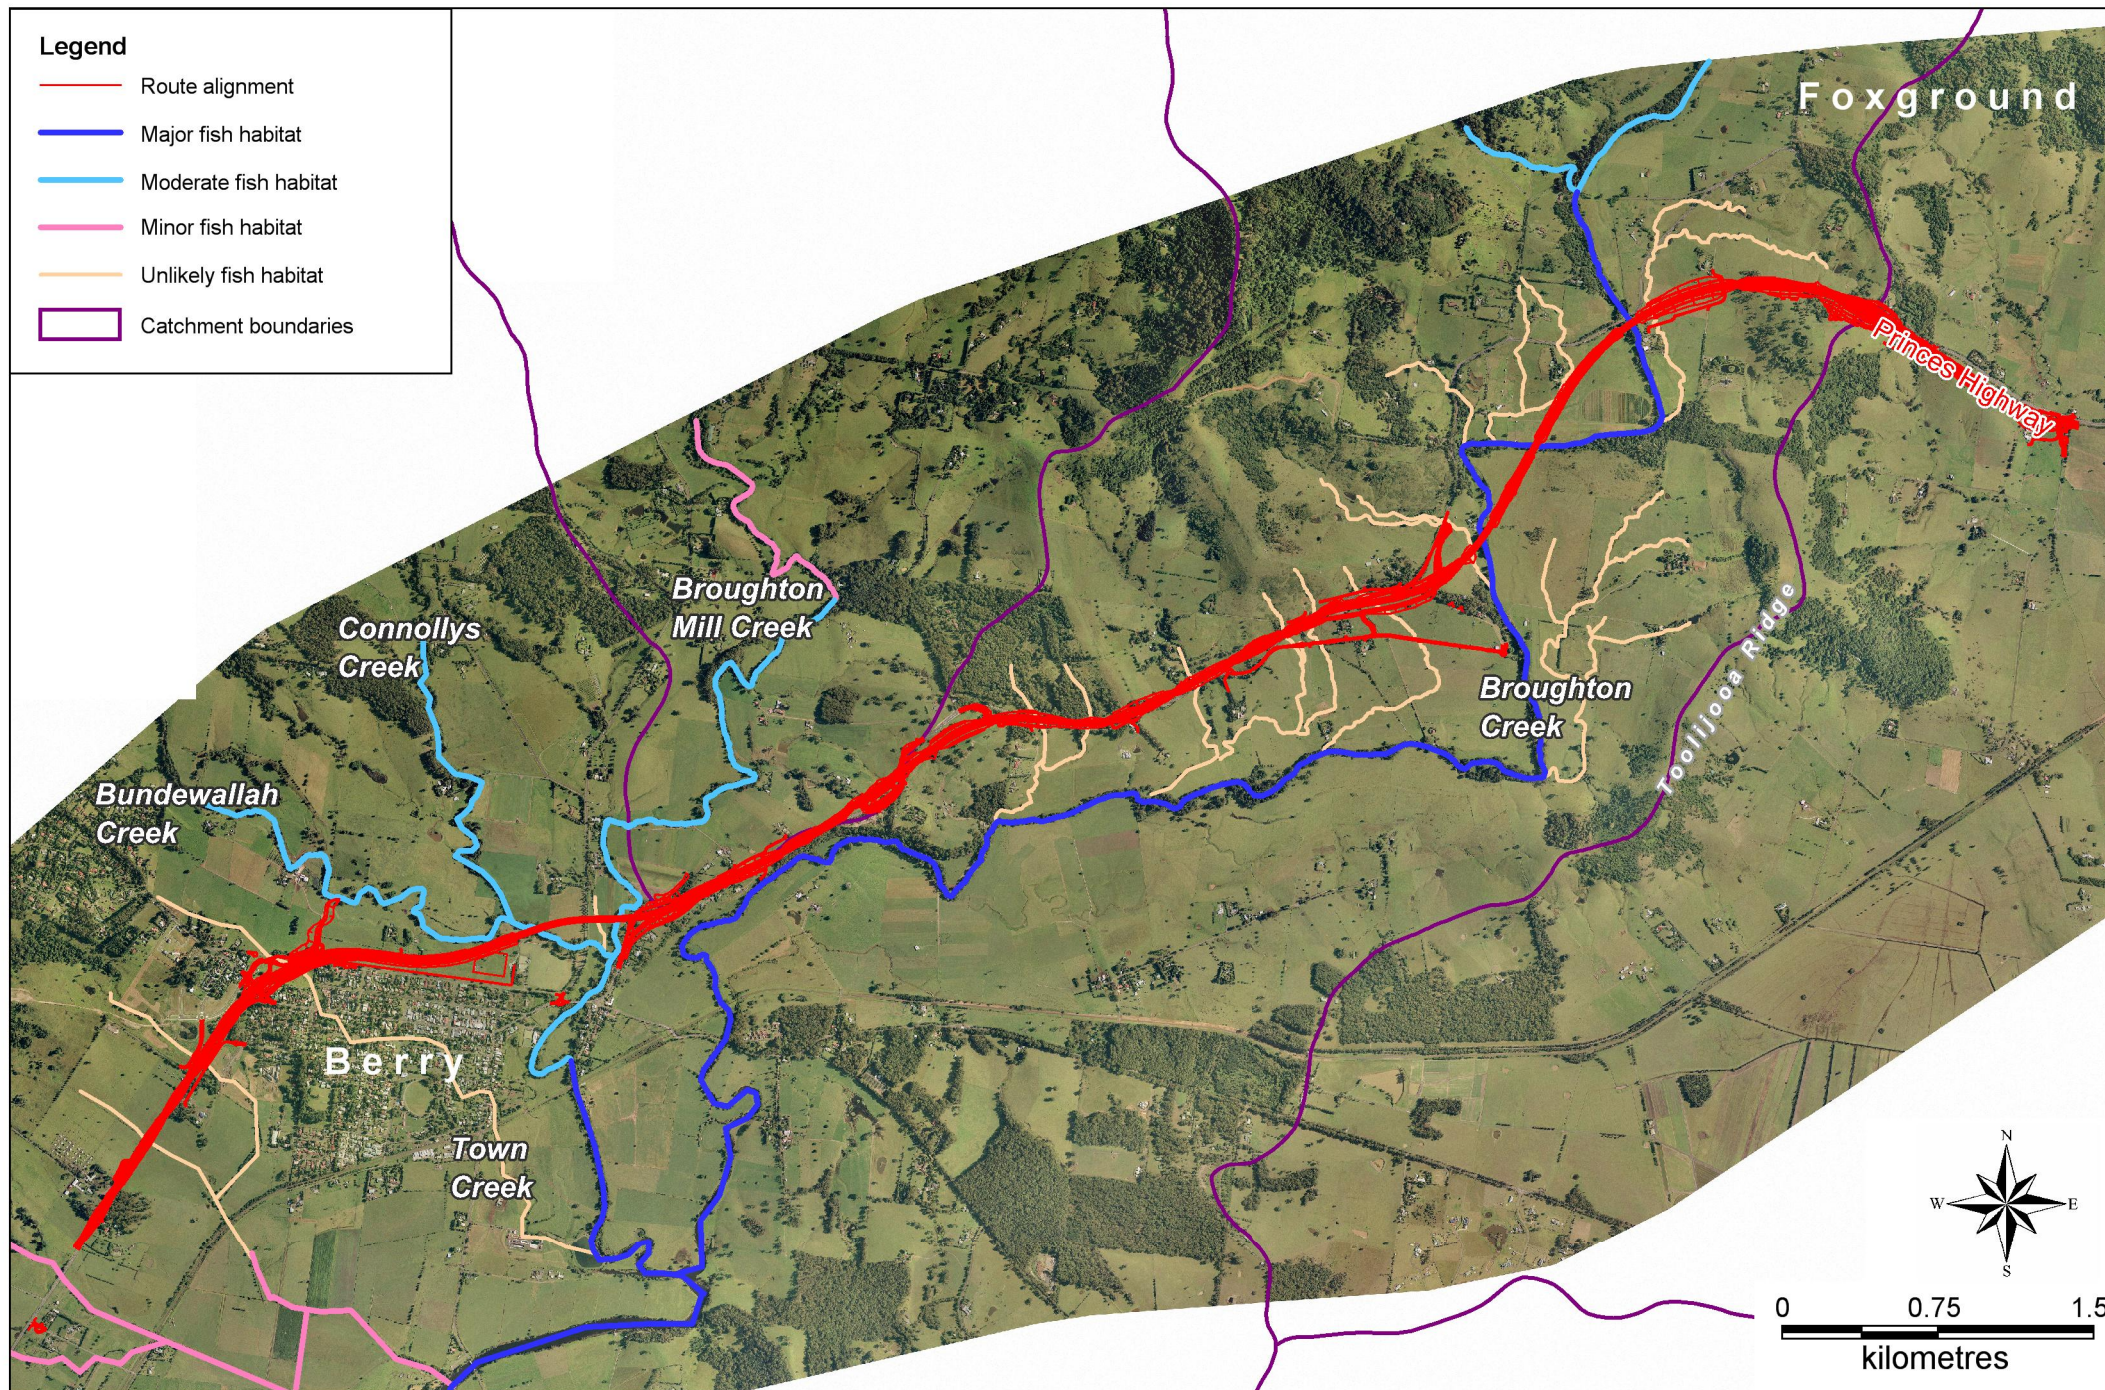
Figure 3.1: Watercourses and physical setting within the study area

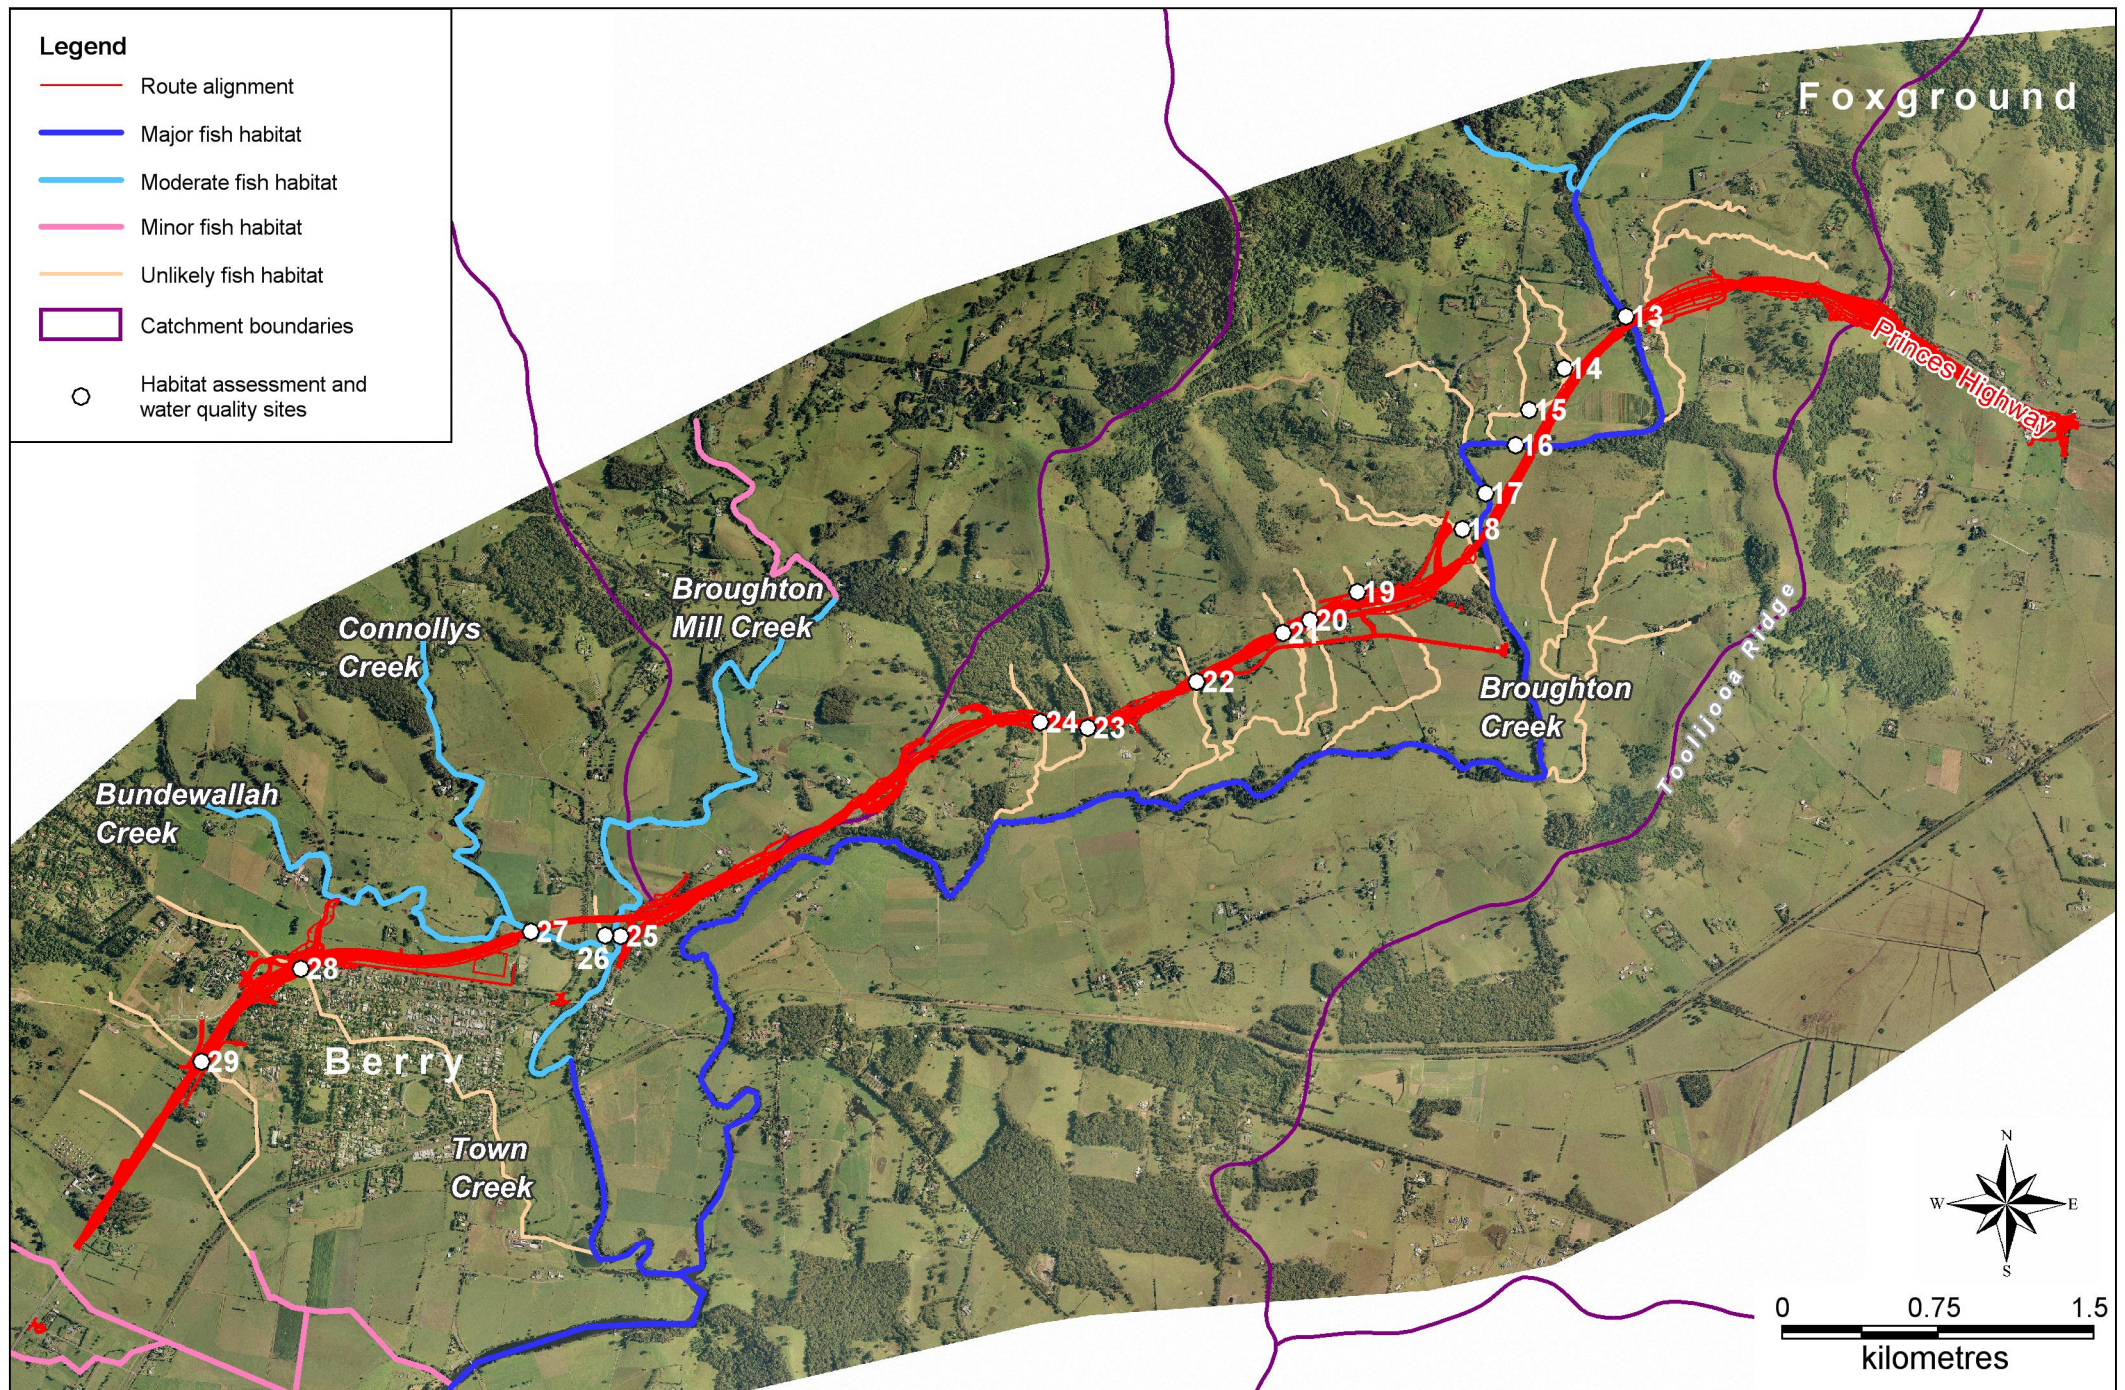
Figure 3.2: Waterways and aquatic ecology monitoring sites within the study area. Classifications are based on criteria established by Fairfull and Witheridge (2003)

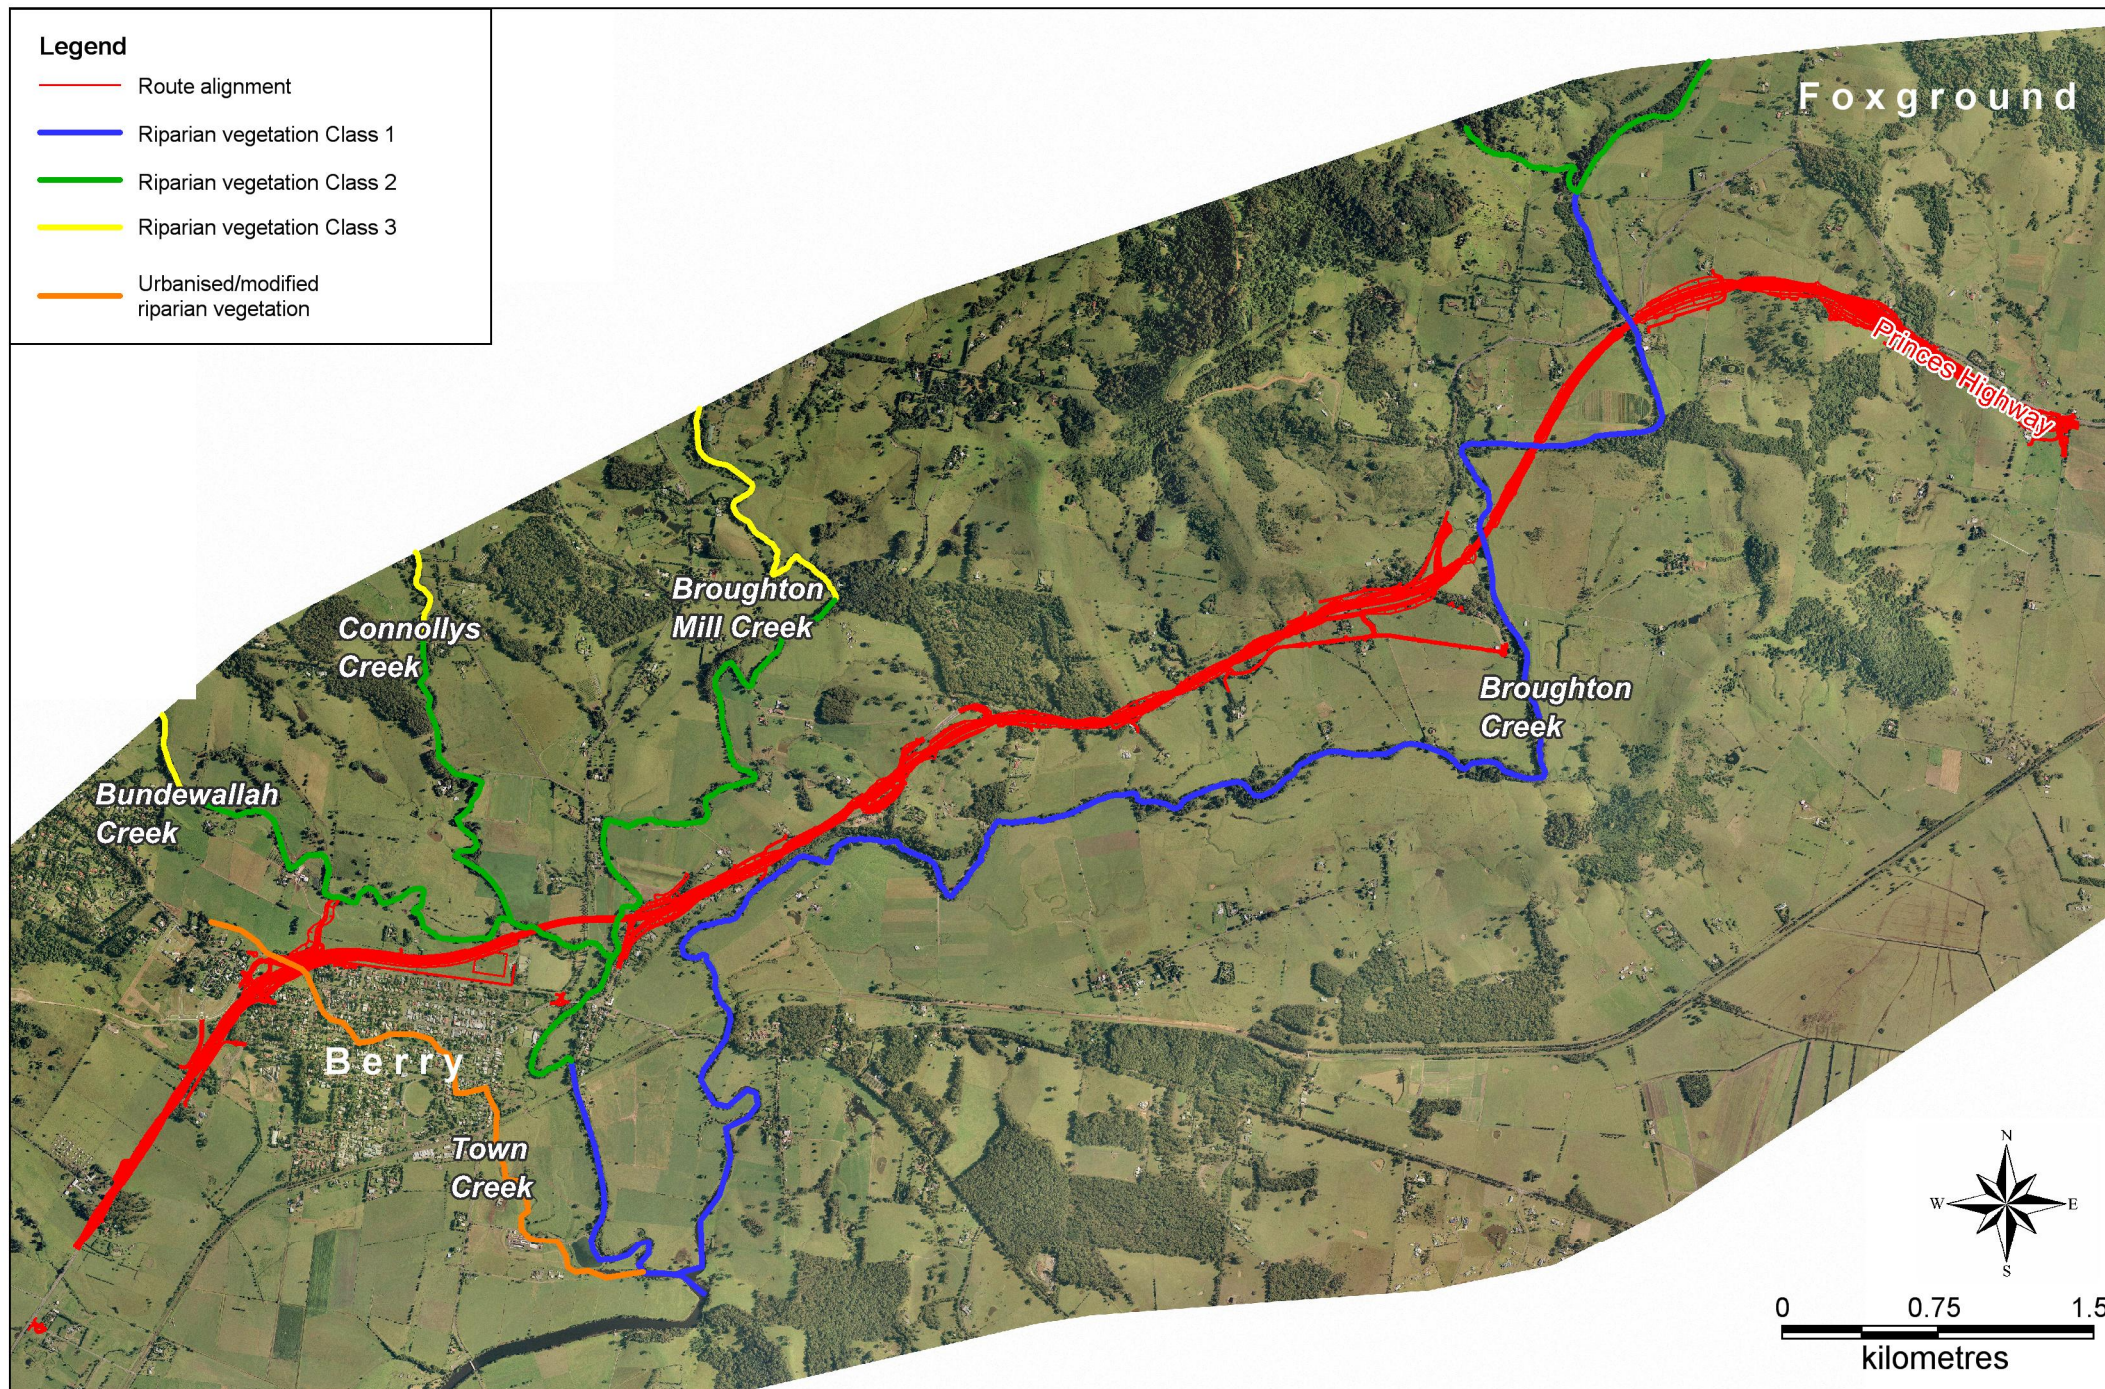
Figure 3.3: Map of waterways based on riparian habitat classification

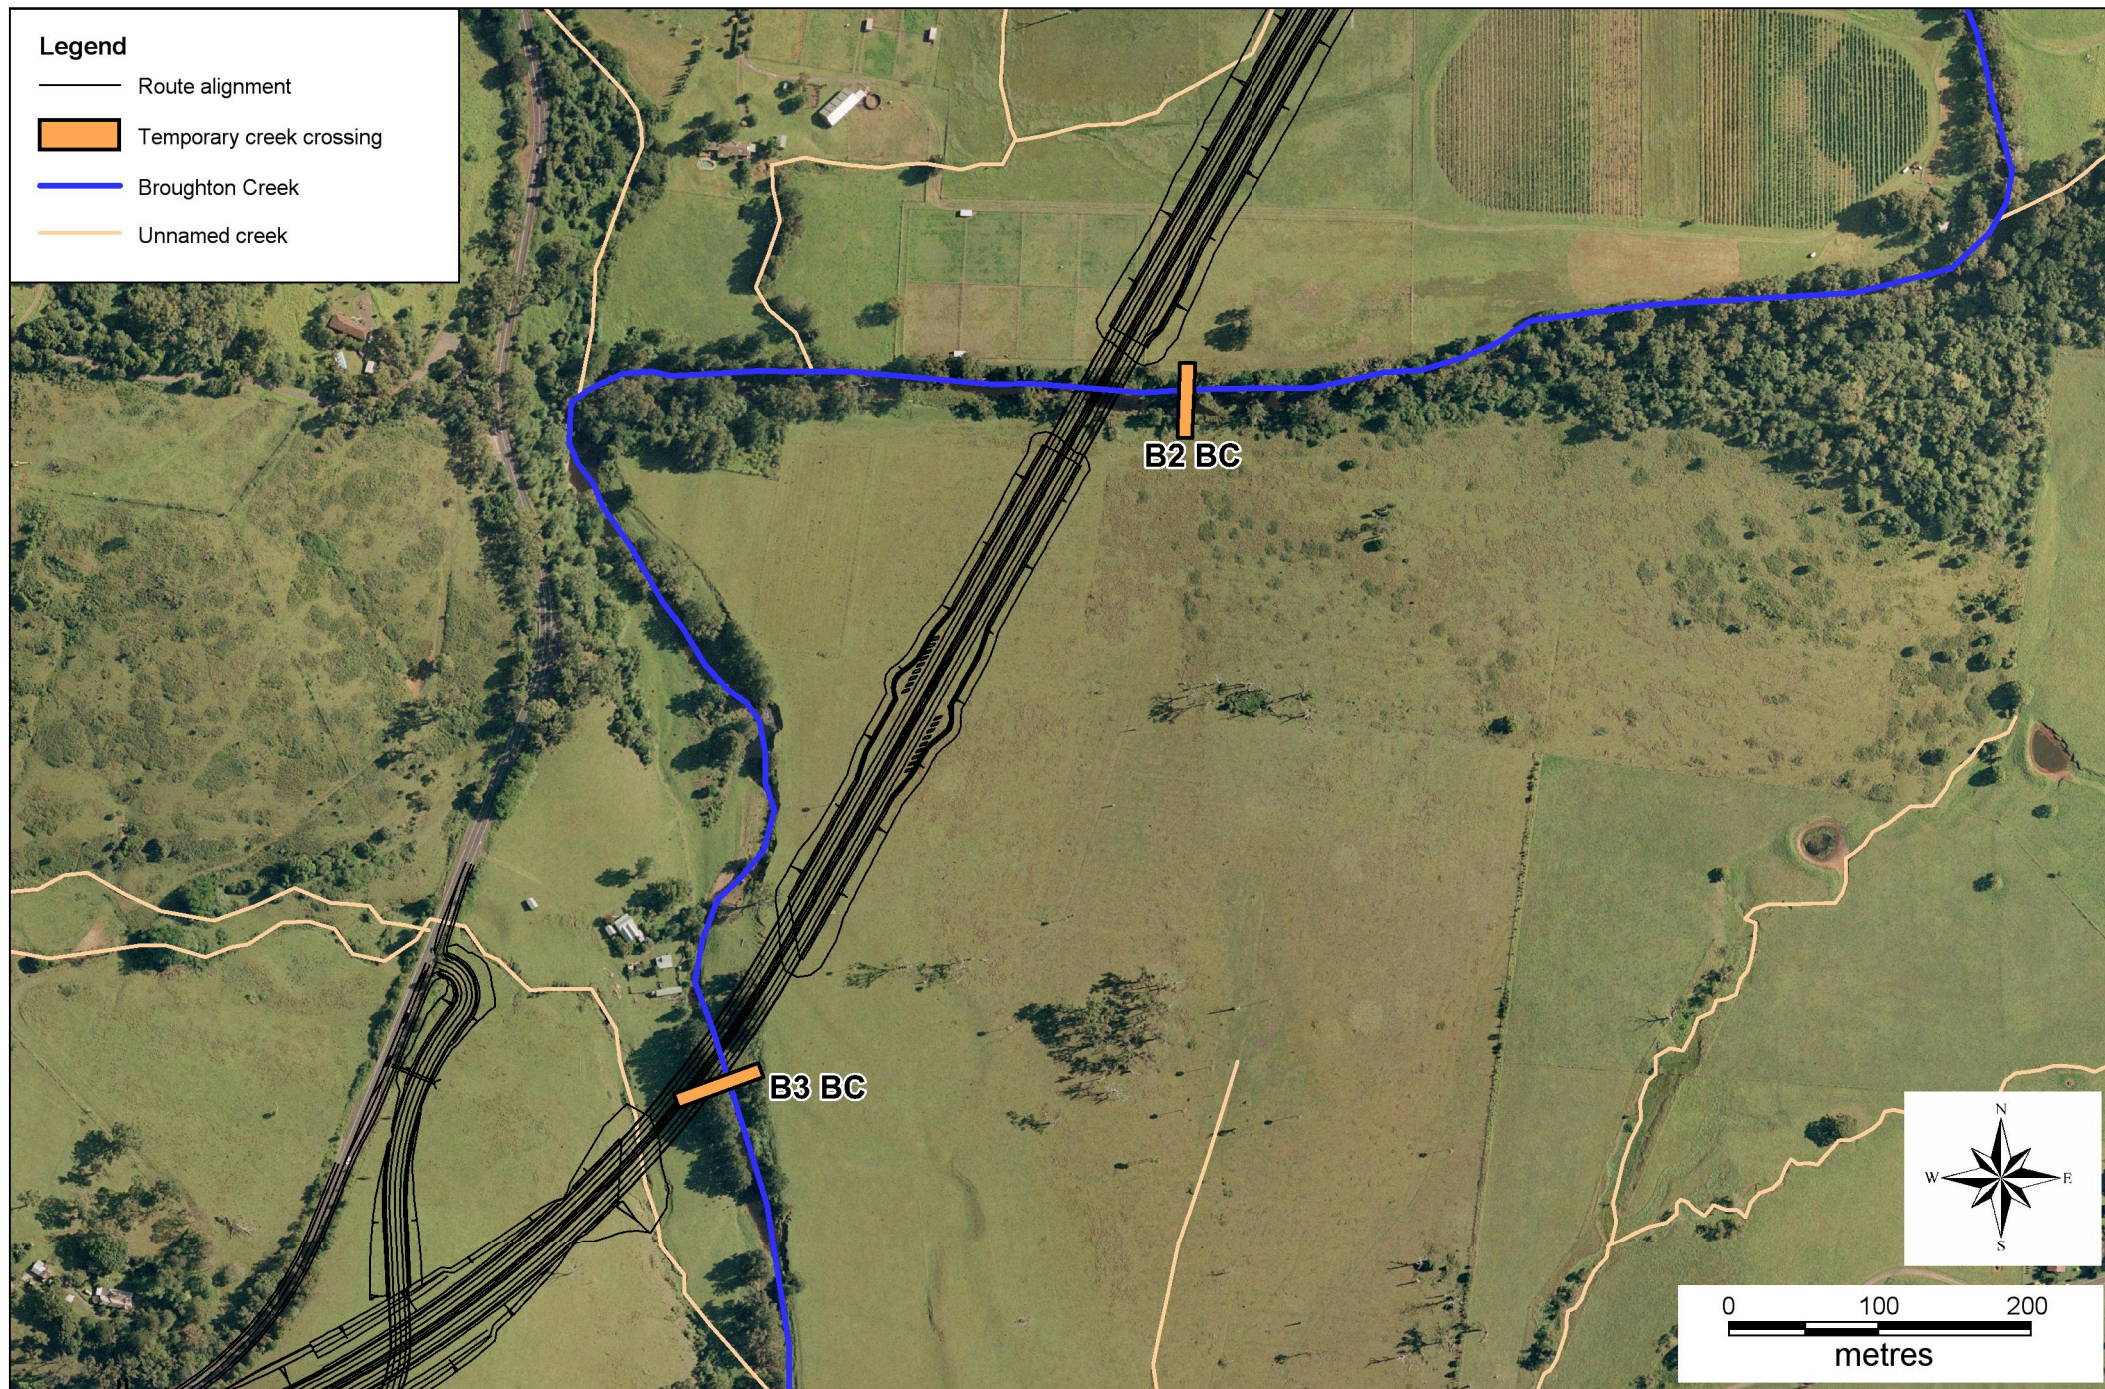
Figure 3.4: Temporary creek crossing sites for Bridge 2 and Bridge 3 at Broughton Creek. B2 BC = temporary crossing of Broughton Creek near proposed bridge 2.
B3 BC = temporary crossing of Broughton Creek near proposed bridge 3

Broughton Creek was a Class 1 waterway with respect to fish habitat and riparian classification at the location of the proposed Bridge 3 crossing. See Site 17 assessment (Section 3.2.2) for a complete description of aquatic ecology and water quality. The preferred temporary crossing site was located south of the proposed bridge structure, about 10 metres downstream and within the concept design footprint (B3 BC in **Figure 3.4, Table 3.7**). The crossing would pass over pool habitat about 15 metres across and over one metre deep and a channel bed dominated by cobble and boulders. There was a narrow but continuous stand of mature river oak along the western bank.

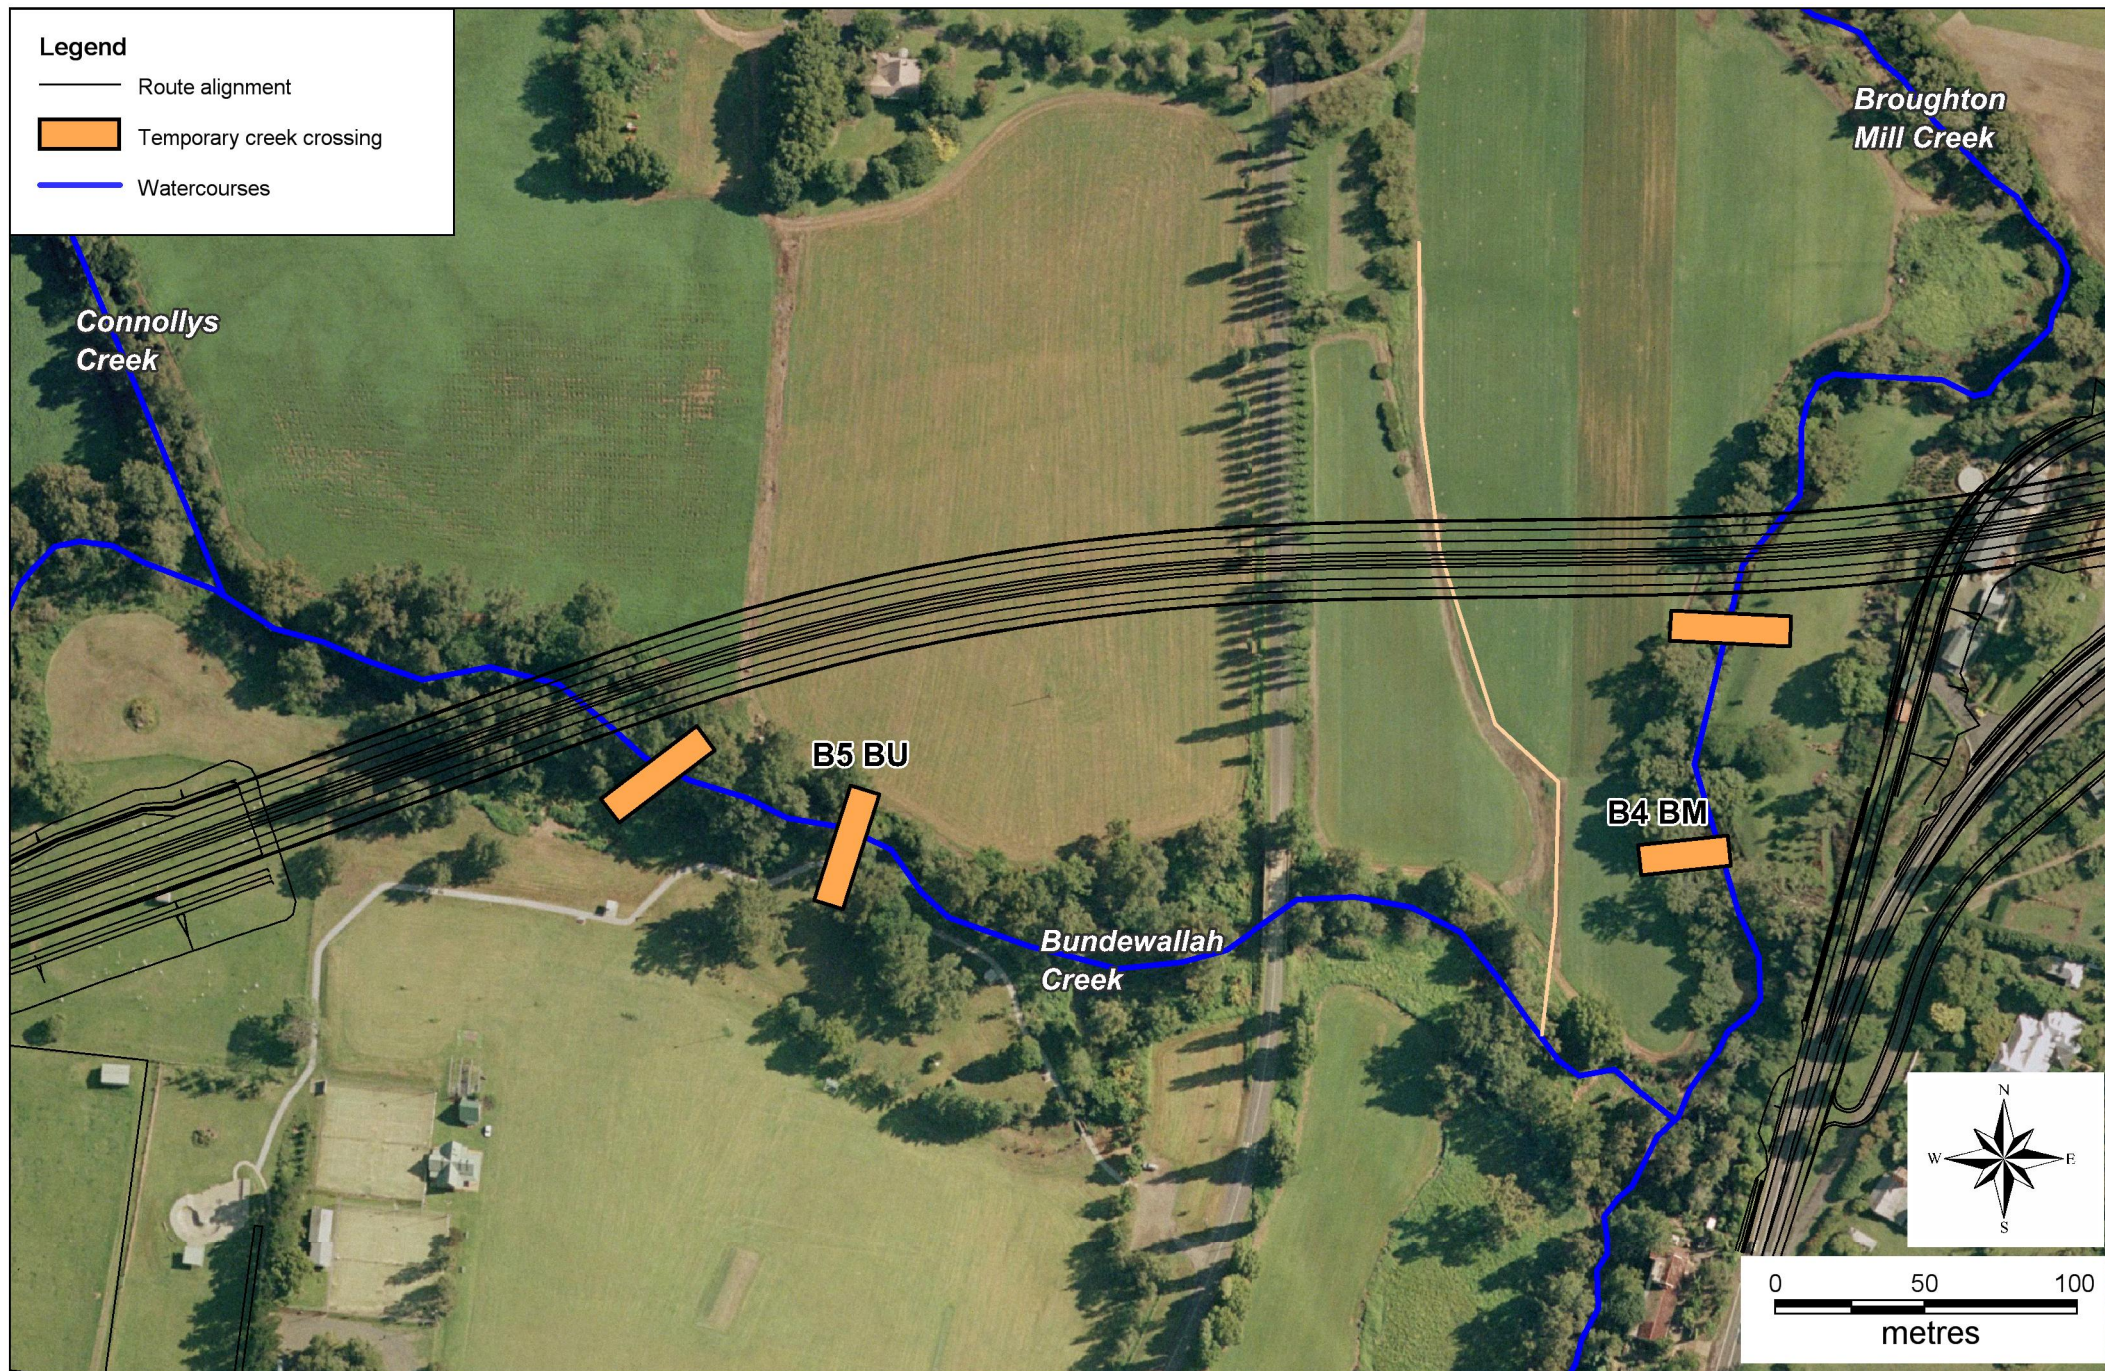
Figure 3.5: Temporary creek crossing sites for Bridge 4 at Bundewallah Creek and Broughton Mill Creek. B4 BM = temporary crossing of Broughton Mill Creek near proposed bridge 4. B4 BU = temporary crossing of Bundewallah Creek near proposed bridge 4

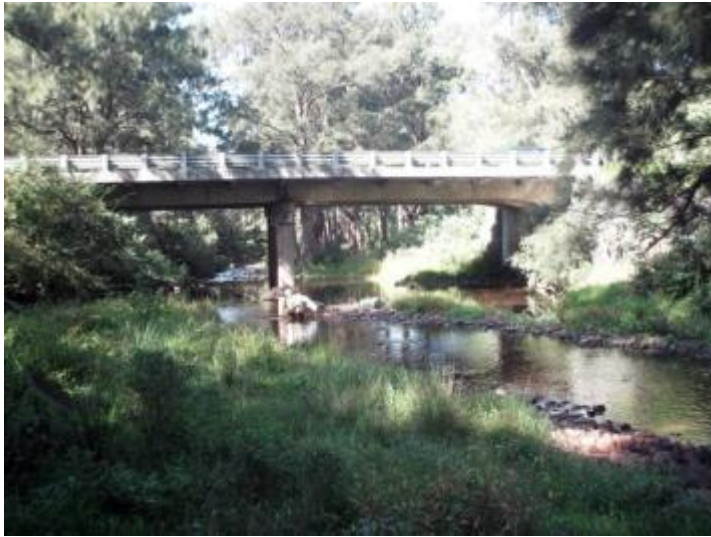
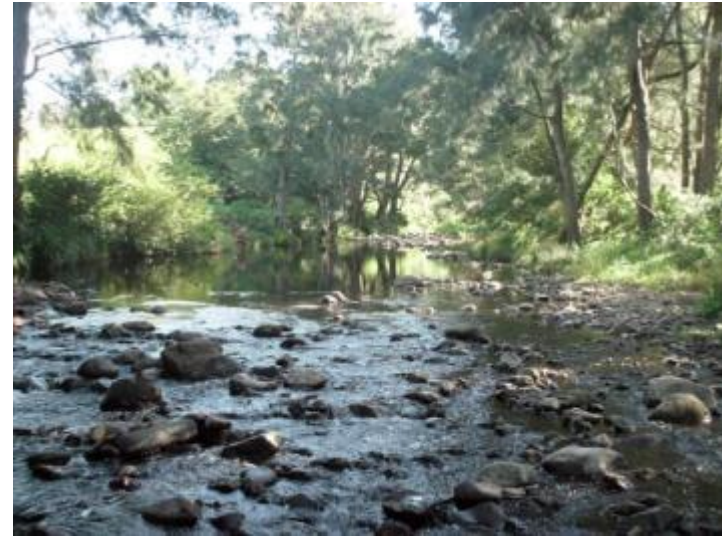
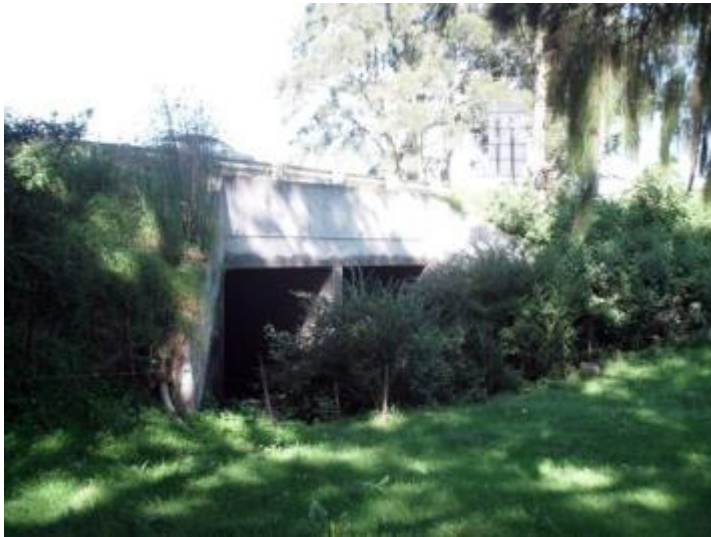
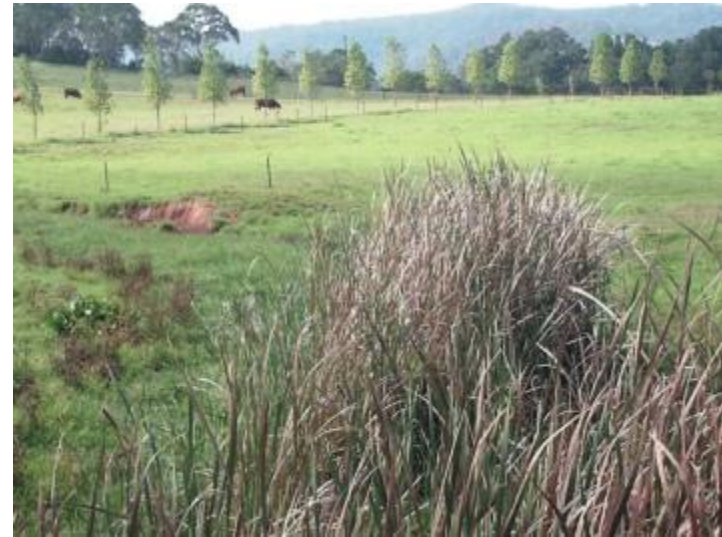
Plates 1a – 1d. (a) Site 13, view downstream of existing Princes Highway two span bridge crossing (b) Site 13, riffle habitat in the foreground and pool habitat upstream (c) Site 13, flood overflow culvert in Princes Highway embankment near the existing Broughton Creek bridge crossing (d) Watercourse at Site 14, view north from Princes Highway and stand of cumbungi (*Typha* sp.).

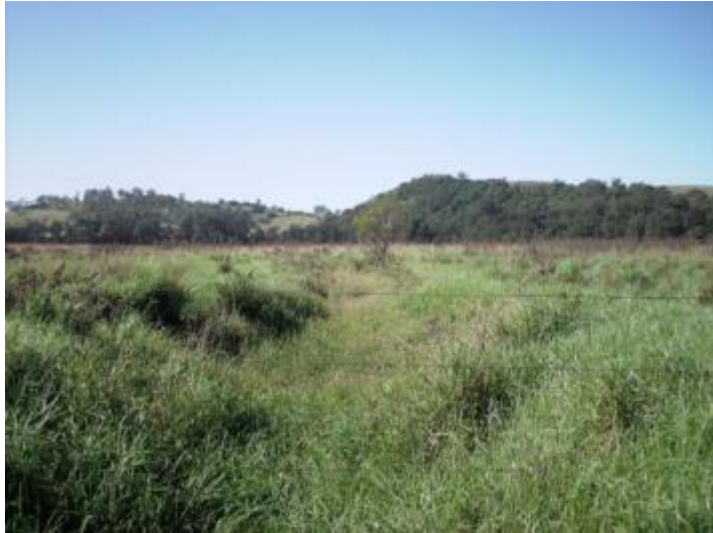
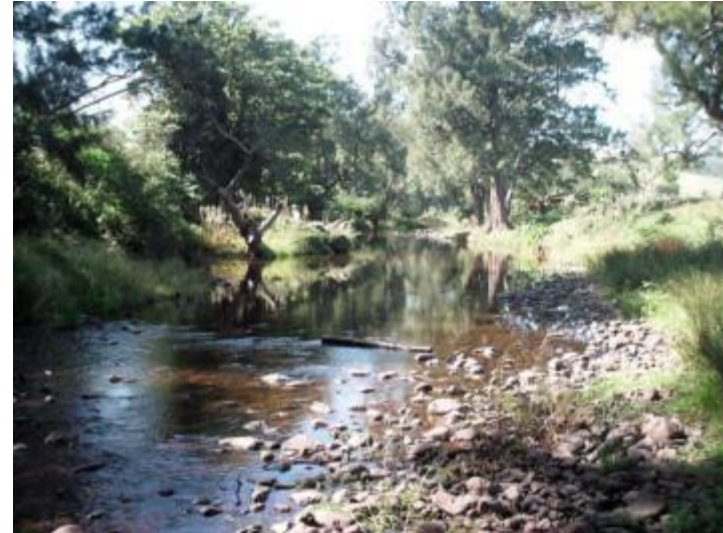
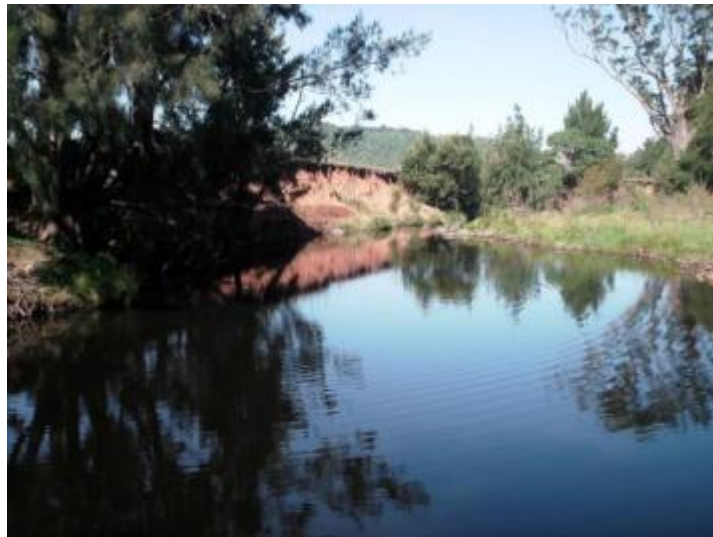
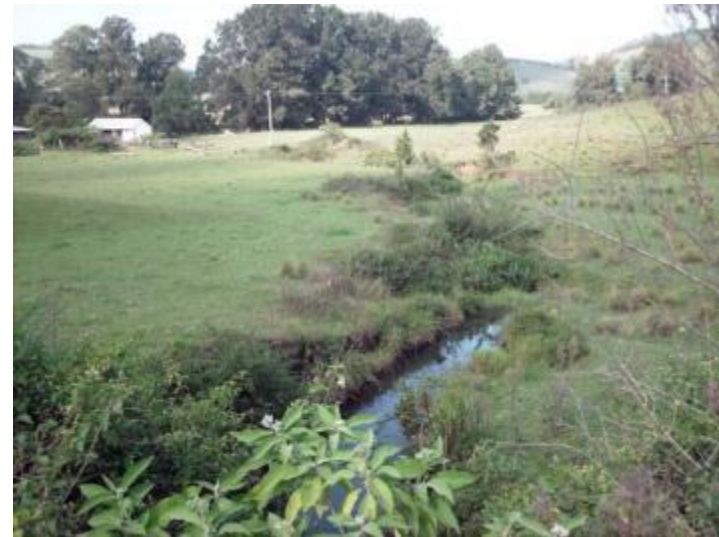
Plates 2a – 2d. (a) Site 15, view upstream from property road crossing (b) Site 16, view upstream from the proposed second crossing of Broughton Creek by the project (c) Deep pool at Site 17, area of proposed third crossing of Broughton Creek by the Foxground and Berry bypass project (d) Site 18, view downstream from Princes Highway. Larger trees in the background mark the channel of Broughton Creek.

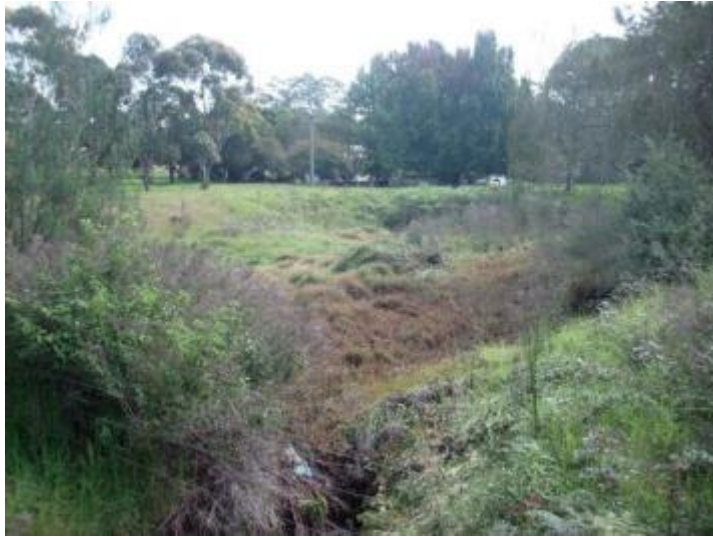
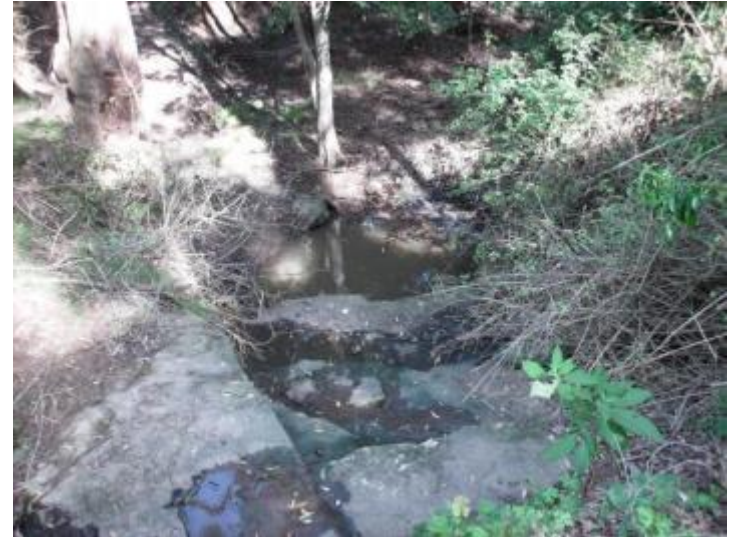
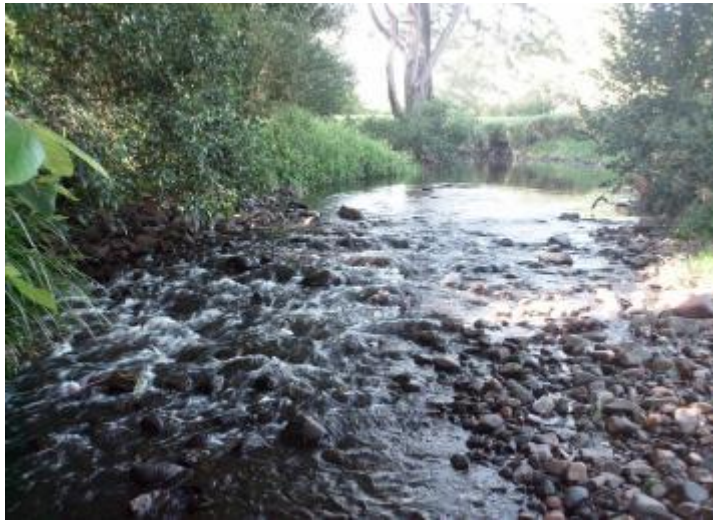
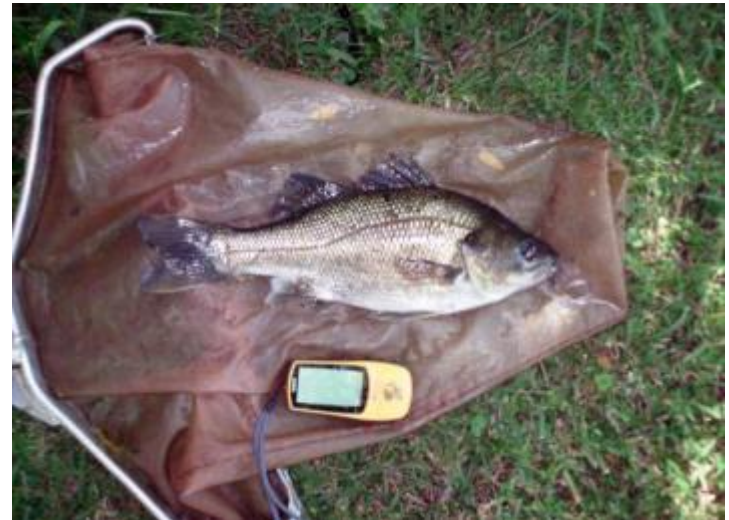
Plates 3a – 3d. (a) Site 22, view upstream from Princes Highway (b) Site 23, view downstream from Princes Highway crossing (c) Site 25, alternating riffle and pool habitat in Broughton Mill Creek (d) Australian bass (*Macquaria novemaculeata*) caught at Site 25, Broughton Mill Creek.
