Foxground and Berry bypass

Princes Highway upgrade

**Technical paper:
Aquatic ecology and
water quality management**

NOVEMBER 2012

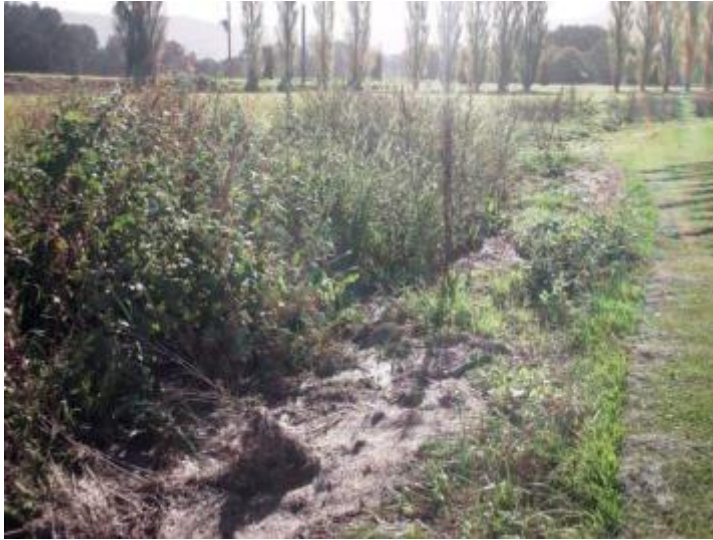
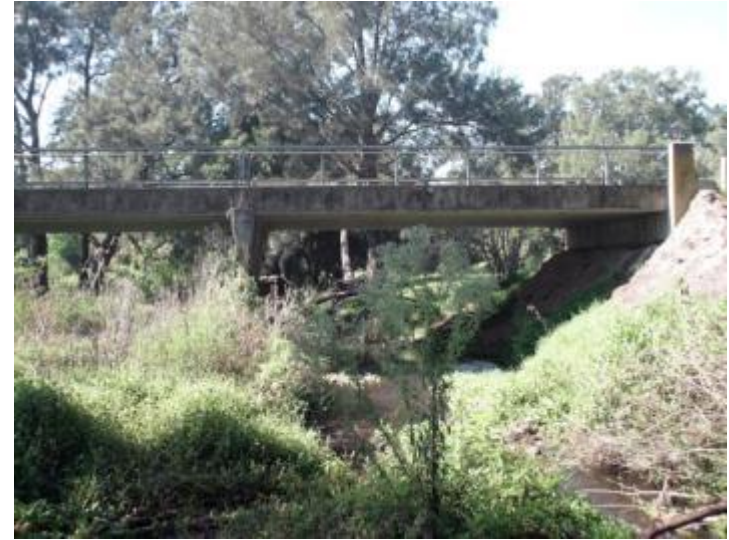
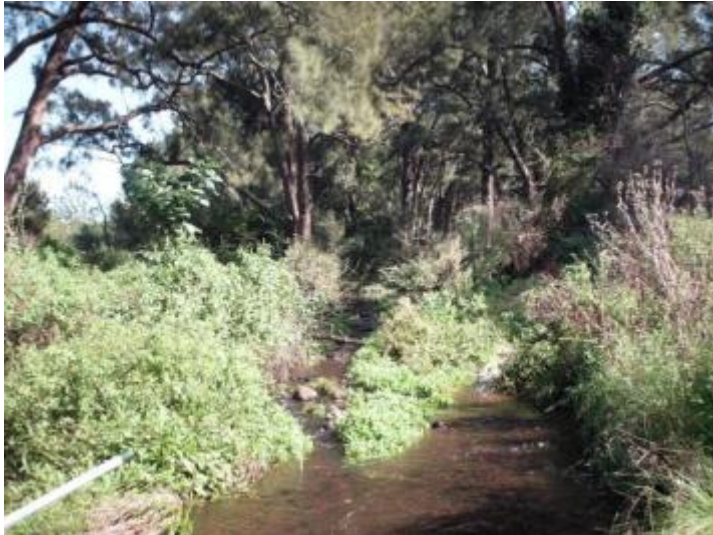
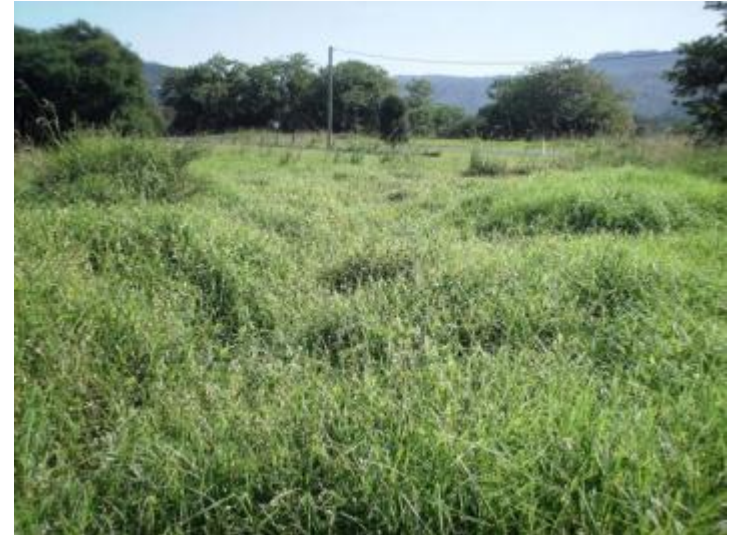
Plates 4a – 4d. (a) Site 26, ephemeral watercourse or drainage ditch lying in between Broughton Mill Creek and Woodhill Mountain Road (b) Site 27, Bundewallah Creek, view upstream (c) Site 28, Town Creek, view upstream to North Street (d) Site 29, view upstream from Princes Highway.
