# Foxground and Berry bypass

Princes Highway upgrade

**Volume 2 – Appendix J**

**Technical paper:  
Aboriginal heritage**

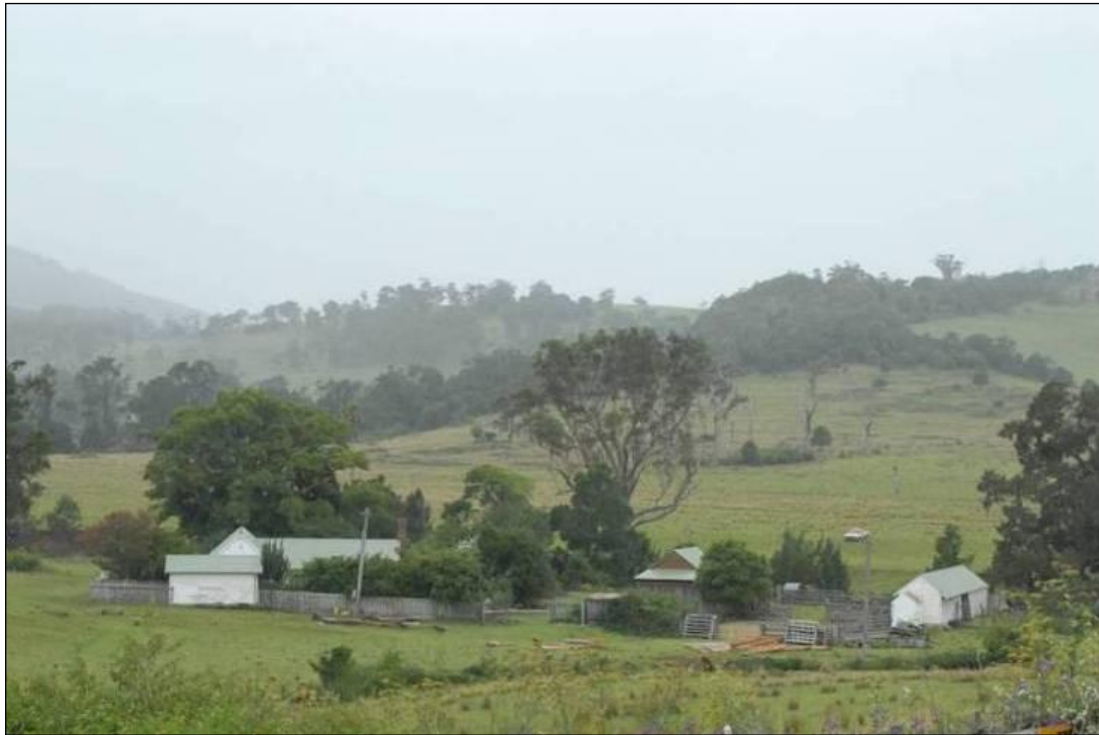
**Figure 4-2: View of 'Brookside' and the adjacent flats of Broughton Creek, at Broughton Village, looking north-east. The creek banks were recorded to be the site of historical Aboriginal encampments**

An area up to 200 metres from the eastern bank of Broughton Creek, and 350 metres up and downstream of the Brookside homestead has been identified as an area within which the Aboriginal encampment may have been situated (refer Appendix C.1).

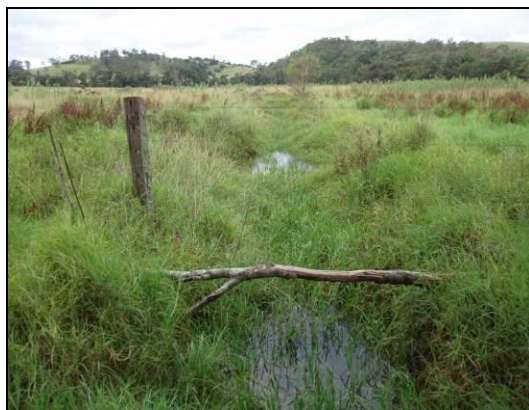
**Figure 4-4: Looking east along a drainage channel within a former wetland basin in the northwestern section of Richard Woods' land holding. This is a possible location for a natural 'Meadow' on Dicky Woods' property**

The other is situated just south and outside of the portion and forms the upper catchment of a small tributary draining the valley floor. Either of these may have supported a natural 'meadow' community and could have been associated with Woods' occupation of the valley floor. The northern basin, being situated mostly within Woods' property is therefore the most likely of these two options (**Figure 4-4 to Figure 4-9**).

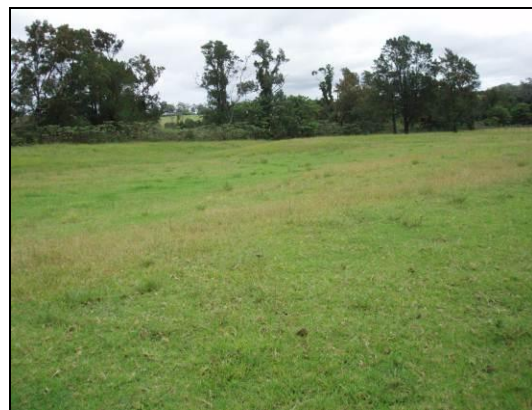
**Figure 4-5: Looking south towards Broughton Creek at the location of a proposed bridge crossing on the bypass alignment. This part of the alignment is situated within Dicky Woods' former land holding (portion 181)**

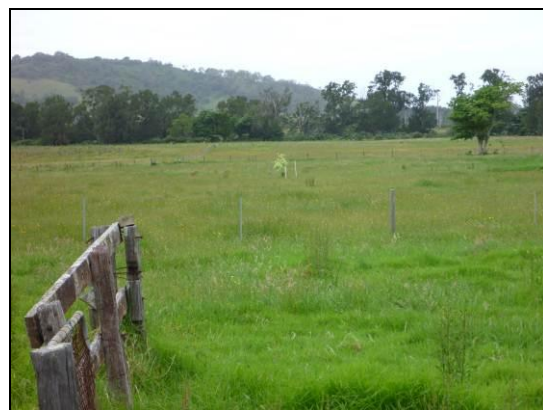
**Figure 4-7: A more distant view, looking south-east, of the same proposed bridge crossing site shown in Figure 4-4 (above). Note former wetland basin in middle left of picture**

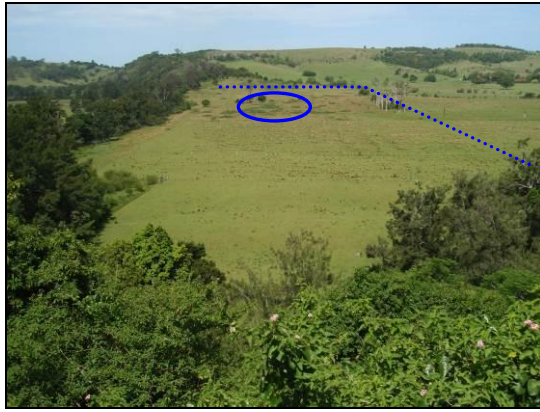
**Figure 4-8: View from the current highway, looking east towards that part of portion 181 situated south of Broughton Creek. The southern boundary is shown as a dotted blue line and the former homestead site is circled. If Dicky Woods' Meadow was a man-made forest clearing it was probably situated on these flats adjacent to the homestead.**

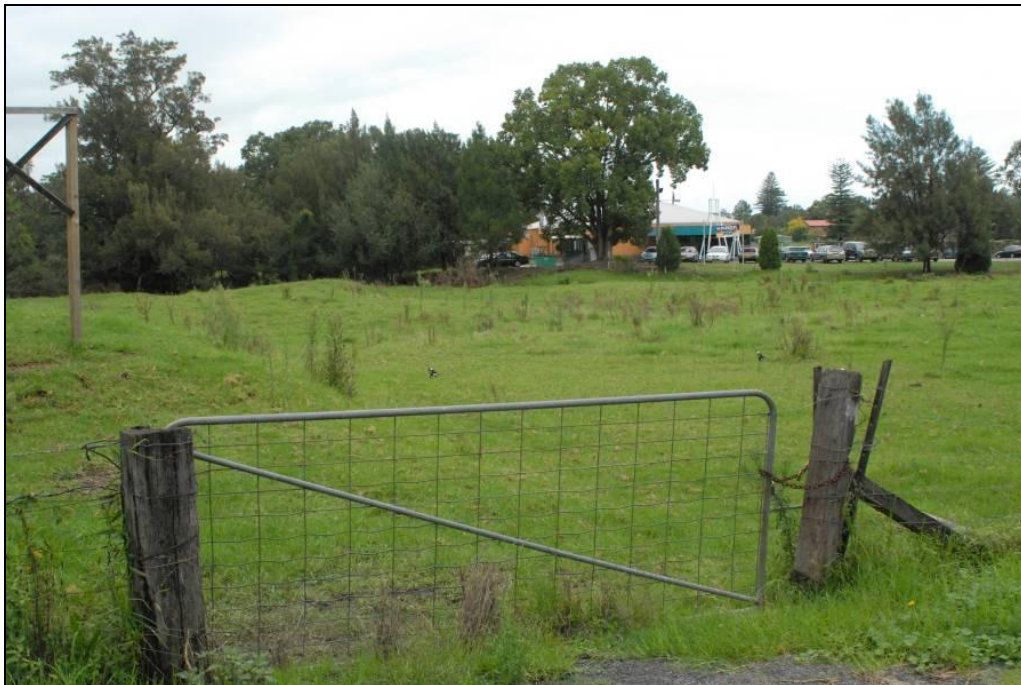
**Figure 4-12:** The flats where the Berry Bowling Club is now situated is the reported location of a former Aboriginal historic encampment. View looking south from the Princes Highway.

Barbara Timbery was born at Roseby Park in 1913. She recalls camping at the Berry Camp and being employed to pick beans on the local farms. The camp was situated on Broughton Creek, just before you get to the town, 'That's where we camped. There near the creek. That's up where the hospital is, across the bridge there. There's a club there now, but that's where we camped back then' (Barbara Timbery in DEC 2004:41). Her reference to the club indicates that the camp was situated on the western flats of Broughton Mill Creek, where the Berry Bowling Club is now situated (**Figure 4-12**).

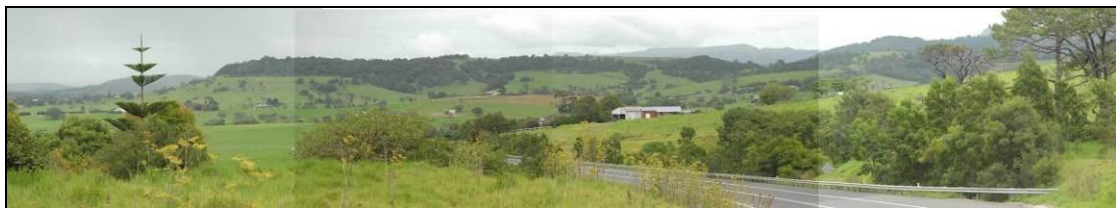
**Figure 4-13: Panoramic view of Toolijooa Ridge, looking west.**  
Bellawongarah Mountain is located in the upper far distance.

Toolijooa Ridge is a locally prominent ridgeline which extends across the coastal plain, southwards from Currys Mountain, (east of Foxground), to Toolijooa and Harley Hill in the south, (adjacent to Foys Swamp) (**Figure 4-13**).

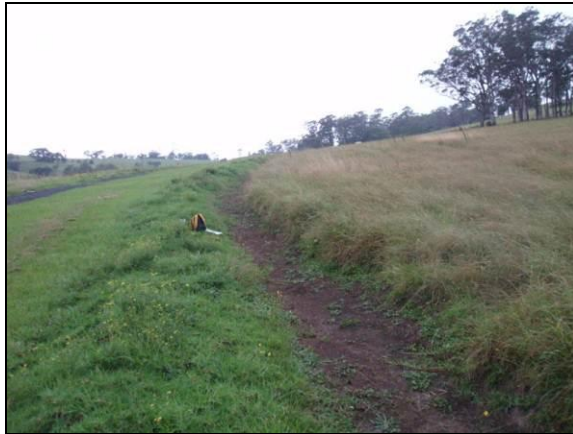
**Figure 6-1: G2B A3 - Looking upslope along drainage ditch in which artefacts are exposed**

The artefacts occur within an interval of 160 metres and have been exposed as a result of mechanical ground disturbance (**Figure 6-1** and **Figure 6-2**). No artefacts were noted outside of mechanical exposures. All artefacts appear to be associated with the upper 10 to 20 centimetres of the exposed soil profile.

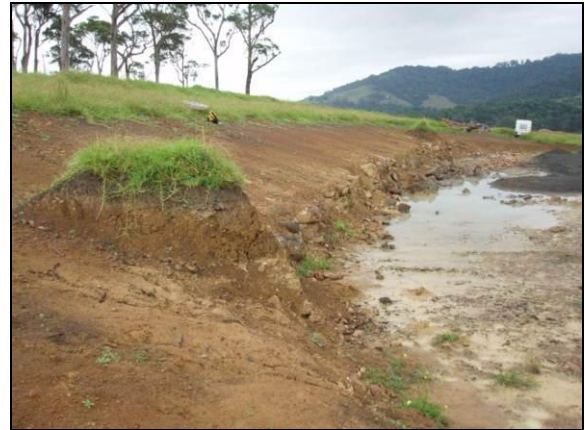
**Figure 6-2: G2B A3 – Looking across excavated platform, artefacts are exposed along upslope edge of embankment**

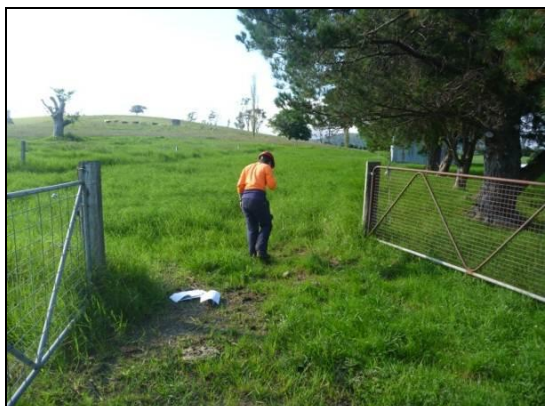
**Figure 6-3: Looking across the location of isolated surface find (G2B A38)**

This site consists of a single surface stone artefact and an associated area of assessed archaeological potential. It is located within a property being considered for use as an ancillary area (NOHC 2012). The artefact was located on the crest of a south facing, descending minor spur, in a basal slope valley context. The site overlooks an unnamed tributary of the Crooked River (**Figure 6-3**, **Figure 6-4** and **Figure 6-5**).

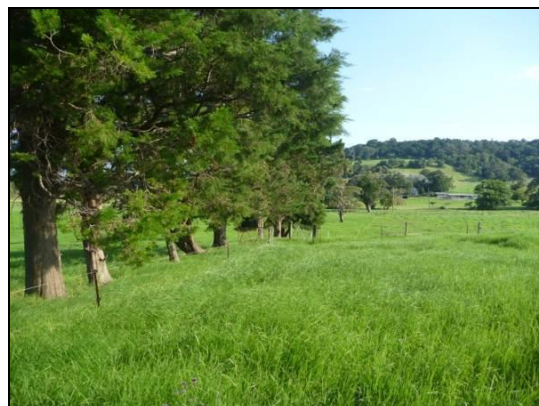
**Figure 6-4: Looking towards site G2B A 38 (at gate in middle of picture)**

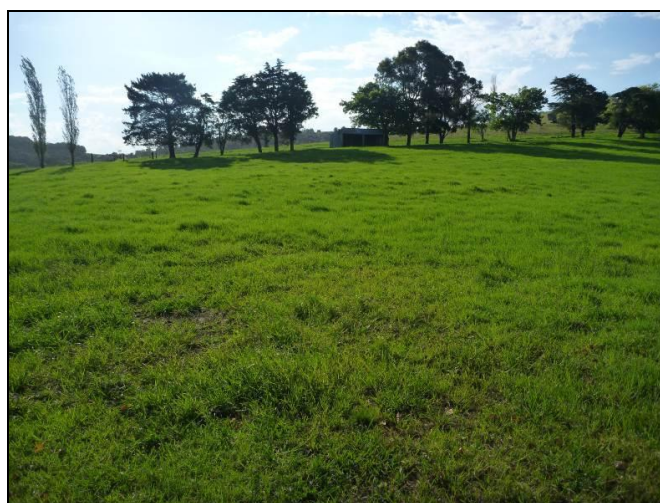
**Figure 6-5: Looking from the valley floor towards G2B A38 and the associated basal slopes which constitute a surrounding area of archaeological potential**

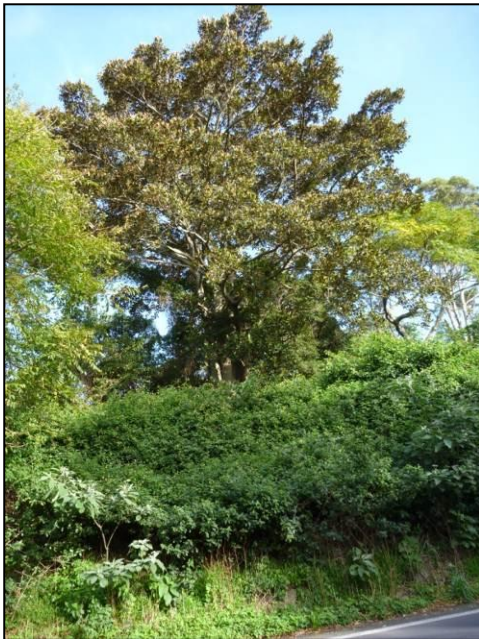
**Figure 6-9:** A low and spreading fig tree (MFT12) on the crest of Toolijooa Ridge. This is the only fig tree within the construction zone.

Only one of these trees, MFT12, located on the crest of Toolijooa Ridge, is situated within an area of anticipated direct construction impact. A review of aerial photography reveals that this tree has grown substantially since 1958, where it is evident as a relatively small tree (**Figure 6-9**).

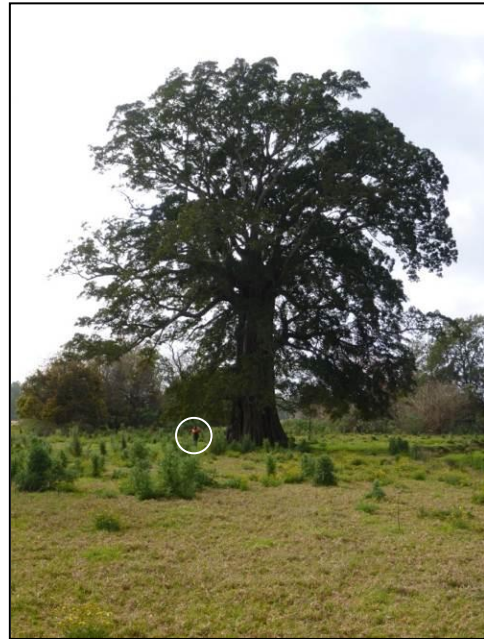
**Figure 6-10:** A tall and formerly epiphytic fig tree (MFT22) which is clearly a pre-European, tall canopy forest remnant. Note human figure for scale.

The exception is MFT22, which, by its growth pattern and height, is clearly an old-growth remnant of a high canopy forest and certainly predates the arrival of Europeans (**Figure 6-10 and Figure 6-12**).

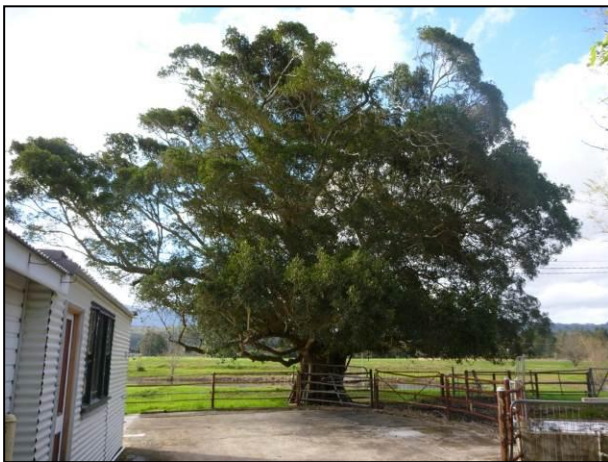
**Figure 6-11:** A low and spreading fig tree which was probably planted as part of farmhouse development (MFT23)

To date, twelve large or old growth fig trees (MFT12 – MFT23) have been noted within or near the project area (**Figure 6-9 – Figure 6-12**). With one exception, all of these are interpreted as trees which have grown and matured within an open grassland environment, after the clearance of the original high canopy forest. This assessment is based on the low and spreading nature of the trees and the absence of any evidence for an early epiphytic phase (i.e. early growth in the canopy branch of another tree and later strangulation of that tree). Based on the location of many of these trees at the sites of extant or former European homesteads, many of these examples are likely to have been planted (**Figure 6-11**).

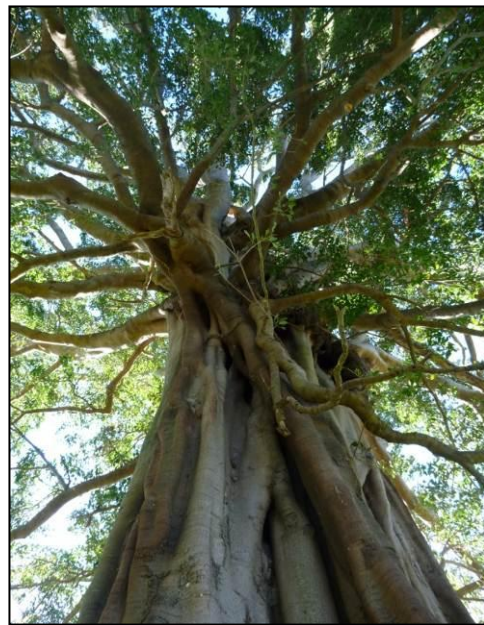
**Figure 6-12:** View looking up MFT22, showing characteristic 'strangler fig' nature of the tall trunk.

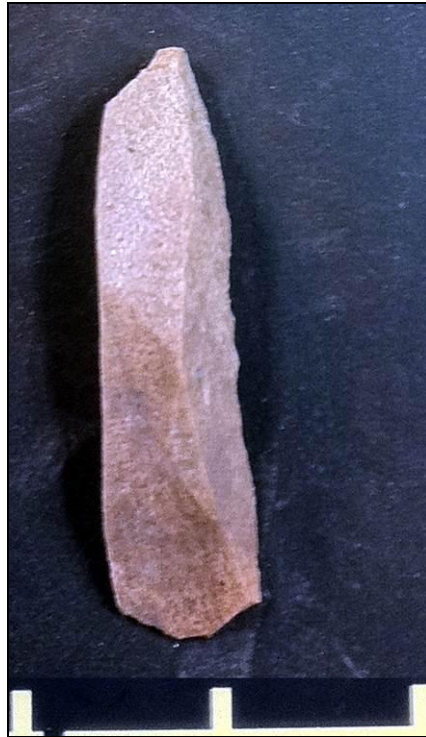
**Figure 7-11: Silcrete microblade (No.27)**

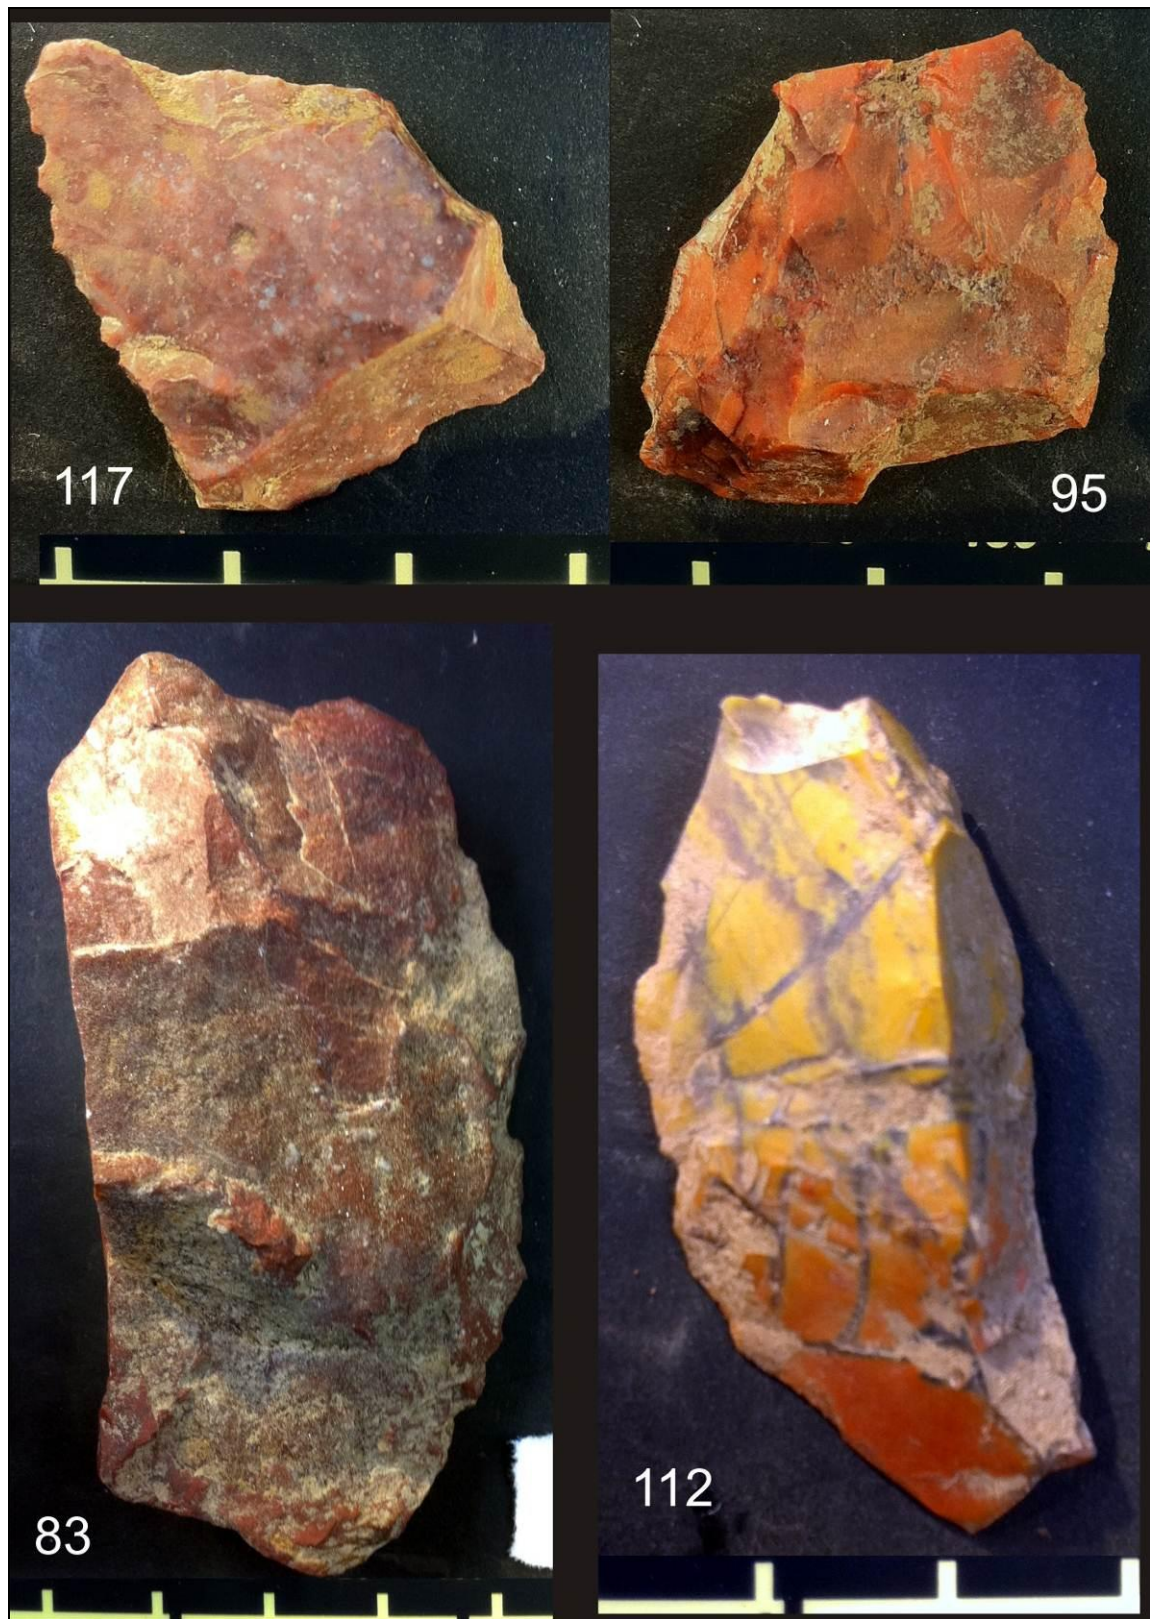
Figure 7-12: Some examples of complete chert flakes

**Figure 7-12** provides examples of complete flakes found in the project assemblage.

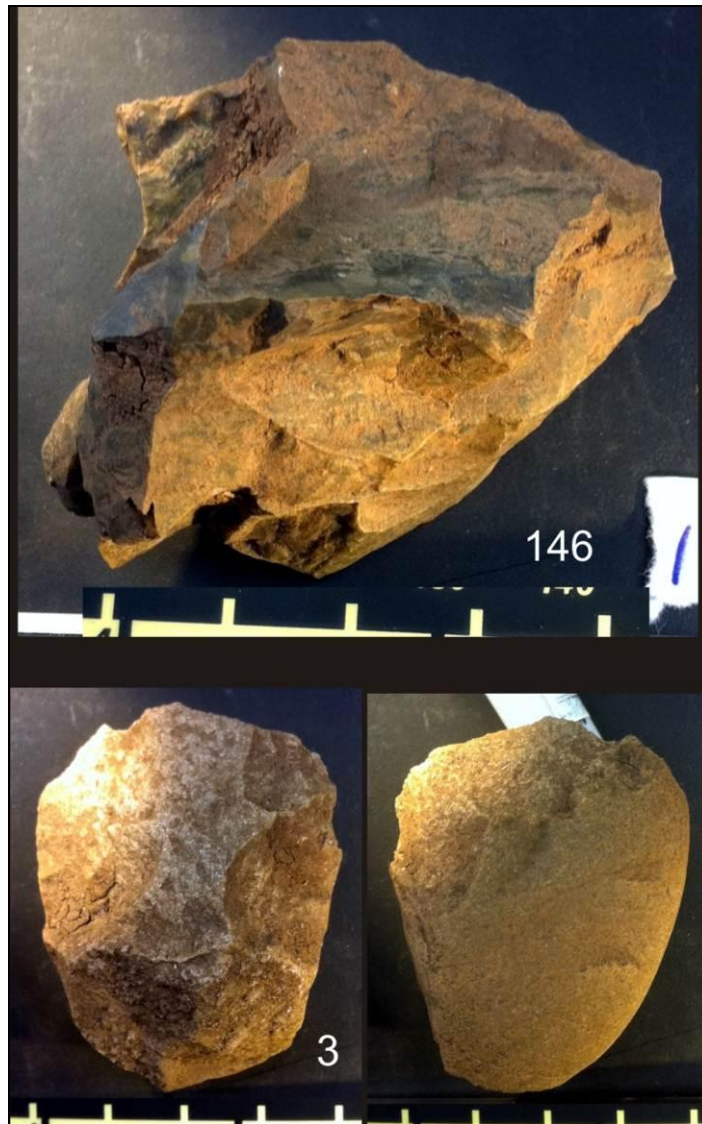
**Figure 7-13:** Examples of cores from the project assemblage. No.146 is an extensively rotated chert core. Number 3 is a quartzite core with a conchoidal platform

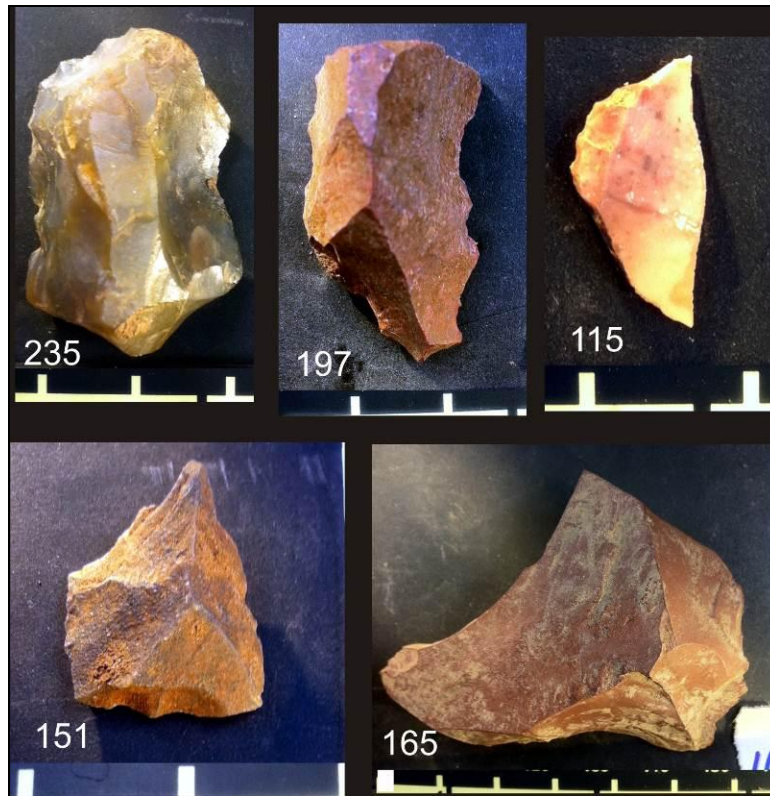
**Figure 7-14:** Retouched flakes from the project assemblages. 235: Notched double side and end scraper, 197: extensively retouched broken scraper, 115: asymmetric backed artefact, 151: end scraper, 165: notched broken scraper.

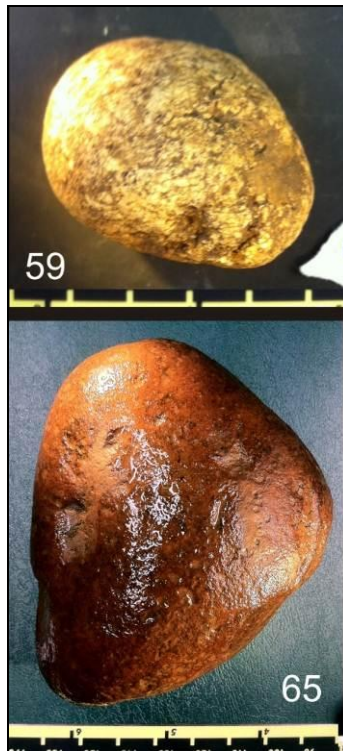
**Figure 7-15: Hammerstones and anvils. No. 59: Hammerstone and No.65: hammerstone with anvil pitting.**

Two are small hammerstones made from unidentified dense rock (probably plutonic or metamorphic) weighing around 70 grams (**Figure 7-15**). Both have broken areas that are suggestive of impact damage. The other hammerstone also shows impact pitting and was likely also used as an anvil. It is much larger and is made from softer stone, most likely mudstone.

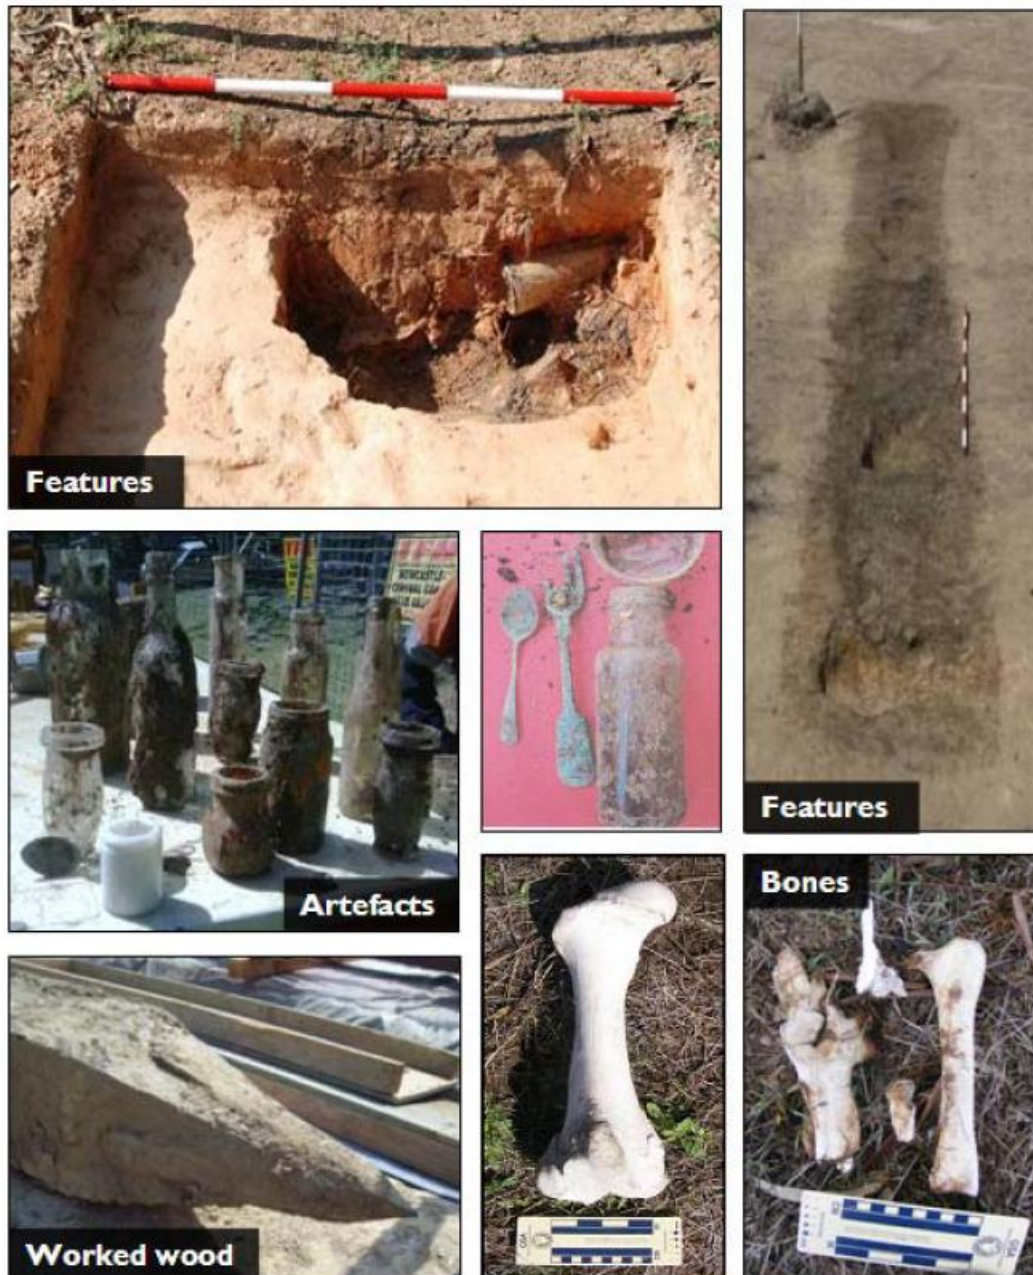
**Top left hand picture continuing clockwise:** Stock camp remnants (Hume Highway Bypass at Tarcutta); Linear archaeological feature with post holes (Hume Highway Duplication), Animal bones (Hume Highway Bypass at Woomargama); Cut wooden stake; Glass jars, bottles, spoon and fork recovered from refuse pit associated with a Newcastle Hotel (Pacific Highway, Adamstown Heights, Newcastle area).

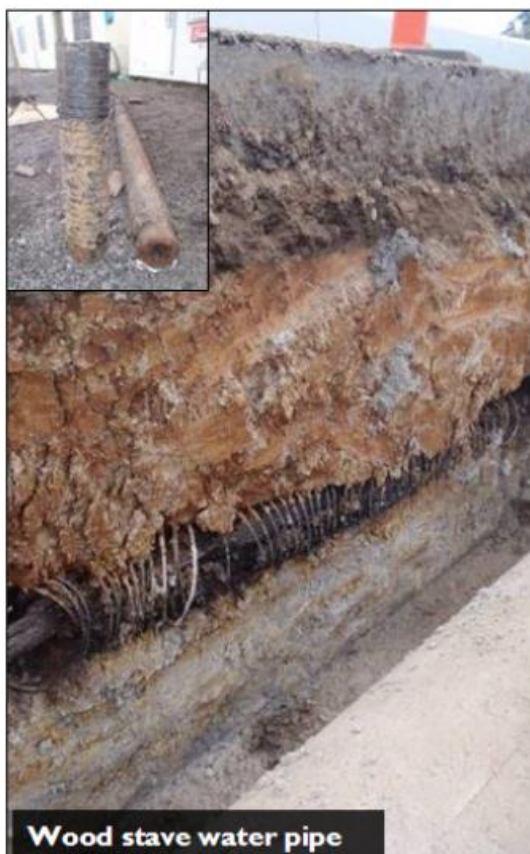
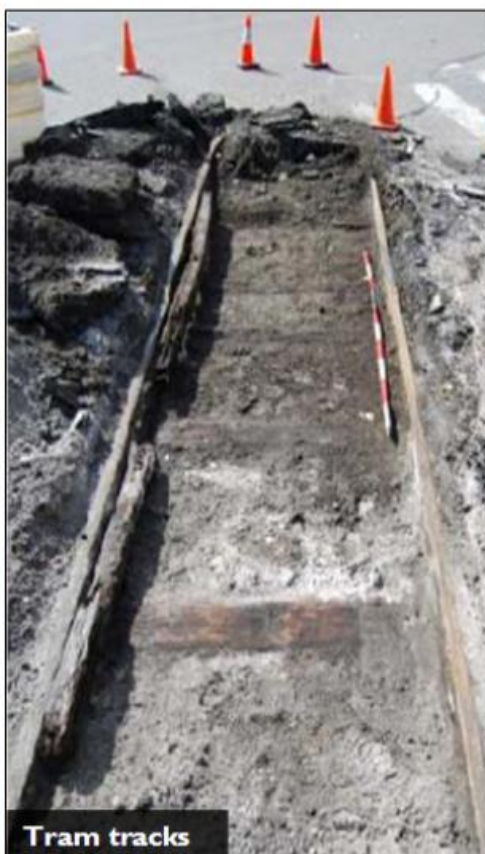
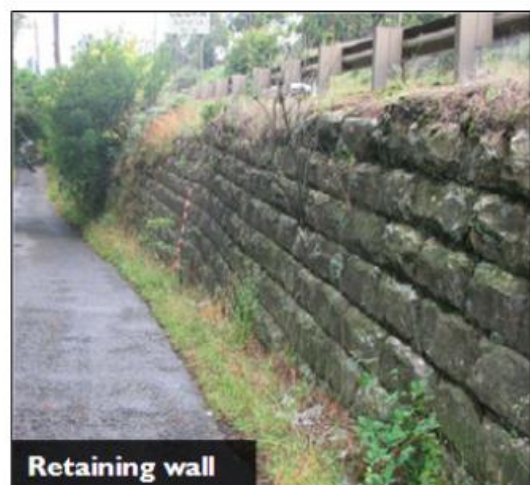
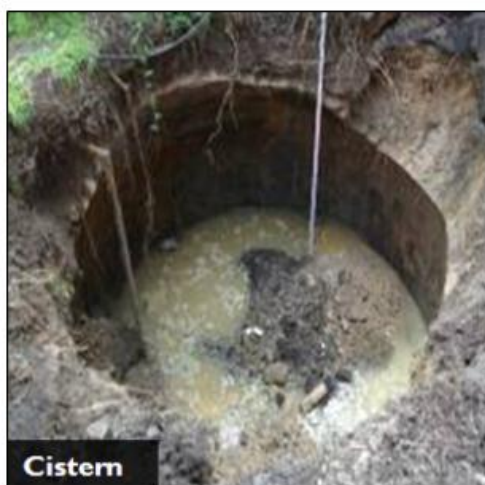
**Top left hand picture continuing clockwise:** Woodstave water pipe with tar and wire sealing (Horsley Drive); Tram tracks (Sydney); Brick lined cistern (Clyde); Retaining wall (Great Western Highway, Leura).

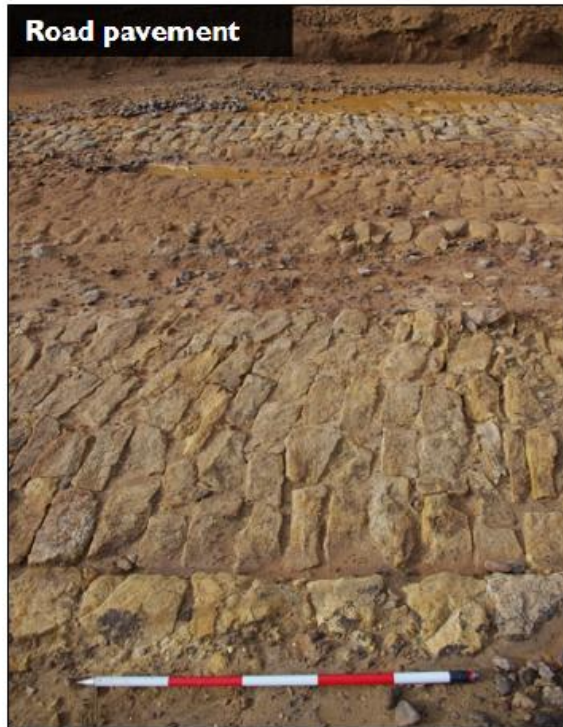
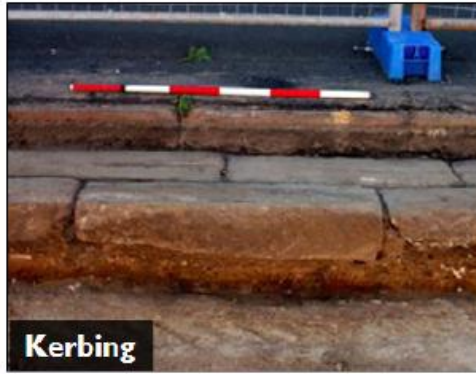
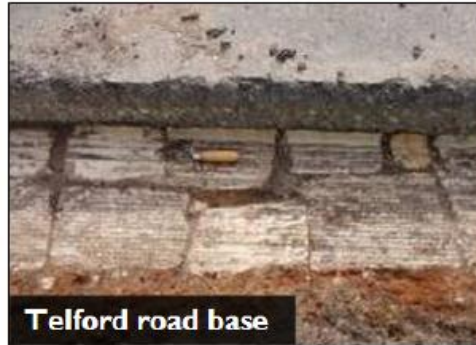
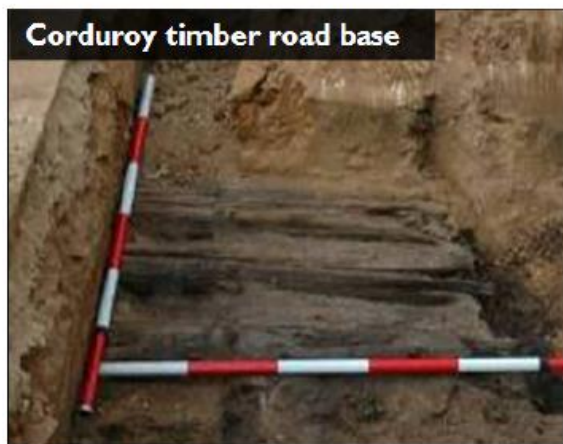
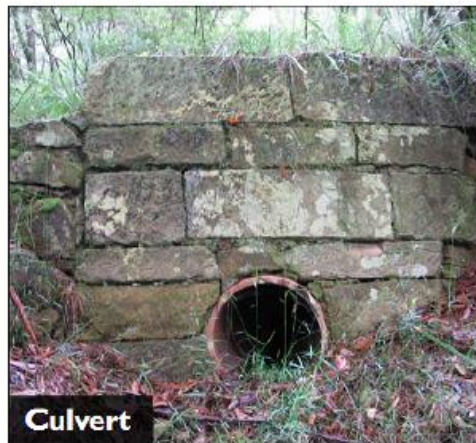
**Top left hand picture continuing clockwise:** Road pavement (Great Western Highway, Lawson); Sandstone kerbing and guttering (Parramatta Road, Mays Hill); Telford road (sandstone road base, Great Western Highway, Leura); Ceramic conduit and sandstone culvert headwall (Blue Mountains, NSW); Corduroy road (timber road base, Entrance Road, Wamberai).

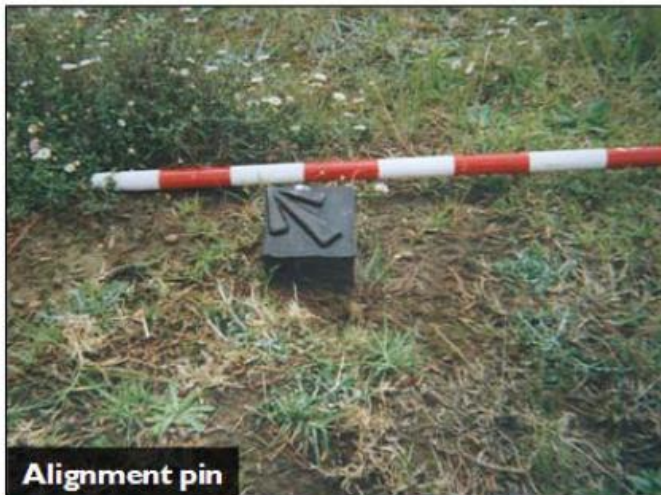
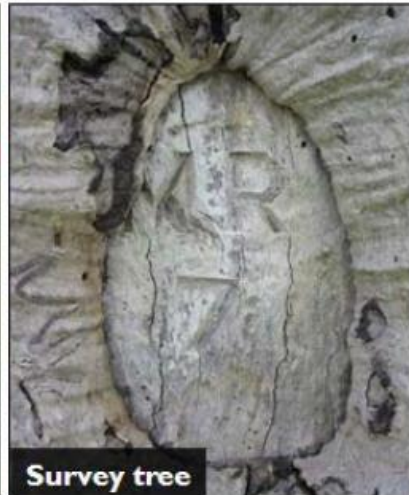
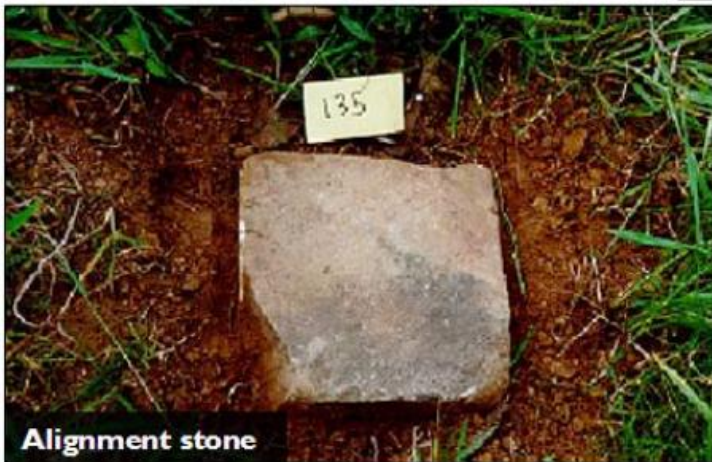
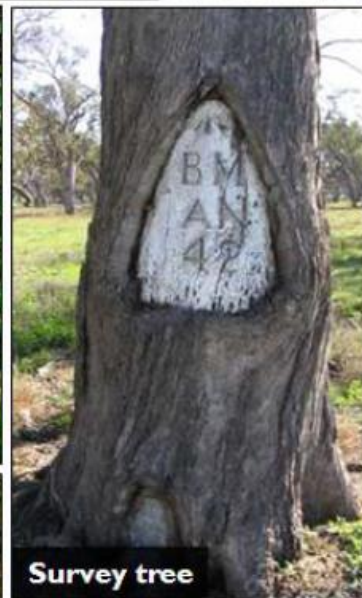
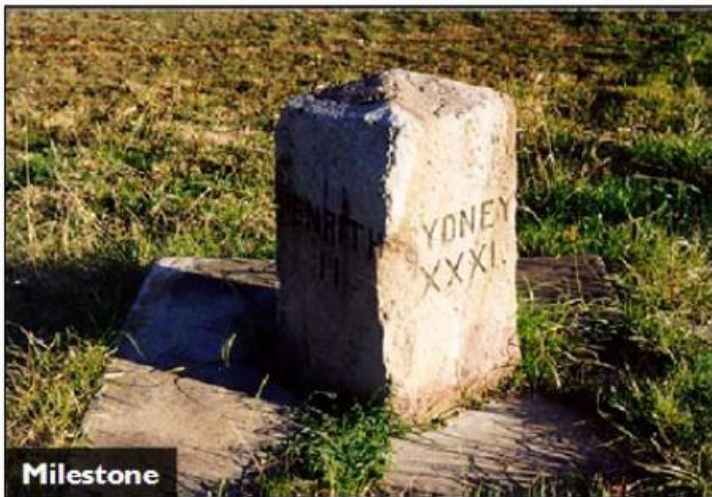
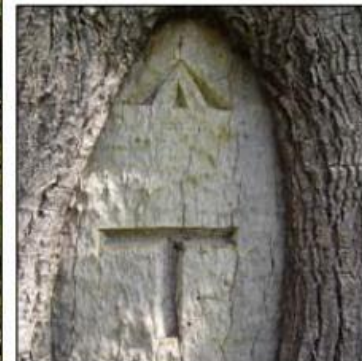
**Top left hand corner continuing clockwise:** Alignment Pin (Great Western Highway, Wentworth Falls); Survey tree (MR7, Albury); Survey tree (Kidman Way, Darlington Point, Murrumbidgee); Survey tree (Cobb Highway, Deniliquin); Milestone (Great Western Highway, Kingswood, Penrith); Alignment Stone (near Guntawong Road, Riverstone). Please note survey marks may have additional statutory protection under the *Surveying and Spatial Information Act 2002*.

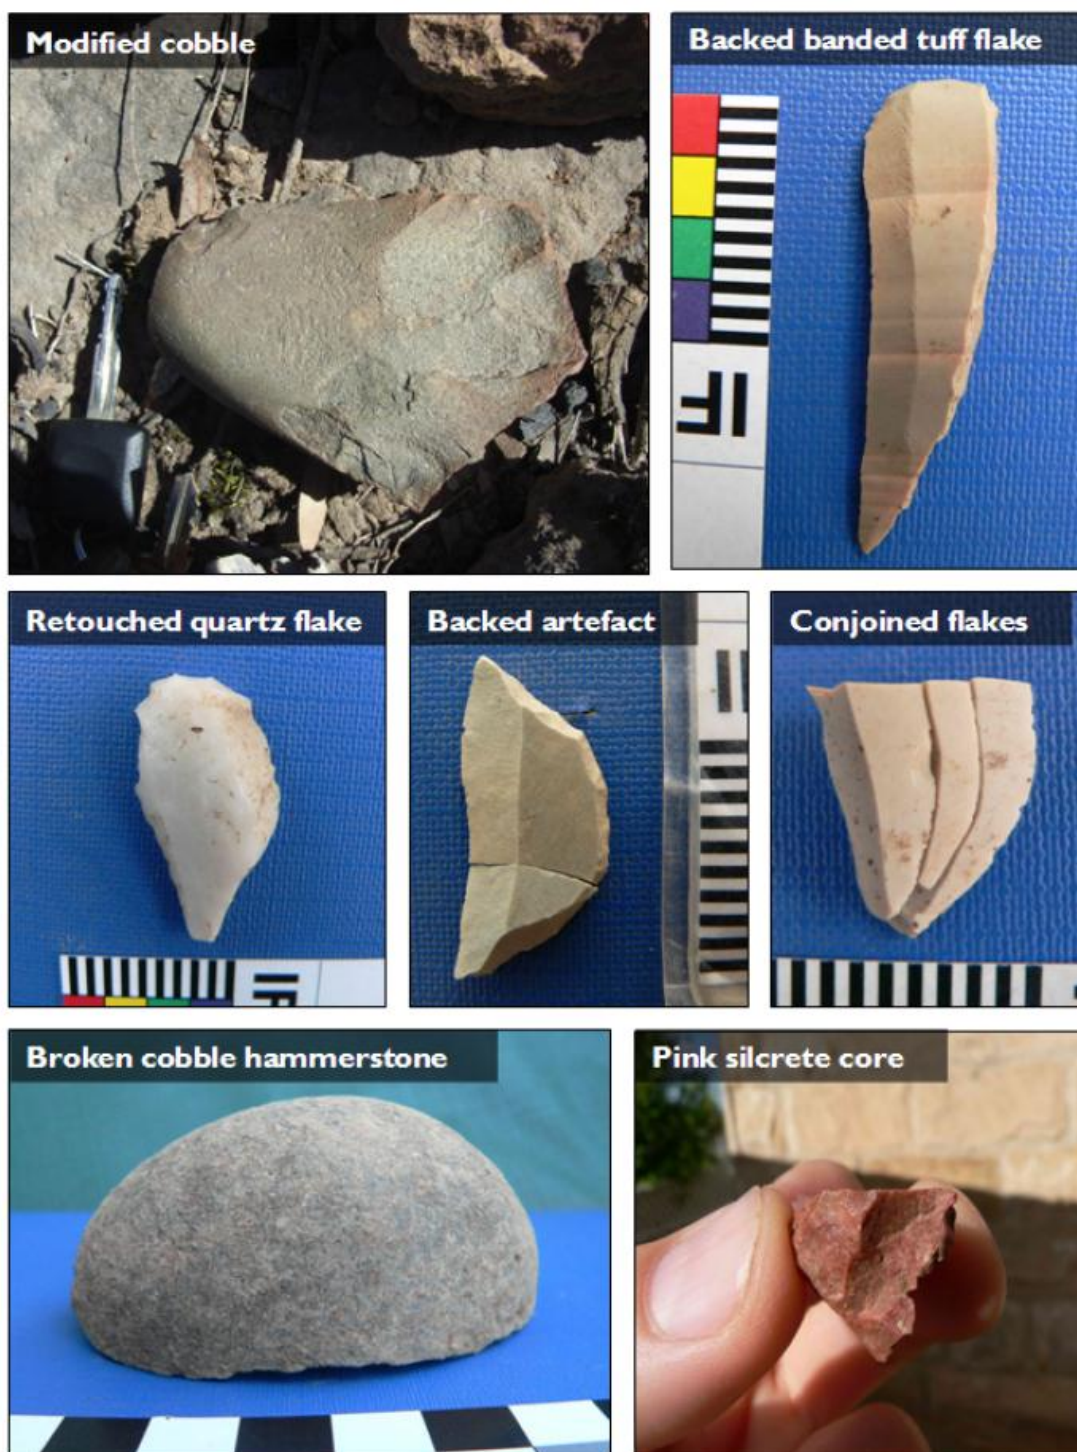
**Top left hand corner:** Culturally modified stone discovered on Main Road 92, about two kilometres west of Sassafras. The rest of the images show a selection of stone artefacts retrieved from test and salvage archaeological excavations during the Hume Highway Duplication and Bypass projects from 2006-2010.

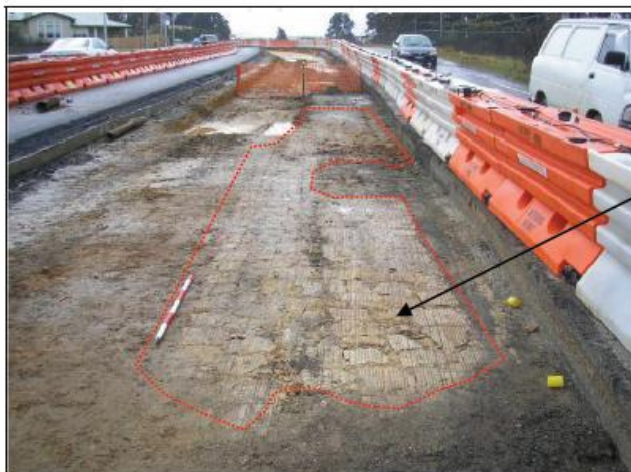
**Figure 1:** Telford road uncovered on the Great Western Highway (Leura) in 2008.

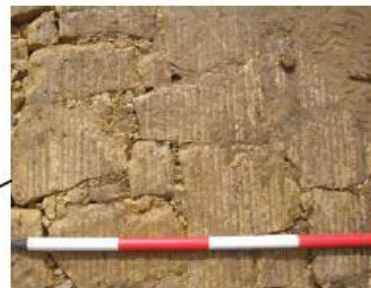
**Figure 2:** Close up detail of the sandstone surface showing material type, formation and construction detail. This is essential for establishing date of the feature.

It is important to take a general photograph (Figure 1) to convey the location and setting of the find. This will add much value to the subsequent detailed photographs also required (Figure 2).

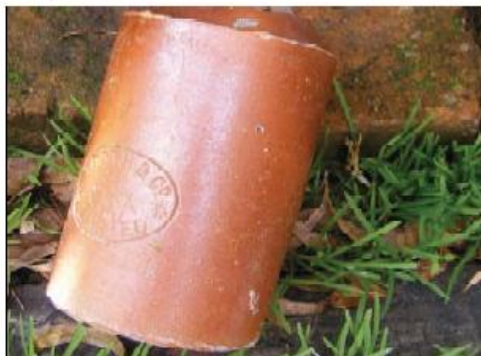
**Figure 3:** Ceramic bottle artefact with stamp.

Where unexpected finds (eg artefacts) have a distinguishing feature, close up detailed photographs must be taken of this, where practicable. See Figures 3 and 4 for examples.

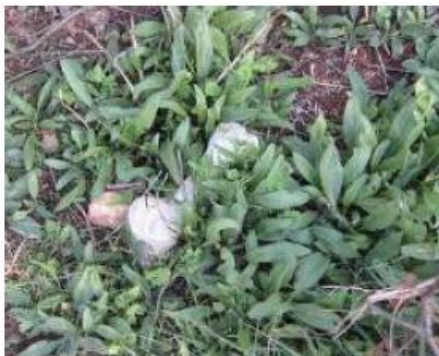
Figure 5: Bone concealed by foliage.

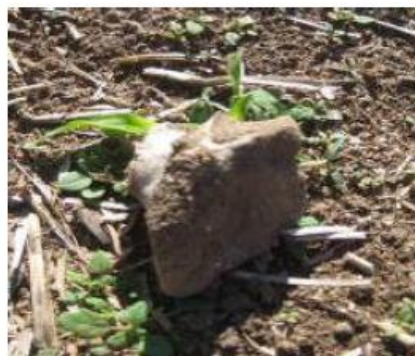
Figure 6: Bone covered in sediment

The majority of bones found on site will be those of recently deceased animal bones often requiring no further assessment (unless they are in archaeological context). However, if bones are human RMS must contact the police immediately (see Appendix F for detailed guidance). Taking quality photographs of the bones can often resolve this issue quickly. Heritage staff in Environment Branch can confirm if bones are human or non-human if provided with appropriate photographs. Ensure that photographs of bones are not concealed by foliage (Figure 5) as this makes it difficult to identify. Minor hand removal of foliage can be undertaken as long as disturbance of the bone does not occur. Excavation of the ground to remove bone(s) should not occur, nor should they be pulled out of the ground if partially exposed. Where sediment (adhering to a bone found on the ground surface) conceals portions of a bone (Figure 6) ensure the photograph is taken of the bone (if any) that is not concealed by sediment.

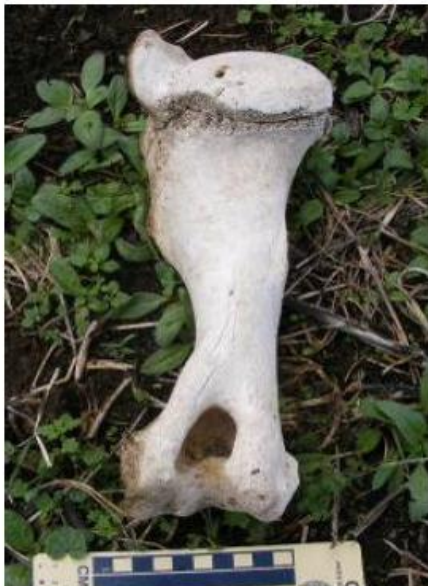
Figure 7: Photograph showing complete bone.

Ensure that all close up photographs include the whole bone and then specific details of the bone (especially the ends of long bones, the *epiphysis*, which is critical for species identification). Figures 7 and 8 are examples of good photographs of bones that can easily be identified from the photograph alone. They show sufficient detail of the complete bone and the epiphysis.

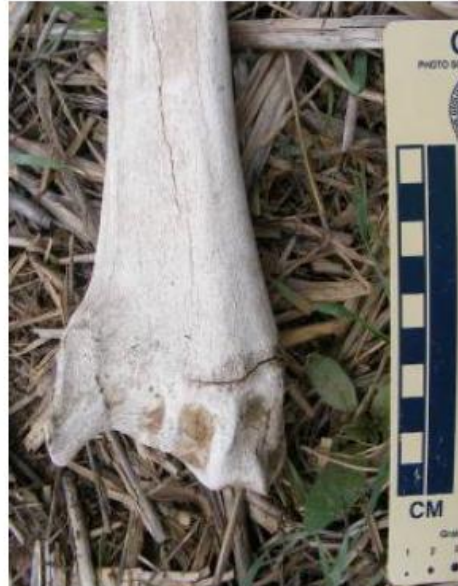
Figure 8: Close up of a long bone's epiphysis.

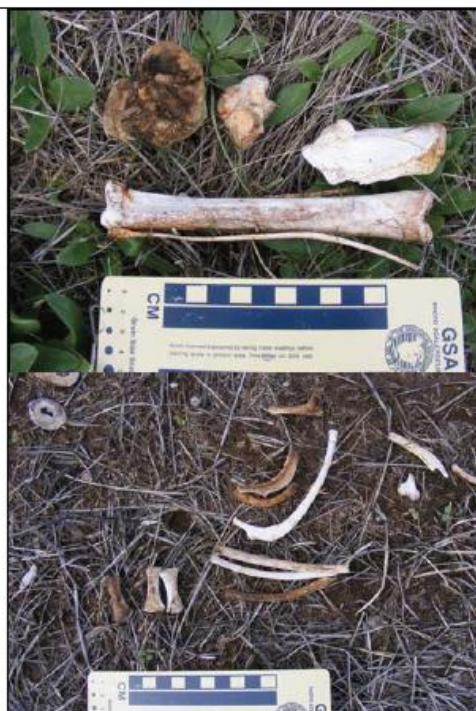
**Figure 2:** Disarticulated bones that require assessment to determine species.

Where it is not 'obvious' that the bones are human (in the majority of cases, illustrated by Figure 2), specialist assessment is required to establish the species of the bones. Photographs of the bones can assist this assessment if they are clear and taken in accordance with guidance provided in Appendix D. Good photographs often result in the bones being identified by a specialist without requiring a site visit; noting they are nearly always non-human. In these cases, non-human skeletal remains must be treated like any other unexpected archaeological find.
