# Foxground and Berry bypass

Princes Highway upgrade

**Technical paper:  
Aquatic ecology and  
water quality management**

**NOVEMBER 2012**

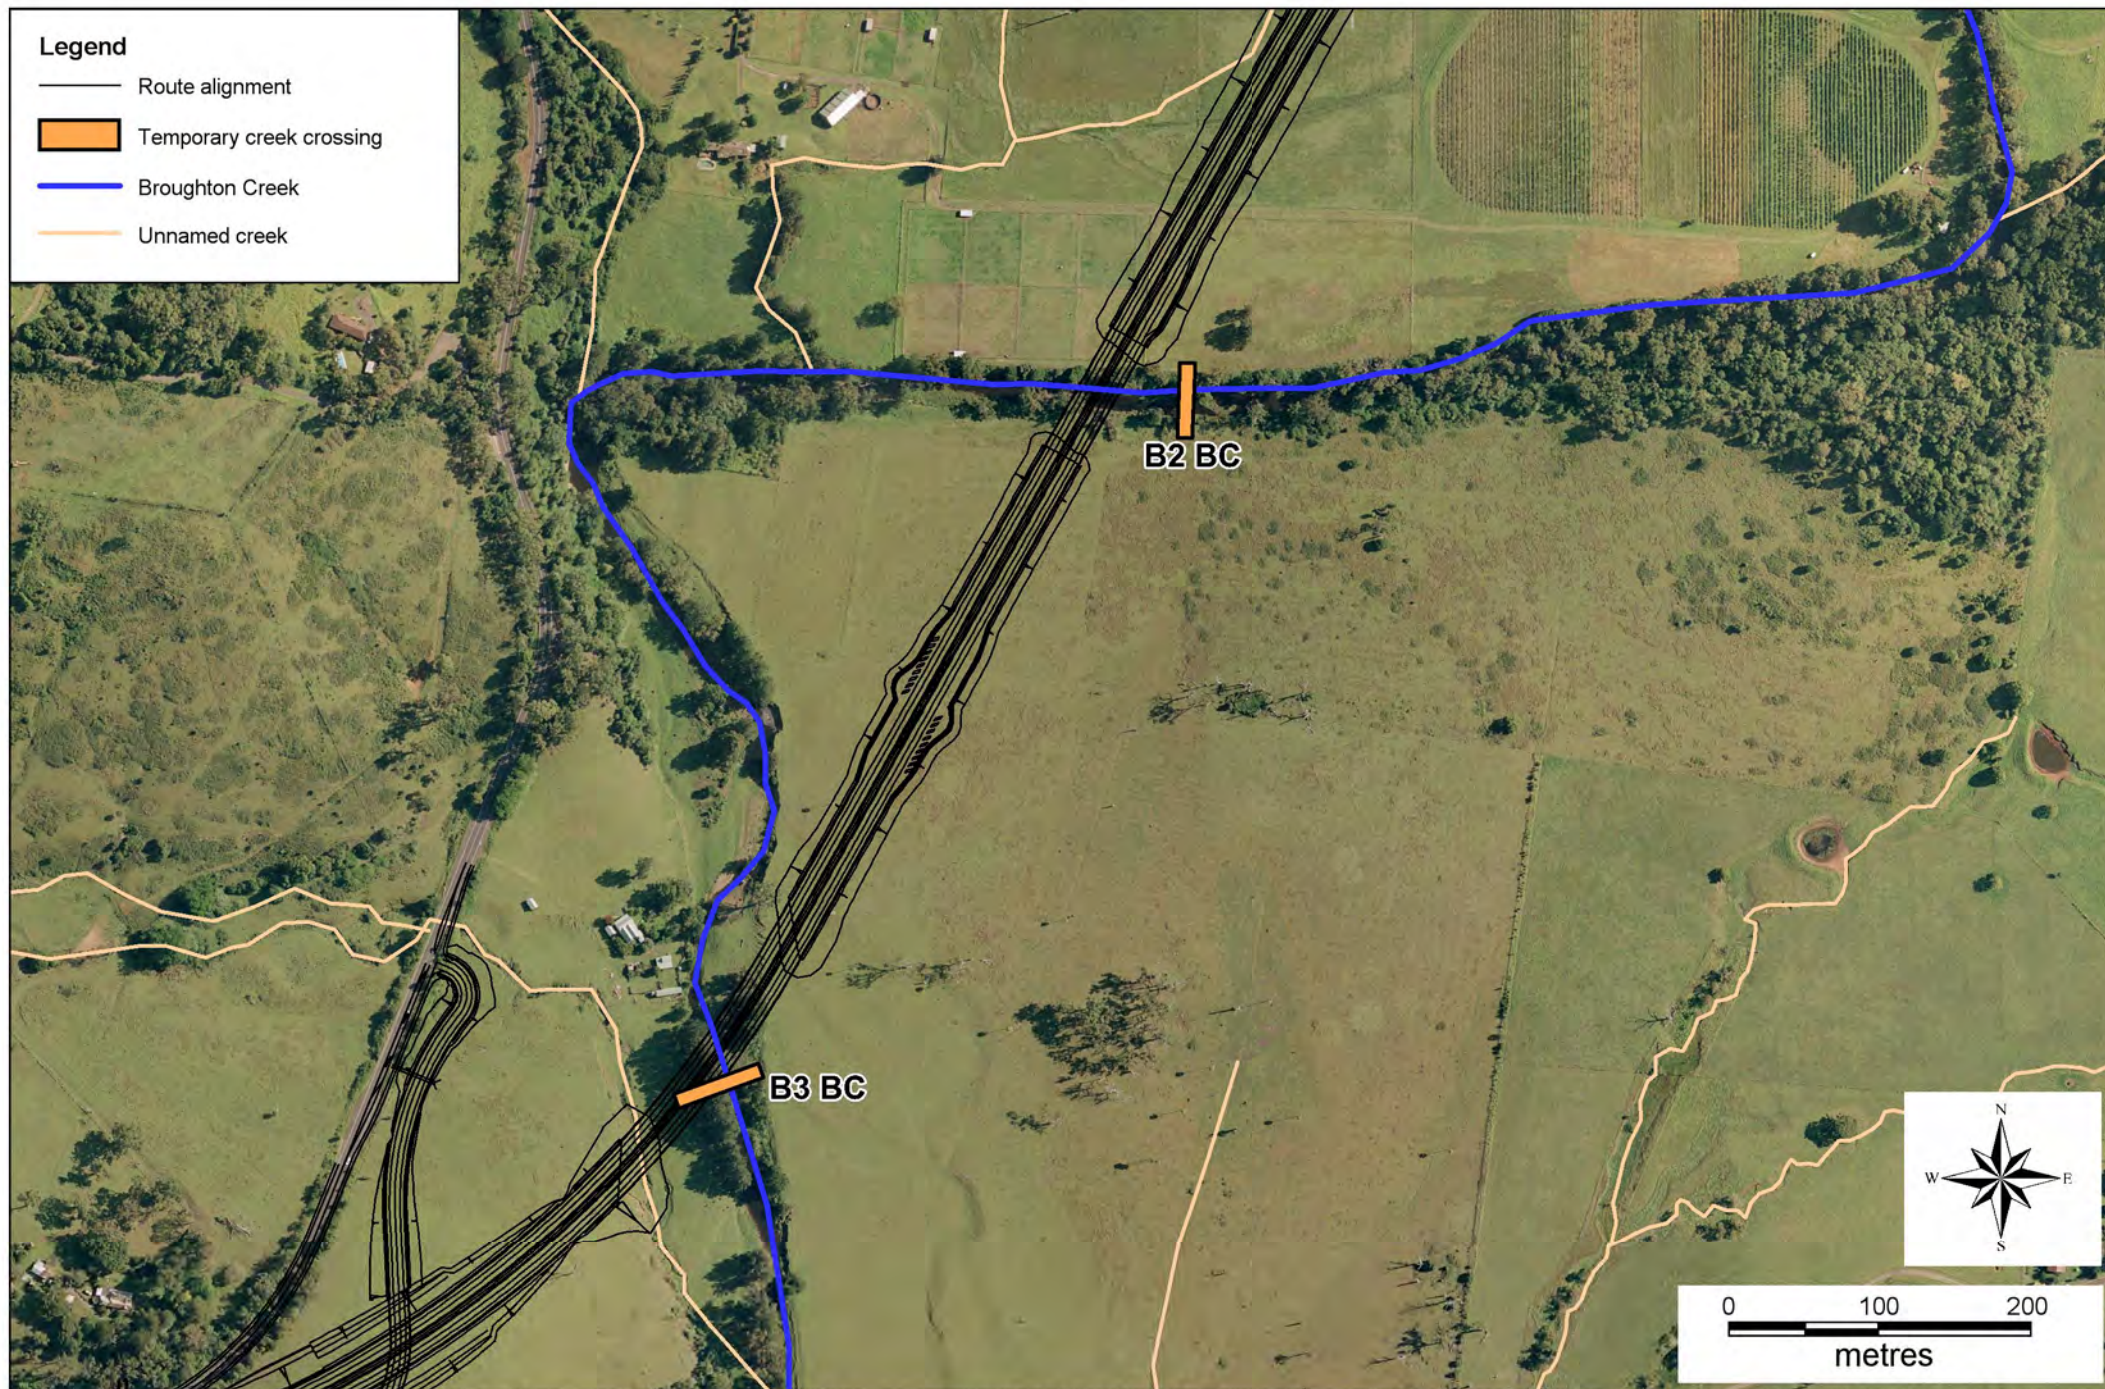
Figure 3.4: Temporary creek crossing sites for Bridge 2 and Bridge 3 at Broughton Creek. B2 BC = temporary crossing of Broughton Creek near proposed bridge 2.  
B3 BC = temporary crossing of Broughton Creek near proposed bridge 3

Broughton Creek was a Class 1 waterway with respect to fish habitat and riparian classification at the location of the proposed Bridge 3 crossing. See Site 17 assessment (Section 3.2.2) for a complete description of aquatic ecology and water quality. The preferred temporary crossing site was located south of the proposed bridge structure, about 10 metres downstream and within the concept design footprint (B3 BC in **Figure 3.4, Table 3.7**). The crossing would pass over pool habitat about 15 metres across and over one metre deep and a channel bed dominated by cobble and boulders. There was a narrow but continuous stand of mature river oak along the western bank.

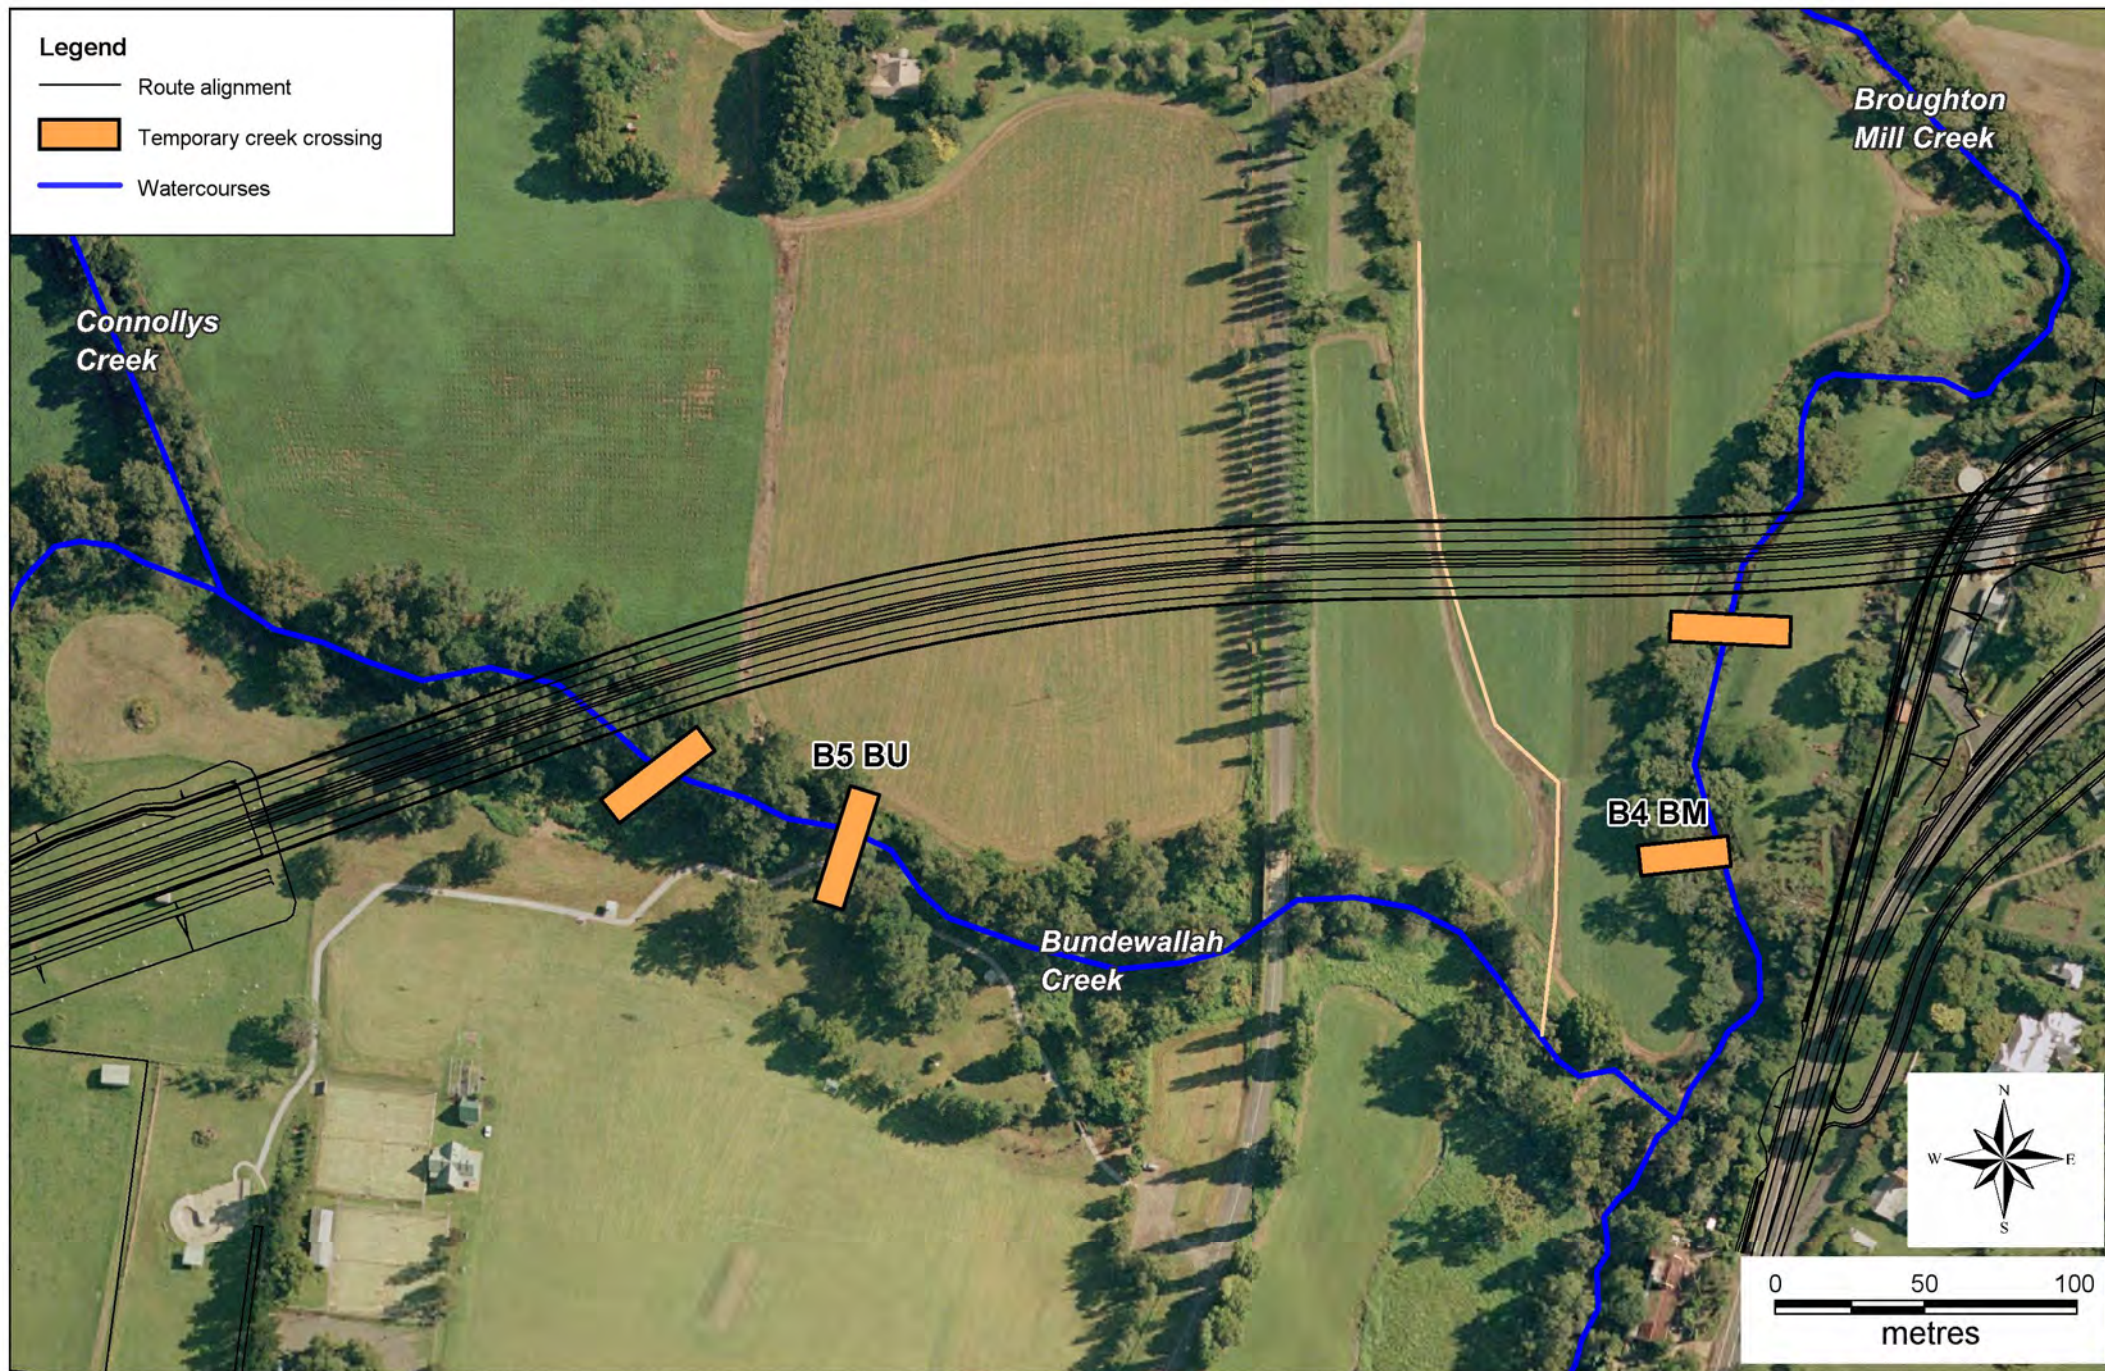
Figure 3.5: Temporary creek crossing sites for Bridge 4 at Bundewallah Creek and Broughton Mill Creek. B4 BM = temporary crossing of Broughton Mill Creek near proposed bridge 4. B4 BU = temporary crossing of Bundewallah Creek near proposed bridge 4

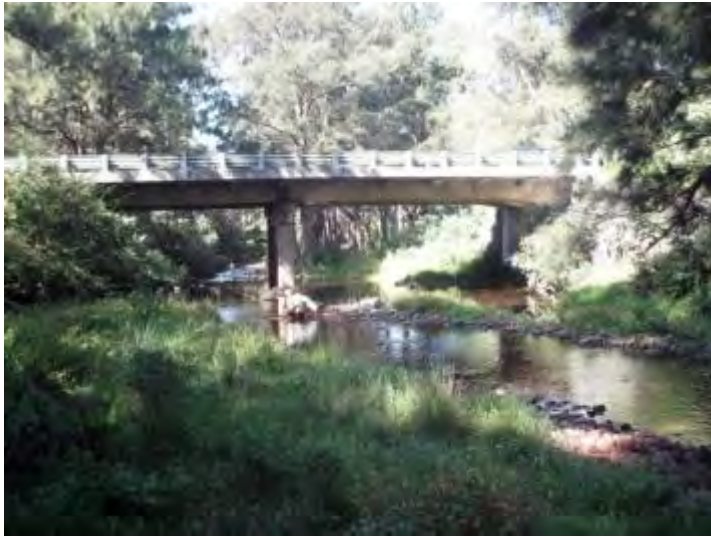
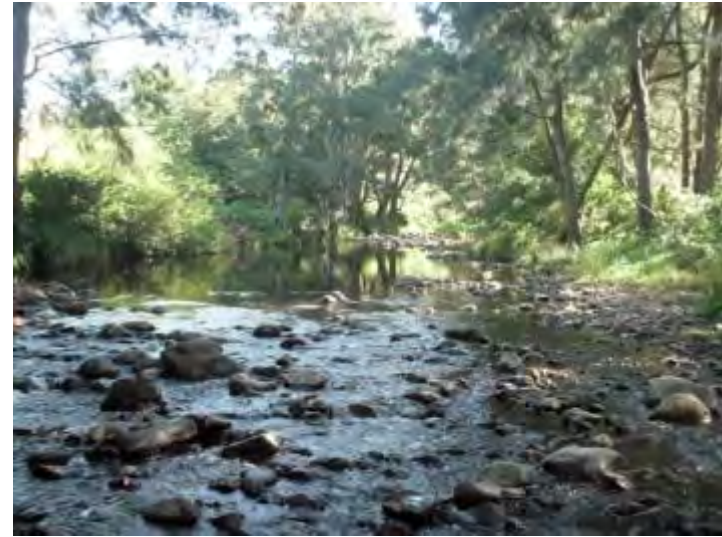
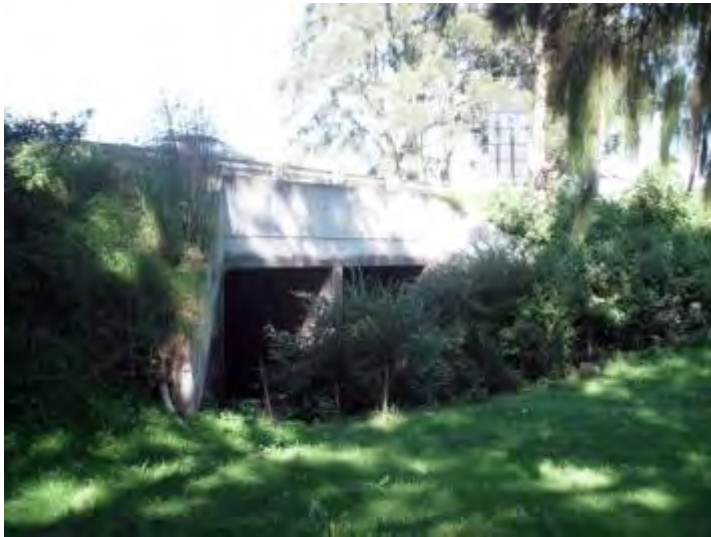
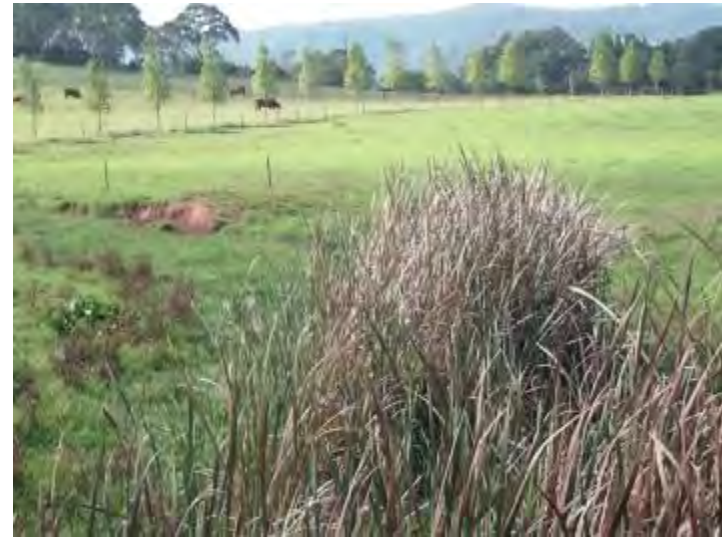
Plates 1a – 1d. (a) Site 13, view downstream of existing Princes Highway two span bridge crossing (b) Site 13, riffle habitat in the foreground and pool habitat upstream (c) Site 13, flood overflow culvert in Princes Highway embankment near the existing Broughton Creek bridge crossing (d) Watercourse at Site 14, view north from Princes Highway and stand of cumbungi (*Typha* sp.).

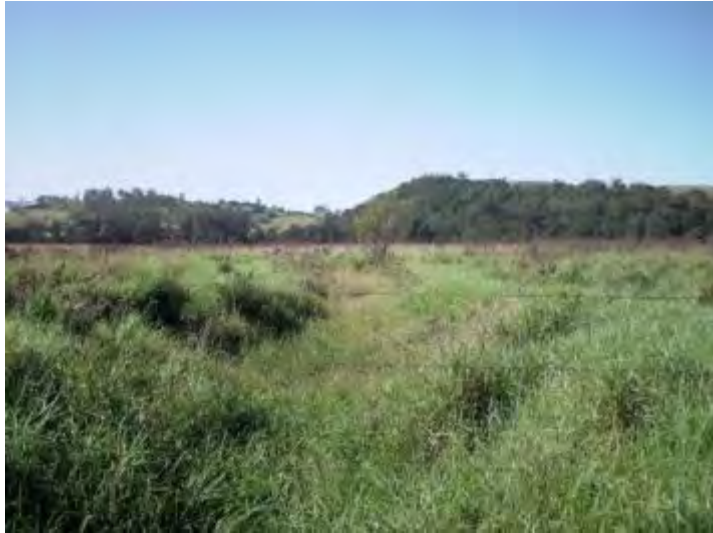
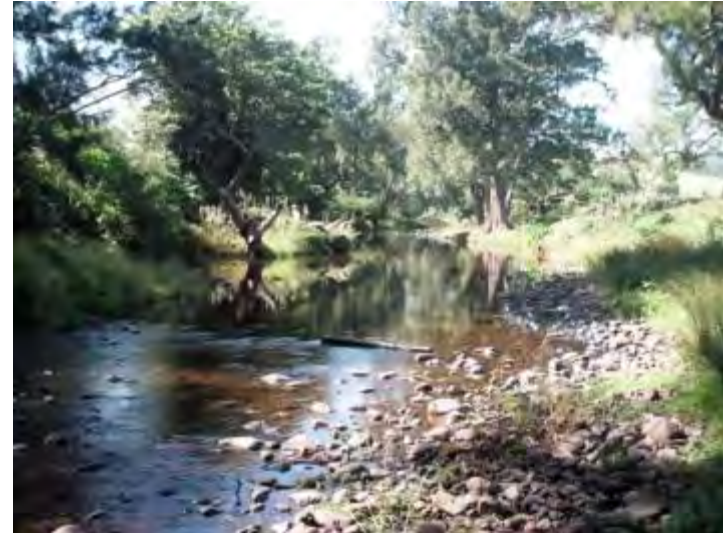
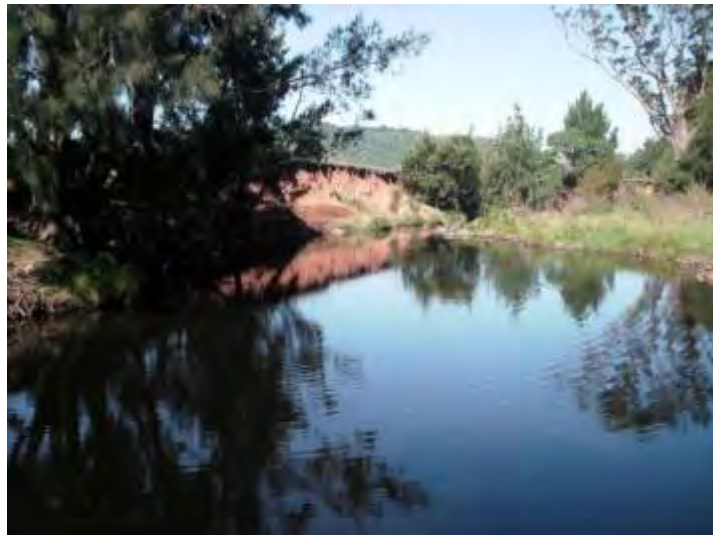
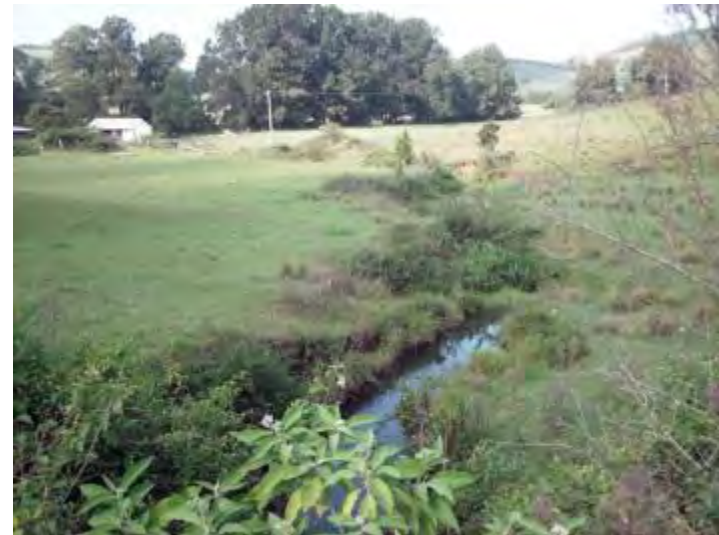
**Plates 2a – 2d. (a) Site 15, view upstream from property road crossing (b) Site 16, view upstream from the proposed second crossing of Broughton Creek by the project (c) Deep pool at Site 17, area of proposed third crossing of Broughton Creek by the Foxground and Berry bypass project (d) Site 18, view downstream from Princes Highway. Larger trees in the background mark the channel of Broughton Creek.**

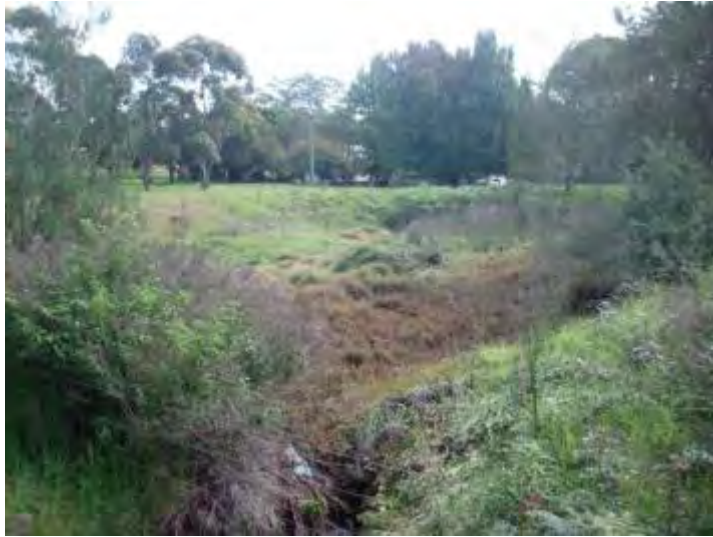
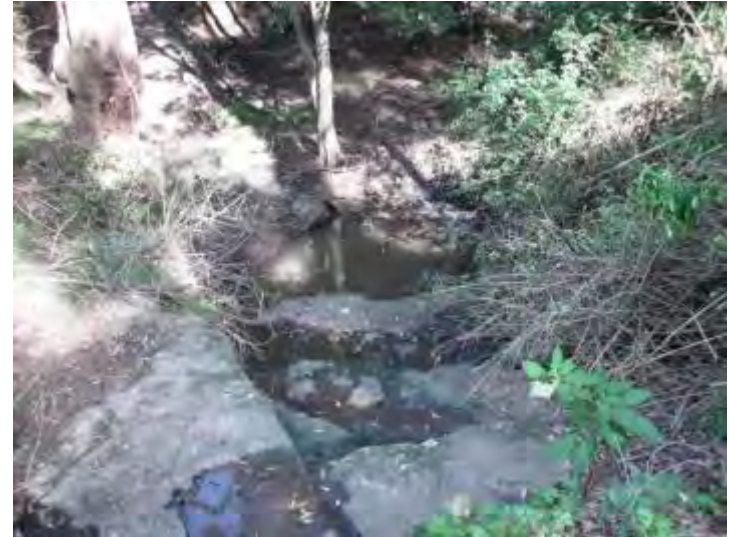
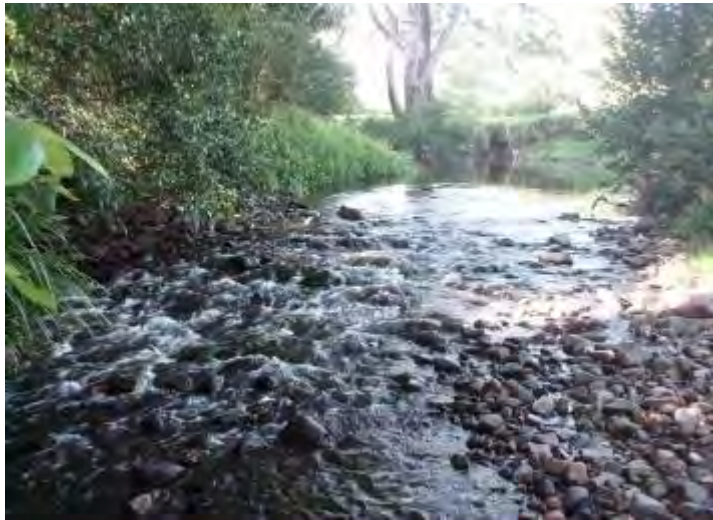
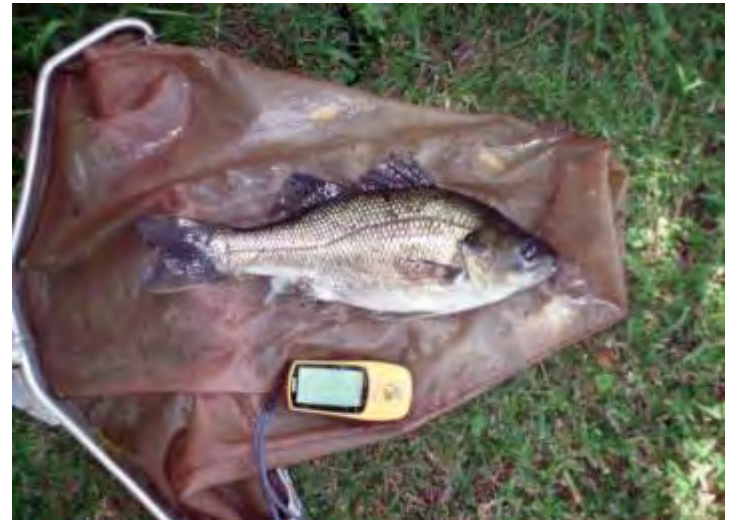
**Plates 3a – 3d. (a) Site 22, view upstream from Princes Highway (b) Site 23, view downstream from Princes Highway crossing (c) Site 25, alternating riffle and pool habitat in Broughton Mill Creek (d) Australian bass (*Macquaria novemaculeata*) caught at Site 25, Broughton Mill Creek.**

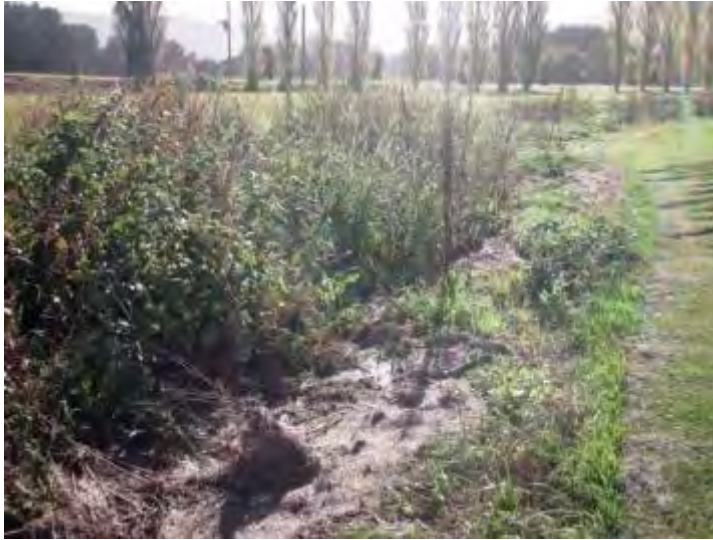
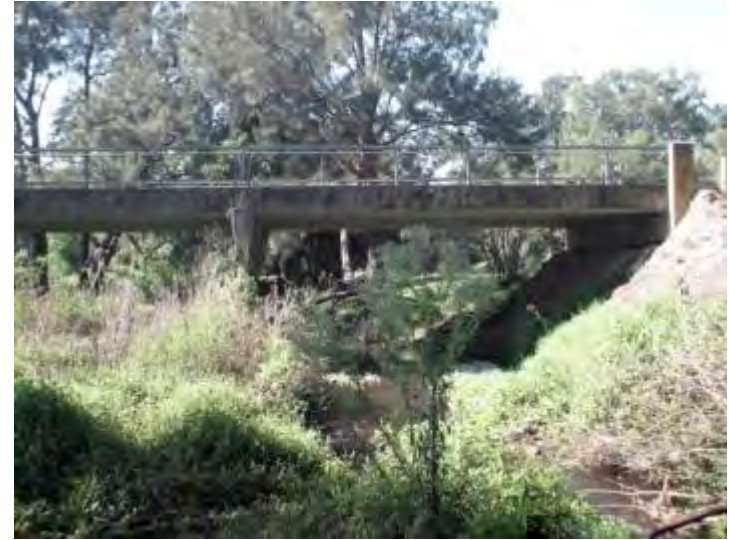
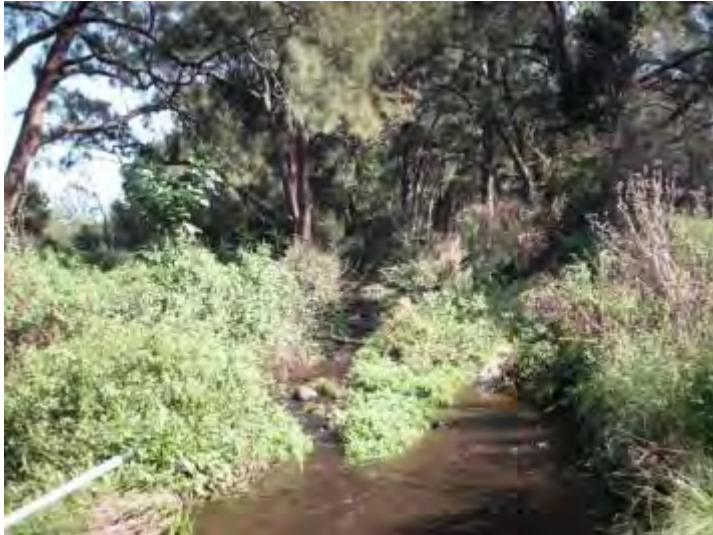
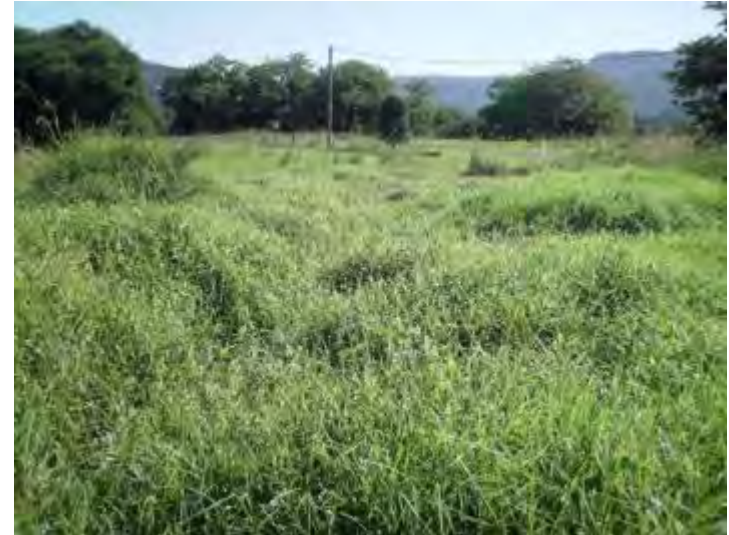
**Plates 4a – 4d. (a) Site 26, ephemeral watercourse or drainage ditch lying in between Broughton Mill Creek and Woodhill Mountain Road (b) Site 27, Bundewallah Creek, view upstream (c) Site 28, Town Creek, view upstream to North Street (d) Site 29, view upstream from Princes Highway.**
