Foxground and Berry bypass

Princes Highway upgrade

**Technical paper:
Aboriginal heritage**

Navin Officer Heritage Consultants Pty Ltd
4/71 Leichhardt Street, Kingston ACT 2604, Australia

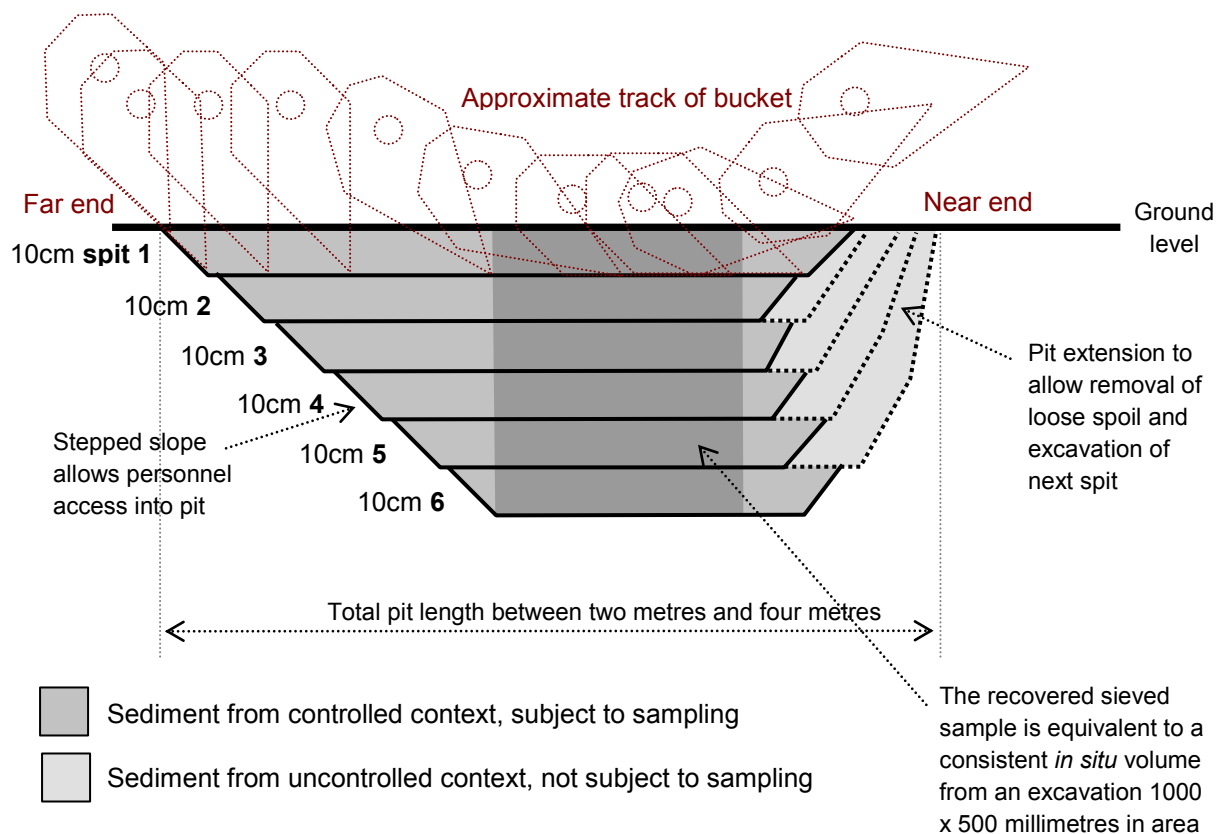
Figure 2-2: Indicative pit profile (not to scale) showing sampling methodology and sequence for mechanical pit excavation

The intended depth interval for each spit was 100 millimetres. In some cases, unforeseeable deposit characteristics, such as large cobbles or sudden changes in consistency, caused the excavated spit depth to vary. This is an unavoidable consequence of the machine methodology and in most cases, involved variation of 40 per cent or less (i.e. up to or less than 40 millimetres).

- Following the removal of spoil from the bucket, a 50-100 millimetre wide strip was removed from (normally) one or (sometimes) both sides of the pit and the spoil set aside in a 'mixed provenance' pile. This was done where the sediment was loose or friable. This pit modification was conducted to make the pit marginally wider than the bucket so that on the next spit excavation, the sides of the bucket did not contact the pit sides and dislodge material into the bucket from upper levels.

- Following the removal of the machine bucket from each spit excavation, loose surface material or other sediment was removed either manually or using the mechanical bucket (depending on the risk of contamination from upper levels) prior to the commencement of the following spit excavation. This spoil was incorporated with the corresponding spit material unless it was considered that contamination from upper levels was likely, in which case it was set aside in the 'mixed provenance' pile.

- Excavation of spit two (and all subsequent spits) began approximately 20-100 millimetres from the far end of the previous spit, this is done to create a 'clean' wall and to prevent contamination from loose sediments at the start of the pit. The bucket was tilted and drawn up and away from the near end of the pit to minimise the risk of contamination from previous spits. The removal of a strip from one or both sides of the pit was conducted as for spit one, as was the manual or mechanical clean-up of the base of the spit prior to the next spit excavation.

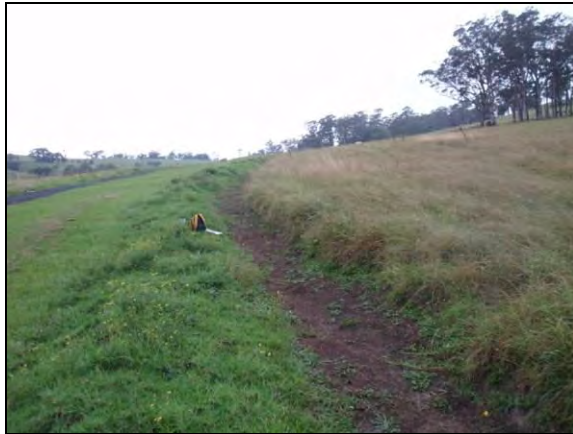
Figure 6-1: G2B A3 - Looking upslope along drainage ditch in which artefacts are exposed

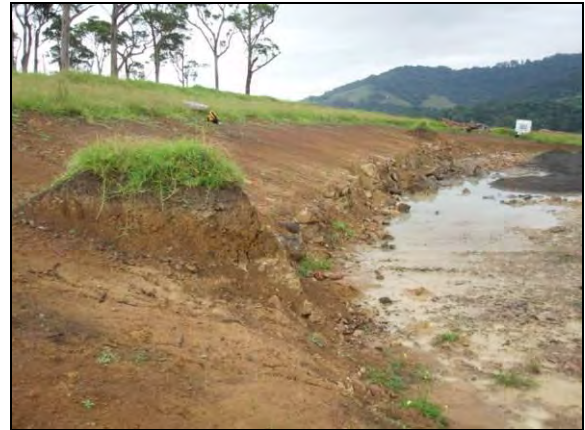
Figure 6-2: G2B A3 – Looking across excavated platform, artefacts are exposed along upslope edge of embankment

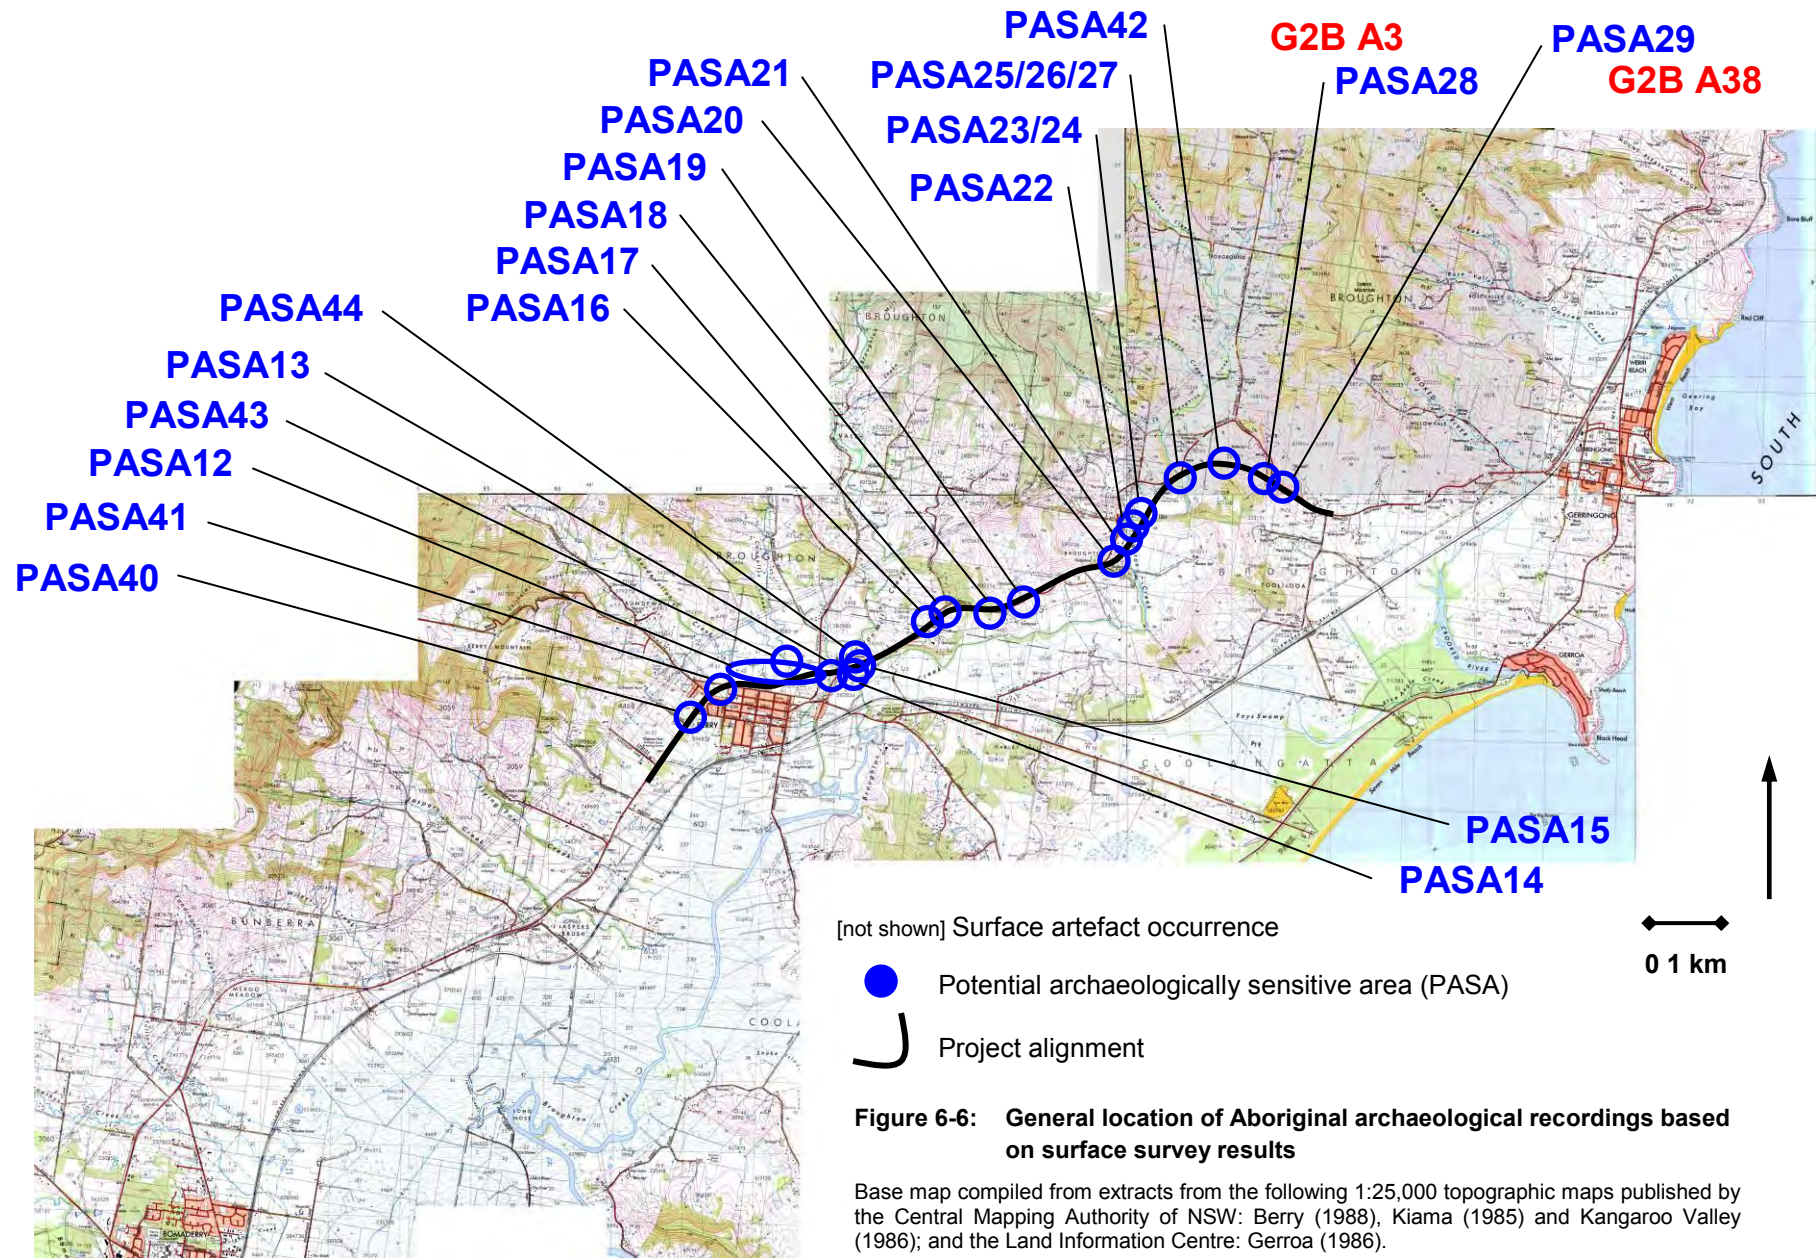
Figure 6-6: General location of Aboriginal archaeological recordings based on surface survey results

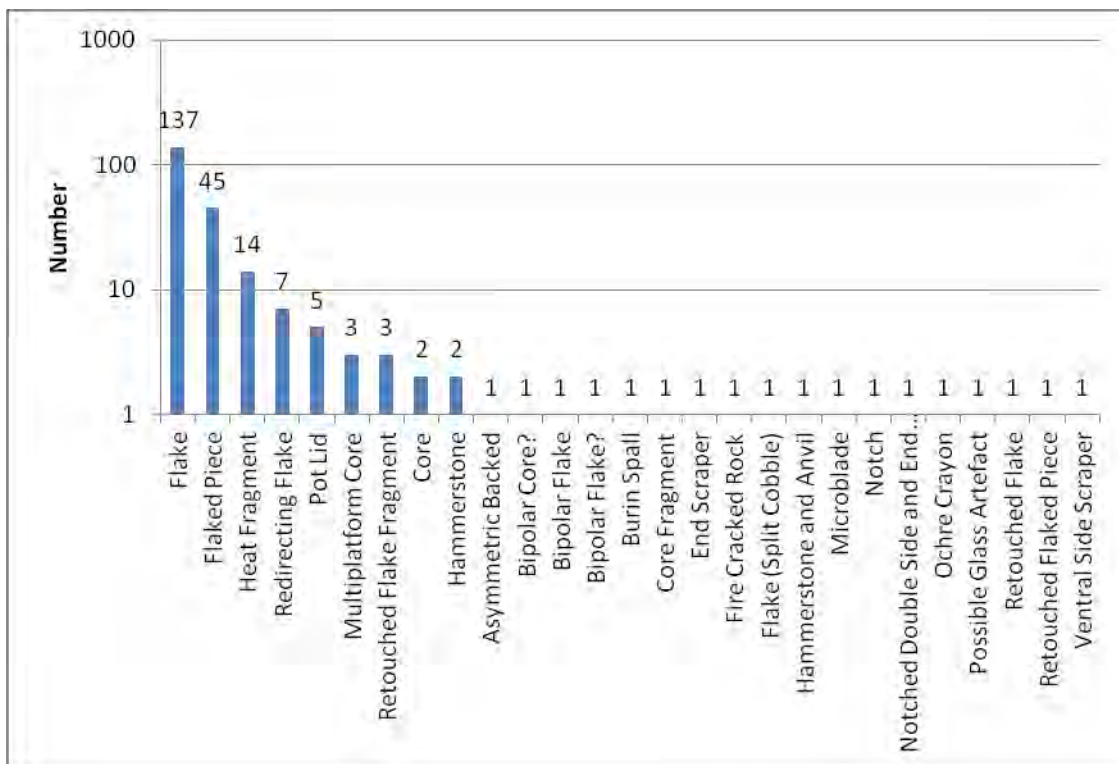
Figure 7-1: Number of items in each technological class from the project assemblage

Artefact class	No	%
Flake	137	58.1
Flaked piece	45	19.1
Heat fragment	14	5.9
Redirecting flake	7	3.0
Pot lid	5	2.1
Multiplatform core	3	1.3
Retouched flake fragment	3	1.3
Core	2	0.8
Hammerstone	2	0.8
Asymmetric backed	1	0.4
Bipolar core?	1	0.4
Bipolar flake	1	0.4
Bipolar flake?	1	0.4
Burin spall	1	0.4
Core fragment	1	0.4
End scraper	1	0.4
Fire cracked rock	1	0.4
Flake (split cobble)	1	0.4
Hammerstone and anvil	1	0.4
Microblade	1	0.4
Notch	1	0.4
Notched double side and end scraper	1	0.4
Ochre crayon	1	0.4
Possible glass artefact	1	0.4
Retouched flake	1	0.4
Retouched flaked piece	1	0.4
Ventral side scraper	1	0.4

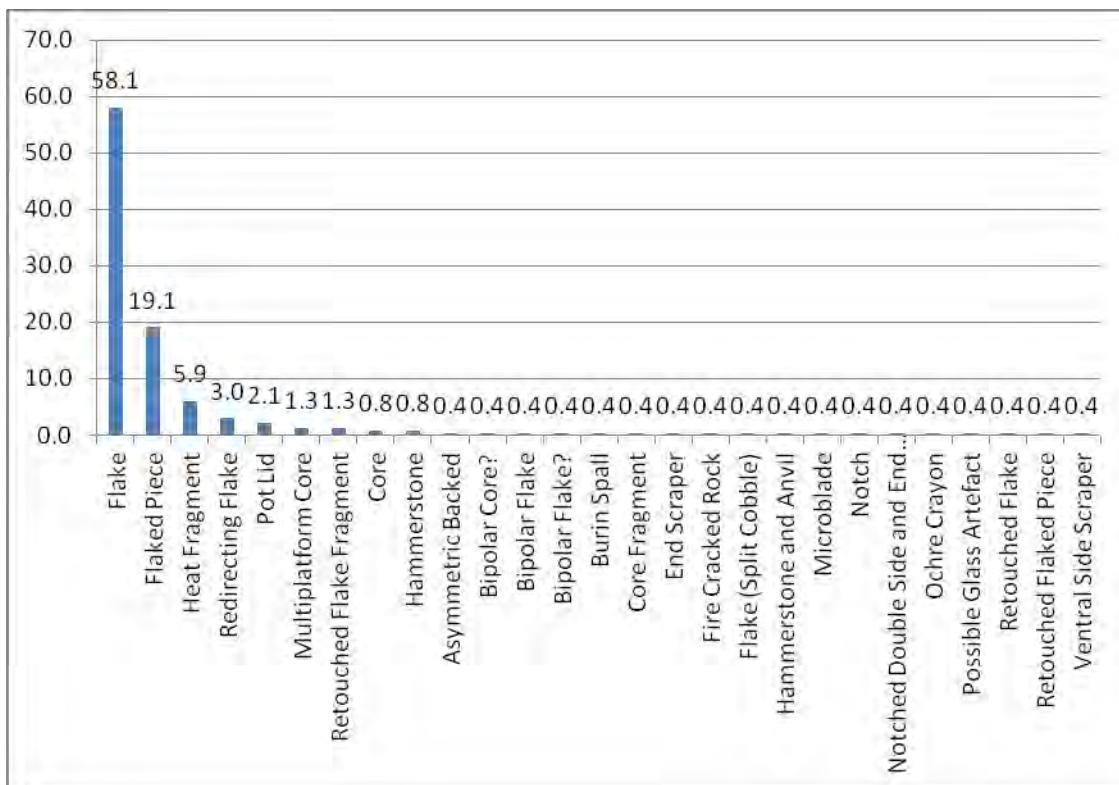
Figure 7-2: Percentage of artefacts in each technological class from the project assemblage

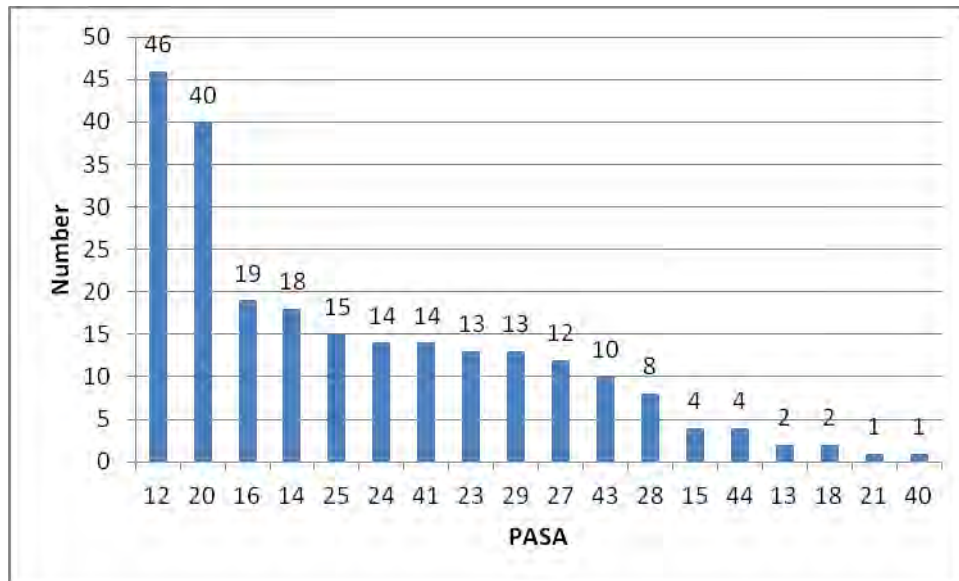
Figure 7-3: Total artefact numbers recovered from each PASA

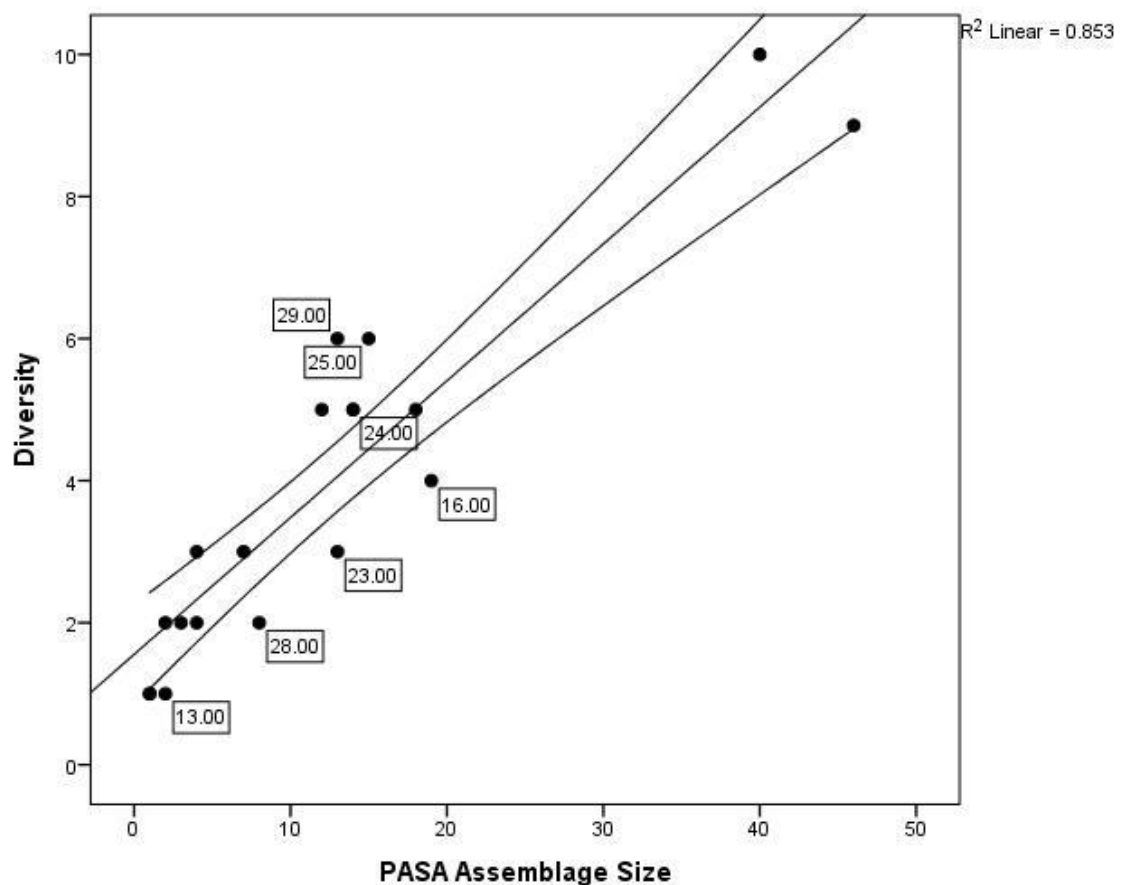
Figure 7-4: Relationship between assemblage size and artefact diversity, revealing two different richness relationships (i.e. high and low diversity for a given sample size). PASA with high or low ranges are labelled.

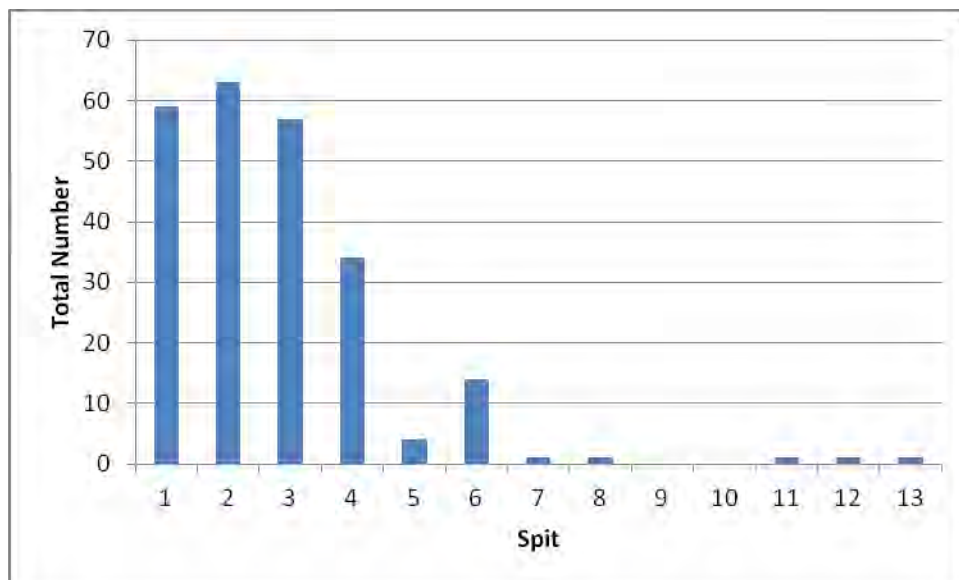
Figure 7-5: Vertical distribution of the assemblage across all PASAs

Not surprisingly, the pattern of decreasing artefact numbers with depth is most evident at PASA12 and PASA20 where the largest assemblages were recovered, hence reducing sample size effects.

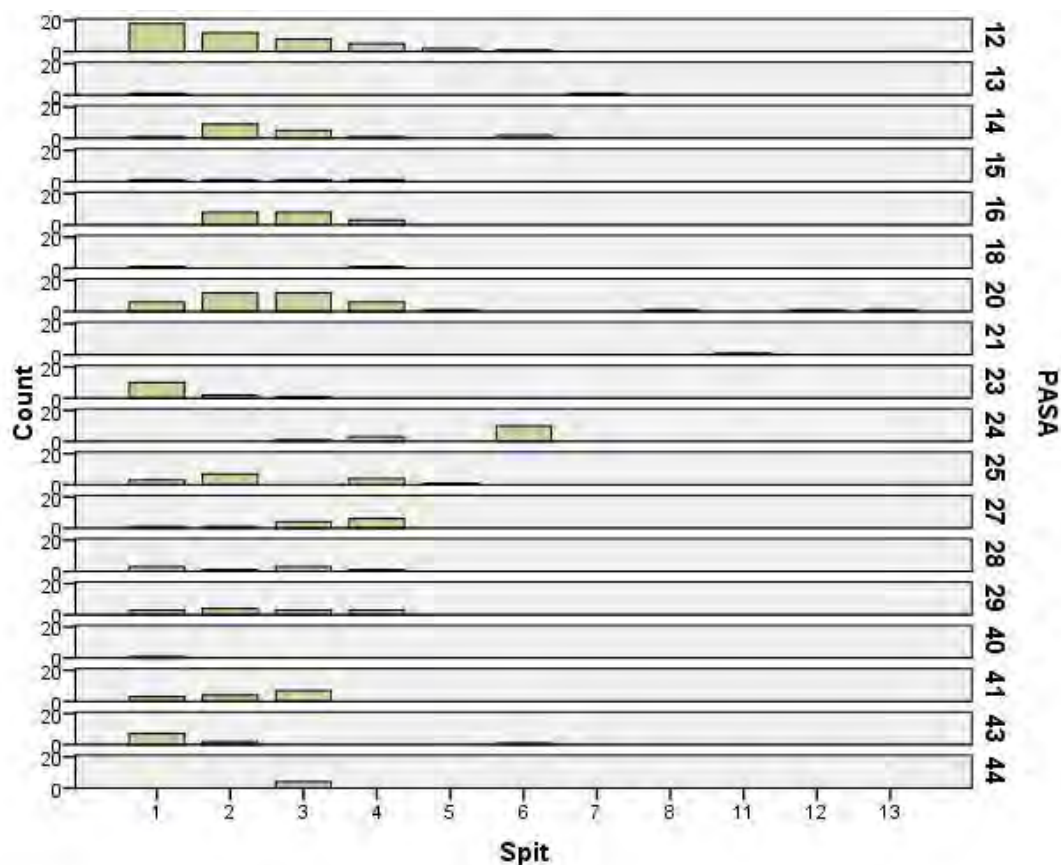
Figure 7-6: Spit counts by PASA

The general pattern of greatest artefact deposition in the top three spits and steeply declining artefact number below that depth could result from the downward movement of artefacts through bioturbation, or it could result from active depositional environments burying artefacts in correct stratigraphic position. Examining the data for evidence of size sorting may help determine whether processes such as bioturbation have altered the vertical distribution of artefacts at the site.

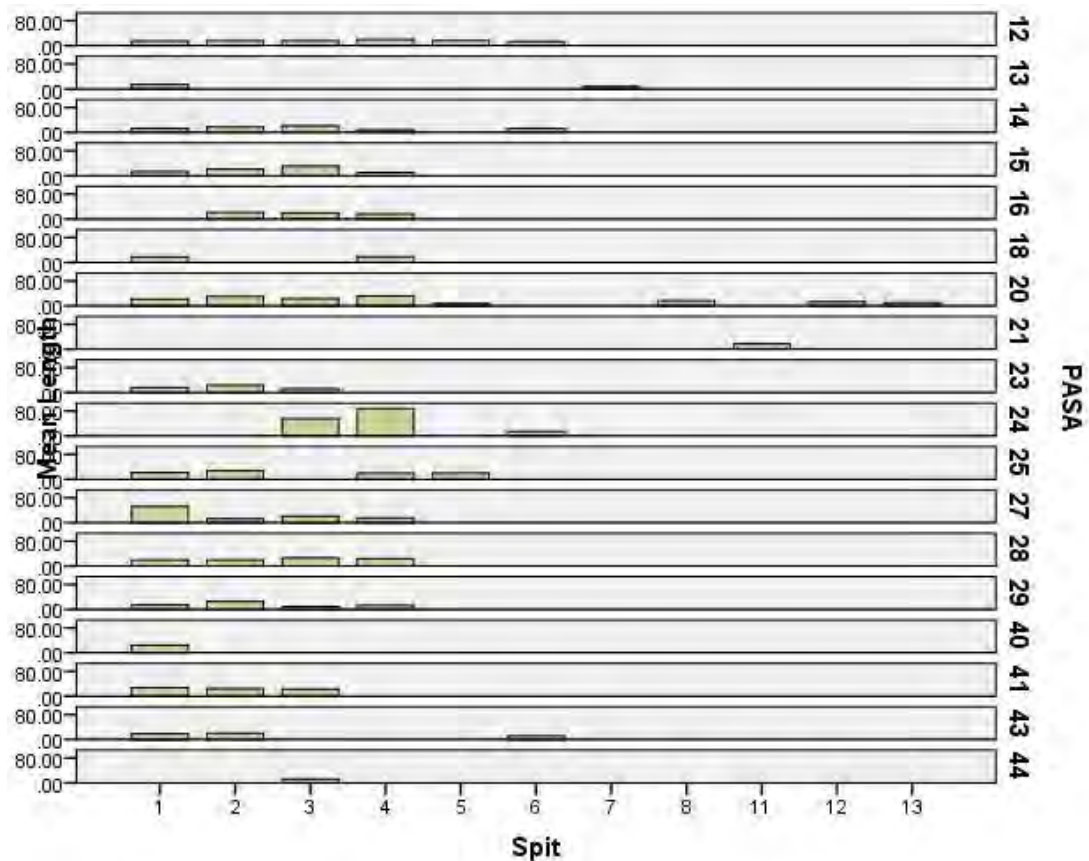
Figure 7-8: Mean artefact length by spit for each PASA

Artefact size sorting therefore seems unlikely to have taken place at any of the PASA in the study, and each PASA appears to show its own specific pattern unrelated to depth.

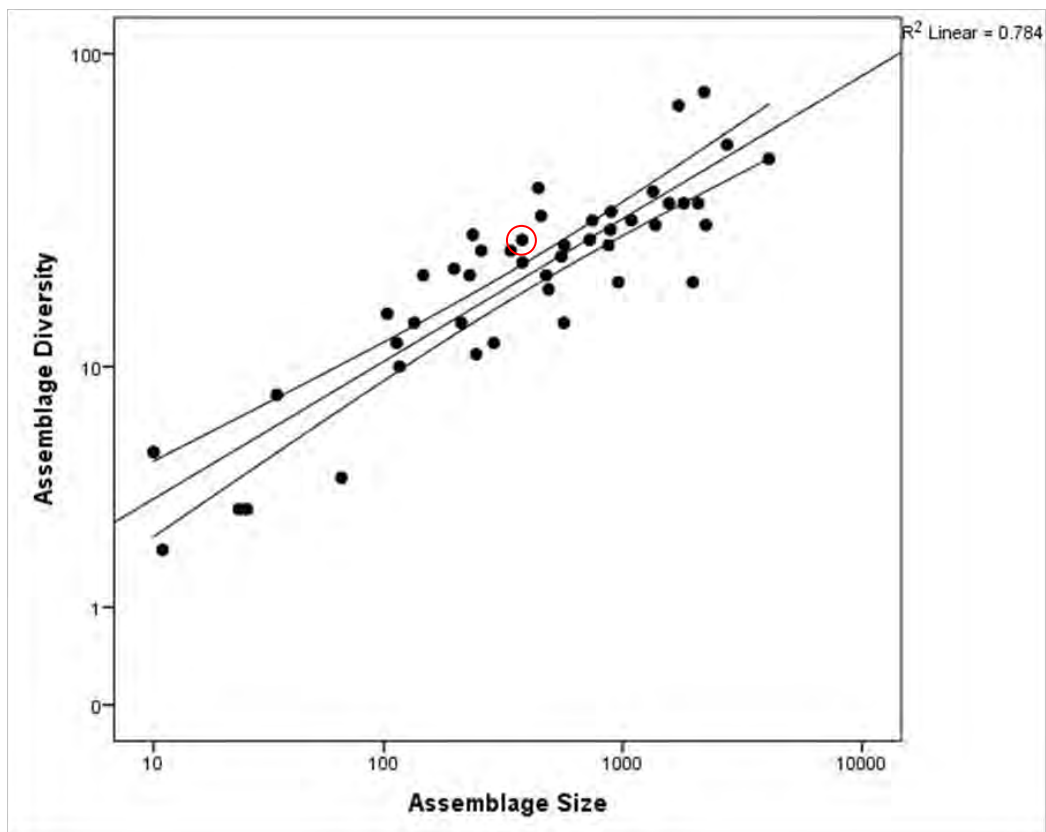
Figure 7-9: Assemblage richness for the project study (red circle) in comparison to 39 assemblages from southeastern Australia.

However, an issue that arises that is further discussed below is that several assemblage types relate to heat damage, and are not representative of cultural factors creating assemblage diversity. Even with heat damage components removed from the assemblage diversity count, the project assemblage remains above the 95 per cent confidence interval.

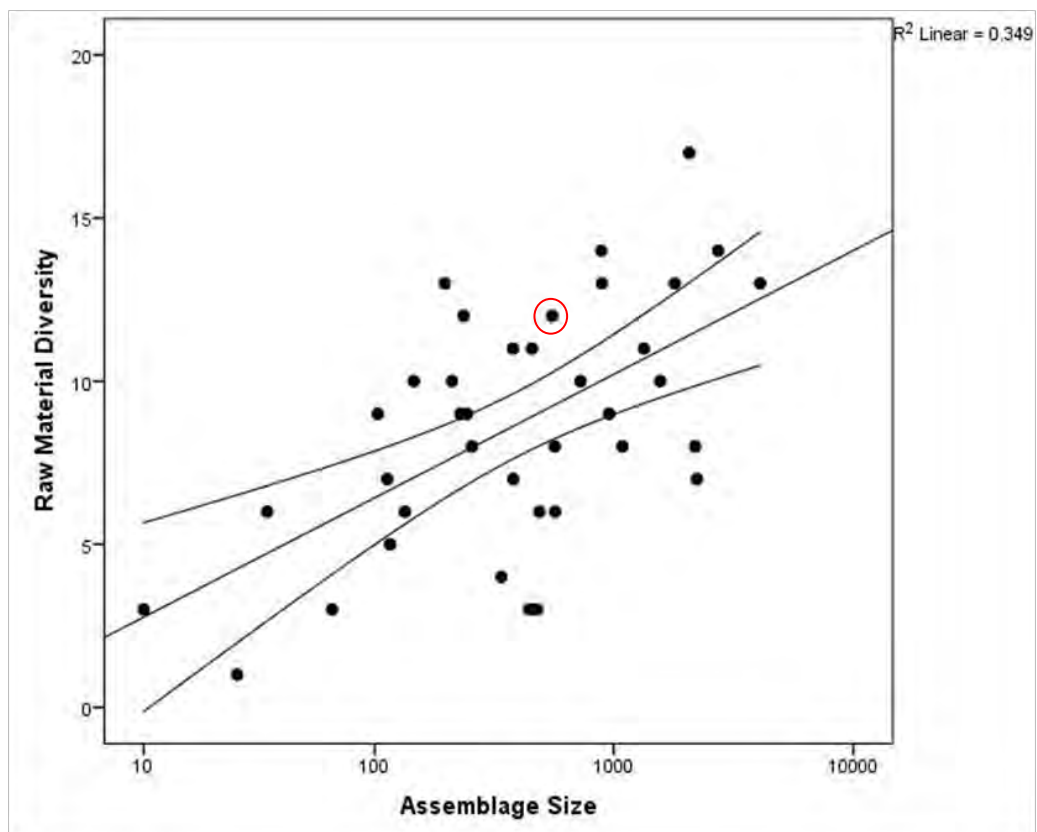
Figure 7-10: Raw material richness for C2B excavated artefacts (red circle) in comparison to 38 assemblages from southeastern Australia.

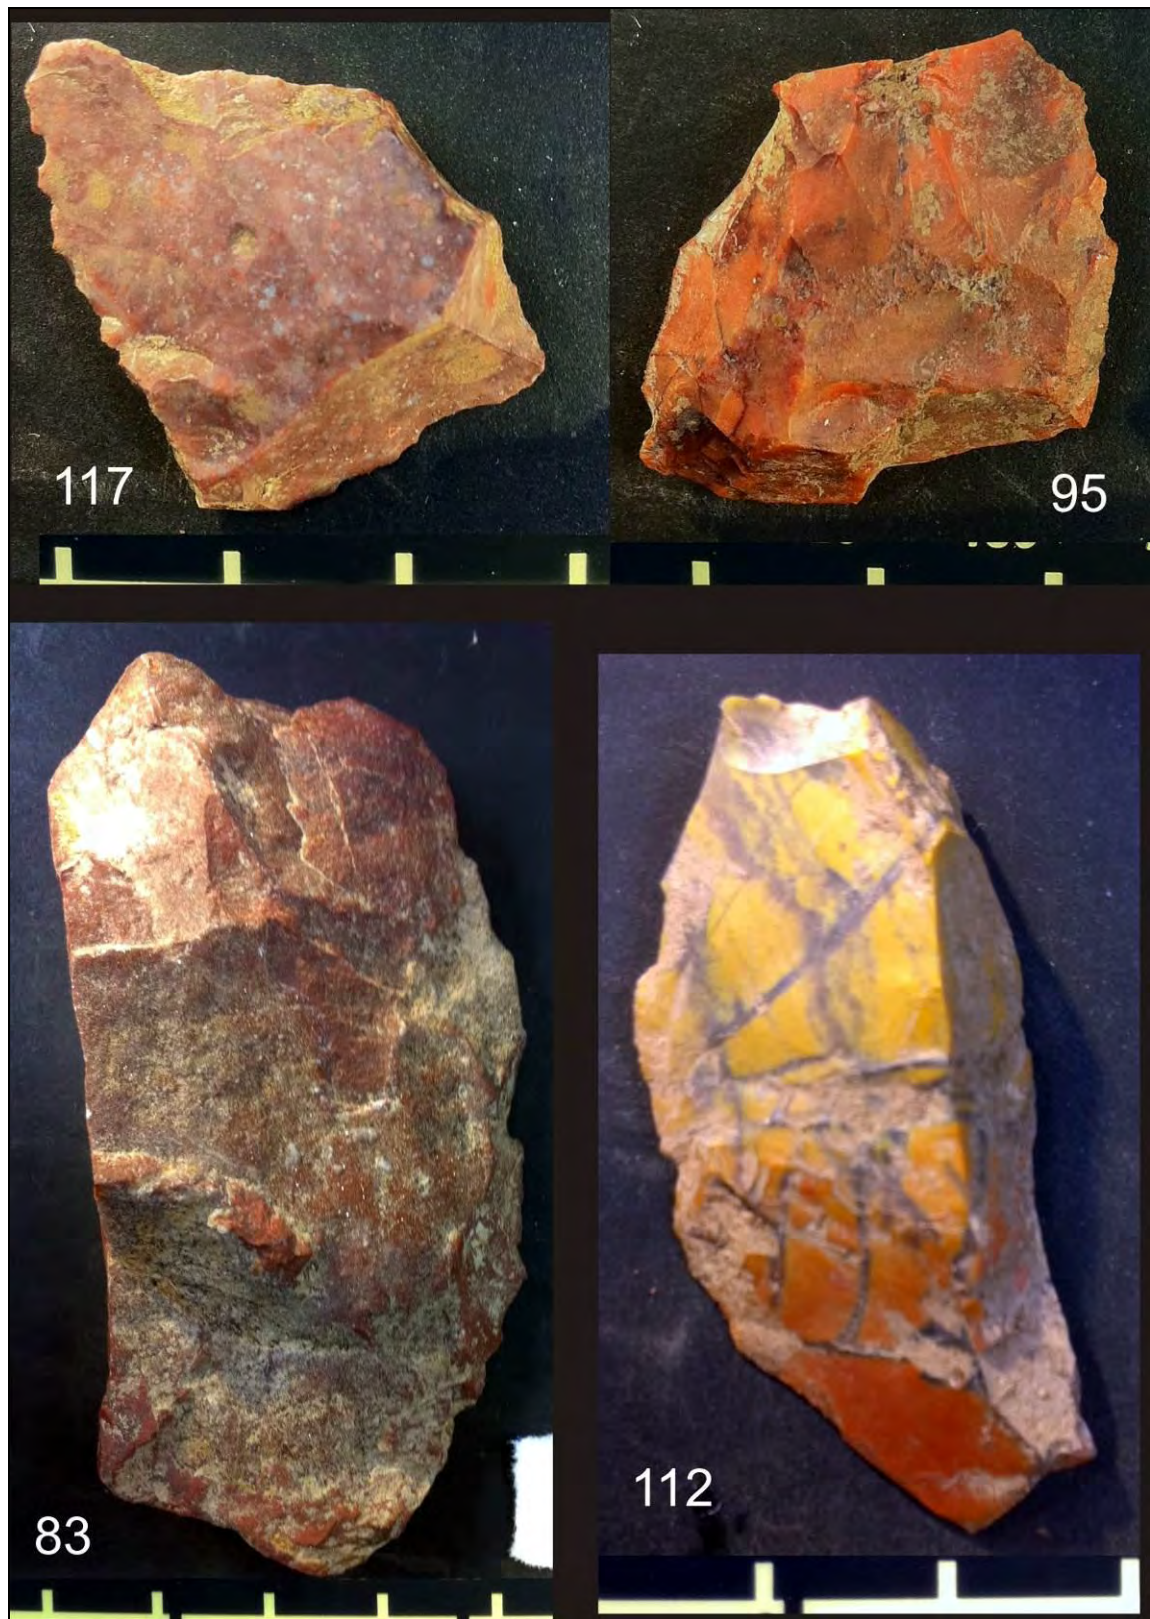
Figure 7-12: Some examples of complete chert flakes

Figure 7-12 provides examples of complete flakes found in the project assemblage.

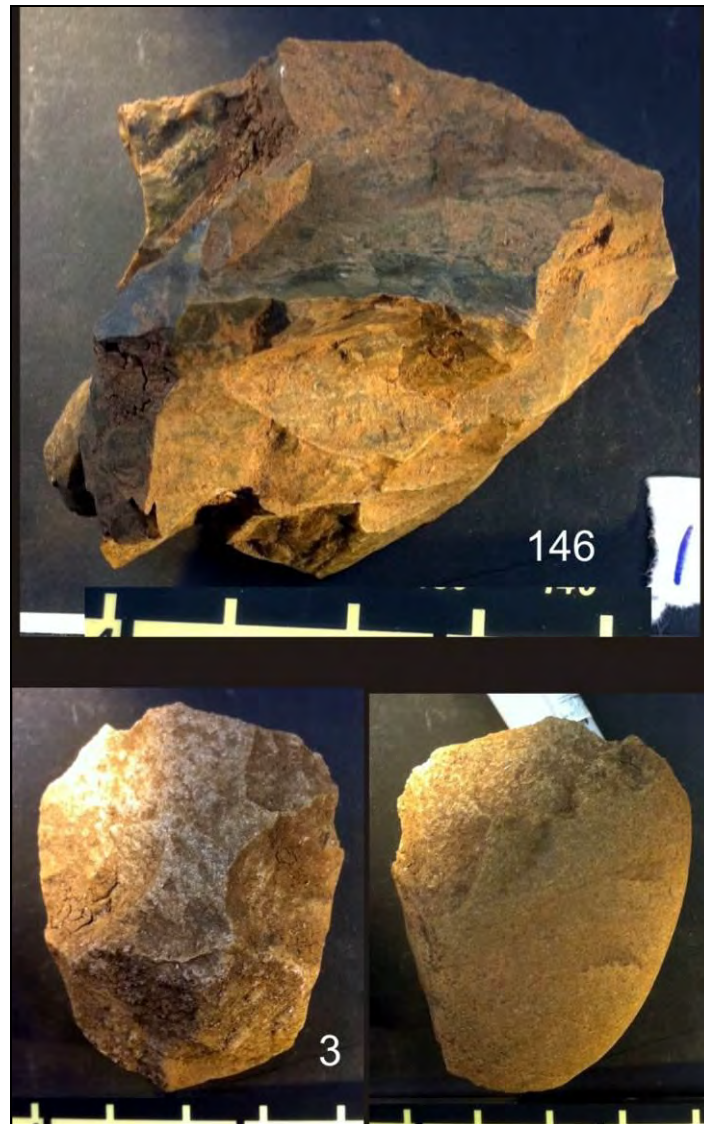
Figure 7-13: Examples of cores from the project assemblage. No.146 is an extensively rotated chert core. Number 3 is a quartzite core with a conchoidal platform

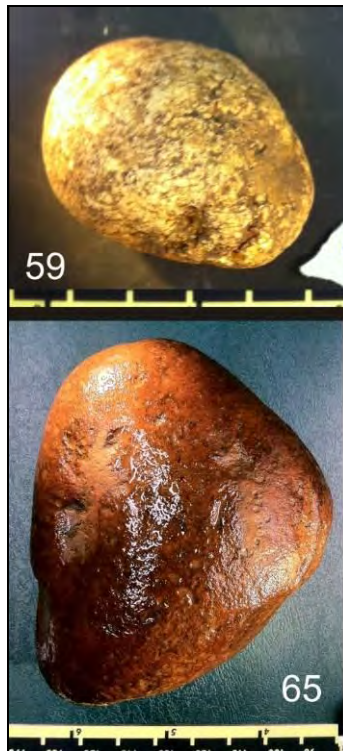
Figure 7-15: Hammerstones and anvils. No. 59: Hammerstone and No.65: hammerstone with anvil pitting.

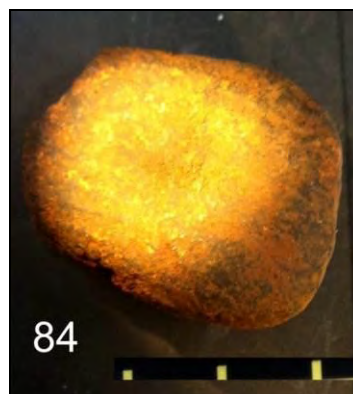
Figure 7-16: Yellow ochre crayon
