Appendix F

Artefact inventory (raw data)

Information from Keith Campbell relating
to the *Boongaree* Aboriginal Encampment

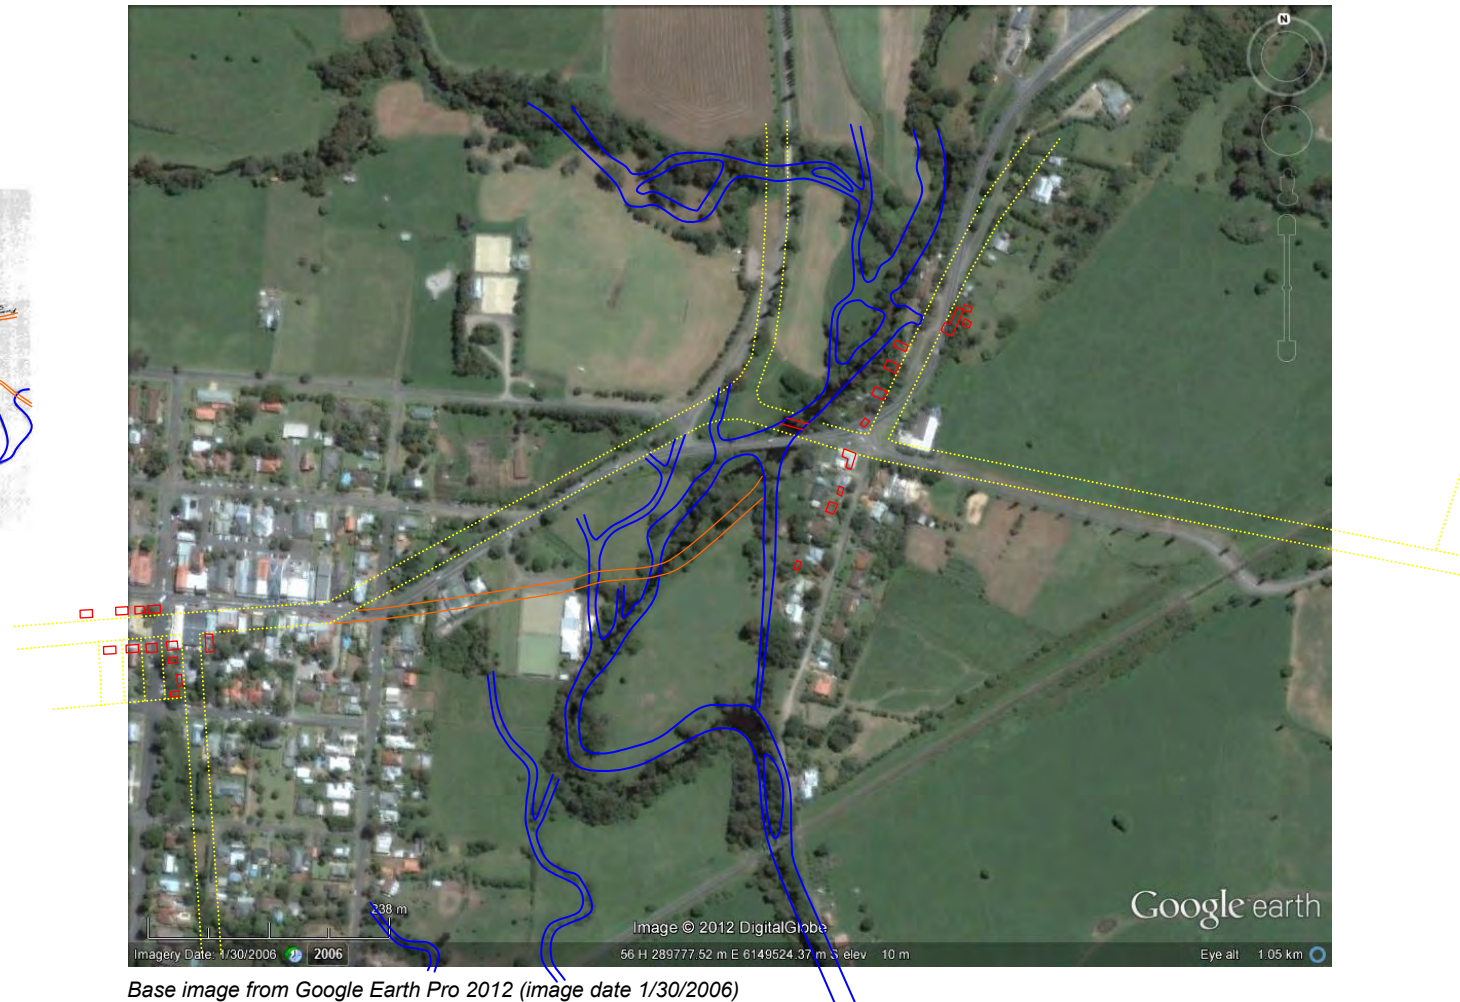
Tracings of disturbance from source material overlaid onto Google Pro (2006) aerial image

Early map of Broughton Creek Village area, probably 1870s (Berry Museum n.d.: 15)

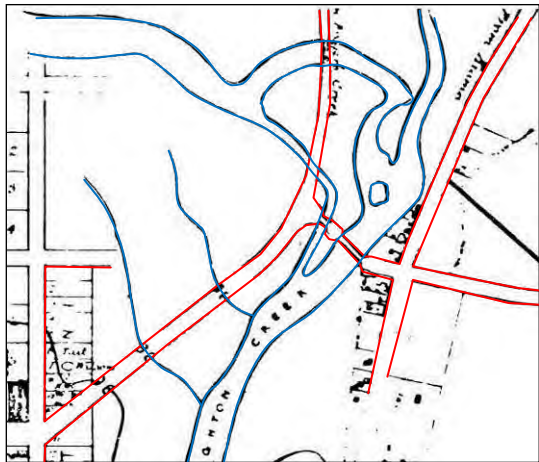
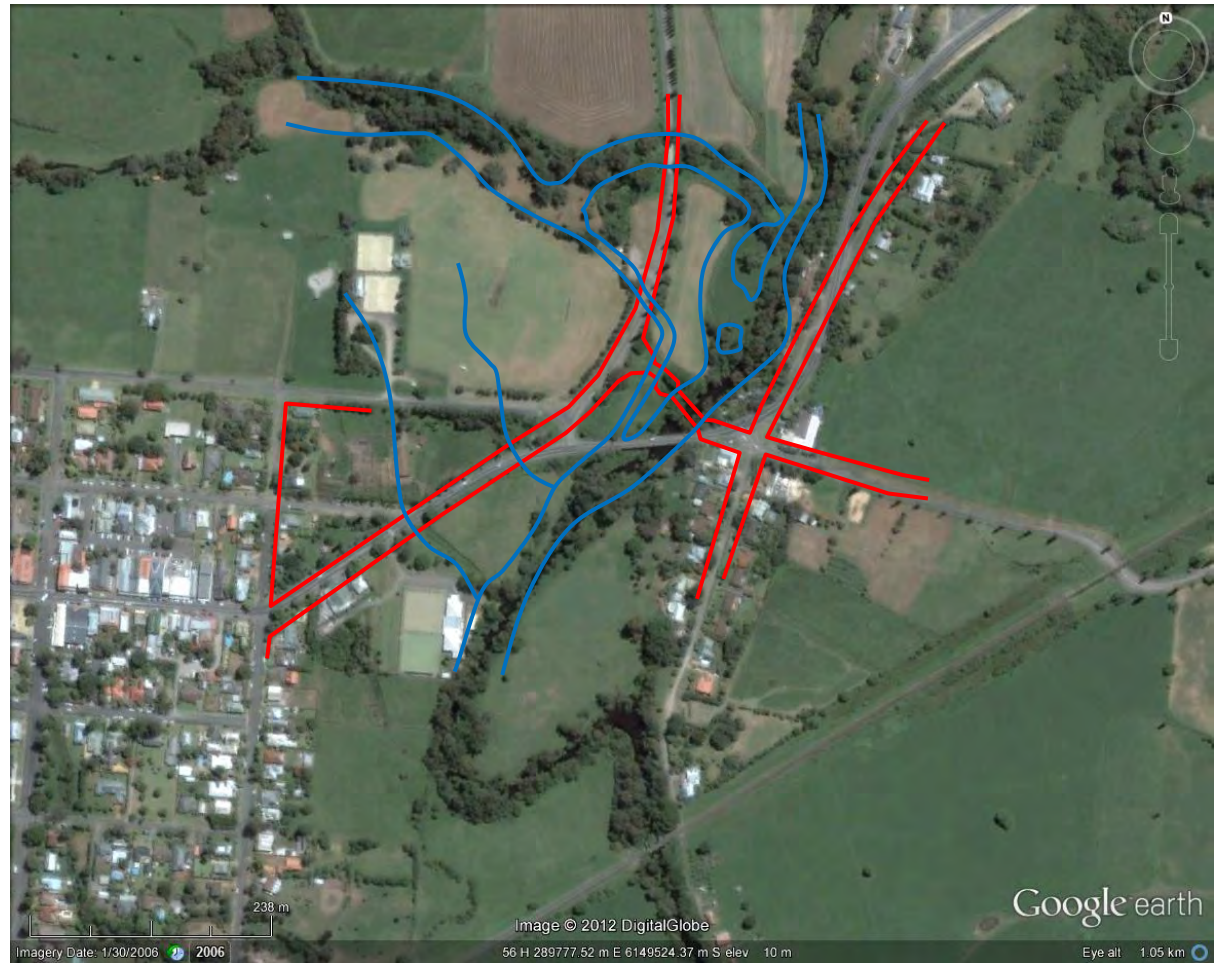
Sketch plan of Broughton Township 1883
(Lidbetter 1993:18)

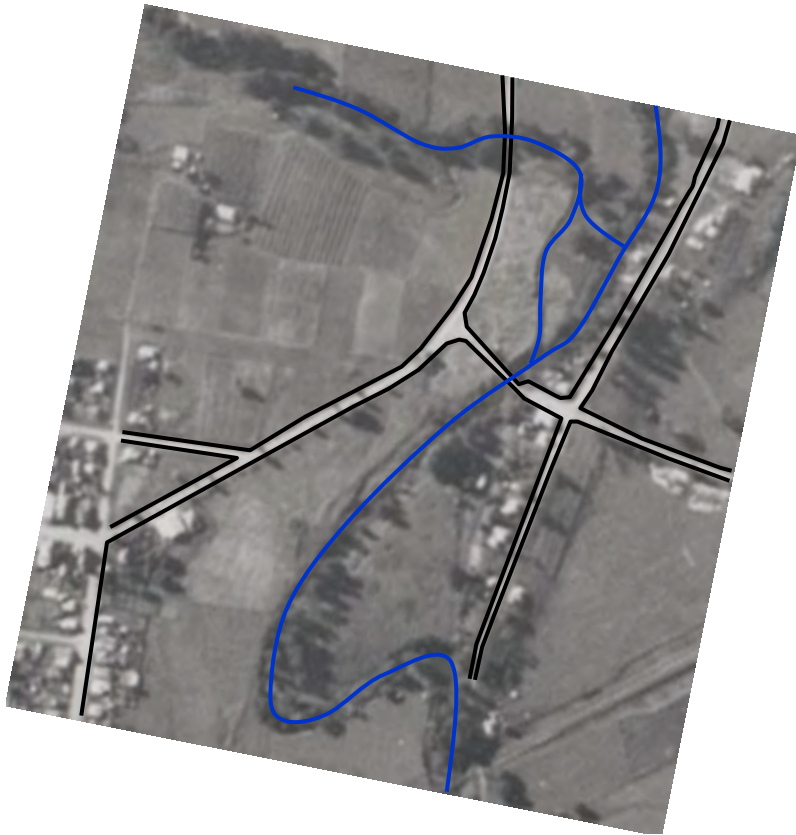
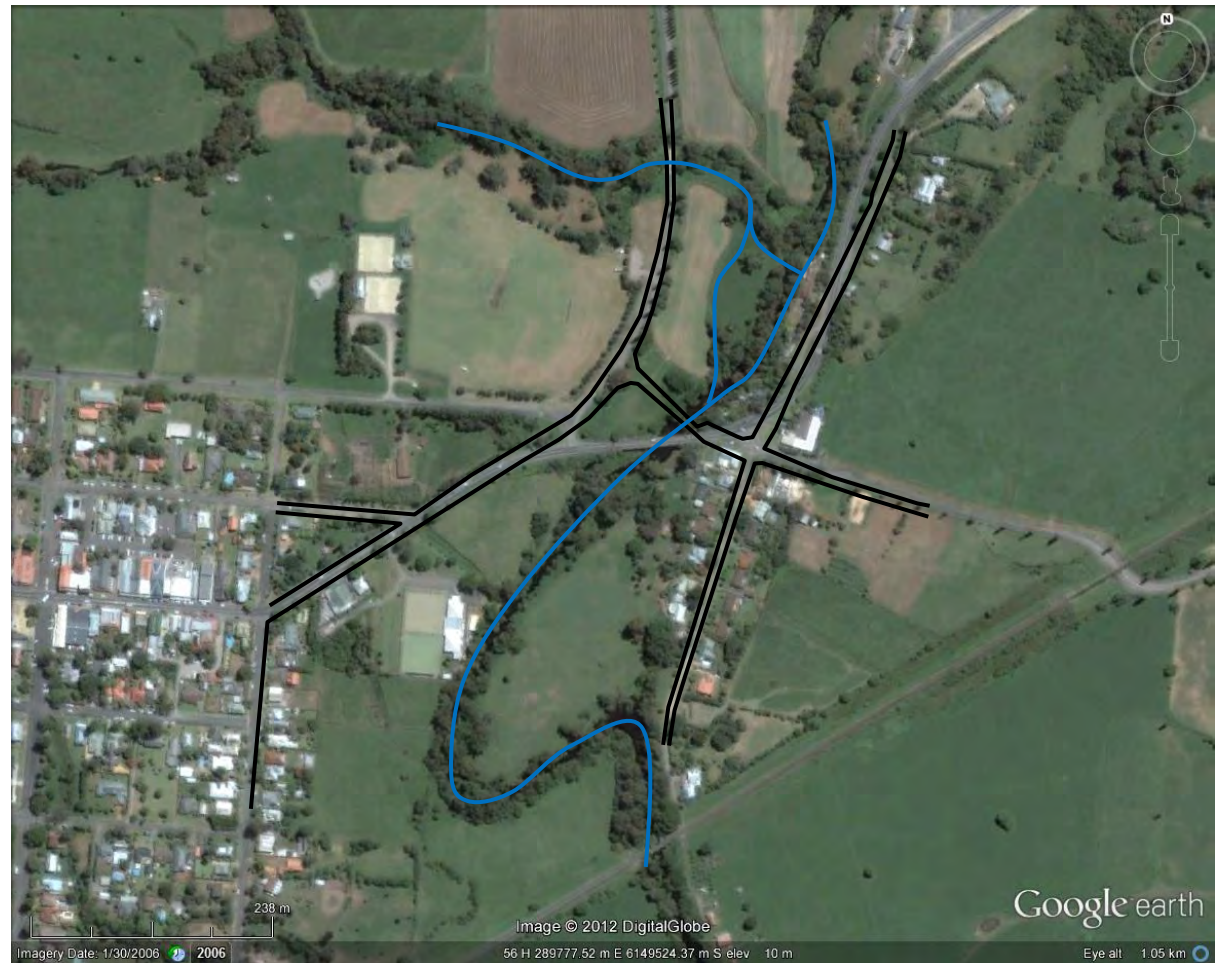
1949 aerial photograph

SVY662/NOWRA Run 2, 5164 (I55-166) 4 Apl 1949

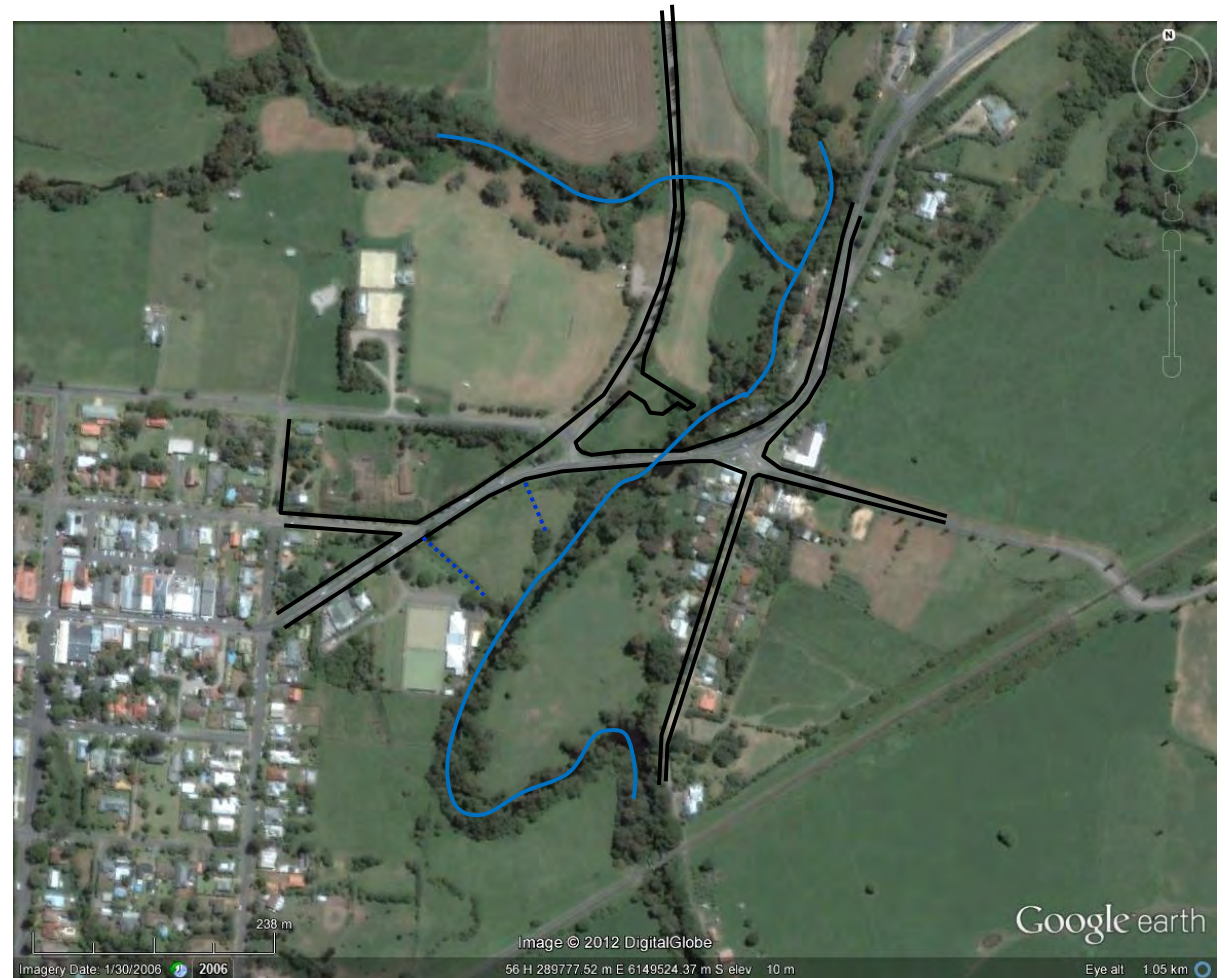
1958 aerial photograph

NSW 699-5036 SH.I DAPTO – ULLADULLA Run GKII 23/7/1958

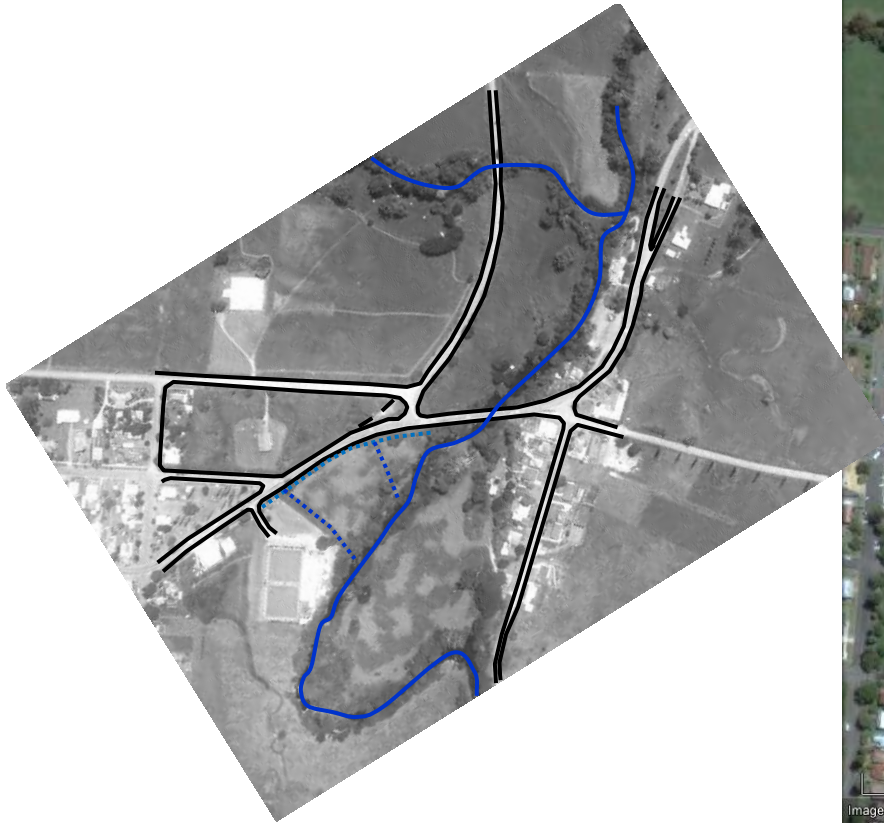
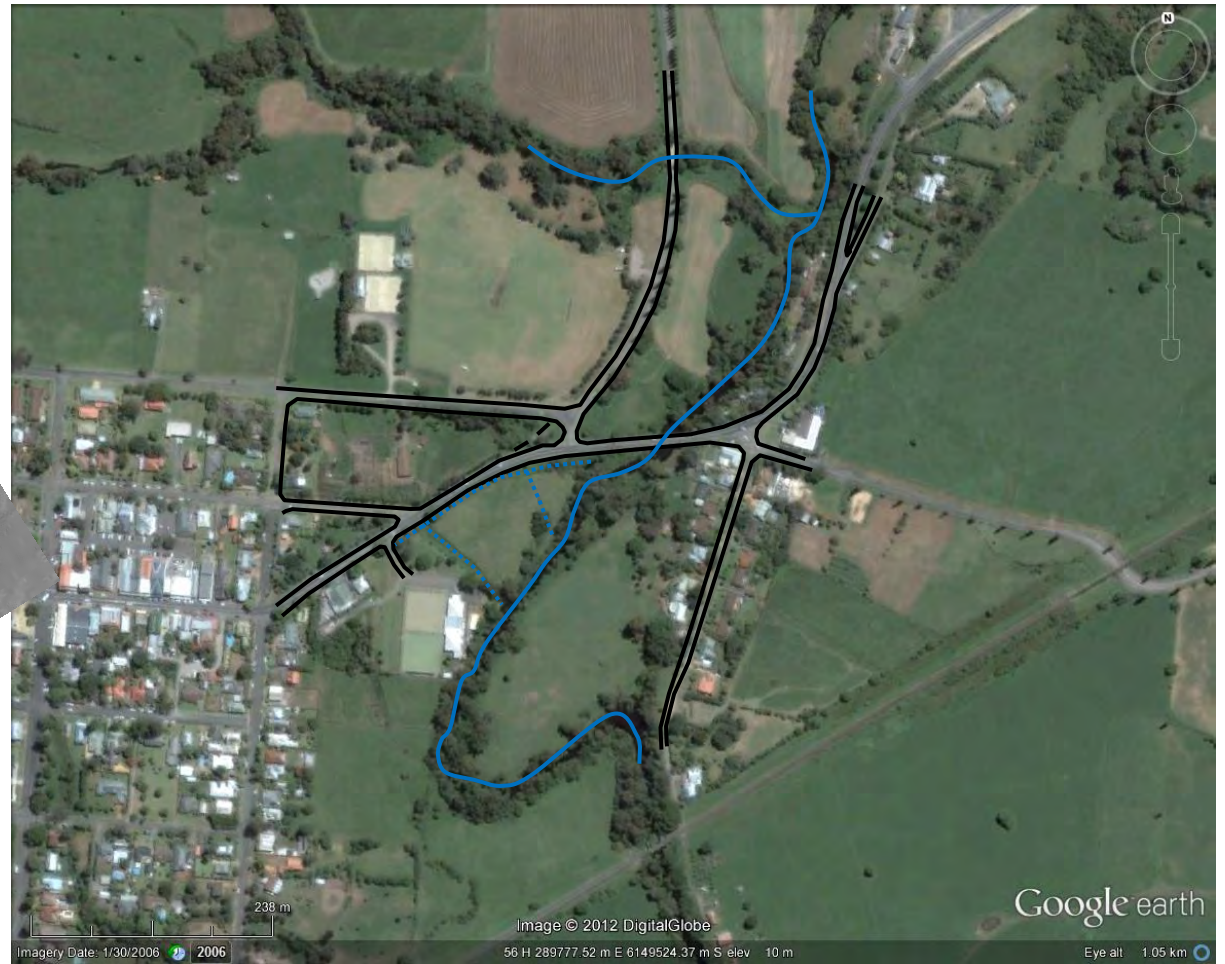
1986 aerial photography

NSW 2652-138 SHI – SUTHERLAND TO NOWRA
Run XD15 7/3/1986

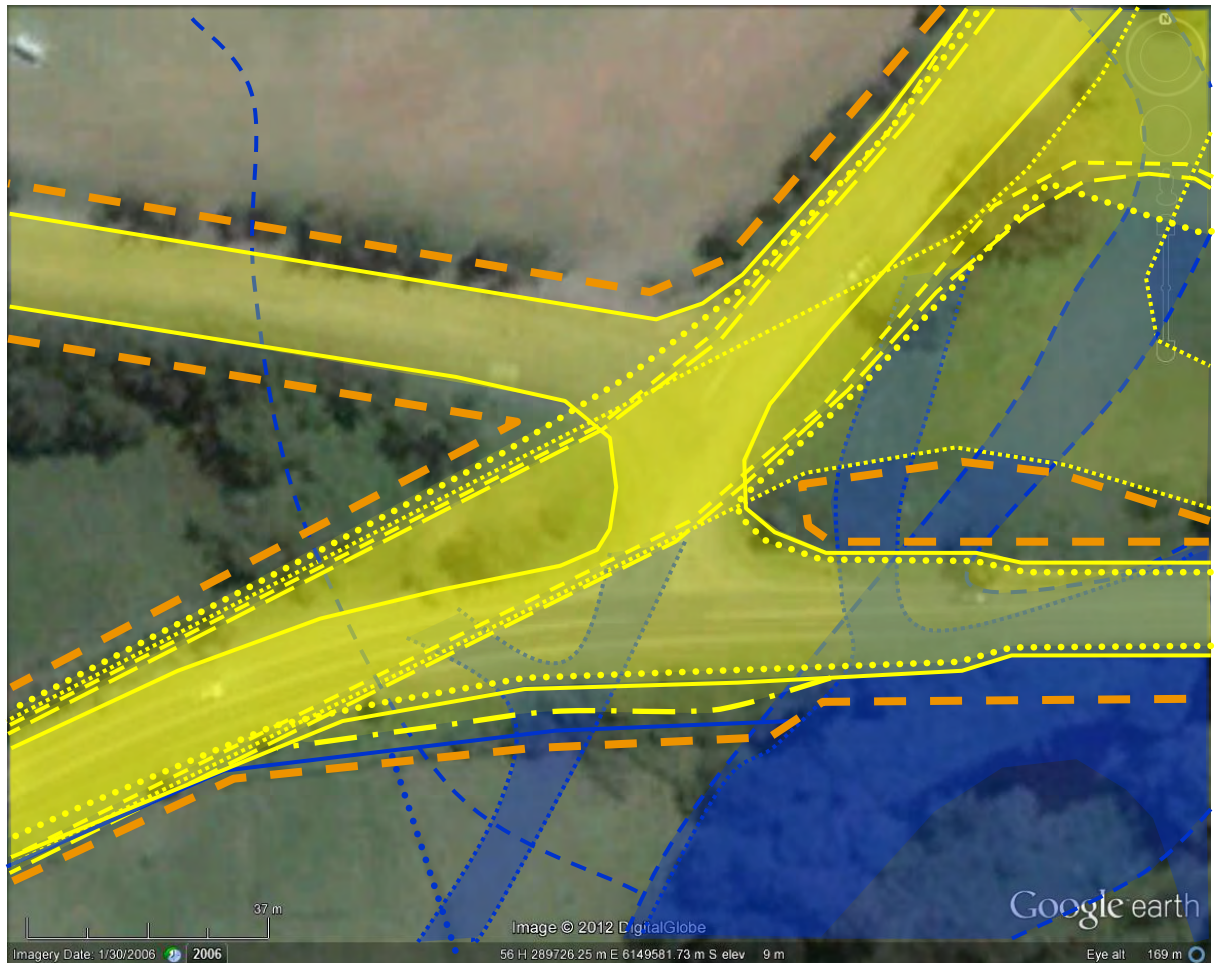
Detail of proposed roundabout area showing composite of past disturbance and drainage features (as interpreted from source material)

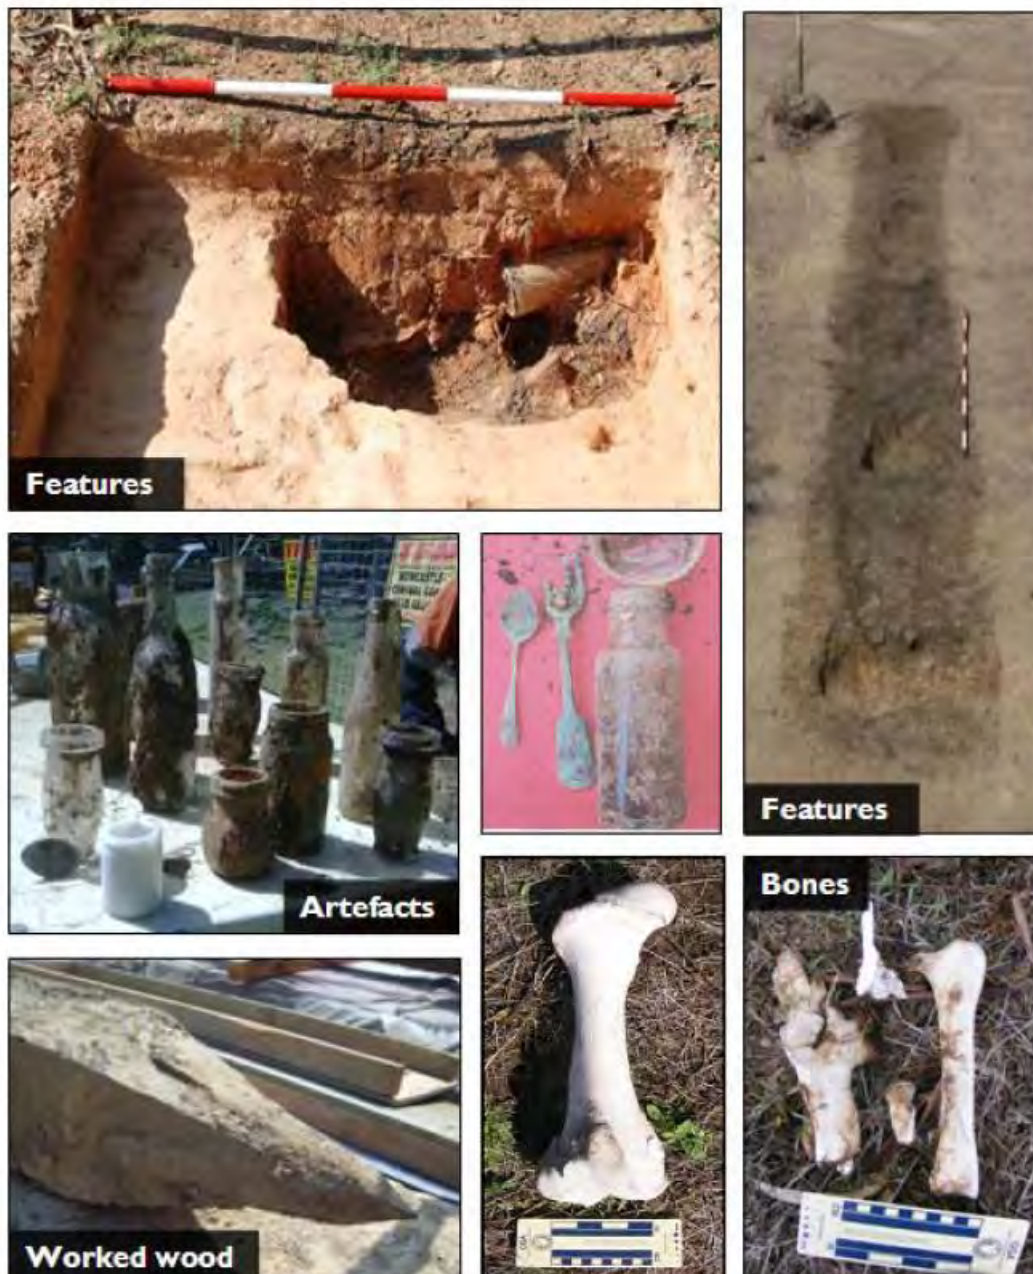
Top left hand picture continuing clockwise: Stock camp remnants (Hume Highway Bypass at Tarcutta); Linear archaeological feature with post holes (Hume Highway Duplication), Animal bones (Hume Highway Bypass at Woomargama); Cut wooden stake; Glass jars, bottles, spoon and fork recovered from refuse pit associated with a Newcastle Hotel (Pacific Highway, Adamstown Heights, Newcastle area).

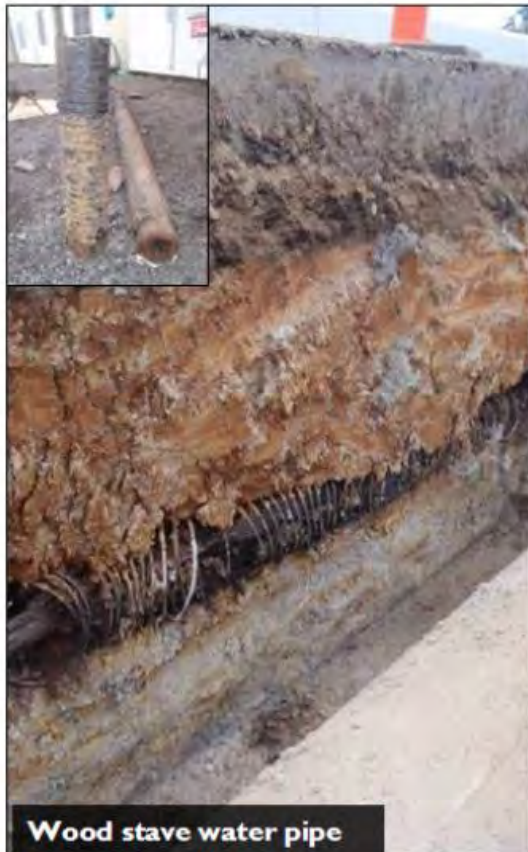
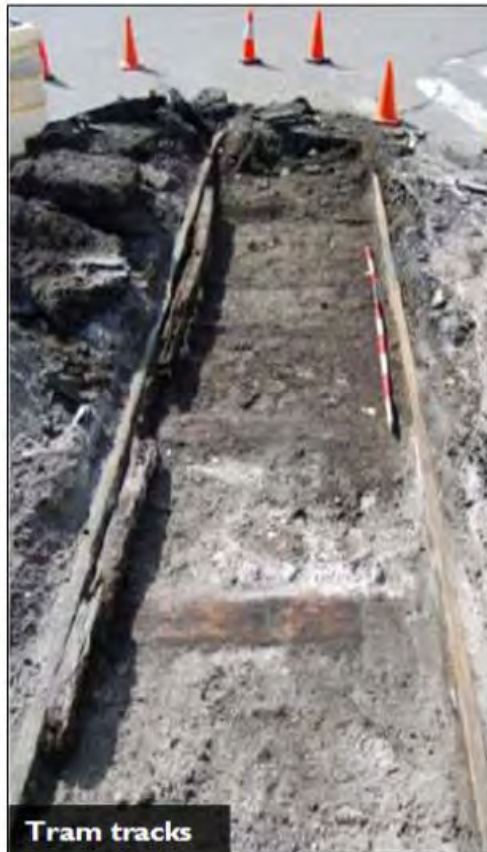
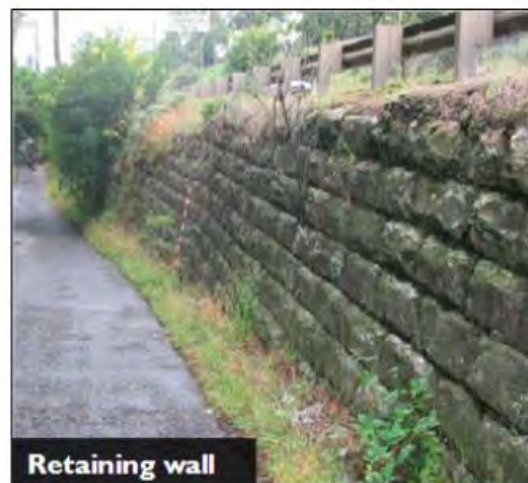
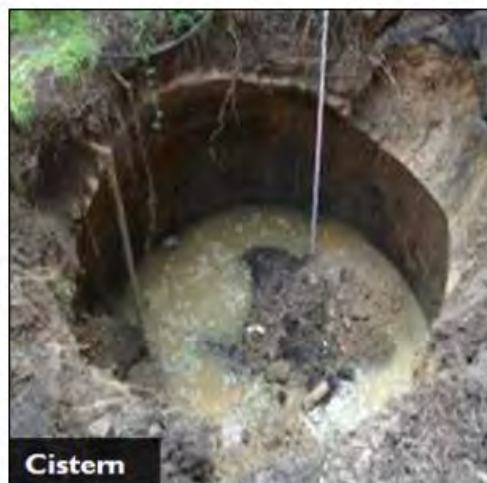
Top left hand picture continuing clockwise: Woodstave water pipe with tar and wire sealing (Horsley Drive); Tram tracks (Sydney); Brick lined cistern (Clyde); Retaining wall (Great Western Highway, Leura).

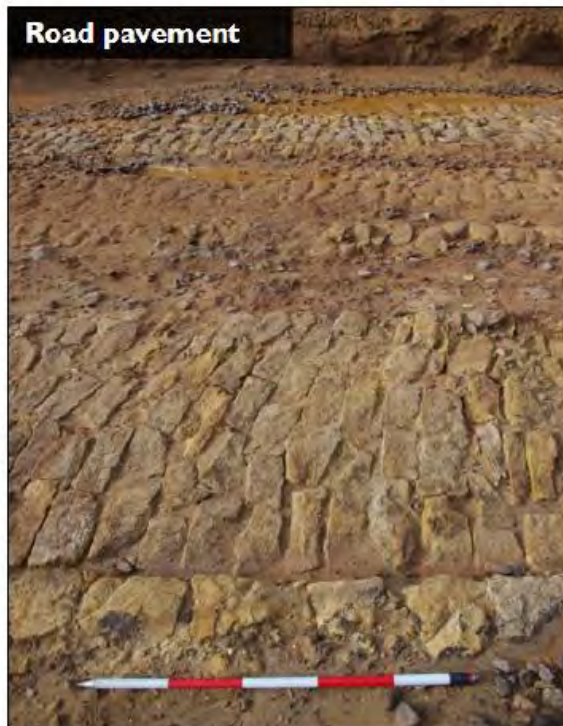
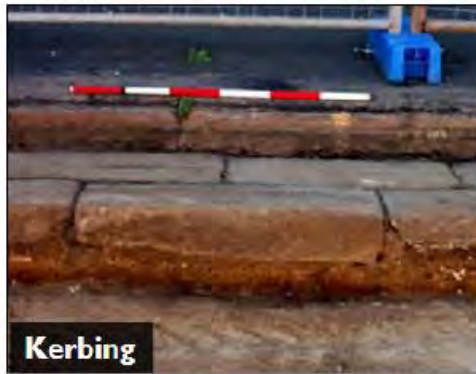
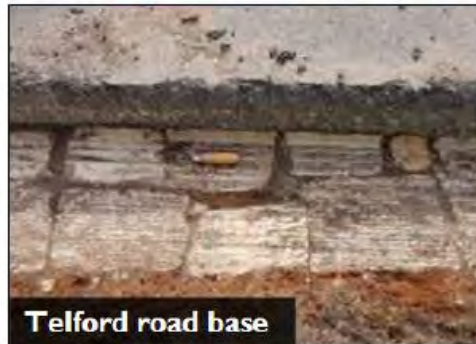
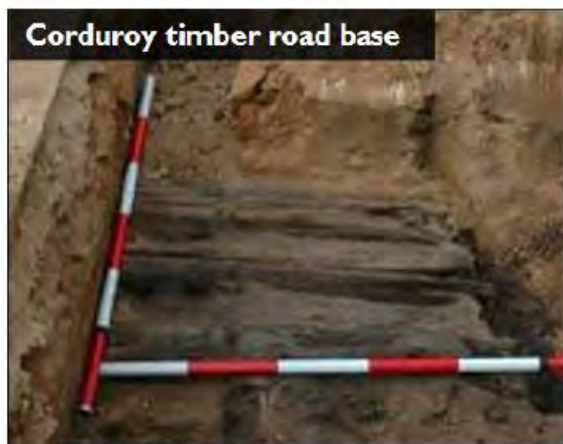
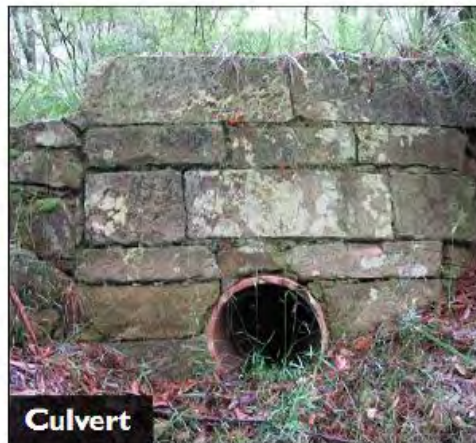
Top left hand picture continuing clockwise: Road pavement (Great Western Highway, Lawson); Sandstone kerbing and guttering (Parramatta Road, Mays Hill); Telford road (sandstone road base, Great Western Highway, Leura); Ceramic conduit and sandstone culvert headwall (Blue Mountains, NSW); Corduroy road (timber road base, Entrance Road, Wamberai).

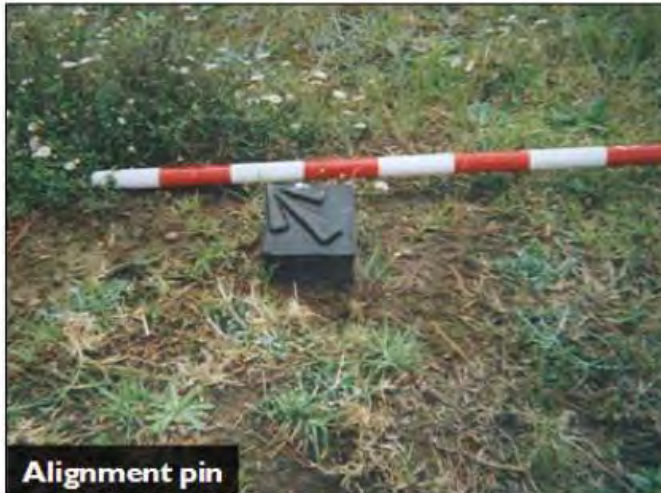
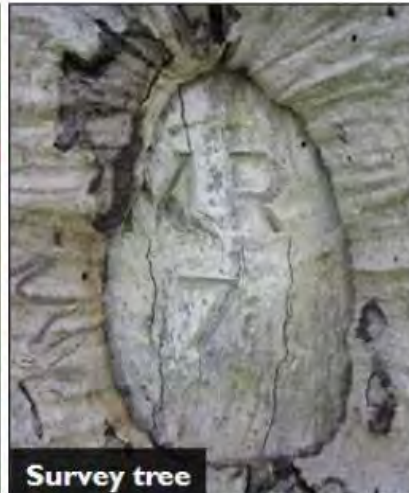
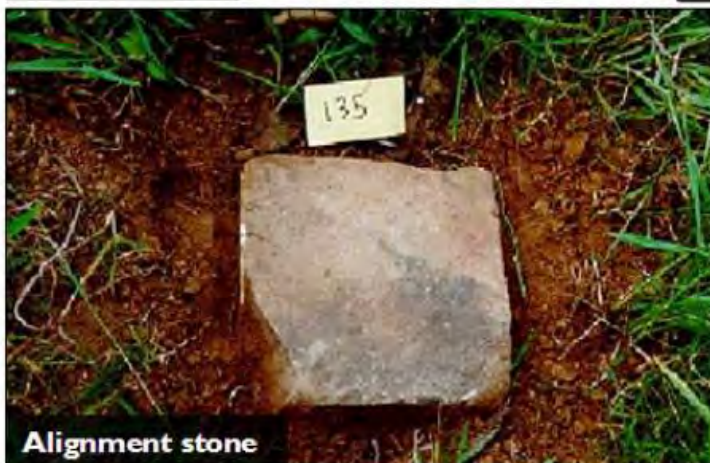
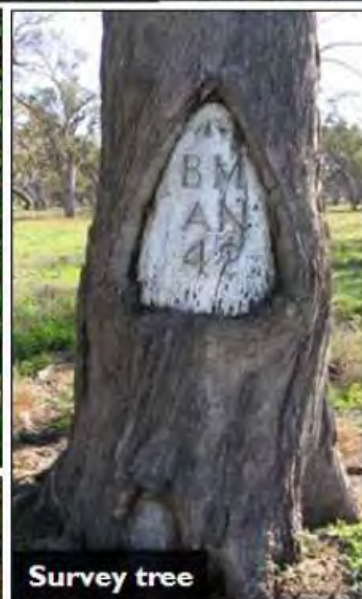
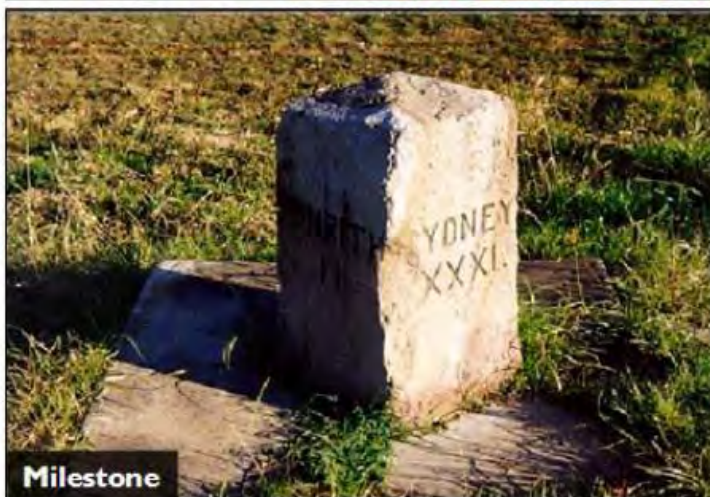
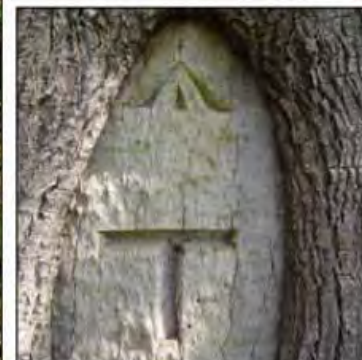
Top left hand corner continuing clockwise: Alignment Pin (Great Western Highway, Wentworth Falls); Survey tree (MR7, Albury); Survey tree (Kidman Way, Darlington Point, Murrumbidgee); Survey tree (Cobb Highway, Deniliquin); Milestone (Great Western Highway, Kingswood, Penrith); Alignment Stone (near Guntawong Road, Riverstone). Please note survey marks may have additional statutory protection under the *Surveying and Spatial Information Act 2002*.

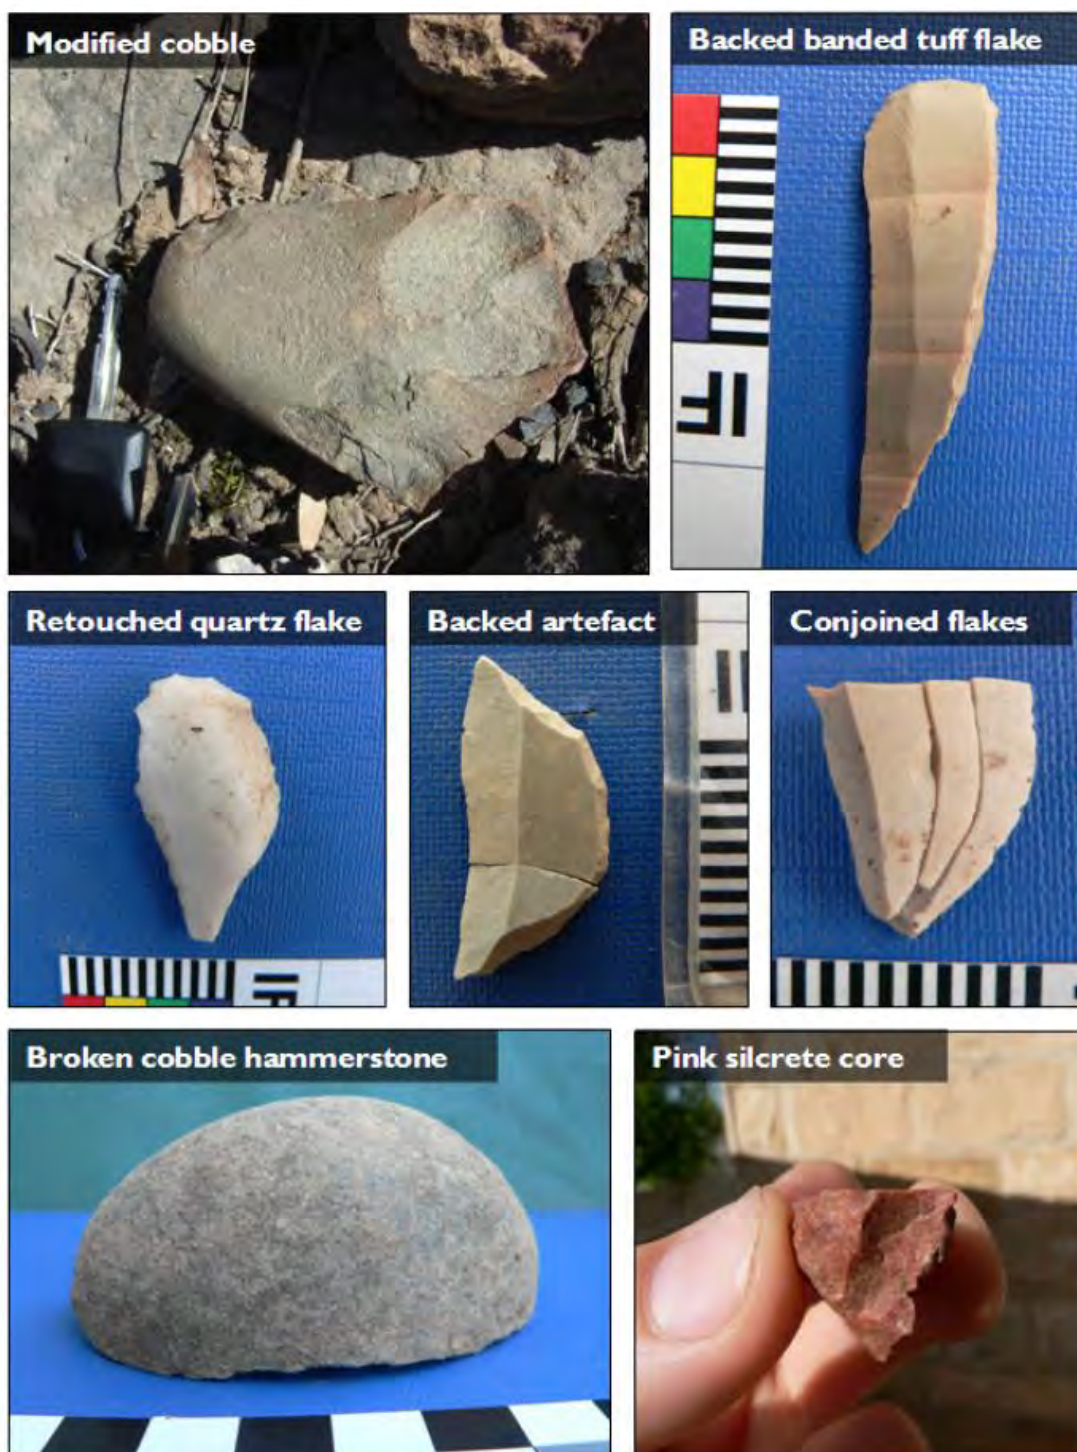
Top left hand corner: Culturally modified stone discovered on Main Road 92, about two kilometres west of Sassafras. The rest of the images show a selection of stone artefacts retrieved from test and salvage archaeological excavations during the Hume Highway Duplication and Bypass projects from 2006-2010.

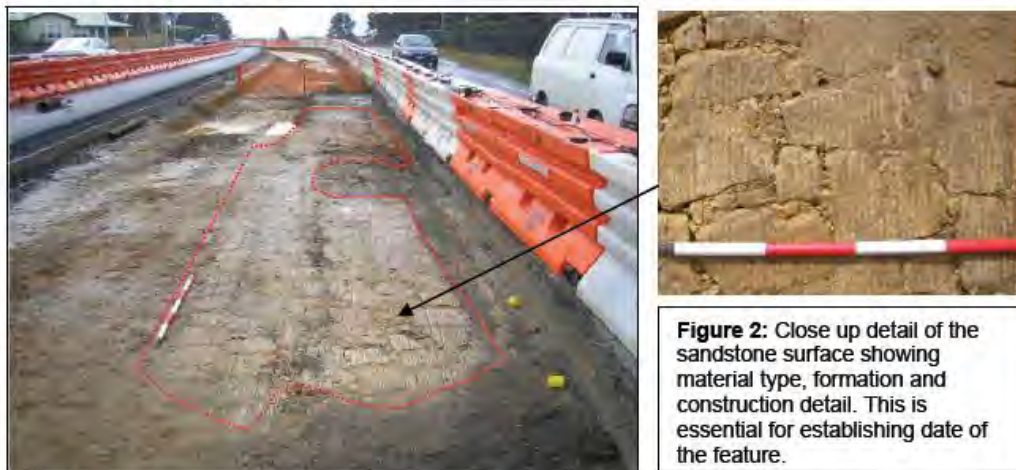
Figure 2: Close up detail of the sandstone surface showing material type, formation and construction detail. This is essential for establishing date of the feature.

Figure 1: Telford road uncovered on the Great Western Highway (Leura) in 2008.

It is important to take a general photograph (Figure 1) to convey the location and setting of the find. This will add much value to the subsequent detailed photographs also required (Figure 2).

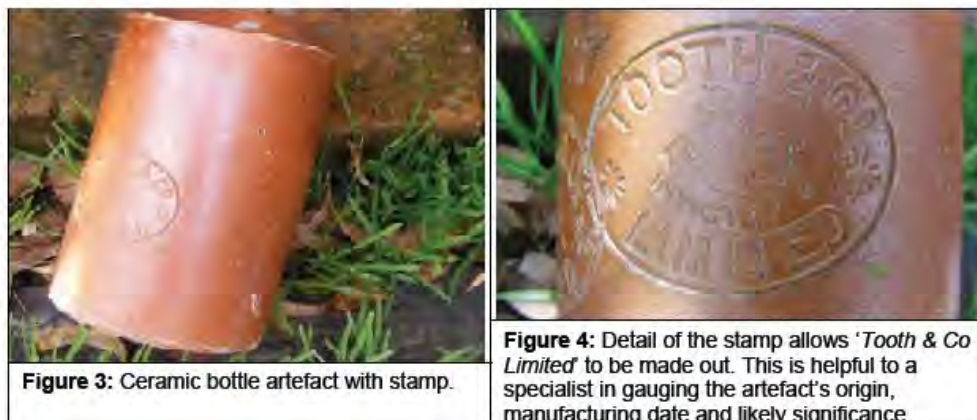
Figure 3: Ceramic bottle artefact with stamp.

Figure 4: Detail of the stamp allows 'Tooth & Co Limited' to be made out. This is helpful to a specialist in gauging the artefact's origin, manufacturing date and likely significance.

Where unexpected finds (eg artefacts) have a distinguishing feature, close up detailed photographs must be taken of this, where practicable. See Figures 3 and 4 for examples.

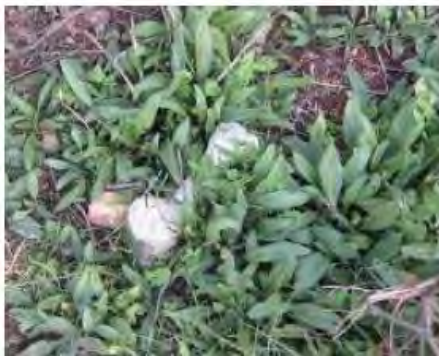
Figure 5: Bone concealed by foliage.

The majority of bones found on site will be those of recently deceased animal bones often requiring no further assessment (unless they are in archaeological context). However, if bones are human RMS must contact the police immediately (see Appendix F for detailed guidance). Taking quality photographs of the bones can often resolve this issue quickly. Heritage staff in Environment Branch can confirm if bones are human or non-human if provided with appropriate photographs. Ensure that photographs of bones are not concealed by foliage (Figure 5) as this makes it difficult to identify. Minor hand removal of foliage can be undertaken as long as disturbance of the bone does not occur. Excavation of the ground to remove bone(s) should not occur, nor should they be pulled out of the ground if partially exposed. Where sediment (adhering to a bone found on the ground surface) conceals portions of a bone (Figure 6) ensure the photograph is taken of the bone (if any) that is not concealed by sediment.

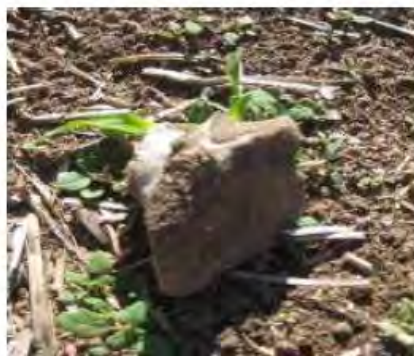
Figure 6: Bone covered in sediment

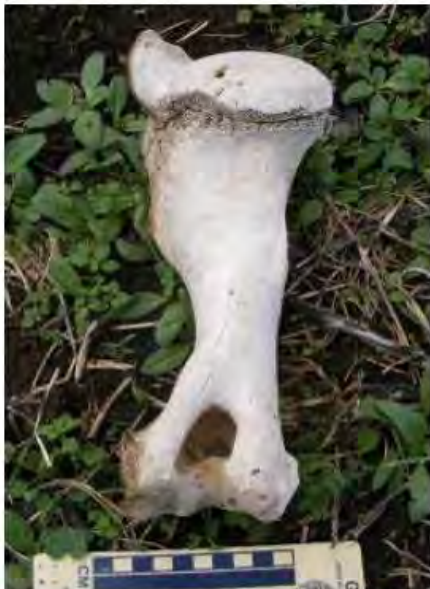
Figure 7: Photograph showing complete bone.

Ensure that all close up photographs include the whole bone and then specific details of the bone (especially the ends of long bones, the *epiphysis*, which is critical for species identification). Figures 7 and 8 are examples of good photographs of bones that can easily be identified from the photograph alone. They show sufficient detail of the complete bone and the epiphysis.

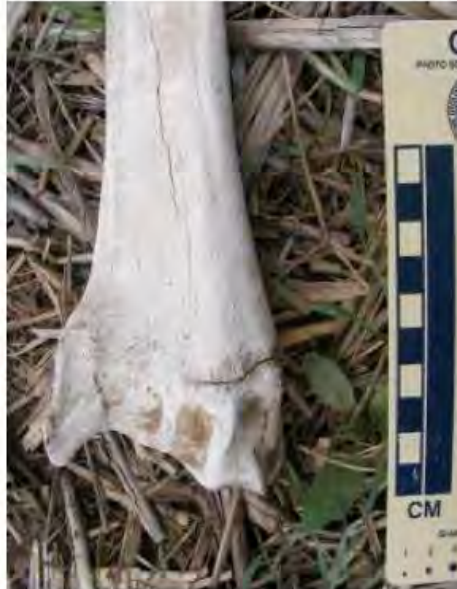
Figure 8: Close up of a long bone's epiphysis.

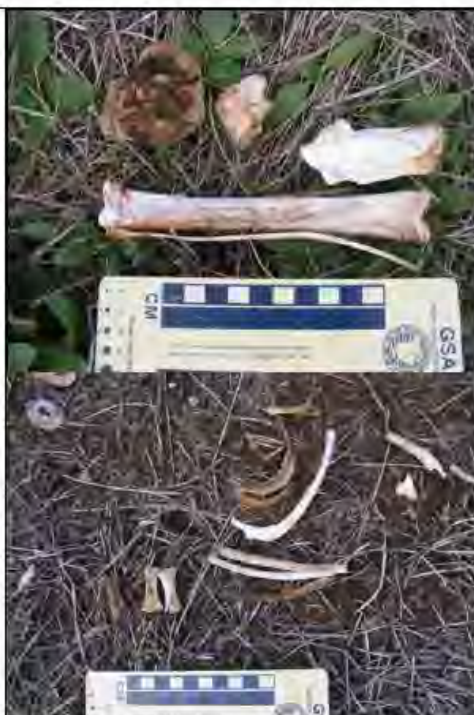
Figure 2: Disarticulated bones that require assessment to determine species.
