Appendix B

Heritage listings

B.1 RMS Section 170 Heritage and Conservation Register

Broughton Creek bridge

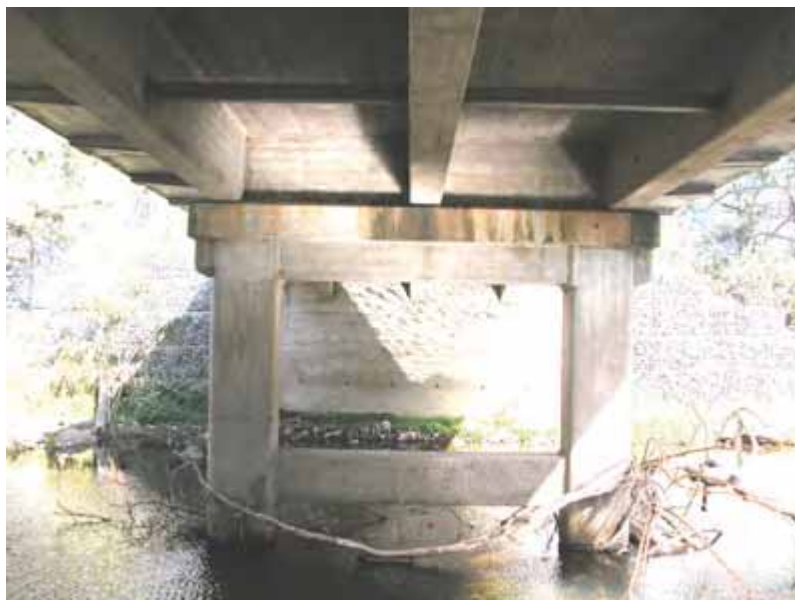
View on centreline under bridge showing main deck beams, cross beams and RHS cantilever stabilising struts. Pier is detailed for simply supported deck.

This bridge is set on a valley bottom with the stream running below on cobbles. The road curves tightly to the north of the bridge and the speed zoning is 90 kph. The bridge is a widened structure of three longitudinal beams which are simply supported at the central pier and curve down to frame compositely with the abutment walls. Each span has a cross girder at the pier. Widening of the bridge

has been effected by means of attaching cantilever deck to each side of the bridge. These cantilevers are supported by small composite cantilever beams which are tapered upward from the main beam. To assist in distributing the twisting effect of loads outside the main beams coming through the cantilevers, three rows of steel struts per span brace the main beams. The new deck edge supports a kerb and Thriebeam style guardrailling.

The central pier has two columns which frame into a cross girder which has a wider upper section to accommodate the two simply supported decks. The abutments, of wall type, have been extended to accommodate the new deck width, and gabion box walls have been used to stabilise the abutment fill.

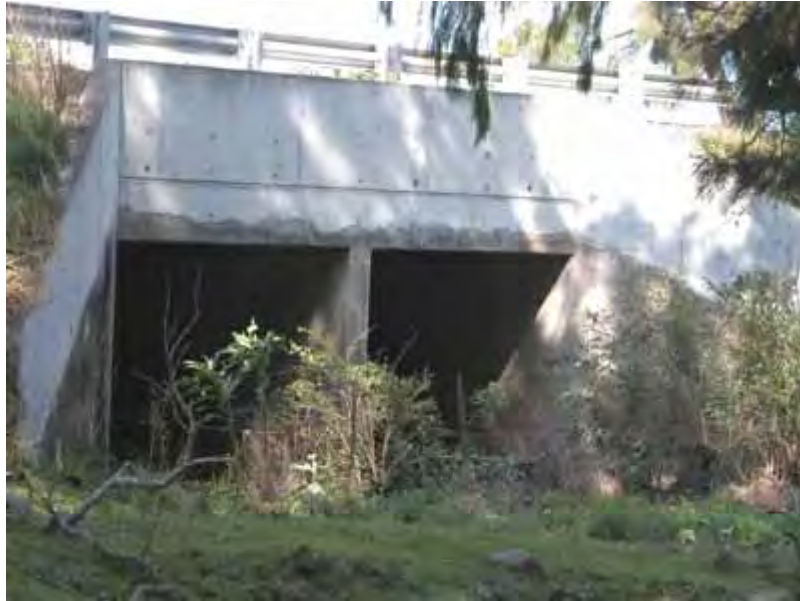
Overflow channel culvert showing raised head and wingwalls to suit road widening.

Approximately 50 metres south of the bridge, a two cell cast in-situ box culvert services an overflow channel of the stream. This has had its end walls and wingwalls raised to allow for increased formation width.

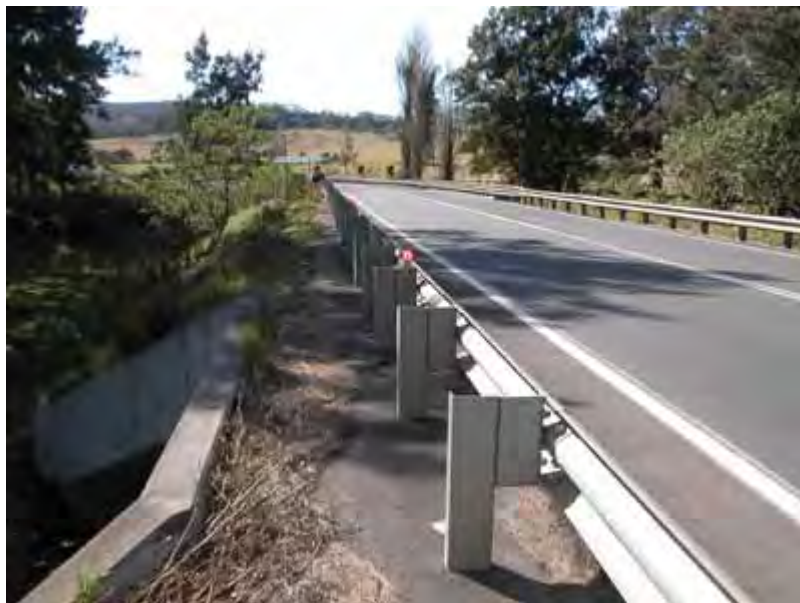
View north across overflow channel culvert with bridge in background having Thierail guardrail

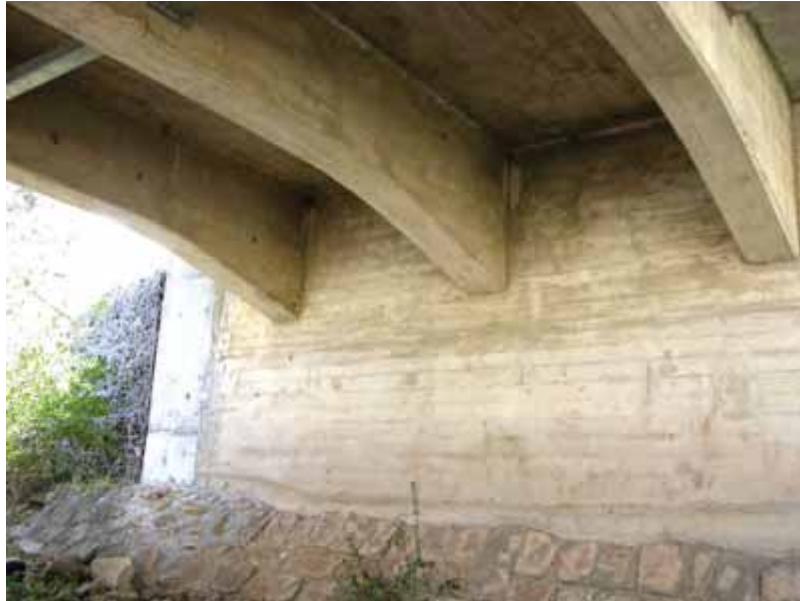
Oblique view of abutment showing deck beams curving to join the abutment wall. Also note abutment widening and gabion wingwalls. Cemented stonework protects toe of abutment wall.

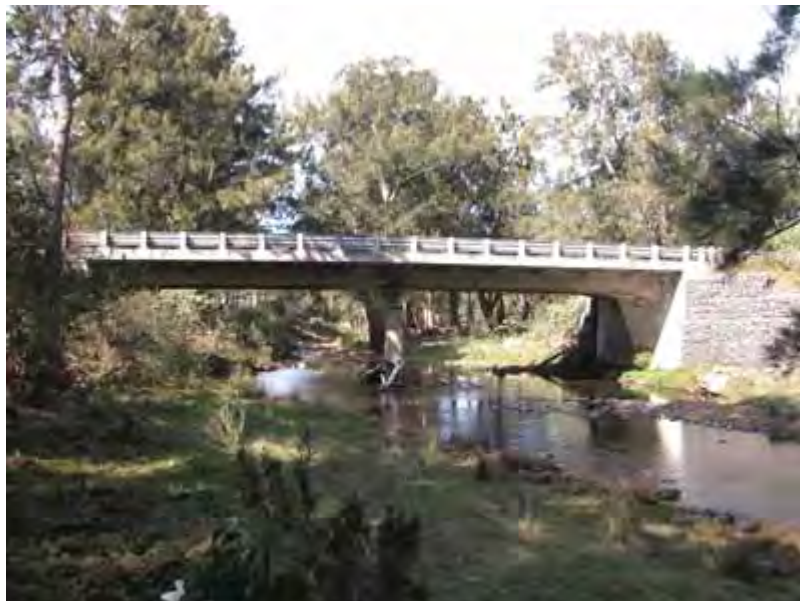
View of bridge looking east

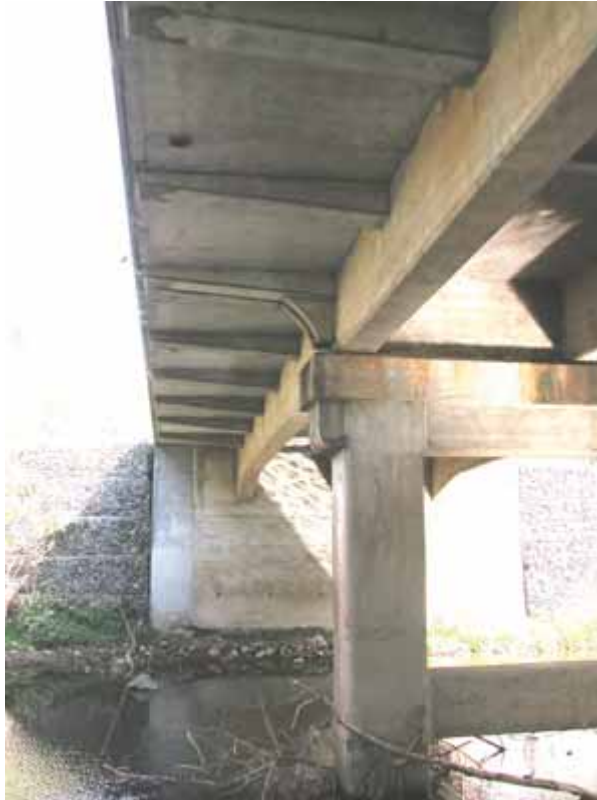
Cantilever widening, using tapered concrete cantilevers and reinforced concrete deck

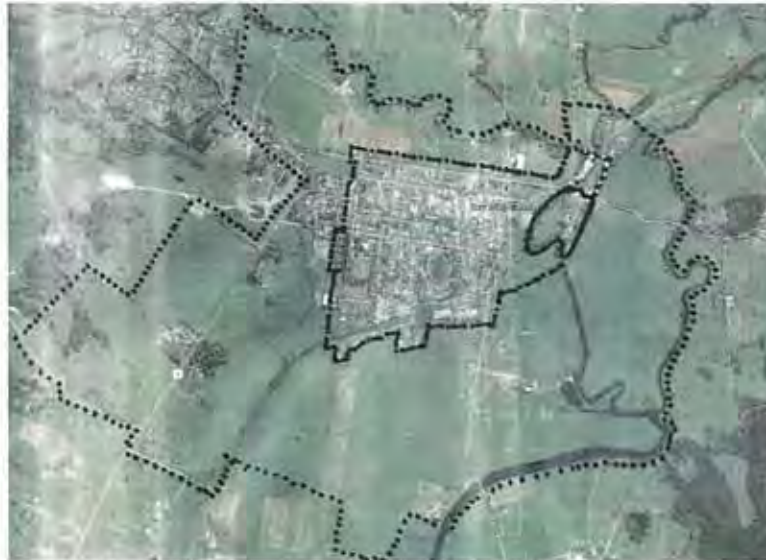
Figure 13 Proposed listing boundary. The Pulman Street Heritage Conservation Area is edged with a solid line. The Subdivision boundary is dashed. The buffer zone is dotted. (Google Earth, 2010 with overlay by Bob Clark, 2010)

1. Visual boundary: This is the boundary of the National Trust's Landscape Conservation Area. It places Berry in its regional context and incorporates views to horizon, surrounding rural landscape and the Illawarra Escarpment. (see Figure 4)
2. Subdivision boundary: relates to the town grid pattern and its development in the latter half of the 19th and the first half of the 20th centuries. It has been extended across to join with the existing Pulman Street Heritage Conservation Area. (see Figure 13)
3. Buffer zone to recognise the importance of Berry's rural setting and to protect the edges of the town within the rural lands surrounding it. This incorporates some creek lines and flood prone lands. (See Figure 13)

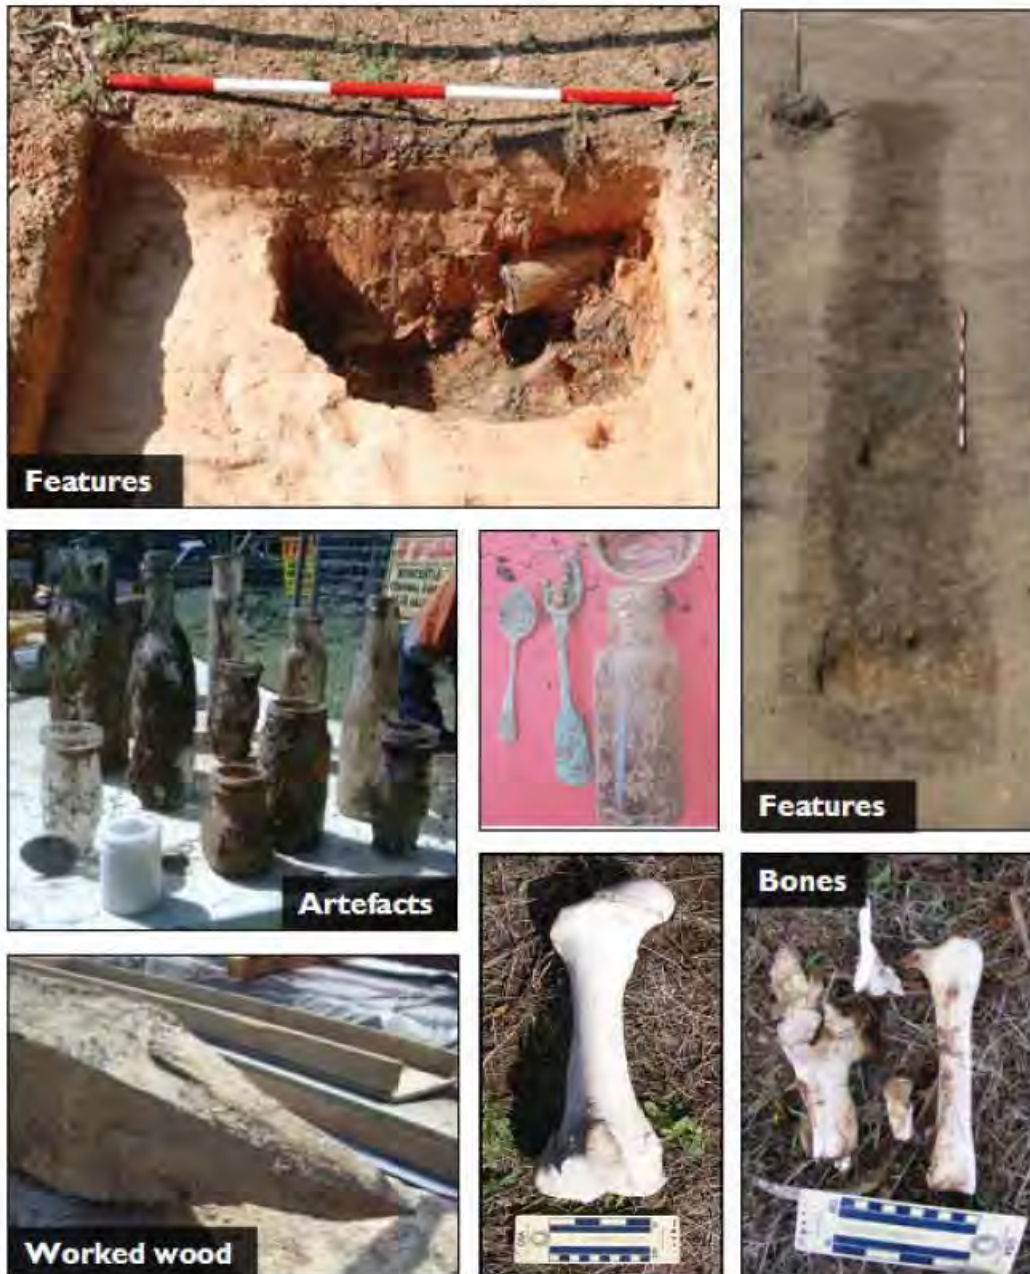
Top left hand picture continuing clockwise: Stock camp remnants (Hume Highway Bypass at Tarcutta); Linear archaeological feature with post holes (Hume Highway Duplication), Animal bones (Hume Highway Bypass at Woomargama); Cut wooden stake; Glass jars, bottles, spoon and fork recovered from refuse pit associated with a Newcastle Hotel (Pacific Highway, Adamstown Heights, Newcastle area).

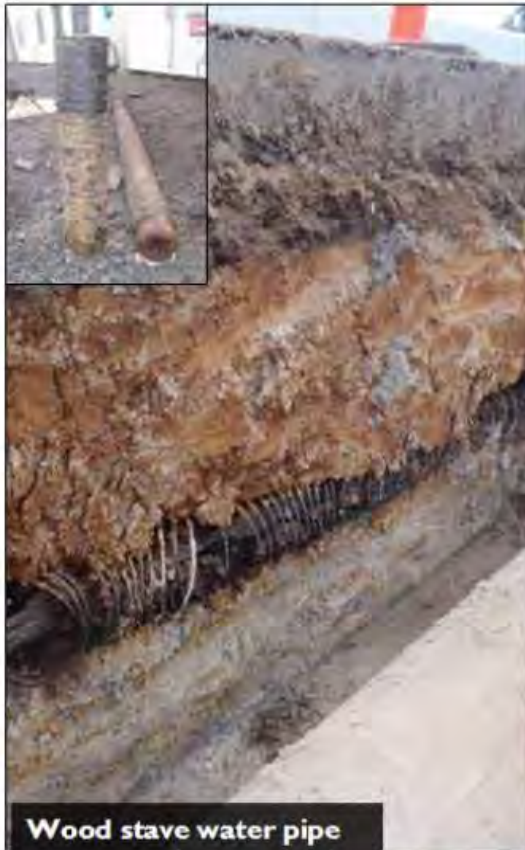
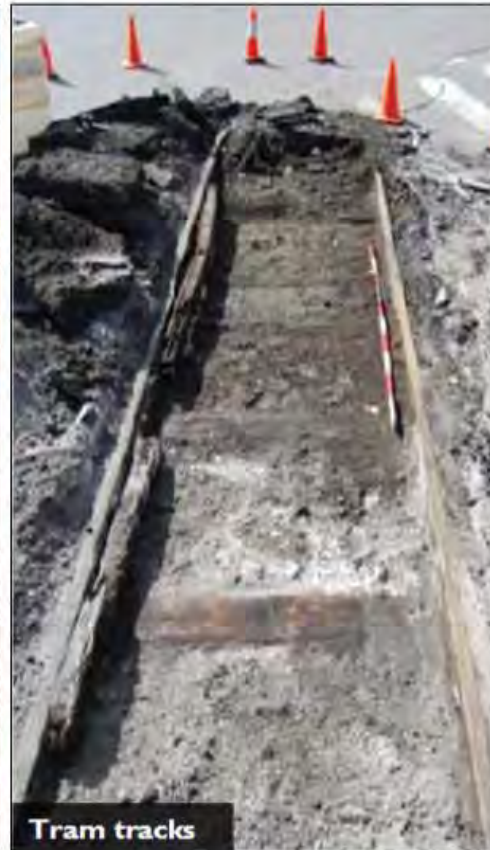
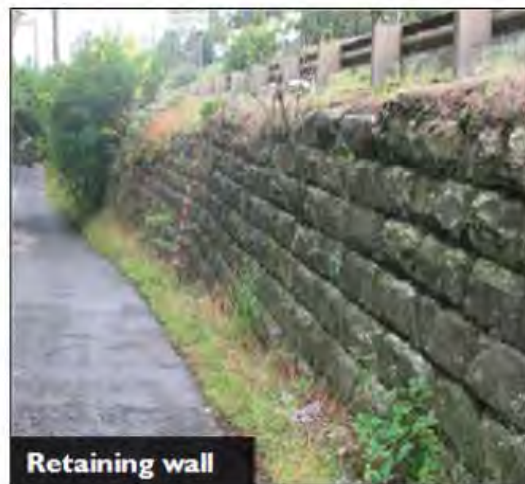
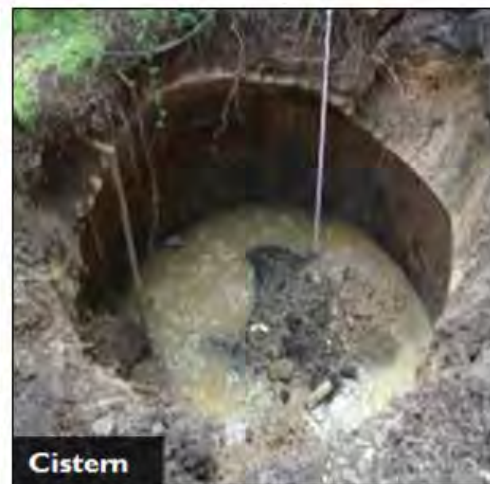
Top left hand picture continuing clockwise: Woodstave water pipe with tar and wire sealing (Horsley Drive); Tram tracks (Sydney); Brick lined cistern (Clyde); Retaining wall (Great Western Highway, Leura).

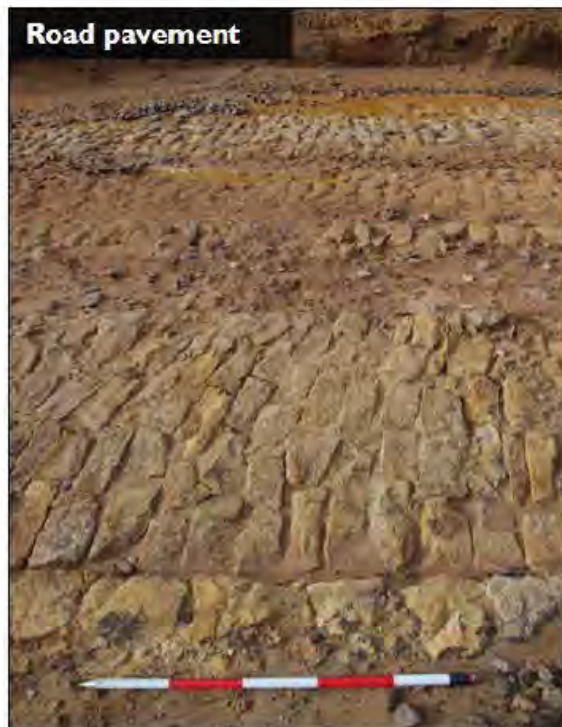
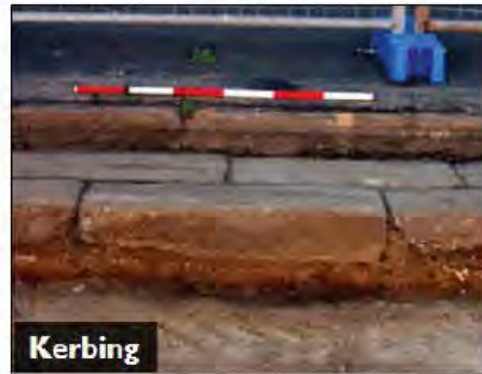
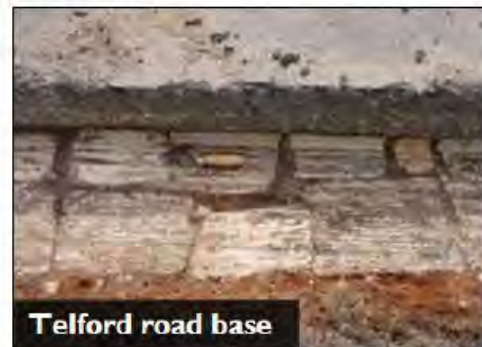
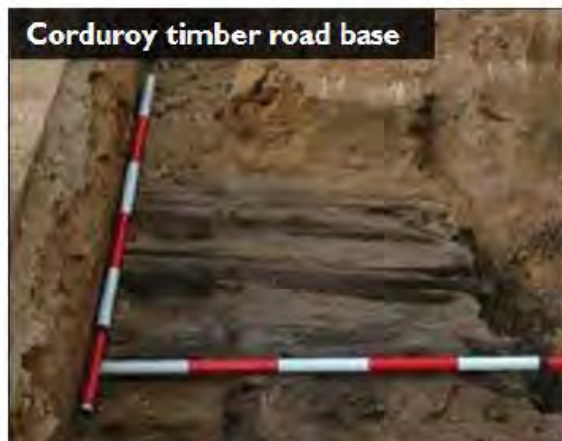
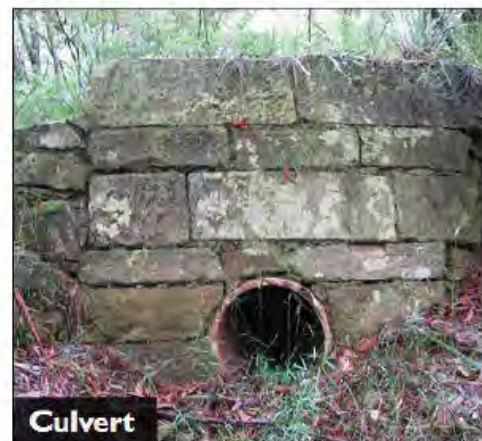
Top left hand picture continuing clockwise: Road pavement (Great Western Highway, Lawson); Sandstone kerbing and guttering (Parramatta Road, Mays Hill); Telford road (sandstone road base, Great Western Highway, Leura); Ceramic conduit and sandstone culvert headwall (Blue Mountains, NSW); Corduroy road (timber road base, Entrance Road, Wamberai).

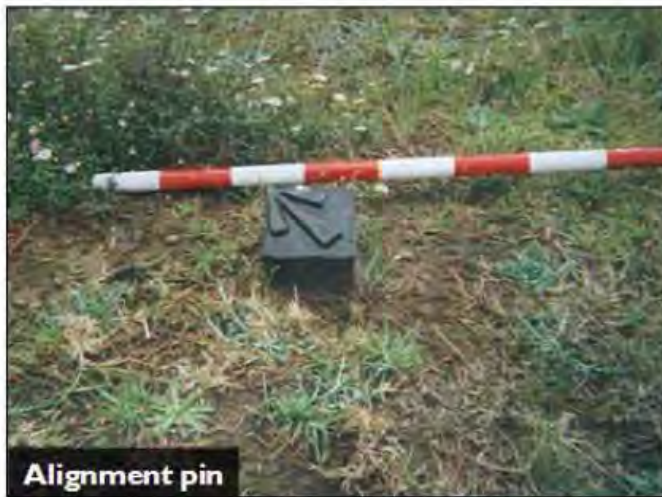
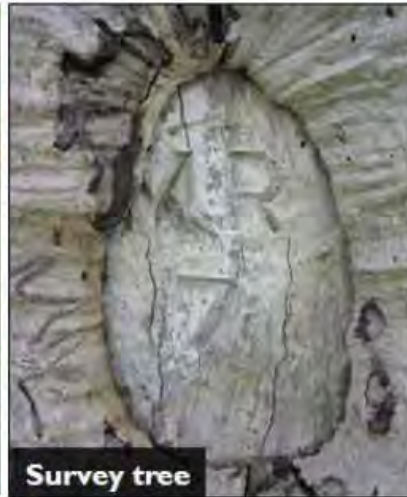
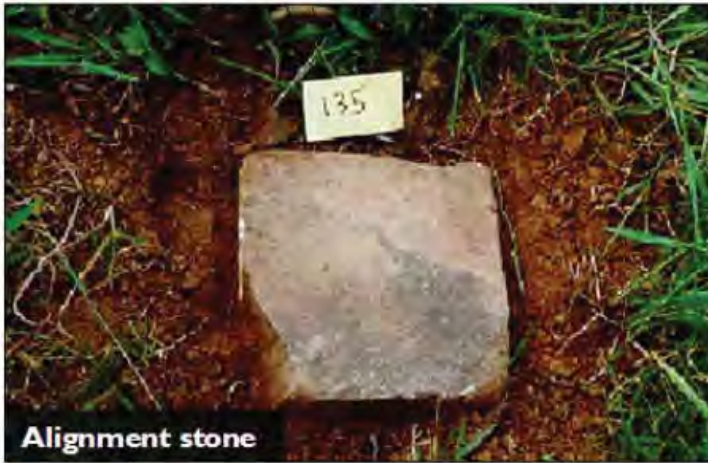
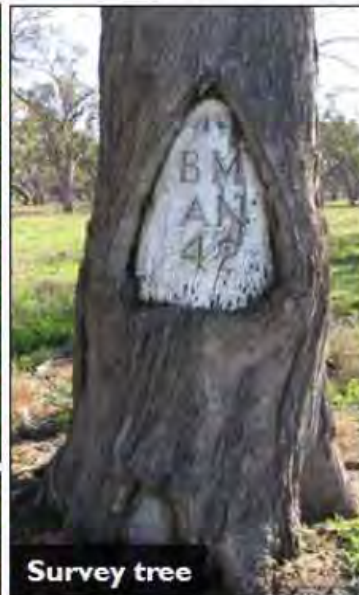
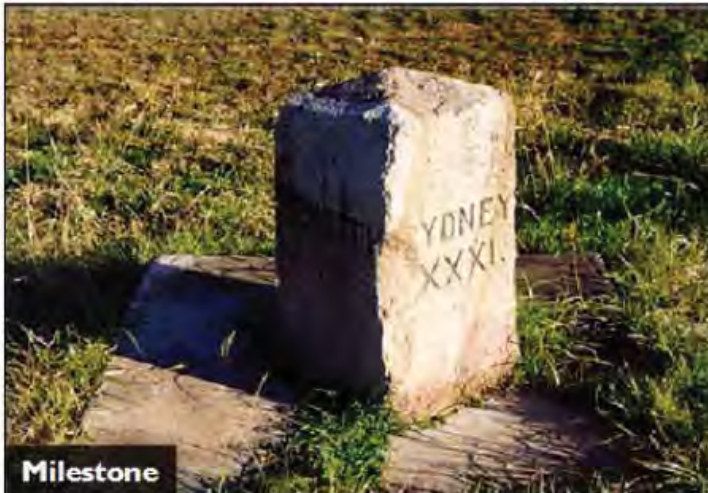
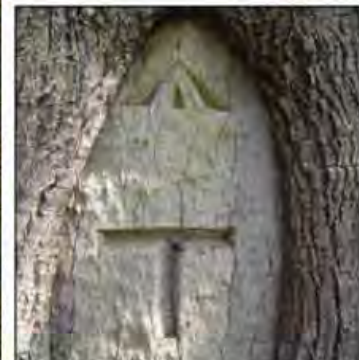
Top left hand corner continuing clockwise: Alignment Pin (Great Western Highway, Wentworth Falls); Survey tree (MR7, Albury); Survey tree (Kidman Way, Darlington Point, Murrumbidgee); Survey tree (Cobb Highway, Deniliquin); Milestone (Great Western Highway, Kingswood, Penrith); Alignment Stone (near Guntawong Road, Riverstone). Please note survey marks may have additional statutory protection under the *Surveying and Spatial Information Act 2002*.

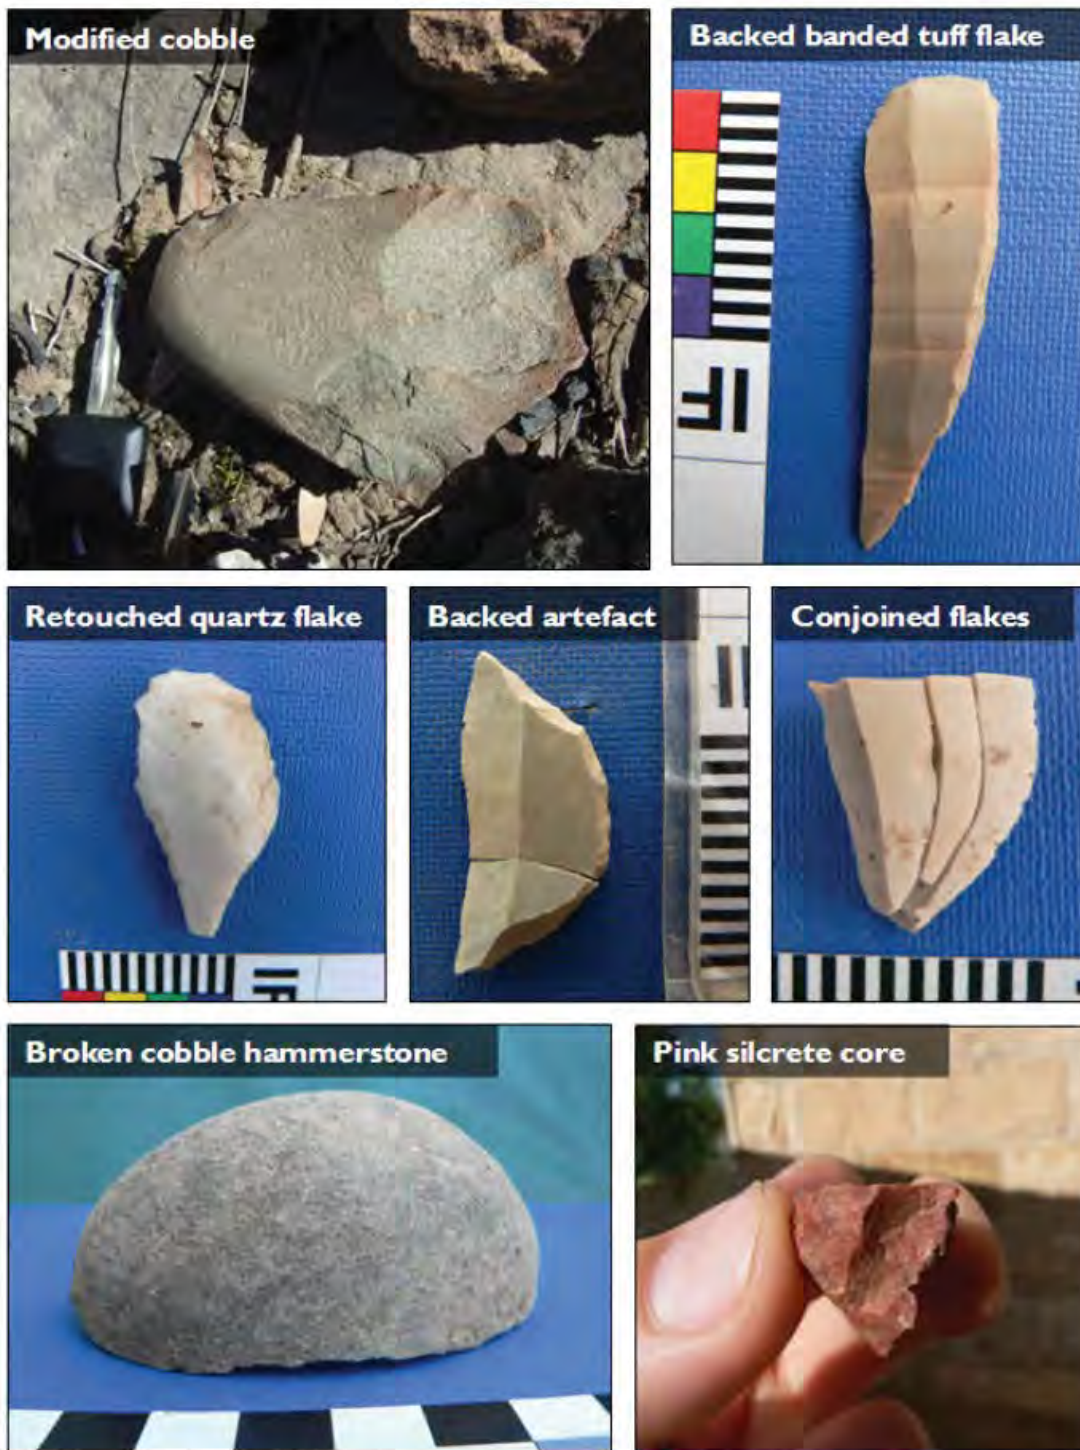
Top left hand corner: Culturally modified stone discovered on Main Road 92, about two kilometres west of Sassafras. The rest of the images show a selection of stone artefacts retrieved from test and salvage archaeological excavations during the Hume Highway Duplication and Bypass projects from 2006-2010.

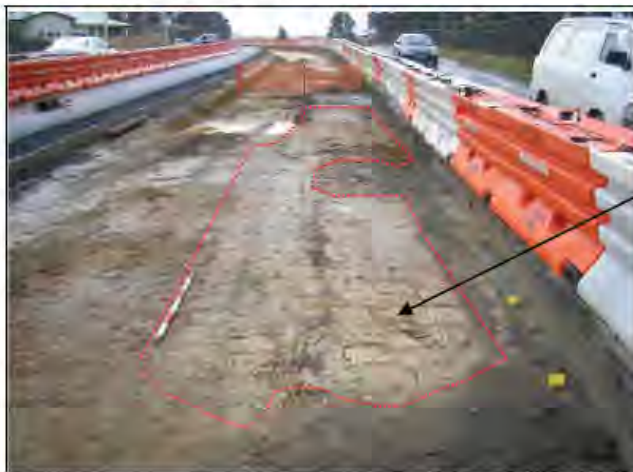
Figure 2: Close up detail of the sandstone surface showing material type, formation and construction detail. This is essential for establishing date of the feature.

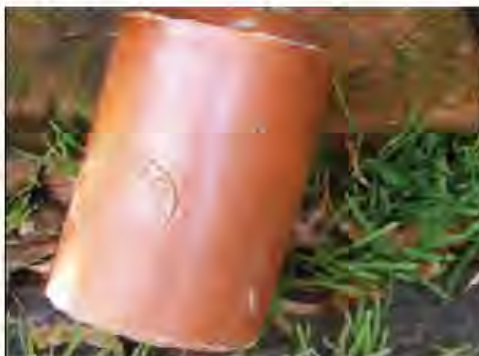
Figure 3: Ceramic bottle artefact with stamp.

Where unexpected finds (eg artefacts) have a distinguishing feature, close up detailed photographs must be taken of this, where practicable. See Figures 3 and 4 for examples.

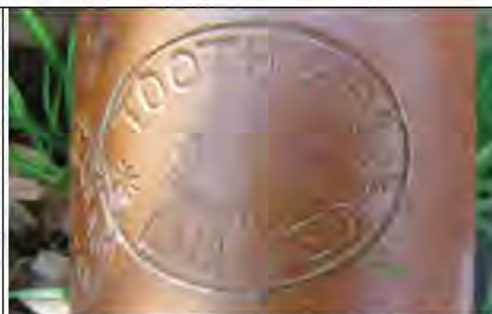
Figure 4: Detail of the stamp allows 'Tooth & Co Limited' to be made out. This is helpful to a specialist in gauging the artefact's origin, manufacturing date and likely significance.

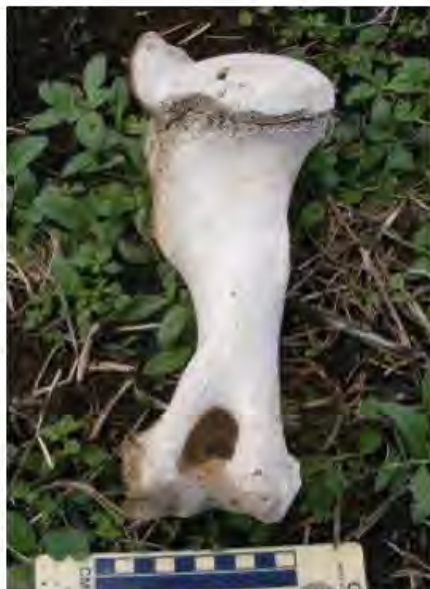
Figure 7: Photograph showing complete bone.

Ensure that all close up photographs include the whole bone and then specific details of the bone (especially the ends of long bones, the *epiphysis*, which is critical for species identification). Figures 7 and 8 are examples of good photographs of bones that can easily be identified from the photograph alone. They show sufficient detail of the complete bone and the epiphysis.

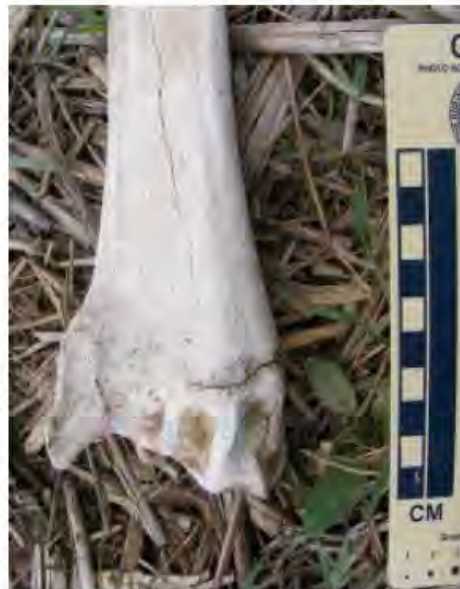
Figure 8: Close up of a long bone's epiphysis.

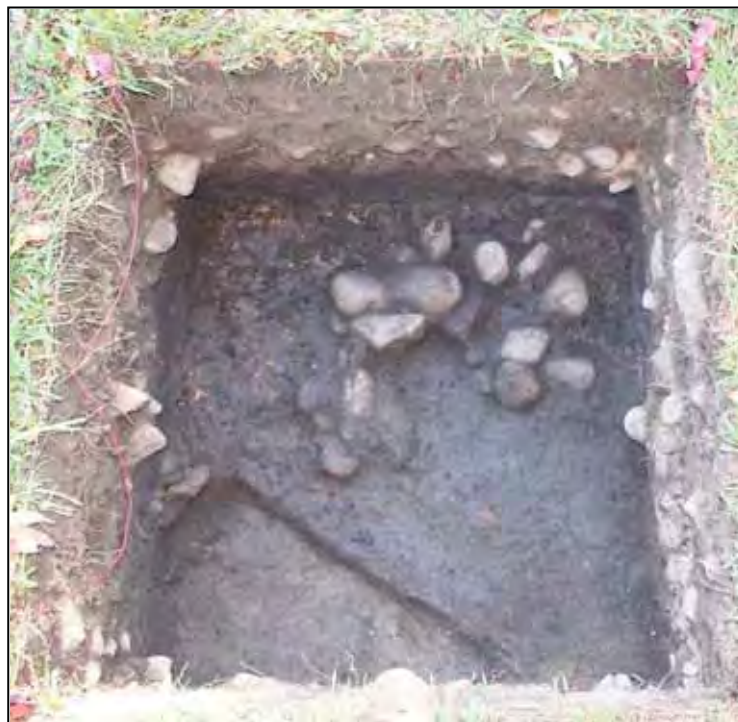
Figure E.1 Trench F20 at completion of excavation – north at top.

Excavation in this area proceeded by stratigraphic context with removal of turf (Context 1), topsoil (Context 2), disturbed fill with alluvial cobbles (Context 9), transitional gravelly matrix with a decrease in cobbles (Context 15), followed by excavation of a darker mixed clay and loam matrix with charcoal and ash (Context 18) down to a natural yellow brown clay subsoil; excavation in Quadrat III also included removal of a pocket of dark brown clay (Context 26) below Context 18 and above the natural clay subsoil (Figure E.1).

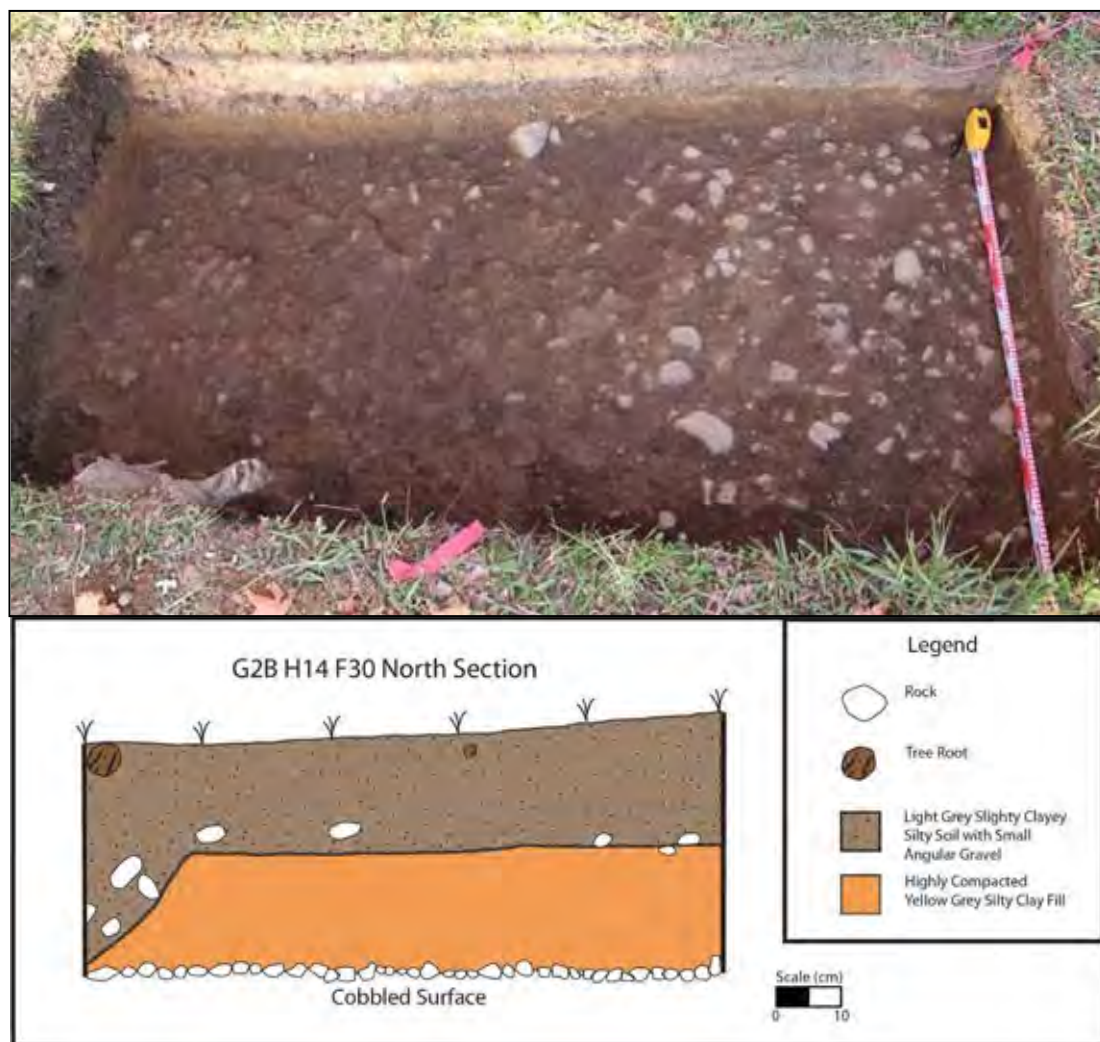
**Figure E.2 Cobbled floor exposed at base of trench F30-31 (top)
Cross section of soil profile in trench F30-31 (bottom)**

The cobbled surface was, on average, at a depth of 20-30 centimetres below the current ground level; it extended across the majority of the trench, the only exception being a narrow strip along the western side, which had been disturbed by installation of a telecommunications trench (Figure E.2).

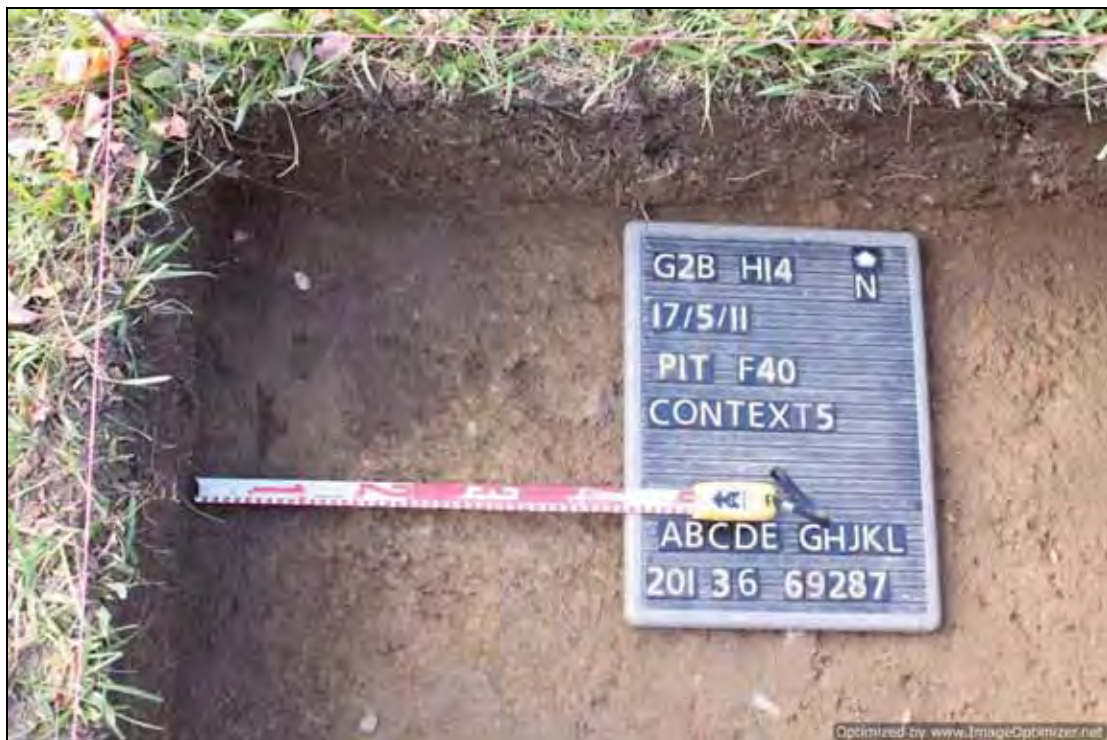
Figure E.3 Possible post hole in F40-I, base of Context 5

Excavation in this trench began in F40, with turf removal (Context 1) and excavation of the modern, brown loam topsoil (Context 2). The gravelly clay fill was then removed (Context 5) to reveal a yellow-brown clay loam at a depth of between 10 centimetres and 15 centimetres. A possible posthole was also visible in the northwest corner of Quadrat I as a pocket of darker brown loam, approximately 15 centimetres across (Figure E.3).

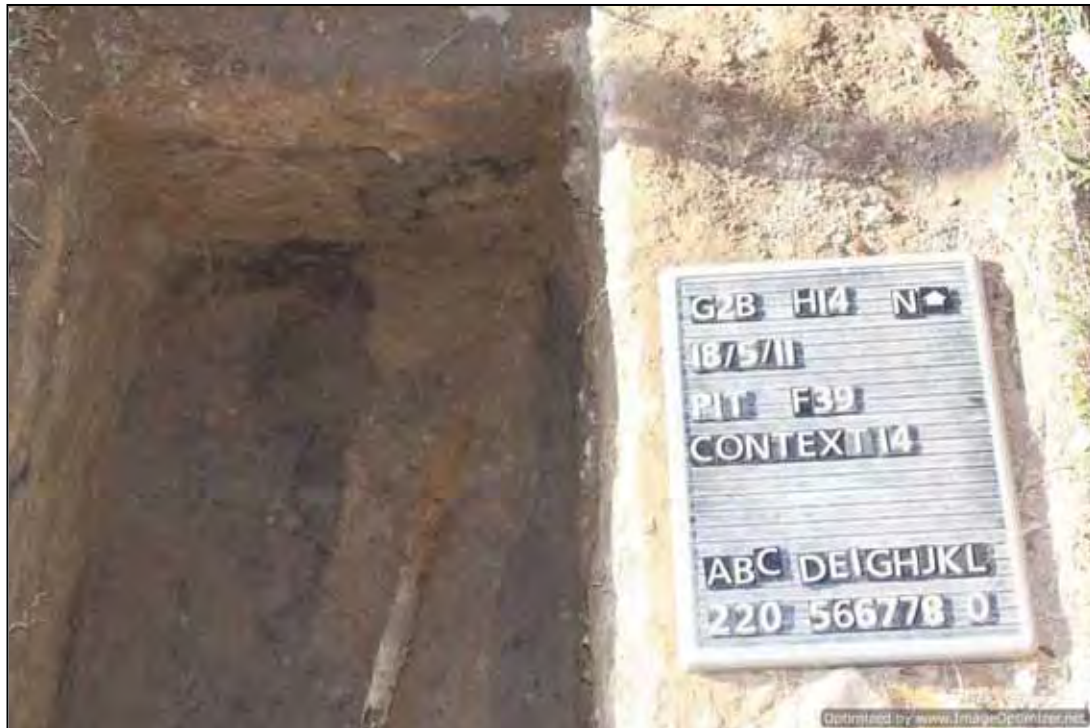
Figure E.4 Telecommunications trench exposed at base of F39.

Excavation in F39 was then conducted as an arbitrary context (Context 8) down to the yellow-brown layer identified in F40 below Context 5, with further sectioning across the western two-thirds of the square (Context 14) to reveal an old telecommunications trench (Figure E.4). This same trench was observed along the western margins of F30-F31 to the south and through B80 to the north.

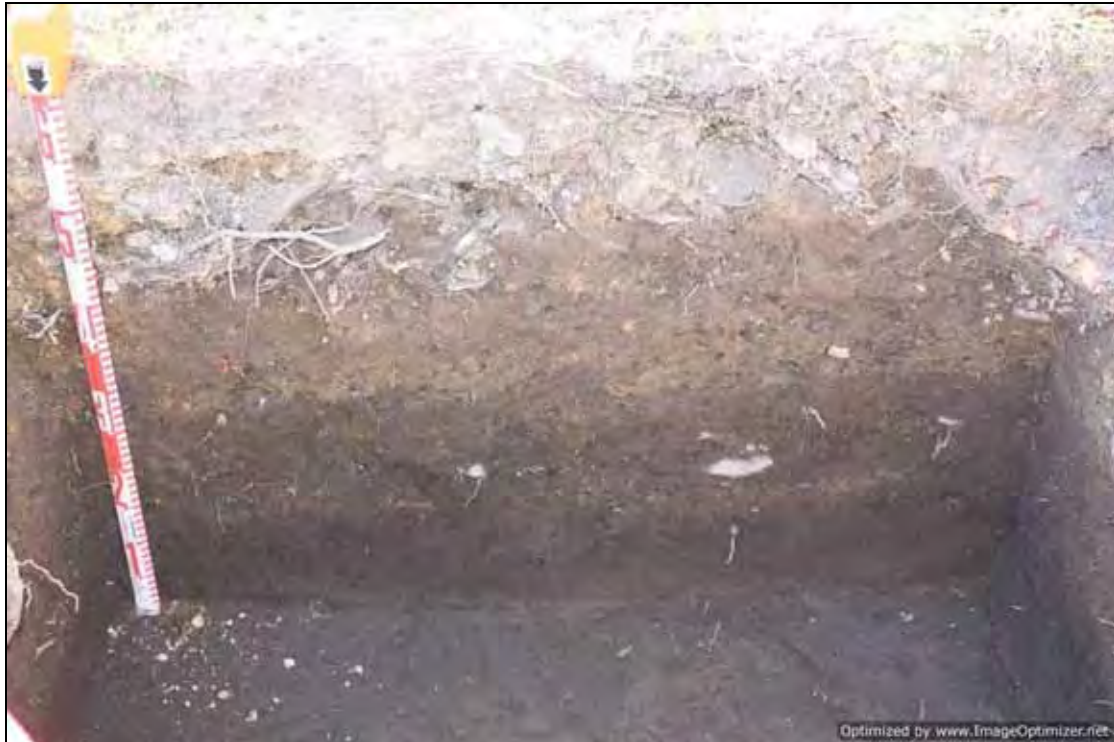
Figure E.5 North wall of C50.

Excavation then proceeded as a section down to the natural clay subsoil, approximately 60 centimetres below the current ground surface. The section revealed that the gravelly fill continued to a depth of 30-40 centimetres, below which a sterile brown loam was encountered that graded into a darker clay loam above the yellow-brown clay subsoil (Figure E.5).

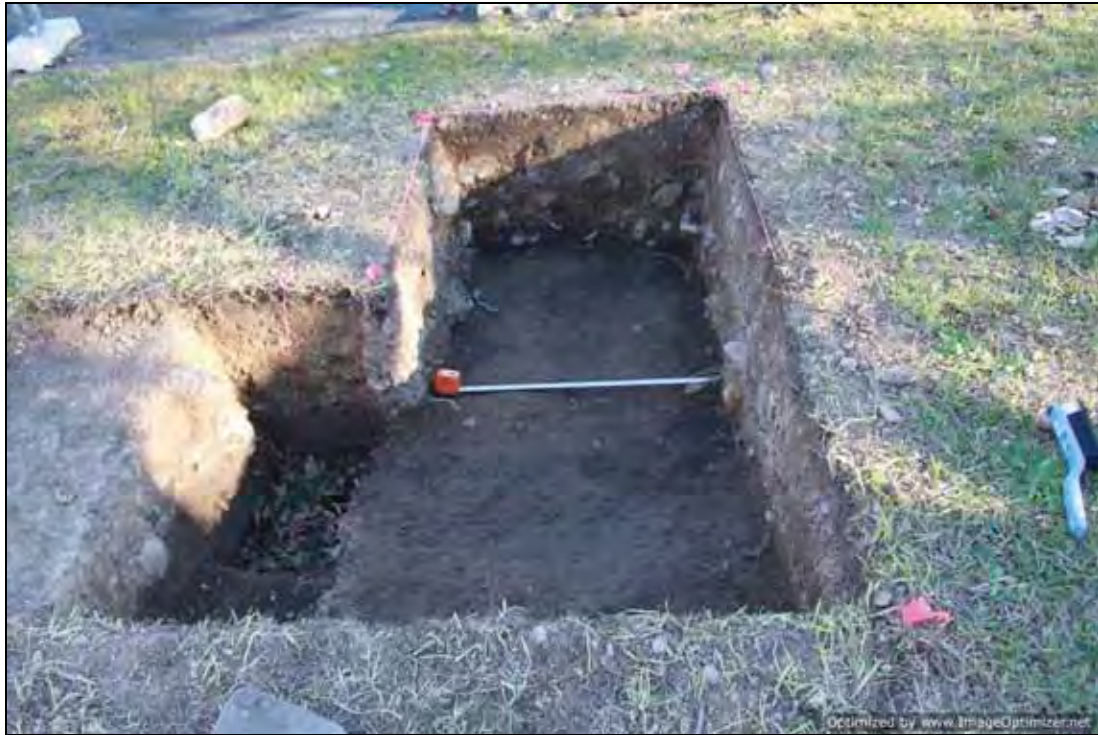
Figure E.6 Trench C60-B61-C61, looking west.

These two trenches, either side of the telecommunications trench known to run north-south through the site, were sectioned down below the old A-horizon in order to reveal something of the original topography across the site. Excavation began in the east across squares E and F (Contexts 1, 16 and 19), which were taken down to a depth of 25-30 centimetres; equivalent to 5-10 centimetres below the old A-horizon in square E (Figure E.7).

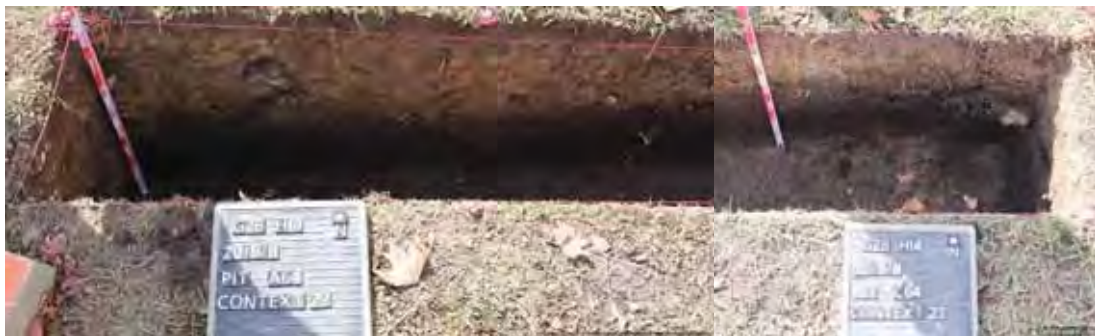
Figure E.7 Trench A64-C64, looking north.

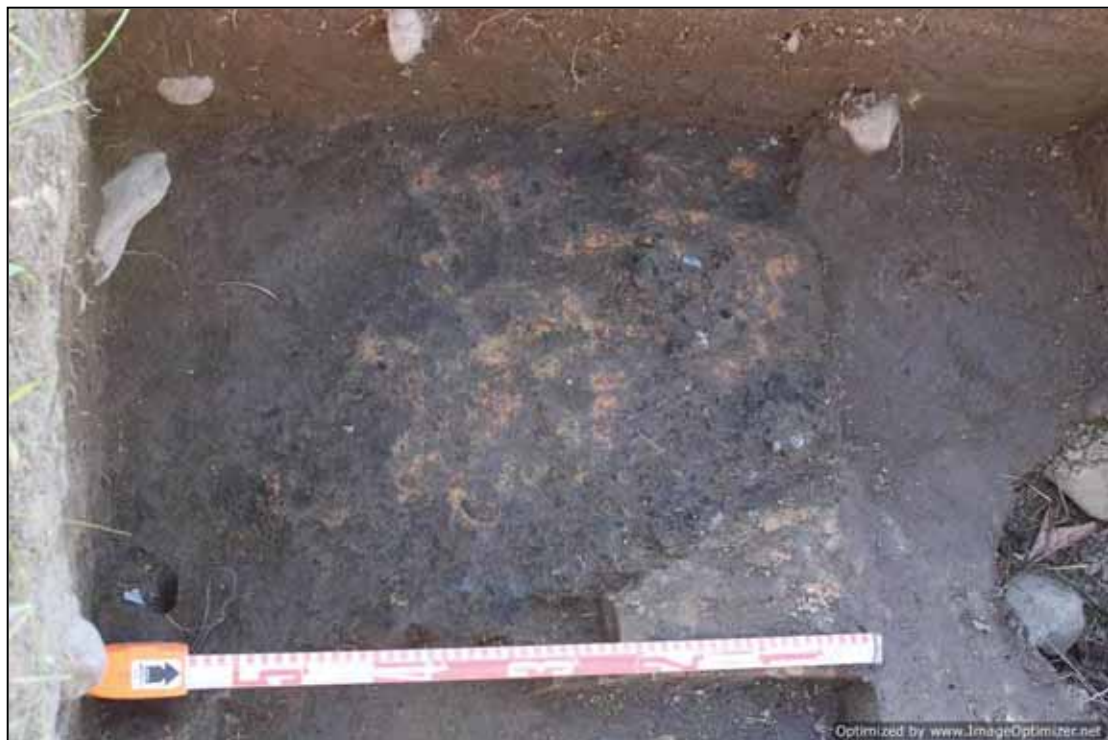
Figure E.10 Burnt clay and possible post hole with associated bottle glass fragments at base of D100-IV (north at right).

Excavation in this area began in E100 with removal of the turf (Context 1) followed by removal of the gravelly clay fill (Context 21) to reveal an *in situ* layer of charcoal and carbonised wood at a depth of 25 centimetres. This burnt layer did not extend across the northern portion of the square, so a section was excavated down to the clay subsoil (average depth of 50 centimetres) across the northern quadrats. The trench was then expanded to the west into D100, with excavation of a single context (Context 27) down to the burnt layer identified in E100. In the course of this process, evidence for disturbance was identified in the form of a 30 centimetre wide trench/burrow extending north south through the middle of the square. A layer of burnt clay was also identified on the western side of this trench, with what appears to be a possible posthole in the southwest corner of Quadrat III (Figures E.10, E.11 & E.12). It was also noted that a number of alluvial pebbles were removed from the fill layer across both squares.

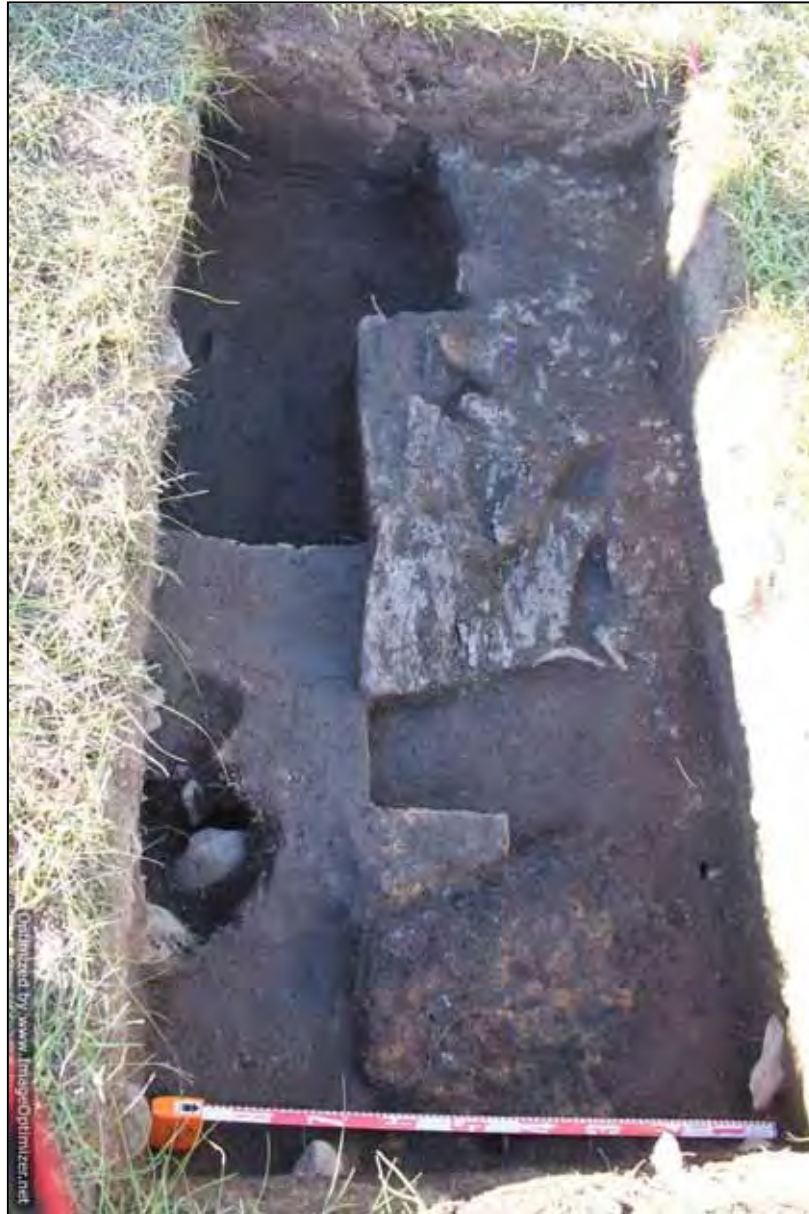
Figure E.11 Trench D100-E100, looking east.

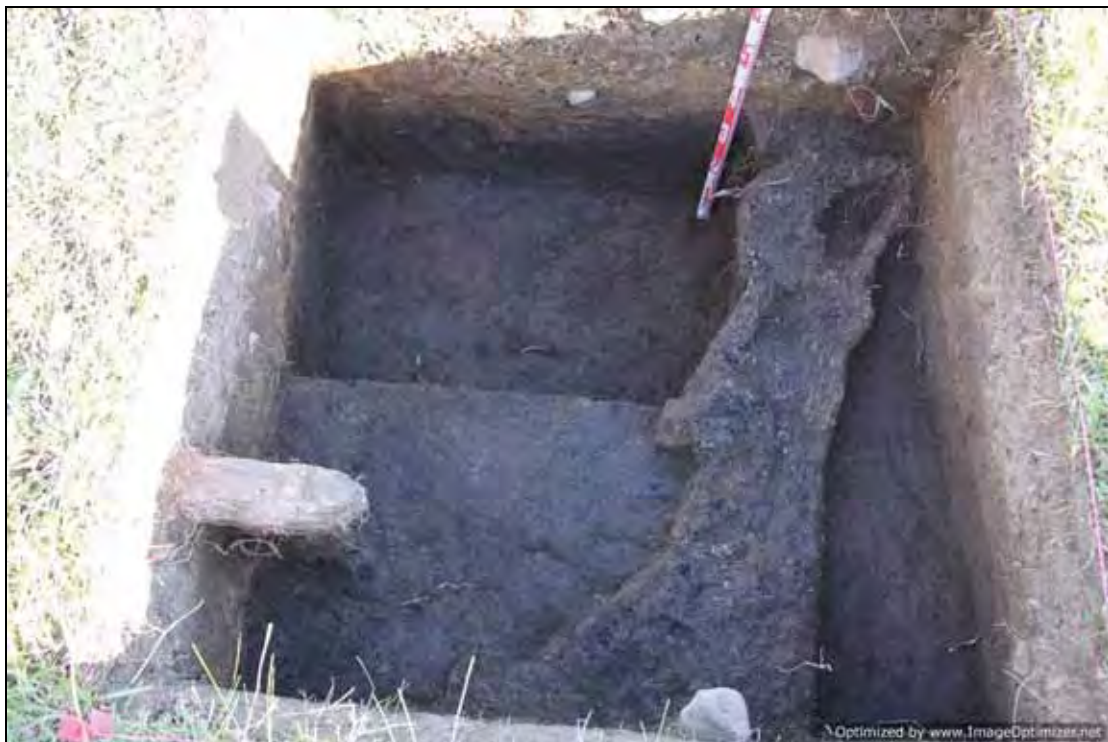
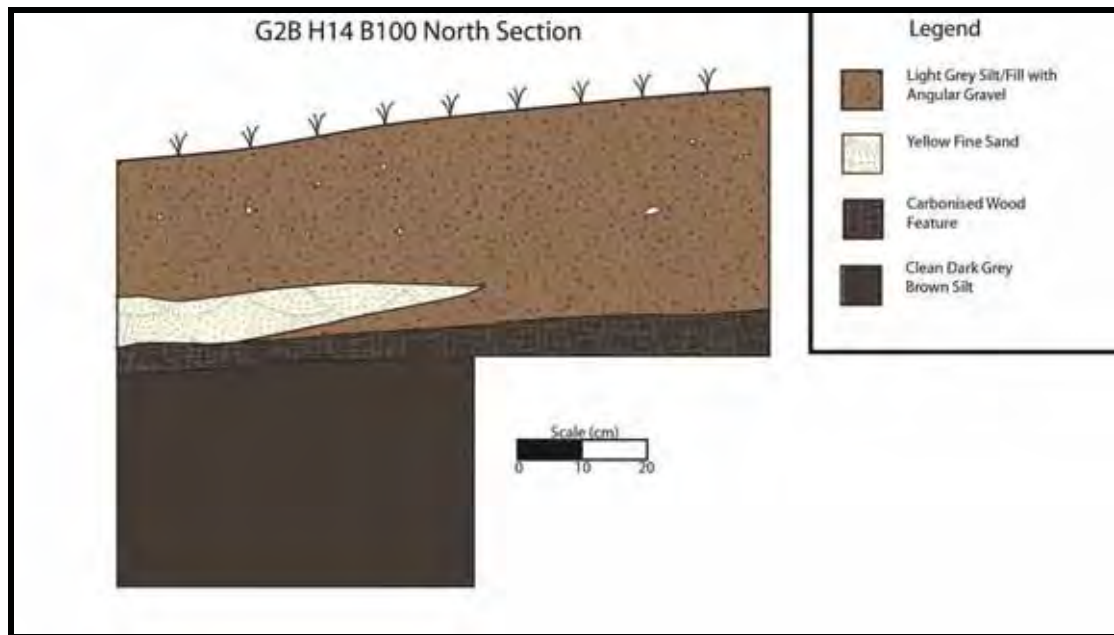
Figure E.13 Termination of excavations in B100, looking west.

Figure E.14 Soil profile at northern end of B100.

Excavation was continued in B100 in order to establish whether the burnt features in D100-E100 extended further to the west. Initially the overburden was removed as a single context (Context 40) to reveal a yellow-brown sandy loam with modern debris, including milled timber and ceramic insulators, sitting in this loam. The sandy loam was then removed (Context 41) to reveal a charcoal rich clay layer, including a piece of carbonised wood across the northern half of the square. The southwestern portion of B100 (Quadrat III and Quadrat I up to the margin of the carbonised wood) was also sectioned down (Context 44) to the clay subsoil (depth of 65 centimetres) (Figure E.13 & E.14).
