Report on
Preliminary Geotechnical Investigation

Proposed Train Support Facility
Woodlands Close, Hexham

Prepared for
QR National

Project 39798.08
November 2012

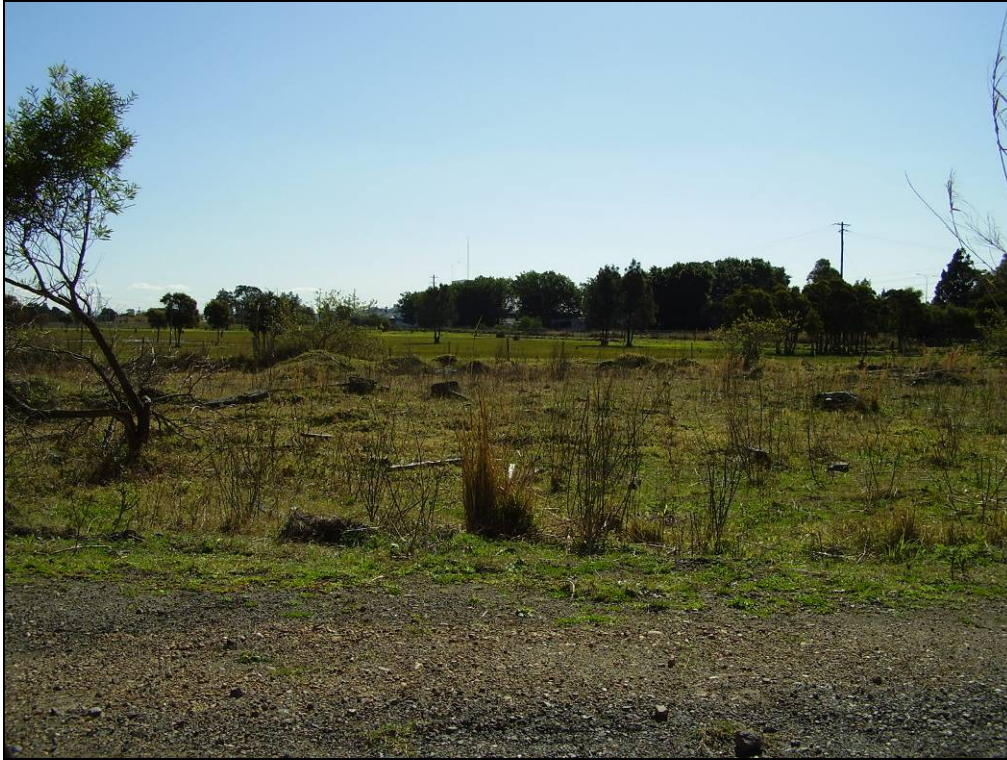
Filling was evident in the central and eastern portions of the site. Surface observations indicated that coal washery reject was the predominant filling type (refer Figure 1).

Figure 1: Filling stockpiles in the eastern portion of the site

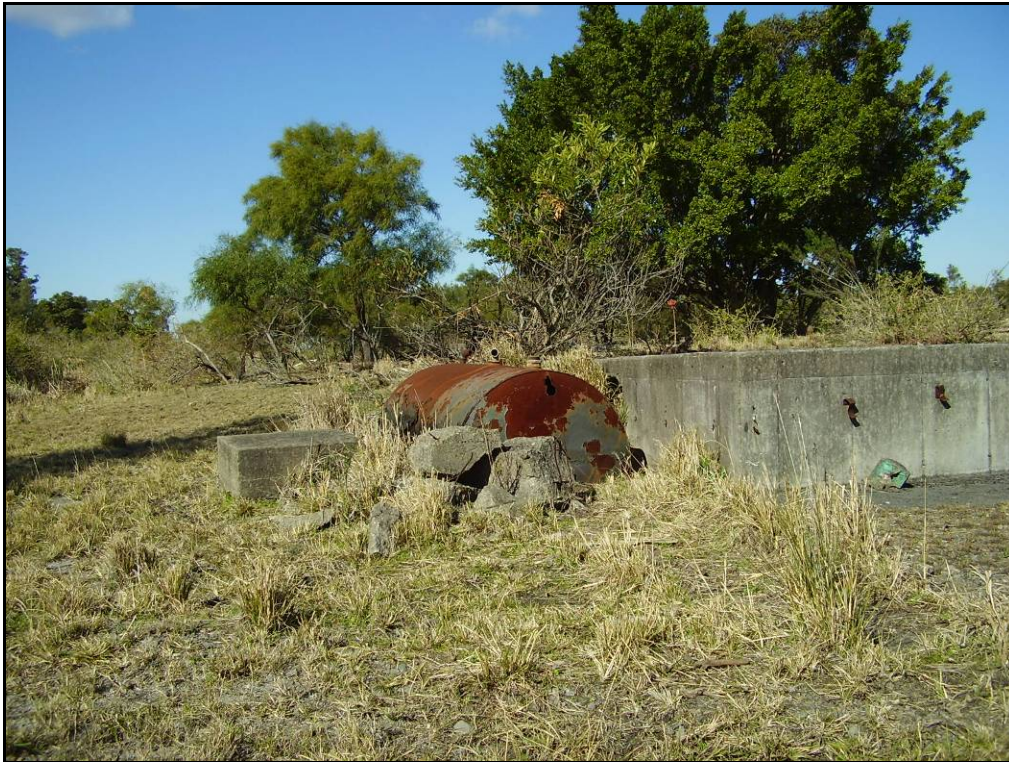
- A former storage tank was located in the central portion of the site near CPT TP15. Some minor surface staining was observed in the vicinity of the tank (refer Figure 2);
- Other stockpiles of filling observed onsite comprised terracotta roof tiles (refer Figure 3), fibro (possibly containing asbestos – Figure 4) and other deleterious material such as concrete, bricks and timber (Figure 5);
- Concrete slabs and piers, relating to the former building and conveyors, were observed across the southern parts of the site.

Figure 2: Storage tank observed in the central/eastern portion of the site

- Presence of building materials (rubble) within filling (possible asbestos) in the southern part of the site (former coal preparation plant);
- Presence of fuel storage area (Figure 2) with some minor staining of adjacent ground surface;
- Presence of coal chitter and filling covering generally the southern parts (Figures 4 and 5) of the site;
- Scattered stockpiles of rubbish including fuel drums generally adjacent to access tracks;
- The results of PID Screening on soil samples are shown on some borehole logs in Appendix B and generally suggest the absence of gross volatile hydro-carbon impact;
- Groundwater was observed in the boreholes; observation of the water suggested the absence of visual or olfactory contamination (ie visible staining and odour). It is noted that groundwater was not sampled or analysed to confirm chemical condition.

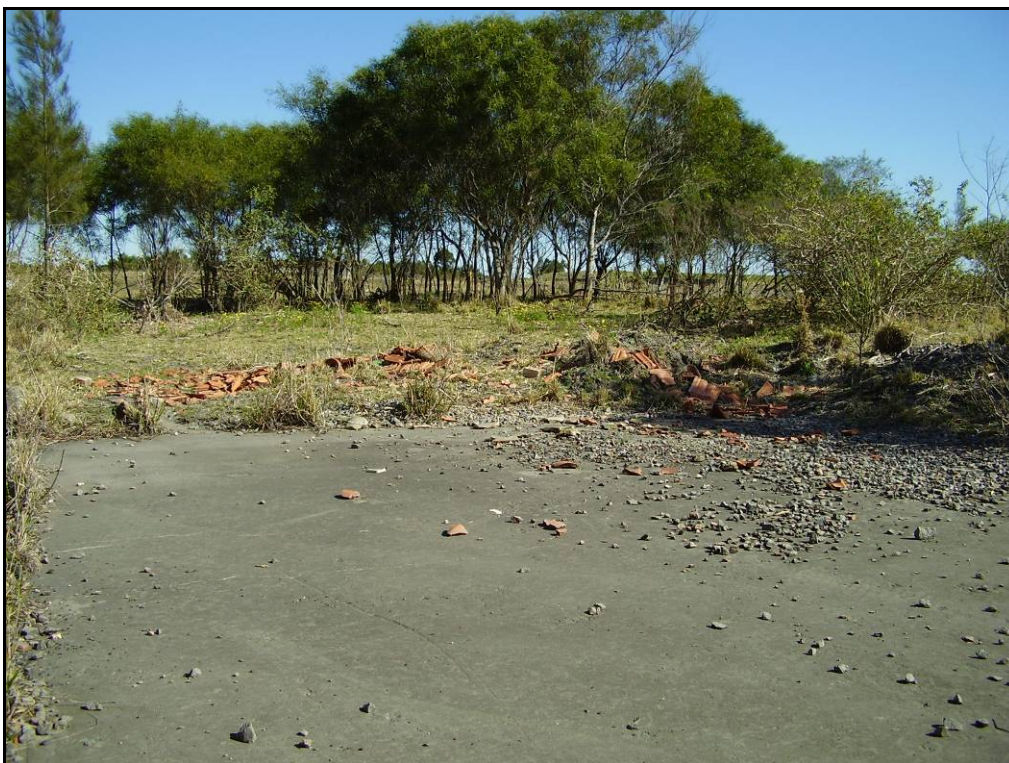
Figure 3: Scattered stockpile of terracotta roof tiles

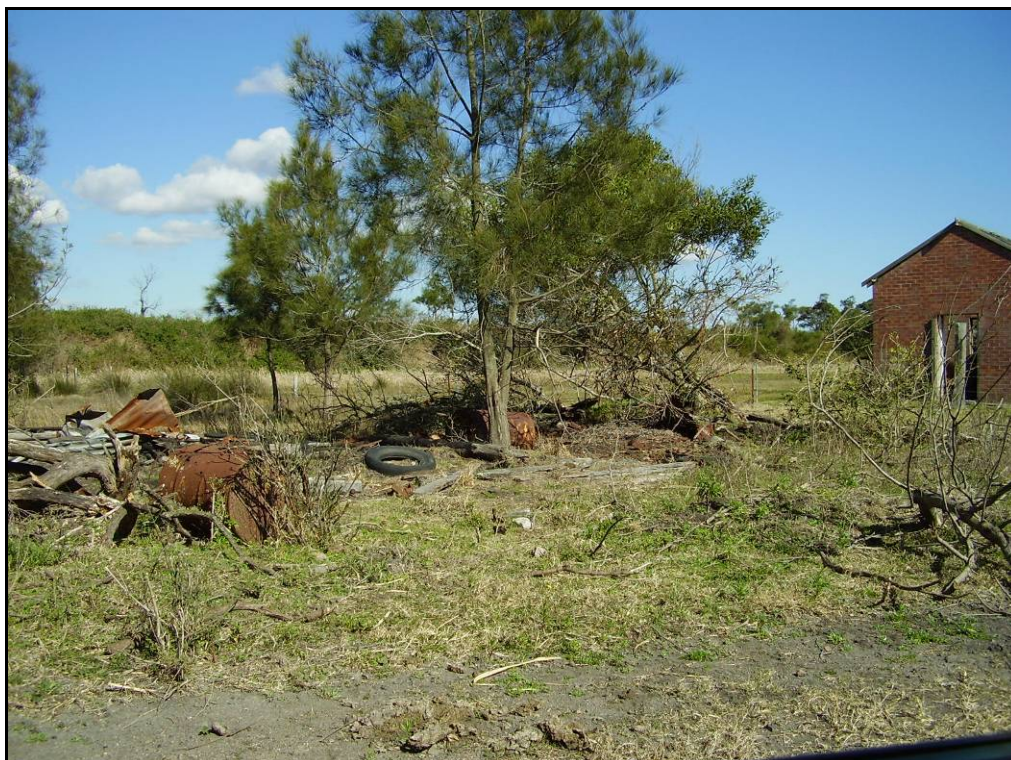
Figure 5: Scattered stockpile of timber, tyres and 44 gallon drums

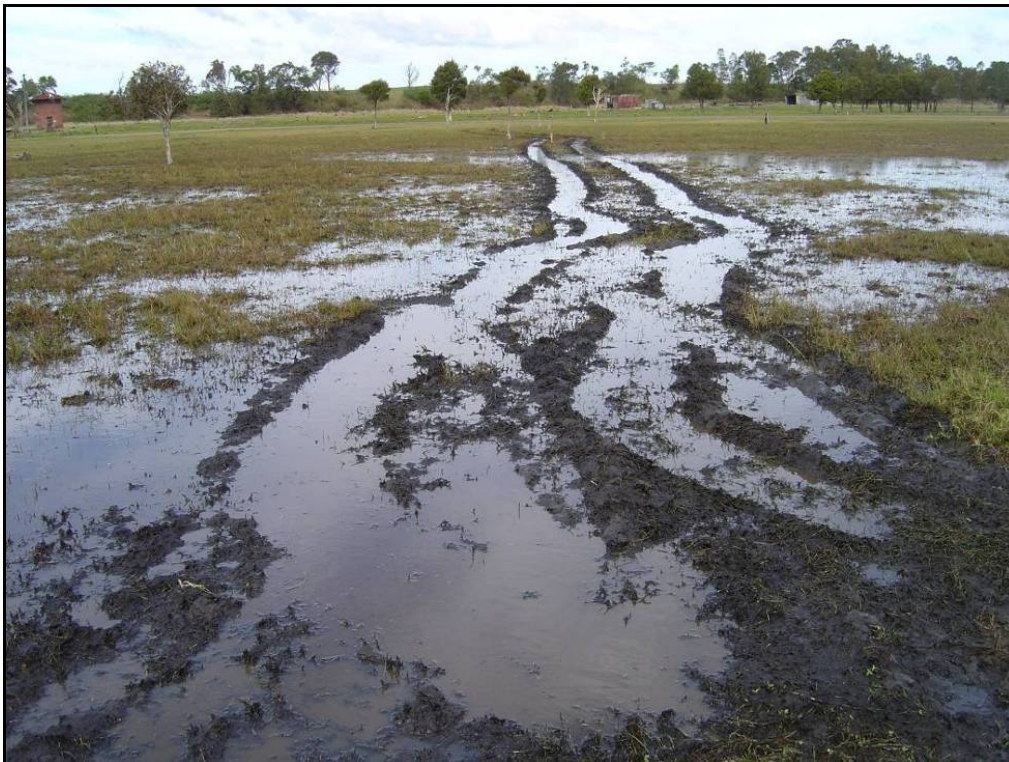
Surface water was ponding at the time of field investigations in July to September 2007 and was generally 0.1 m to 0.4 m in depth. The water was observed over the central low-lying areas of the site (ie CPT 2 to 10) and Bore TP35. The area was not accessible to standard vehicles and a specialised light weight "all terrain" vehicle was required to gain access to this section of the site (refer Figure 6).

Figure 6: General site figure showing low lying areas

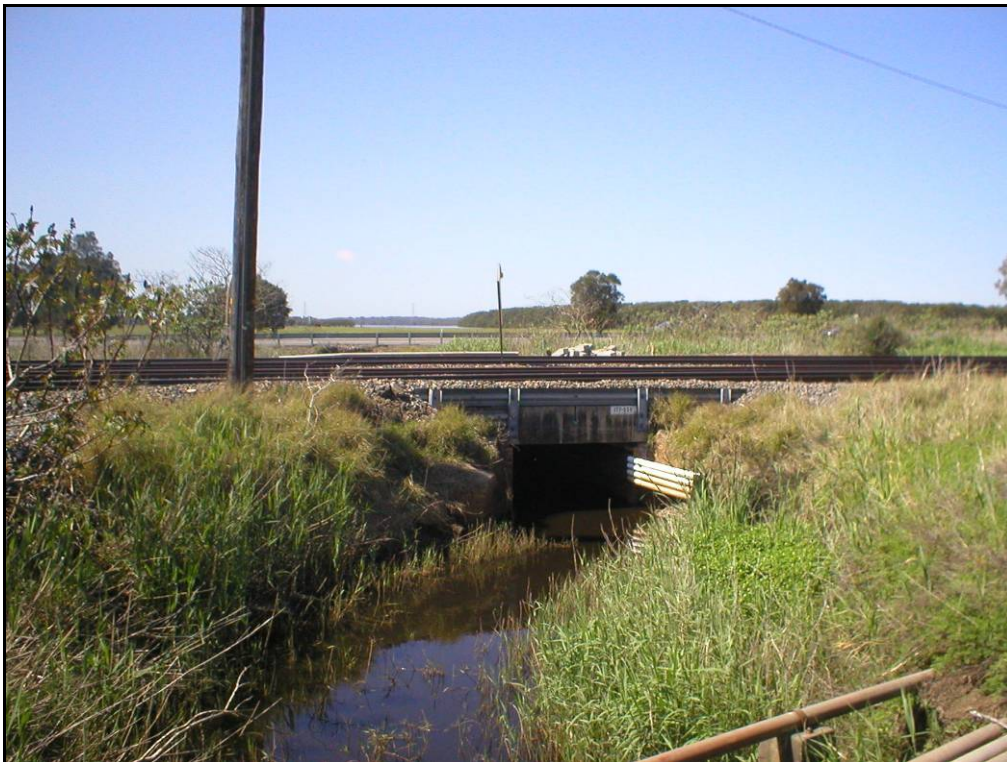
One major drain is situated at the northern part of the site. The drain flows from west to east via an unlined grassed channel which appears to have been excavated below former ground levels. The drain passes beneath the rail embankment at Ch 177.060 km via a concrete culvert (refer Figure 7). Water was ponding in the base of the drain.

Figure 7: Culvert beneath existing track at Ch 177.060 km

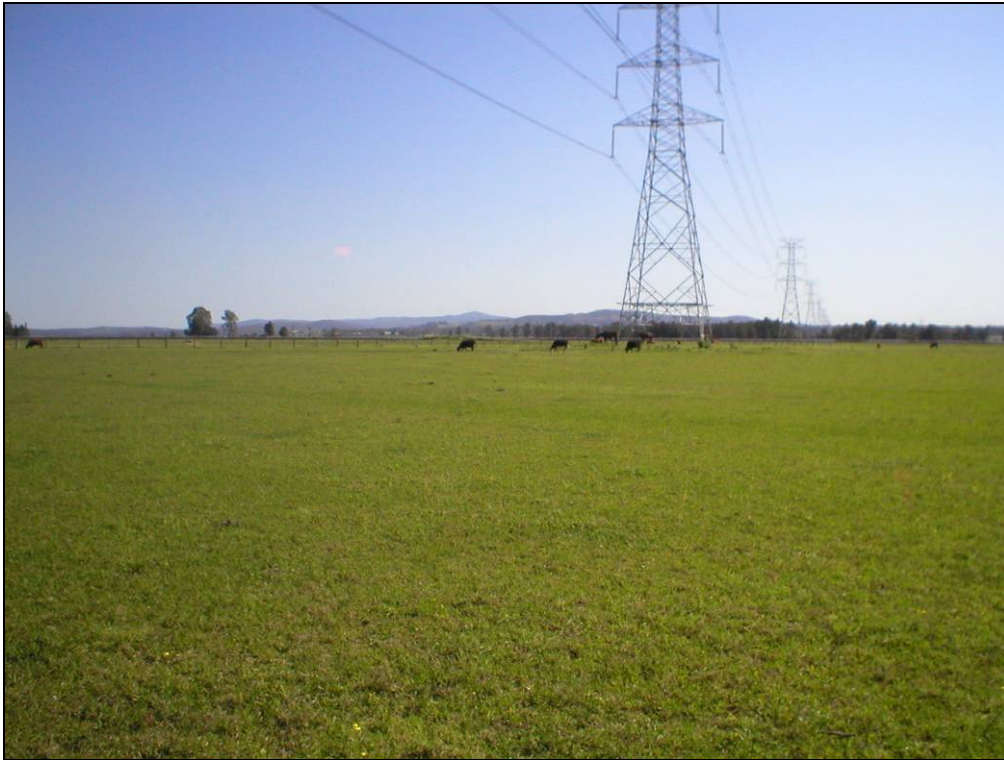
Figure 8: Western part of the site

The western part of the site between Woodlands Close and the Tarro interchange where the access road is proposed comprises flat grassed paddocks (refer Figure 8).

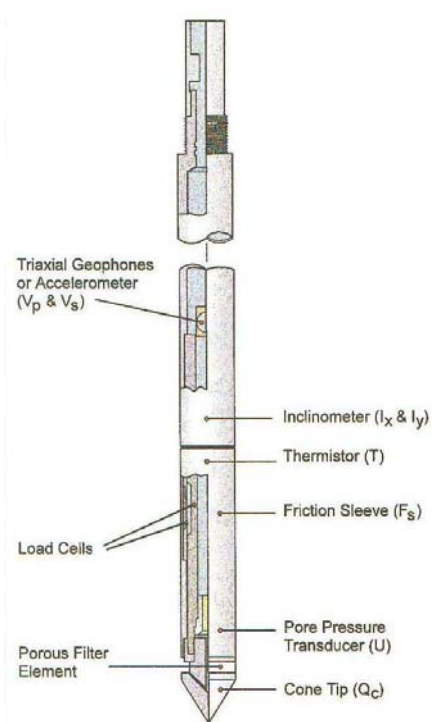
- Cone tip resistance q_c
- Sleeve friction f_s
- Inclination (from vertical) i
- Depth below ground z

Figure 1: Cone Diagram

The inclinometer in the cone enables the verticality of the test to be confirmed and, if required, the vertical depth can be corrected.

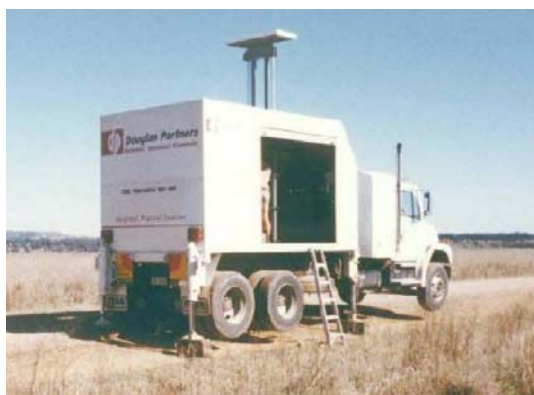
The cone is thrust into the ground at a steady rate of about 20 mm/sec, usually using the hydraulic rams of a purpose built CPT rig, or a drilling rig. The testing is carried out in accordance with the Australian Standard AS1289 Test 6.5.1.

Figure 2: Purpose built CPT rig
