Appendix C

Geotechnical Laboratory Test Results

Client :	Queensland Rail	Project No. :	39798
Project :	Preliminary Geotechnical Investigation	Report No. :	N07-179g
Location :	Woodlands Close, Hexham	Report Date :	12/09/2007
Test Location :	TP 36	Date Sampled :	6/08/2007
Depth / Layer :	0.1-1.0m	Date of Test:	8/09/2007
		Page:	1 of 1

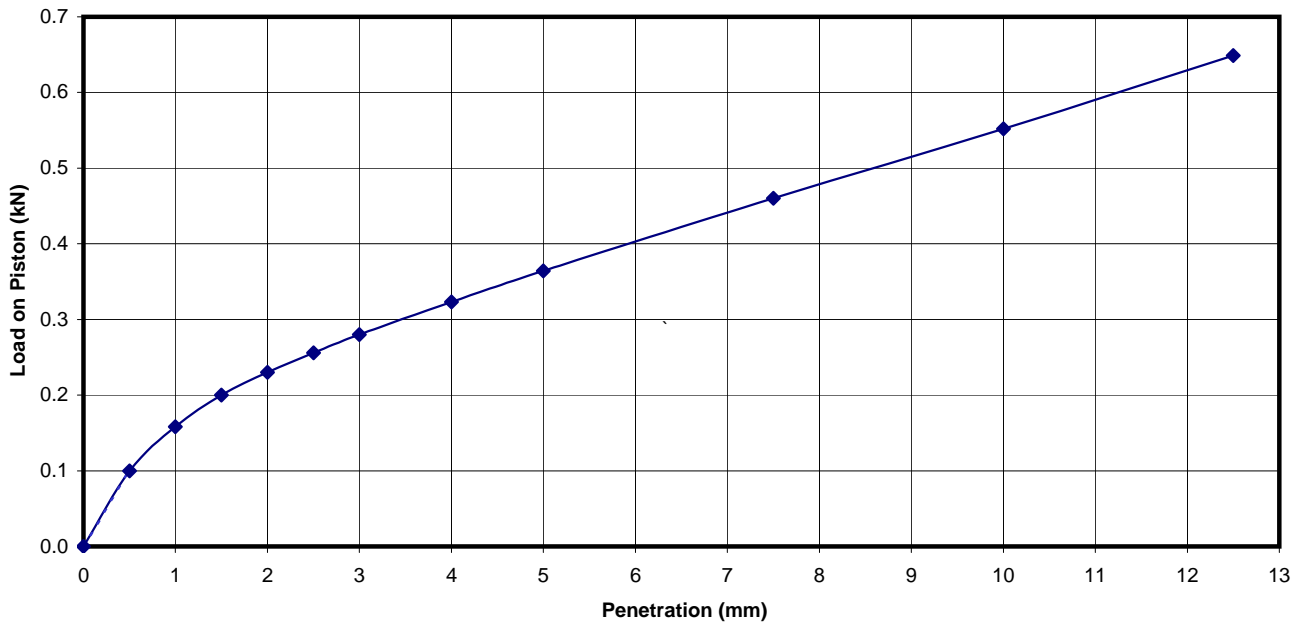
RESULT OF CALIFORNIA BEARING RATIO TEST

Description: Sandy CLAY - Dark brown

LEVEL OF COMPACTION: 100% of STD MDD
MOISTURE RATIO: 100% of STD OMC

SWELL: 2.0%

CONDITION	MOISTURE CONTENT %	DRY DENSITY t/m ³
At compaction	25.4	1.49
After soaking	27.7	1.46
After test		
Top 30mm of sample	32.6	-
Remainder of sample	26.8	-
Field values	28.5	-
Standard Compaction	25.5	1.50

RESULTS		
TYPE	PENETRATION	CBR (%)
TOP	2.5 mm	2.0
	5.0 mm	2.0

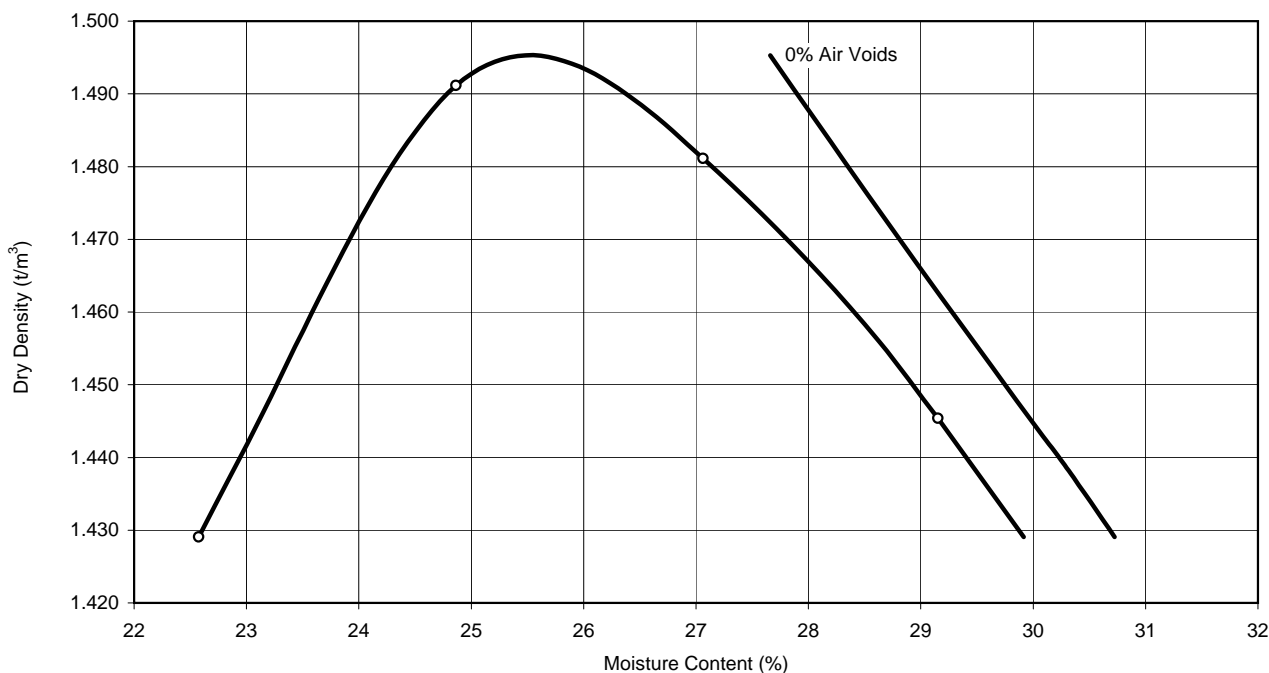
RESULTS OF COMPACTION TEST

Sample Details **Location:** TP 36
Depth: 0.1-1.0m

Description: Sandy CLAY - Dark brown

Maximum Dry Density:	1.50 t/m³
Optimum Moisture Content:	25.5 %

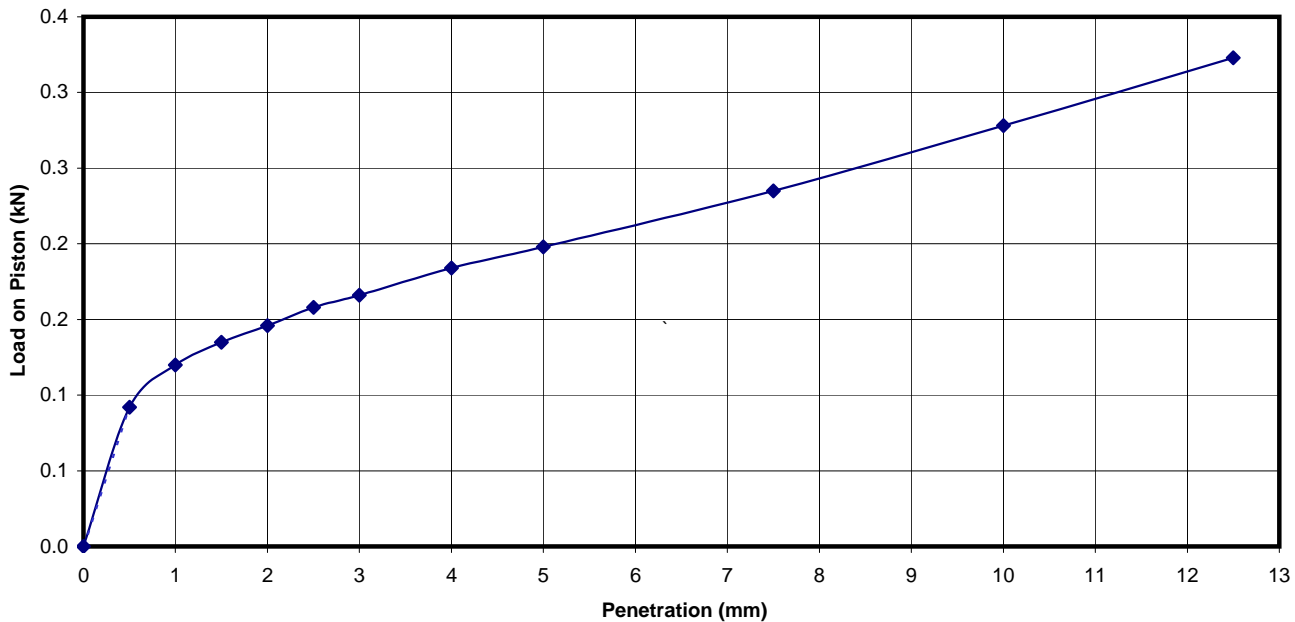
RESULT OF CALIFORNIA BEARING RATIO TEST

Description: Silty CLAY - Dark grey/brown

LEVEL OF COMPACTION: 100% of STD MDD
MOISTURE RATIO: 99% of STD OMC

SWELL: 4.0%

CONDITION	MOISTURE CONTENT %	DRY DENSITY t/m ³
At compaction	34.2	1.32
After soaking	39.5	1.27
After test		
Top 30mm of sample	48.4	-
Remainder of sample	35.1	-
Field values	51.4	-
Standard Compaction	34.5	1.32

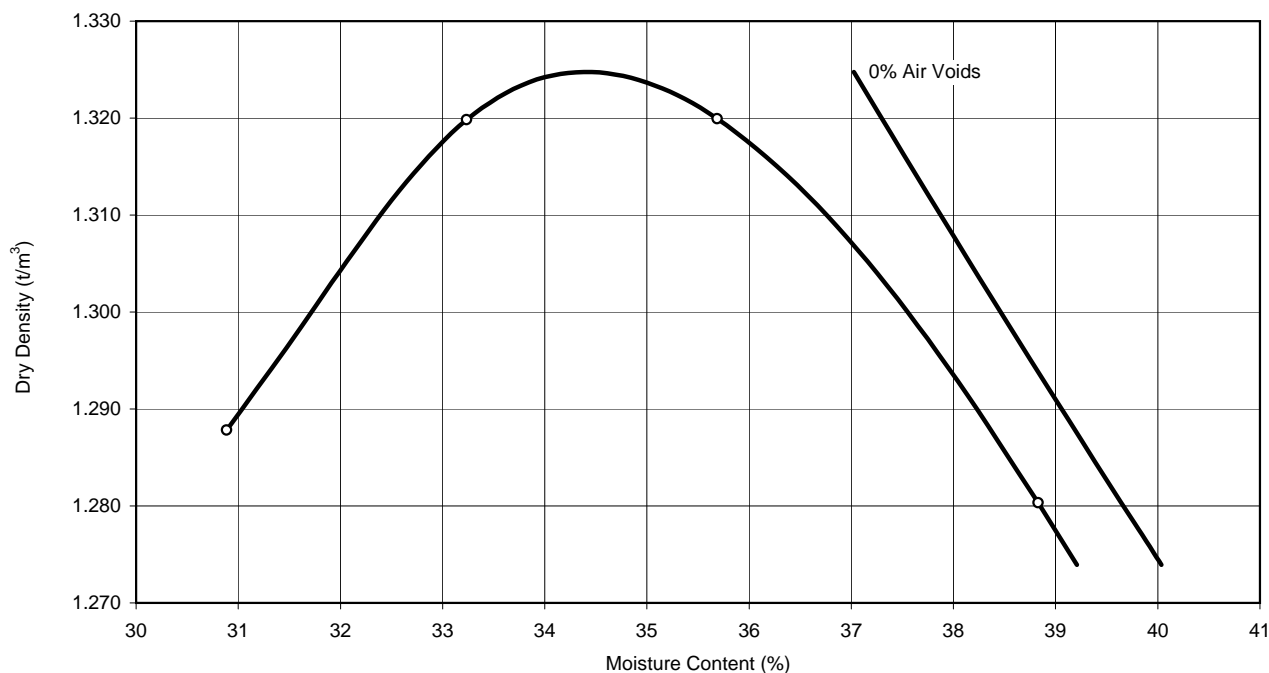
RESULTS OF COMPACTION TEST

Sample Details **Location:** TP 34
Depth: 0.7-1.0m

Maximum Dry Density:	1.32 t/m³
Optimum Moisture Content:	34.5 %

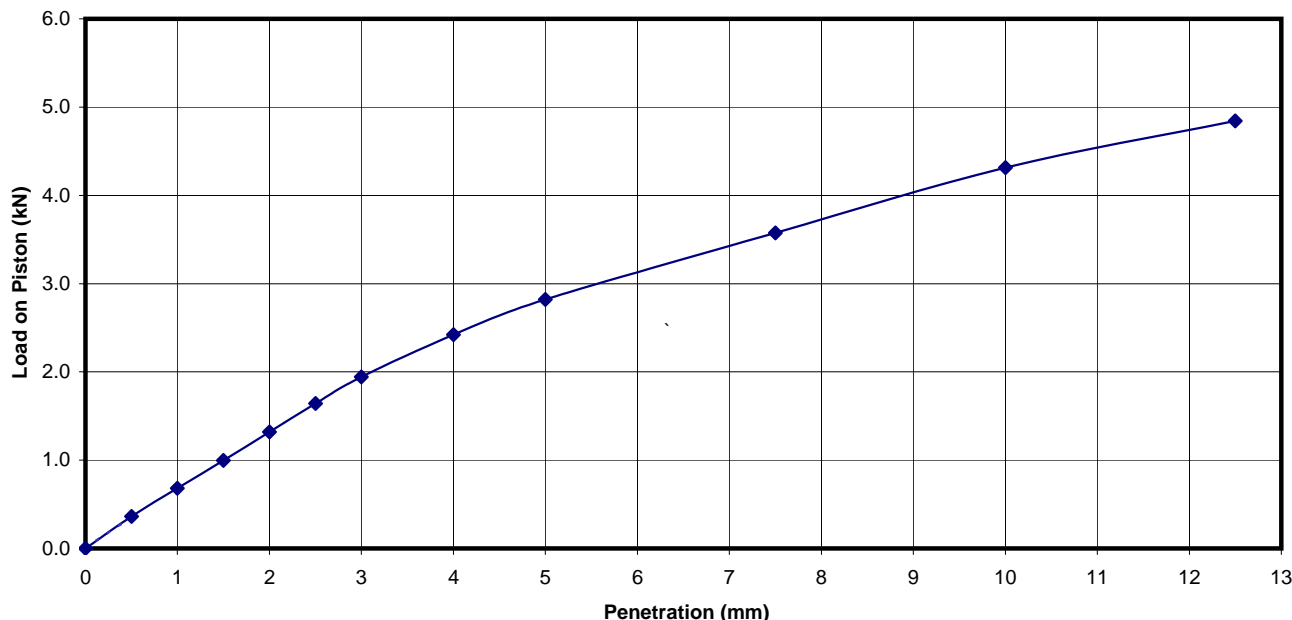
RESULT OF CALIFORNIA BEARING RATIO TEST

Description: Gravelly CLAY - Dark grey (Coal Chitter)

MOISTURE RATIO: 99% of STD OMC

CONDITION	MOISTURE CONTENT %	DRY DENSITY t/m ³
At compaction	14.8	1.48
After soaking	16.1	1.48
After test	17.9	-
Top 30mm of sample	15.1	-
Remainder of sample	20.7	-
Field values	15.0	1.48
Standard Compaction

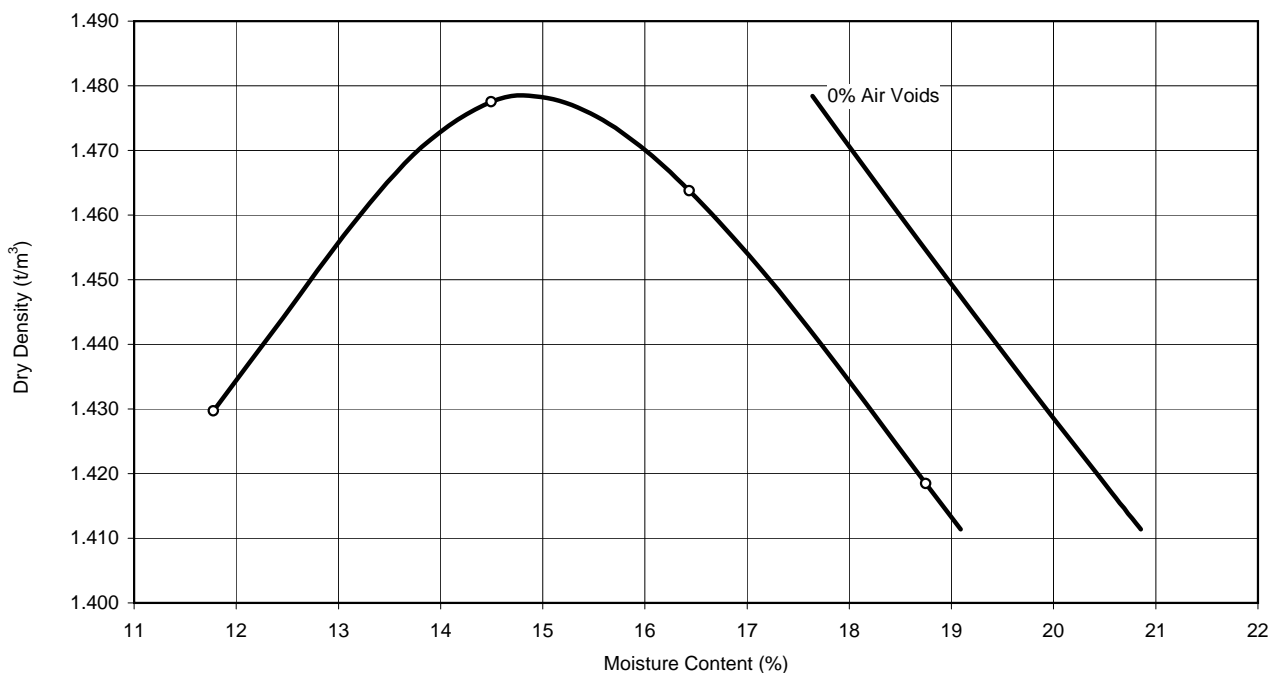
RESULTS OF COMPACTION TEST

Sample Details **Location:** TP 27
Depth: 1.0-1.5m

Particles > 19mm: 15%

Maximum Dry Density:	1.48 t/m³
Optimum Moisture Content:	15.0 %

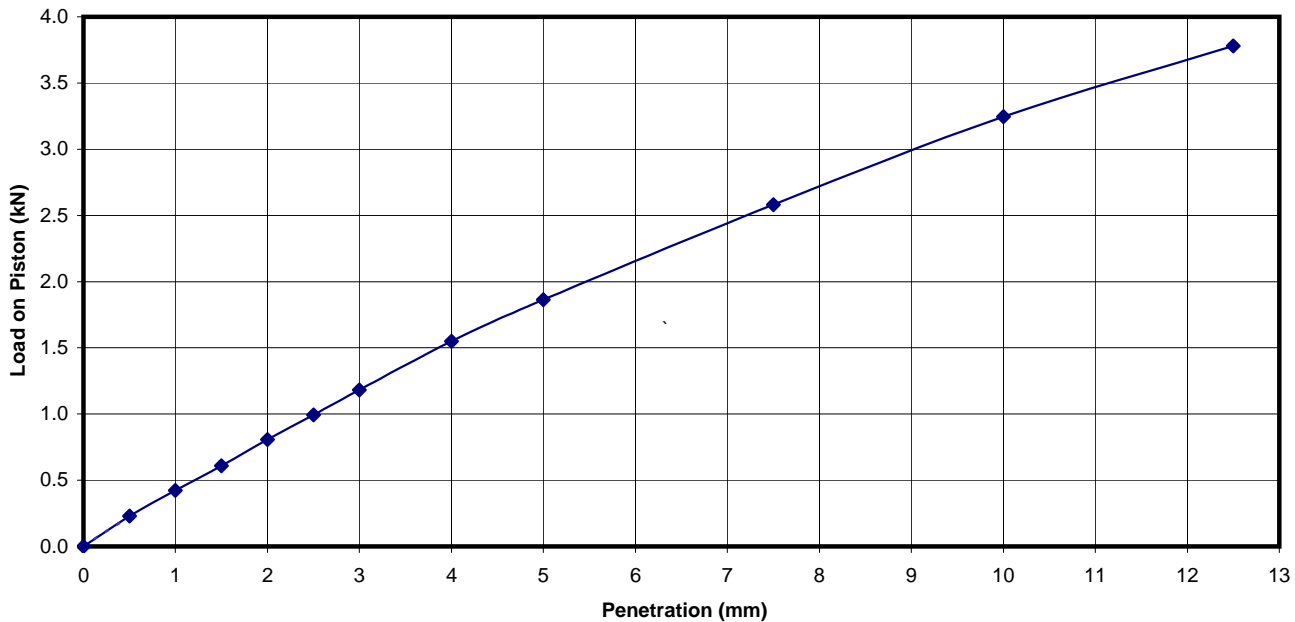
RESULT OF CALIFORNIA BEARING RATIO TEST

Description: Coal Rejects

LEVEL OF COMPACTION: 100% of STD MDD
MOISTURE RATIO: 99% of STD OMC

CONDITION	MOISTURE CONTENT %	DRY DENSITY t/m ³
At compaction	13.4	1.58
After soaking	14.8	1.58
After test	16.3	-
Top 30mm of sample	14.6	-
Remainder of sample	11.7	-
Field values	13.5	1.58
Standard Compaction

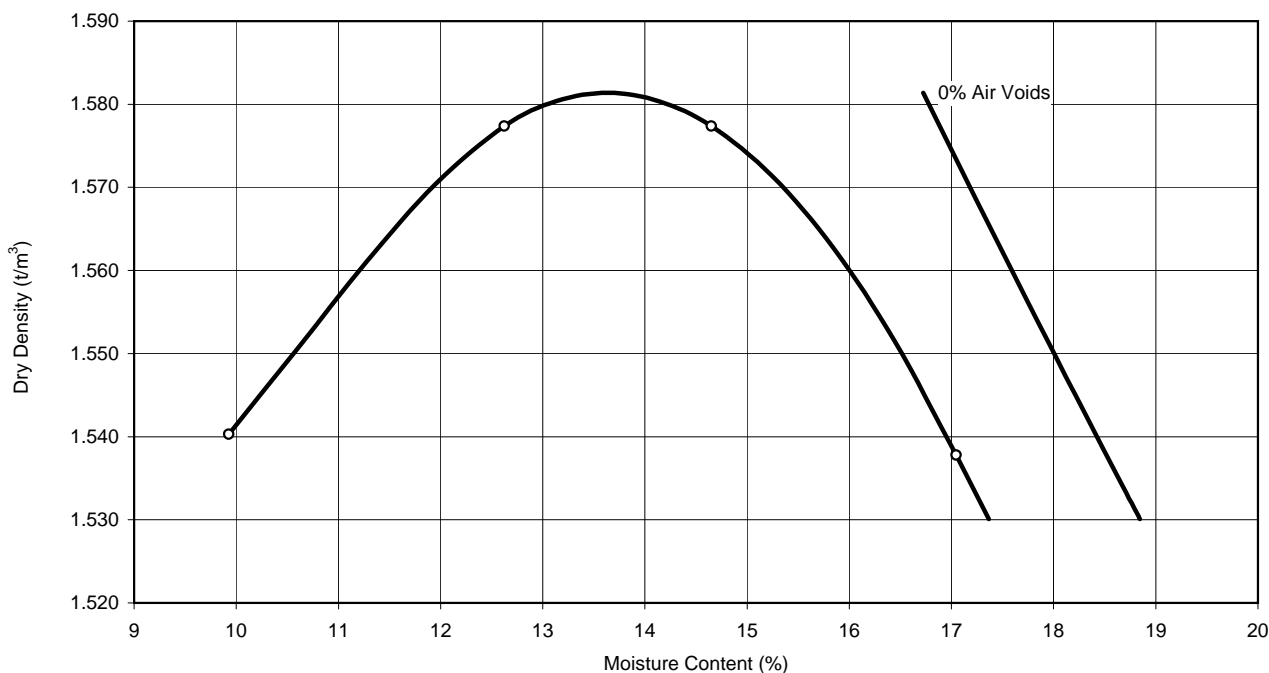
RESULTS OF COMPACTION TEST

Sample Details **Location:** TP 18
 Depth: 0.0-1.0m

Maximum Dry Density:	1.58 t/m³
Optimum Moisture Content:	13.5 %

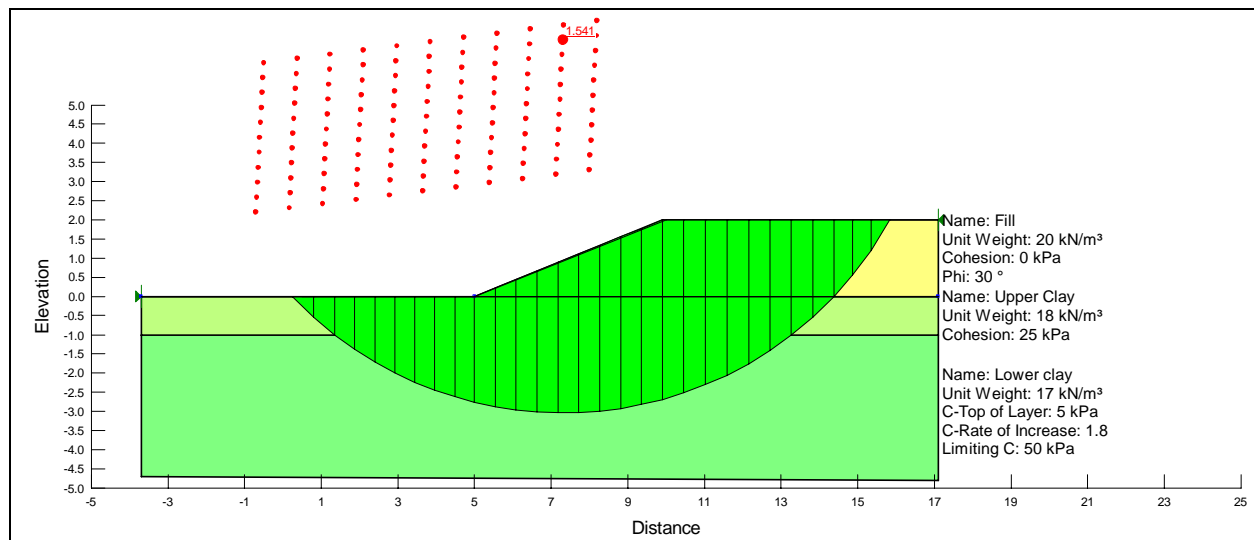
Figure 3: Results of Stability Analysis (no ground improvement, no load at crest)

The results of the analysis are shown in Figure 3 below and indicate that the factor of safety against slope failure during preload is 1.5 which is considered satisfactory for no load at crest.

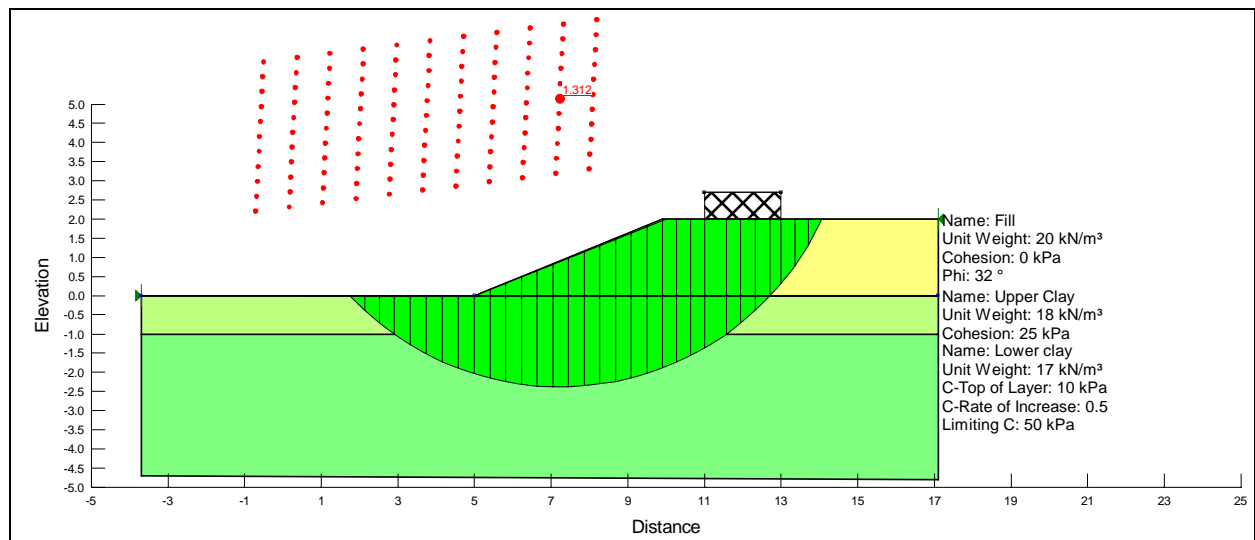
Figure 4: Results of Stability Analysis (following 1 year preload)

The results of the stability analysis are presented in Figure 4 and indicate that the factor of safety following 1 year preload is about 1.3.

A factor of safety against slope failure of greater than 1.5 is generally considered the minimum acceptable for long term structures. The results of the above analysis suggest that a factor of safety of only 1.3 will be achievable following partial preload after 1 year and less if the preload is in place for a period of only 6 months. The factor of safety will increase over time to about 1.5 after the clay fully consolidates.

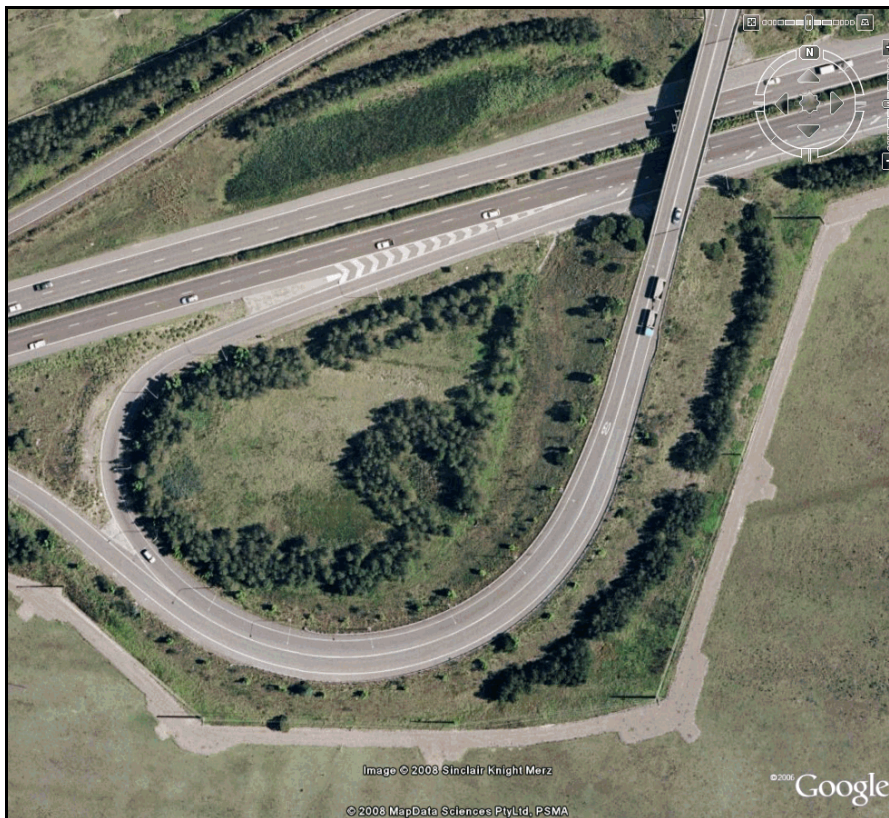
Figure 1: Southern Abutment of Tarro Interchange

The existing Tarro interchange comprised a concrete bridge spanning over the New England Highway with an earth-filled embankment on either end. The site of the geotechnical investigation is situated at the southern abutment (Figure 1). The earth filled embankment is about 8 m high and has grassed batters of between 2.5H:1V to 3H:1V. A row of semi mature trees is located at the eastern toe of the fill embankment.

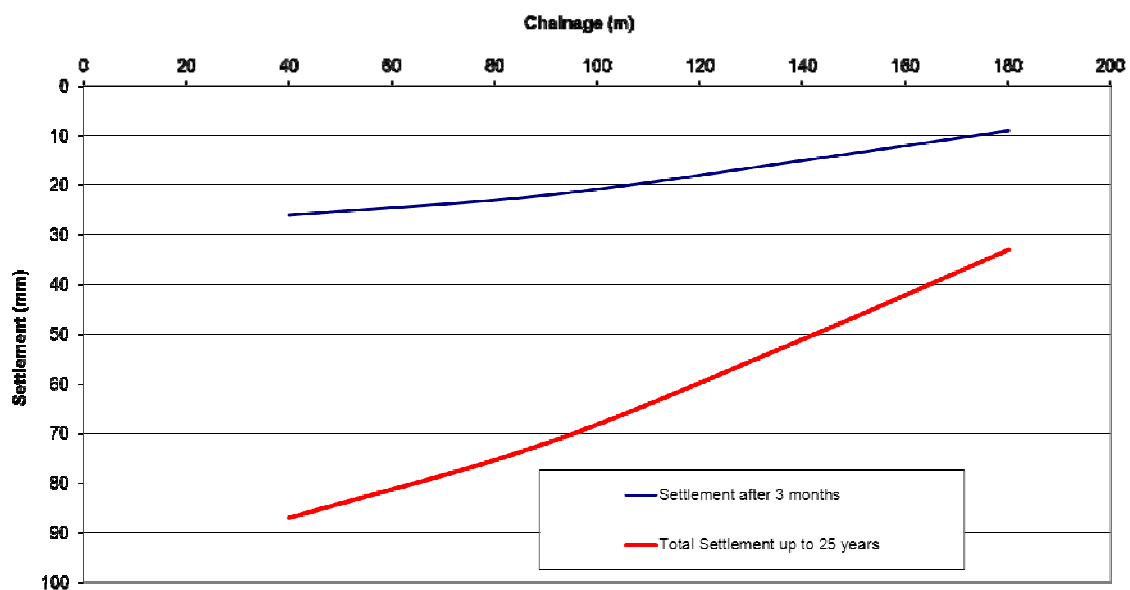
Figure 1 - Estimated Settlement of Unimproved site along Road Alignment

At each CPT location a time-settlement plot was determined for an unimproved site. Figure 1 shows the settlement estimates at 3 months and following placement of filling and are compared to the total estimated settlement over 25 years and the total post construction settlement following 3 months.

Based on the above plot, the largest expected settlement along the road embankment will be between Ch 35 m and 80 m. This area correlates to the area where the depth of proposed filling is greatest (about 10 m high) which would subject a load of about 200 kPa onto the foundation soils.

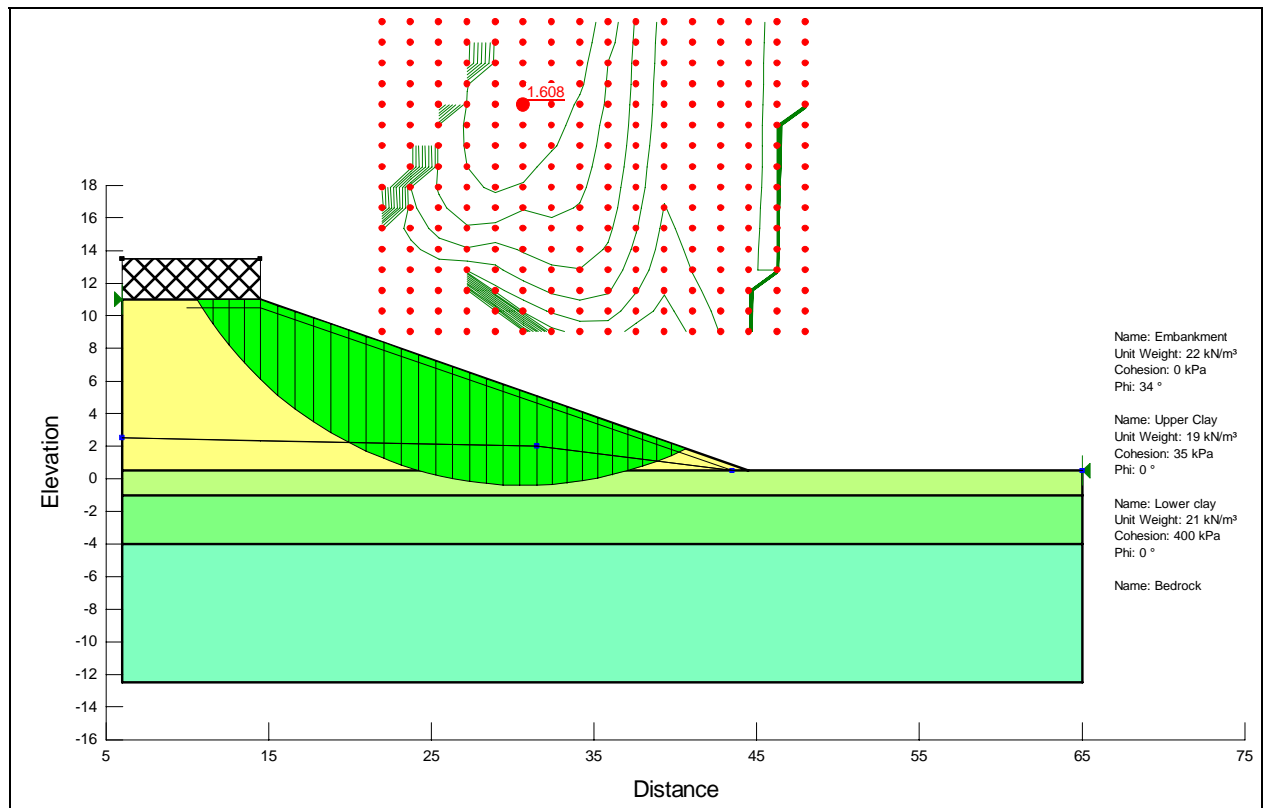
Figure 2: Results of Stability Analysis (3H:1V batters)

The stability was reanalysed for a batter slope 3H:1V. The results of the analysis indicated a factor of safety of 1.6, as shown in Figure 2, which was considered acceptable.

In summary, the results of the analysis indicate that for embankments greater than 6 m in height, the batter slope should be no steeper than 3H:1V and for embankments less than 6 m in height, batters should be no steeper than 2.5H:1V.

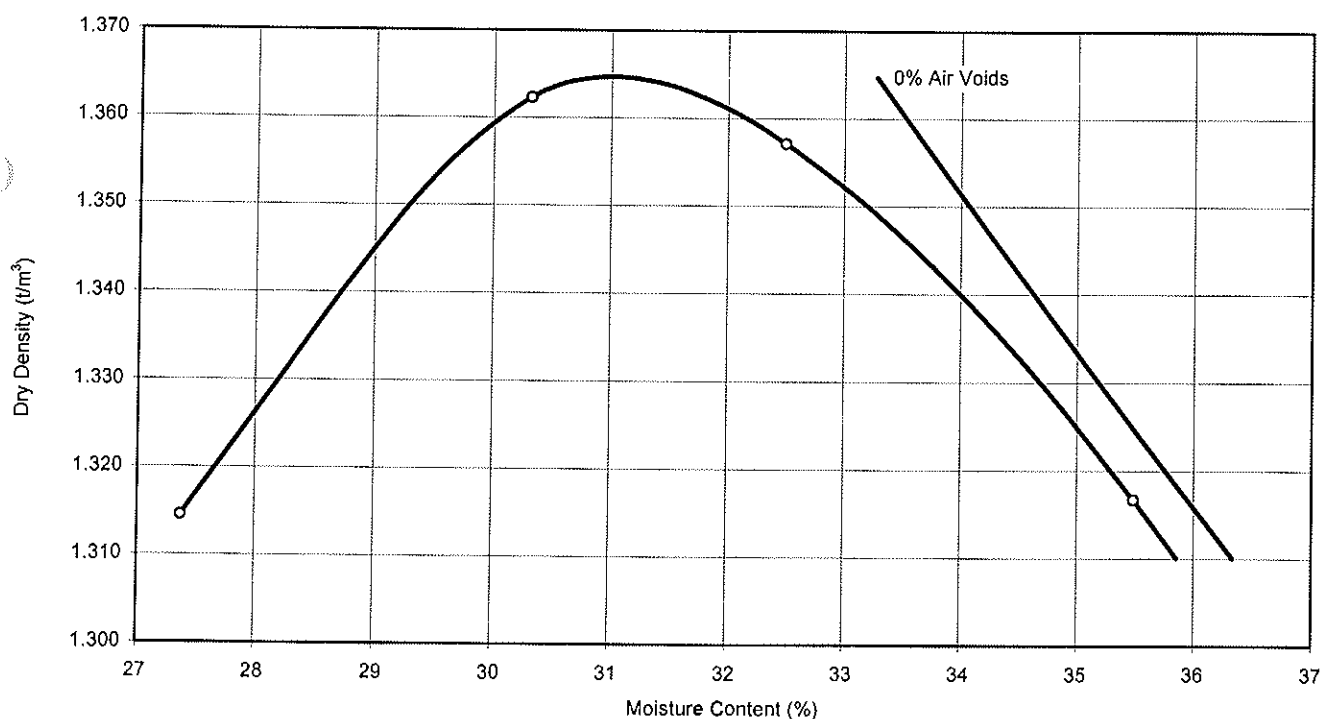
Sample Details Location: Bore 503B
Depth: 0.20-0.50m

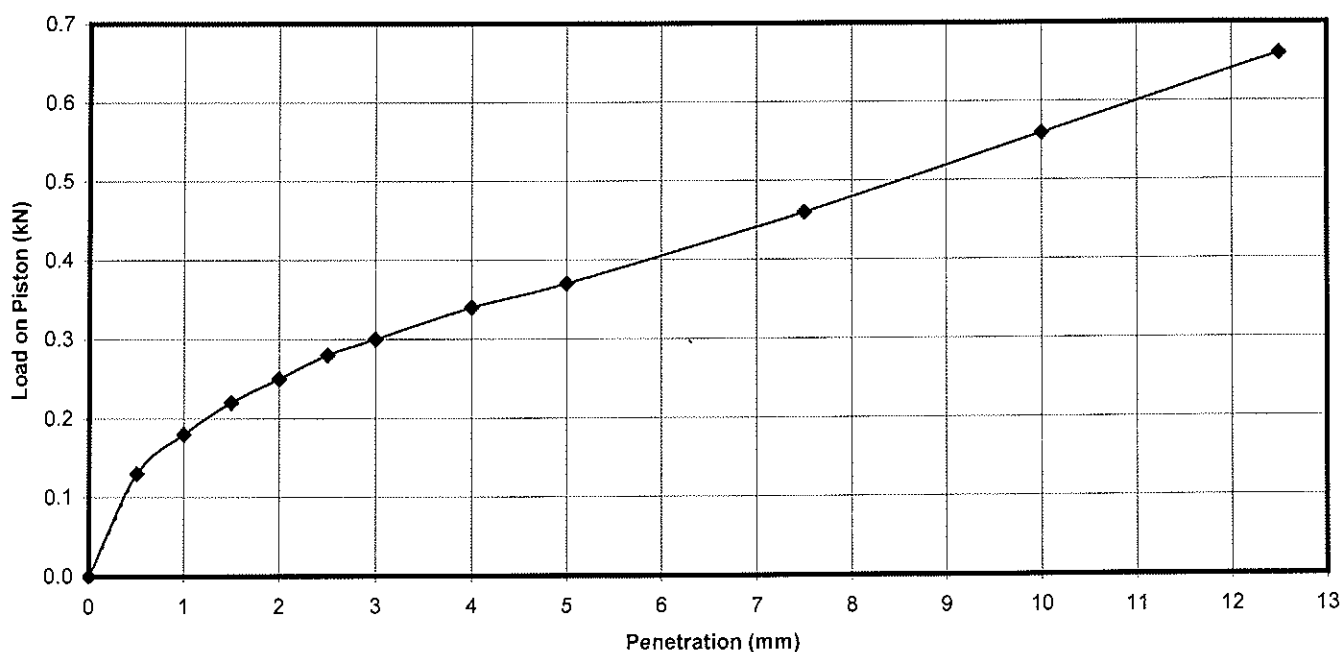
RESULT OF CALIFORNIA BEARING RATIO TEST

Description: CLAY - Grey/brown

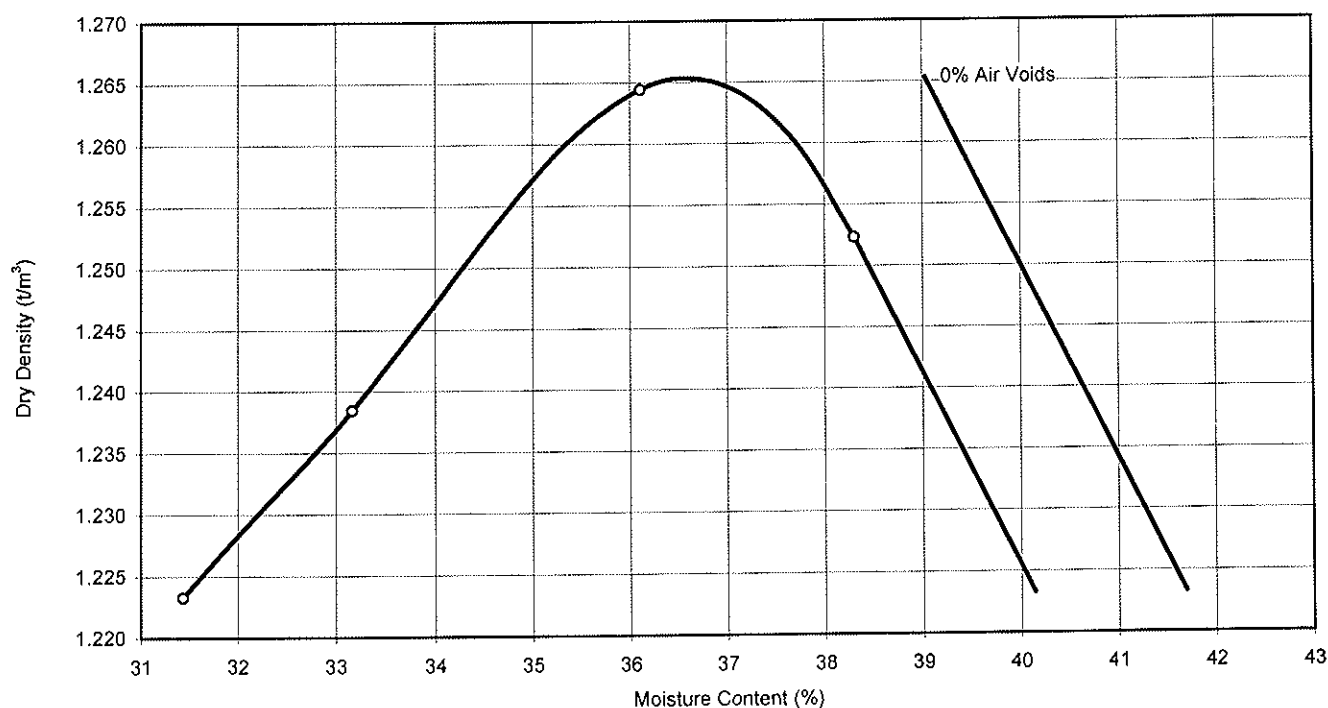
RESULTS OF COMPACTION TEST

Sample Details Location: Bore 505
Depth: 0.75-1.20m

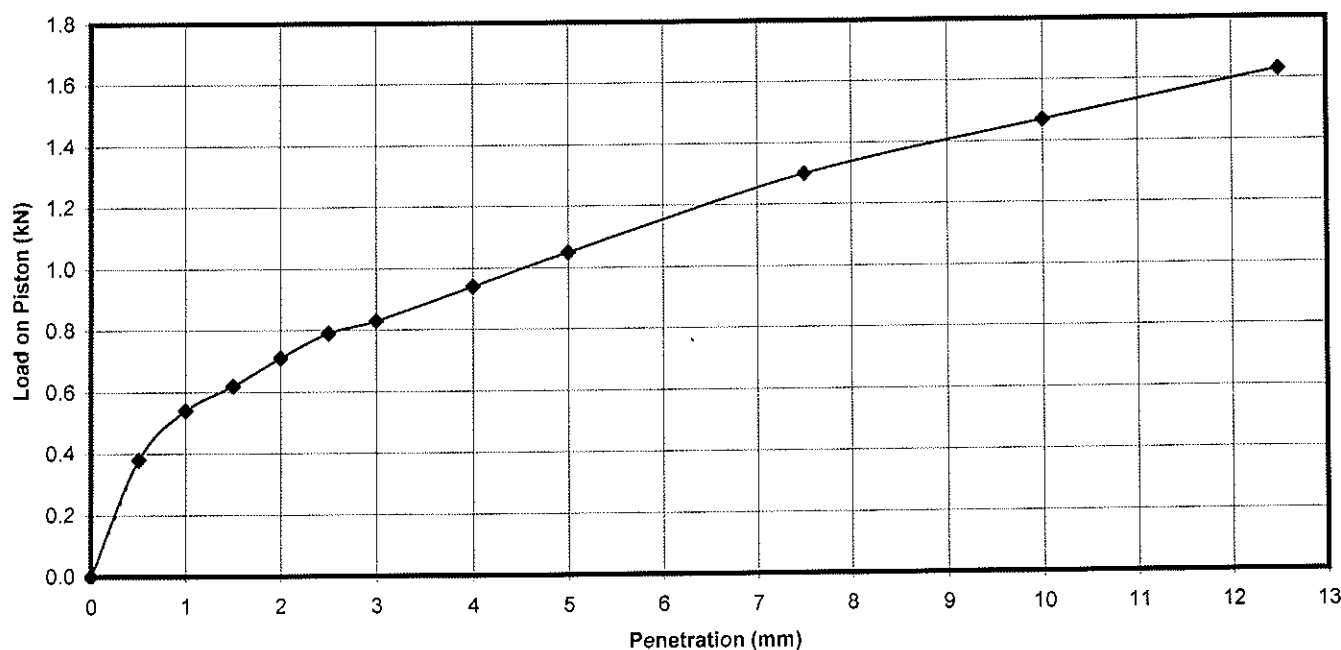
RESULT OF CALIFORNIA BEARING RATIO TEST

Description: CLAY - Brown, trace silt, sand and gravel

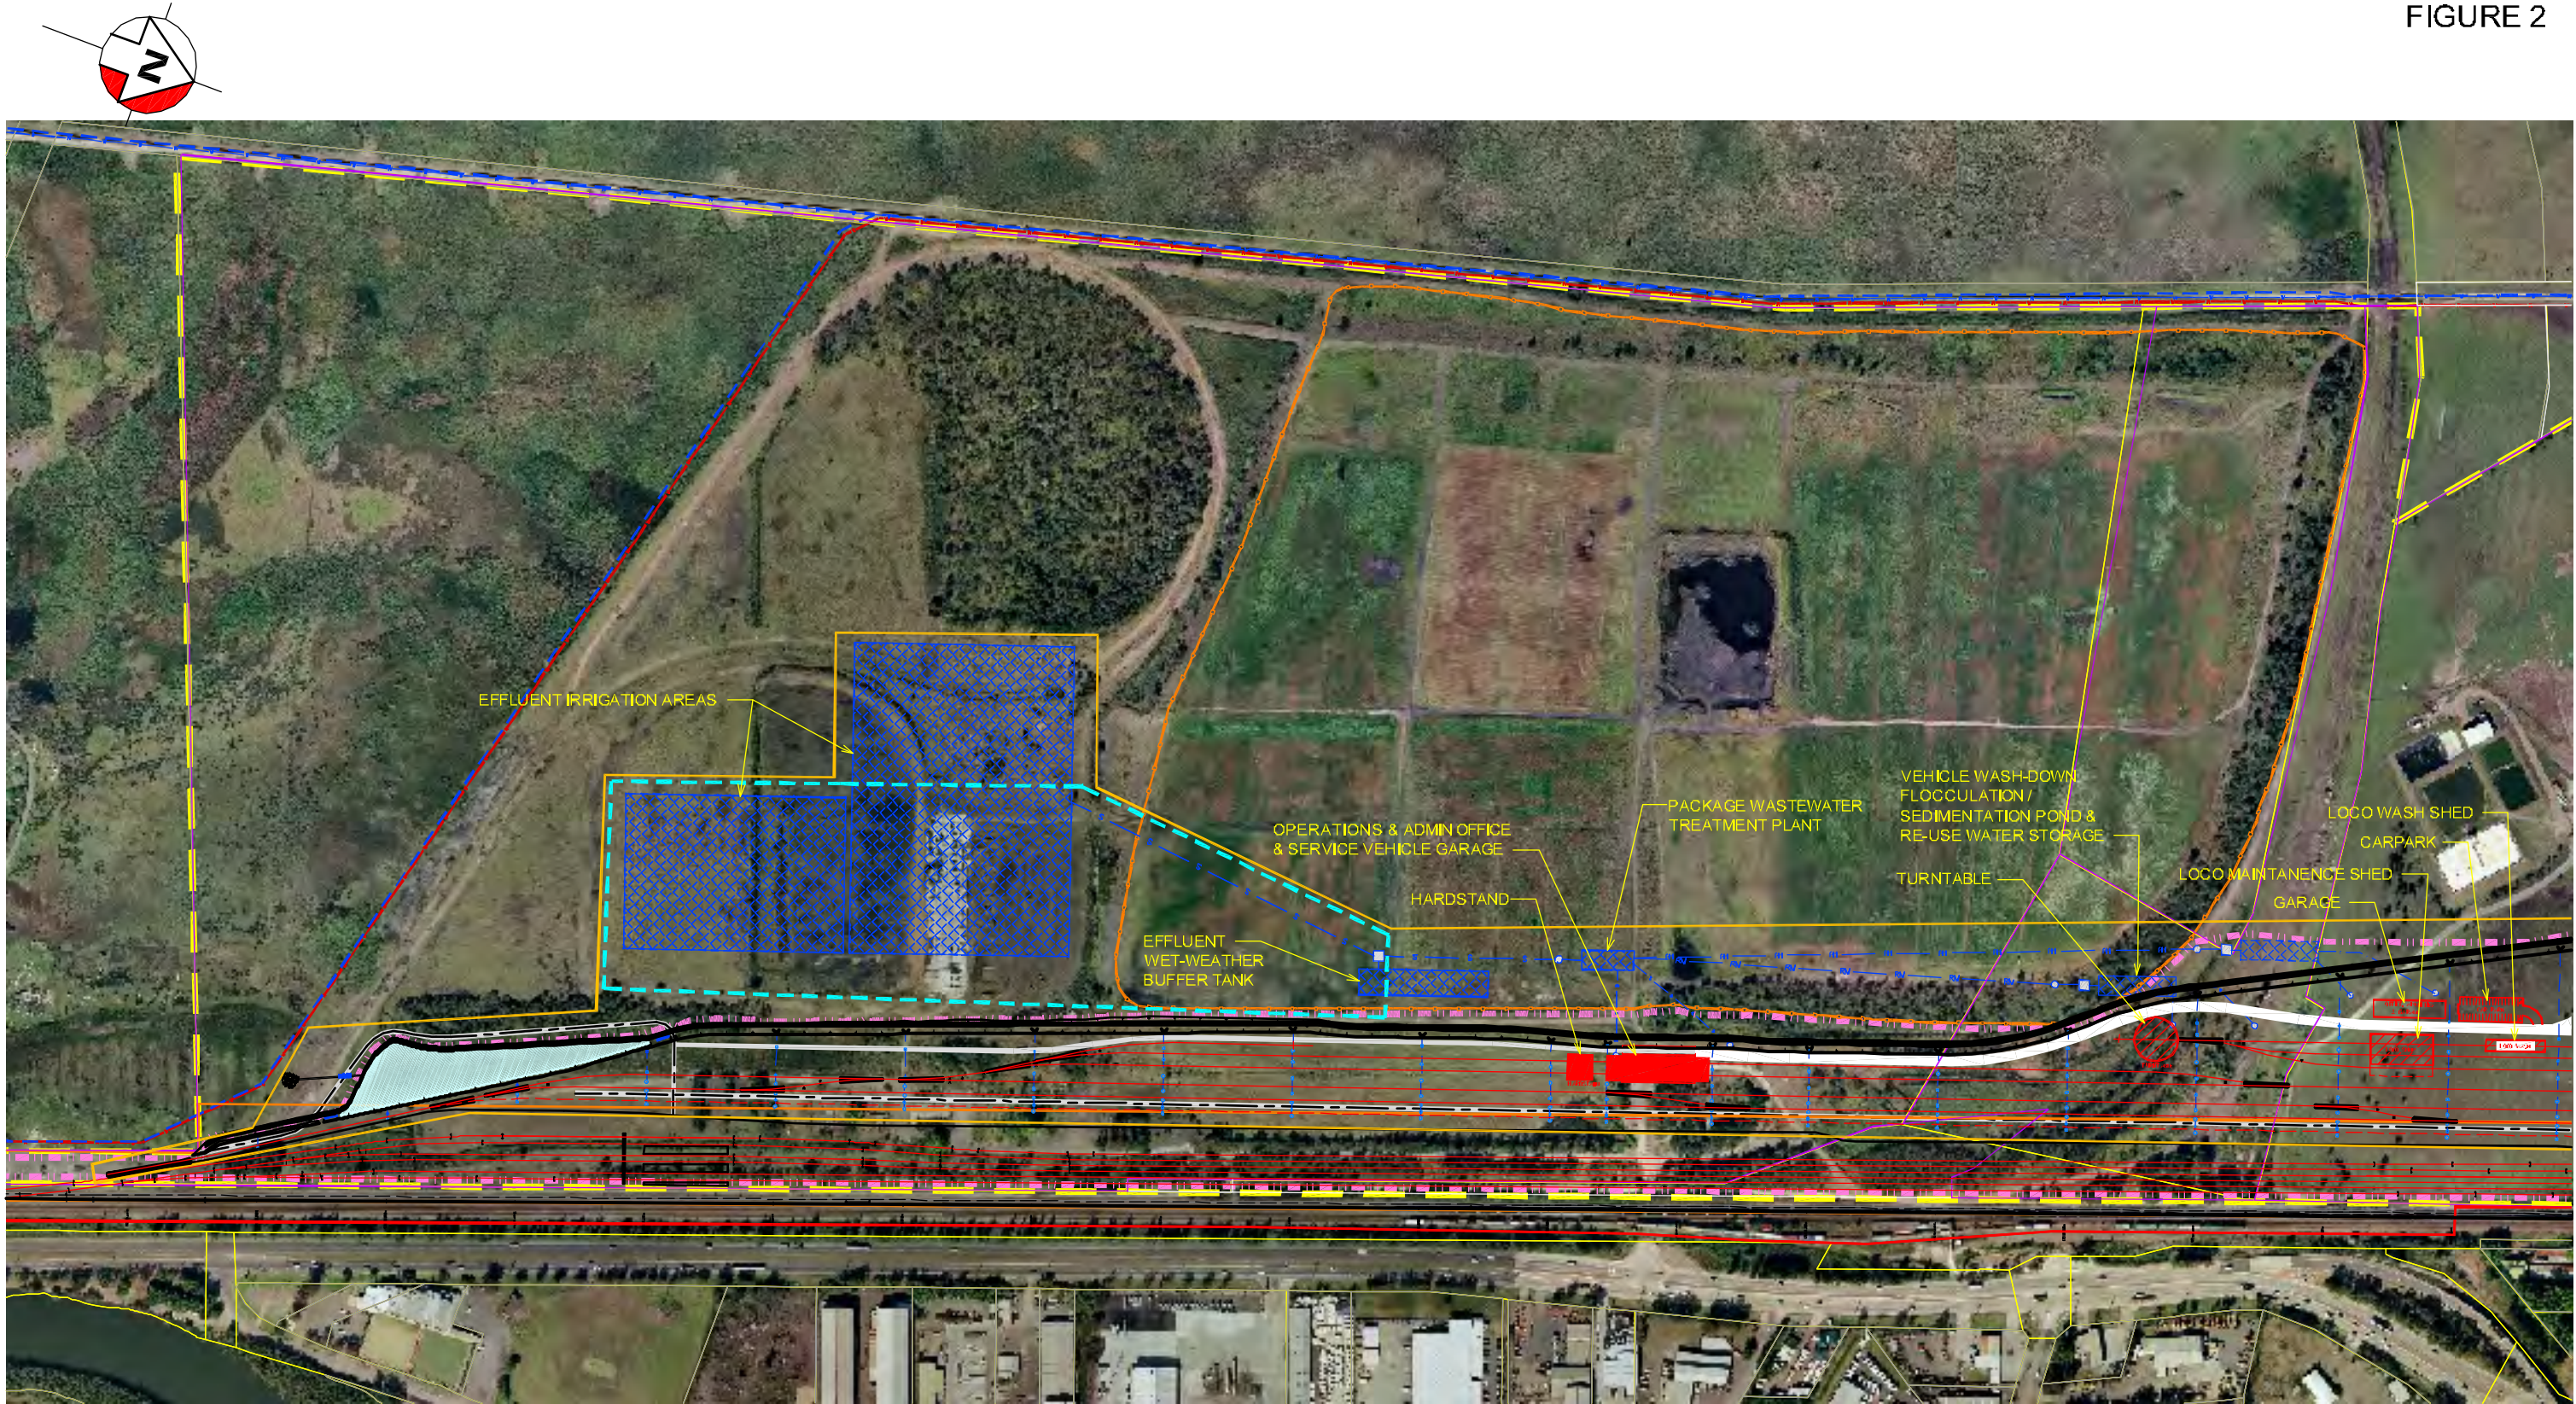
FIGURE 2

Figure 2 – Proposed Arrangement – Train Support Facility
(WorleyParsons) (Sheet 1 of 2 and Sheet 2 of 2)
Drawing 1-1 – Location of Previous Investigations
Drawing 1-2 – Test Location Plan
Drawing 1- 3 – Section A-A
Areas of Disturbance Cut – Drawings 2216395-16-FIG-
C0002 (GHD) – Rev 4 – 10 October 2012
Areas of Disturbance of Fill – Drawings 2216395-16-FIG-
C0003 (GHD) – Rev 2 – 26 September 2012

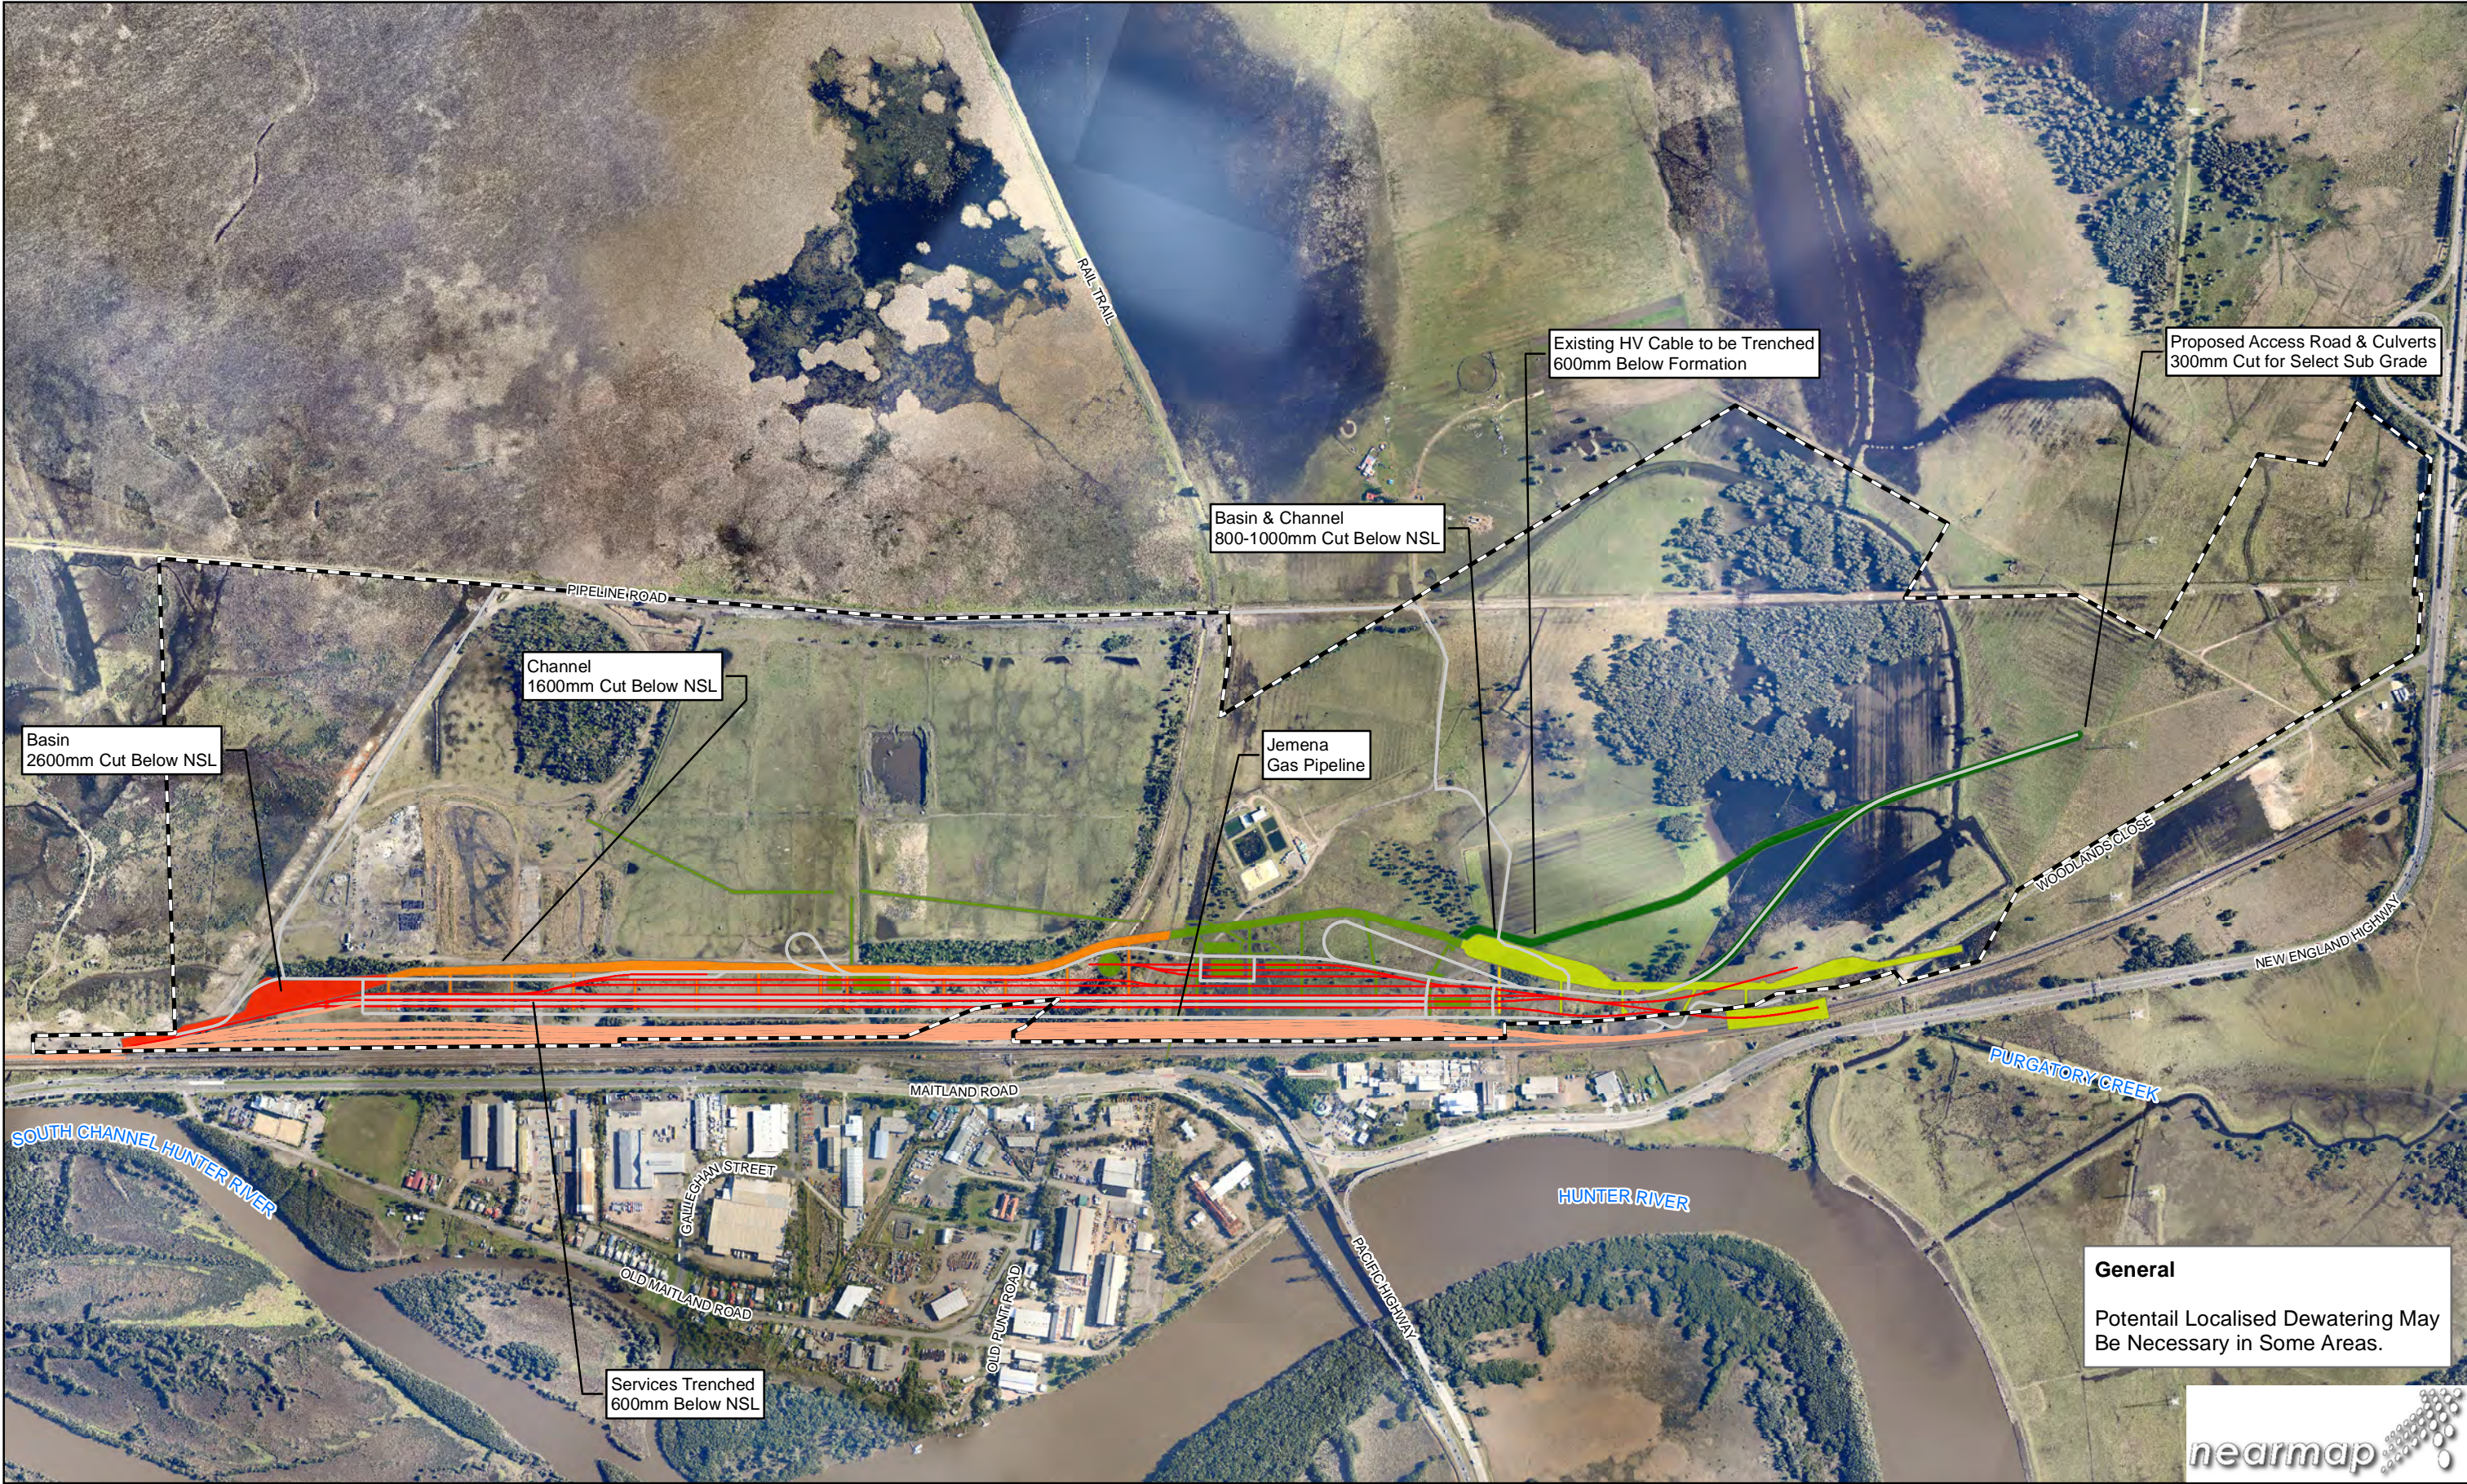
Ref:P:/39798.08/Drawings/39798.08 Drawing 1-3

1. Refer Drawing 1-2 "Test Location Plan" for location of section
2. Reference should be made to detailed CPTs for detailed descriptions
3. Layer boundaries have been estimated from discrete test locations and has involved interpolation between data points.
