Site Audit Report Overarching Remedial Action Plan, Barangaroo

Prepared for:
Barangaroo Delivery Authority

Prepared by:
ENVIRON Australia Pty Ltd

Audit Number:
GN 439A

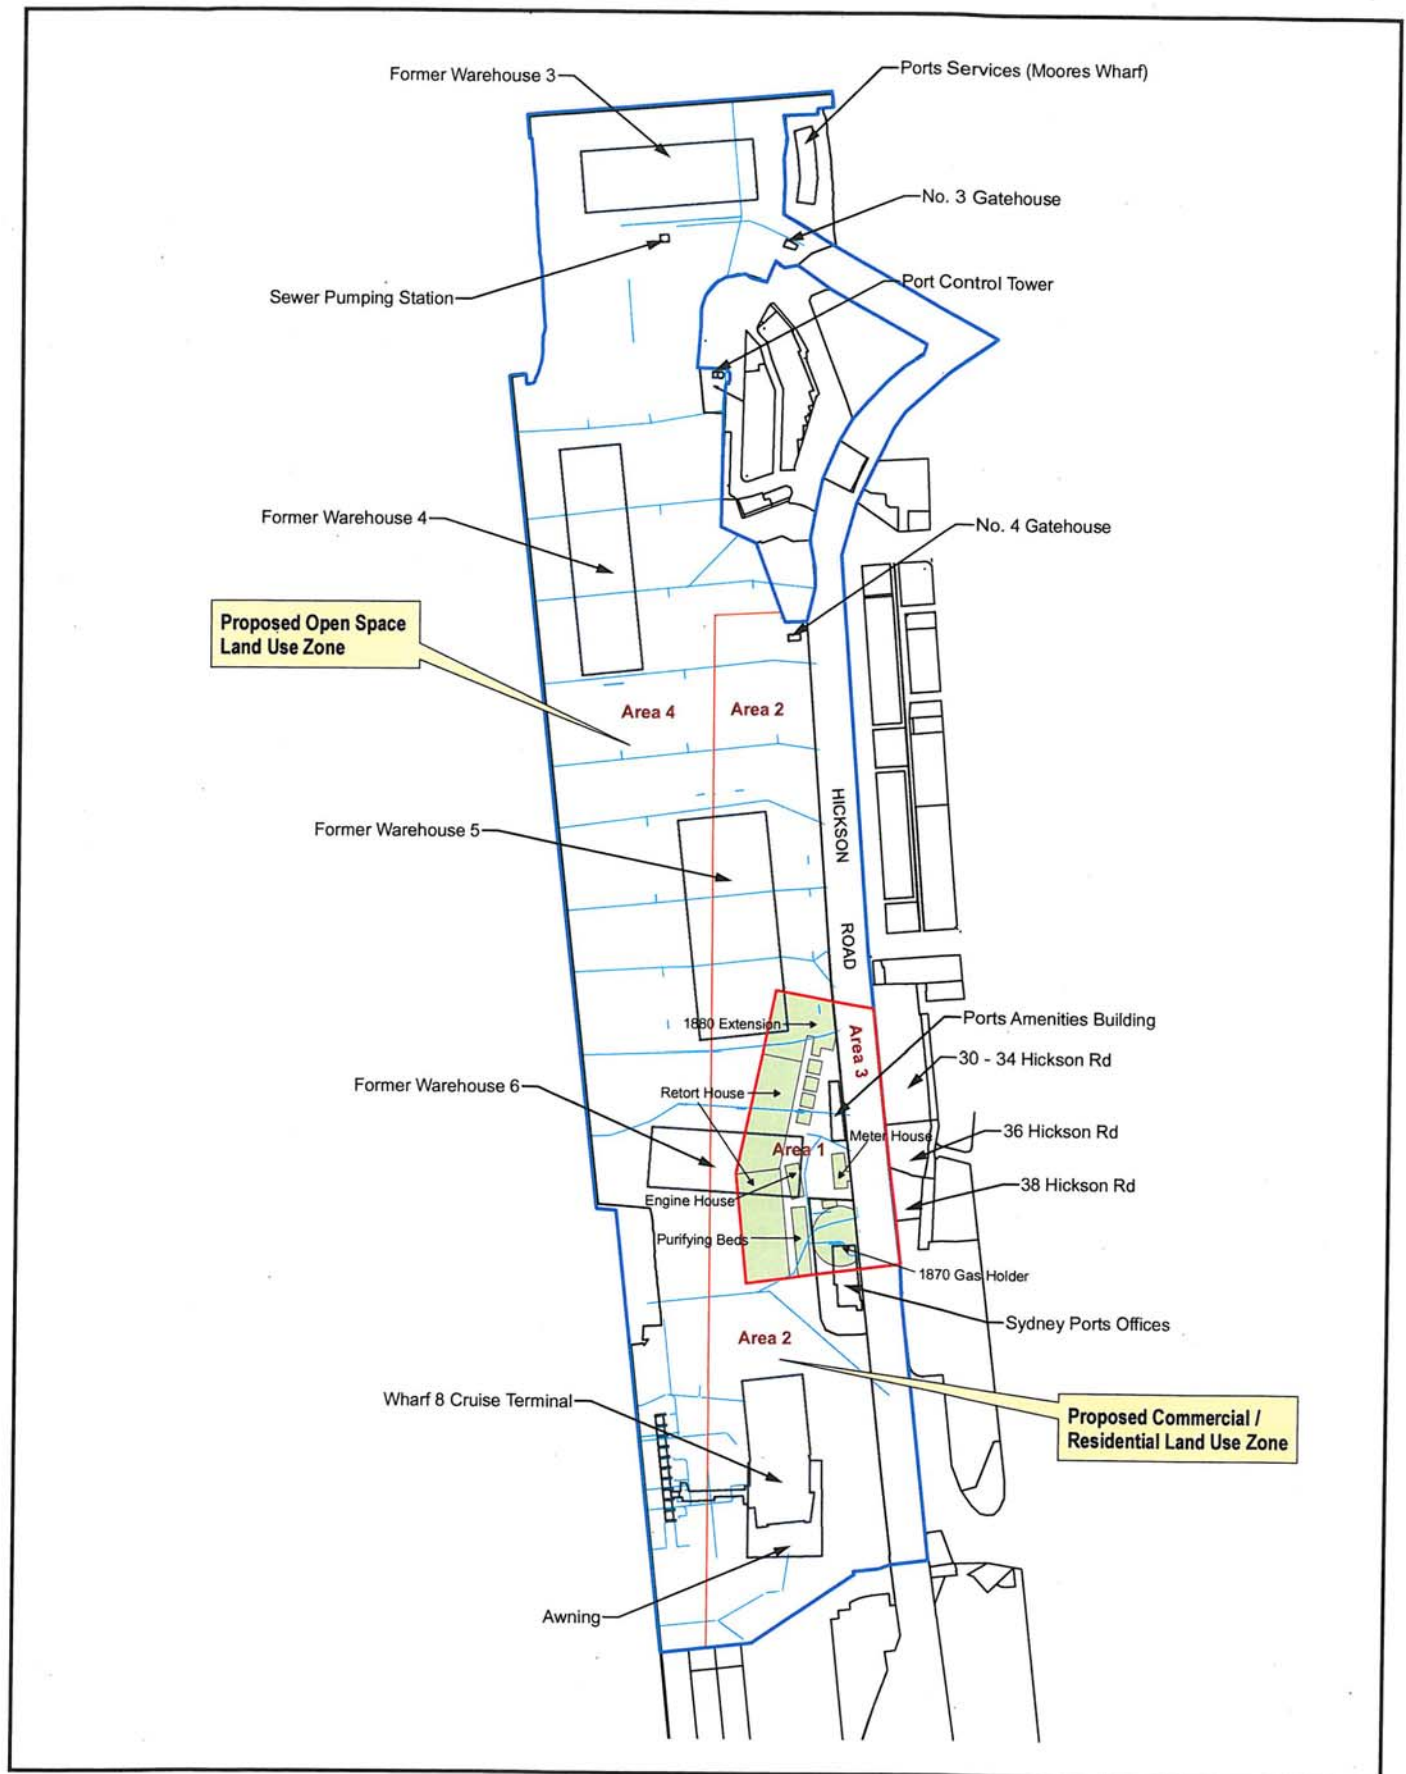
Attachment 2: Site Layout and Remedial Areas

- Legend**
- Remediation Site
 - Lot Boundaries
 - Existing or Former Site Features
 - Approximate Boundary of Landuse Zones
 - Site Drainage
 - Approximate Location of Former Gasworks Structures
 - Barangaroo Project Site

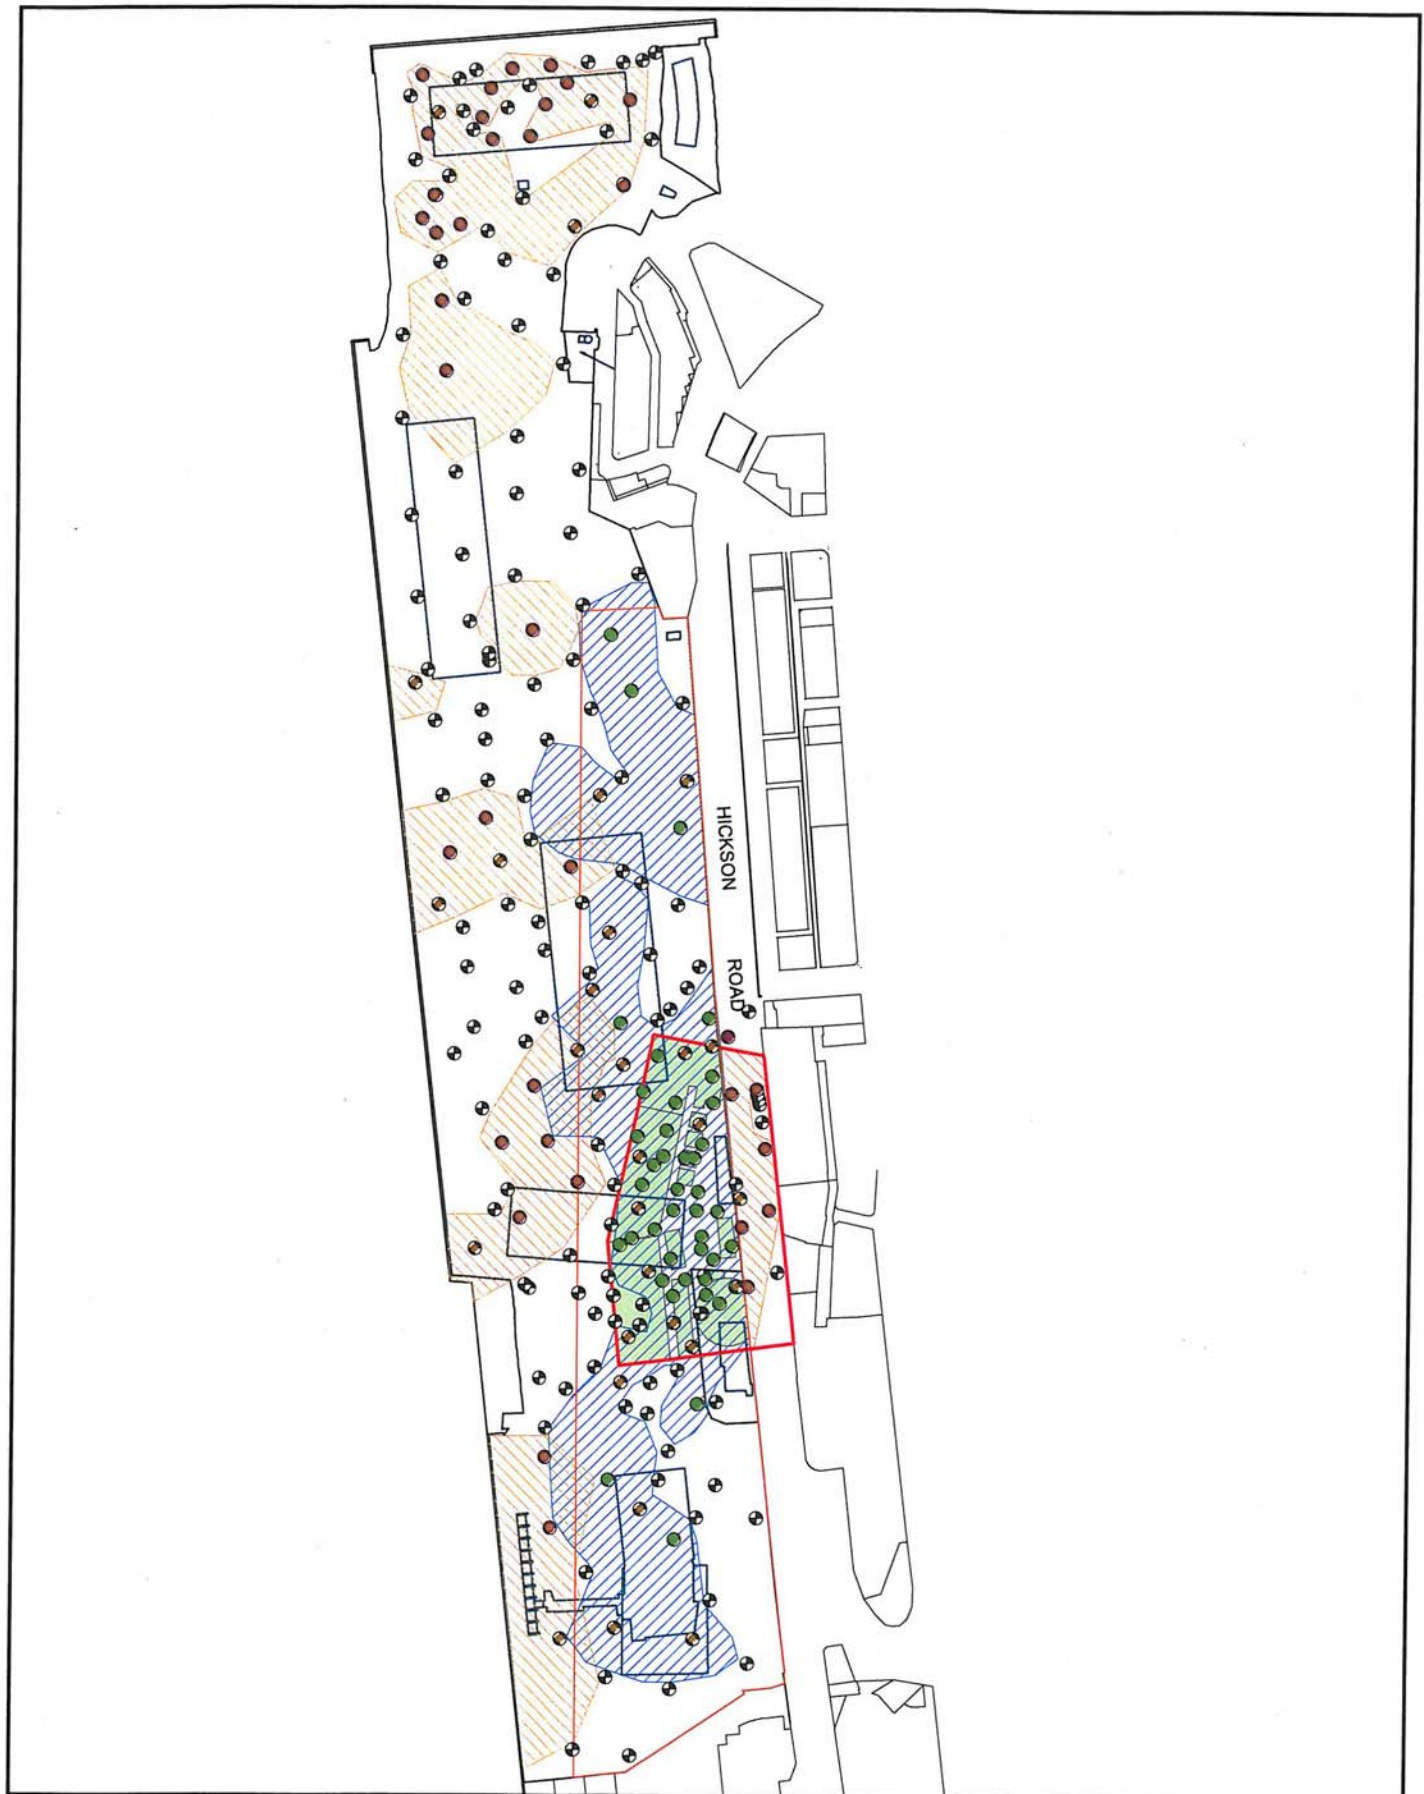
Attachment 3: Soil Impacts

- Remediation Site
- Approximate Location of Former Gasworks Structures
- Approximate Extent of Soils Exceeding Comm/Residential Screening Values
- Approximate Extent of Soils Exceeding Open Space Screening Values
- Approximate Boundary of Landuse Zones
- Existing or Former Site Features
- Lot Boundaries
