Proposed Residential Subdivision, Settlers Ridge, South West Rocks

**Geotechnical and Preliminary Site Contamination Assessment -
Revised Report**

Report No. RGS20027.1-AC

22 August 2012

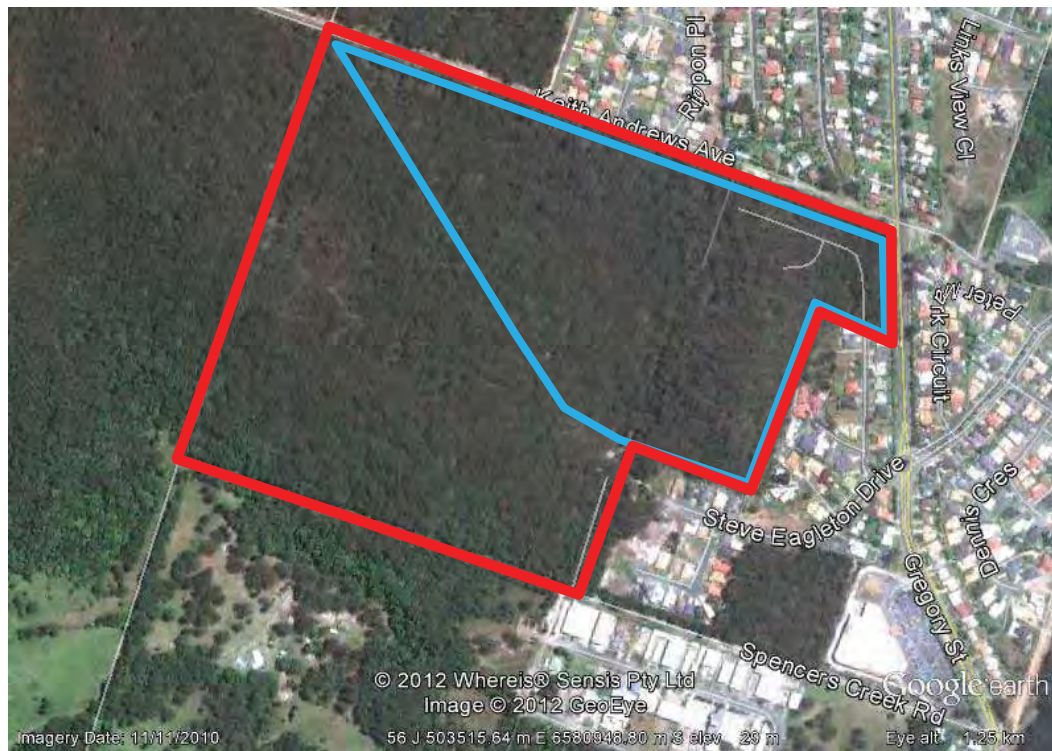
Approximate boundary of the Settlers Ridge site is shown in red and the general area proposed for development is outlined in blue.

- Intermittent drainage paths and depressions are present on the site and flow either north west or to the south as shown in Figure 1.

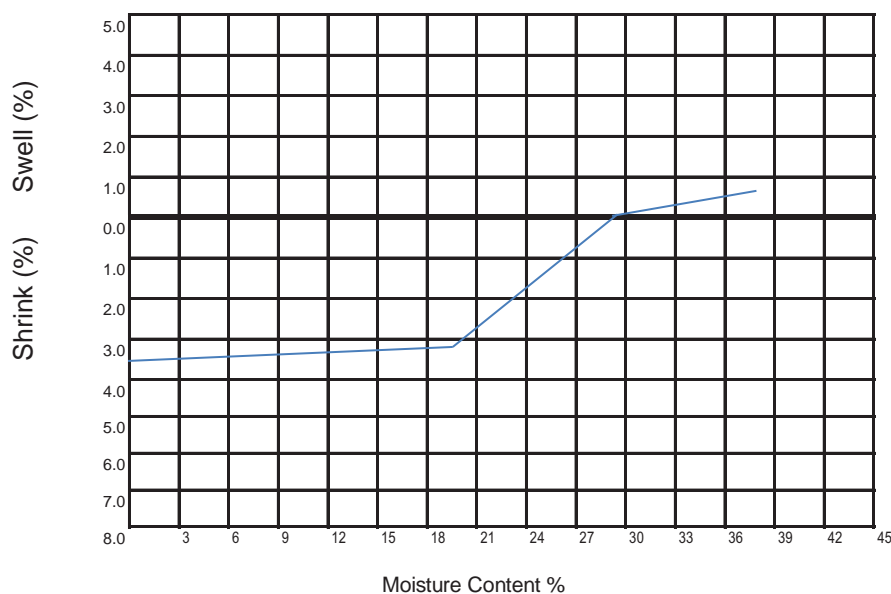
Moisture Content - Air Dried	19.6%	Pocket Penetrometer - Initial	440kPa
Shrinkage - Air Dried	3.3%	Pocket penetrometer - Final	340kPa
Field Moisture Content - Oven Dried	29.2%	Moisture Content - Final	37.9%
Shrinkage - Oven Dried	3.6%	Swell under load	0.60%

Iss = 2.17 % per ΔpF

Laboratory shrink-swell testing was undertaken on samples of clay considered representative of foundation conditions likely to be encountered on the residential lots. Test results are presented in Appendix C and revealed I_{ss} values ranging from 0.69 to 2.17 for the clay soils present in Geotechnical Terrain C where the majority of the development will occur.

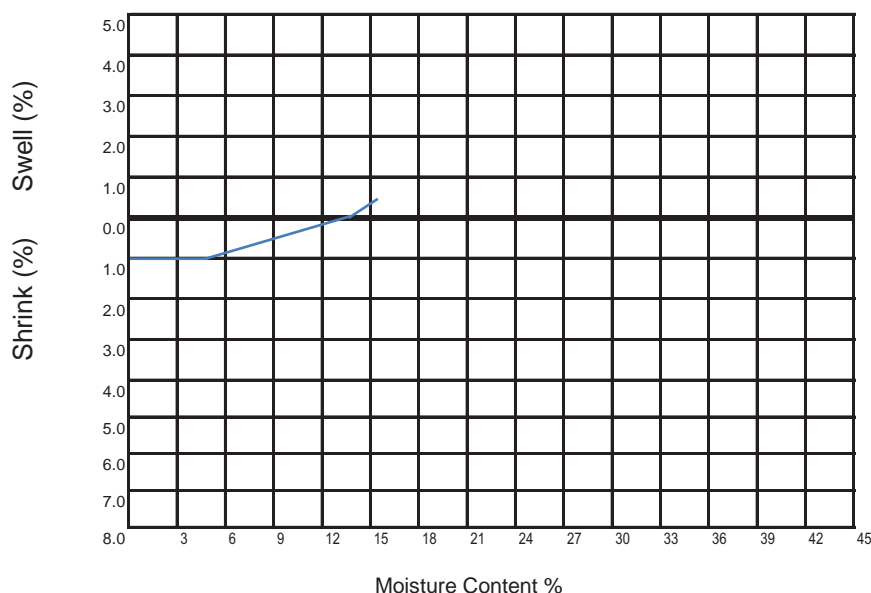
Moisture Content - Air Dried	4.6%	Pocket Penetrometer - Initial	600kPa
Shrinkage - Air Dried	1.0%	Pocket penetrometer - Final	250kPa
Field Moisture Content - Oven Dried	13.4%	Moisture Content - Final	15.3%
Shrinkage - Oven Dried	1.0%	Swell under load	0.48%

$$I_{ss} = 0.69 \% \text{ per } \Delta pF$$
