Crighton Properties Pty Ltd

Concept Integrated Water Cycle Management Strategy (Revised) Riverside, Tea Gardens, NSW

P0902346JR08V02
January 2013

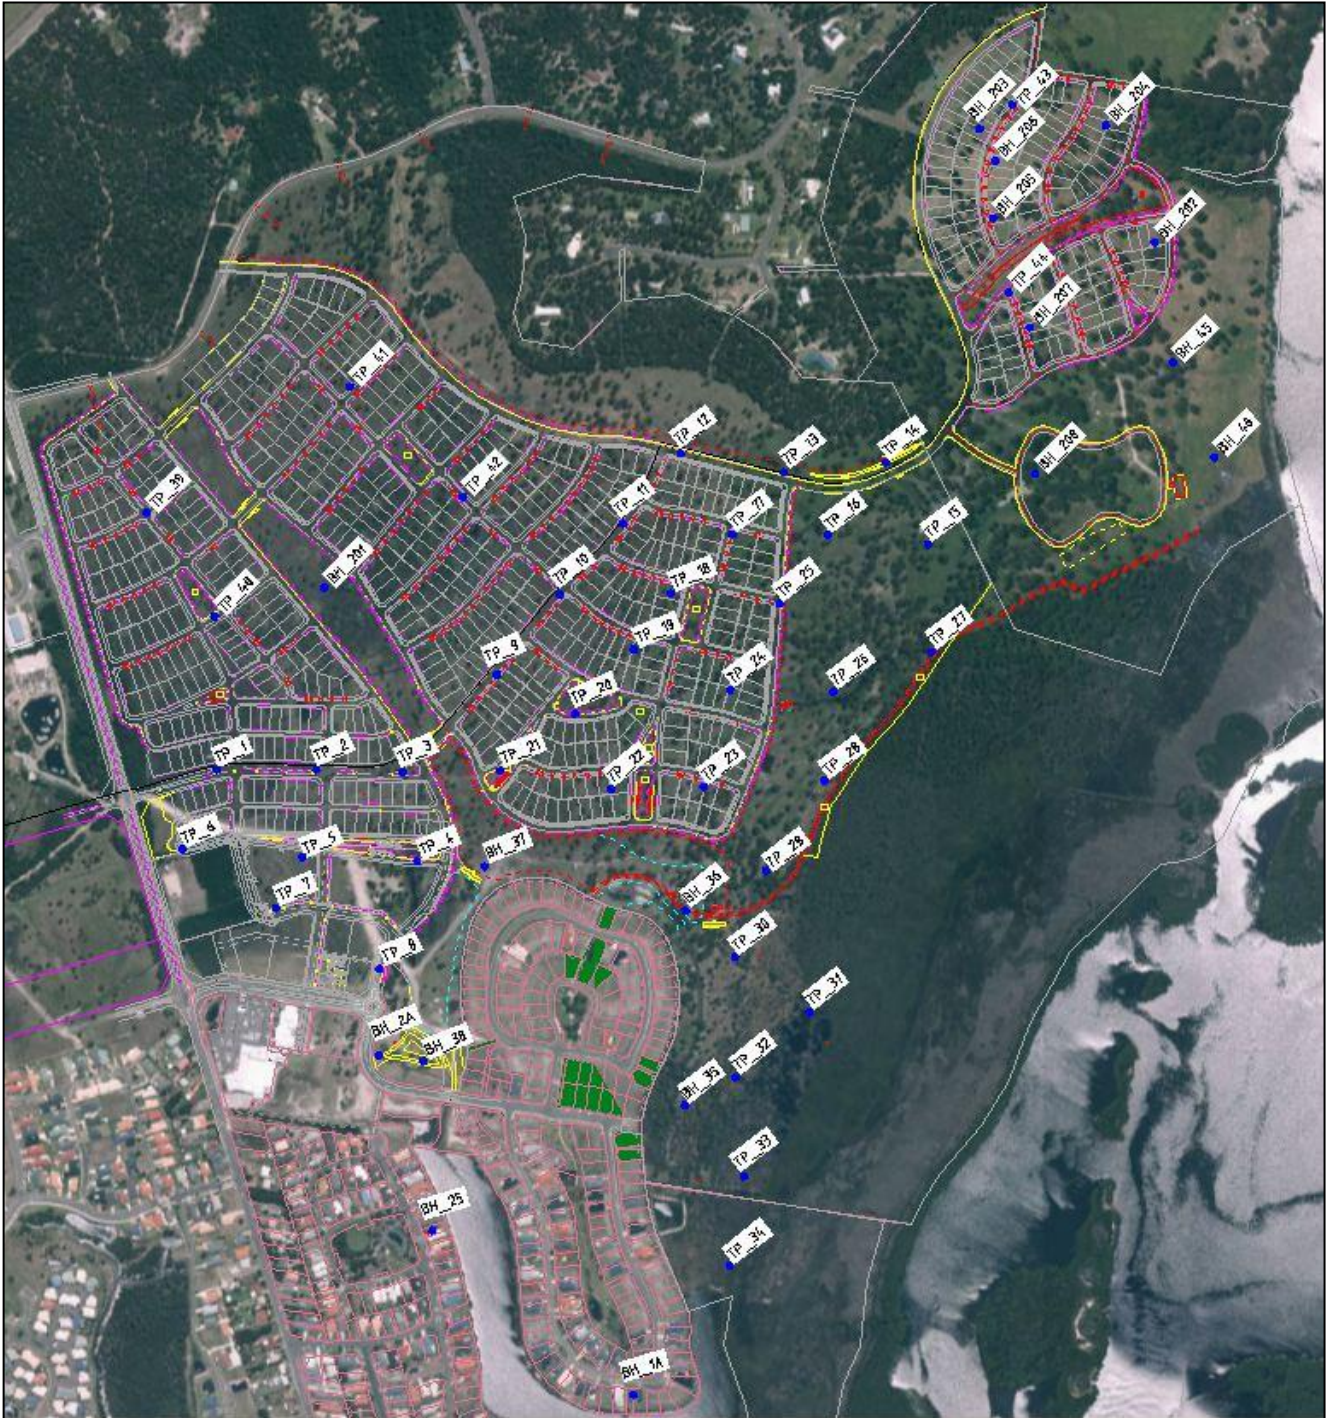
Martens & Associates Pty Ltd ABN 85 070 240 890		Environment Water Wastewater Geotechnical Civil Management		
Drawn:	MLK	Site Testing Plan		
Approved:	DM			Attachment H
Date:	29.11.2012			
Scale:	NA			Job No: P0902346

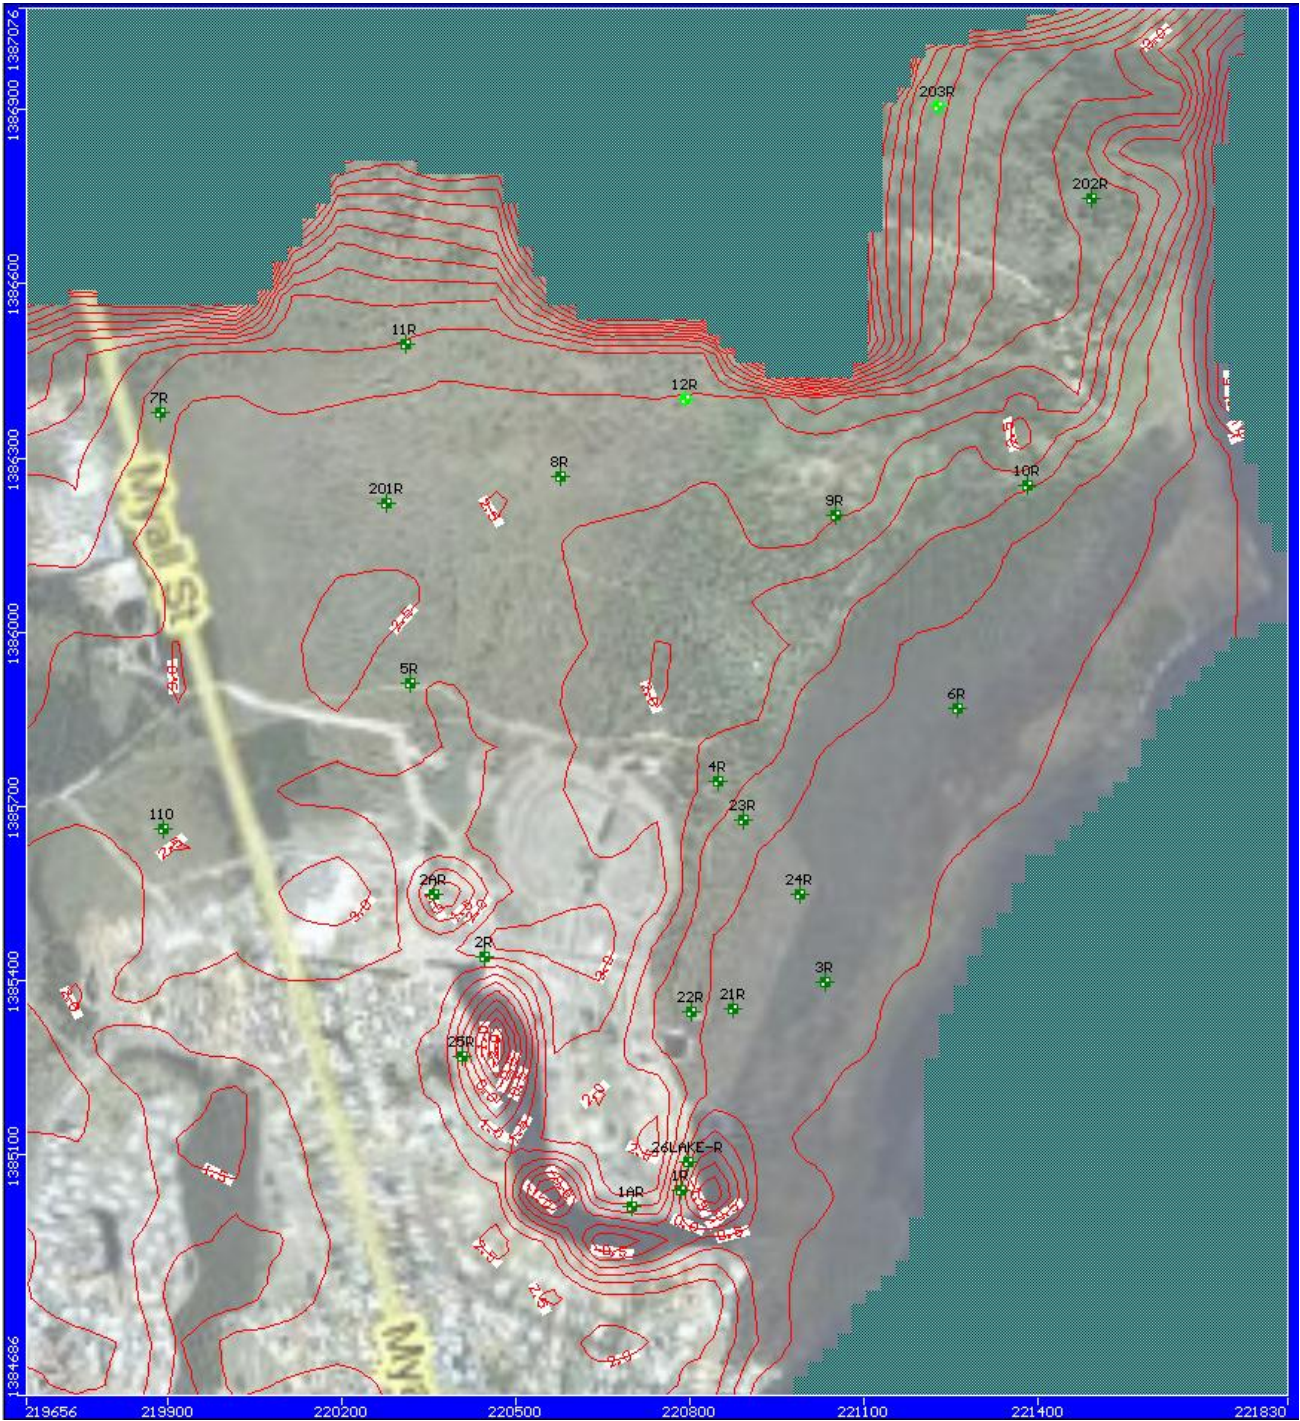
Part 3a Submission to N.S.W. D.O.P.

DATE

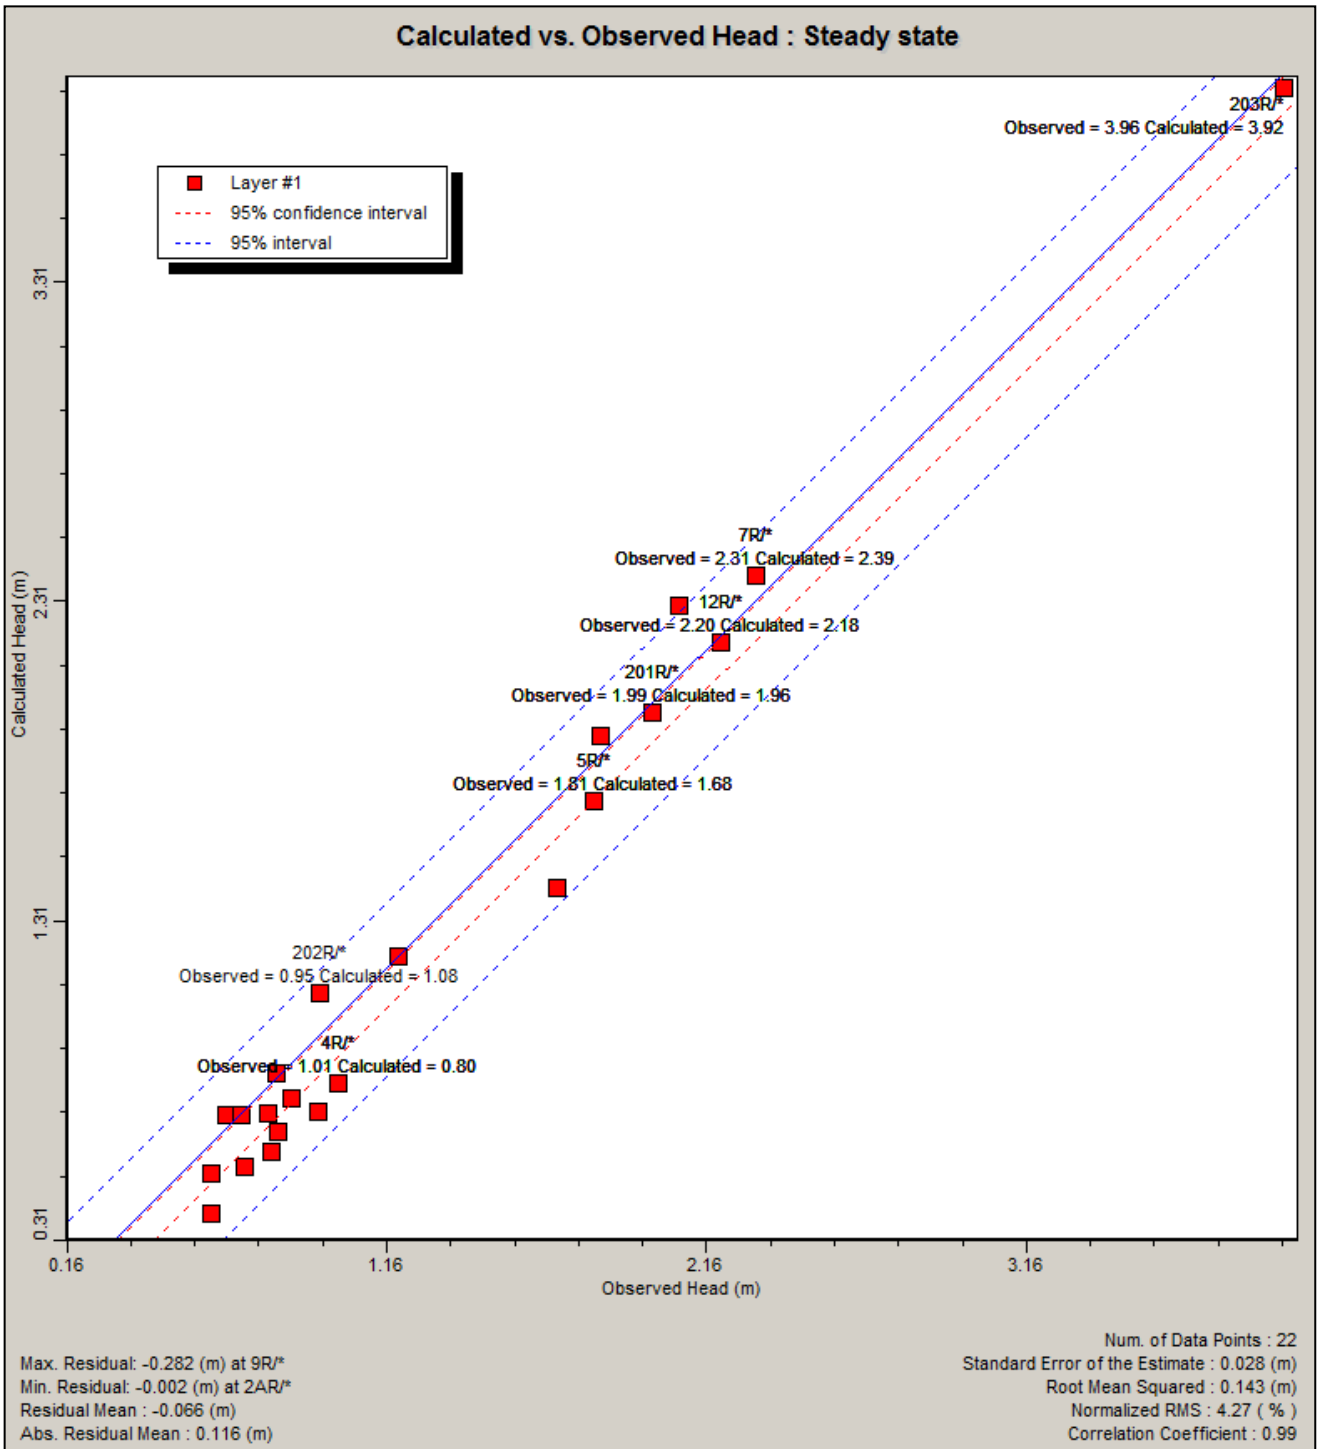
REVISION

- M0: Calibration model - Existing terrain and conditions
Using available site geotechnical data and GMB level data, a calibrated single layer steady state model was developed.

A calibration model (M0) was developed to establish base recharge values for existing site conditions and involved:

- Definition of hydraulic conductivity (K) zones across the site based on field testing results (Figure 16, Attachment 4A; Attachment 4D).
- Definition of recharge zones across the site based on site landform, vegetation type and drainage conditions (Figure 17, Attachment 4A).
- Calibration of head equipotentials against observed heads (at GMBs) by iterative adjustment of recharge zones values whilst keeping K values constant. Calibrated recharge values are summarised in Table 11.
