LIMITED PHASE 2 ENVIRONMENTAL SITE INVESTIGATION

BANK STREET PYRMONT SYDNEY

RCA ref 8535-401/1

**LIMITED PHASE 2 ENVIRONMENTAL SITE INVESTIGATION
AURECON CONSTRUCTION COMPOUND, ANZAC BRIDGE MAINTENANCE
PYRMONT, SYDNEY**

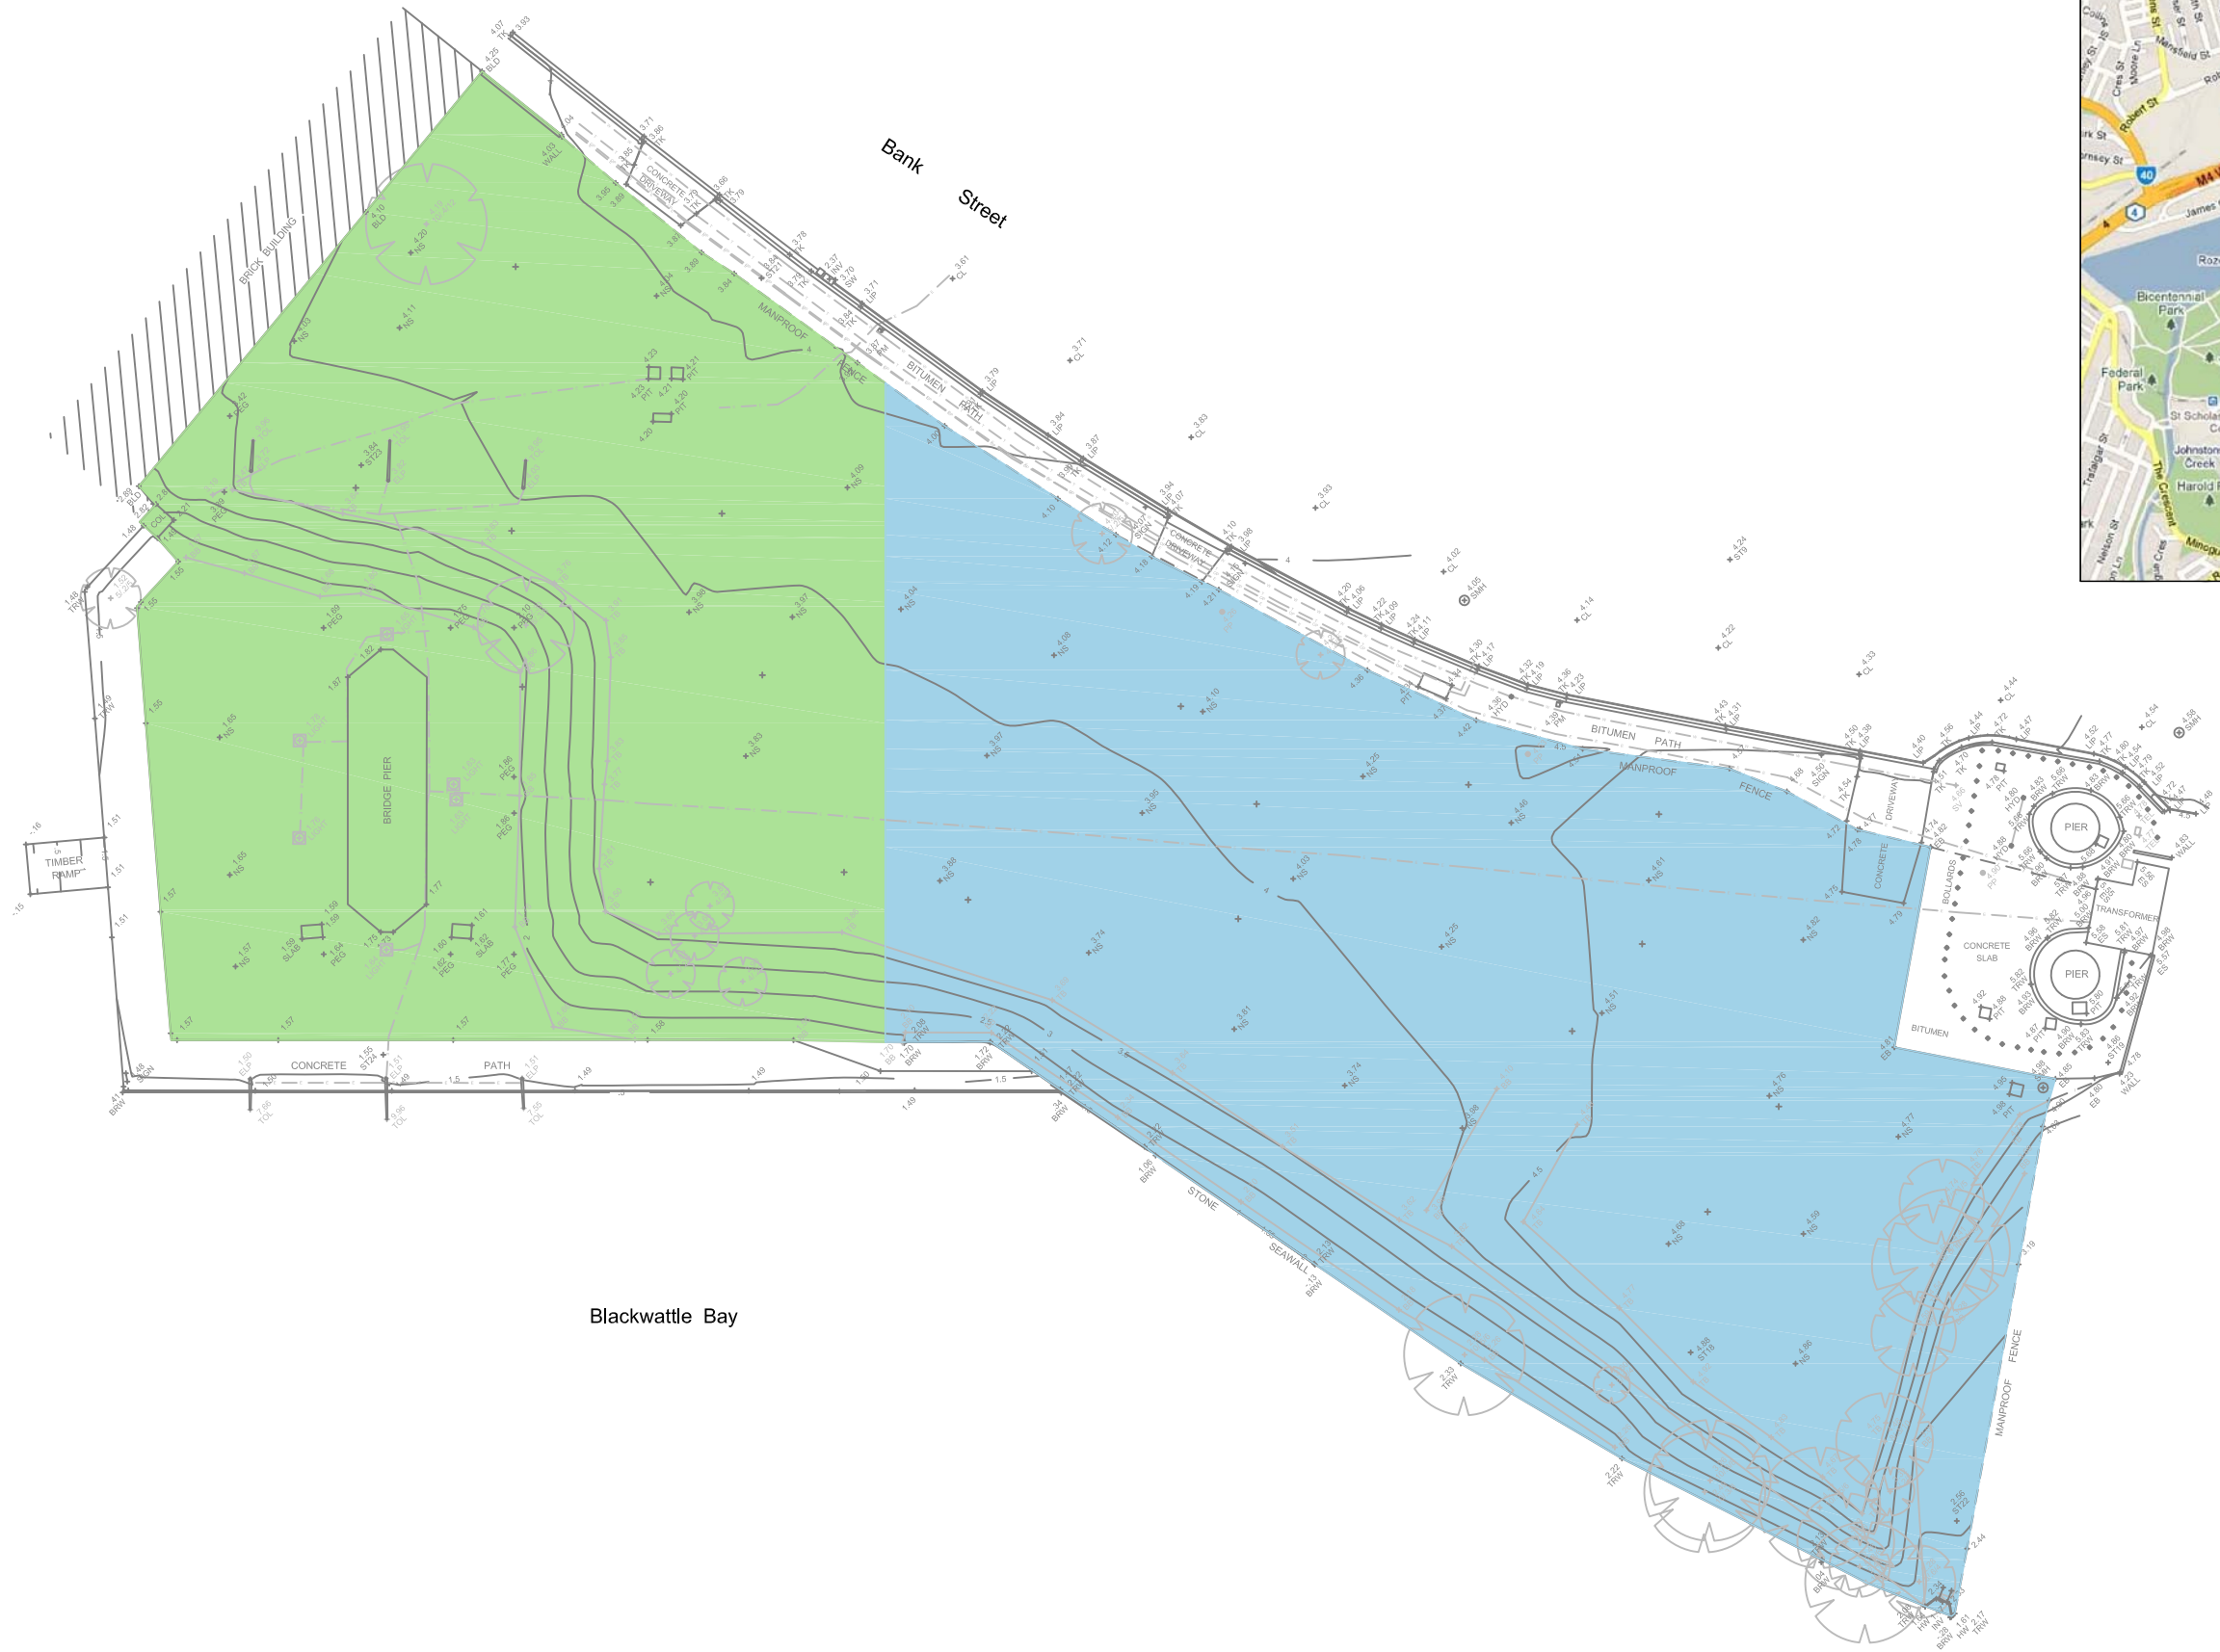
CLIENT Aurecon Group			RCA Ref 8535-401/1		
DRAWN BY	NH	SCALE	1 : 600 (A3)	DRAWING No	1
APPROVED BY	FB	DATE	27/5/2011	OFFICE	NEWCASTLE
				REV	1

The site has been divided into two (2) individual sites according to proposed site use, as shown on **Drawing 1, Appendix A**, to be used for:

The closest environmental feature is Blackwattle Bay, as shown on **Drawing 1, Appendix A**. The closest sensitive site is KU Maybanke preschool, located approximately 400m east of the site.
