REMEDIATION ACTION PLAN

Cronulla Sharks Redevelopment

Stage 1 Commercial and Retail including Carpark

**Part Lot 11 in DP526492
461 Captain Cook Drive
Woollooware NSW**

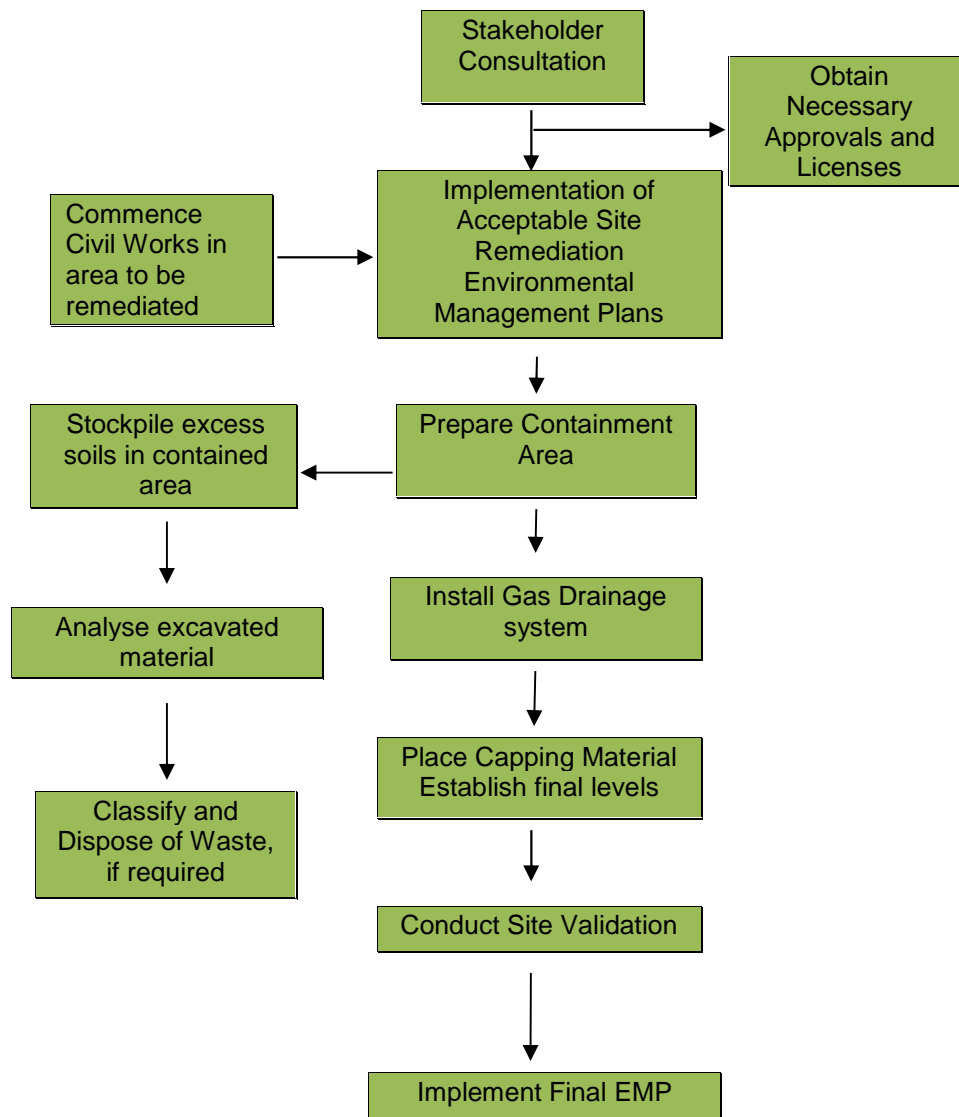
REMEDIATION PROCESS

A schematic of the **Remediation Process** is set out below in the Flow Diagram:

The preferred remediation strategy will be in general accordance with the requirements as outlined in the **Methane Gas Management Plan** as included as **Appendix B**. It is recognised that during Final Development Design the finer detail of the capping and methane gas drainage systems will be required. (Site Works Remediation Plan).

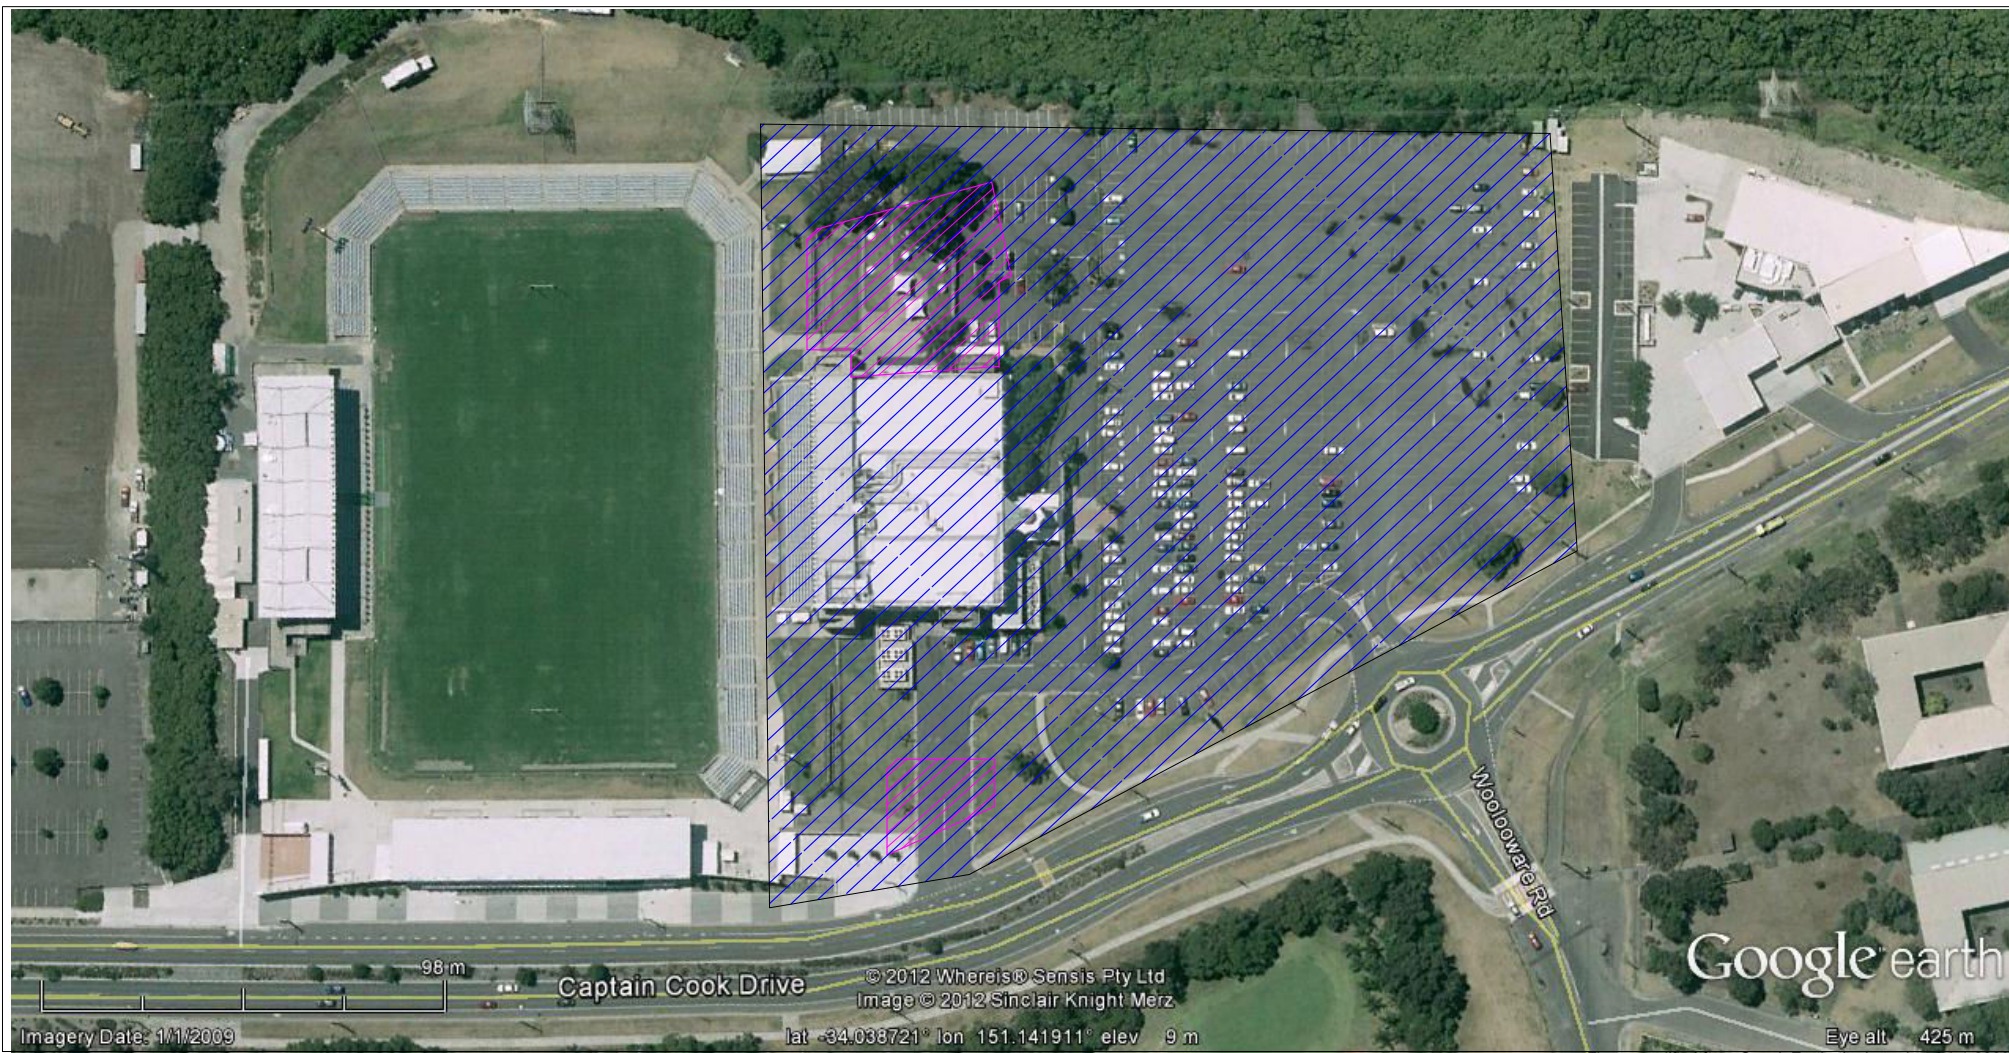
Figure 2

Site Layout

Figure modified from GoogleEarth air photo dated 1-1-2009

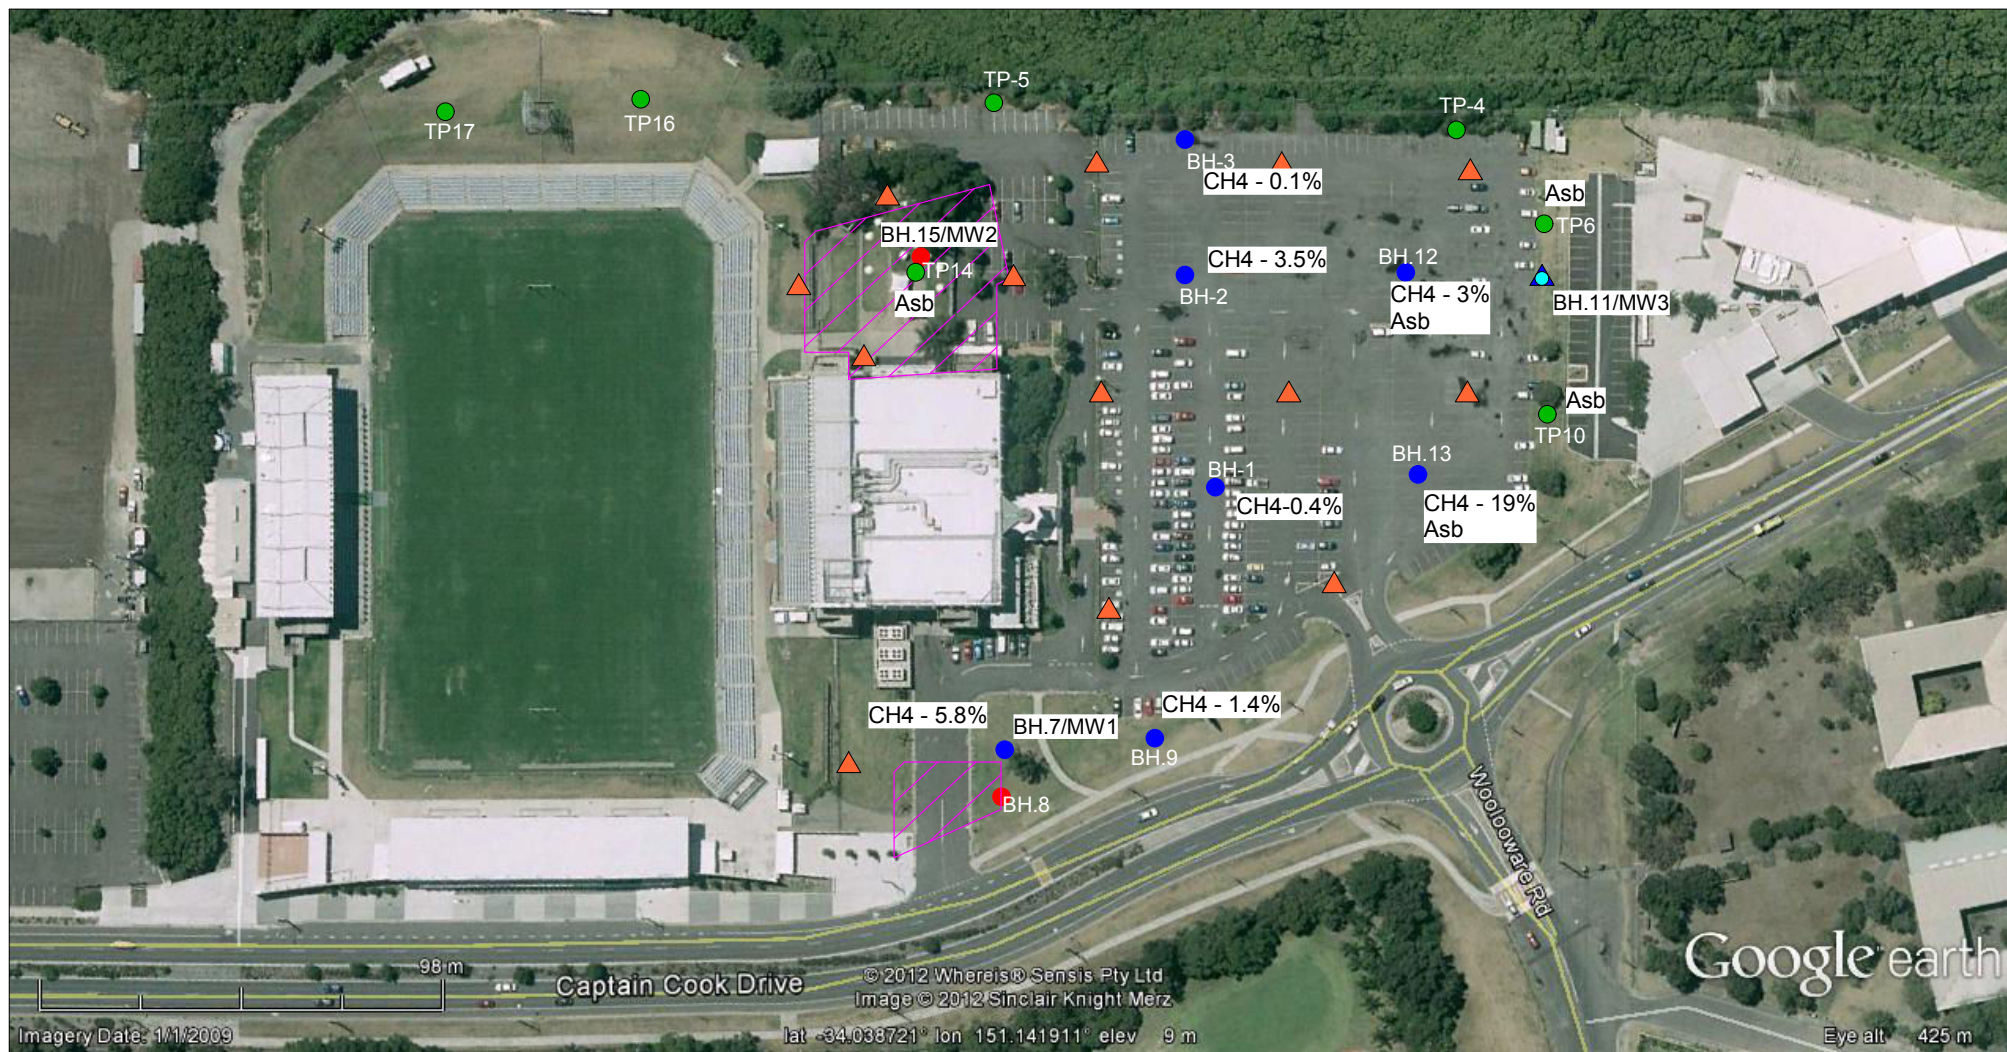
Figure 3

Sampling Locations

Figure modified from GoogleEarth air photo dated 1-1-2009

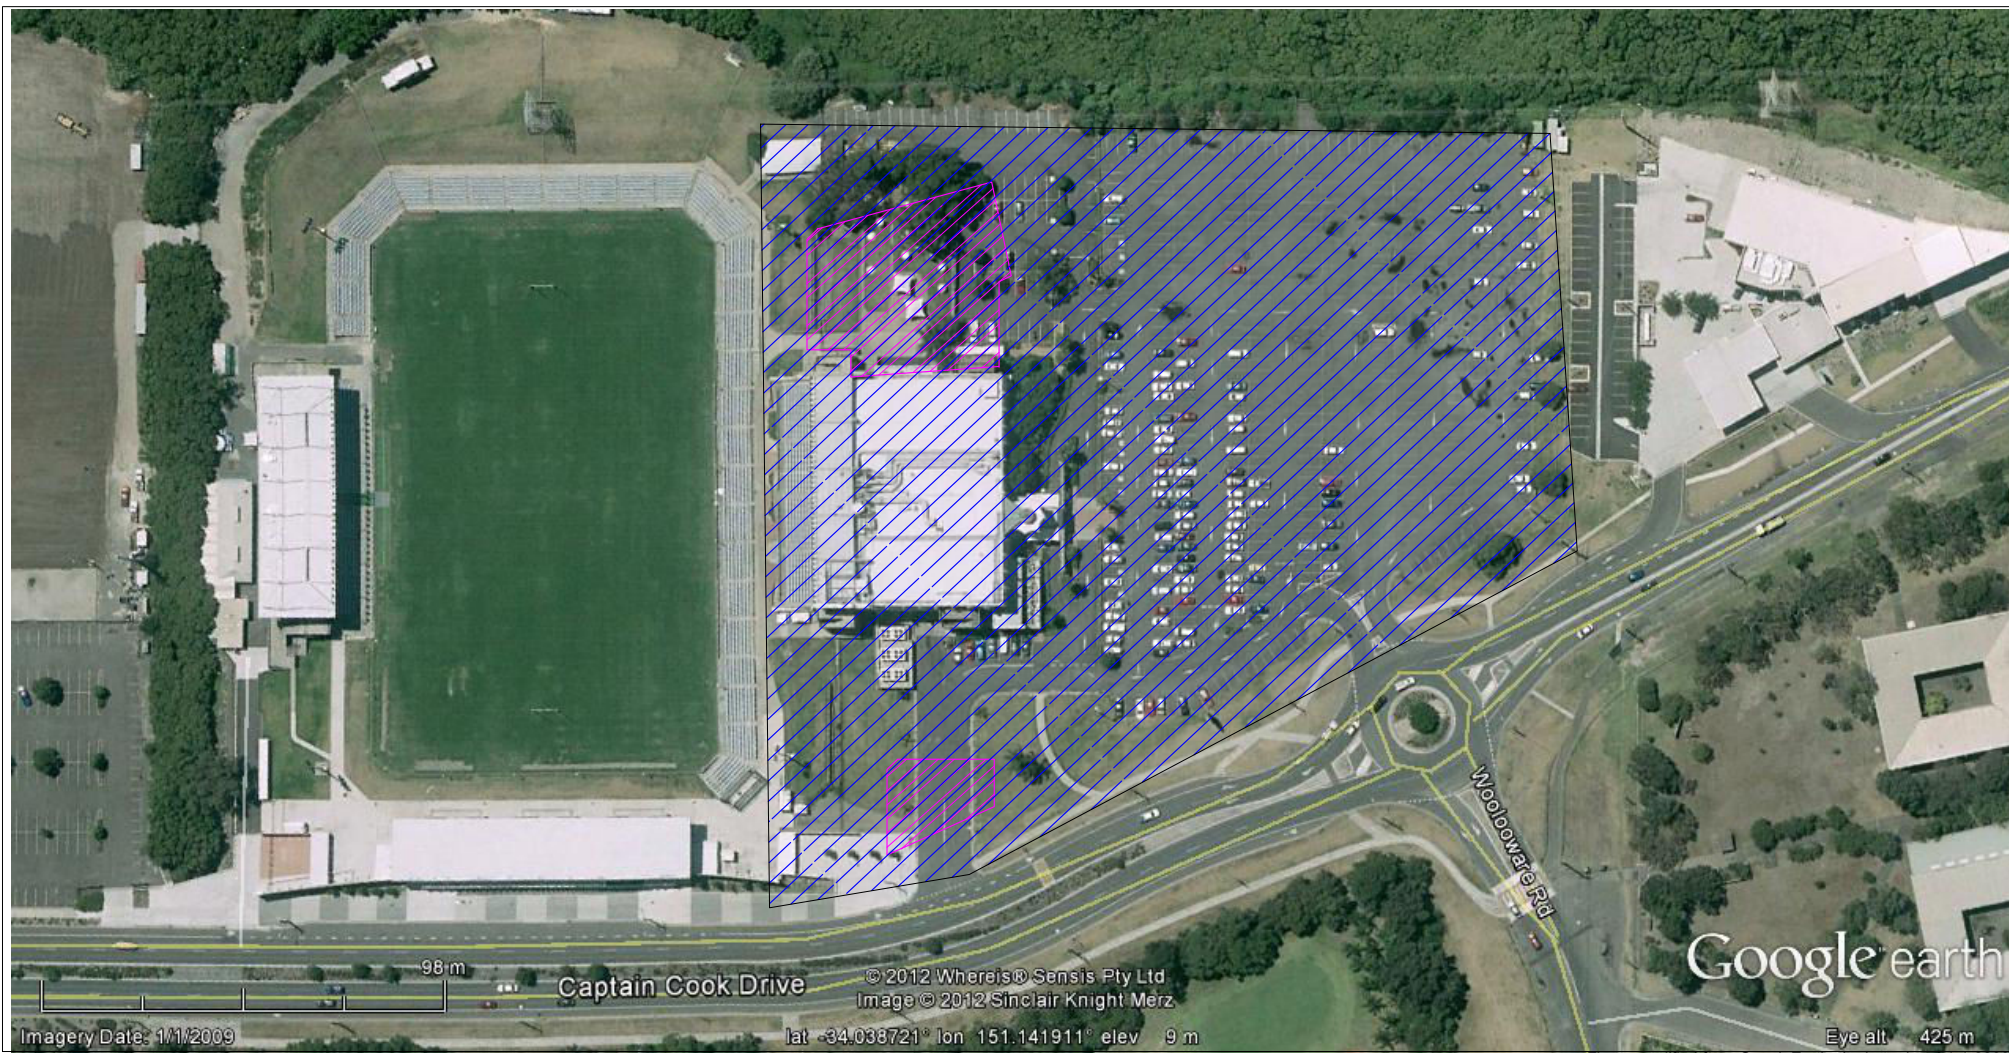
Figure 2

Planned Development Stage Layout

Figure modified from GoogleEarth air photo dated 1-1-2009

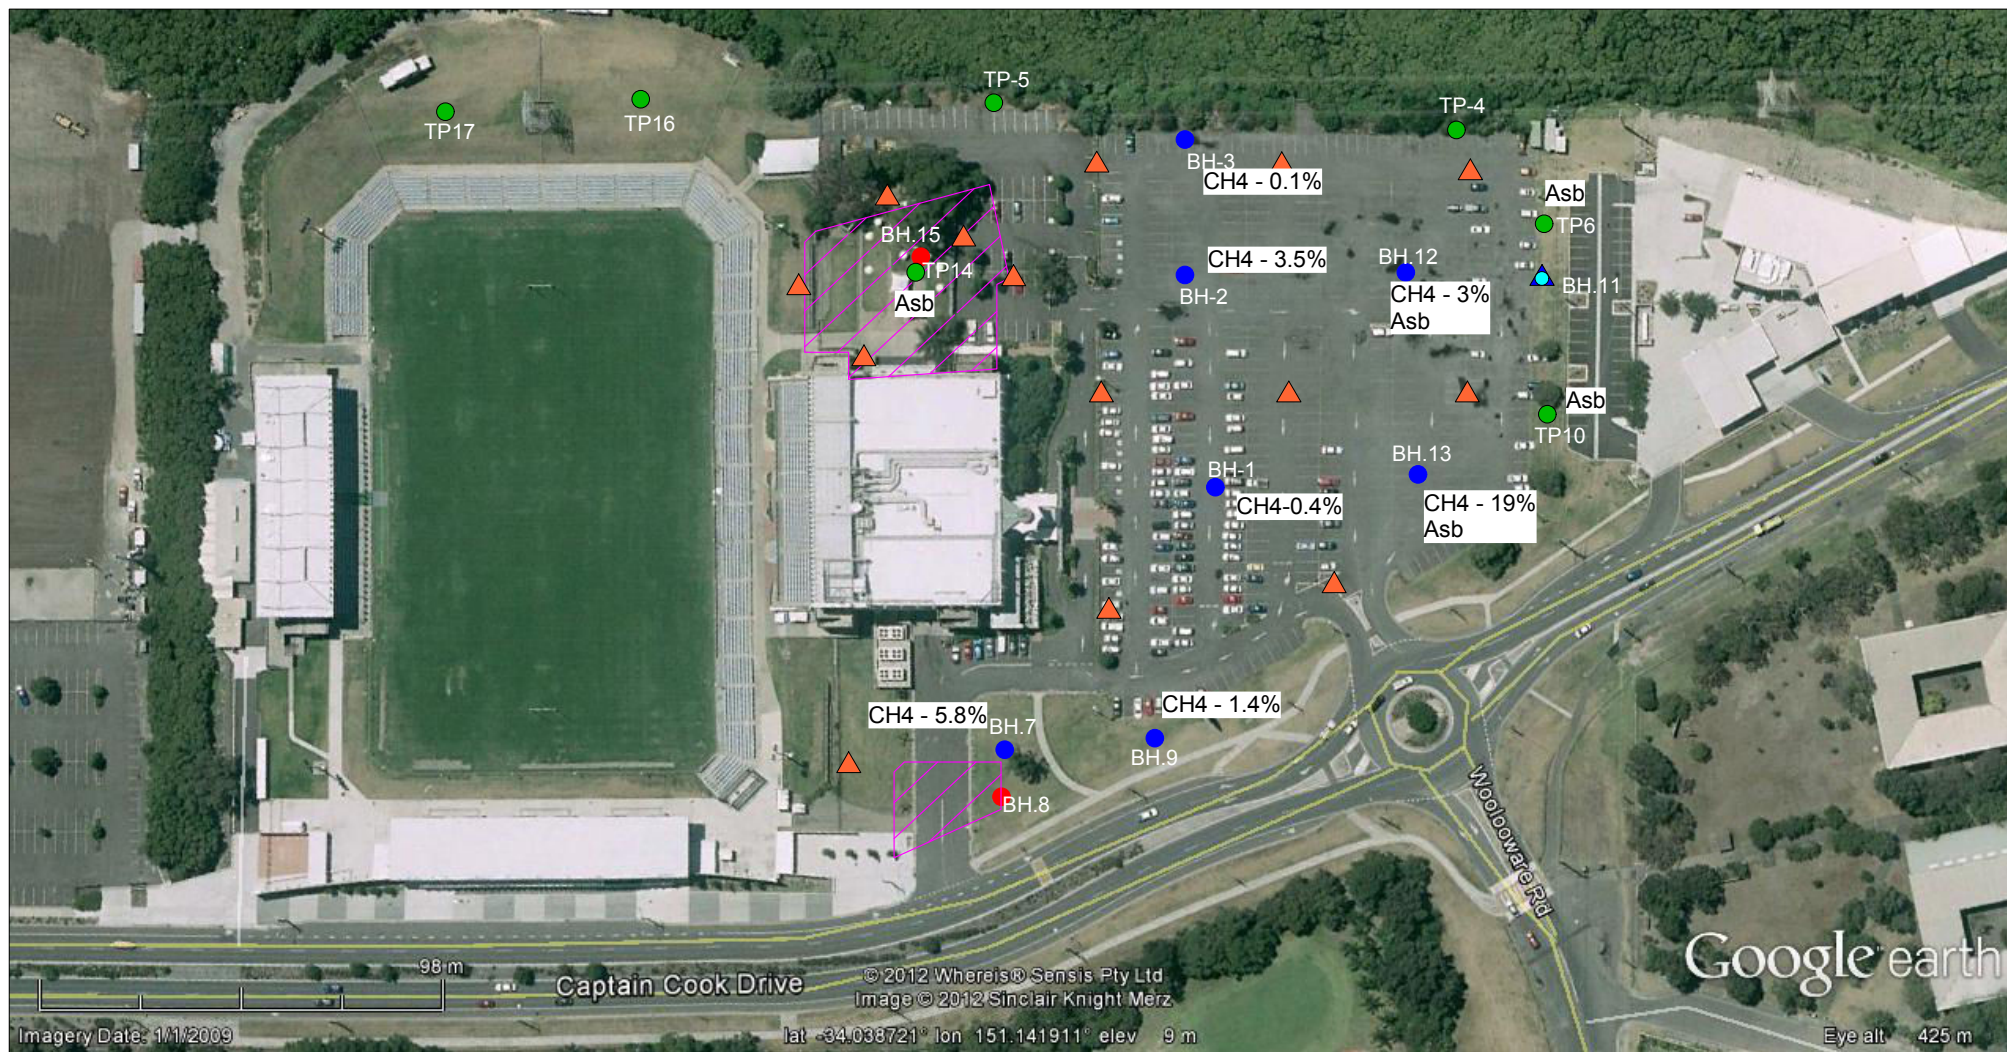
Figure 1

Site Layout with Sample Locations

Figure modified from GoogleEarth air photo dated 1-1-2009

Groundwater was found to be present at a depth of 3 - 4m. Three (3) groundwater monitoring wells were installed, MW#1, MW#2 and MW#3. Refer to **Figure 2 – Site Layout with Sample Locations**.
