## **Phase 2 Detailed Environmental Site Assessment**

**Cronulla Sharks Redevelopment  
Stage 1**

**Lot 11 in DP 526492**

**461 Captain Cook Drive  
Woollooware NSW**

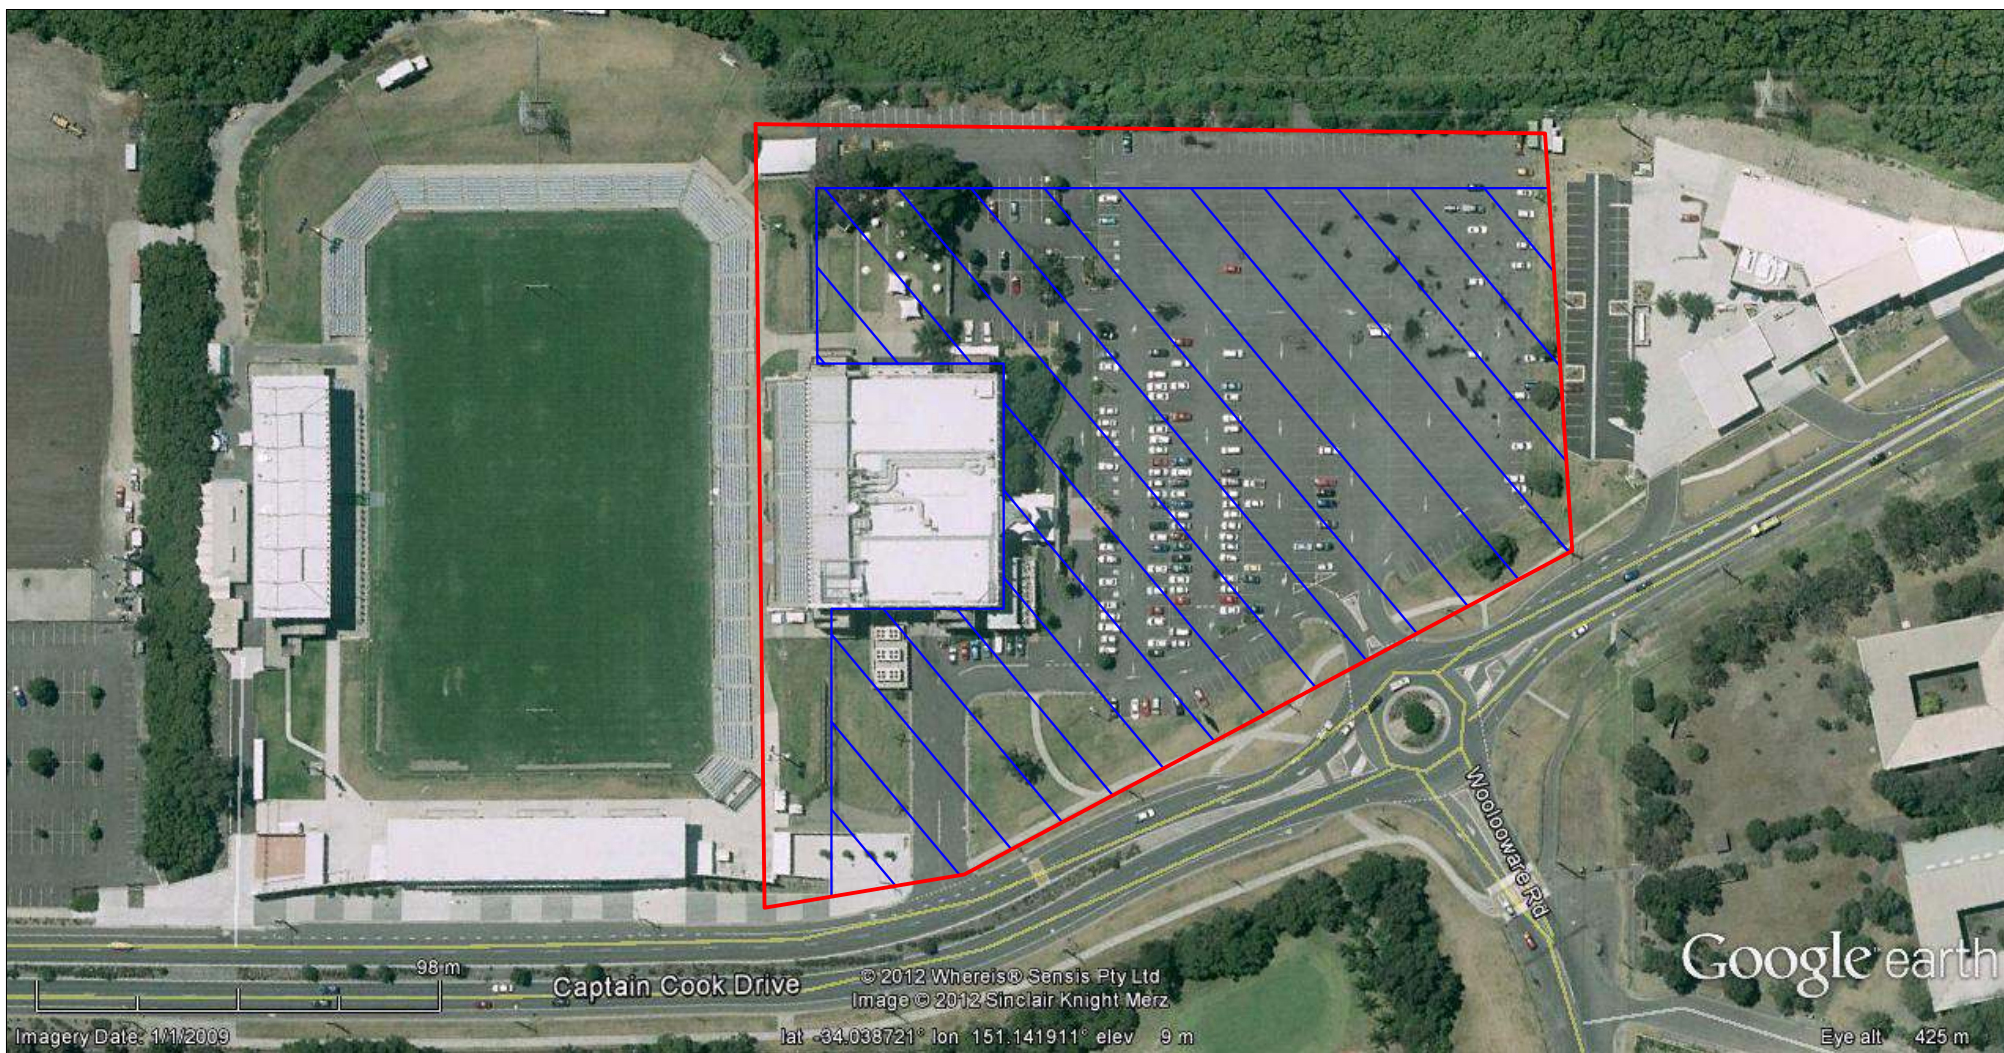
**Figure 2**  
**Site Layout**

Figure modified from GoogleEarth air photo dated 1-1-2009

DLA Environmental (DLA) was commissioned by Bluestone Capital Venture No.1 Pty Ltd. to prepare a Phase 2 Detailed Environmental Site Assessment as part of the Stage 1 re-development works of the Cronulla Sutherland Leagues Club and associated facilities on the property (Site) bounded by Captain Cook Drive and Woollooware Road North Woollooware NSW, formerly identified as Part Lot of Lot 11 in DP 526492. Refer to **Figure 1** – Site Location and **Figure 2** – Site Layout
