Mining Geomechanics and Materials Engineering

**RE: DEFINITION OF BARRIER PILLAR STABILITY**

## **Slope Stability Assessment of Sandstone Cliffs Next to Proposed Open Cut Mining, Invincible and Cullen Valley Mines**

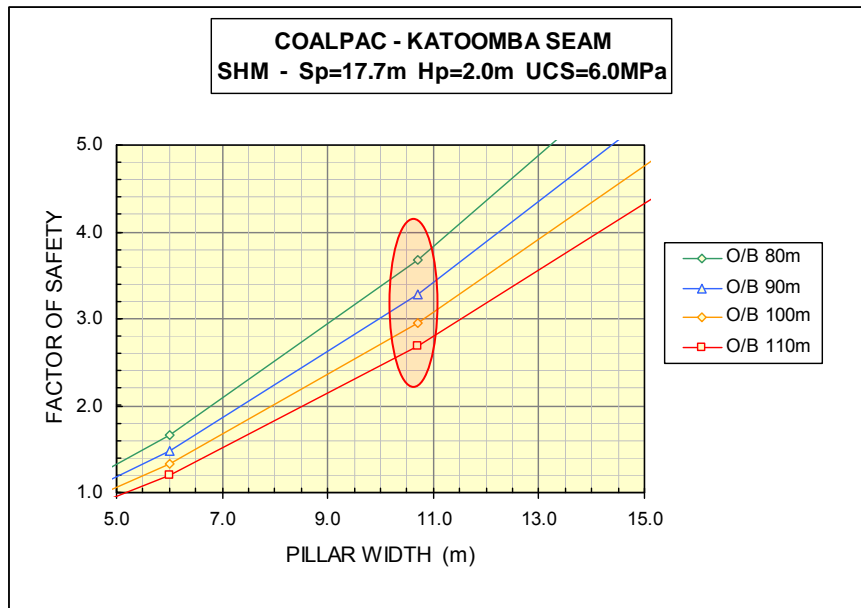
**Figure 1(a): Limiting Factor of Safety in Katoomba seam highwall mining panels.**

Using the appropriate variables for each coal seam, viz. overburden thickness (O/B), extraction height ( $H_p$ ), pillar width ( $W_p$ ) and span between barrier pillars ( $Sp$ ) the limiting Factor of Safety is calculated. The results are presented as design charts in Figures 1(a), 2(a), 3(a) and 4(a) for each seam, respectively, and summarised for the recommended barrier pillar width in Table 1.

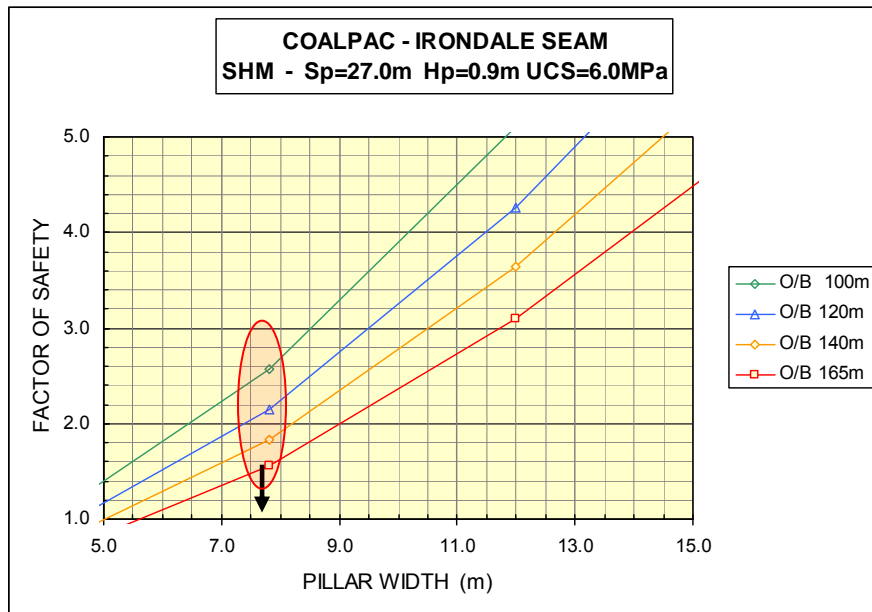
**Figure 3(a): Limiting Factor of Safety in Irondale seam highwall mining panels.**

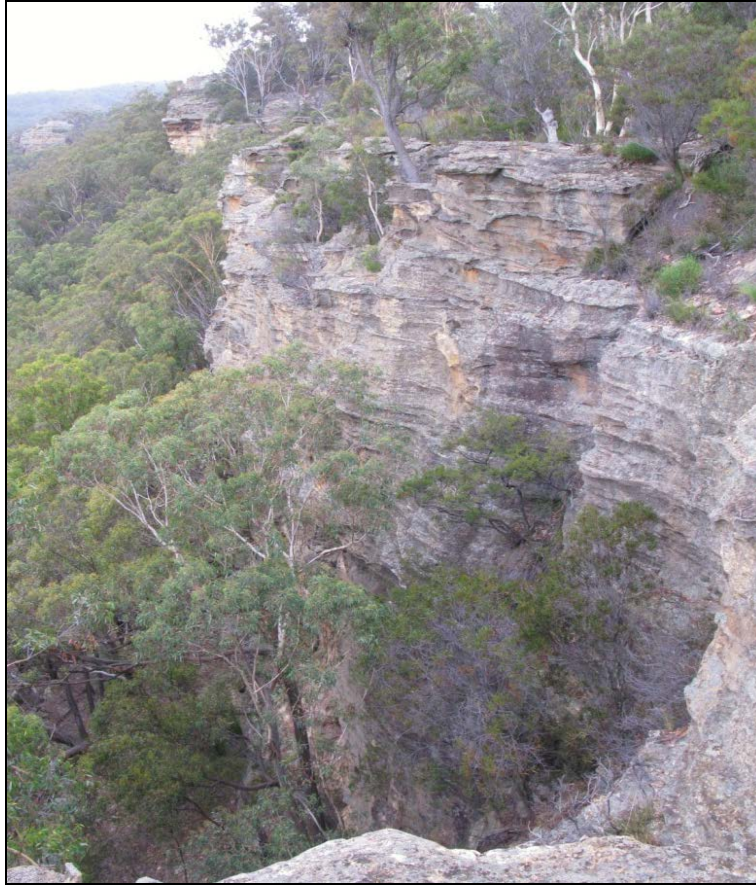
The sandstone capping consists mostly of well-cemented, cross-bedded, medium and coarse grained sandstone composed mainly of quartz grains and subsidiary lithic fragments. The intact rock is generally of medium strength (estimated UCS typically 25 to 35 MPa). By way of comparison, the required strength for house-slab concrete is typically 20 to 25 MPa. The sandstone is usually dissected by very widely spaced, near-vertical joints and, because the rock is so strong, it forms cliffs rather than weathering to a much flatter slope like the underlying Permian strata. The cliff lines tend to follow the dominant joint directions. Where the sandstone is sufficiently thick, cliff faces are generally 40 to 60 m high but may, locally, be higher. A typical cliff is shown in Figure 1.

**Figure 1 Typical cliff in Narrabeen Group sandstone.**

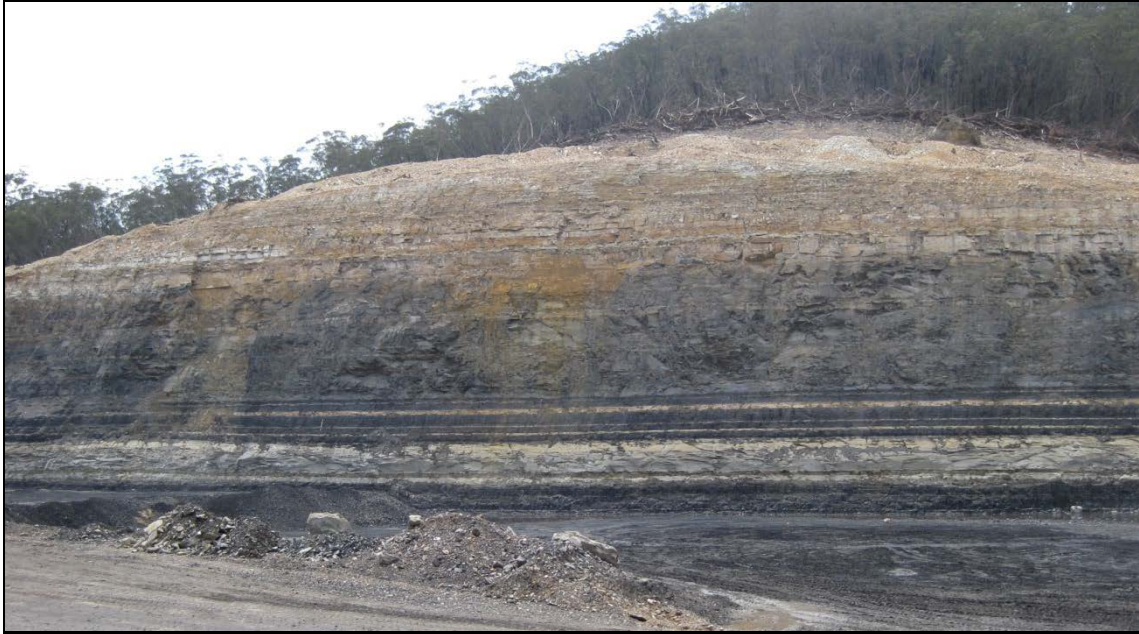
**Figure 2 Cullen Valley showing a stable, 80 m highwall face cut at an angle of approximately 80°.**

The strength of the intact coal measures rocks is, on average, slightly less than that of the Narrabeen Group sandstone. However, as can be seen in Figure 2, the strength of the rock mass is more than adequate to support an 80 m high, sub-vertical highwall.

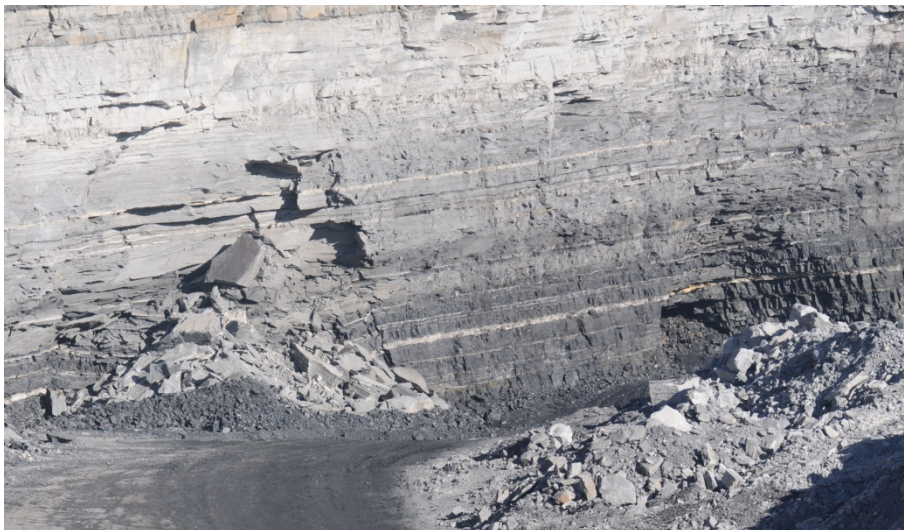
The observed cliff behaviour is consistent with my observations during routine geotechnical inspections that the damage to the strata above the old bords (tunnels) rarely extends more than 3 or 4 times the height of the bord, as shown, for example in Figure 5. There may be some immediate roof collapse as shown in the LHS of Figure 5 but not above the old bord on the RHS of the figure. Within a short distance above the roof, arching has occurred, and no further deformation of the roof strata occurs.

**Figure 5 View of highwall intersecting old coal mine workings.**

The strength and arching behaviour of the roof strata and the relatively low coal recovery from the historical workings, together with the benign structural geological conditions within the Project area also explain why there has never been a recorded failure caused by a highwall intersecting old workings.
