# Remedial Action Plan

Nine Network Australia

24 Artarmon Rd, Willoughby, NSW

November 2012  
JBS 42410-52334 (Rev A)  
JBS Environmental Pty Ltd

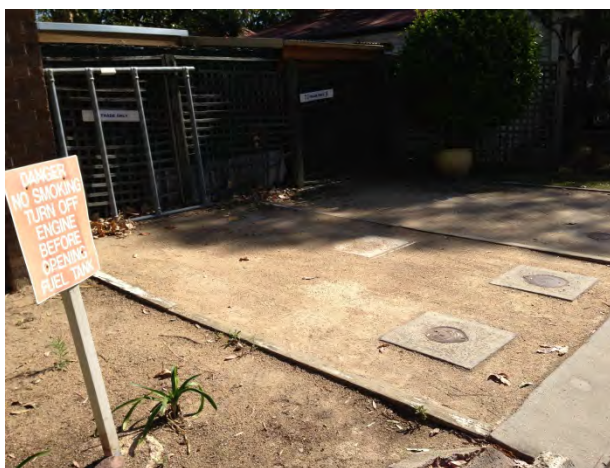
**Photo 1** – Dip points and Danger sign associated with USTs tanks 2 and 3.

Six USTs and an above ground storage tank (AST) were located within the southern portion of the carpark located to the west of the studio/technical block building (**Photos 1 and 2**)(**Figure 4**). There was no staining observed within the vicinity of the USTs and AST. Groundwater monitoring wells were observed approximately 15 m south of the USTs (**Photo 3**). A helipad was located to the south of the studio/technical block building and comprised an elevated grassed platform approximately 0.5 m above the surrounding site areas. An AST was located to the east of the helipad containing JET A-1 fuel (**Photo 4**).

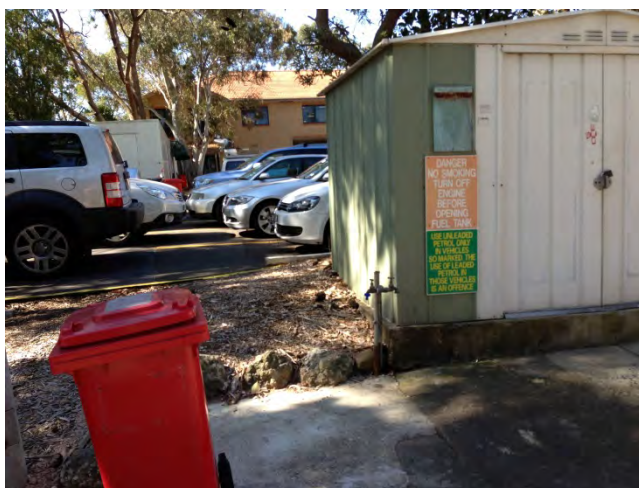
**Photo 2** – Danger sign associated with USTs petrol tanks 1 and 2.

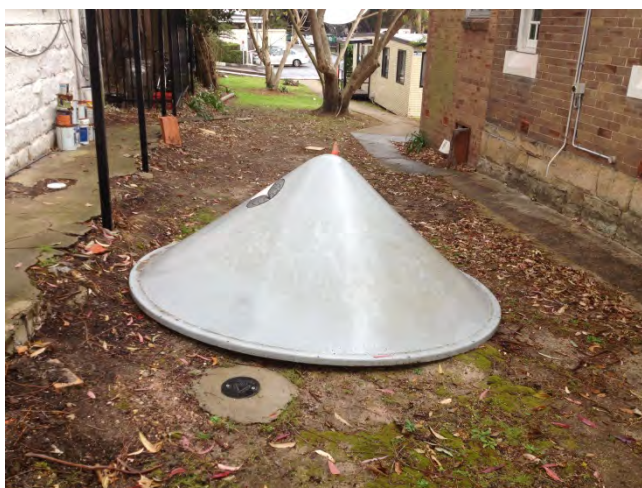
**Photo 3** –Groundwater monitoring wells downgradient of USTs.

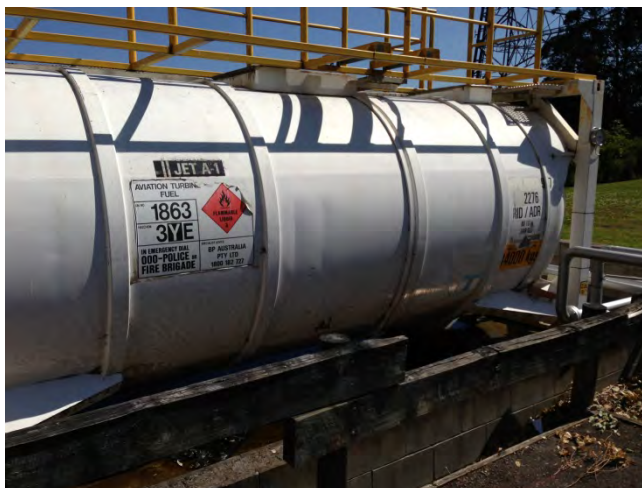
**Photo 4** –AST located to the east of the helipad.

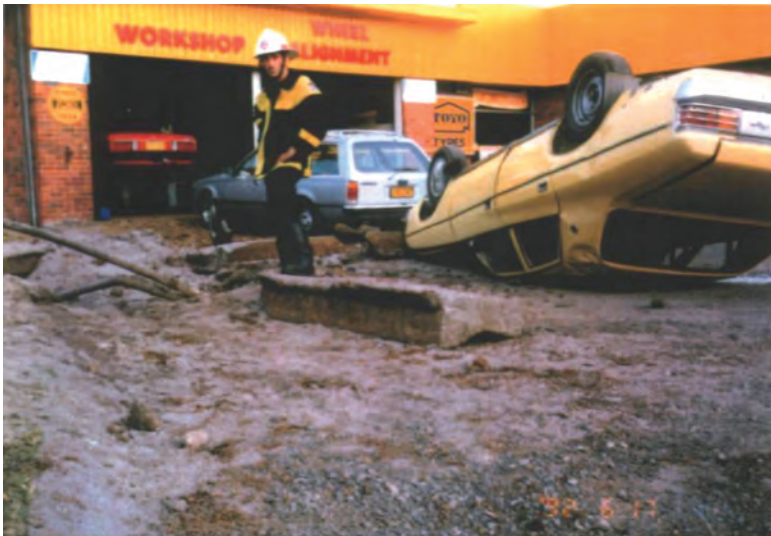
*Welding the tank vent pipe caused vapours in the tank to explode.*
