**Appendix D – Arboricultural Report & Landscape Design
Concept Report**
Sydney Arboricultural Services Pty Ltd & Context Landscape
Design

Arboricultural Report:

Site: "Caritas" 299 Forbes St Darlinghurst

Heritage Impact Statement

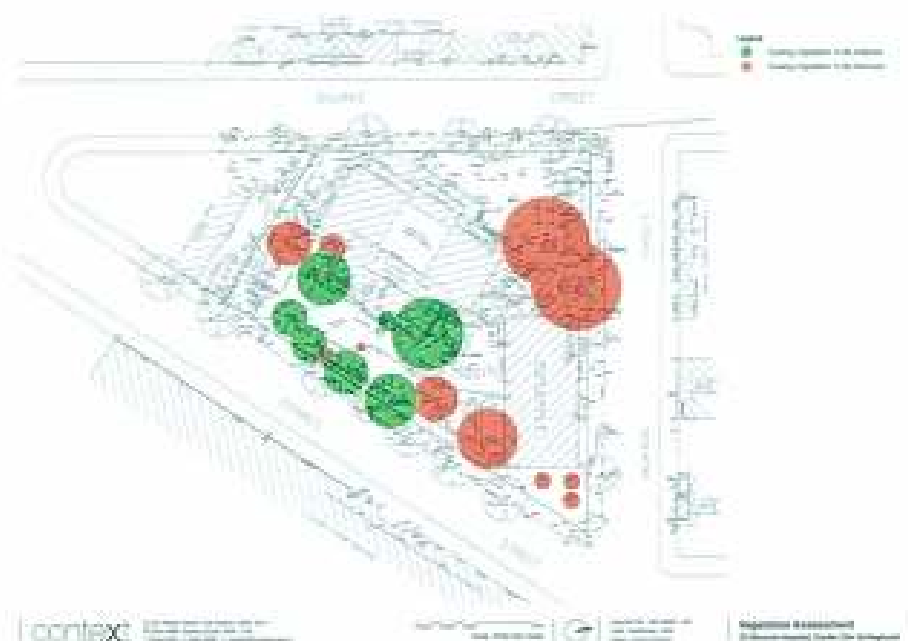
Existing site vegetation has been assessed by Arboricultural Planning Services in their report dated July 2006. The key findings have been shown in the Vegetation Assessment Plan (refer drawing No LSK 06589 - 001). Two categories (retain or remove) have been applied to the site vegetation and follow recommendations as supplied by the arborists.

Significantly key vegetation to remain is associated with the Forbes Street frontage of Caritas. The majority of vegetation to be retained is likely to represent the original plantings of the site including particularly the Bull Bay Magnolia, Cockspur Coral Tree, Jacaranda, Cactus and Prunus trees. The specimens provide interesting seasonality and texture contrast and contribute a positive enframing elements to the Forbes Street frontage.

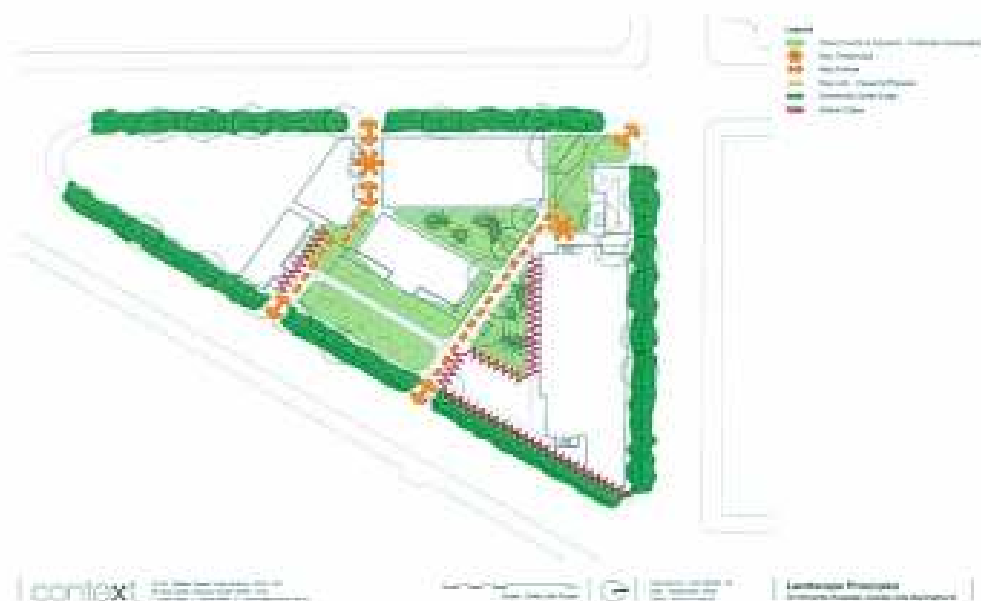
Key site features (refer drawing LSK 06589-002), which inform the identity and address of the site include positive features such as

- The terraces at RL 47 surrounding Caritas Building will be energised by the active edges of the ground floors of proposed new and retained buildings
- Visual links across the site with a key vista north west from Forbes Street to the intersection of Bourke and Burton St

- Five distinct courtyard spaces with a range of microclimates and spatial qualities site wide including the lower Burton Street, Forbes Street lawn, Caritas frontage, south facing court of Burton Street buildings and the north facing central court between Caritas and the Bourke Street buildings

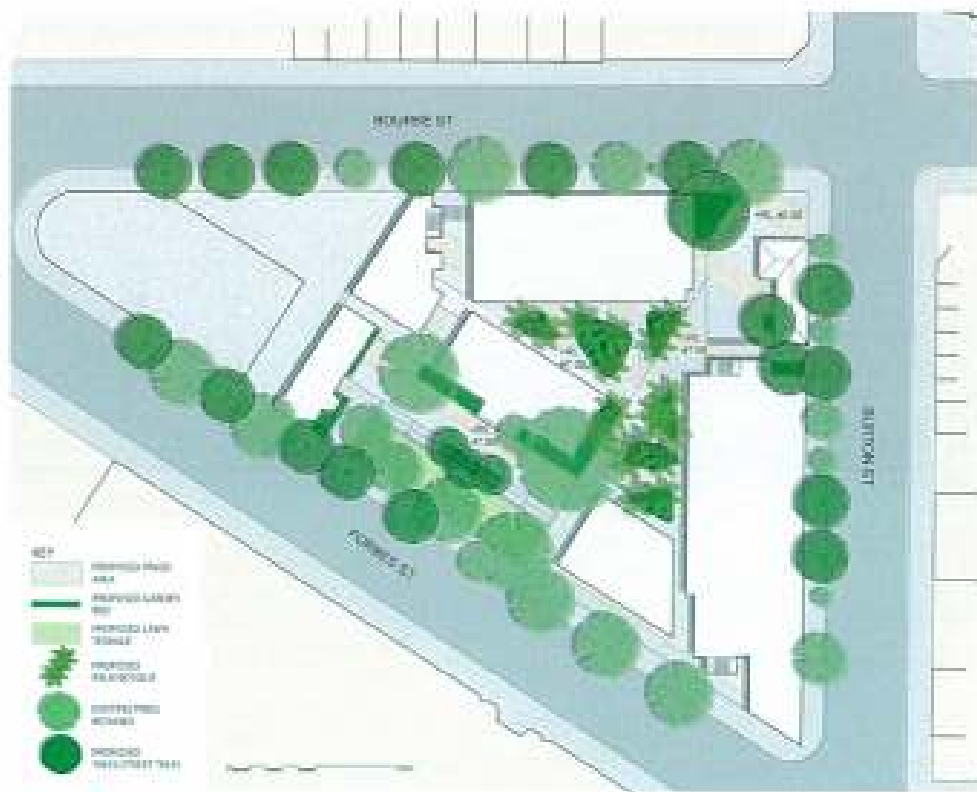
Key features of the concept plan (refer to LSK06589 -004) are:

- creating the Forbes Street lawn terrace with stepped and ramped access to the Caritas front paved terraces
- creating two palm courtyards to the north and west of the Caritas Building as outdoor rooms with active edges
- Reinforcing landscape settings of the with foundation planting garden beds to Caritas Building and Bangalow Palms to the palm courts with ground covers and small shrubs under .
- introduction of sandstone as a highlight material on retaining walls to reinforce the natural change of level of the site
- utilizing to maximum effect existing retained trees which are likely to represent the original planting of the Caritas gardens in the Forbes Street frontage
- use of high quality pavement finishes which are uniform site wide to develop a cohesive site image
- Bring a consistent streetscape edge to the site with new street tree planting and boundary treatments

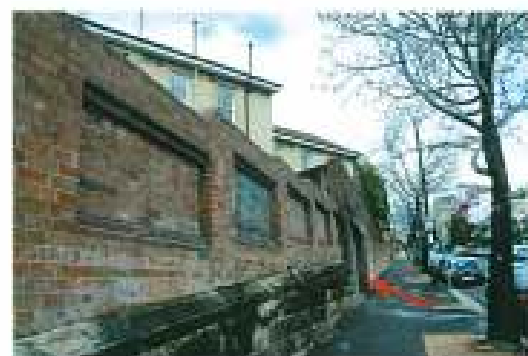
Figure 6:
Showing the brick and stone perimeter wall along Bourke Street at the rear of the compound. The Bourke Street wall is intersected by two entrance-ways
(Source: Graham Brooks & Associates, July 2006)

The **perimeter walls and fencing** also have local listing as a heritage item. They comprise stone, metal and brickwork elements with perhaps the most significant components being the stone columns, sandstone bases and the iron-work.

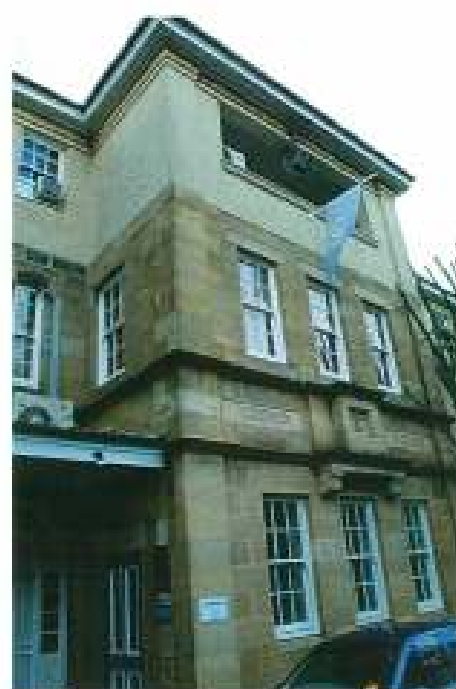
Figure 8:
Central portion of the front facade of the main building, clearly displays the third floor addition and etched Caritas signage.
(Source: Graham Brooks & Associates, July 2006)

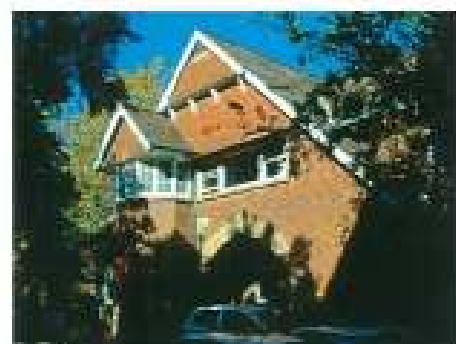
Figure 9:
The gate-house, Caritas cottage, early 20th century construction, exhibiting combinations of rustic features.
(Source: Graham Brooks & Associates, July 2006)

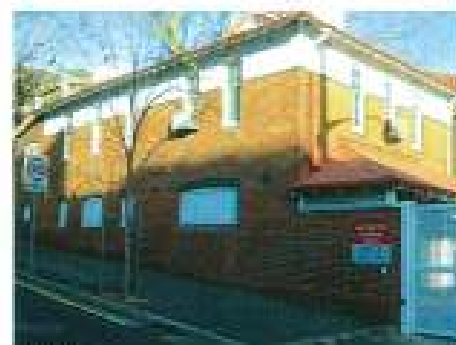
Figure 10:
The old kitchen block at the northwest corner of the site and lying longitudinally along Burton Street.
(Source: Graham Brooks & Associates, July 2006)

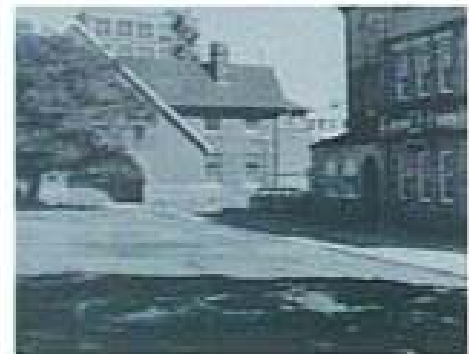
Figure 11:
From a newspaper clipping in the early 1960s soon after the hand over of the site. Note the closed-in verandah spaces. Up until this time the etched stone work at the centre front of the building appears to have read as Darlinghurst Reception Centre. It seems that the same stones were etched on their reverse sides.
(Source: St. Vincent's Archives, July 2006)

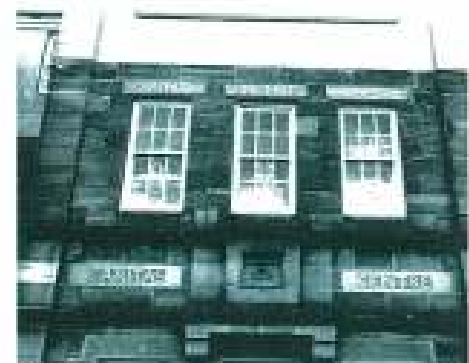
Figure 13:
Stone engraving work has been changed in this photo taken soon after hand-over, probably effected on the reverse side. Note the older appearance of the establishment signs, which was probably placed in the later 1930s.
(Source: St. Vincent's Archives, July 2006)

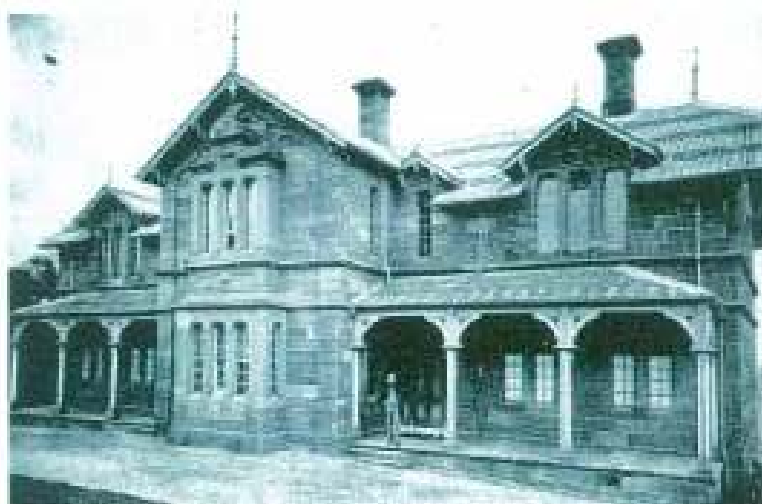
Figure 14:
The Reception House as it originally appeared. It was divided into two equal sections: male and female. Later alterations (about 1907) demolished the central bay, re-configured the windows and added the third floor.
(Source: Kerr, J. Out of Sight Out of Mind)

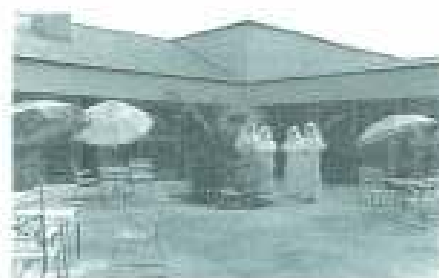
Figure 20:
Newly renovated courtyard area, after opening in 1962. The glassed-in ambulances were added at that time.
(Source: St. Vincent's Archives, July 2006)

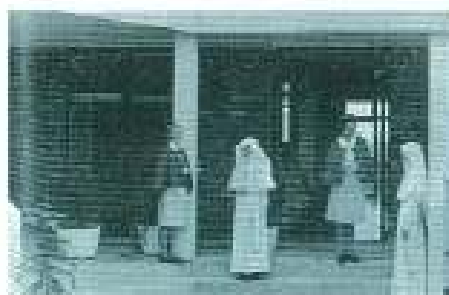
Figure 21:
The newly opened 36 bed ward at the northeast corner of the site, which was completed in April 1965.
(Source: St. Vincent's Archives, July 2006)

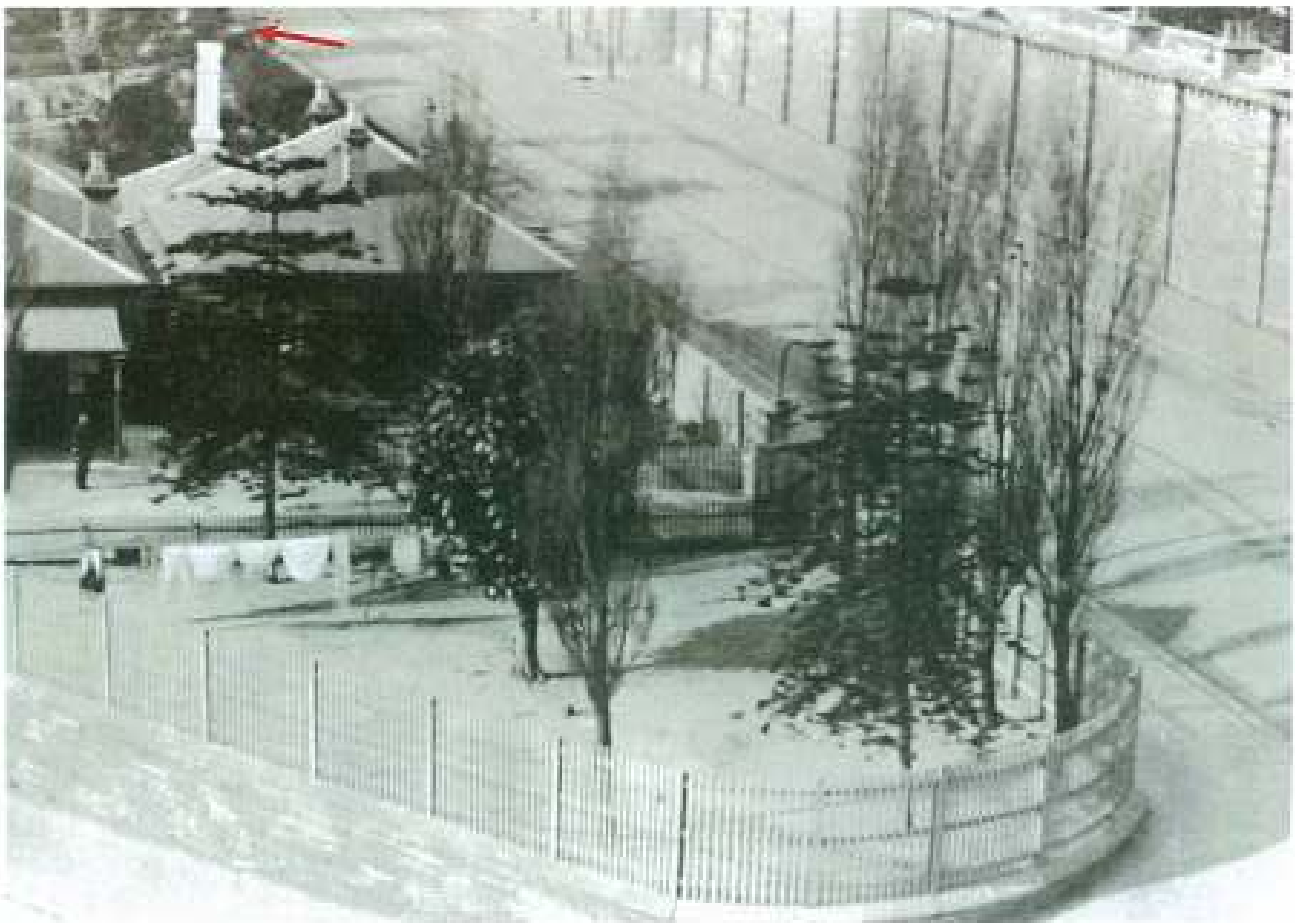
Figure 26:
Historic photo – probably 1890s, of the Darlington Police Station at the south corner of the precinct, and taken from a considerable height. The Reception House front gardens are shown; the House itself would be situated towards the top left of the photograph (arrow indicating the entrance). Gas lines and picket fences are in evidence. There is a sign hanging outside the main entrance to the Police Station; an officer stands on duty at the front doorway, with posters in evidence behind. The police station complex is, by this time of considerable size, probably incorporating some of what would later become the Caritas Cottage site. The wall of the gaol is seen on the opposite side of Forbes Street.
(Source: PICMM/ Mitchell Library, sourced July 2000)

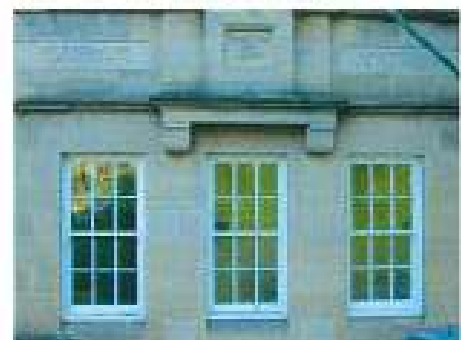
Figure 37:
Showing the re-configured centre front face, undertaken in the mid 1930s. This is probably when the 1870s stone was placed
(Source: Graham Brookes & Associates, July 2006)

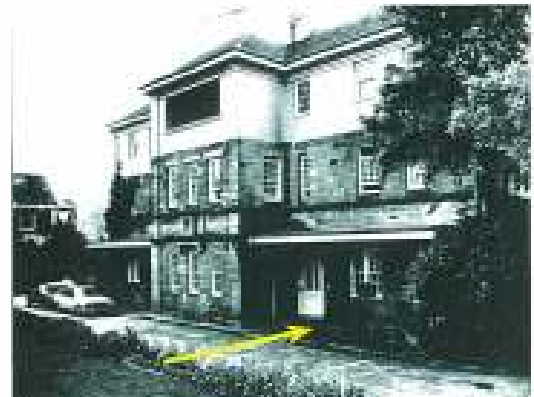
Figure 39:
Image taken in the 1980s, showing the re-opened verandahs with their skillion roofs.
(Source: St. Vincent's archives, sourced July 2006)

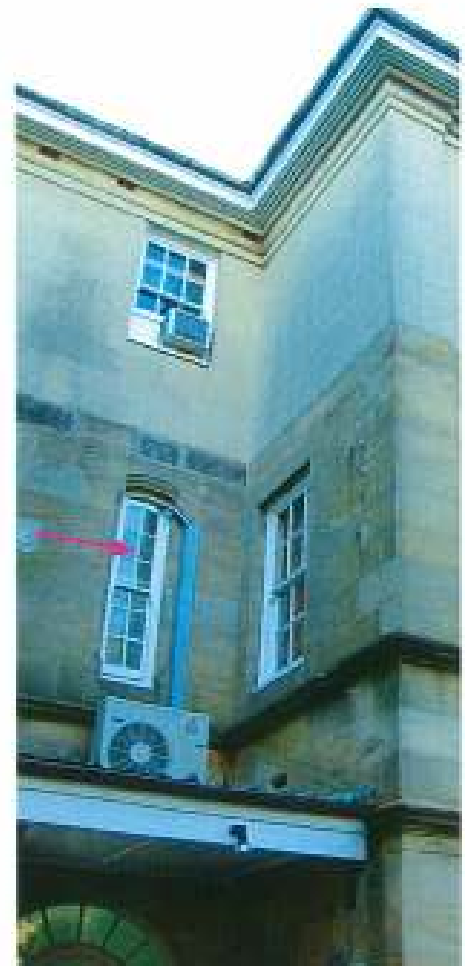
Figure 41:
Front of the building taken at the entrance, showing the top of original lanlight, the re-configured, poor quality verandah (showing the line of the original gradient) and one of the original regency windows, being for a former bathroom (red arrow).
(Source: Graham Brooks & Associates, July 2006)

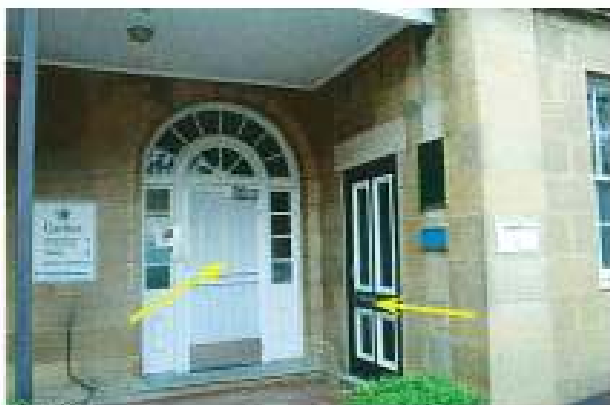
Figure 42:
Front entrance-way, showing original door and fanlight elements, under a more recently constructed verandah. The green door on the right is a recent addition, serving as a fire escape. The stone work on the two lower levels presents with a good degree of intactness and condition. It is complemented in the wing areas by rendered concrete in 'flax' stone finish. A number of individually elegant features have survived various phases of change.
(Source: Graham Brooks & Associates, July 2006)

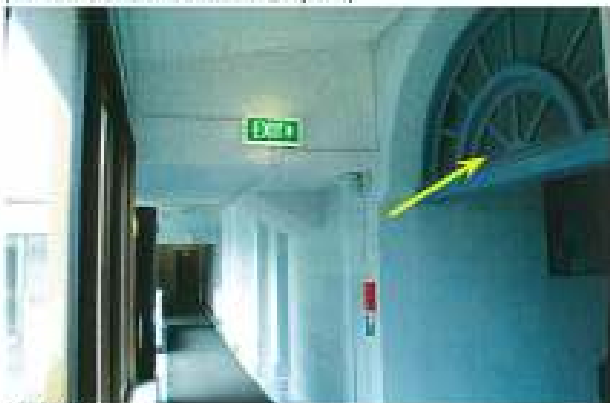
Figure 44:
Passage-ways around the internal courtyard are a mixture of design and construction ones. Original elements include the fanlight, the timber ceiling and the stone walls. Most of the courtyard perimeter was sealed in during the reconstructions of the early 1990s. It is a mixture of aluminium framed windows and large skillion style roofing. Many of the interior arrangements have been re-configured in an ad hoc manner according to need during different eras. They thus show a considerable mixture of aesthetic presentation and sympathy with original components.
(Source: Graham Brooks & Associates, July 2006)

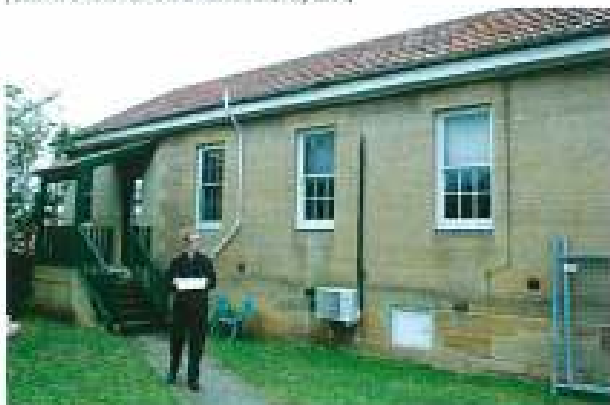
Figure 46:
Ground floor wings were added in the later 1930s, being shown in the 1935 plan as a proposal. The external walls are in large part an imitation (faux) stonework, being constructed in rendered concrete, but with some stone elements incorporated, such as levels and footings. While the current presentation of the buildings is highly utilitarian, they have been maintained in a good state of repair.
(Source: Graham Brooks & Associates, July 2006)

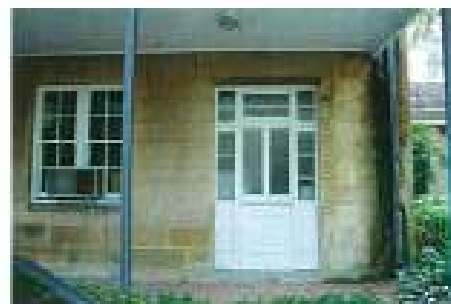
Figure 43:
Detail of front verandah showing various modifications, including door and window replacements, floor tiling, posts and roofing.
(Source: Graham Brooks & Associates, July 2006)

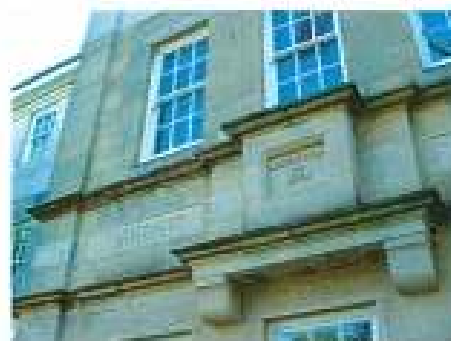
Figure 45:
Central facade was substantially modified in the mid 1950s, including removal of original bay and placement of various stone engravings, including the Cartouche Stone noting 1867.
(Source: Graham Brooks & Associates, July 2006)

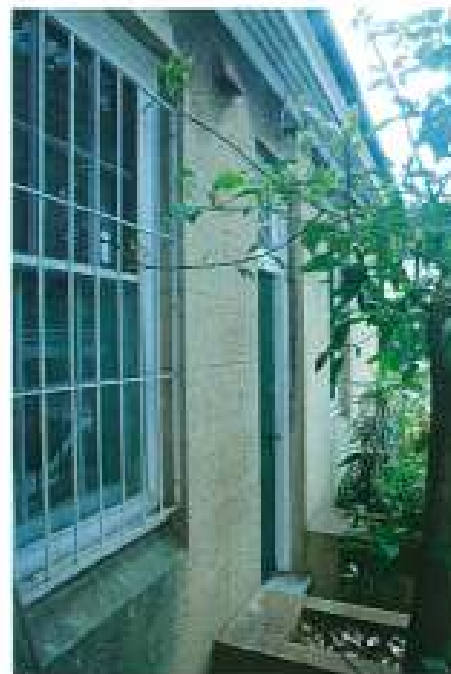
Figure 47:
Exterior wall of the wing additions are rendered in a concrete faux stone finish. They were probably constructed in the 1930s and generally present in good order.
(Source: Graham Brooks & Associates, July 2006)

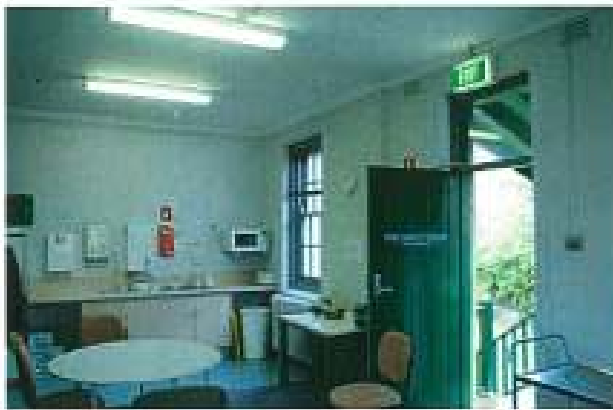
Figure 49:
Interior view of the south wing area, showing the general adaptations made over time for utility in operations, including interventions for doorways, installation of various facilities, plumbing and so forth.
(Source: Graham Brooks & Associates, July 2006)

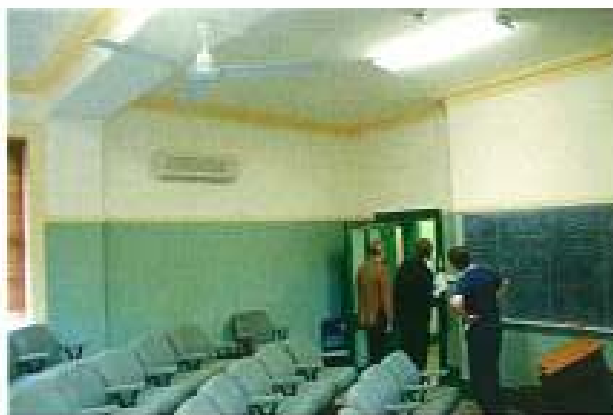
Figure 50:
The lecture theatre is a good example of the many interior re-configurations that have taken place. Note removal of wall, new ceilings, tiered flooring, installation of other services such as air-conditioning, fire safety devices and so forth. The original windows were replaced in the 1930s.
(Source: Graham Brooks & Associates, July 2006)

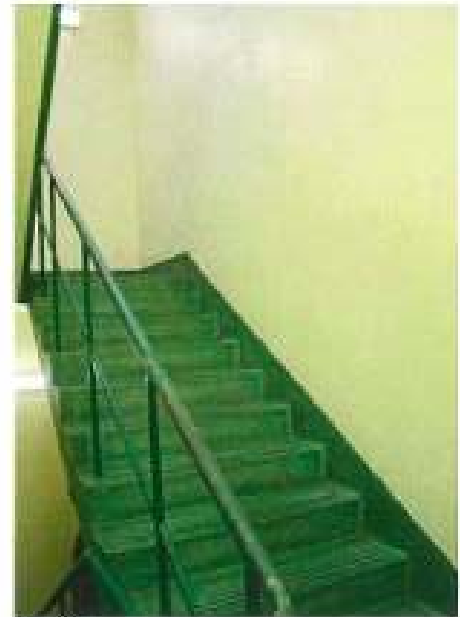
Figure 51:
Current main central stairway, also serving as a fire rated, fire escape. This is probably the third or fourth stairway complex that was built within the building. The one it replaced was an exceptionally narrow security stairway.
(Source: Graham Brooks & Associates, July 2006)

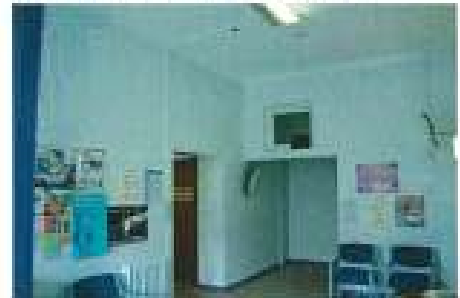
Figure 52:
Typical example of interior modifications. Note doorways, ceilings and modern electrical services.
(Source: Graham Brooks & Associates, July 2006)

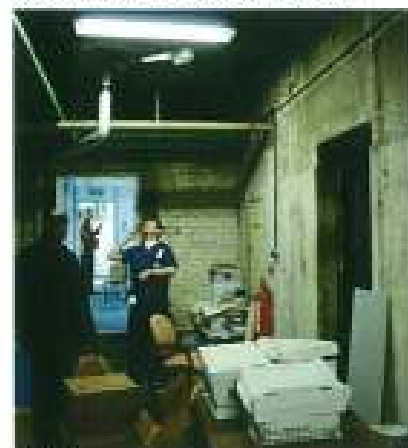
Figure 53:
Basement areas are a mixture of functional and storage space and contain some remnants of earlier plumbing services.
(Source: Graham Brooks & Associates, July 2006)

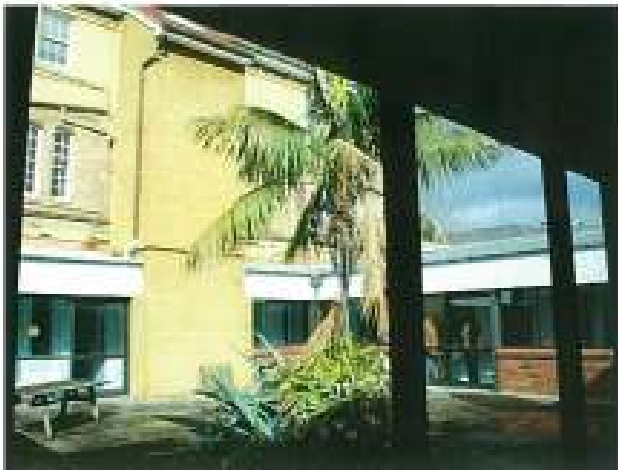
Figure 54:
Interior courtyard looking towards main building. The view shows the messy composite materials and adaptations of the complex. The third floor addition is seen, roofing configurations, modern masonry work, aluminium window components and plumbing installations.
(Source: Graham Brooks & Associates, July 2006)

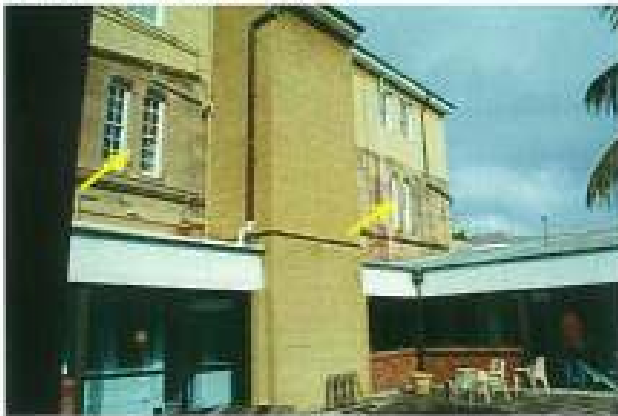
Figure 55:
Interior courtyard looking towards main building. The original 1930s windows have been retained at the rear and the sides of the building. The third floor was probably added in the 1930s reconstruction. The top floor windows appear to be of that era. The board-in courtyard walkway is of mixed materials: handpainted, aluminium, glass, and face brick. Plumbing and other services are highly visible.
(Source: Graham Brooks & Associates, July 2006)

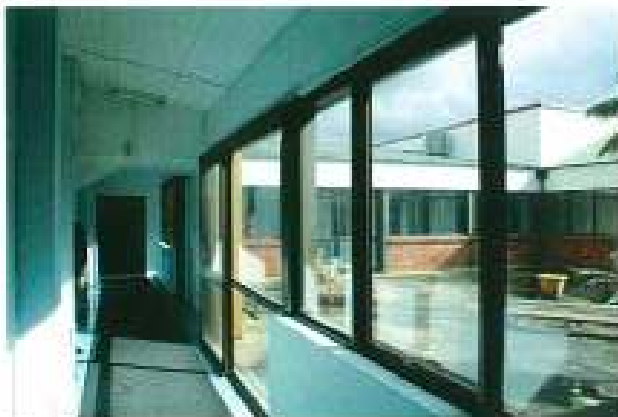
Figure 56:
Interior courtyard view, again showing the mix of building components and roofing arrangements and extensive paving.
(Source: Graham Brooks & Associates, July 2006)

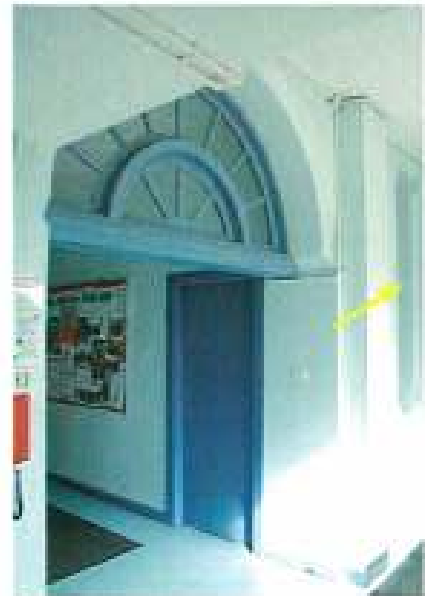
Figure 57:
Remnant lanlight contained within the main building, as it leads through to the courtyard. Note original window at right and interventions such as the doorway.
(Source: Graham Brooks & Associates, July 2006)

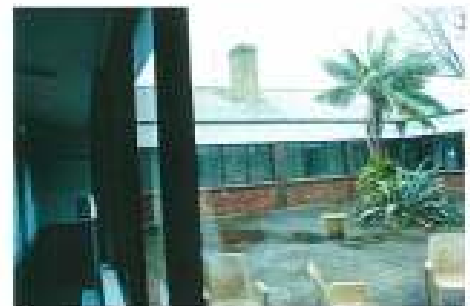
Figure 58:
Interior courtyard. The single story component at rear was an early addition. It is now a bathroom facility.
(Source: Graham Brooks & Associates, July 2006)

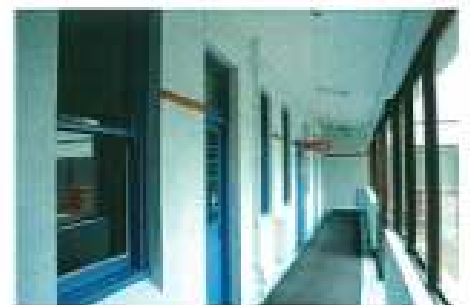
Figure 59:
Modern windows and masonry work around the central courtyard, probably dating from the building works of the early 1960s. Some evidence of the original verandah remains in the timber ceiling, stonework walls and fanlights.
(Source: Graham Brooks & Associates, July 2006)

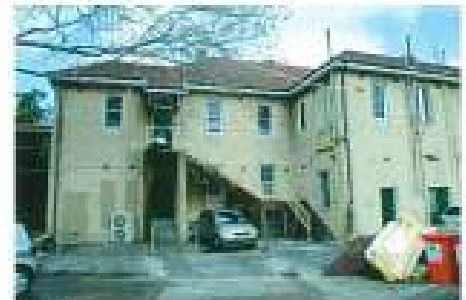
Figure 63:
Two story building at the rear of the main building, constructed in the late 1930s. It is surrounded by extensive concrete paving.
(Source: Graham Brooks & Associates, July 2006)

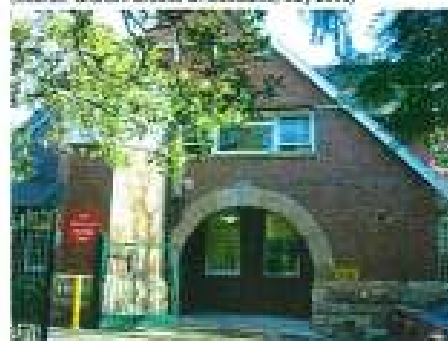
Figure 67:
The cottage comprises a mixture of building materials, including sandstone, face brick, slate and timber.
(Source: Graham Brooks & Associates, July 2006)

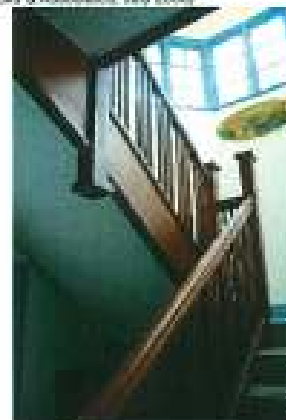
Figure 68:
Cottage stairway shows typical Jeaffreson Jackson features including joinery components in triple section.
(Source: Graham Brooks & Associates, July 2006)

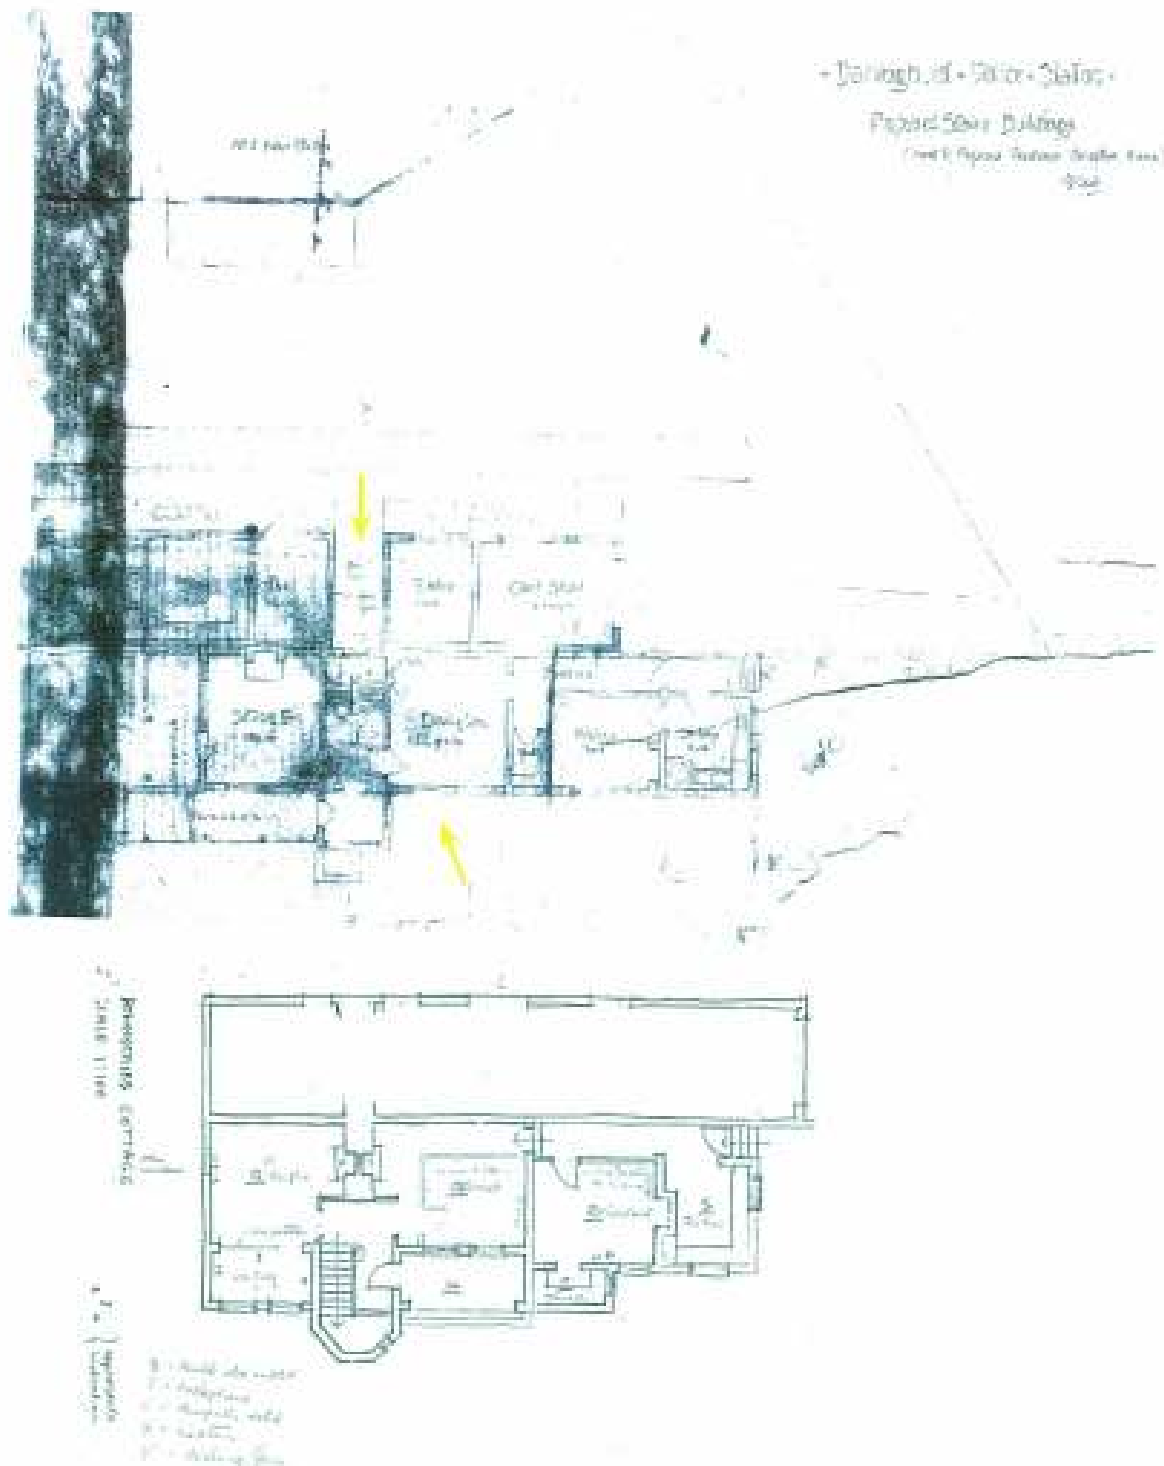
Figures 70 and 71: The floor plan above is dated 5 January 1910 and proposes alterations to what it terms Police Stables, next to proposed residences, Reception House. Note the double wall arrangement through the centre of the building and the entrance-way through from the police grounds. This floor plan below is the public works sketch for works to be undertaken in 1903 and shows the residence as it was at that time, and as it probably had been since its reconstruction in current external form in the early 20th century. What is particularly noteworthy is that the re-built dwelling mirrors almost exactly the configuration of the one above, which it seems was partly oriented towards police use. It is an unusual arrangement for a plan which presents under the one roof as a self-contained dwelling. The garage at the top right corner has since been demolished. The double fireplace arrangement replaces part of the entrance-way void, the stairway is in a reverse position with a bay added to the front. The current building has fireplaces in approximately the same locations. It would seem that at least the original footings, and perhaps other parts of the original building were re-deployed in the construction of the current dwelling. Again the terrazzo work in the entrance porch is another puzzle. It would not have been likely that such work could have been undertaken before the First World War and more likely that it belongs to the mid 1920s. It could well be a replacement for an earlier surface.

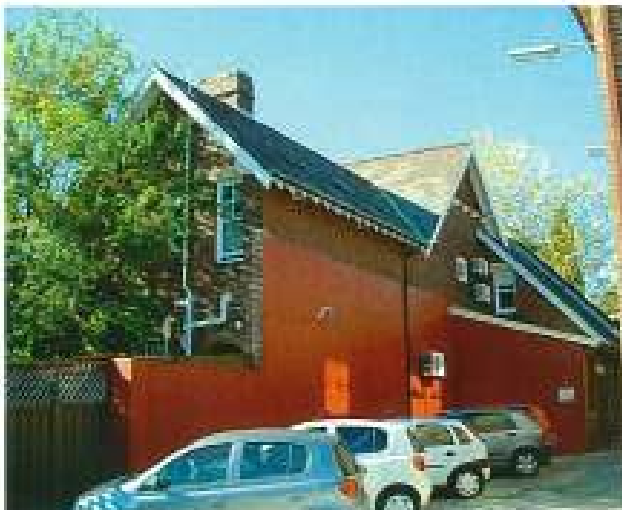
Figure 72:
South side (rear) of the Caritas Cottage presents with a 'sheared-off appearance' which corresponds with the land boundary. Additional storage areas were at one time situated along this building, at the red painted area where the cars are parked.
(Source: Graham Brooks & Associates, July 2006)

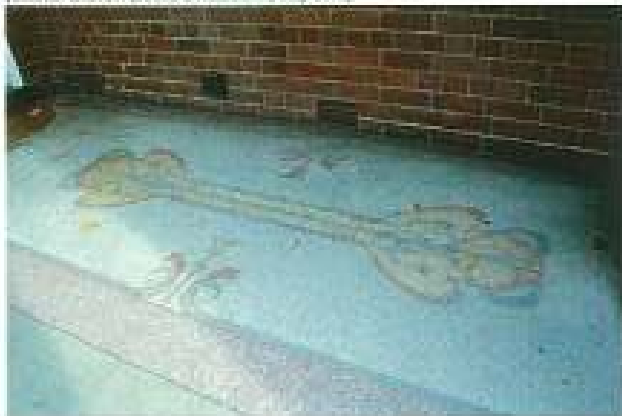
Figure 74:
Terrazzo work on first porch is a typical Art Deco motif. It suggests that further work may have been undertaken on this dwelling during the 1930s. This may account for the relatively large modern window on the first floor immediately above this porch area.
(Source: Graham Brooks & Associates, July 2006)

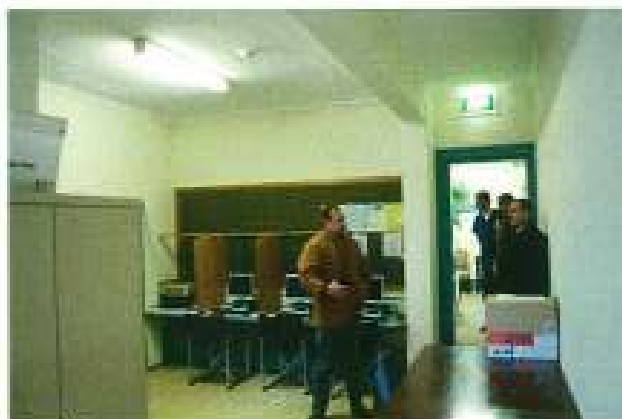
Figure 76:
The interior of the Caritas Cottage has undergone substantial modification and re-configuration and introduction of various services. Note supportive beam above wall removal.
(Source: Graham Brooks & Associates, July 2006)

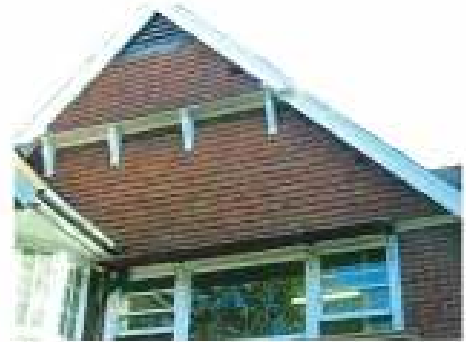
Figure 73:
Detail components such as timber joinery, slings, breaking form gables, bay windows, and other mixed components are typical of early twentieth century Arts and Crafts style.
(Source: Graham Brooks & Associates, July 2006)

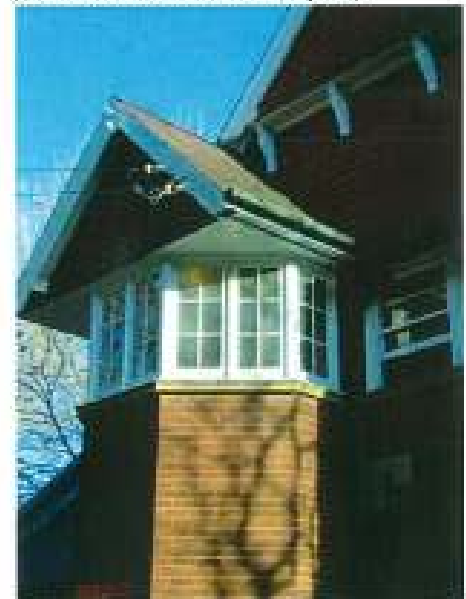
Figure 75:
Bay construction around stairway shows attractive detail in sandstone cappings, slate roofing over smaller gable, quality copper gutters and detail joinery.
(Source: Graham Brooks & Associates, July 2006)

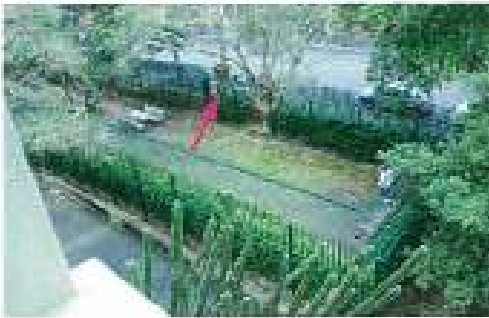
Figure 78:
View from top floor of Main House towards Forbes Street, showing external perimeter fence, consolidated by the current security arrangements, and evidencing typical stone columns.
(Source: Graham Brooks & Associates, July 2006)

The perimeter fencing, which comprises stonework, ironwork and brick elements (and exhibits a number of fine stone columns should be carefully repaired and enhanced. There is also a particular foreground presence of the site in its Forbes Street aspect which combines a range of quality built elements, trees and gardens in a manner which has a potential public and welcoming aspect. This setting serves as substantial basis for enhancement. Similarly, the established trees form an integral feature of the site and are considered to have high significance.

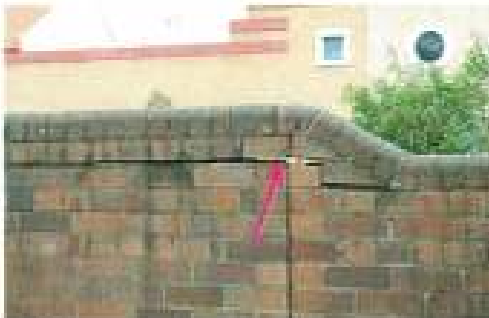
Figure 80:
The state of repair on the perimeter walls is at some points quite poor.
(Source: Graham Brooks & Associates, July 2006)

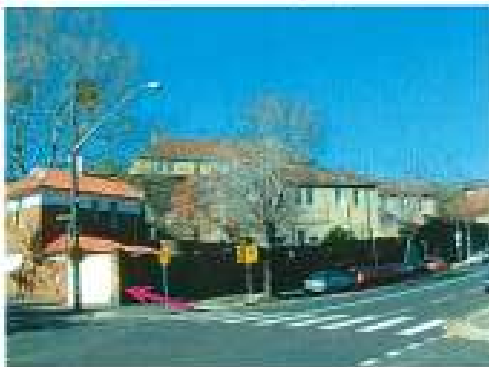
Figure 81:
Typical stone corner column at intersection of Bourke and Burton Streets, indicated by arrow.
(Source: Graham Brooks & Associates, July 2006)

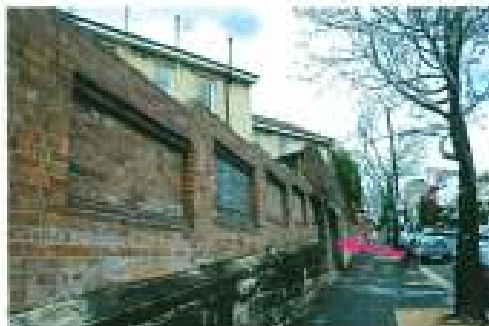
Figure 83:
Face brick and stone wall along Bourke Street with existing openings.
(Source: Graham Brooks & Associates, July 2006)

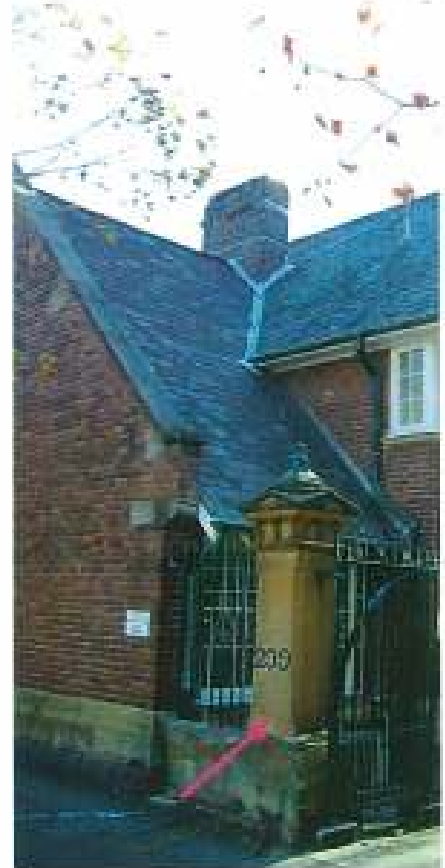
Figure 79:
Example of prominent stone column work which intersects the stone, face brick and iron fencing around the perimeter of the compound. The fencing/walls have local listing as a heritage item under City of Sydney Council.
(Source: Graham Brooks & Associates, July 2006)

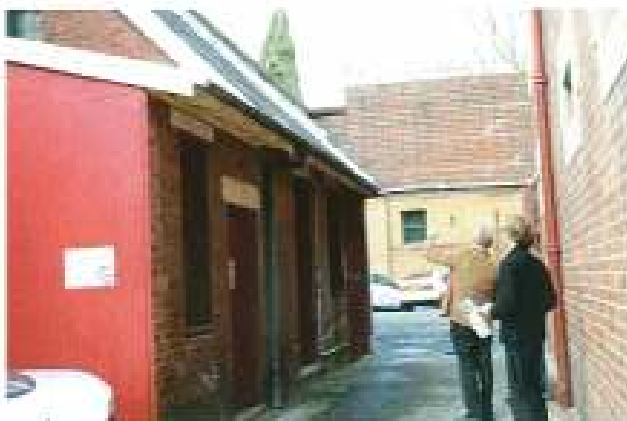
Figure 87:
This section of the Caritas Cottage once formed part of the Police Station Compound for storage and stable purposes. The visible section immediately to the left is situated on Crown land, but under the same roof line as the northern part of the Cottage.
(Source: Graham Brooks & Associates, July 2008)

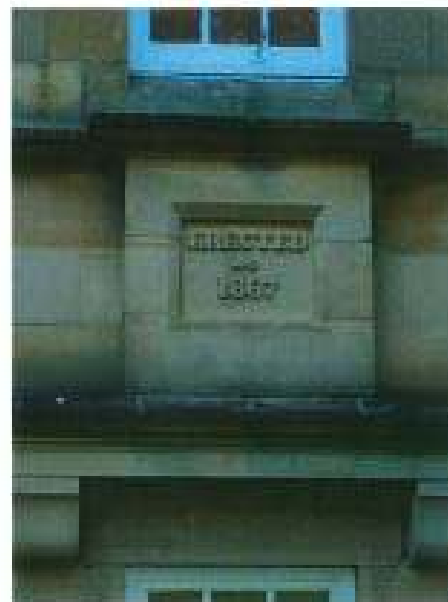
Figure 89:
The engraved Carlouche stone, proposed 1887 as the construction year for the Caritas Main House. This stone however, seems to have been placed during the extensive building works which took place soon after 1935.
(Source: Graham Brooks & Associates, July 2008)

The engraved date on the centre top *cartouche-stone* of the original building notes completion at 1867. This engraved stone does not appear in the early photograph of the building however. It is believed that it was placed in 1935 during significant alterations which in part involved the removal of the bay section of the building at the centre front. Other stone engravings which currently indicate *St. Vincent's Hospital* and *Caritas Centre* appear to be reversals of these earlier engraved stones which in early photographs appear to read *Darlinghurst Reception Centre*.

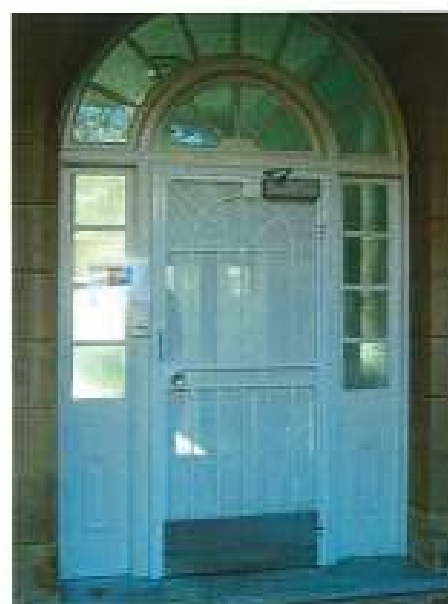
Figure 93:
Original Georgian fanlight doorway, main entrance
(Source: Graham Brooks & Associates, July 2006)

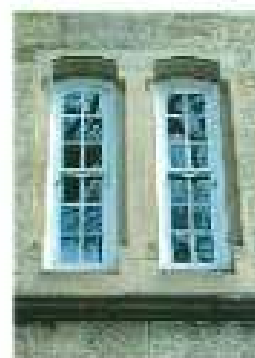
Figure 94:
Original Regency Style window openings and scalloped ledges
(Source: Graham Brooks & Associates, July 2006)

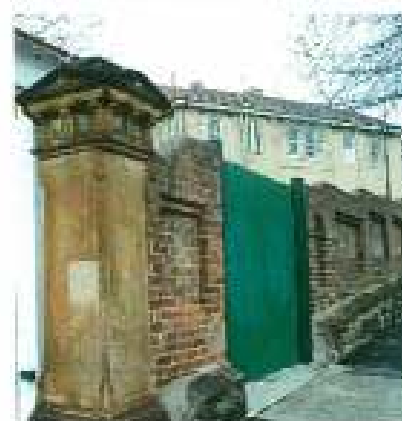
Figure 95:
Stone support columns which intersect the wall and fencing arrangement around the perimeter of the site
(Source: Graham Brooks & Associates, July 2006)

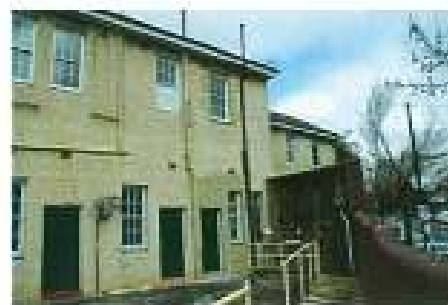
Figure 95:
1930s ablutions and service block at rear of site (west)
(Source: Graham Brooks & Associates, July 2008)

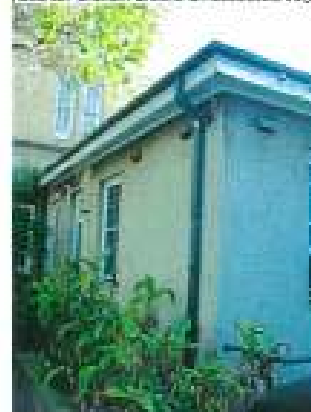
Figure 97:
Wing accretions of concrete render on Main Building
(Source: Graham Brooks & Associates, July 2008)

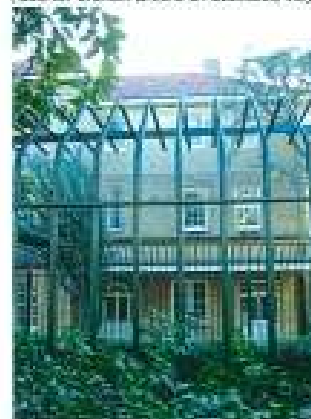
Figure 98:
Example of current security fencing arrangement
(Source: Graham Brooks & Associates, July 2008)

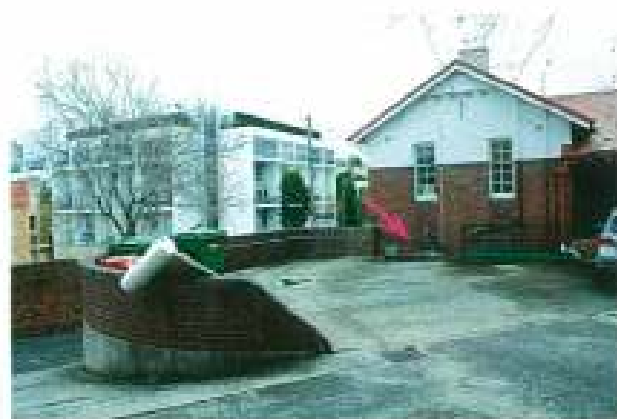
Figure 99:
Example of levelled area at the rear (west) of the site, with retaining wall. As indicated by the arrow, these raised areas have at various junctures interrupted the original integrity of the principal buildings.
(Source: Graham Brooks & Associates, July 2008)

Artificially levelled areas and retaining walls;

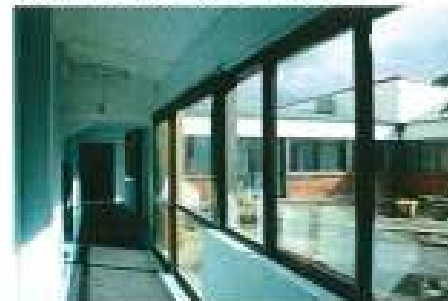
Figure 100:
Mixture of building materials around the interior courtyard.
(Source: Graham Brooks & Associates, July 2008)

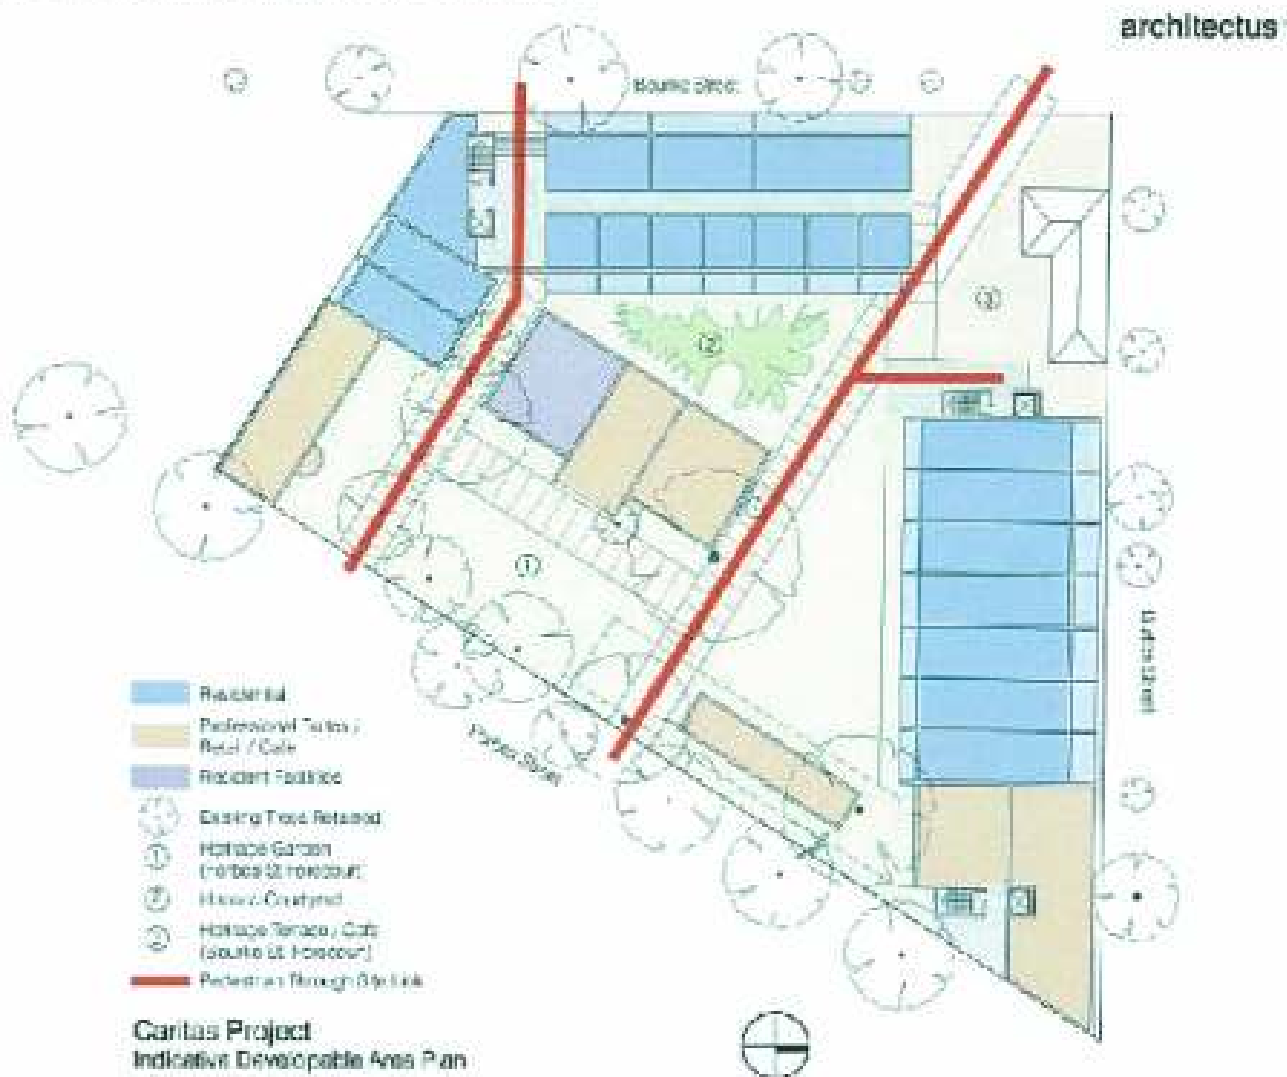
Figure 101:

The Indicative Development Plan proposes a mixture of Residential, Commercial and Professional components. The principal heritage buildings and elements are retained within the proposal including the Caritas Main House, the Caritas Cottage, the perimeter walls and fencing and the Old Kitchen Block contributive building. The proposal maintains the ambience of a central courtyard area. It has a principal orientation towards Forbes Street, with an open, landscaped and treed frontage which is well suited for public engagement and enhanced visibility of the site. The proposed development blends well with the surrounding residential areas and the former Darlinghurst Police Station, by proposing a series of vertical alignments in sympathy with the alignment of the surrounding terraces. It constitutes a blend of historic and contemporary forms and finishes which are non-competitive.
