**Appendix D – Arboricultural Report & Landscape Design
Concept Report**
Sydney Arboricultural Services Pty Ltd & Context Landscape
Design

Arboricultural Report:

Site: "Caritas" 299 Forbes St Darlinghurst

Heritage Impact Statement

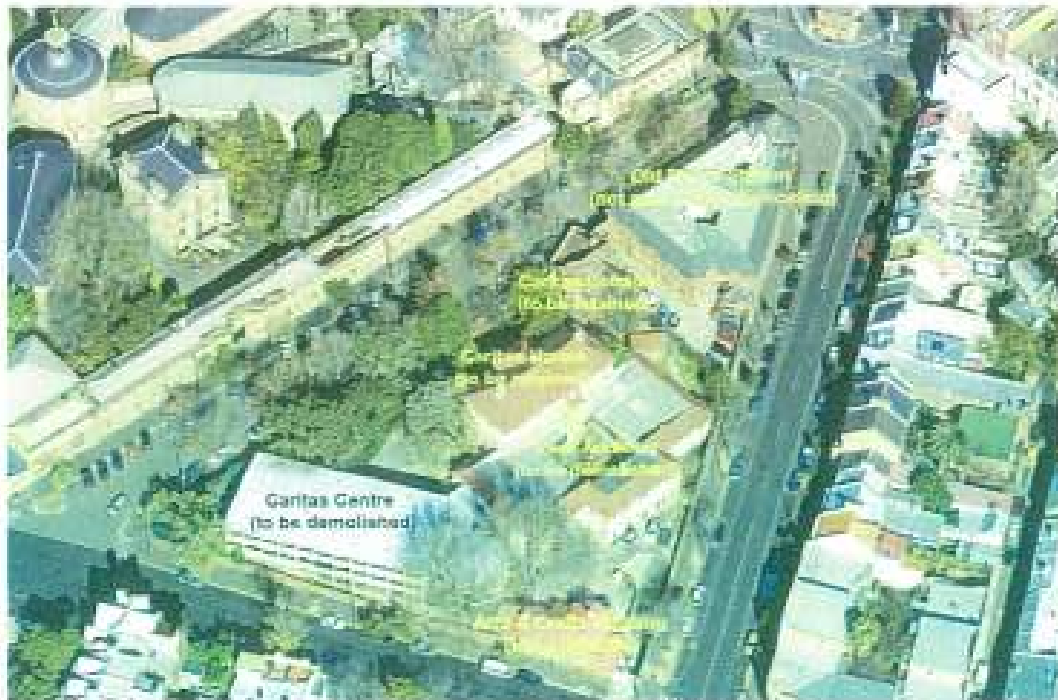
Figure 100: Aerial view of site, showing the proposed demolition and retention. The Indicative Development Plan proposes a mixture of Residential, Commercial and Professional components. The principal heritage buildings and elements will be retained within the proposal including the Gartas Main House, the Gartas Cottage, the perimeter walls and fencing and the Old Kitchen Block contributive building. The proposal maintains the ambience of a central courtyard area. It will have a principal orientation towards Forbes Street, with an open, landscaped and treed forecourt which is well suited for public engagement and enhanced visibility of the site. The proposed development blends well with the surrounding residential areas and the former Darlinghurst Police Station, by proposing a series of vertical alignments in sympathy with the alignment of the surrounding tenements. It constitutes a blend of historic and contemporary forms and finishes which are non-competitive.

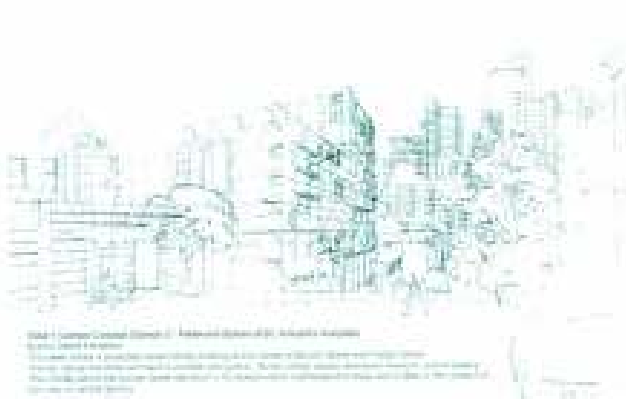
Figure 101: Architectural impression - corner Burton and Bourke Streets looking west. (Source: Architectus, August 2000)

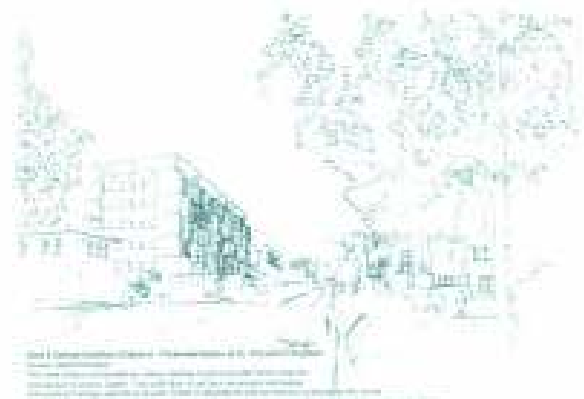
Figure 102: Architectural impression - Bourke Street looking south. (Source: Architectus, August 2000)

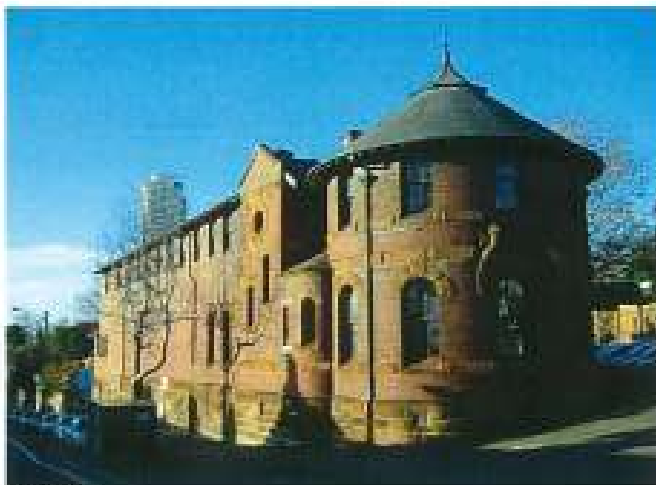
Figure 103:
Southwest corner of the Former Police Station, with view down Bourke Street, along the west side of the Caritas complex.
(Source: Graham Brooks & Associates, July 2006)

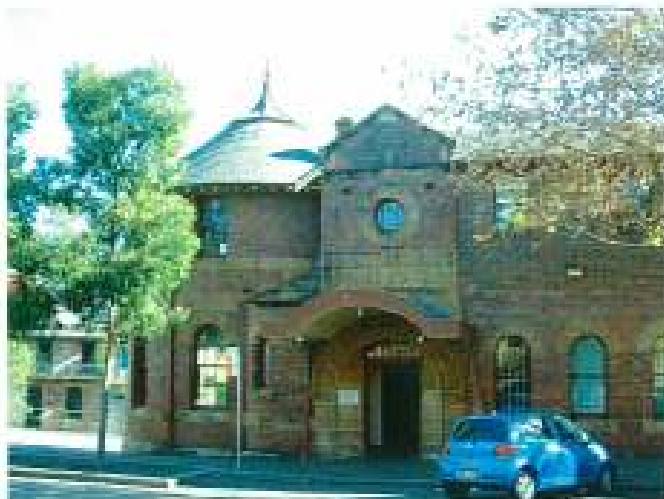
Figure 106:
View of the main entrance of the former Darlinghurst Police Station showing fine detail work in face brick, sandstone and slate.
(Source: Graham Brooks & Associates, July 2006)

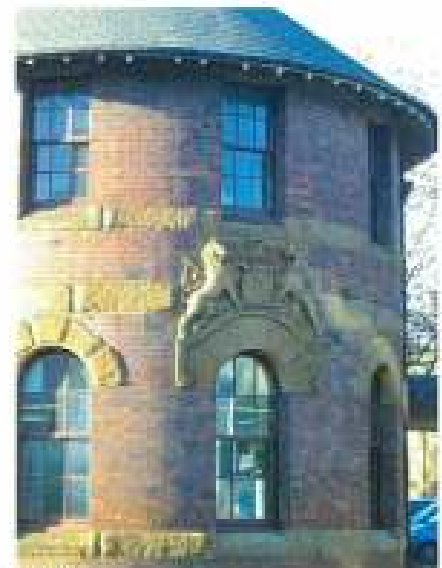
Figure 104:
View of the circular section of the Police Station at the southern apex, showing detail sandstone engraving work.
(Source: Graham Brooks & Associates, July 2006)

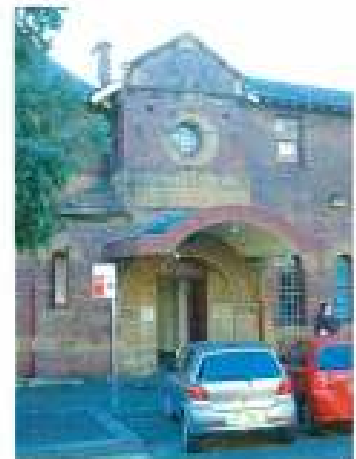
Figure 105:
Main entrance detail. The Station was known as Metropolitan Number Three, being one of the principal stations in the inner Sydney area.
(Source: Graham Brooks & Associates, July 2006)

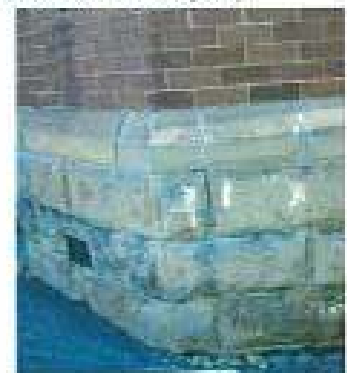
Figure 107:
Typical detail work, showing sandstone roofings and face brick work.
(Source: Graham Brooks & Associates, July 2006)

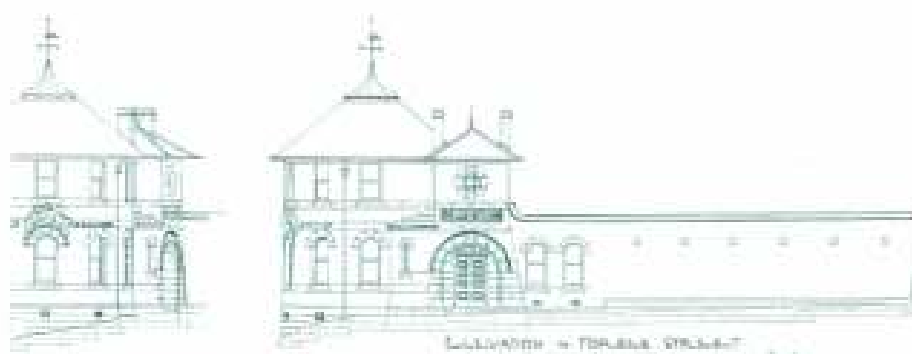
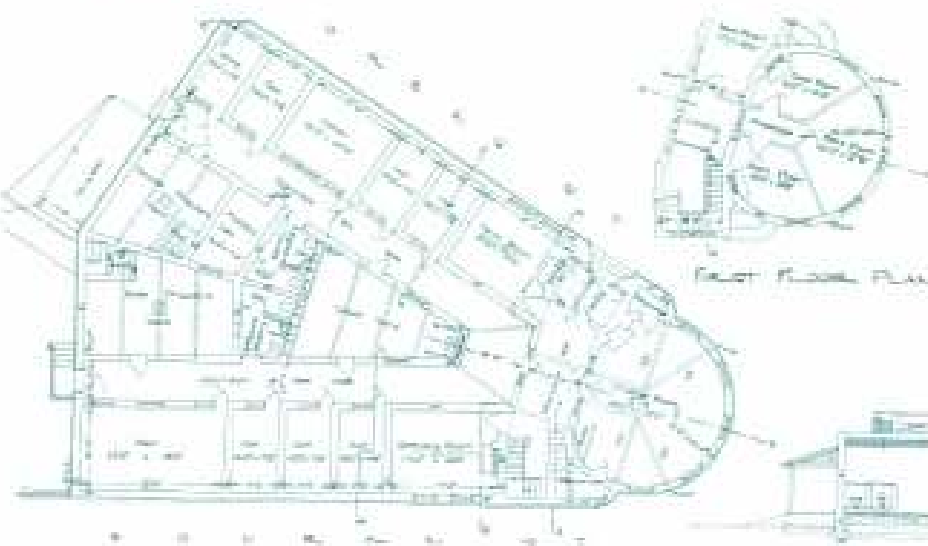
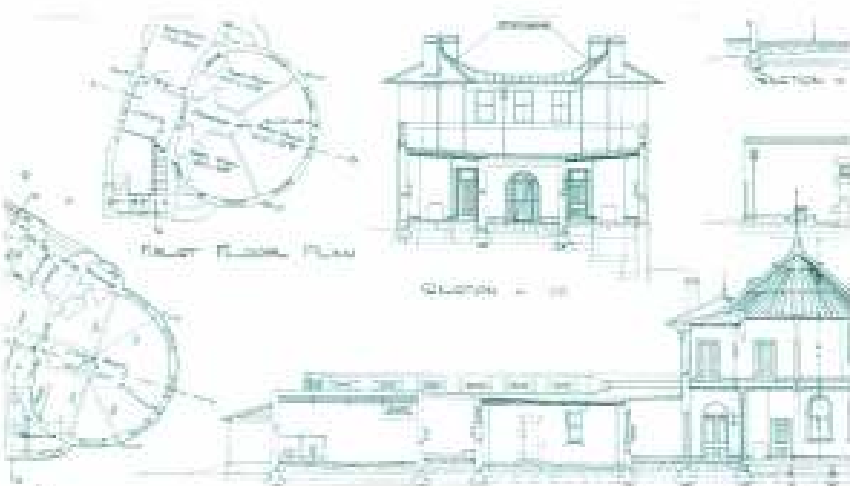
Architectural Drawings, this page and following
 Copies of Original drawings held at the State Archives, evidence the fine detail work in the plans drawn up by
 W.L. Vernon, the Government Architect, and dated 18 July, 1898, it seems that the Station was constructed
 by 1901.
 (Source: State Archives, Kingswood. Sourced July 2006)
